10 Mile Road Sediment Reduction Project – Mendocino County Photolog

Located in the Garcia River Watershed, this sediment reduction project helped to prevent the delivery of over 4,000 cubic yards of sediment to a stream.

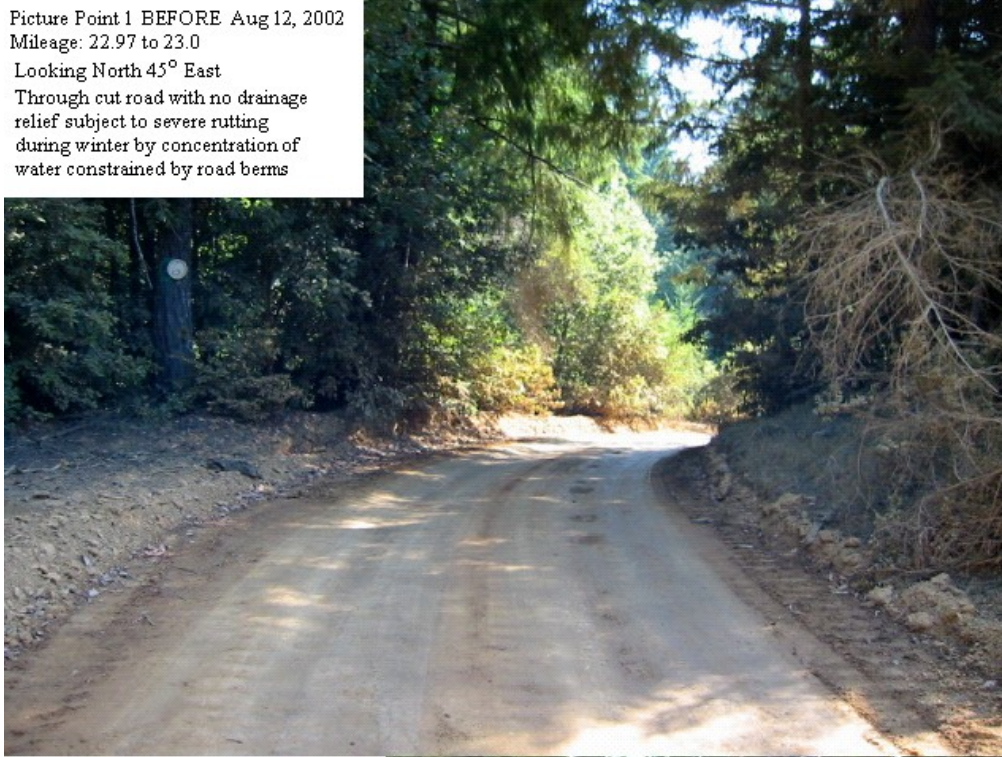
Picture Point 1 BEFORE Aug 12, 2002
Mileage: 22.97 to 23.0
Looking North 45° East
Through cut road with no drainage
relief subject to severe rutting
during winter by concentration of
water constrained by road berms

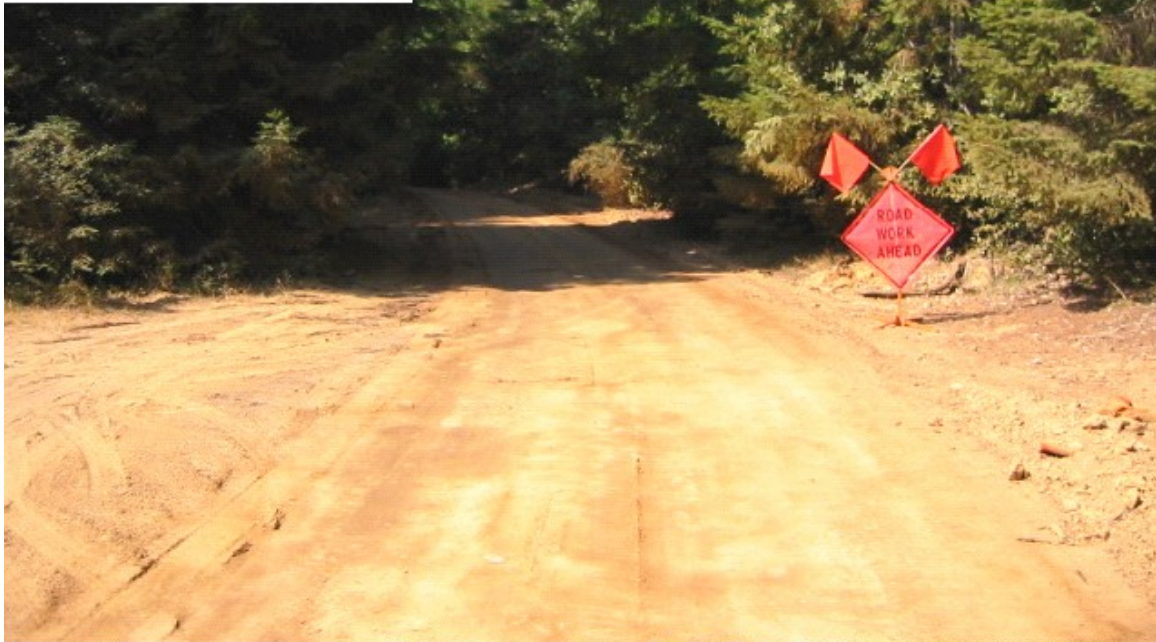
Picture Point 1 BEFORE Aug 12, 2002
Mileage: 22.92 to 23.0
Looking South 15° West
Through cut road with no drainage
relief subject to severe rutting
during winter by concentration of
water contained by road berm

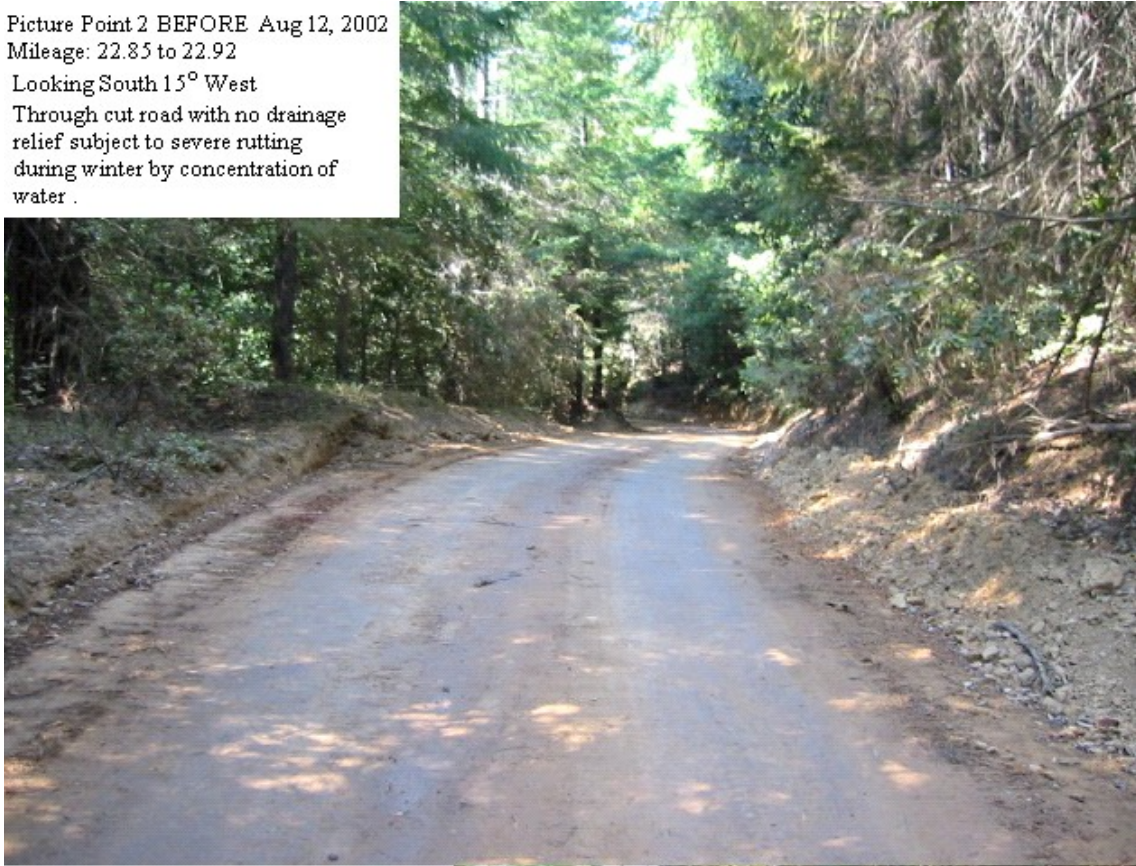
Picture Point 2 BEFORE Aug 12, 2002
Mileage: 22.85 to 22.92
Looking South 15° West
Through cut road with no drainage
relief subject to severe rutting
during winter by concentration of
water .

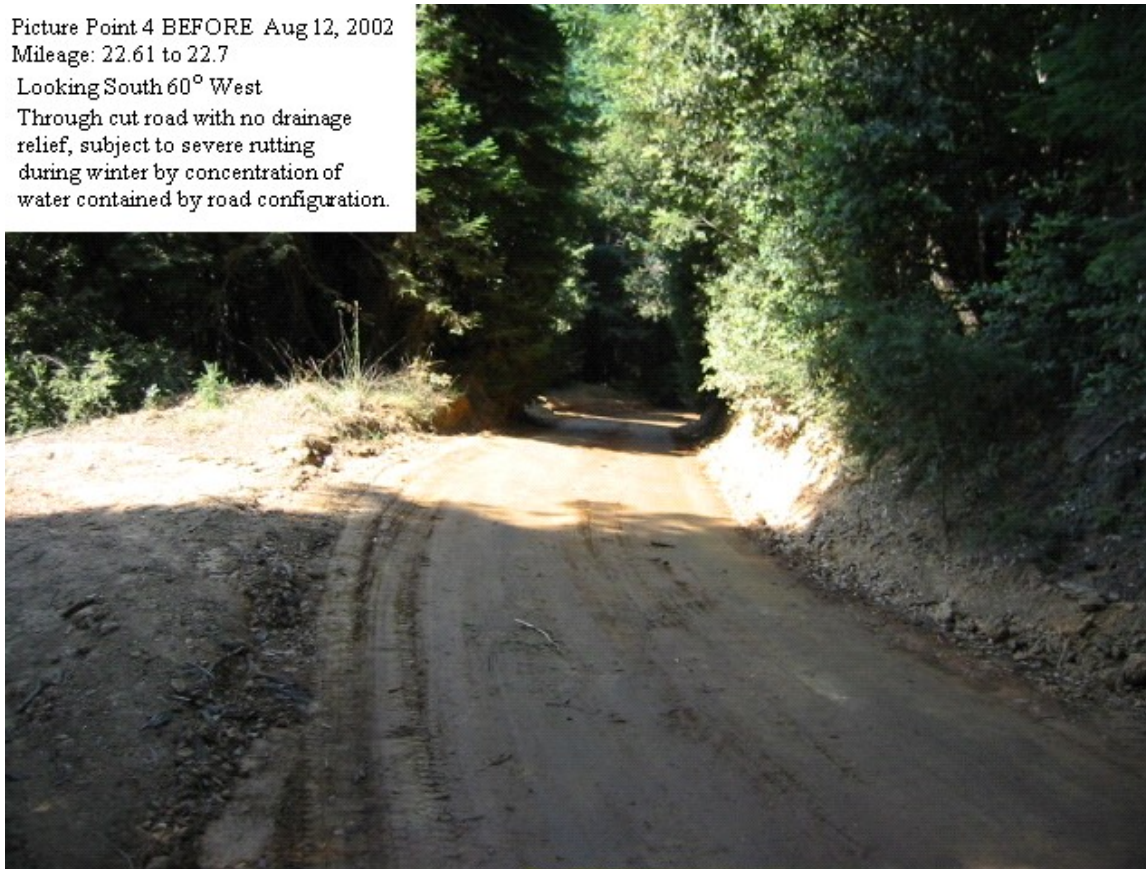
Picture Point 4 BEFORE Aug 12, 2002
Mileage: 22.61 to 22.7
Looking South 60° West
Through cut road with no drainage
relief, subject to severe rutting
during winter by concentration of
water contained by road configuration.

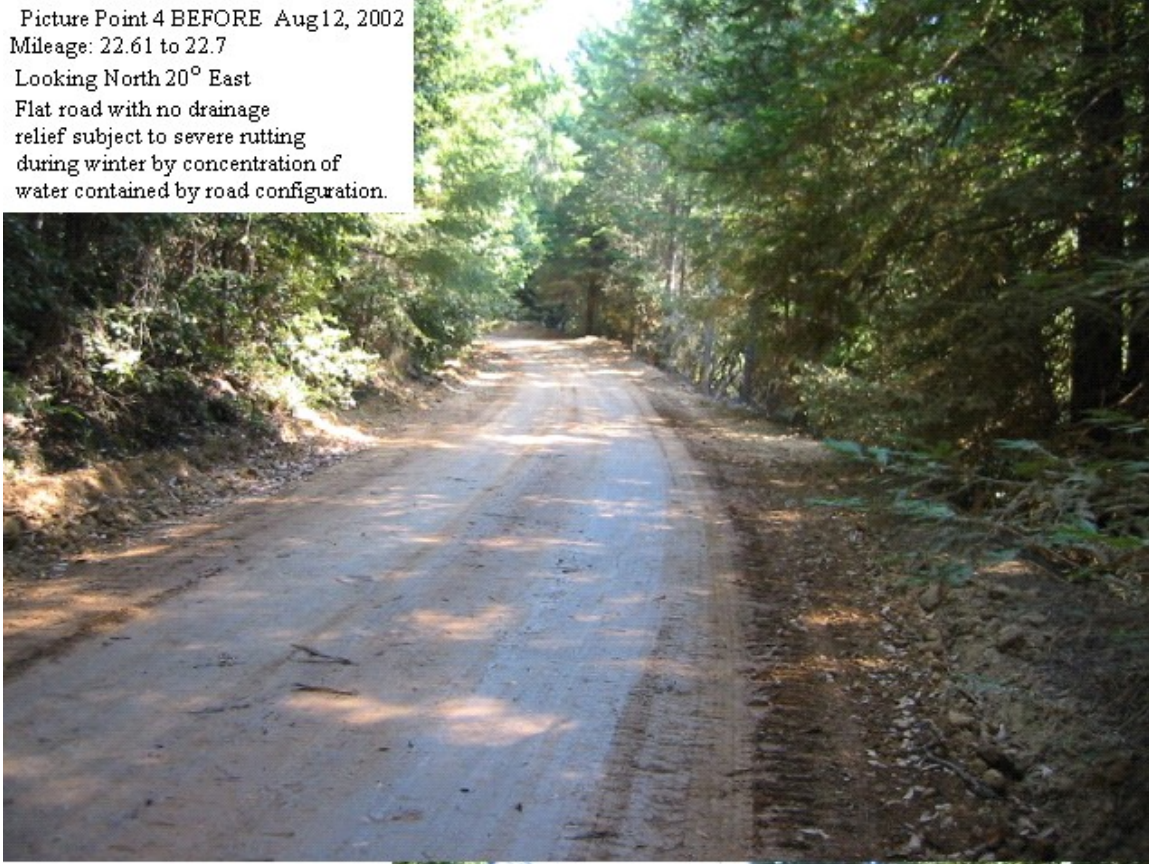
Picture Point 4 BEFORE Aug 12, 2002
Mileage: 22.61 to 22.7
Looking North 20° East
Flat road with no drainage
relief subject to severe rutting
during winter by concentration of
water contained by road configuration.

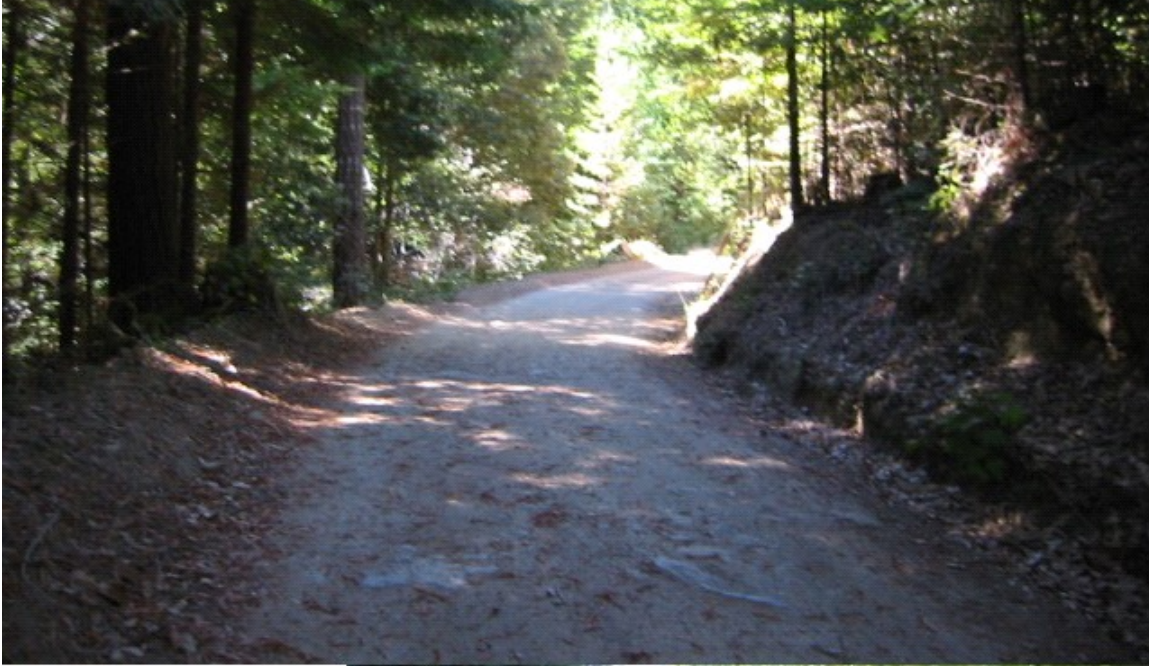
Picture Point 6 BEFORE
Looking South 30° West
Through cut road with no drainage
relief subject to severe rutting
during winter by concentration of
water contained by road berms

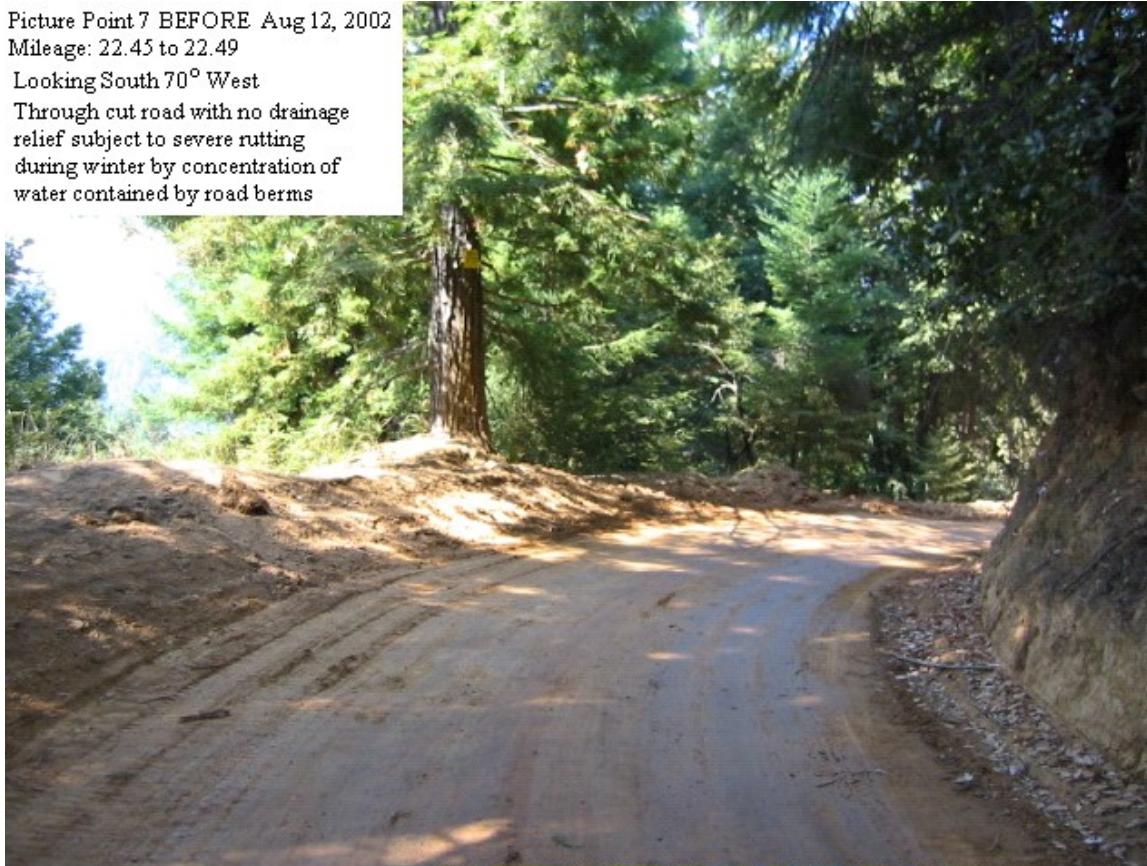
Picture Point 7 BEFORE Aug 12, 2002
Mileage: 22.45 to 22.49
Looking South 70° West
Through cut road with no drainage
relief subject to severe rutting
during winter by concentration of
water contained by road berms

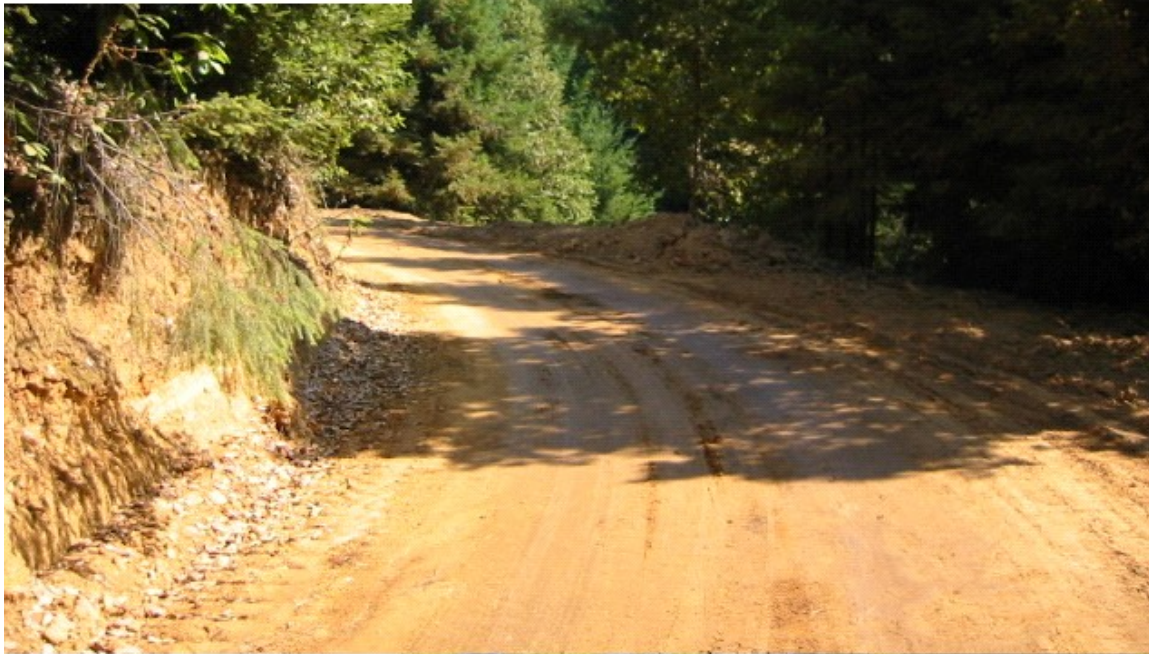
Picture Point 7 BEFORE Aug 12, 2002
Mileage: 22.45 to 22.49
Looking East
Flat road with no drainage
relief subject to severe rutting
during winter by concentration of
water contained by road configuration.

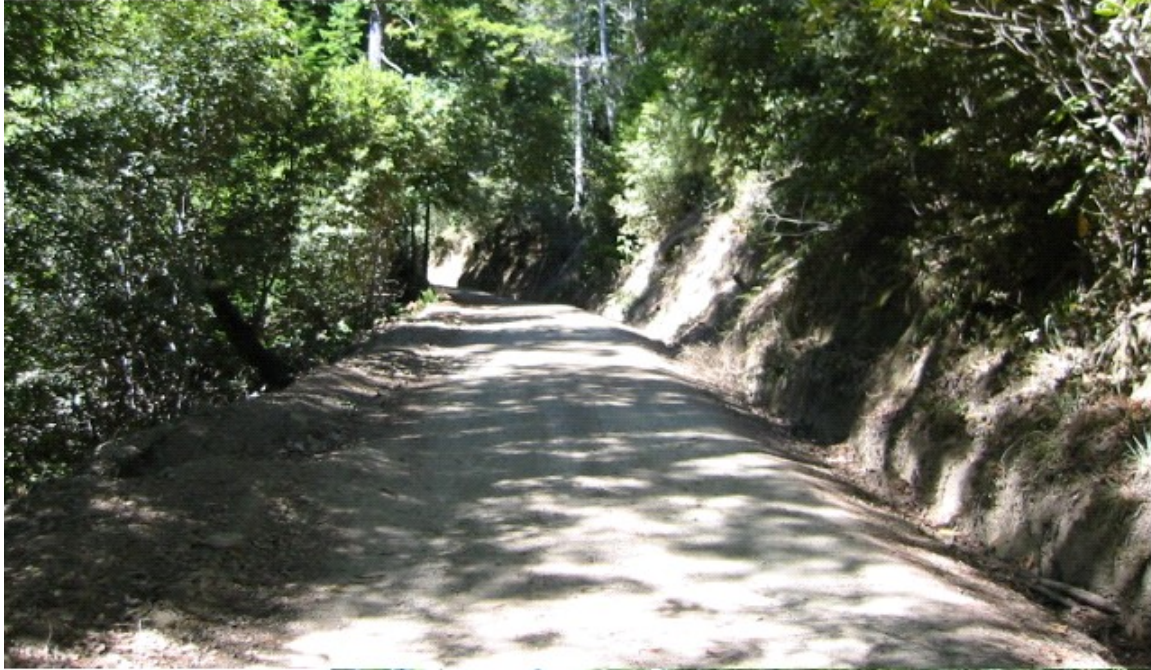
Picture Point 8 BEFORE
Looking North 40° West
Inboard ditch road with no drainage
relief for 1000 feet subject to severe
rutting during winter by concentration of
water contained by road berm.

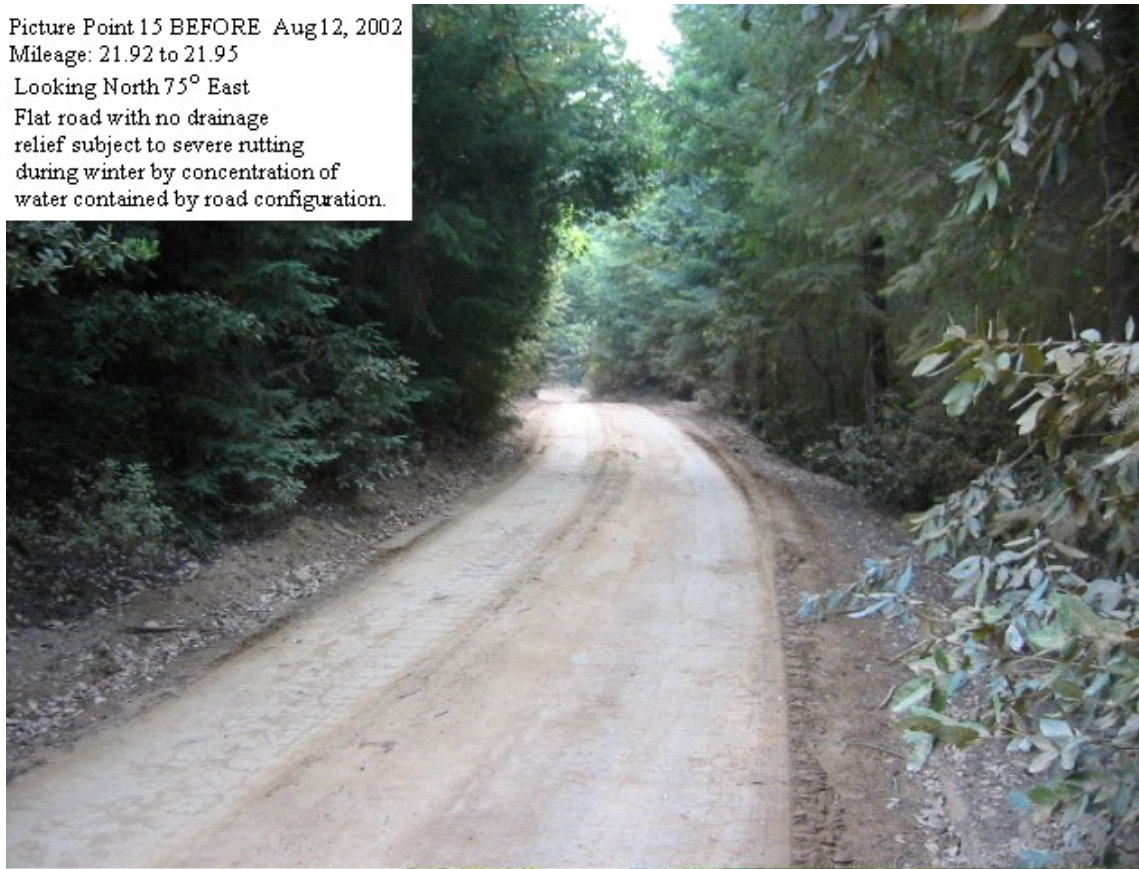
Picture Point 15 BEFORE Aug 12, 2002
Mileage: 21.92 to 21.95
Looking North 75° East
Flat road with no drainage
relief subject to severe rutting
during winter by concentration of
water contained by road configuration.

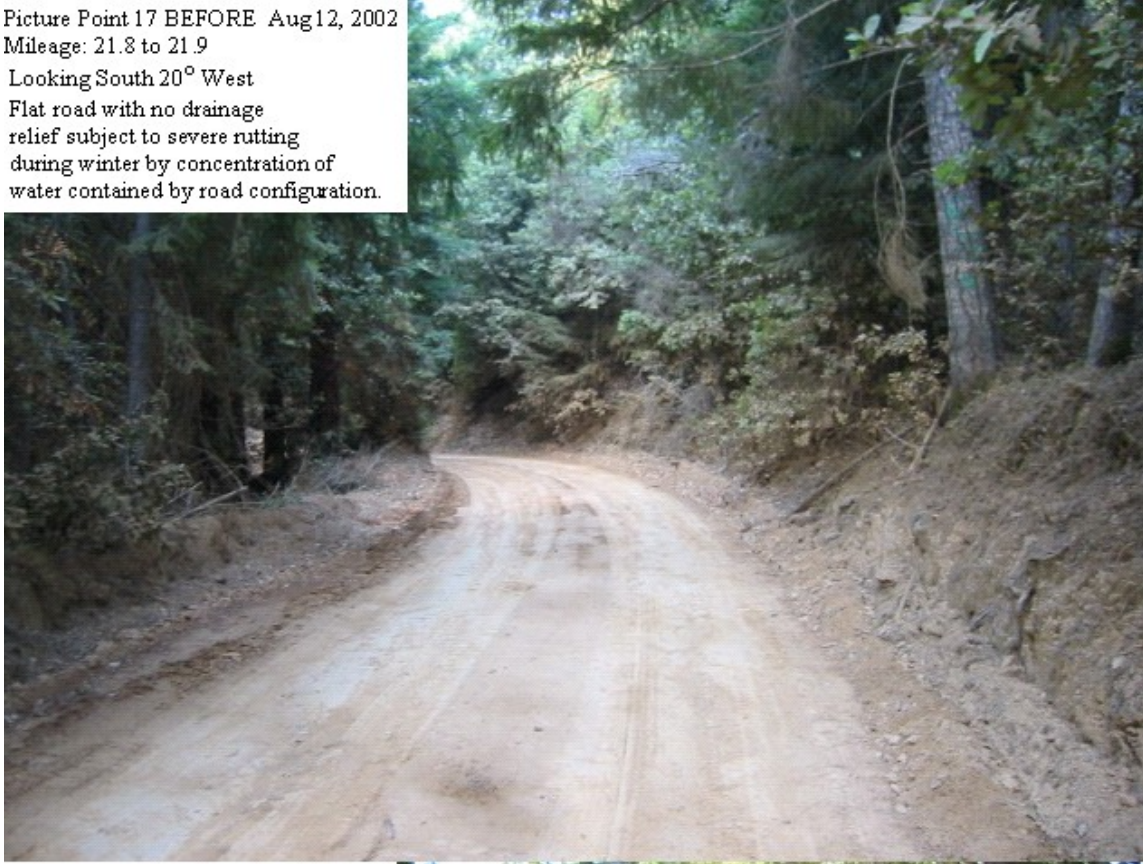
Picture Point 17 BEFORE Aug12, 2002
Mileage: 21.8 to 21.9
Looking South 20° West
Flat road with no drainage
relief subject to severe rutting
during winter by concentration of
water contained by road configuration.

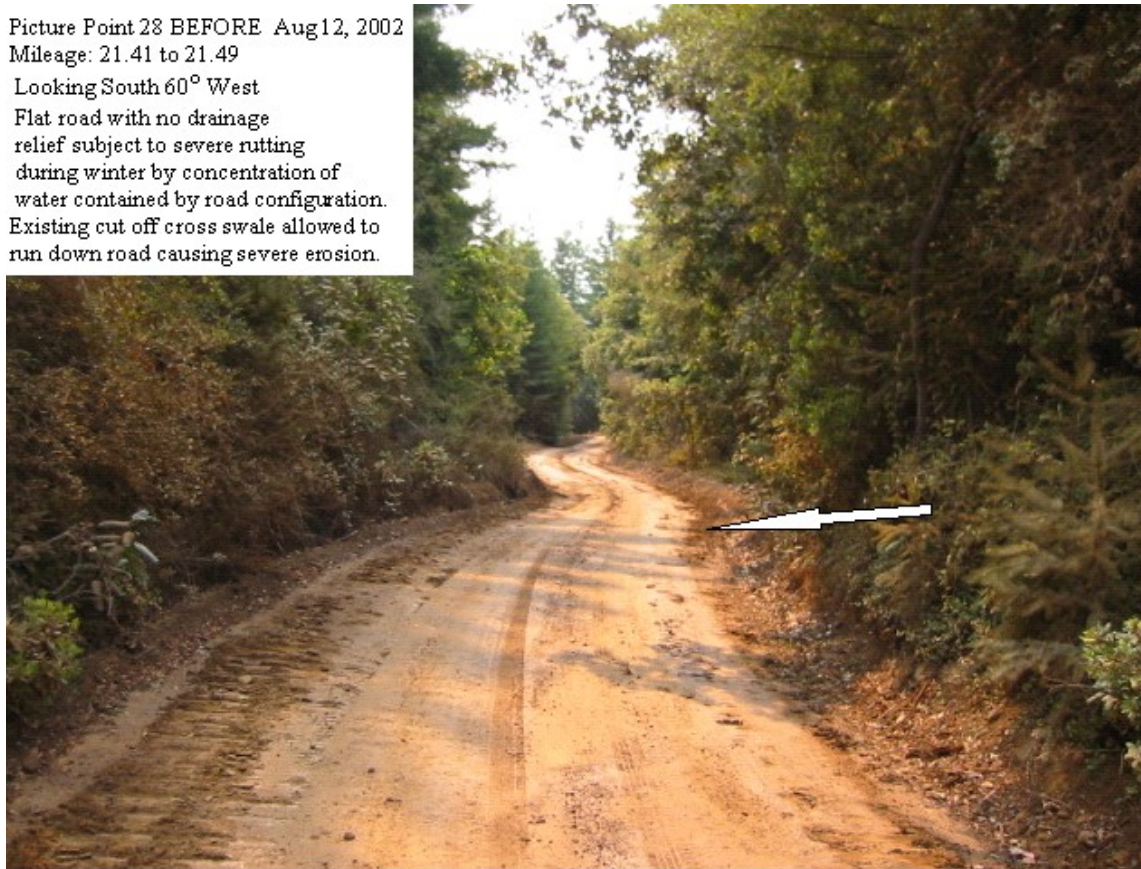
Picture Point 28 BEFORE Aug 12, 2002
Mileage: 21.41 to 21.49
Looking South 60° West
Flat road with no drainage
relief subject to severe rutting
during winter by concentration of
water contained by road configuration.
Existing cut off cross swale allowed to
run down road causing severe erosion.

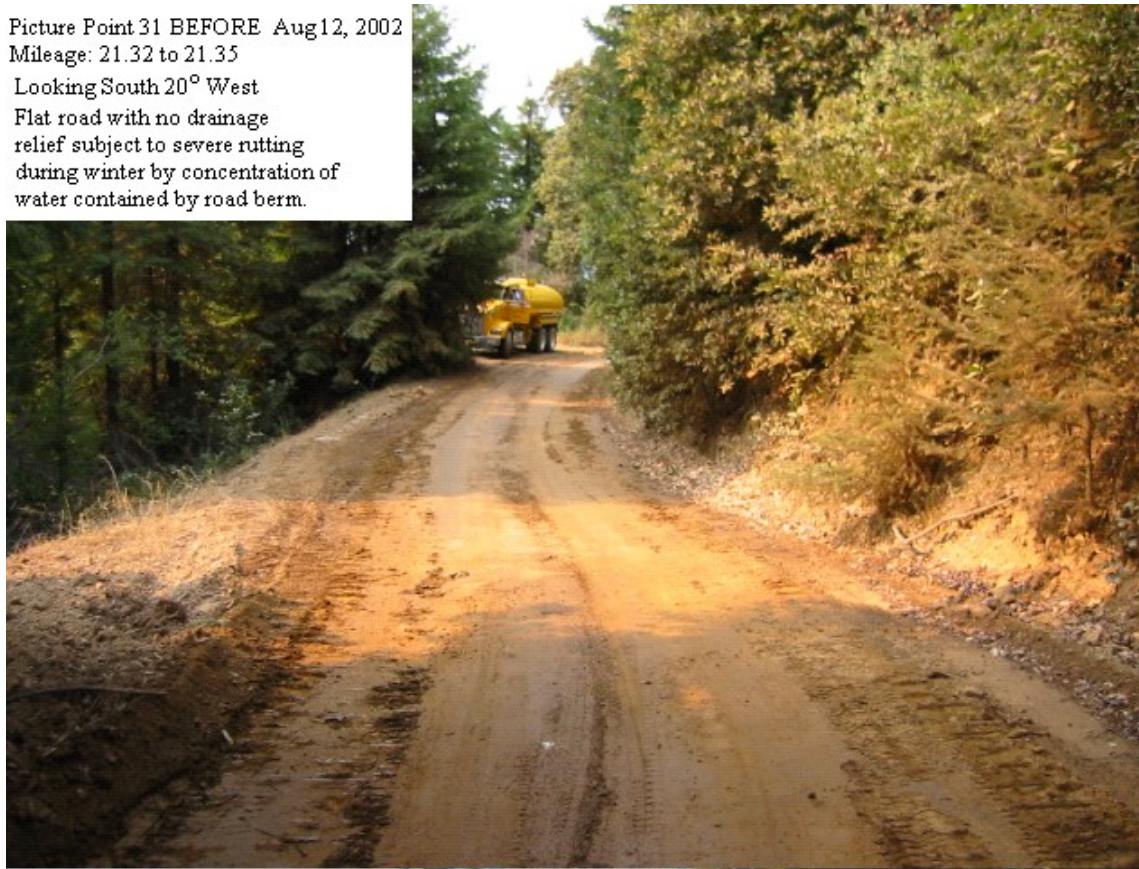
Picture Point 31 BEFORE Aug 12, 2002
Mileage: 21.32 to 21.35
Looking South 20° West
Flat road with no drainage
relief subject to severe rutting
during winter by concentration of
water contained by road berm.

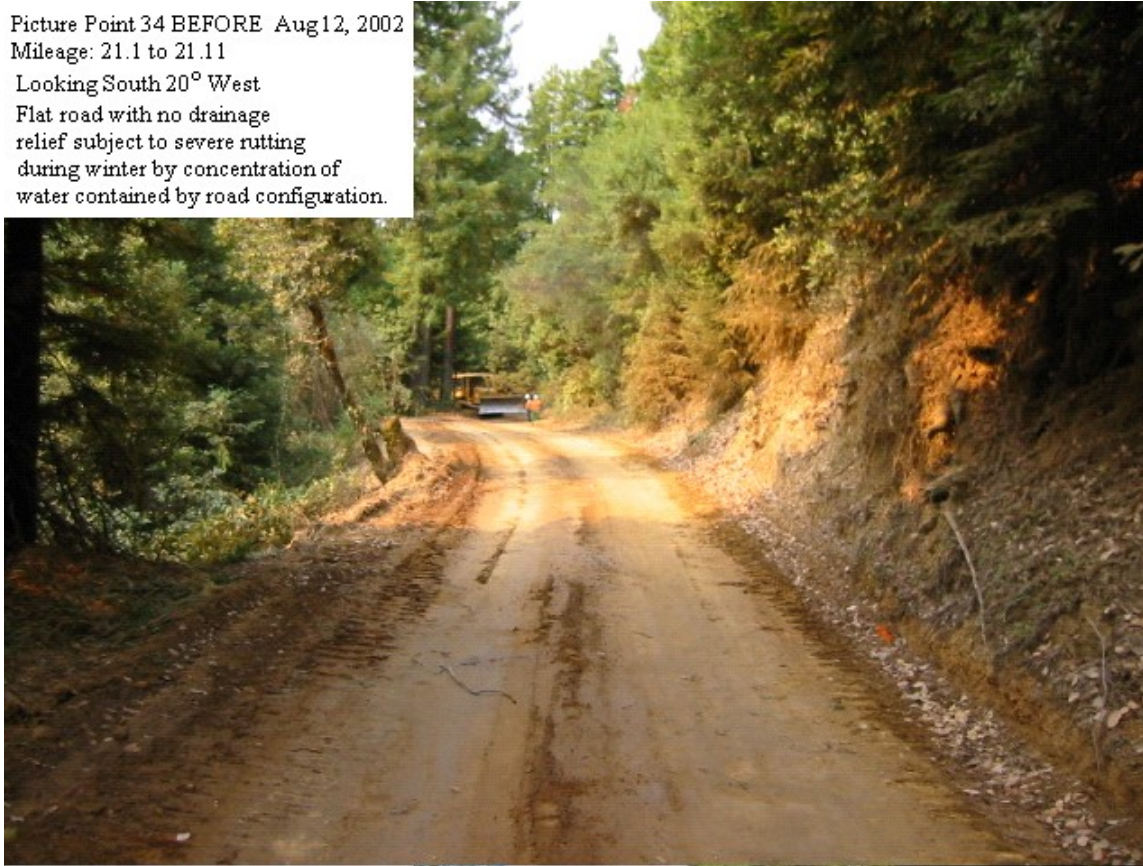
Picture Point 34 BEFORE Aug12, 2002
Mileage: 21.1 to 21.11
Looking South 20° West
Flat road with no drainage
relief subject to severe rutting
during winter by concentration of
water contained by road configuration.
