# **JORDAN CREEK MIGRATION BARRIER REMOVAL PROJECT**

### **DESCRIPTION OF CONDITIONS BEFORE PROJECT WAS EXECUTED**

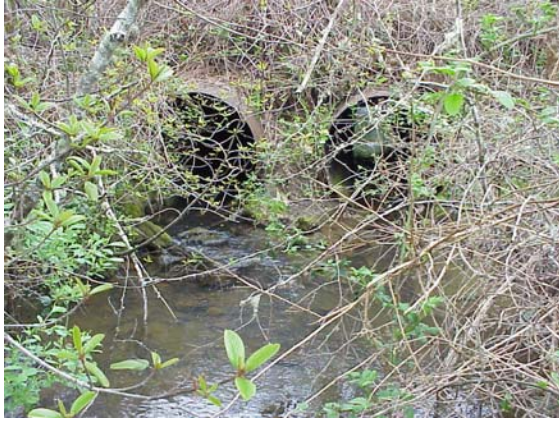
These corrugated metal pipes exhibited high winter flow velocities and low summer flows. The outfall of the corrugated metal pipes were elevated and had deteriorated bottoms (figures 3 & 4). With the migration barrier removed down stream forty feet, the new elevation of the corrugated pipes would result in a migration barrier to the upper reaches of Jordan Creek, which originates within the boundaries of Jedediah Smith Redwoods State Park. A study prepared by the CDFG in 1975 recognized Jordan Creek as essential habitat for the maintenance of salmonid populations for Lake Earl.

**Figure 3 - Migration Barrier Jordan Creek**

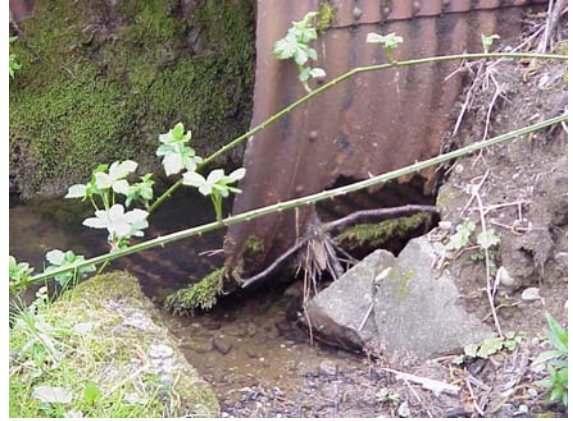
**Figure 4 Deteriorated Corrugated Metal Pipe**

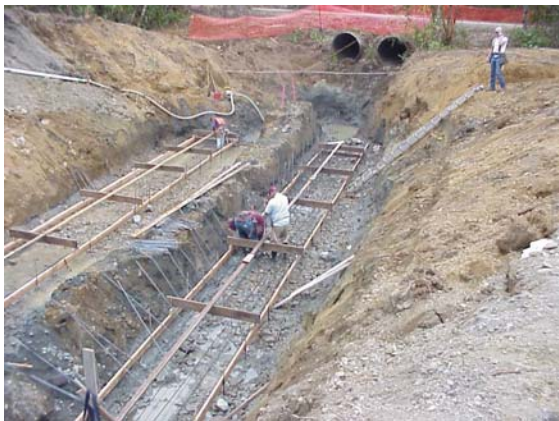
**Figure 13 New Footings for Upstream Structure**

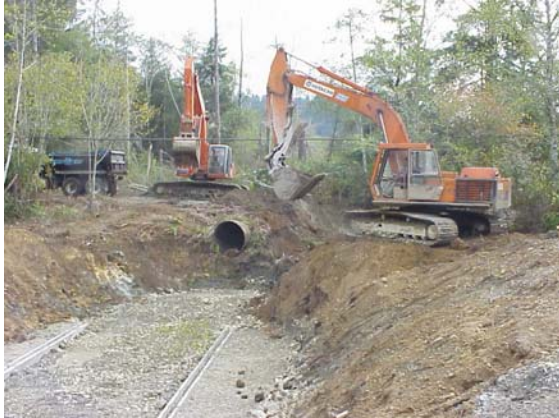
**Figure 15 Removal of Twin Culverts**

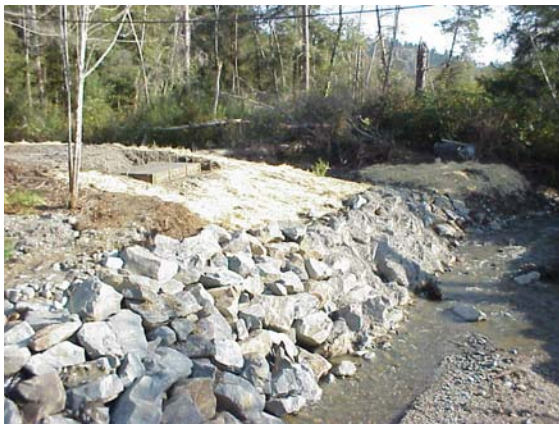
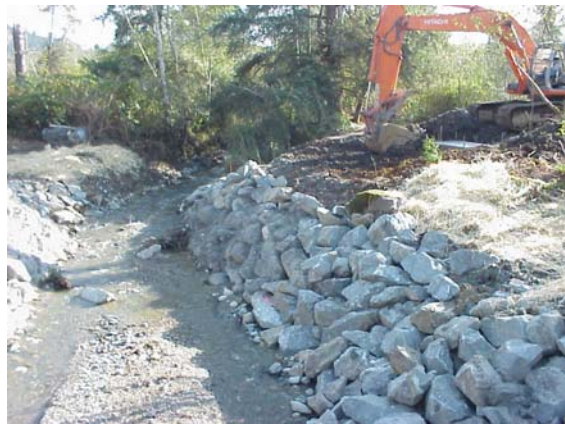
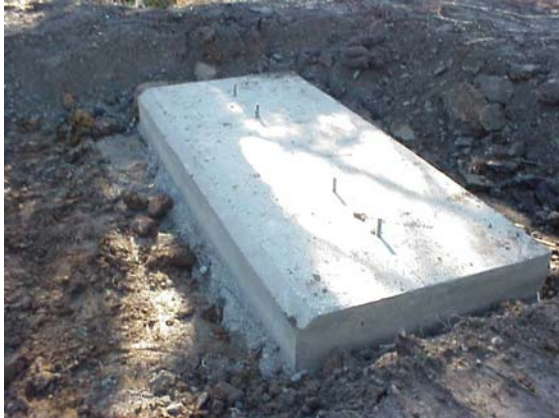
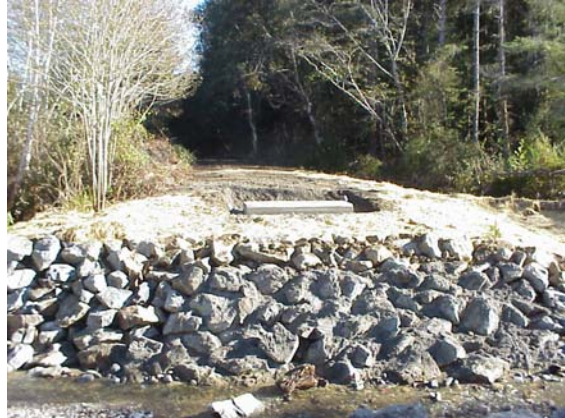
Once the stream restoration was completed, the footings for the flatcar bridge were built. The footings were constructed one foot deep concrete, five feet long and ten and a half feet wide. They were far enough from the stream bank to prevent erosion from transpiring (figure 31-34).  
California

**Figure 31 Concrete Footing on the Eastbank**

**Figure 32 Concrete Footing on the Westbank**

**Figure 33 Concrete Footing for Flatcar Bridge**

**Figure 34 Concrete Footing Placement on Eastbank**

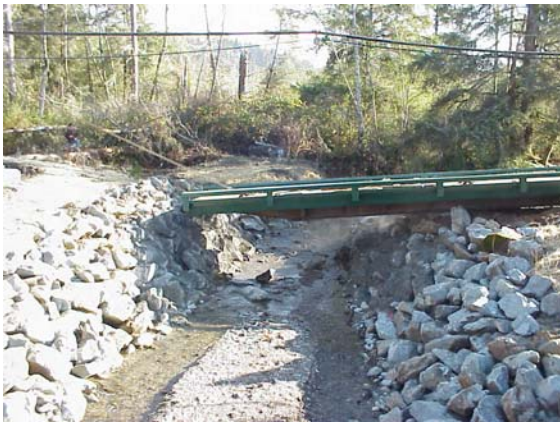
There was a minor delay delivering the flatcar bridge. These problems were with the flatcar bridge supplier and not the contractor hired to install the bridge. The bridge finally arrived at noon and was unloaded with the same two excavators that restored the streambed and stream bank. The process could have gone easier if a large crane was used to unload and install the flatcar bridge on to the footings. But the extra expense of bringing a large crane from Medford, Oregon, did not warrant its use. After an hour, the flatcar bridge was unloaded and transported to the project site (figure 36-42). A steel plate was bolted on the footings so that once the flatcar bridge was in place it would be welded to the concrete footings (figure 43). One of the excavators crossed Jordan Creek, by way of Parkway Drives culvert replacement, while the other brought the bridge as close as it could to the stream crossing. At the stream crossing, the excavator on the other side of the stream attached a cable to the flatcar bridge and began pulling it across the stream while the other lifted the back end of the bridge and carried it forward (figure 44-48). Within three hours after the flatcar bridge was delivered to the project side, the installation was complete (figure 49 & 50).

**Figure 47 Flatcar Bridge Hitting Embankment**

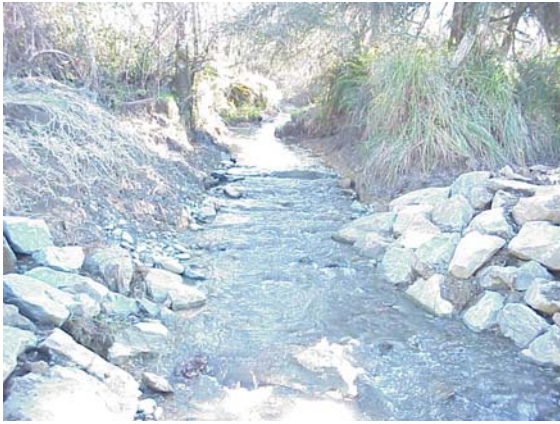
After several months, the project site has a natural appearance (figure 51-55).

**Figure 51 Grade Control After Several Months of Flow**
