LINDSAY CREEK CULVERT REPLACEMENT

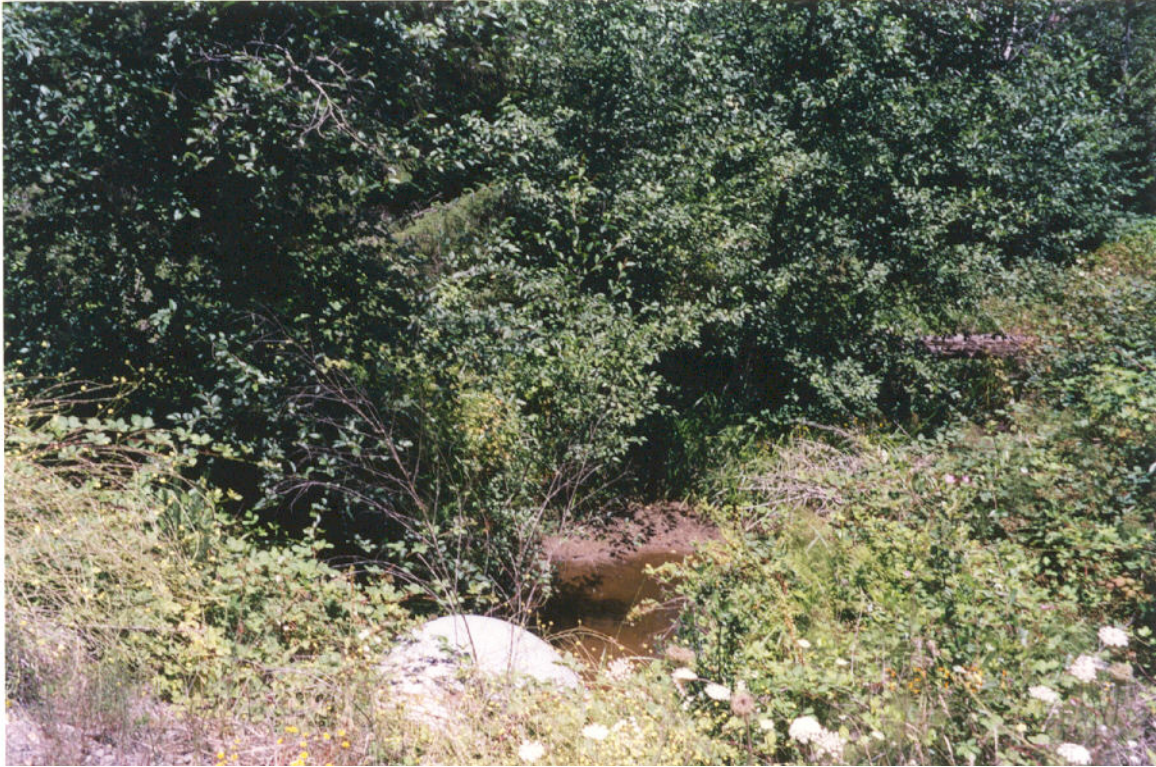
Upstream View before Construction

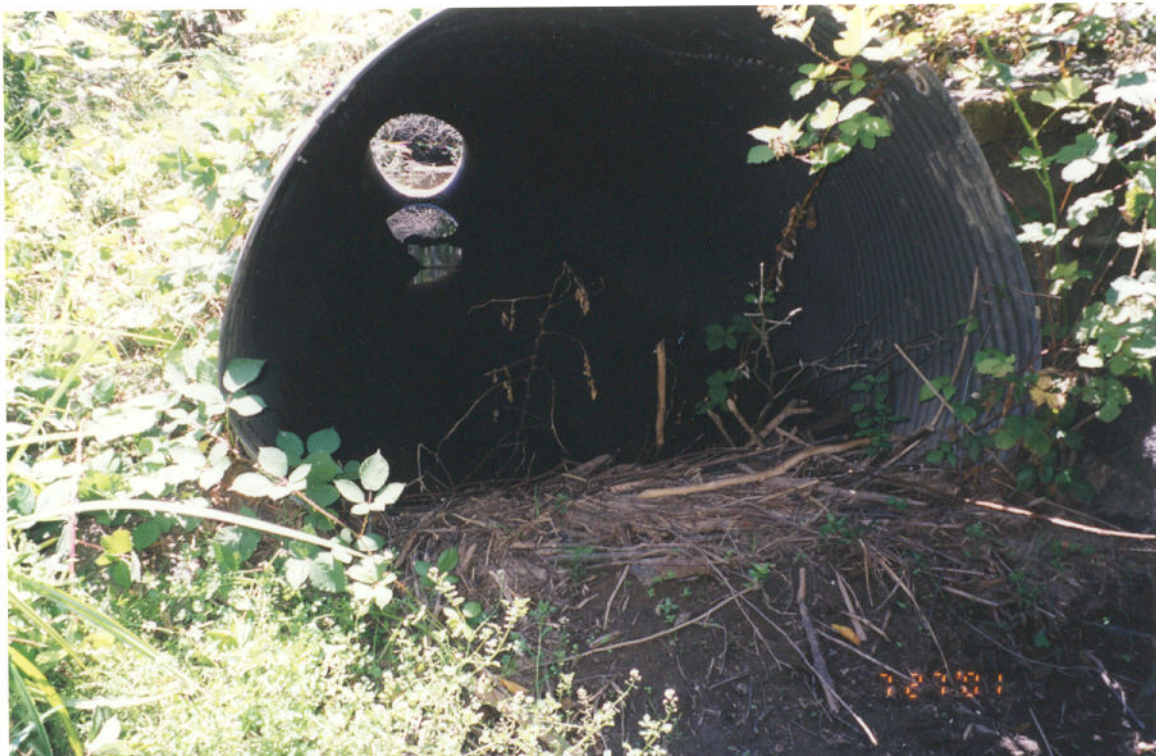
Debris Dam in inlet and Deteriorated Condition of Culvert

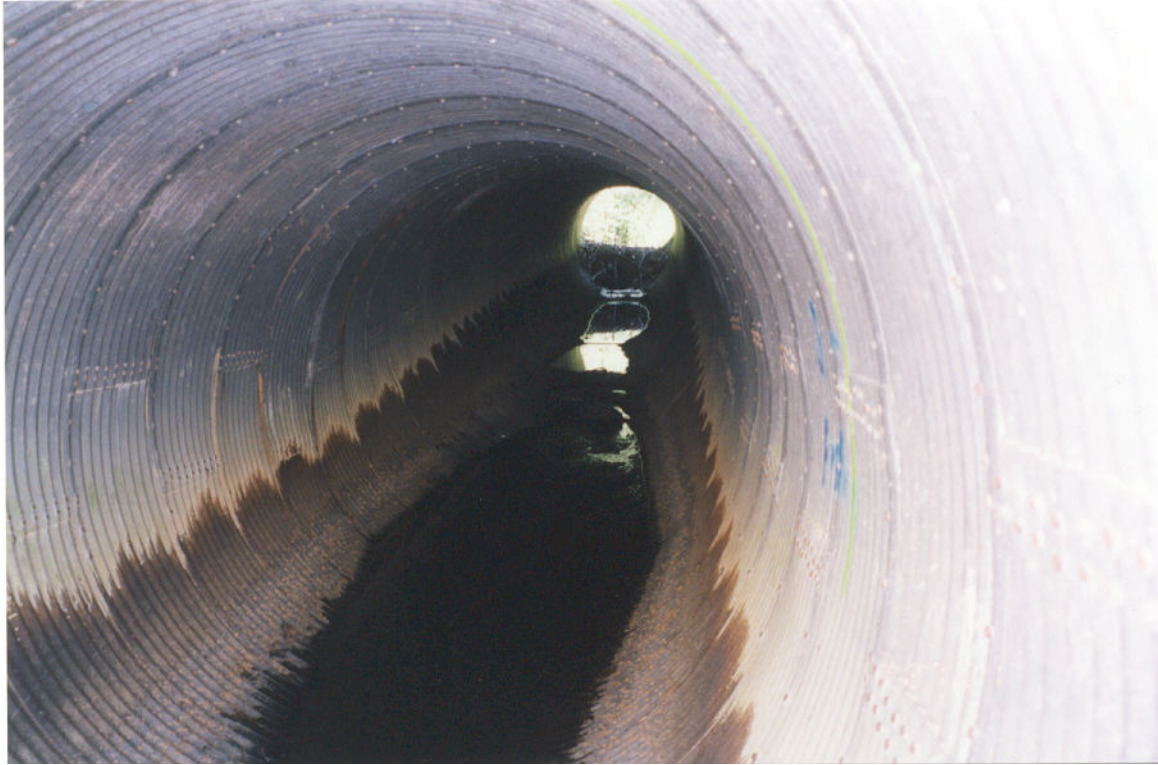
View Towards Inlet

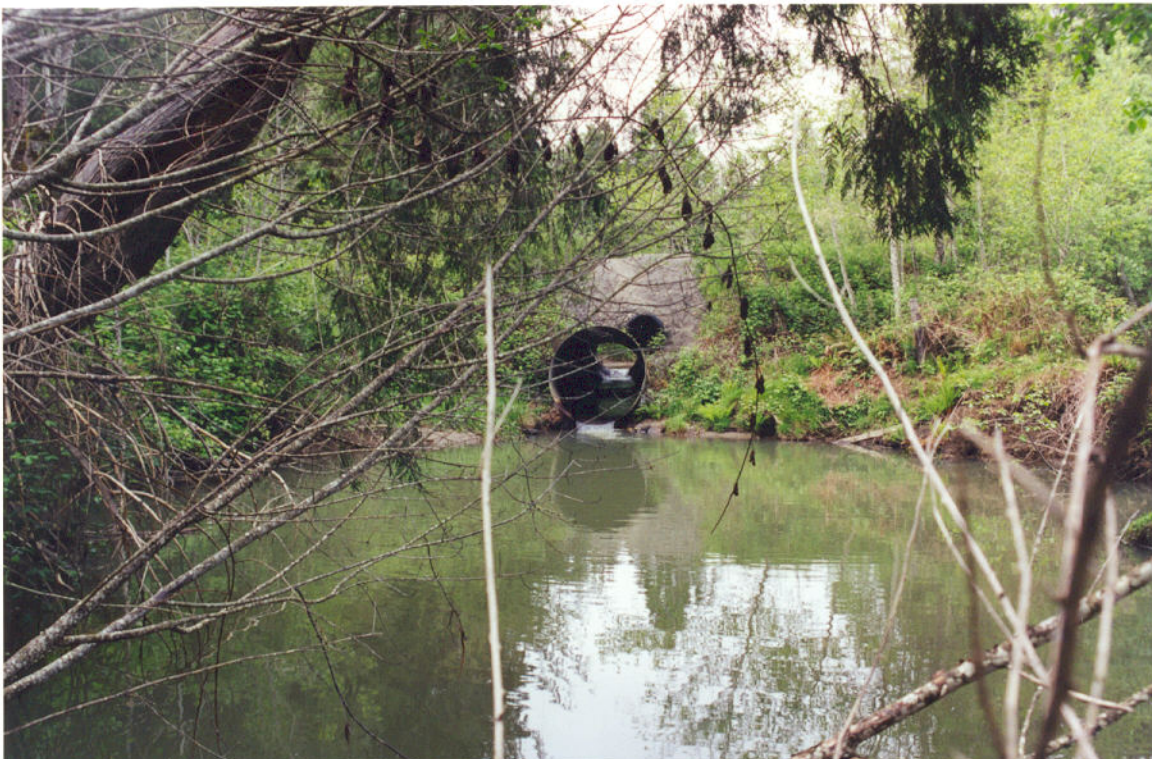
Outlet View from Downstream

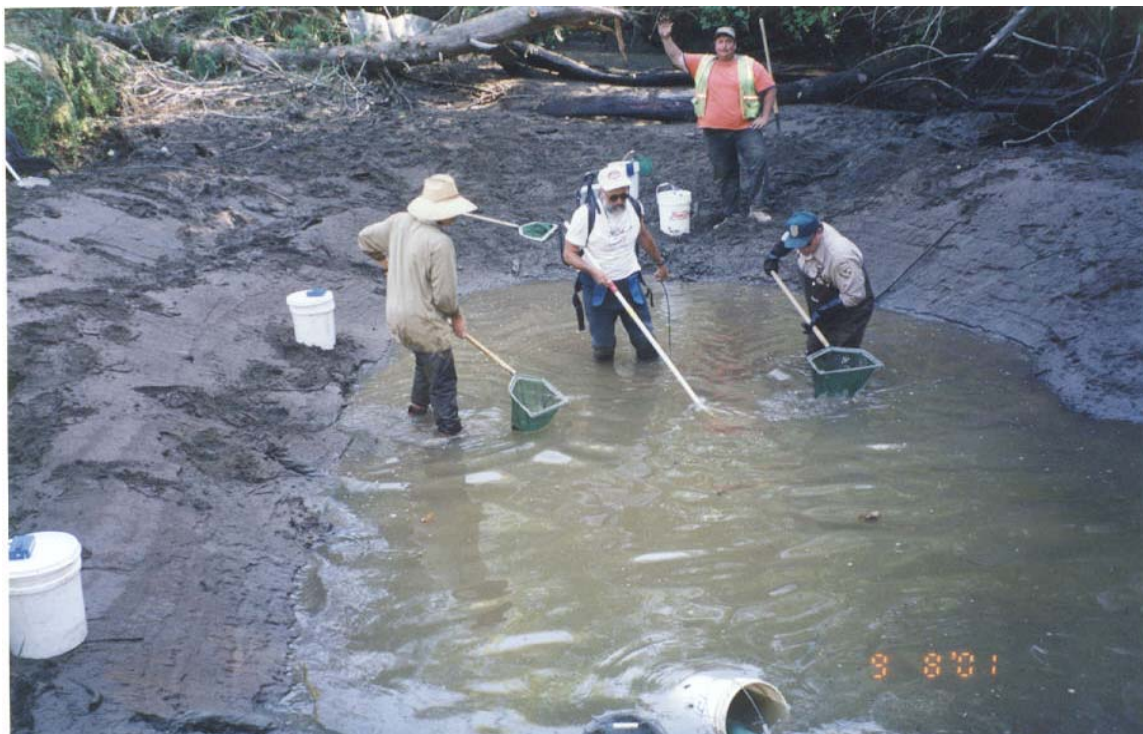
Fish Removal by Tetra Tech and CDFG

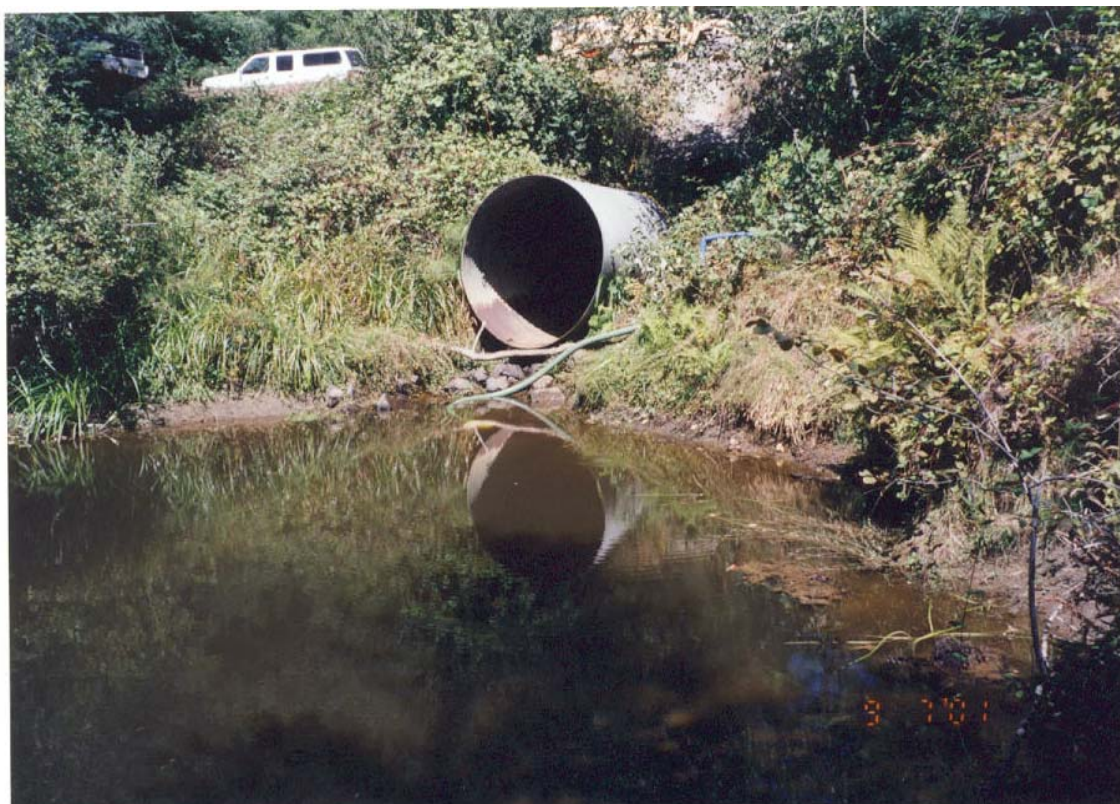
Plunge Pool was drawn Down Slightly to Facilitate Electro Fishing

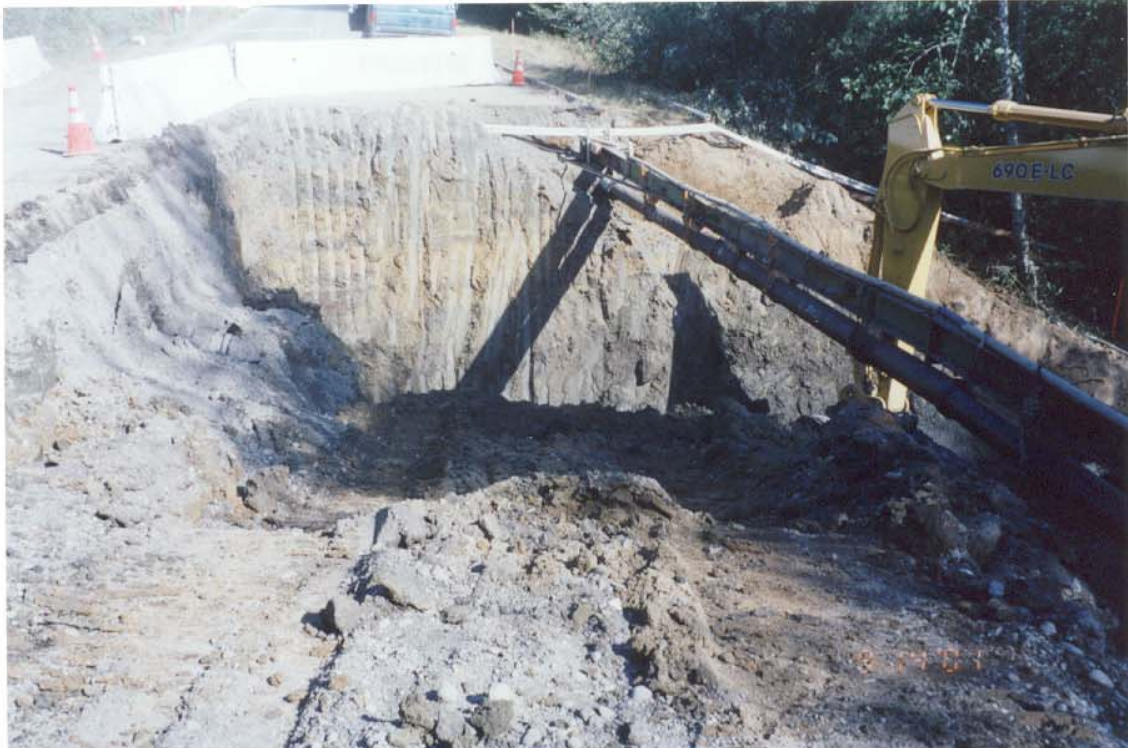
Waterline Suspended above Excavation

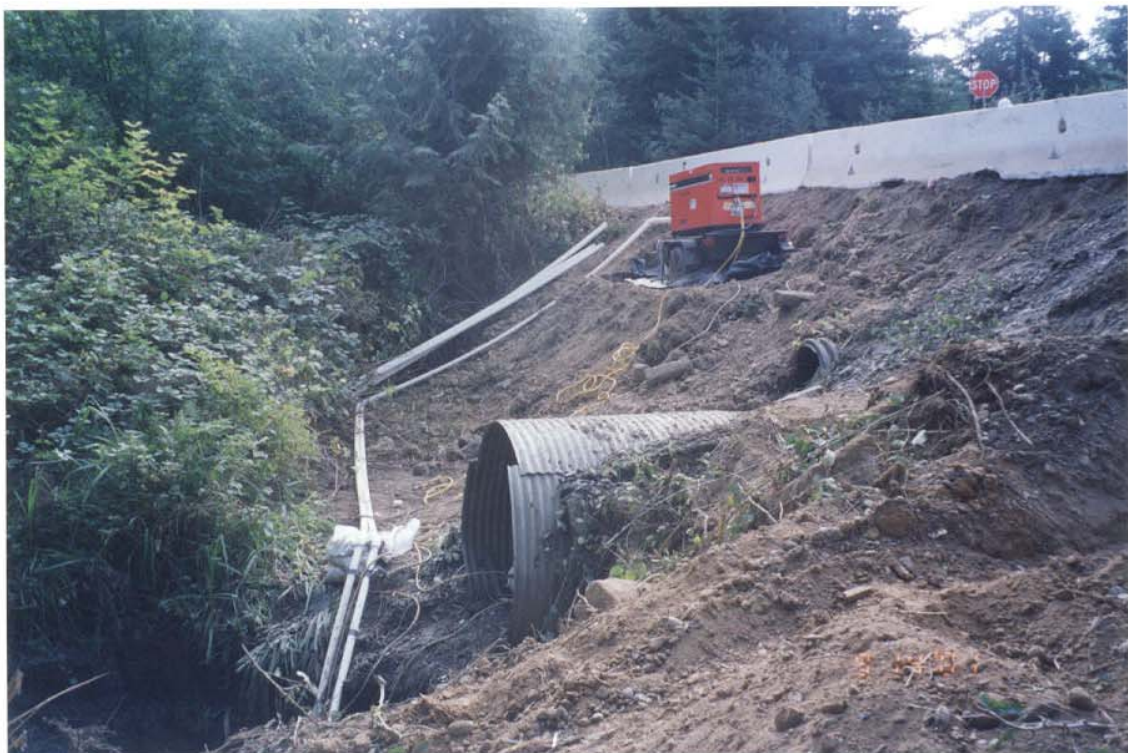
Creek Flow was Pumped around the Project

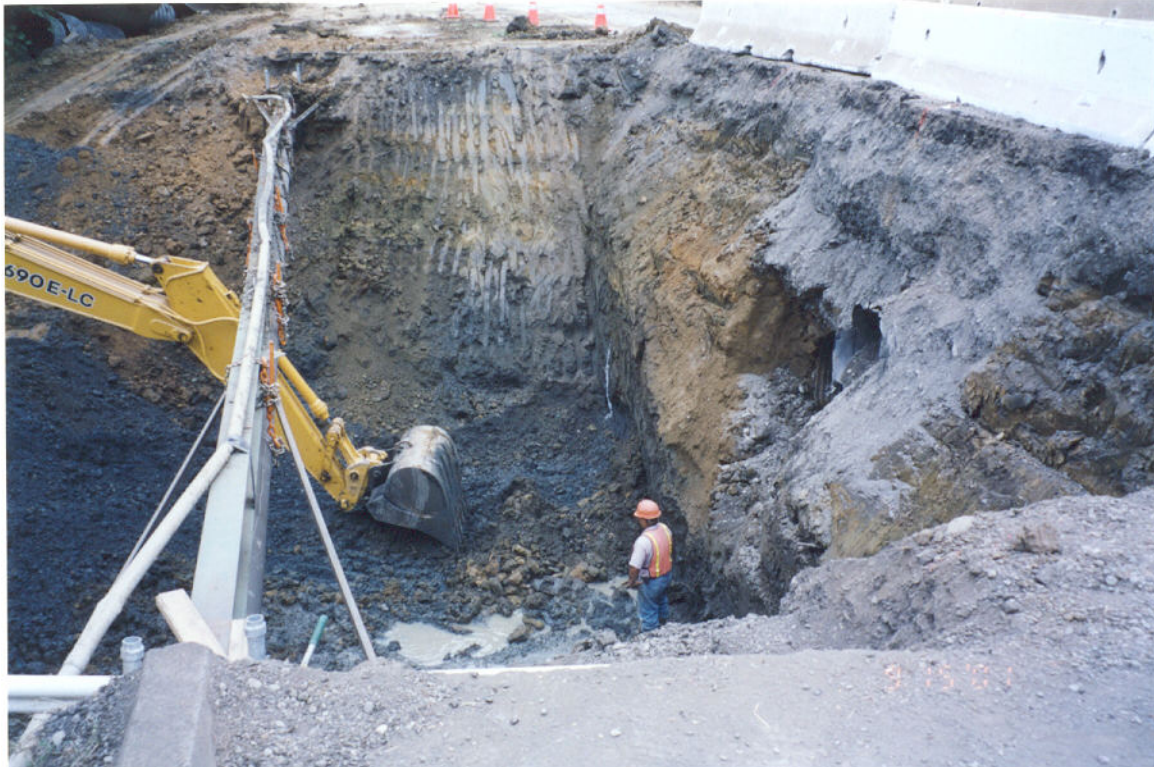
Excavation Prior to Placement of Temporary Flatcar Bridge

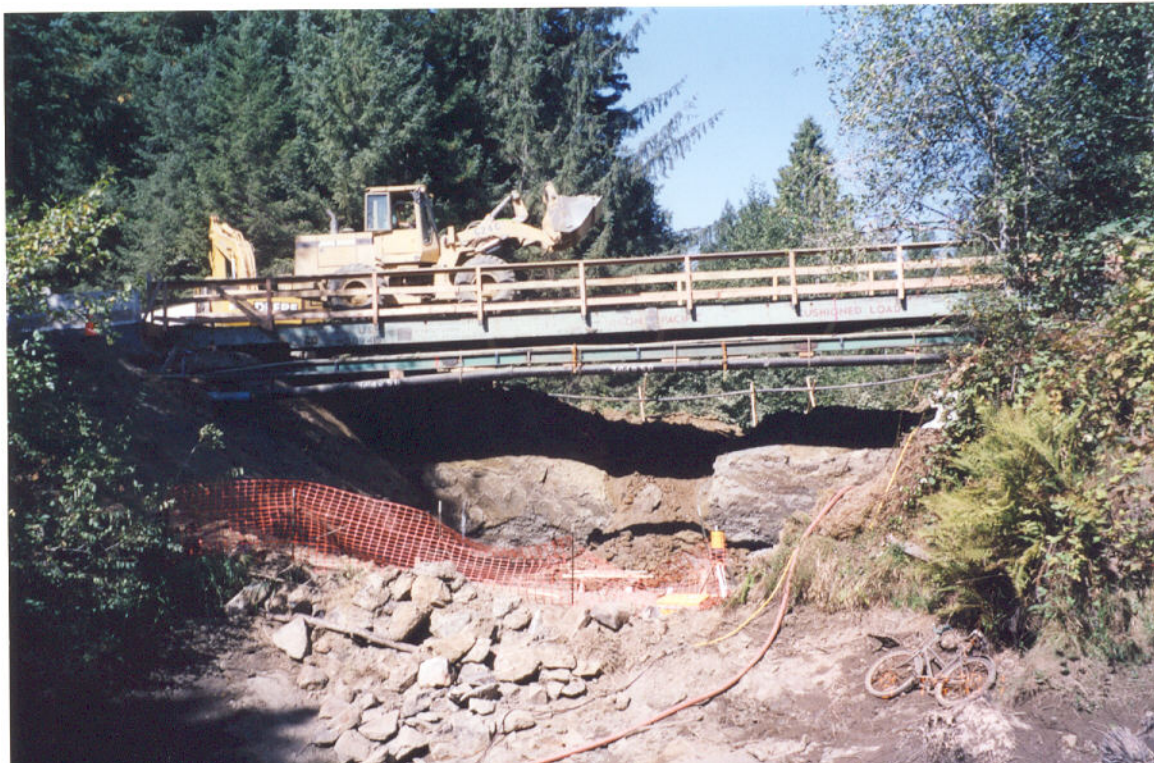
Temporary Flatcar Bridge Viewed from Downstream

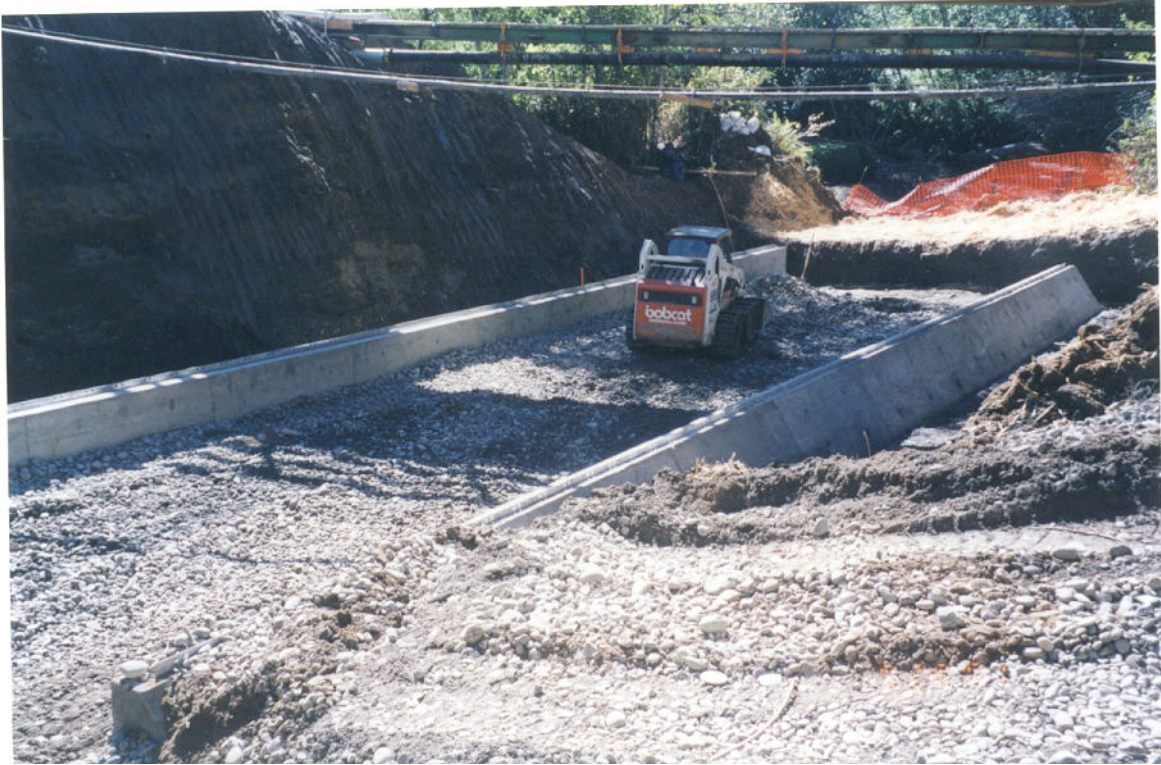
River Gravel Stream Channel Backfill

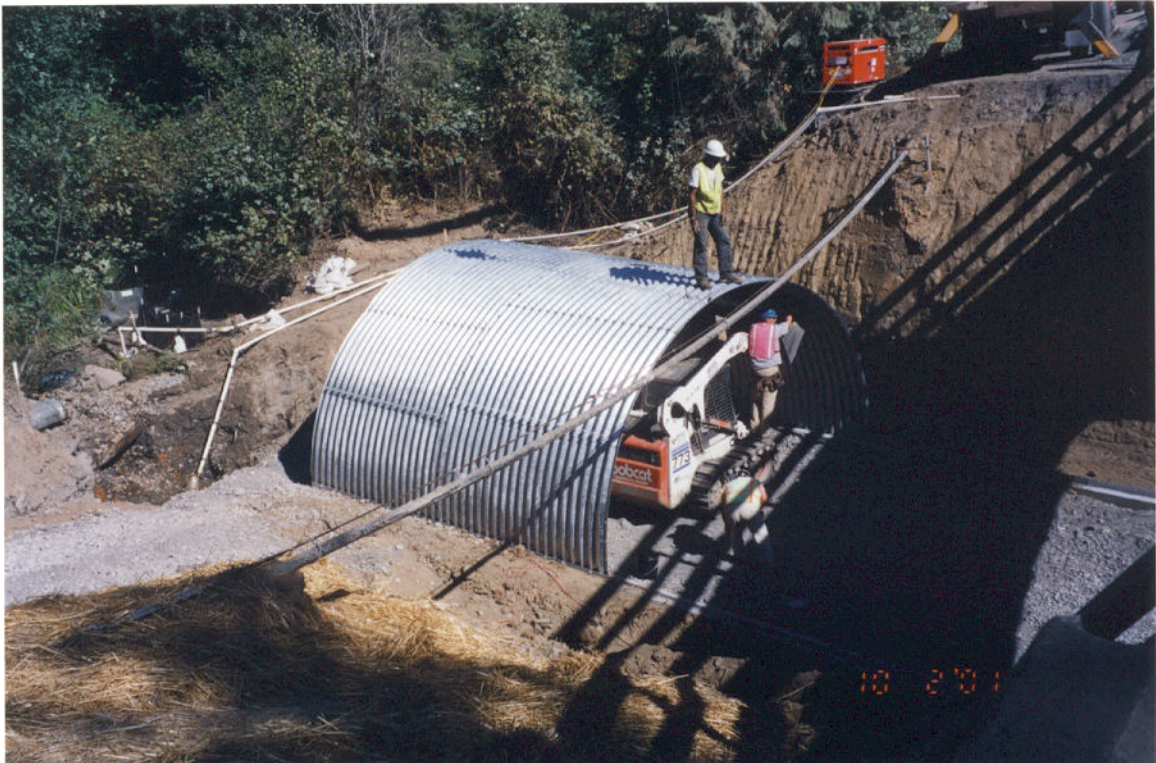
Assembly of Arch Panels

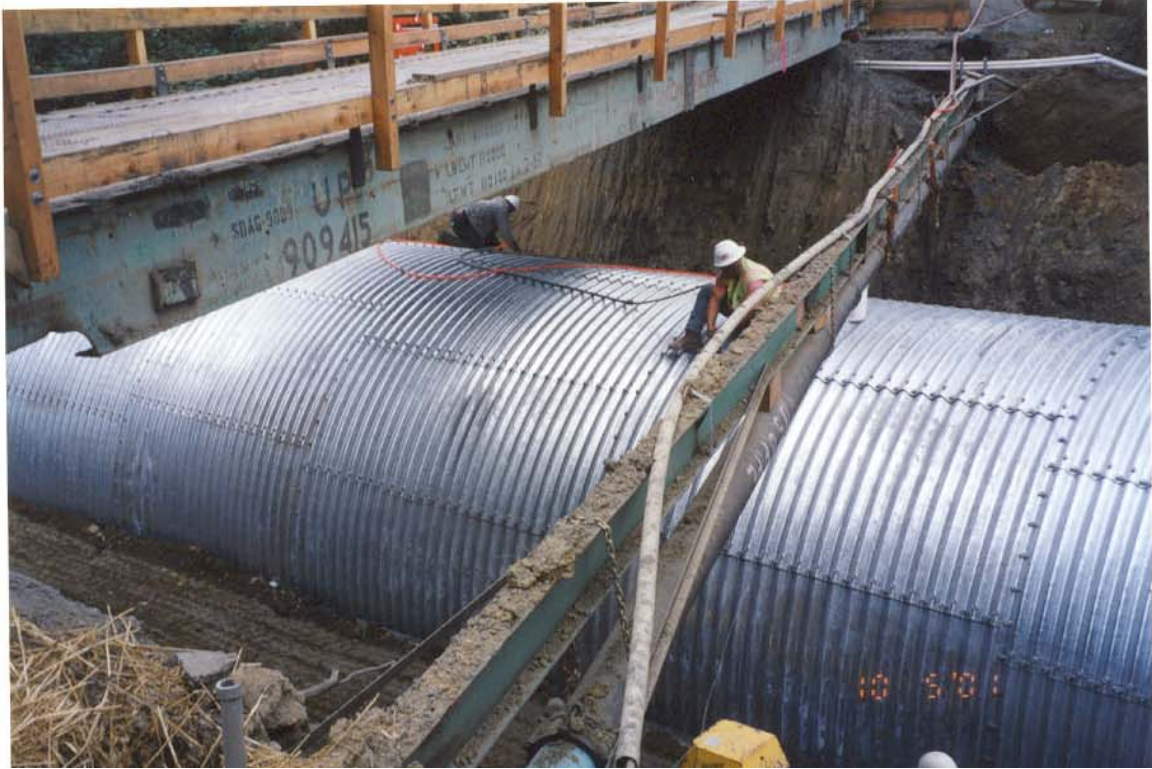
Bolt Tightening and Backfill

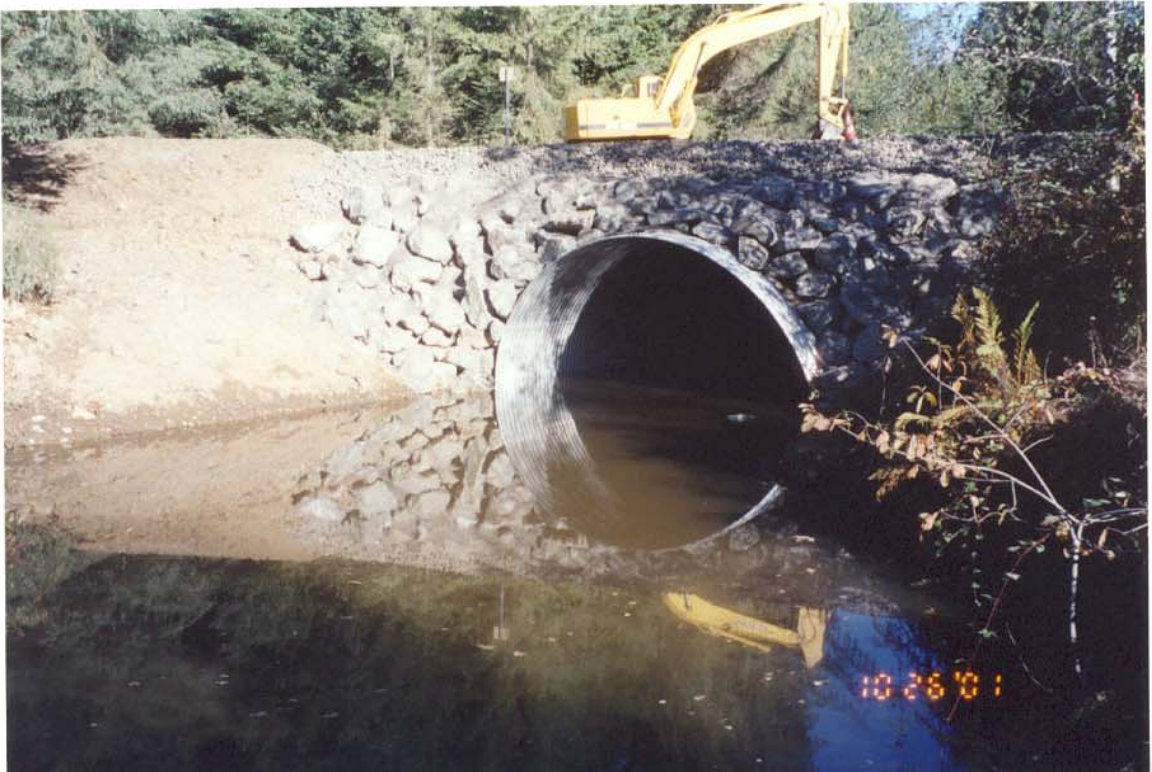
Outlet Rip Rap before Being Concreted

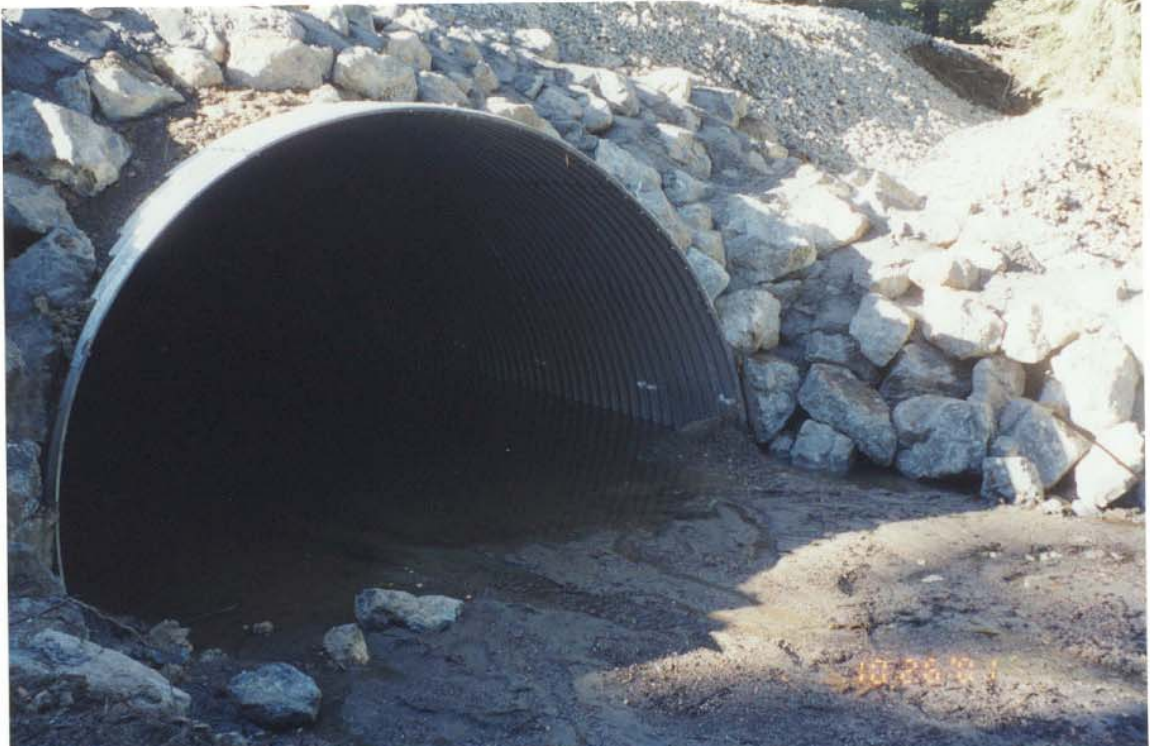
Inlet Rip Rap before Being Concreted

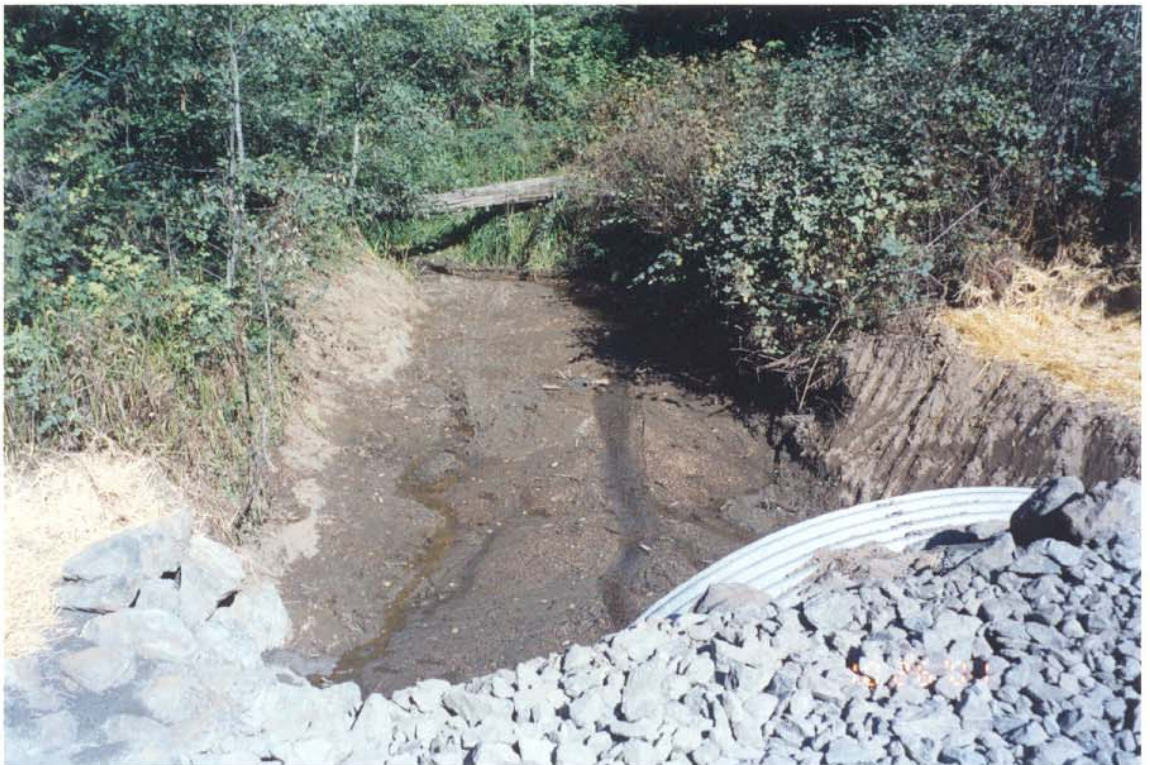
Upstream View at Completion of Project
