**APPENDIX B:**

**CATALOG OF DEL NORTE COUNTY CULVERTS LOCATED  
ON FISH-BEARING STREAM REACHES**

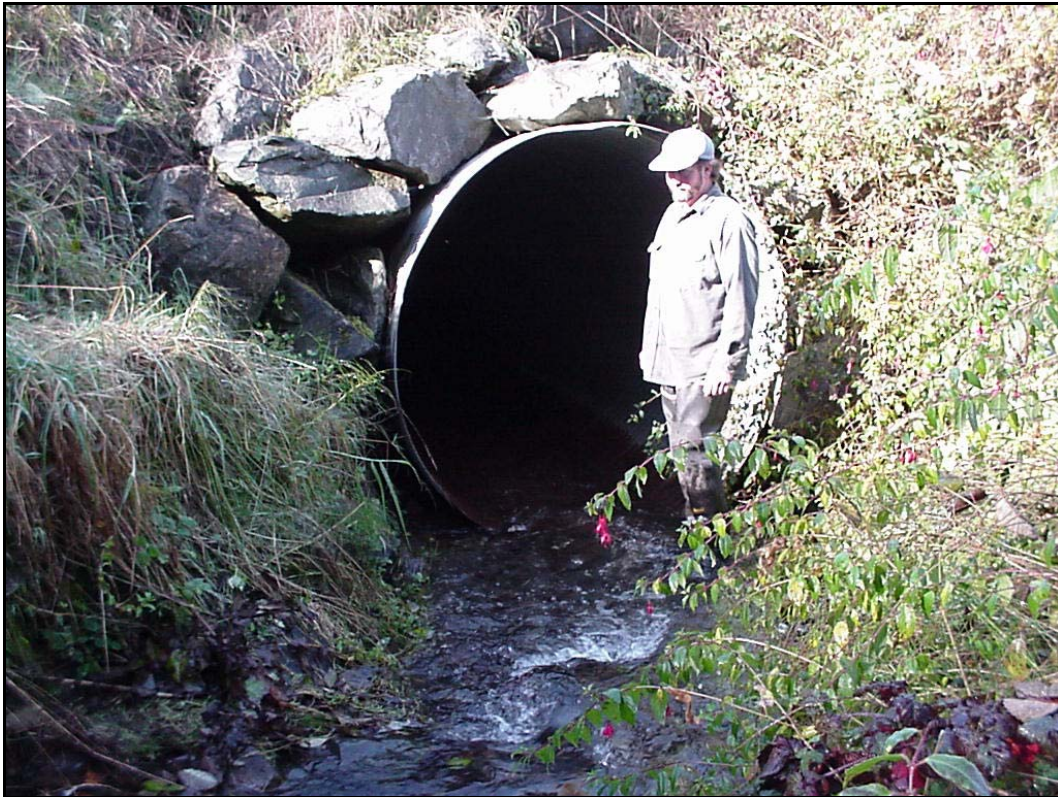
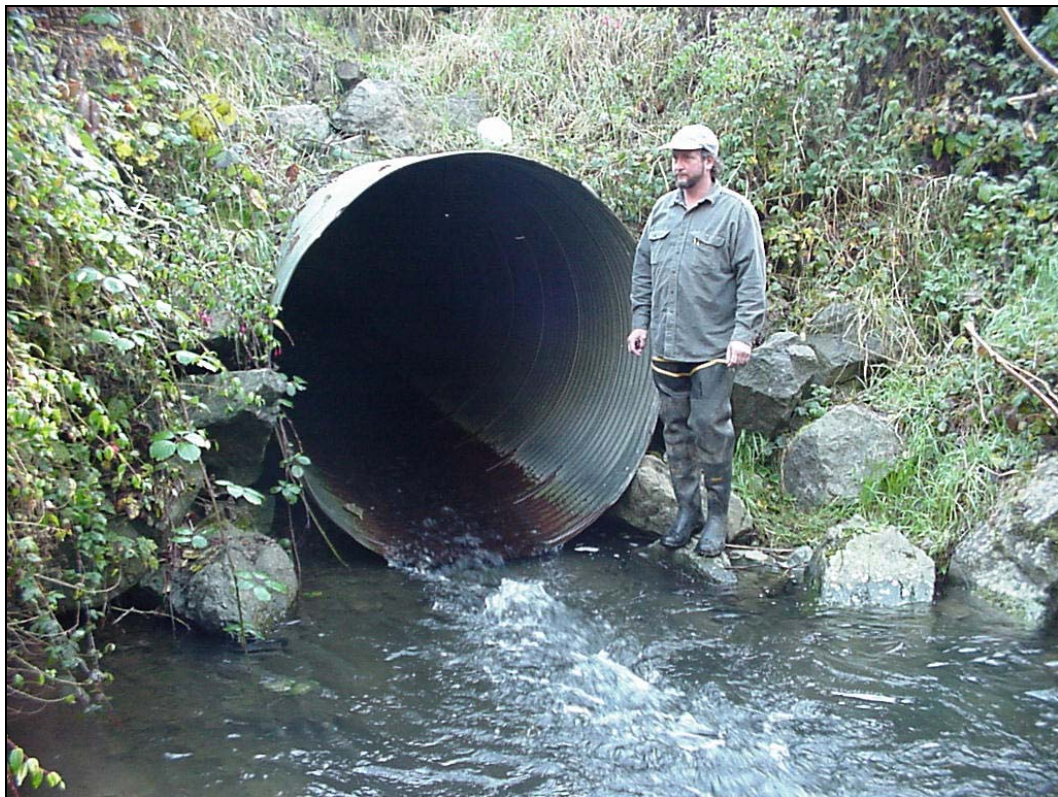
**Site #1: Lopez Creek/Oceanview Drive Photographs:**

**Overall condition:** Good. **Sizing:** Undersized, inlet is topped on approximately a two-year storm.

**Barrier Status:** FishXing determined for juveniles (all age classes) = 100% barrier due to excessive velocities caused by steep slope. Adults (coastal cutthroat and steelhead) = 100% barrier due to excessive velocities. Culvert also lacks adequate depth on lower range of migration flows. Fish observed upstream of Oceanview Road may be resident trout, or progeny of steelhead able to negotiate this crossing.

**Preferred Treatment:** Properly-sized culvert or arch-culvert set at or below stream grade.

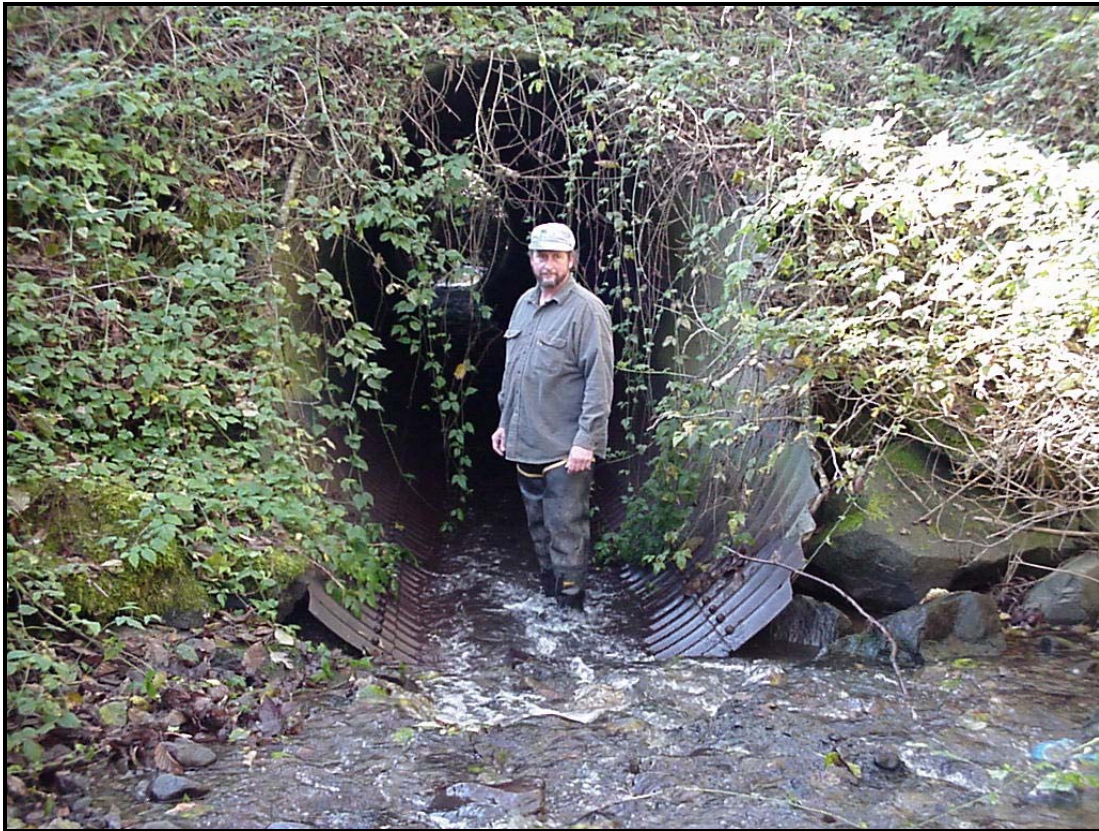
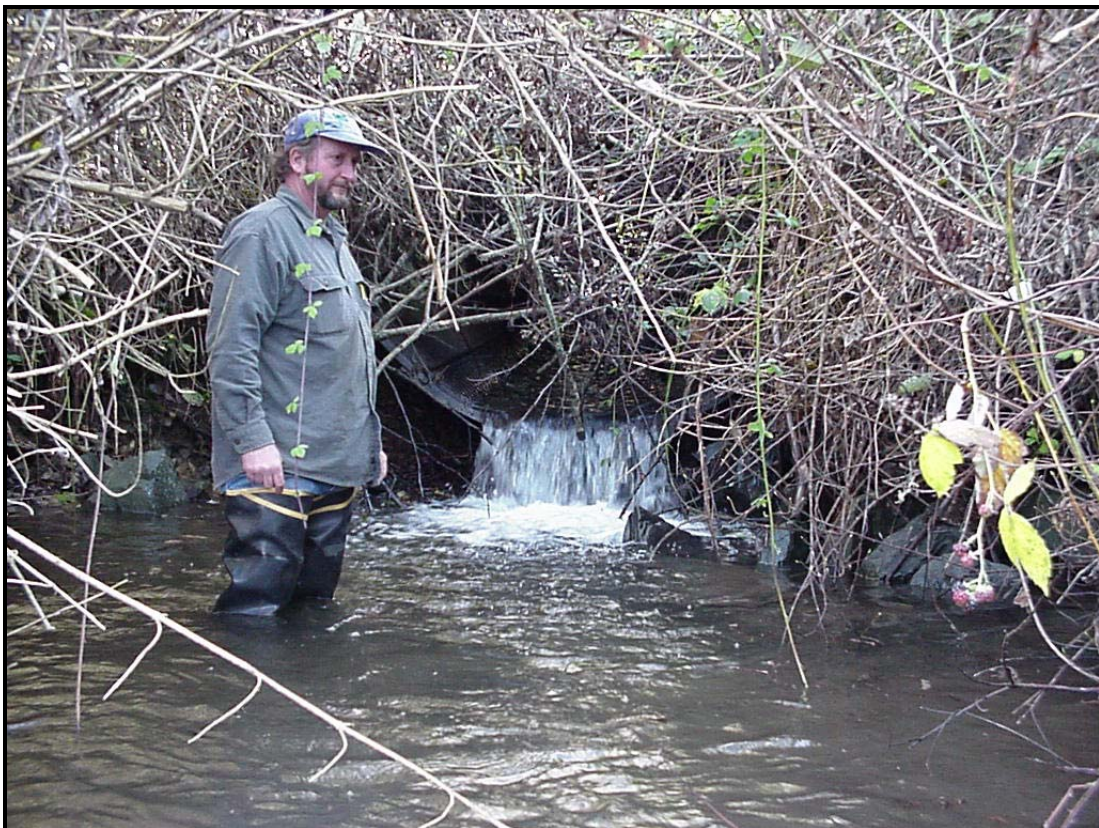
**Site #2: Ritmer Creek/Oceanview Drive; tributary to Smith River**

**Fill Estimate:** 3,975 cubic yards. **Overall condition:** Good. **Sizing:** Undersized, inlet is topped on approximately a 11.6 year storm flow.

**Barrier Status:** FishXing determined for juveniles (all age classes) = 0% passable due to excessive velocities caused by steep slope over a long distance. Adult coho and steelhead = 10% passable (near the upper range of migration flows); is a barrier at most flows due to lack of depth and excessive velocities. Adult coastal cutthroat trout = 0% passable due to excessive velocities over a long length of culvert.

**Preferred Treatment:** Properly-sized culvert or arch-culvert set at or below stream grade.

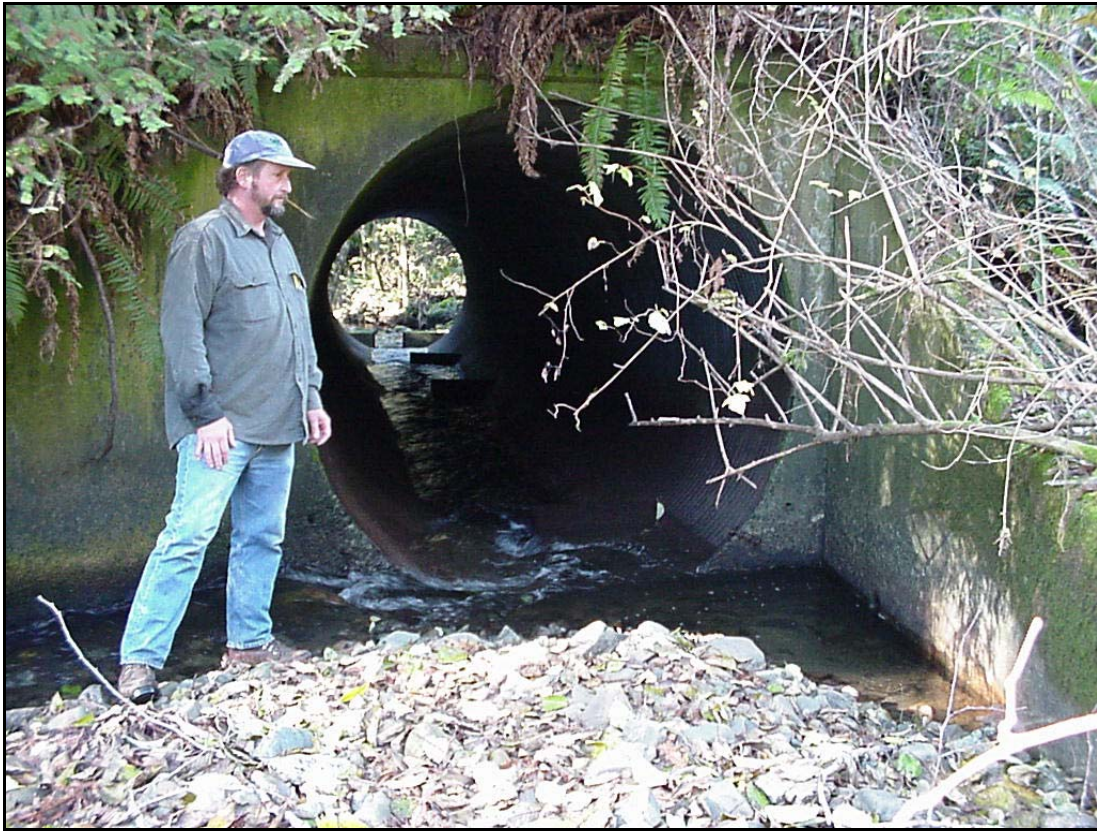
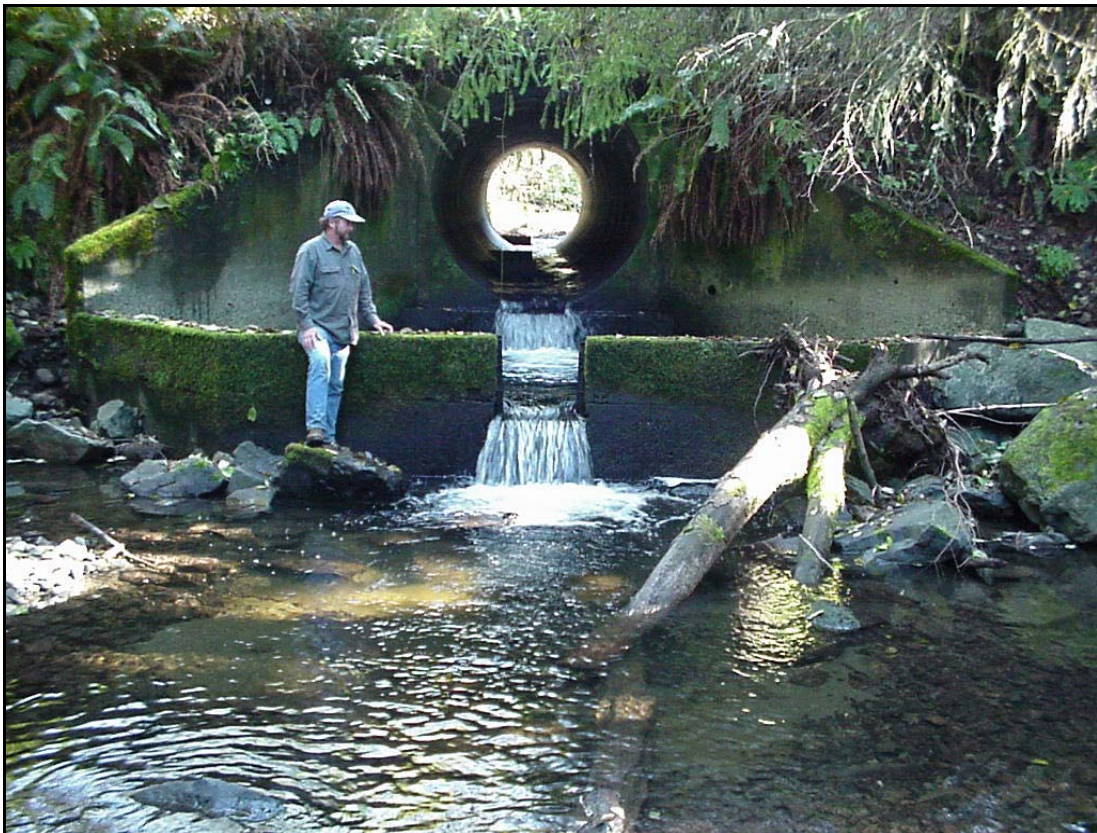
Site #3: Peacock Creek/Tan Oak Drive; lower Smith River tributary

**Dimensions:** 7.5' **Length:** 54.5' **Slope:** 3.05% **Modifications:** Steel ramp baffles (damaged) and concrete outlet pool structure with rectangular low-flow notch.

**Fill Estimate:** N/A, at least several thousand cubic yards. **Overall condition:** Fair, some signs of wear and abrasion. **Sizing:** Undersized, inlet is topped on approximately a 3.3-year storm flow.

**Barrier Status:** FishXing determined for adult coho salmon, steelhead, and coastal cutthroat = 0% passable; juveniles (all age classes) = 0% passable. Barrier is caused by too high of entry leap, lack of depth in pool below concrete weir, and excessive velocities within culvert. Direct observation confirmed during migration flows that water exits through notch in concrete weir at an excessive velocity. Turbulence also occurs at the inlet, where the creek enters inlet at nearly a 90° angle.

**Preferred Treatment:** Properly-sized arch-culvert on footings or a bridge. County should also consider feasibility of removing the crossing since Tan Oak Drive is a short loop with alternate access.

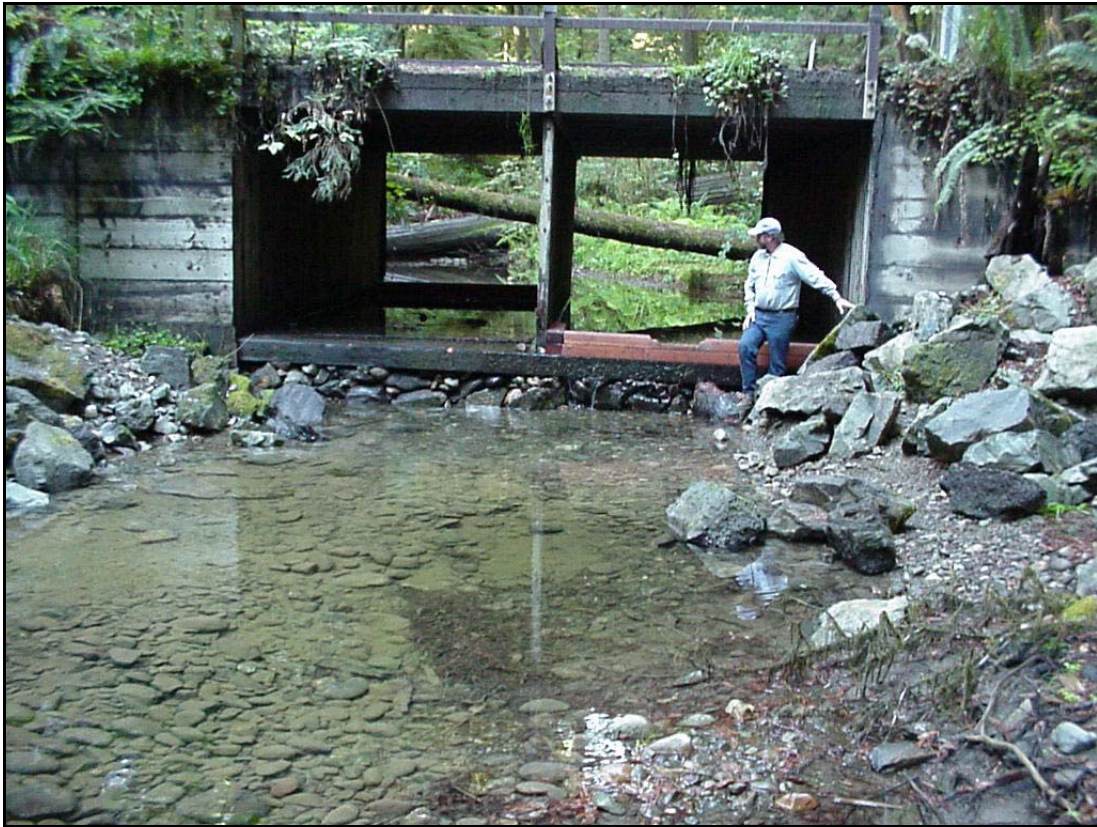
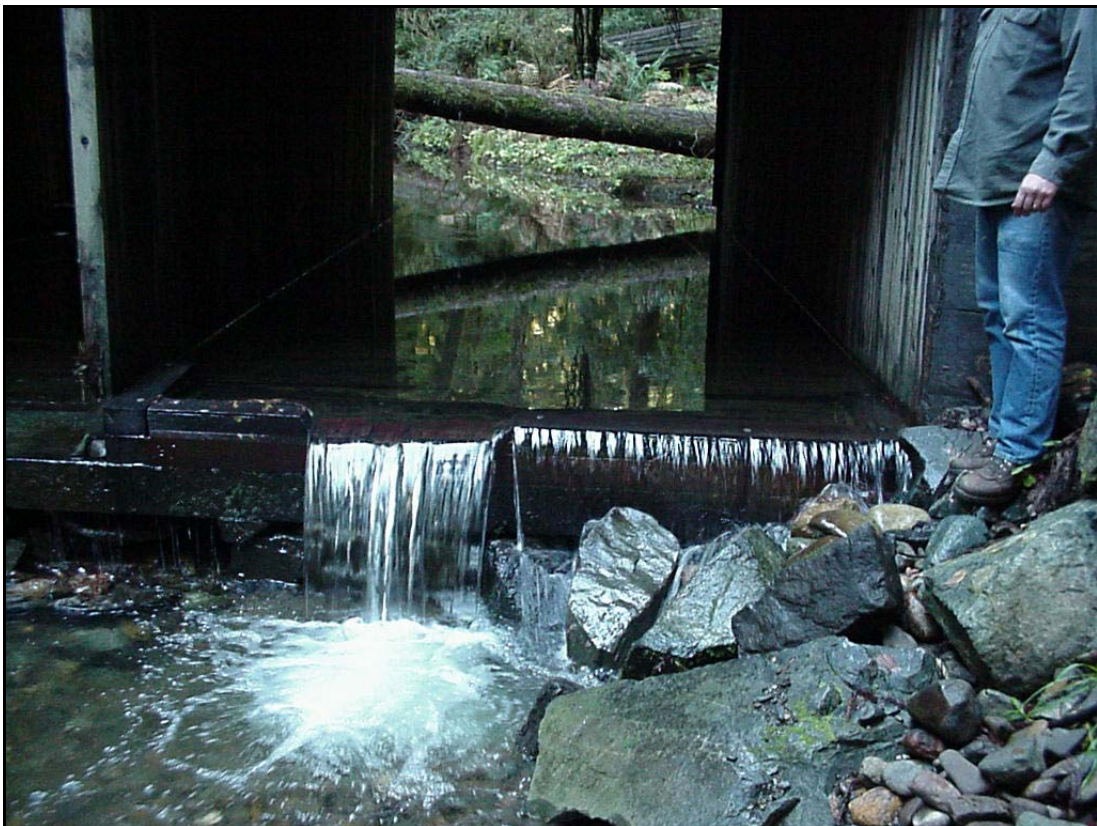
**Dimensions:** each bay = 7.0'H x 9.0'W **Length:** 26.0' **Slope:** <0.5% **Modifications:** None when evaluated, as of 11/00 an outlet beam was installed on left bank bay and a beam on the inlet of the right bank bay. Funding for replacement with bridge recently awarded; construction will occur during fall of 2001.

**Fill Estimate:** N/A; minimal fill on road <500 cubic yards. **Overall condition:** Fair/poor, noticeable wear occurring to planks with leakage. **Sizing:** Undersized, inlet is topped on approximately a six-year storm flow.

**Barrier Status:** FishXing determined the box culvert is 0% passable for all species and lifestages presumed present (coho salmon, steelhead, coastal cutthroat trout). Lack of depth in culvert was the major concern for adults, while the height of entry jump and velocity was more a concern for juveniles. Riprap at outlet may inhibit leap attempts. Three redds were observed upstream in winter of 1999/2000, so some passage does occur.

**Site #4: Clark's Creek/Walker Road Photographs (after 11/00 modifications)**

**Preferred Treatment:** Long-term: properly-sized arch-culvert on footings or a doublewide flatcar bridge. Short-term: outlet beams to increase depth within both bays; downstream weirs to raise outlet pool elevation.

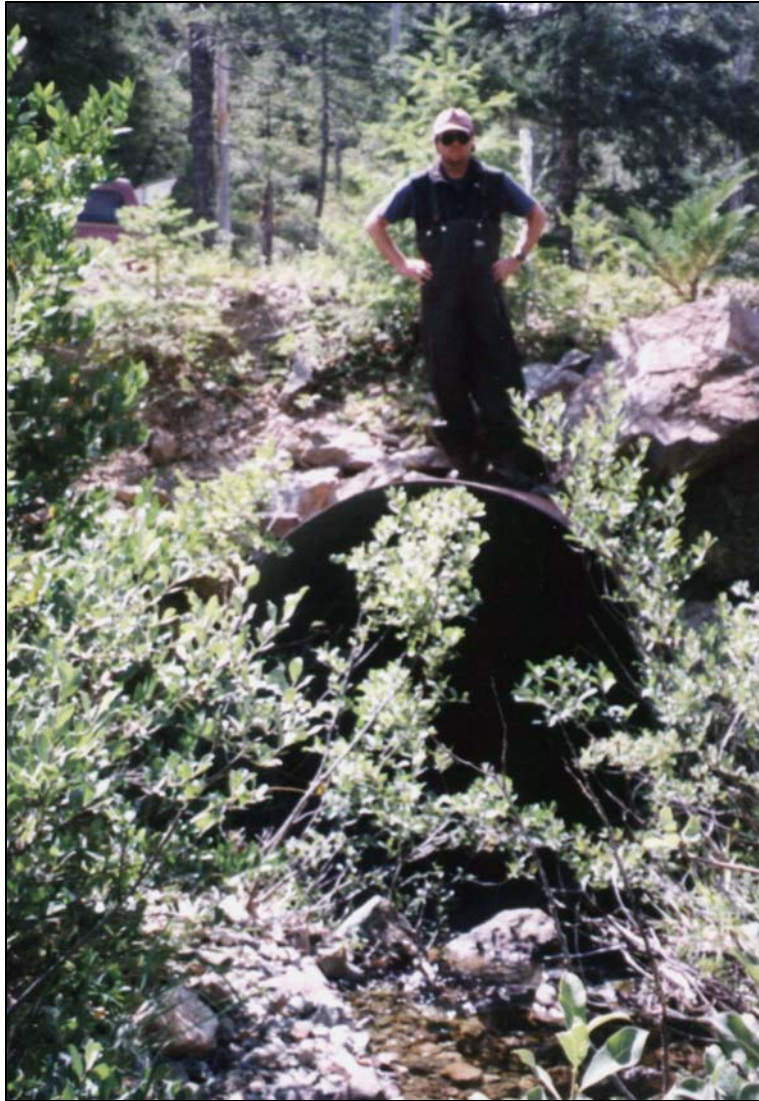
Site #5: Shelly Creek/Patrick's Creek Road Photographs:

**Fill Estimate:** 1,015 cubic yards. **Overall condition:** Fair, some noticeable wear/rusting of culvert floor.

**Sizing:** Undersized, HW/D =1 on approximately a six-year storm flow. A diversion potential exists at this stream crossing – if culvert was to plug and fail, storm flow would be diverted down a remote, unpaved county road. Note: slope of road prism evident in the outlet photograph.

**Preferred Treatment:** replace with properly-sized bridge and re-grade road to eliminate diversion potential.

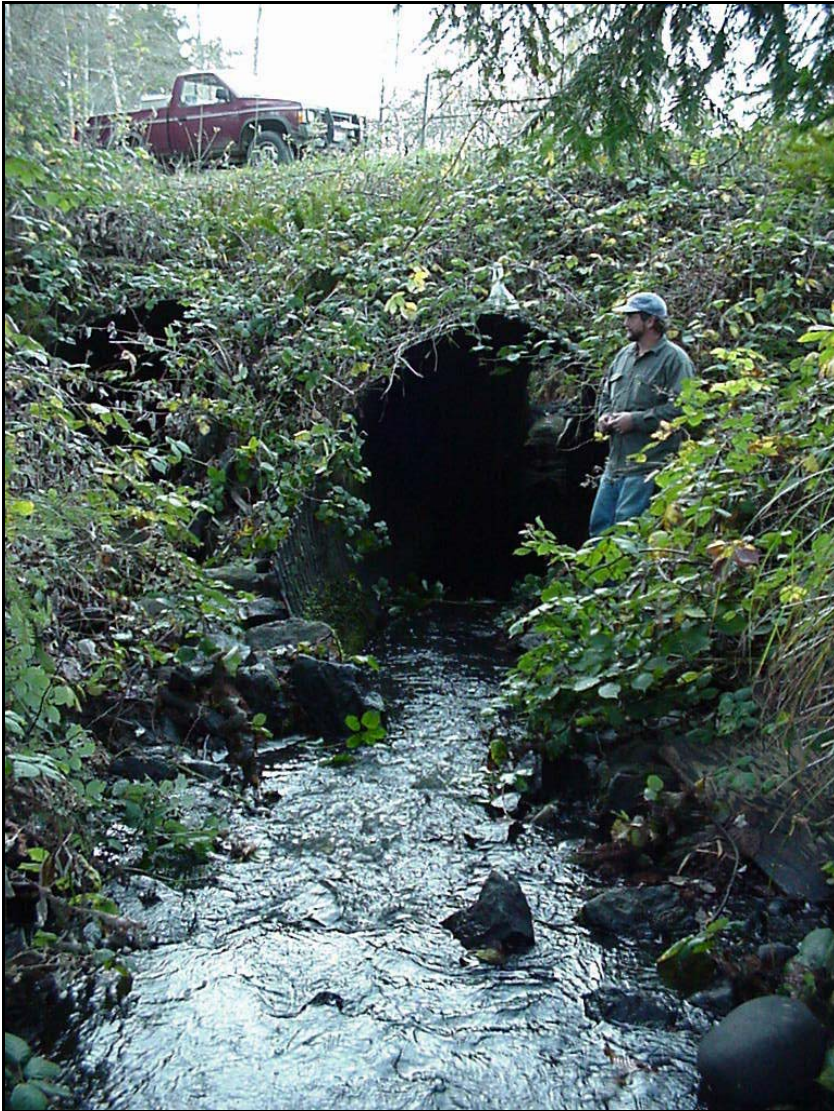
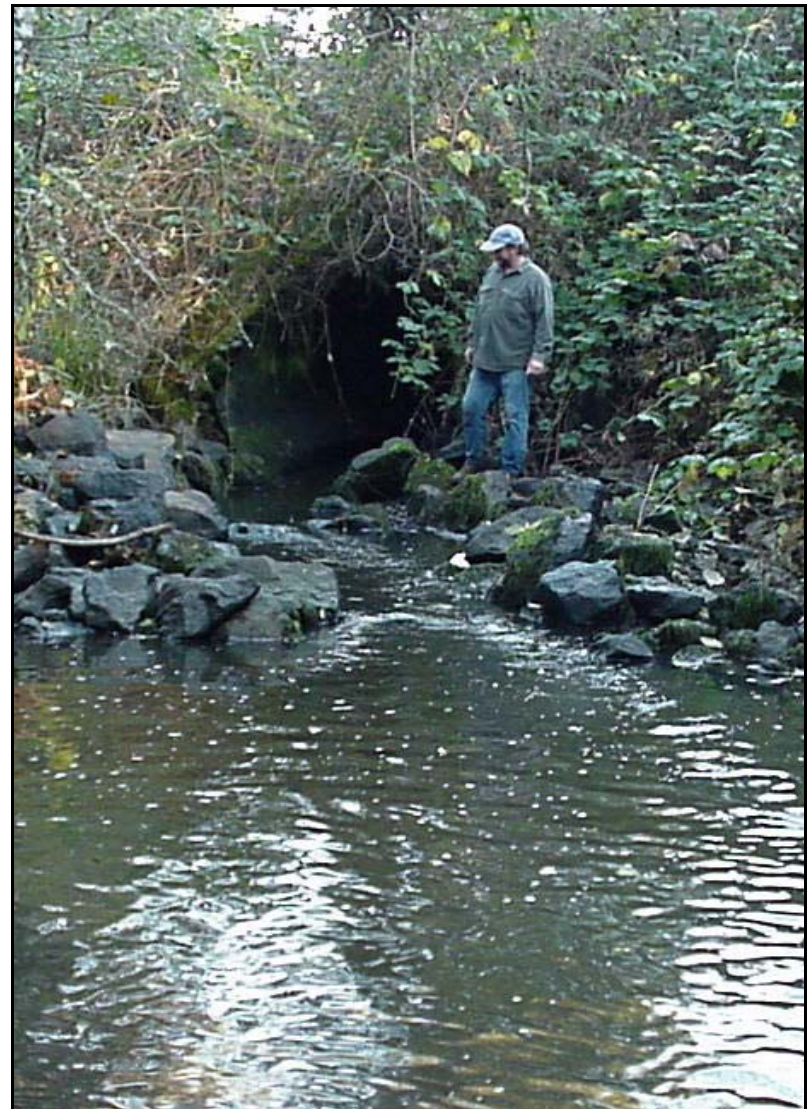
**Site #7: Yonker's Creek #1/Lake Earl Drive; tributary to Lake Earl**

**Fill Estimate:** 3,973 cubic yards. **Overall condition:** Good. **Sizing:** Undersized, inlet is topped on a 15-year storm flow.

**Barrier Status:** FishXing determined 70% passable for adult coho and steelhead; 95% passable for adult cutthroat; 60% passable one-year old juveniles; and 10% passable for young-of-year. Annually, numerous coastal cutthroat and steelhead observed spawning in upper Yonker's Creek

**Preferred Treatment:** when culvert wears-out, replace with a properly-sized arch-culvert on footings or bridge. Periodically check culvert during migration flows to confirm continued presence of backwatering near outlet.

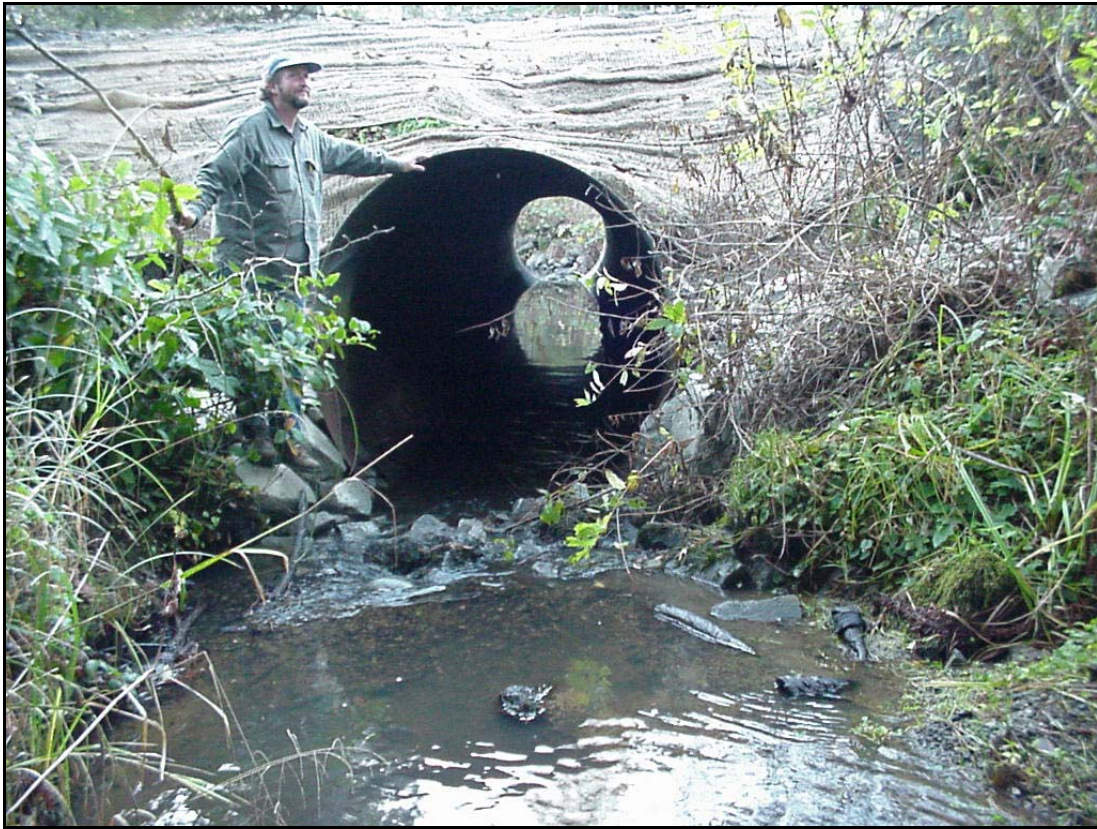
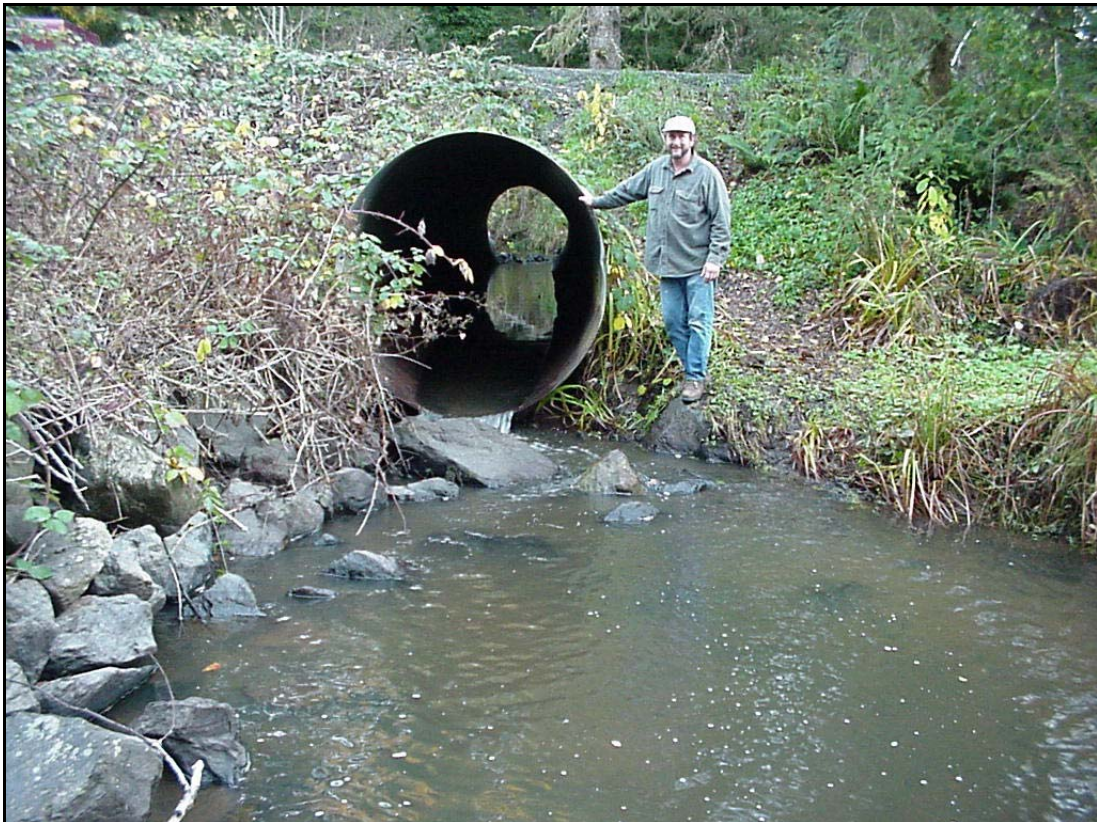
Site #8: Yonker's Creek #2/Wonderstump Road; tributary to Lake Earl

**Fill Estimate:** 873 cubic yards. **Overall condition:** Poor, rusted through culvert floor, seepage of flow apparent during summer and fall low flows.

**Barrier Status:** FishXing estimated this site to be 50% passable for adult steelhead and a complete barrier to adult coastal cutthroat trout and all juveniles due to excessive velocities. Winter site visits confirm high velocities within culvert and turbulent flow at outlet. Outlet pool and banks immediately below culvert have eroded (and been rip-rapped). However, annually numerous coastal cutthroat and steelhead observed spawning in upper Yonker's Creek

**Preferred Treatment:** replace with a properly-sized arch-culvert on concrete footings or a bridge.

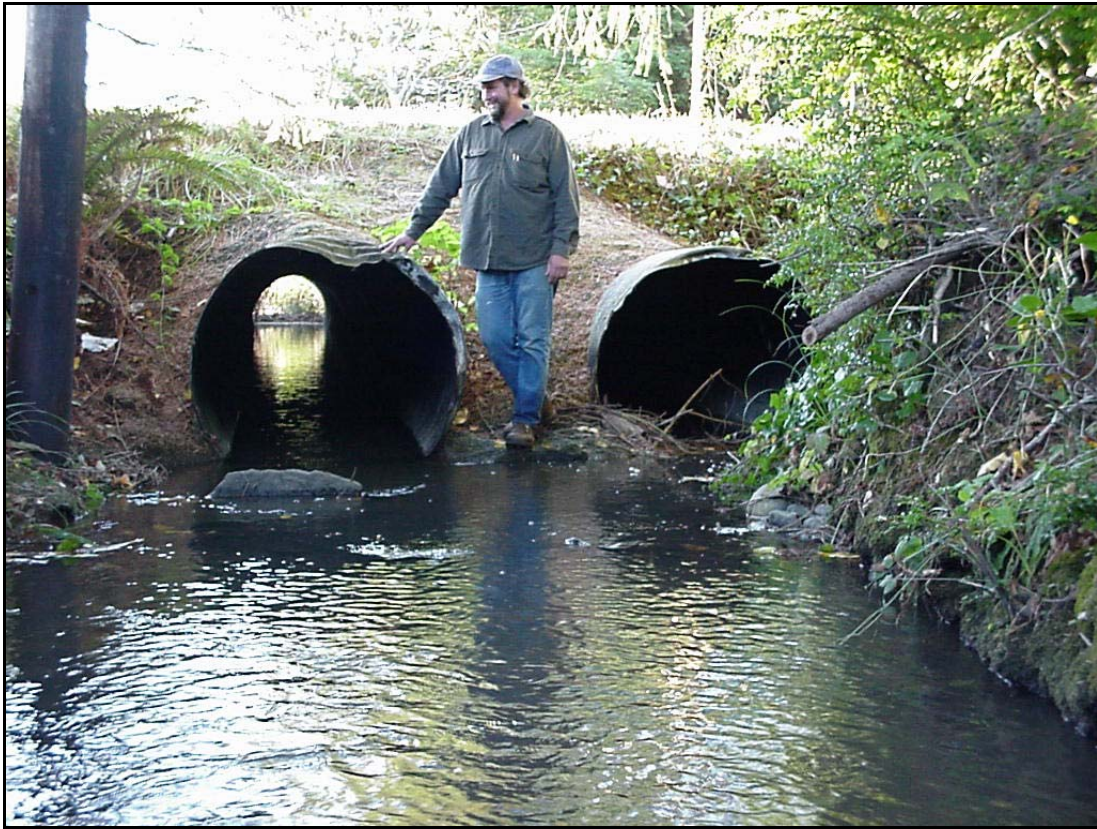
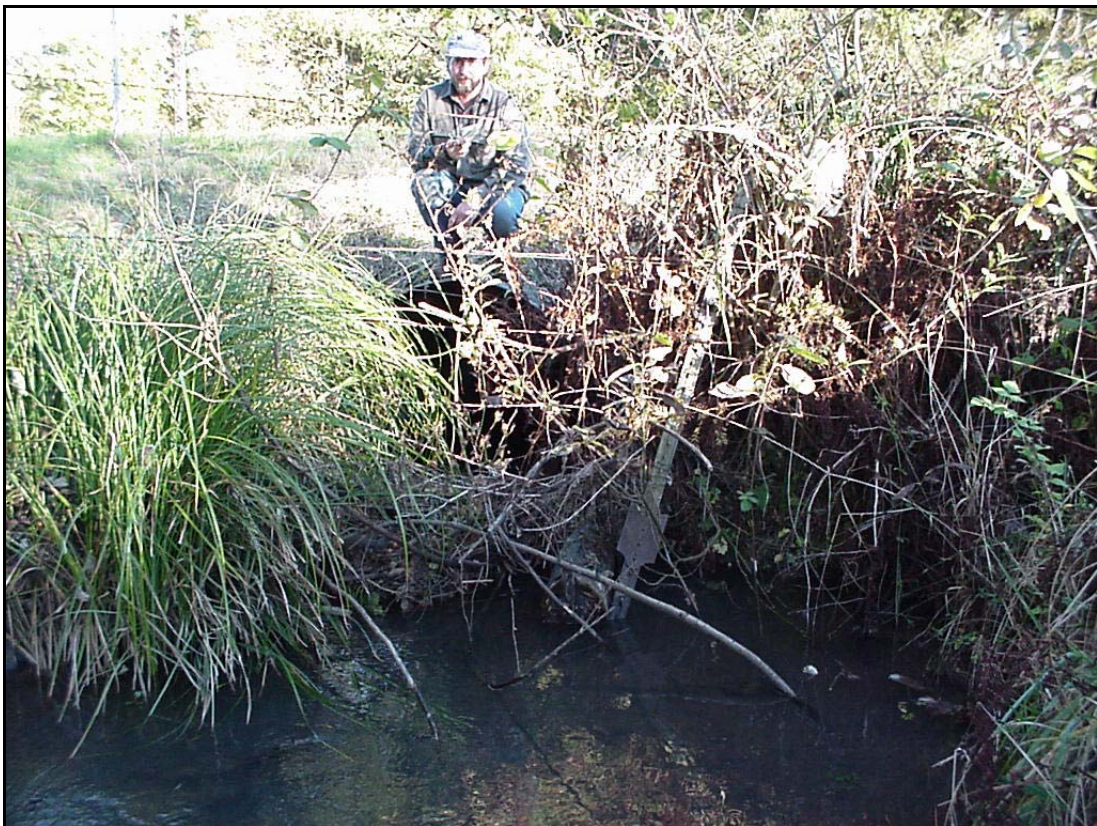
**Site #9: Brush Creek #1/Lake Earl Drive; tributary to Lake Earl**

**Fill Estimate:** 473 cubic yards. **Overall condition:** Good. **Sizing:** Undersized; HW/D = 1 on approximately a one-year storm flow.

**Barrier Status:** FishXing predicted as 100% passable for adult steelhead, coho salmon, coastal cutthroat trout, and 1+ juveniles. Is only 30% passable for young-of-year fish. Both culverts are set at-grade, swim-throughs. Annually, numerous coastal cutthroat and steelhead observed spawning in upper Brush Creek (Burgess, Schlotter; pers. com.).

**Preferred Treatment:** when current culverts wear-out, replace with a properly-sized arch-culvert on concrete footings or a bridge.

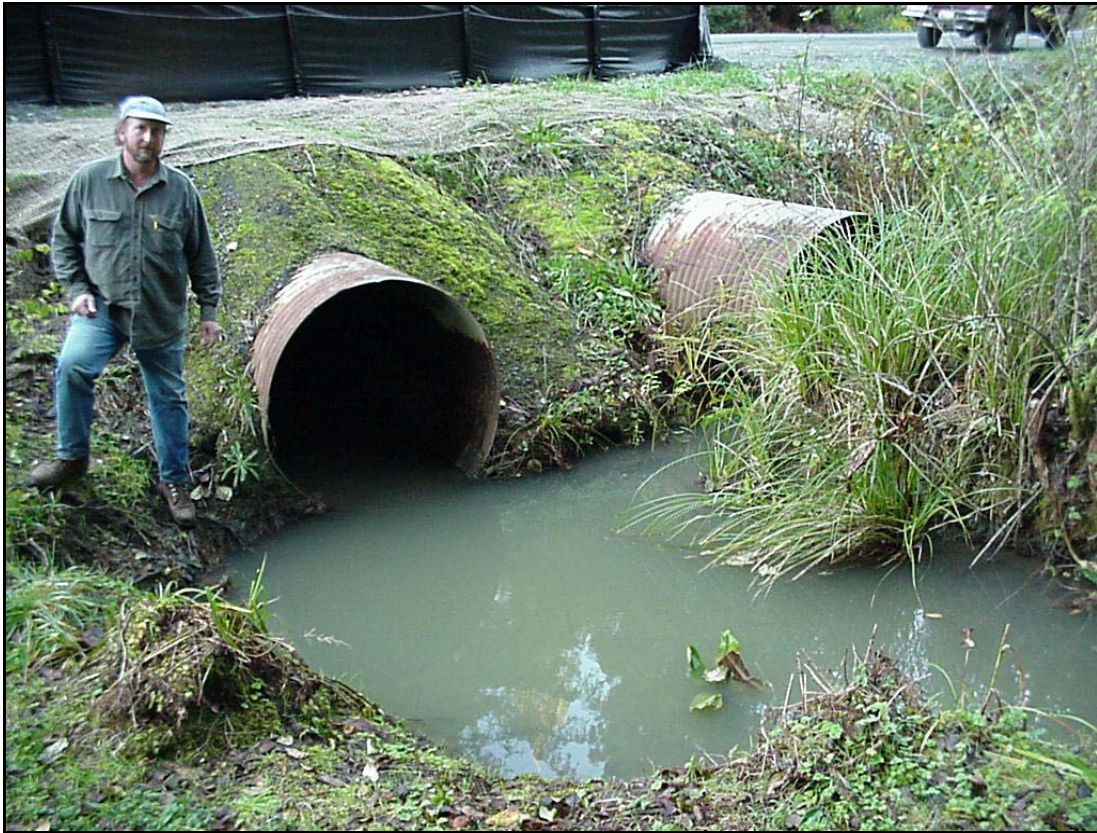
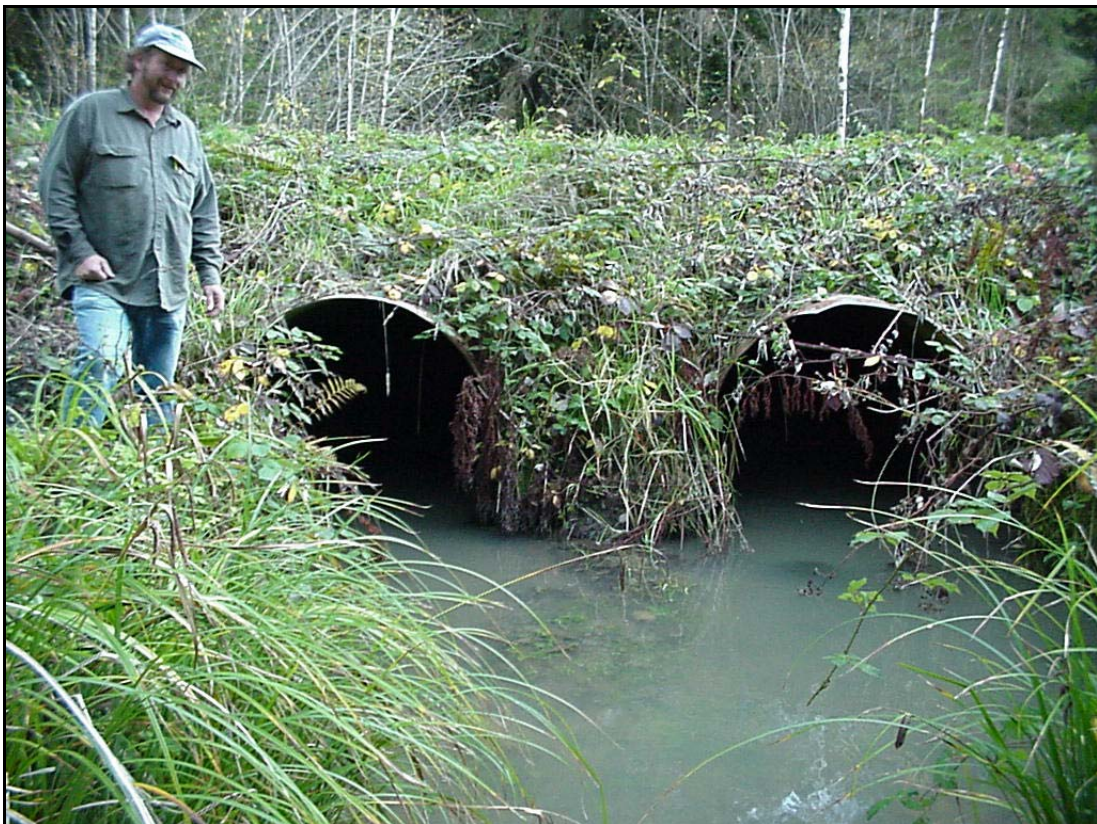
**Site #10: Brush Creek #2/Wonderstump Road; tributary to Lake Earl**

**Fill Estimate:** 550 cubic yards. **Overall condition:** Poor, both culvert floors rusted through. Most of low flow seeps through and under culverts.

**Barrier Status:** FishXing predicted crossing was 80% passable for adult steelhead and coho; 95% passable for adult coastal cutthroat; 60% passable for 1+ juveniles; and 20% passable for young-of-year fish. Annually, numerous coastal cutthroat and steelhead observed spawning in upper Brush Creek

**Preferred Treatment:** replace with a properly-sized arch-culvert set on concrete footings.

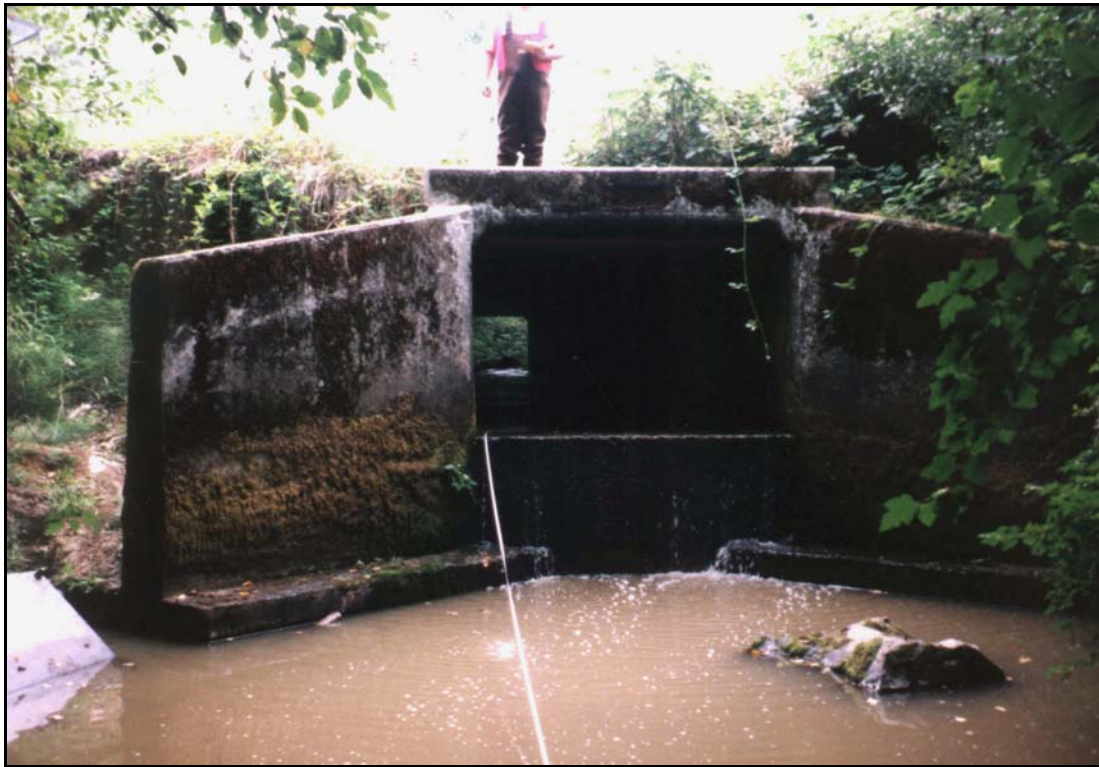
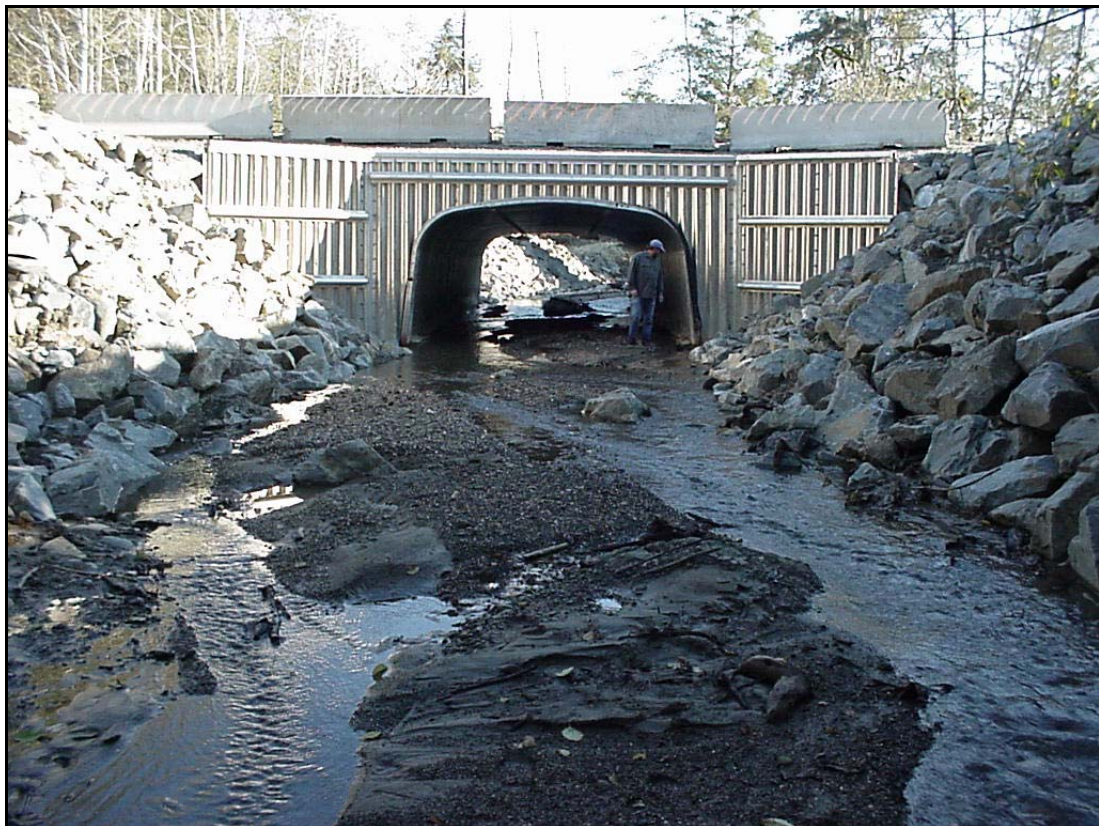
Site #11: Jordan Creek #1/Parkway Drive; tributary to Lake Earl

**Fill Estimate:** 1,122 cubic yards. **Overall condition:** Fair. **Sizing:** Undersized, HW/D = 1 on approximately a two-year storm flow.

**Barrier Status:** Yes, FishXing determined to be a barrier to all species and lifestages over the range of expected migration flows. Perched outlet makes for difficult entry jump. Depending on amount of flow, the smooth concrete floor creates both a lack-of-depth and velocity barriers. Annually, numerous coastal cutthroat and steelhead observed jumping at the culvert outlet. This site has a long history of poaching during the spawning migrations of coastal cutthroat trout, steelhead, and coho salmon from Lake Earl.

**Note:** Photographs are a before/after sequence of the Jordan Creek/Parkway Drive outlet. Treatment (15'9" W x 8' H aluminum arch set on concrete footings) was completed in September-October, 2000.

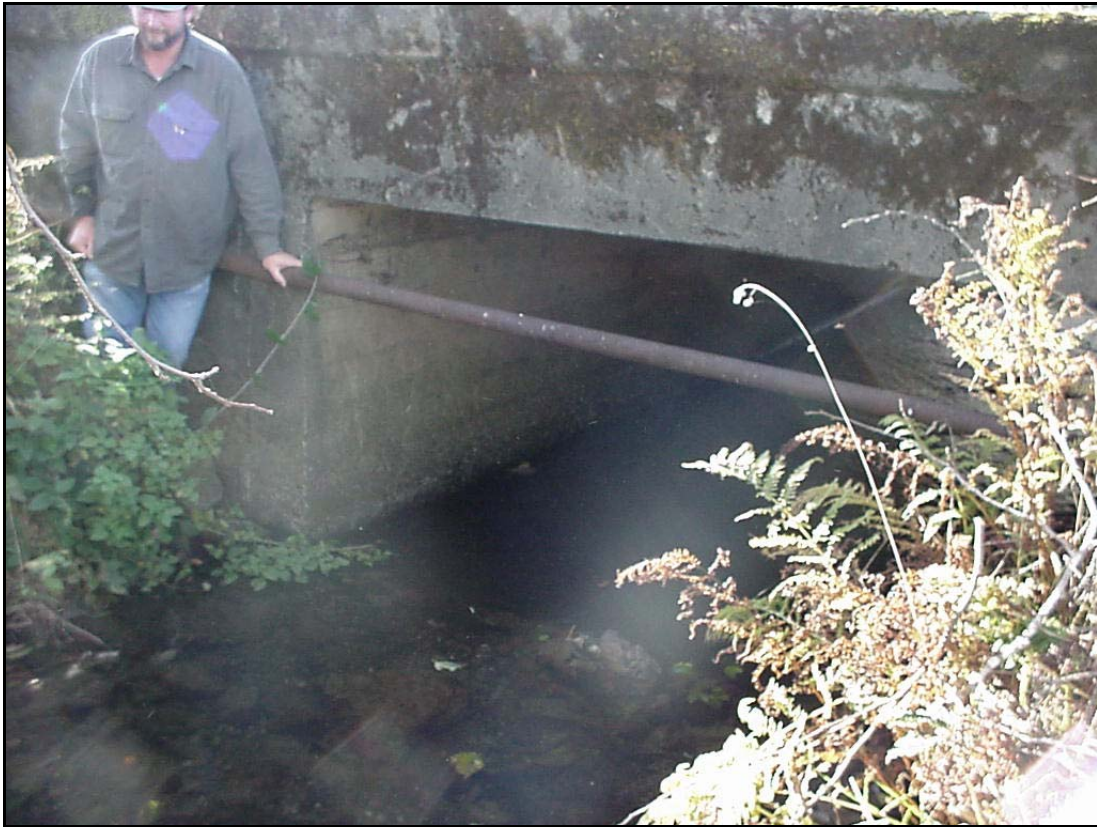
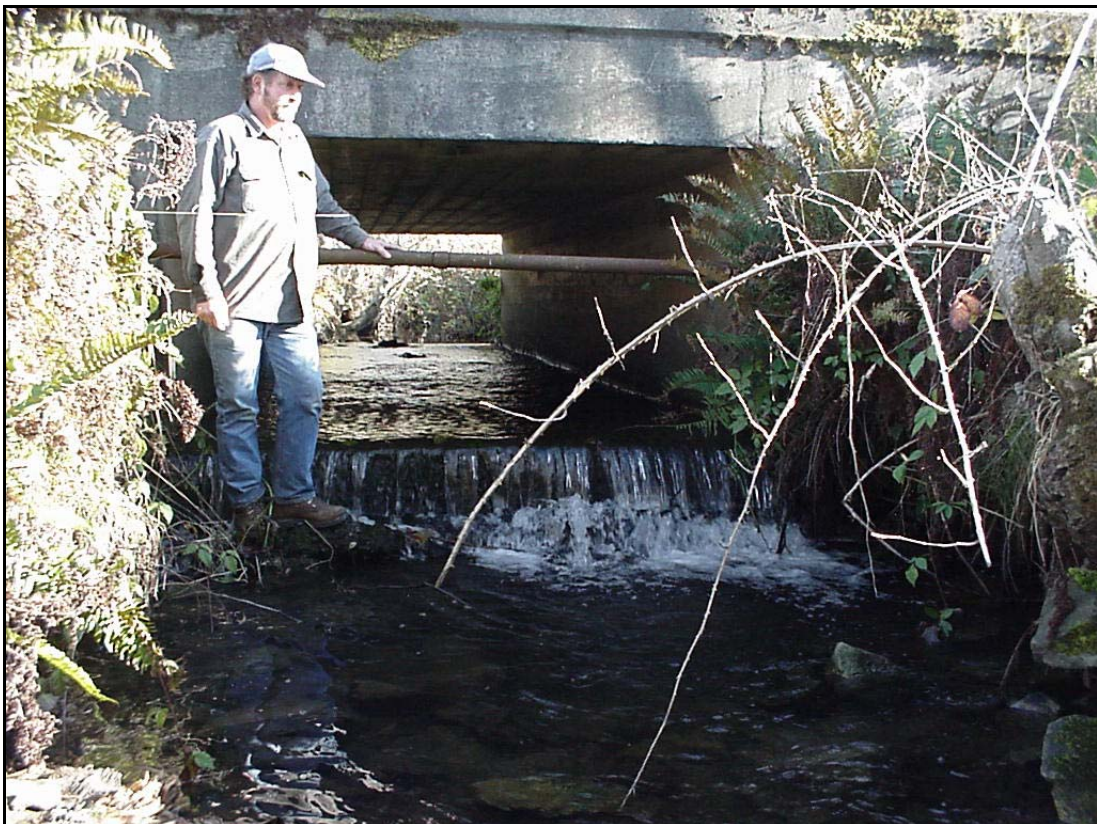
**Site #12: Jordan Creek #2/Elk Valley Road; tributary to Lake Earl**

**Fill Estimate:** 202 cubic yards. **Overall condition:** Good. **Sizing:** Undersized, HW/D = 1 on approximately a two-year storm flow.

**Preferred Treatment:** replace with a properly-sized arch-culvert on concrete footings or a bridge.

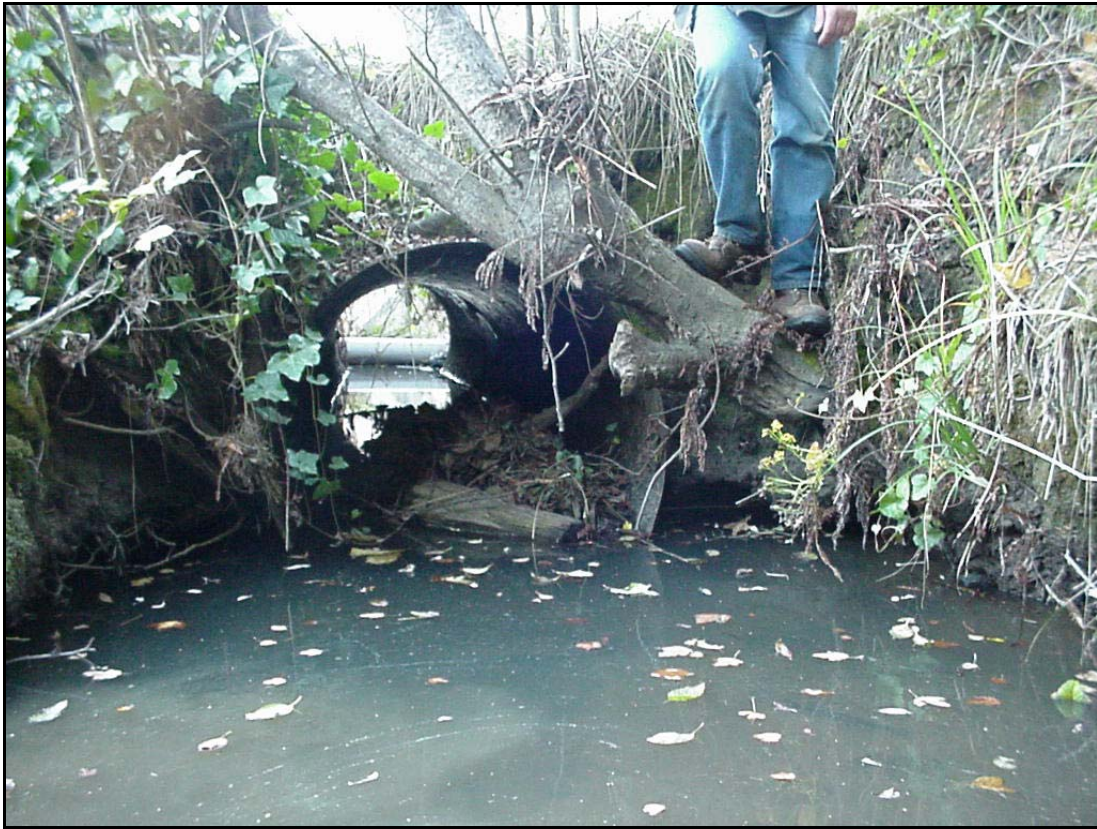
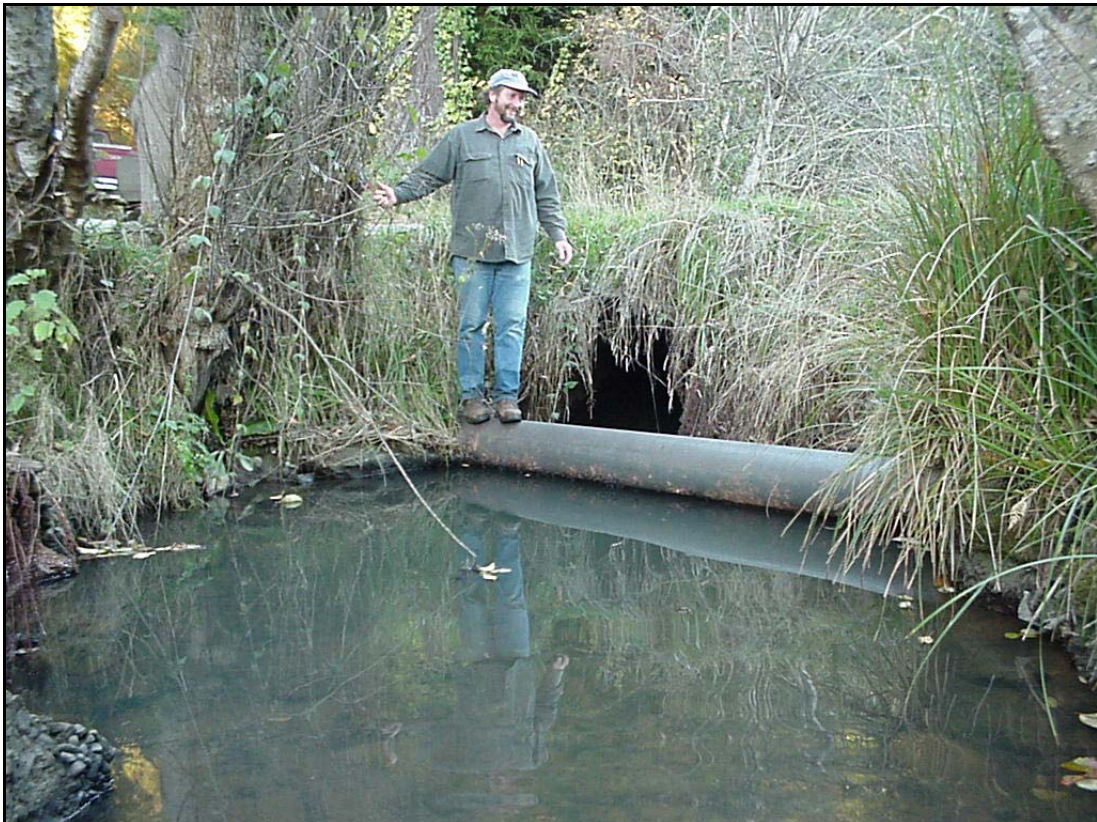
**Site #13:** Jordan Creek Tributary #1/Railroad Avenue; tributary to Lake Earl

**Fill Estimate:** 120 cubic yards. **Overall condition:** Fair, some signs of wear, but not yet rusted through.

**Barrier Status:** FishXing predicted this crossing is 100% passable for adult steelhead, 60% passable for adult coastal cutthroat trout, and 40% passable for 1+ and young-of-year juveniles. Annually, numerous coastal cutthroat observed spawning in this tributary within Florence Keller County Park.

**Preferred Treatment:** when culvert wears-out, replace with a properly-sized arch-culvert on concrete footings or pipe-arch set below stream grade.
