**APPENDIX B:**

**CATALOG OF DEL NORTE COUNTY CULVERTS LOCATED  
ON FISH-BEARING STREAM REACHES**

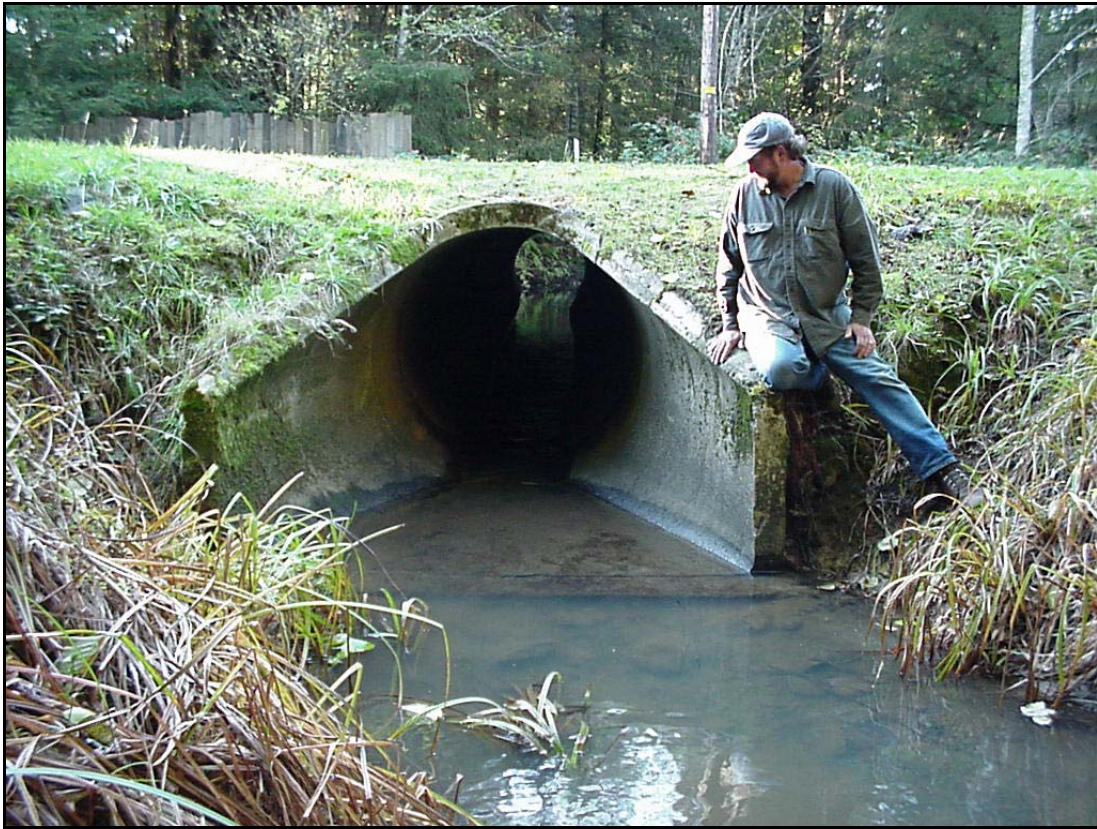
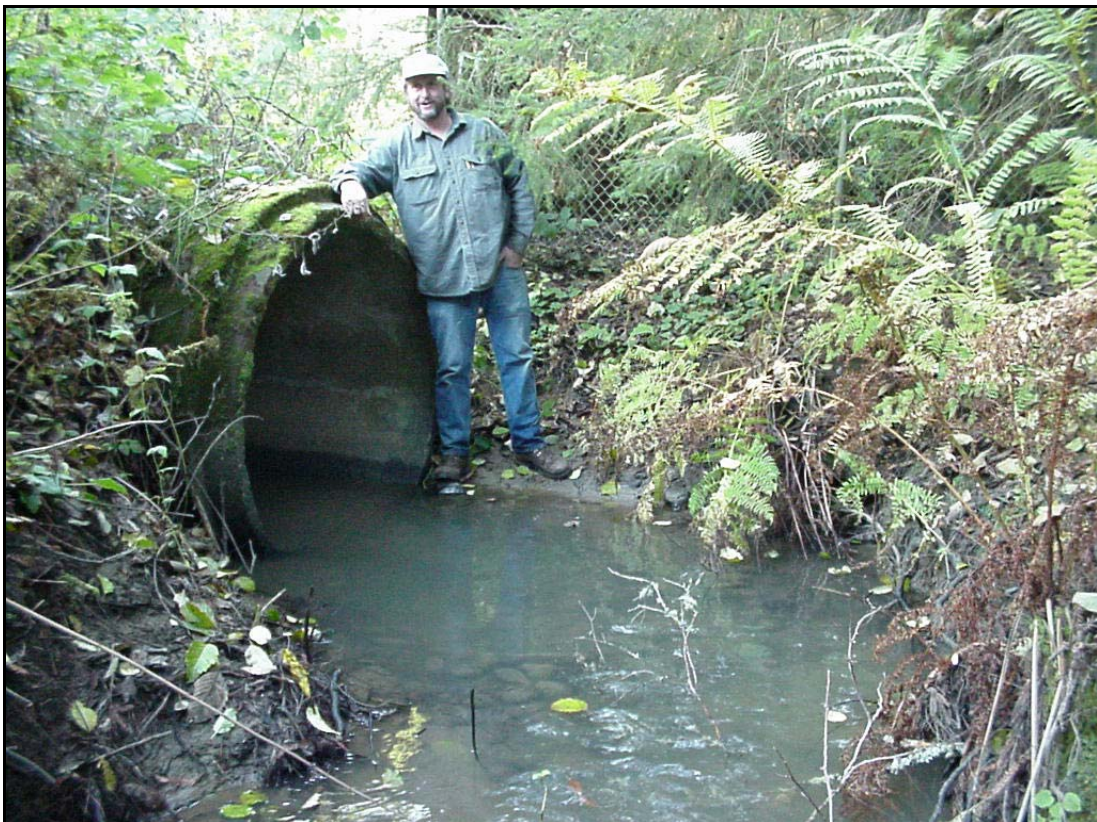
**Site #14: Jordan Creek Tributary #2/Cunningham Lane; tributary to Lake Earl**

**Slope:** 1.25% **Modifications:** None. **Fill Estimate:** 278 cubic yards. **Overall condition:** Good.

**Barrier Status:** FishXing determined is 40% passable for adult steelhead, 20% passable for adult coastal cutthroat, and 13% passable for 1+ and young-of-year juveniles. However, crossing is at-grade and numerous winter site visits documented slow velocities and adequate depths at a wide range of flows. Annually, numerous coastal cutthroat observed spawning in this tributary within Florence Keller County Park.

**Preferred Treatment:** when culvert wears-out, replace with a properly-sized arch-culvert on concrete footings or pipe-arch set below stream grade. Adjust crossing alignment to channel direction on downstream side.

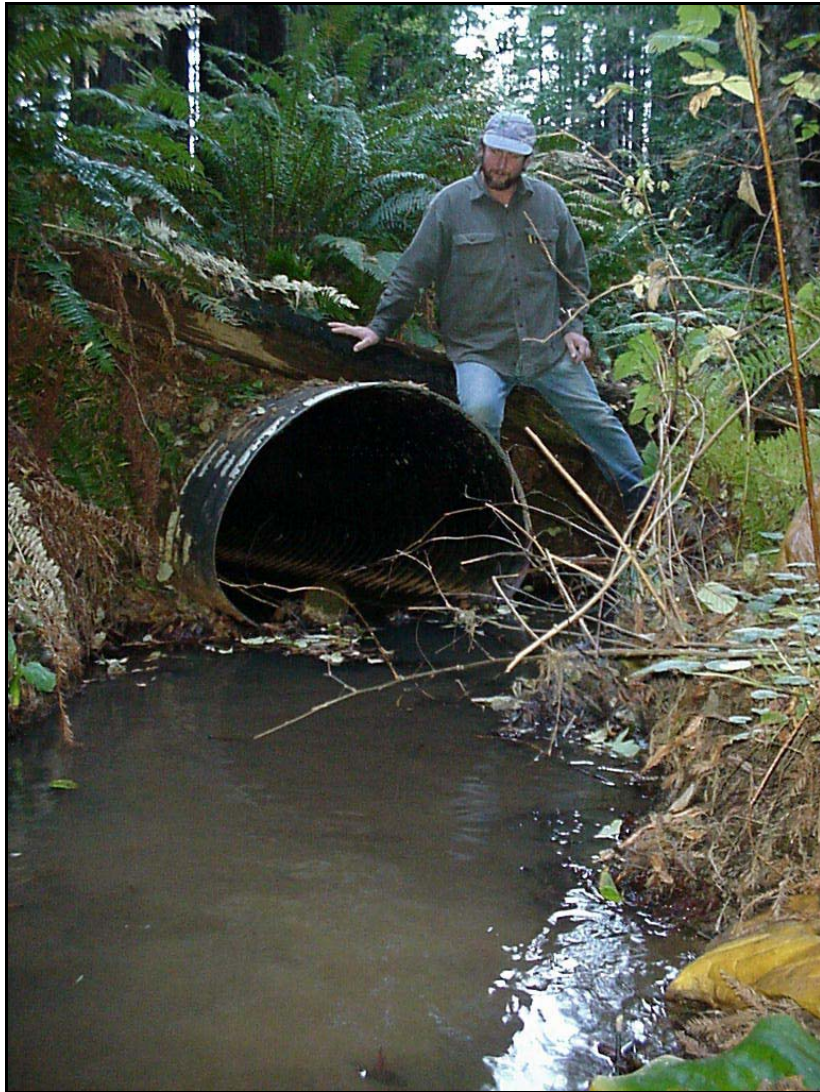
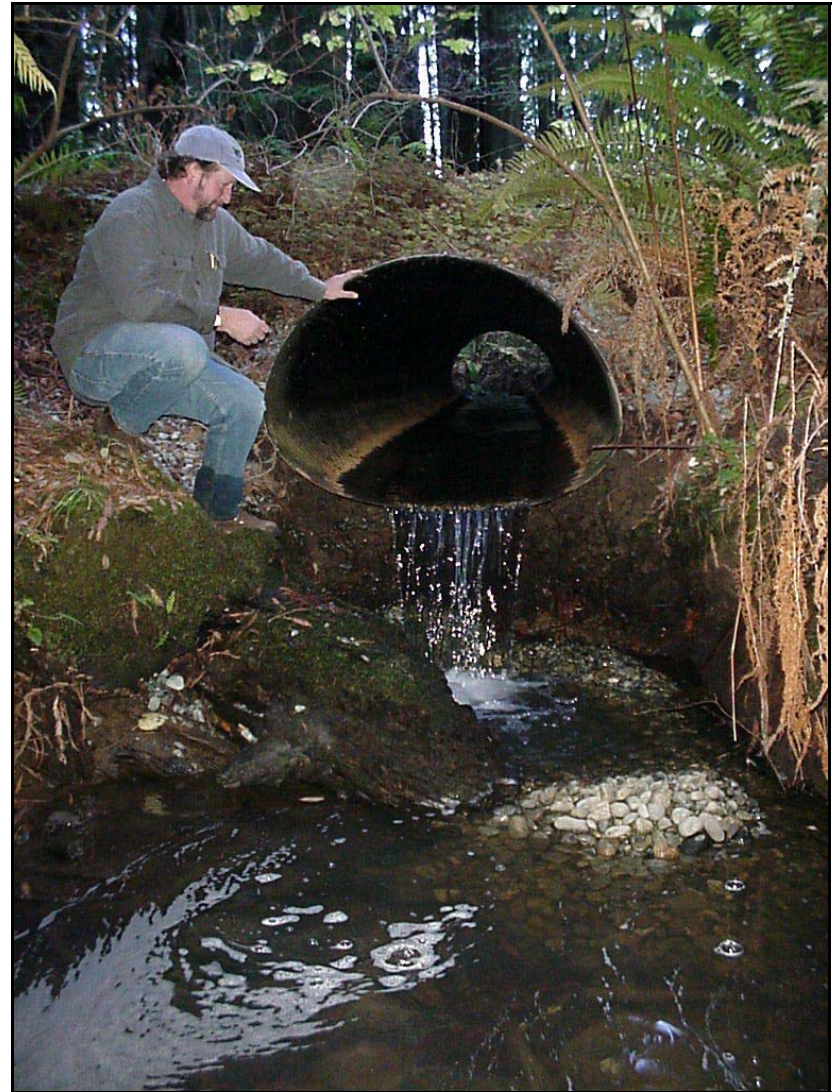
Site #15: Jordan Creek Tributary #3/Keller Park Campground Loop.

**Overall condition:** Fair, some wear, not yet rusted through. **Sizing:** Undersized, HW/D = 1 on approximately a one-year storm flow

**Barrier Status:** FishXing predicted to be a 100% for adult and juvenile coastal cutthroat trout. Has perched outlet (1.6' at low flow) however, annually, numerous coastal cutthroat observed spawning upstream of this culvert.

**Preferred Treatment:** when culvert wears-out, replace with a properly-sized arch-culvert on concrete footings or pipe-arch set below stream grade. Adjust crossing alignment to channel direction on upstream side.

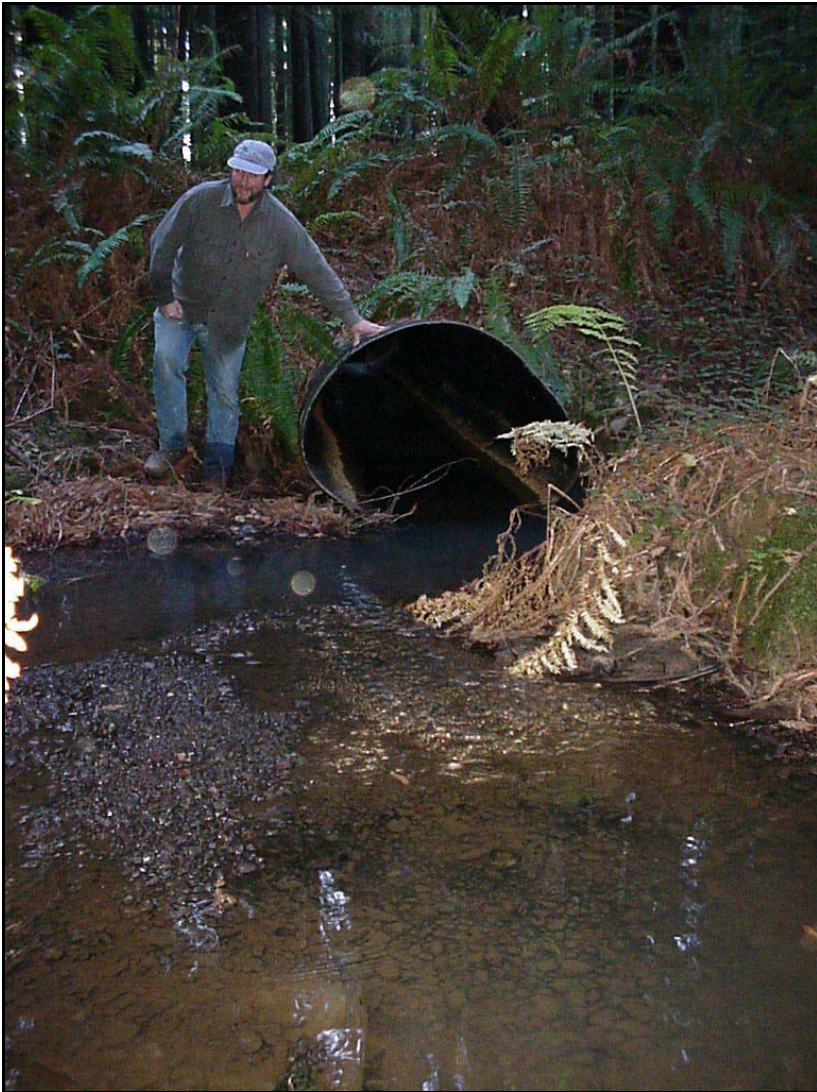
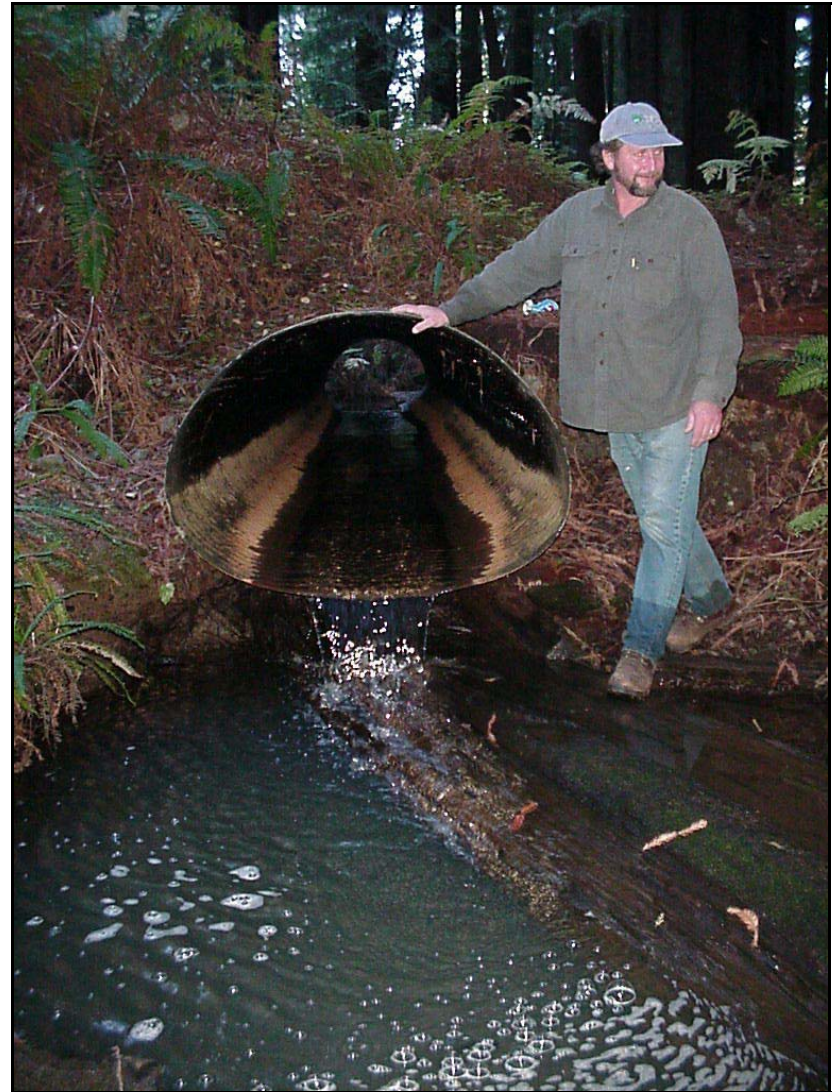
Site #16: Jordan Creek Tributary #4/Keller Park Campground Loop

**Modifications:** None. **Fill Estimate:** <200 cubic yards. **Overall condition:** Fair, signs of wear, not rusted through.

**Barrier Status:** Not evaluated with FishXing because of the limited length of upstream habitat. Has perched outlet (1.5' at low flow). Three (15"-18") coastal cutthroat observed spawning upstream of this culvert on 11/18/99. Two more redds observed in reach above culvert on 1/13/00.

**Preferred Treatment:** when culvert wears-out, replace with a properly-sized arch-culvert on concrete footings or pipe-arch set below stream grade.

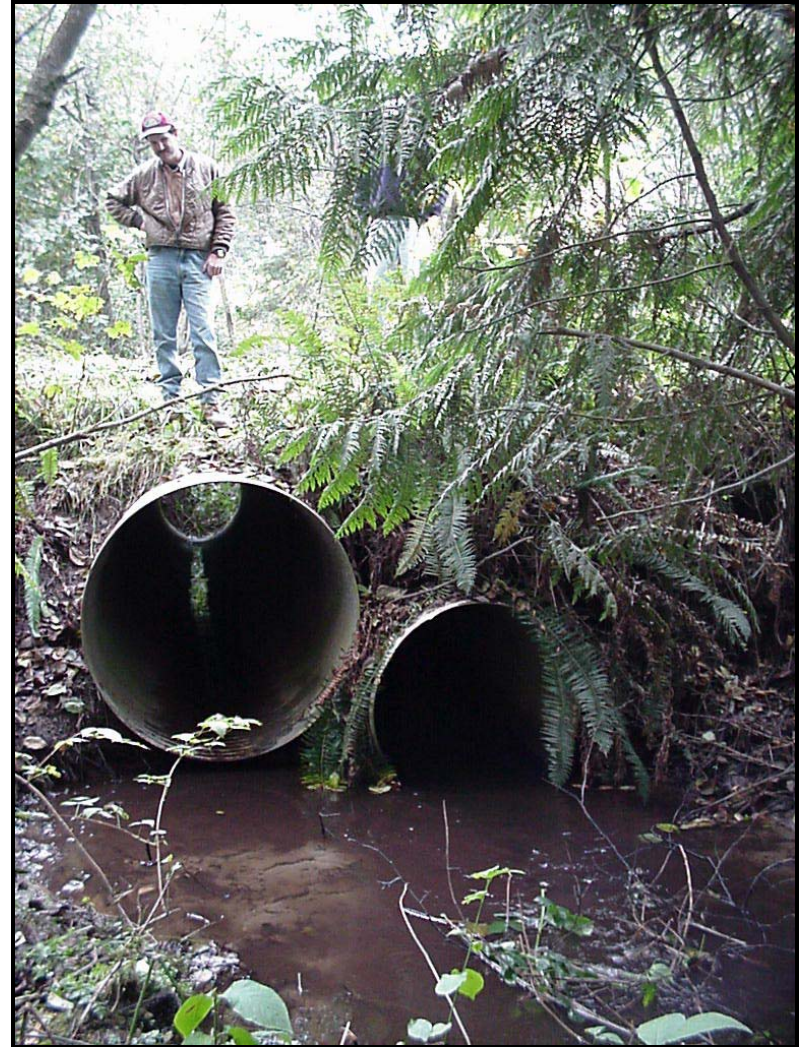
**Site #24:** Elk Creek Tributary #2/Elk View Road; tributary to Elk Creek

**Overall condition:** Good, no apparent wear or damage.

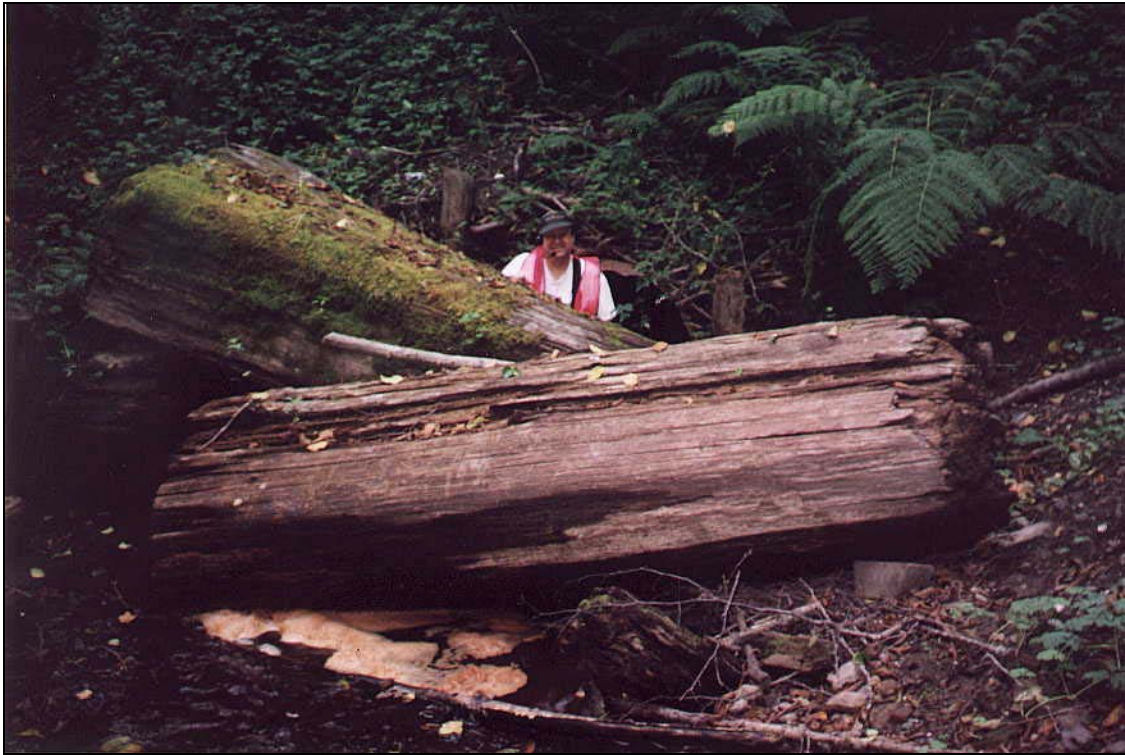
**Site #26: Richardson's Creek/Klamath Beach Road: Before and After shots of blocked inlet**

**Preferred Treatment:** when culvert wears-out, replace with a properly-sized arch-culvert on concrete footings or pipe-arch set below stream grade. National Park trail located along upstream side of road fill; suggest requesting National Park share cost of upgrading this crossing.
