APPENDIX B:

**CATALOG OF COASTAL MENDOCINO COUNTY
CULVERTS LOCATED ON FISH-BEARING STREAM
REACHES**

NOTE: This catalog contains two pages for each culvert included inventoried. The first page consists of location information, site-specific data, habitat notes, and a map. The second page has inlet and outlet photographs, with the inlet photo on the left side (or top) and the outlet photo on either the right side or bottom. Generally, sites are ordered in their location within Mendocino County from north to south, and from lowermost to uppermost road/stream intersection within a watershed.

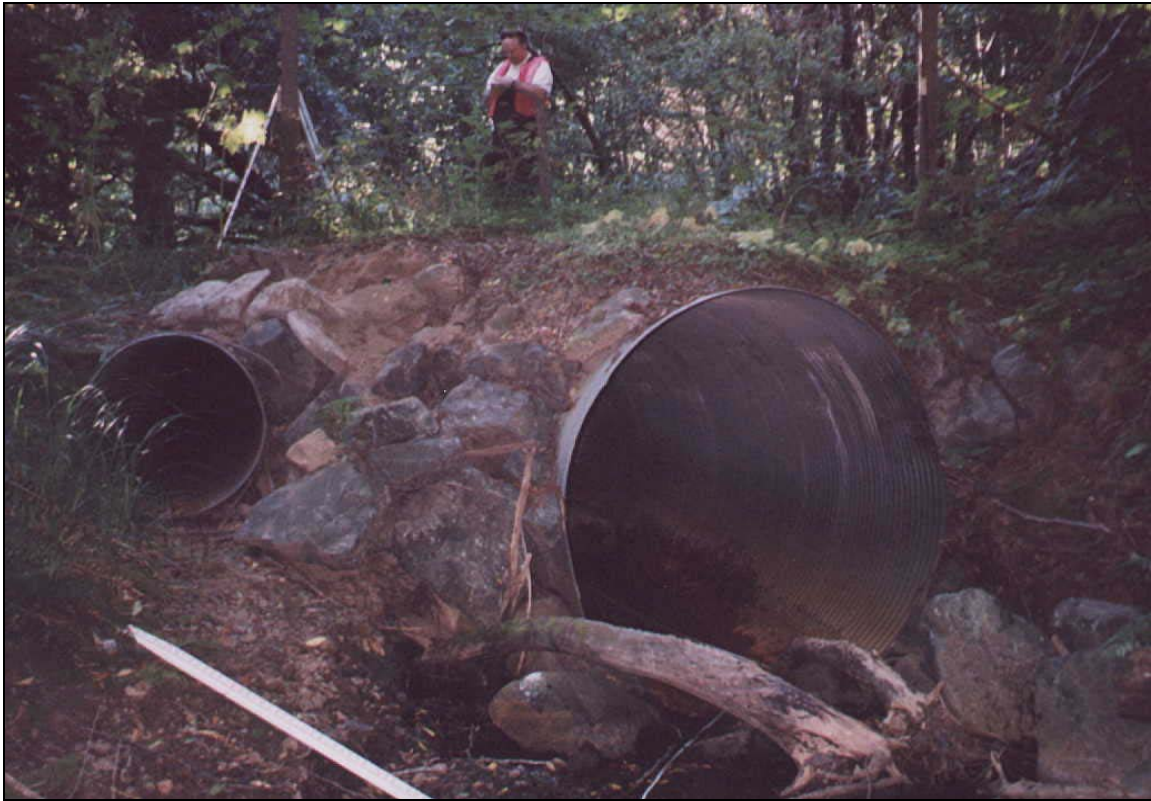
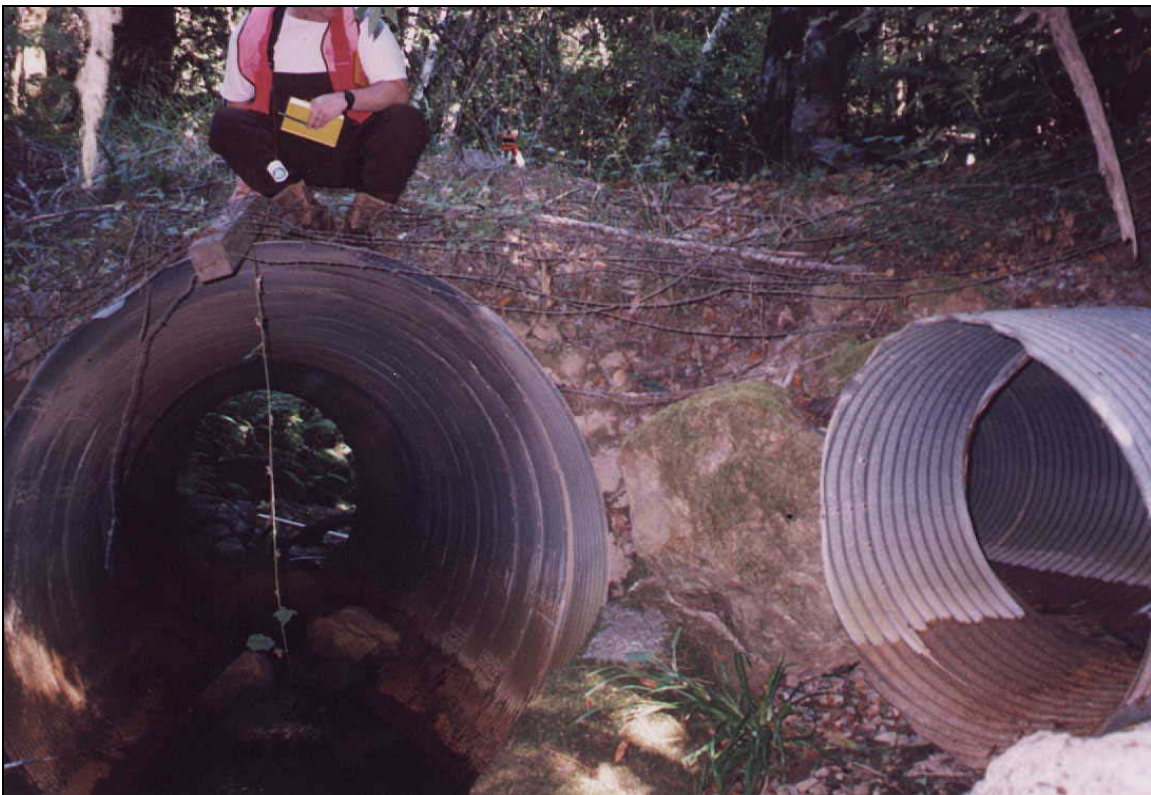
Site #1: Ancestor Creek/Briceland Road; Mattole River

Modifications: None **Fill Estimate:** 320 cubic yards **Overall condition:** Poor.

Sizing: Undersized; HW/D = 1 on a storm flow with approximately an eight-year recurrence interval. Briceland Road is overtopped on approximately a 13-year storm flow.

Barrier Status: For the range of migration flows ($Q_{lp} - Q_{hp}$), FishXing predicted this crossing to be a 100% barrier for adult coho salmon and steelhead; and all age classes of juveniles (young-of-year coho and y-o-y, 1+ and 2+ steelhead).

Preferred Treatment: Properly-sized bridge or arch-culvert set on concrete footings.

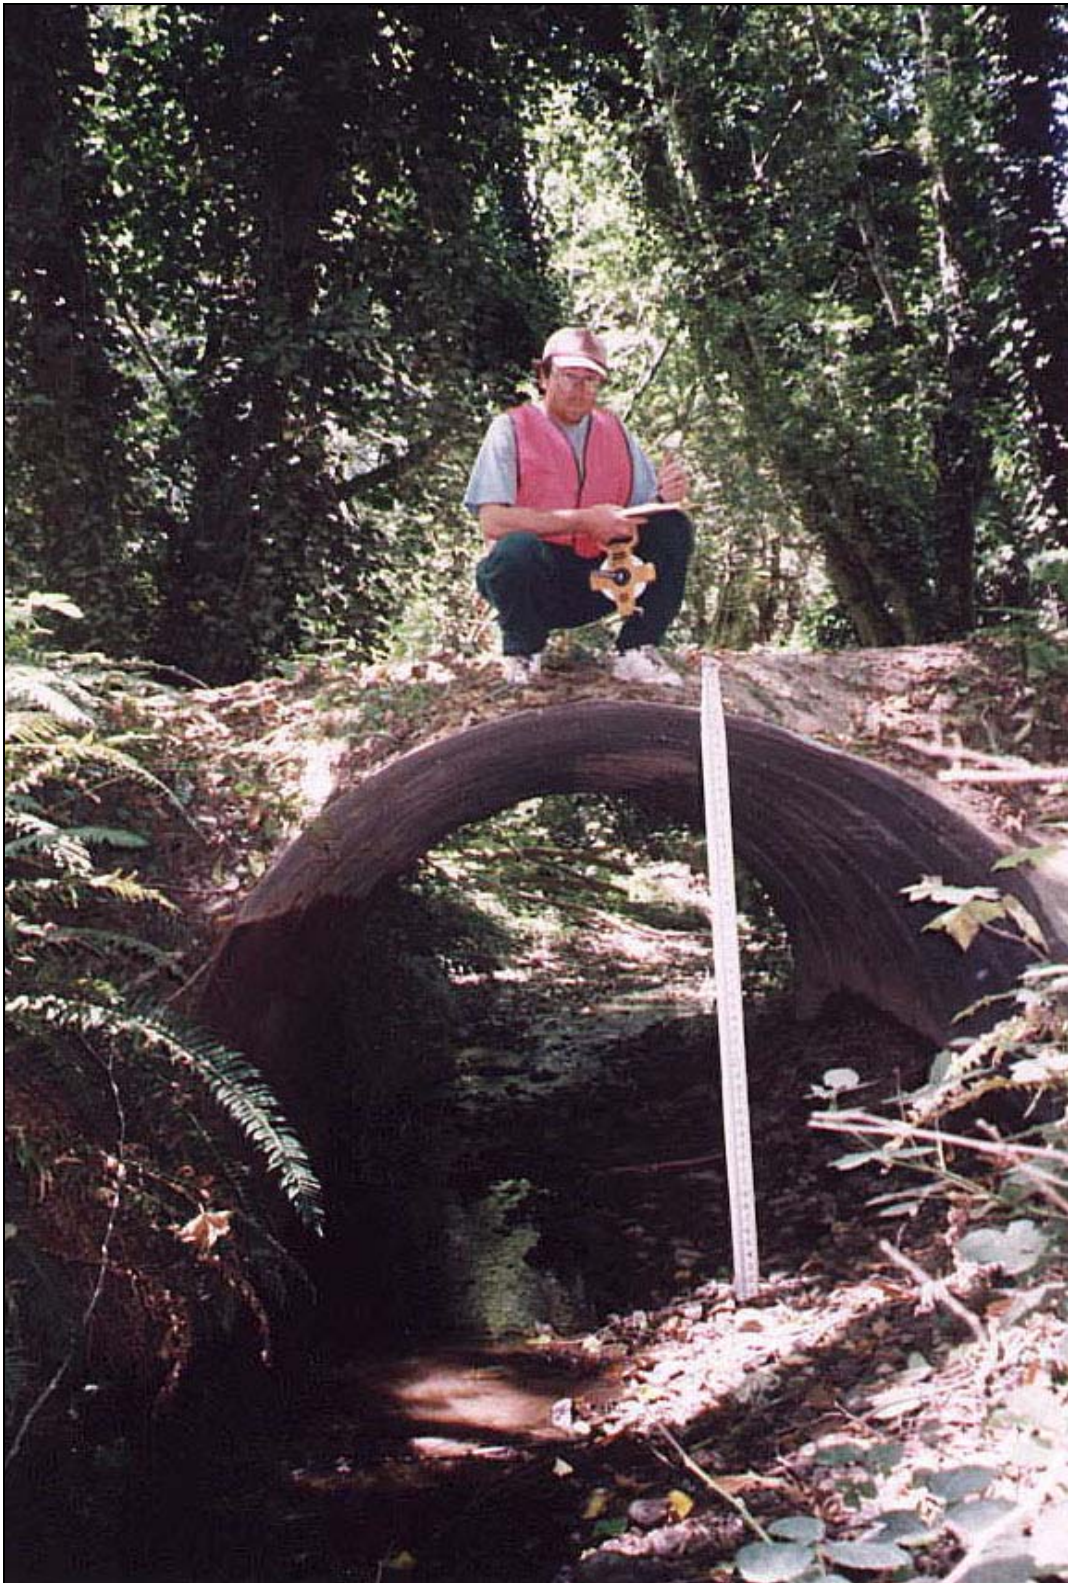
Site #2: Hotel Gulch/Usal Road; Usal Creek: Outlet Photograph only.

Fill Estimate: 153 cubic yards **Overall condition:** Poor, from skewed angle of rustline appears crossing has failed and was reset.

Preferred Treatment: Properly-sized bridge or arch-culvert set on concrete footings.

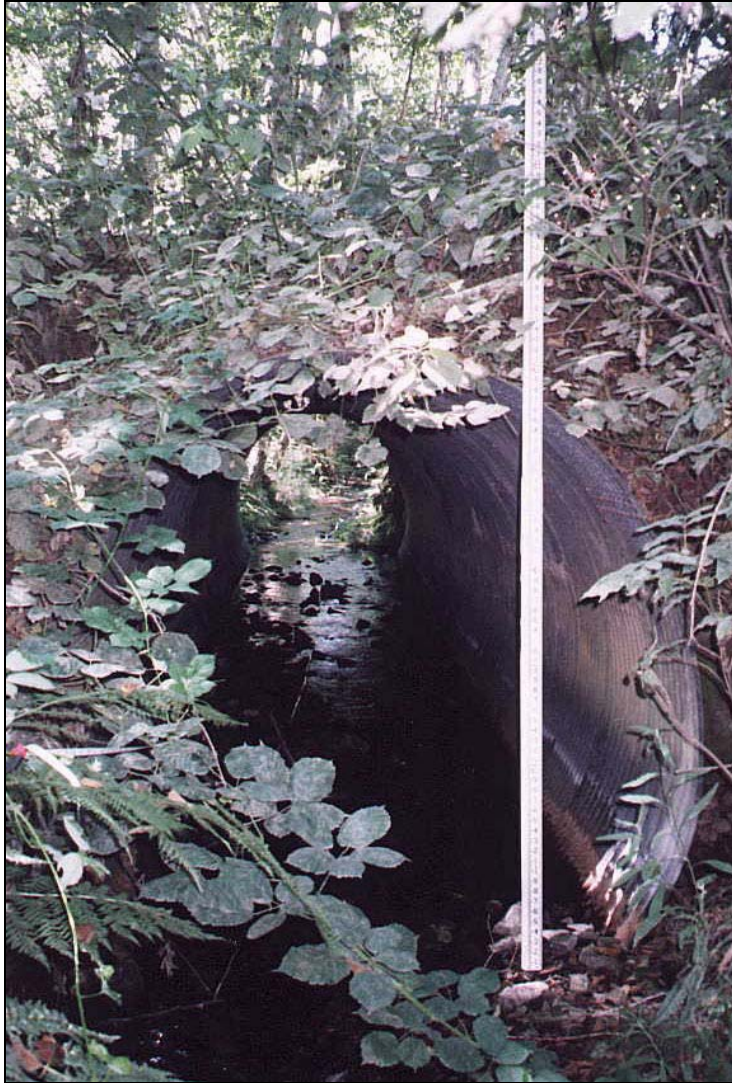
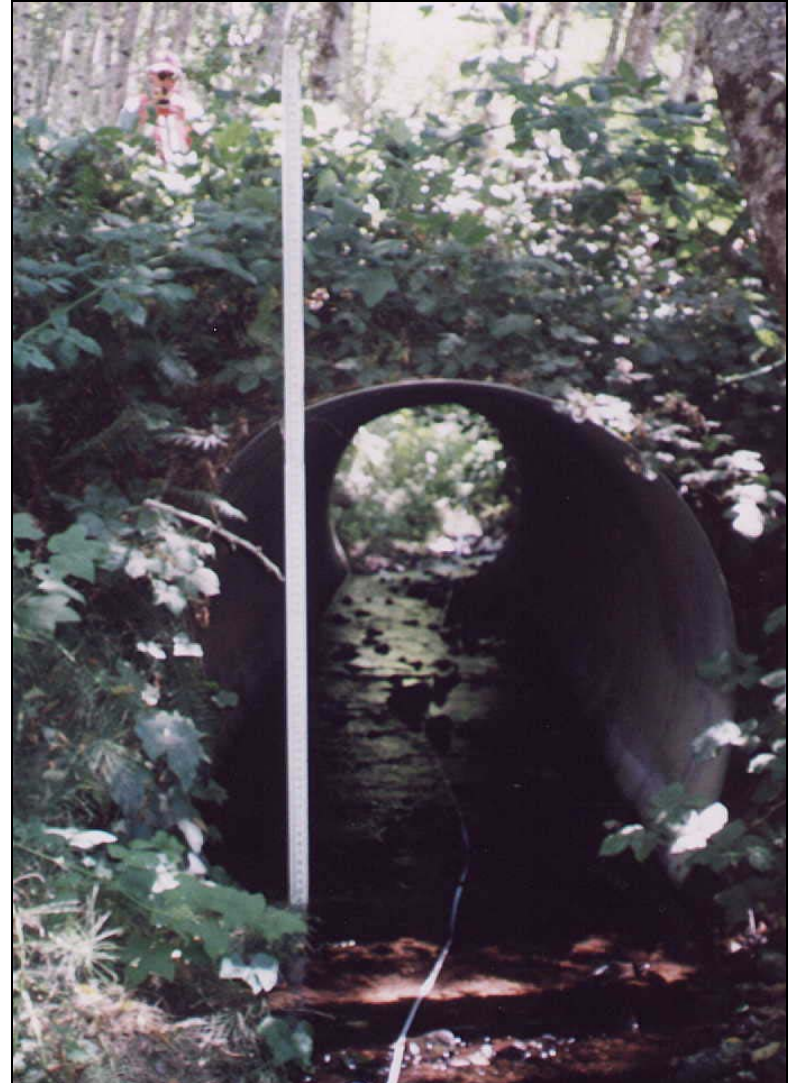
Site #3: Shady Dell/Usal Road; Usal Creek

Overall condition: Good.

Preferred Treatment: Properly-sized bridge or arch-culvert set on concrete footings.

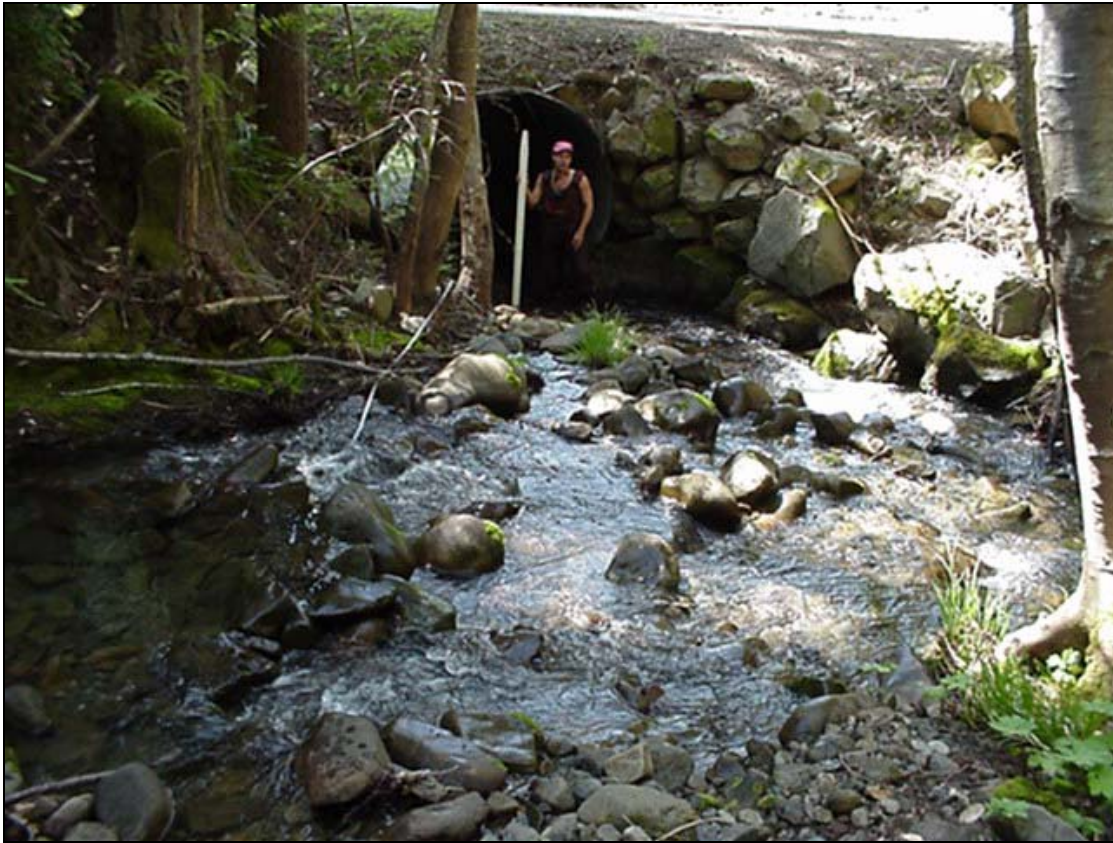
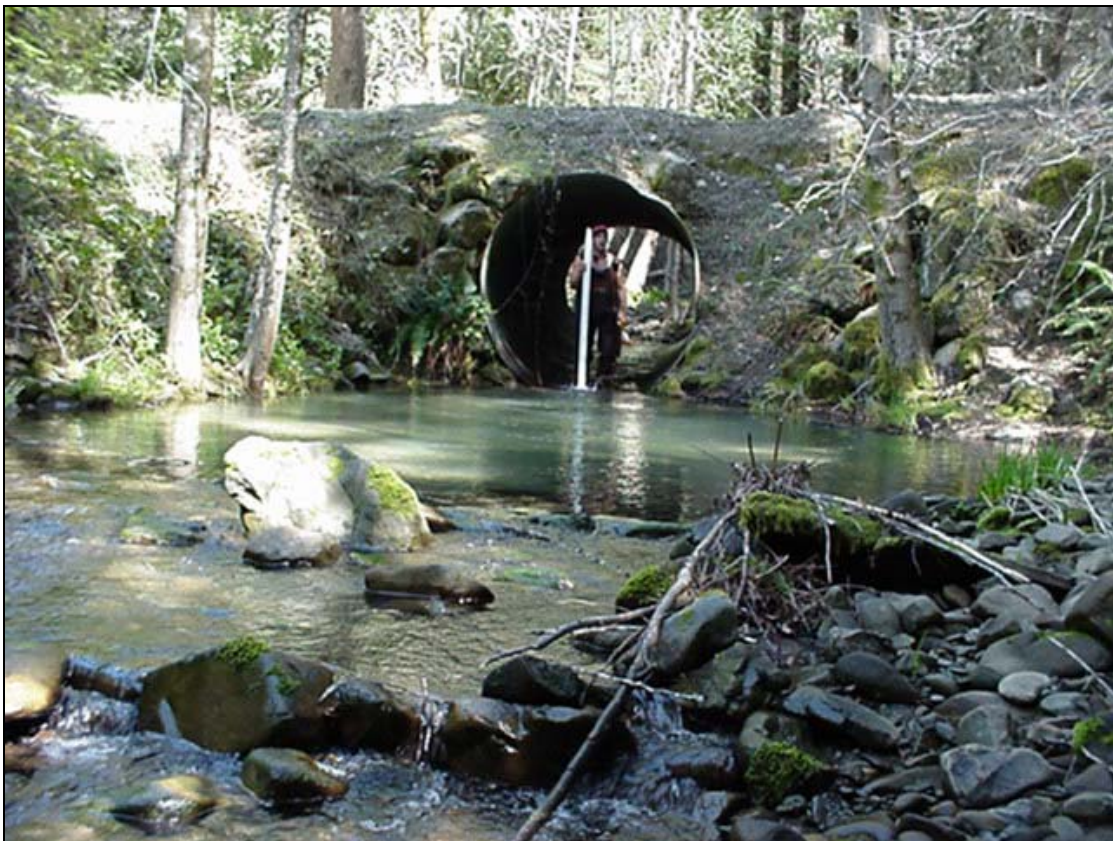
Site #4: Deer Creek/Wilderness Lodge Road; South Fork Eel River

Fill Estimate: 511 cubic yards **Overall condition:** Fair.

Preferred Treatment: Properly-sized bridge or arch-culvert set on concrete footings.

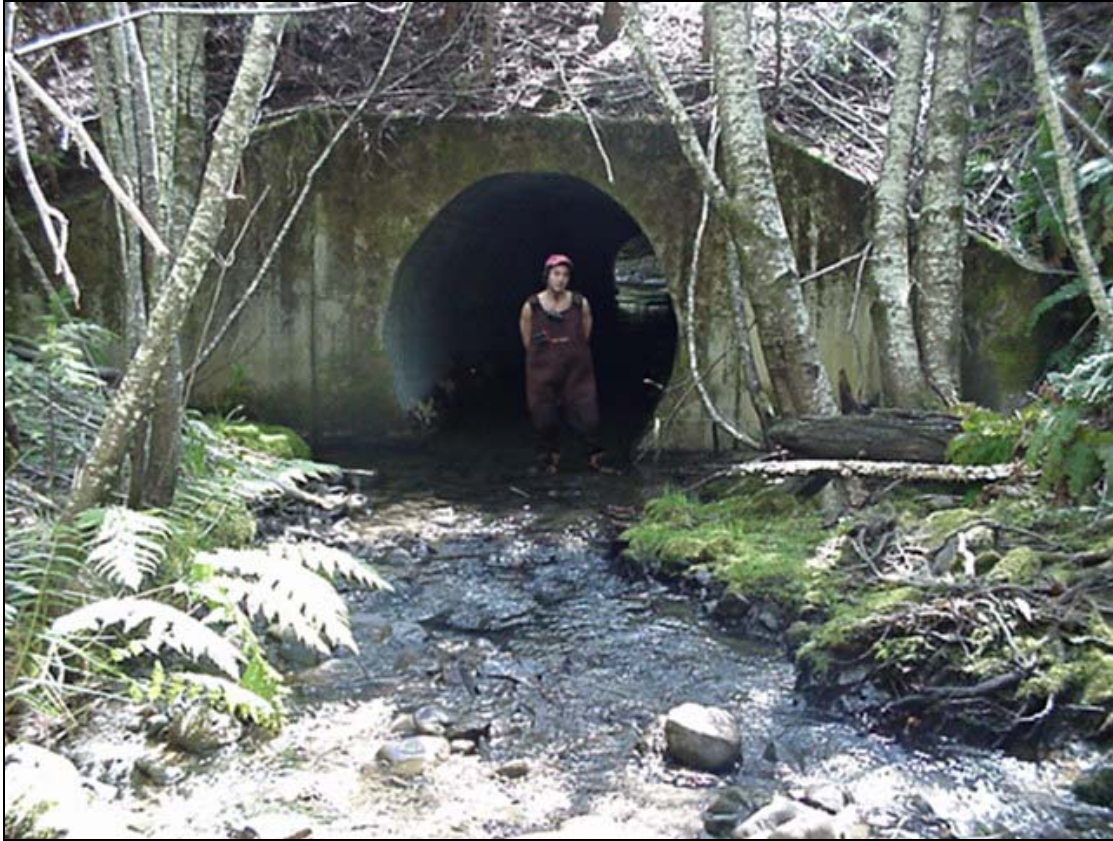
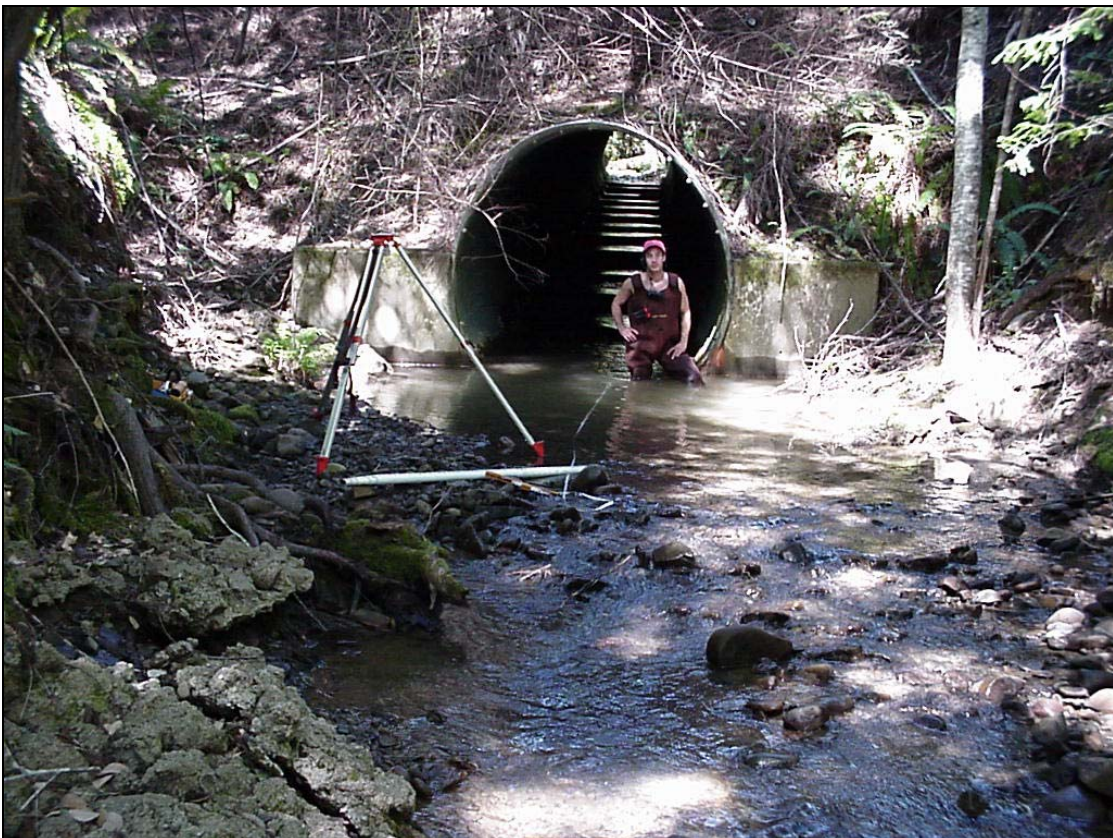
Site #5: Taylor Creek/Branscomb Road; South Fork Eel River

Modifications: Yes, 12 sets of notched redwood baffles. Appear to retain substrate and break-up steep slope, three sets have completely failed and others are close to failure. Floor is lined with concrete.

Fill Estimate: 11,548 cubic yards **Overall condition:** Fair, but baffles need repair/replacement.

Barrier Status: For the range of migration flows ($Q_{lp} - Q_{hp}$), FishXing predicted this crossing to be 99% passable for adult coho salmon and steelhead; and 100% passable for all age classes of juveniles (young-of-year coho and y-o-y, 1+ and 2+ steelhead). The passage analyses assumed all 12 baffles were functioning properly; however three sets of baffles have failed and others are deteriorating.

Preferred Treatment: Modify existing culvert by replacing all 12 sets of baffles.

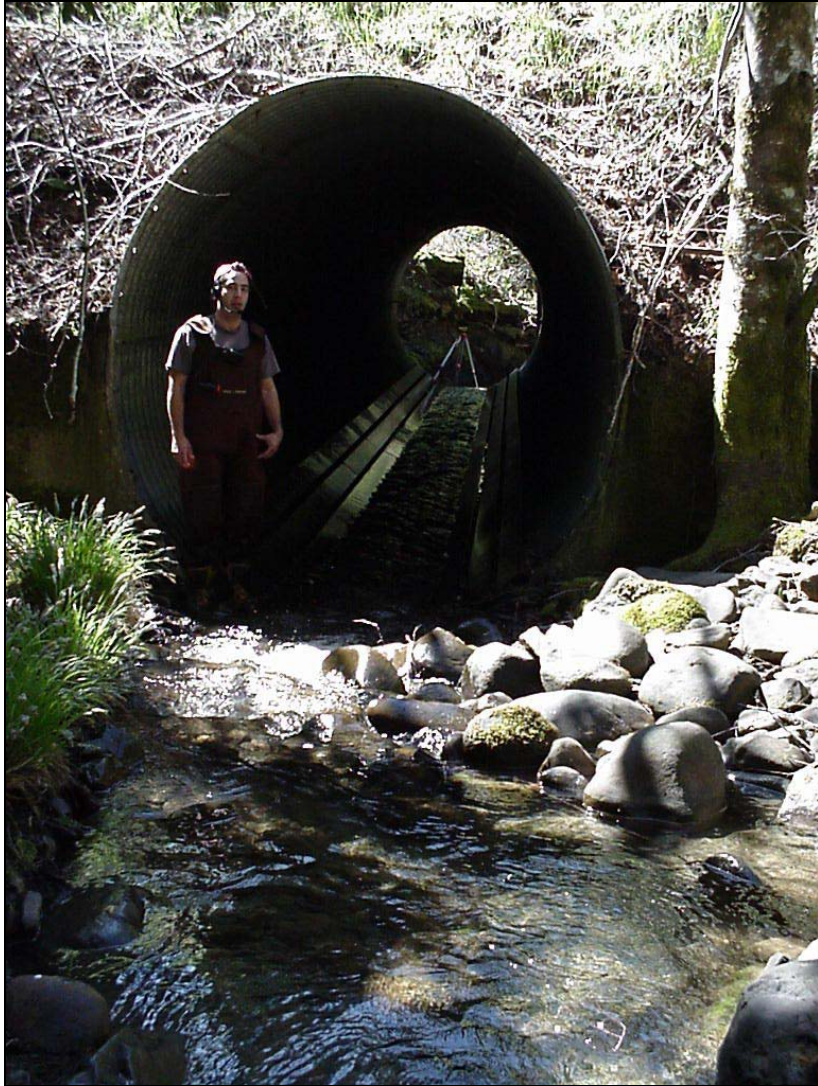
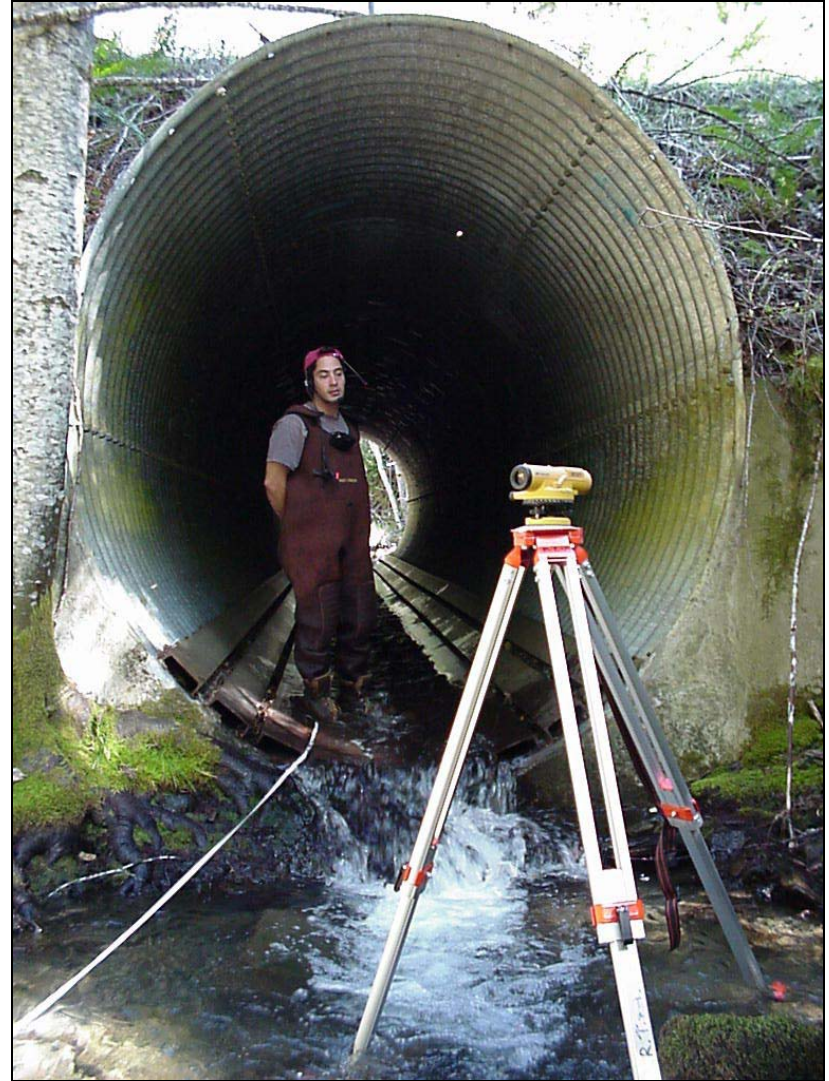
Site #6: Bear Creek/Branscomb Road; South Fork Eel River

Barrier Status: For the range of migration flows ($Q_{lp} - Q_{hp}$), FishXing determined for juveniles (all age classes) = 100% barrier due to excessive velocities caused by steep slope. Adults (coho salmon and steelhead) = 100% barrier due to excessive velocities. Culvert also lacks adequate depth on lower range of migration flows. A single steelhead young-of-year observed below road crossing.

Preferred Treatment: Remove steel plates and install series of weirs similar to Taylor Creek culvert.

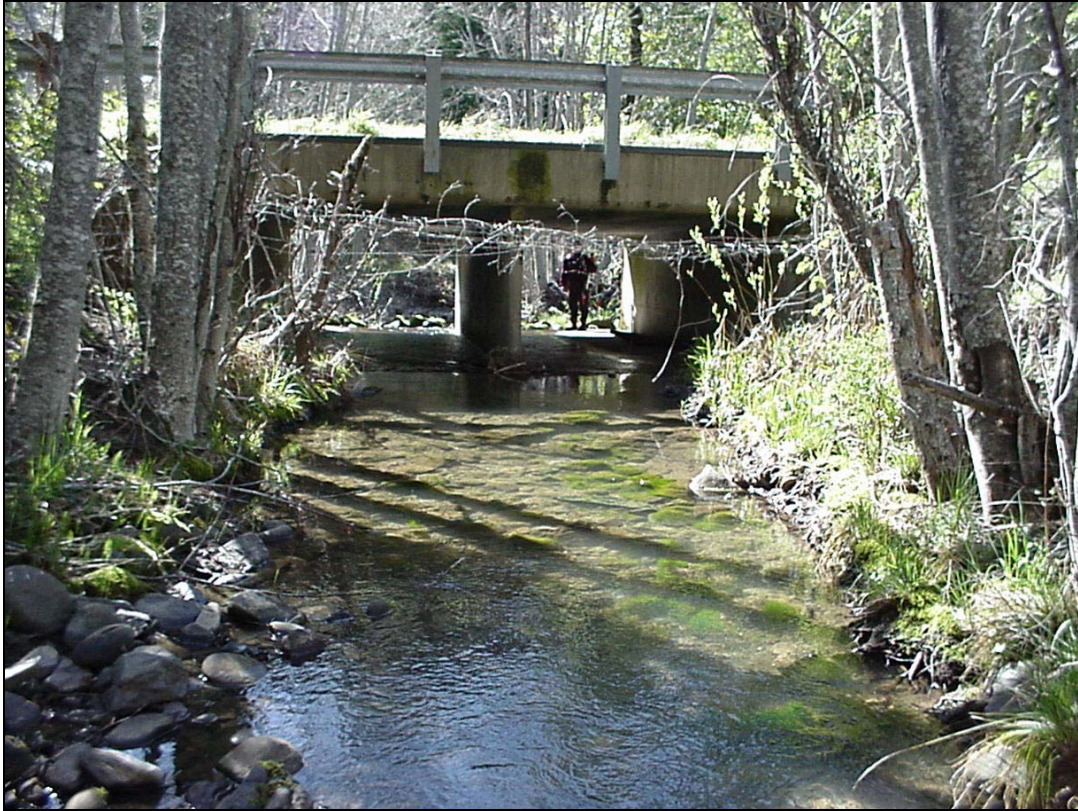
Site #7: Windem Creek/Branscomb Road; South Fork Eel River

Barrier Status: For the range of migration flows ($Q_{lp} - Q_{hp}$), FishXing determined for juveniles (all age classes) = 100% barrier due to excessive velocities caused by steep slope and smooth floor. Adults (coho salmon and steelhead) = 20% passable; barrier due to lack of depth on lower flows and excessive velocities on higher migration flows. Steep drop over riprap below outlet may impede passage too.

Preferred Treatment: Modify both bays of existing box culvert with a notched outlet beam and baffles within each bay. Riprap at outlet may require some modification too.

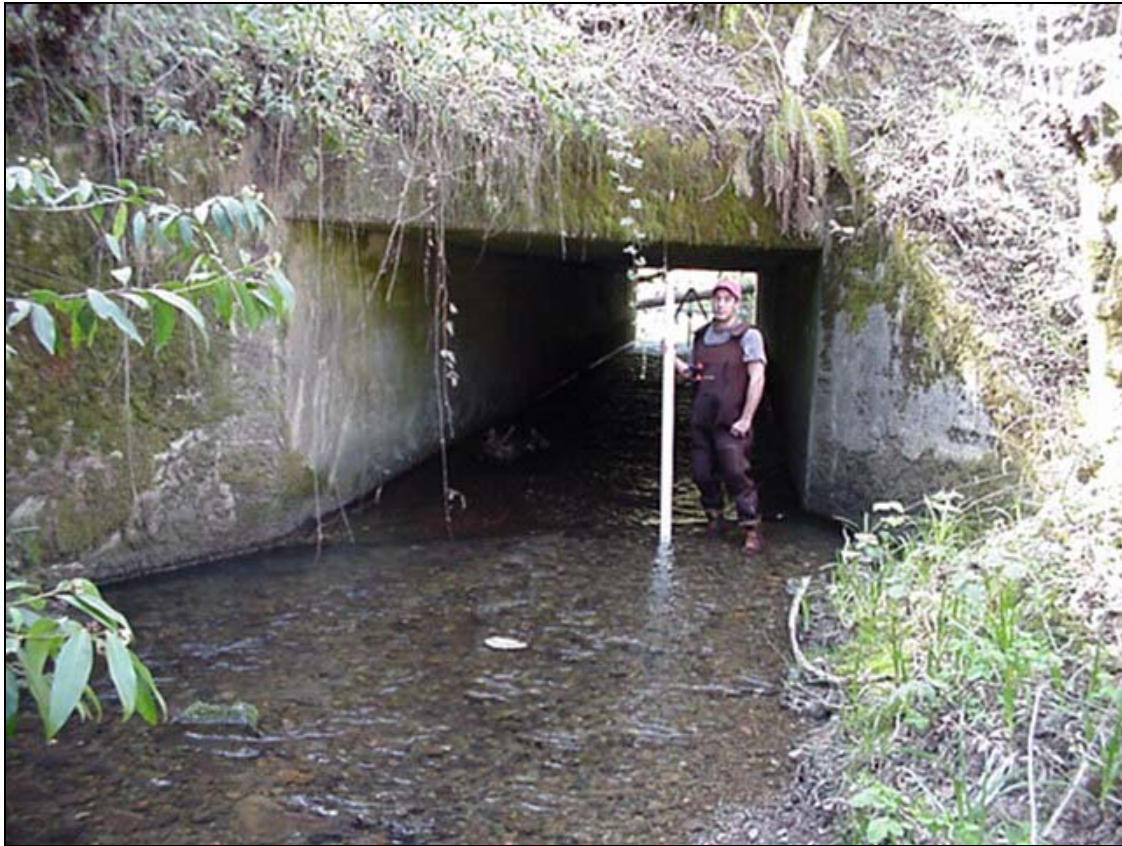
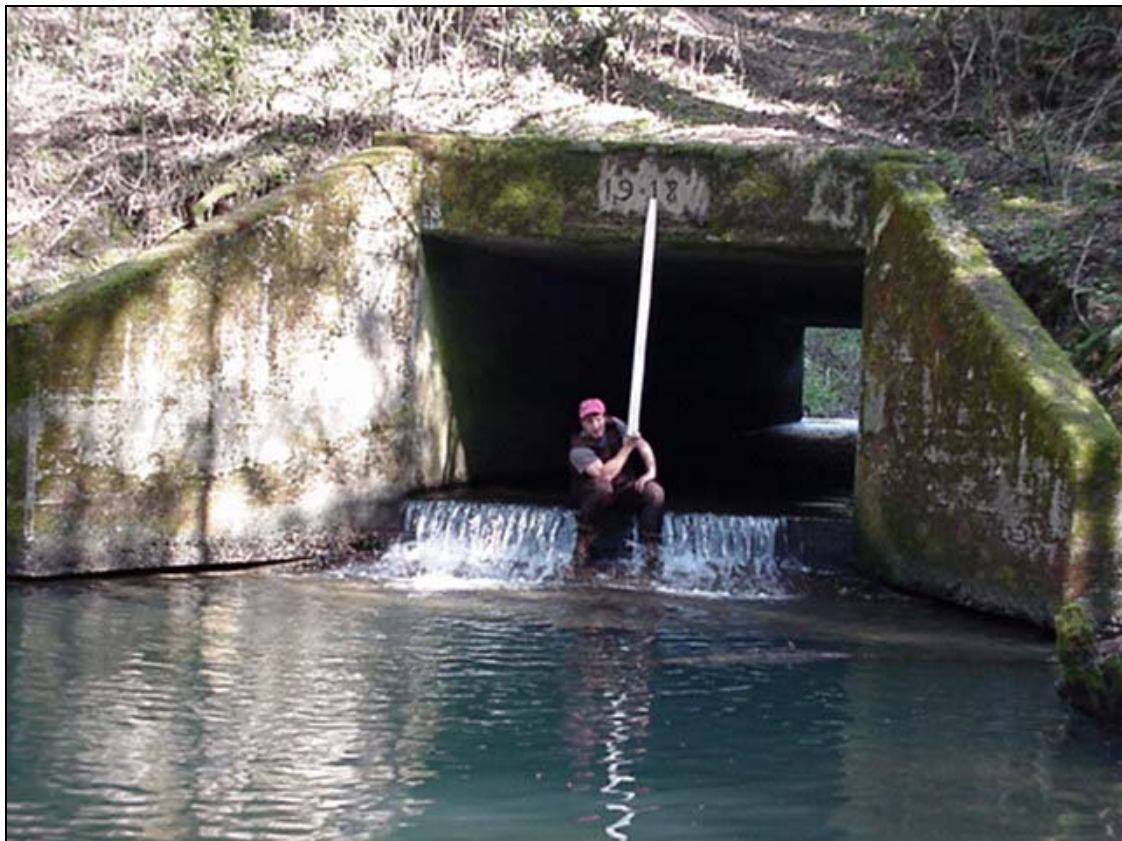
Site #8: Ryan Creek/Ryan Creek Road; Outlet Creek/South Fork Eel River

Fill Estimate: 7,975 cubic yards **Overall condition:** Poor; outlet apron cracked and slumped (see photo).

Barrier Status: For the range of migration flows ($Q_{lp} - Q_{hp}$), FishXing determined crossing is 20% passable for adults (coho salmon, chinook salmon, and steelhead). For juveniles (all age classes) = 100% barrier due to excessive velocities and entry jump required at outlet. Broken concrete apron at outlet is a major impediment to fish migration (Harris, pers. comm.).

Preferred Treatment: Replace existing crossing with a properly-sized bridge or arch-culvert set on concrete footings. Removal of crossing is also an option since access to Highway 101 is possible in either direction.

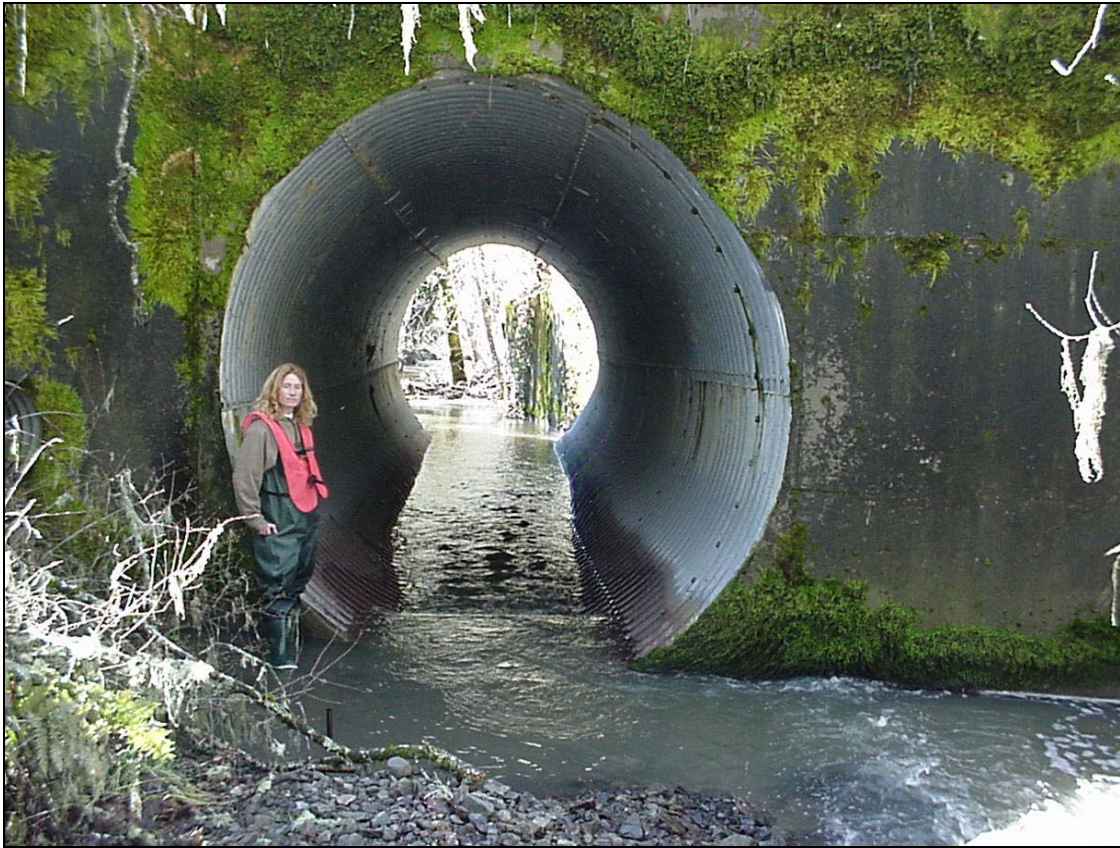
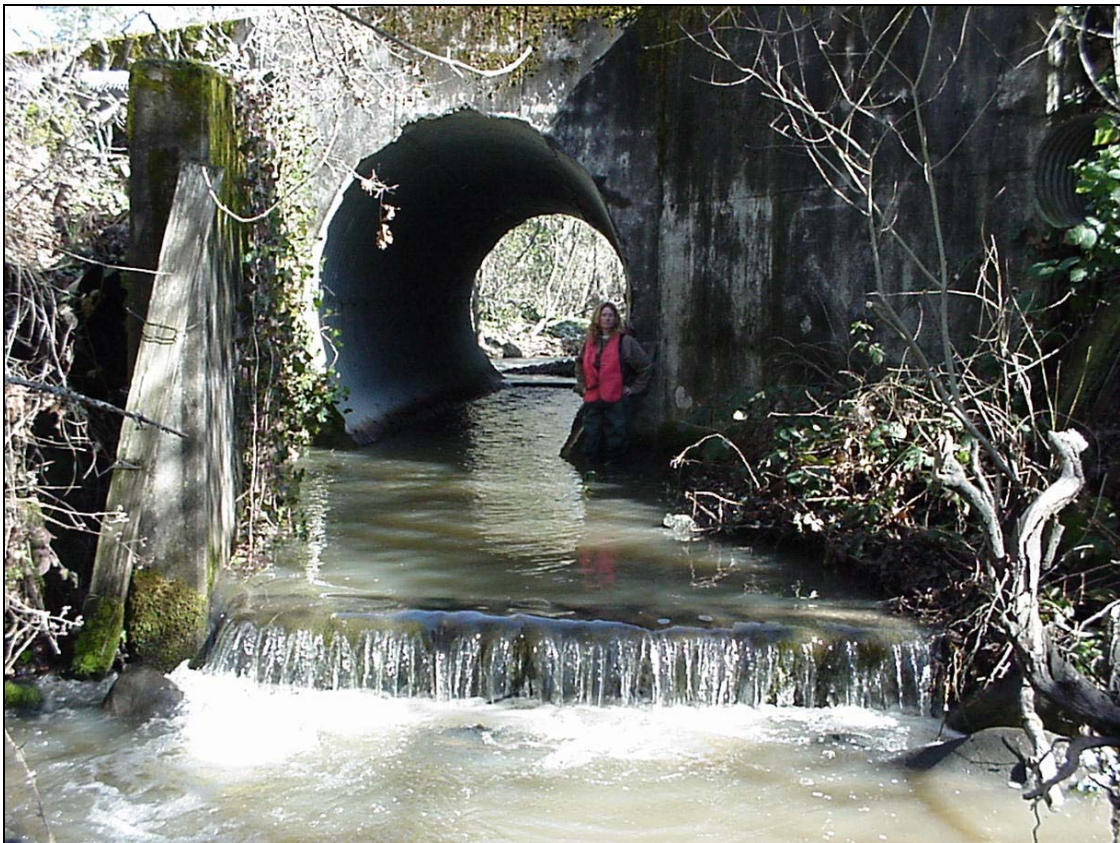
Site #9: Davis Creek tributary/Eastside Road; Outlet Creek/South Fork Eel River

Fill Estimate: 1,044 cubic yards **Overall condition:** Poor; floor rusted through in several locations.

Preferred Treatment: When current crossing fails, replace with a properly-sized bridge or arch-culvert set on concrete footings.

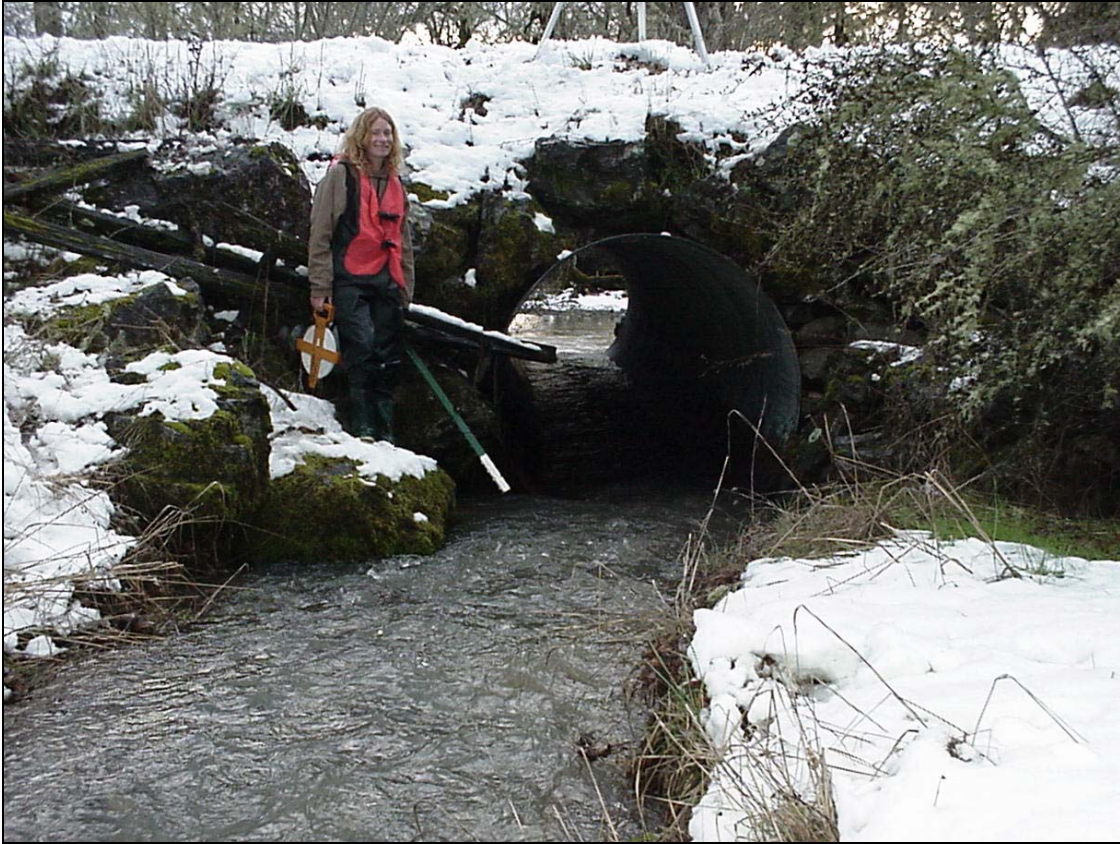
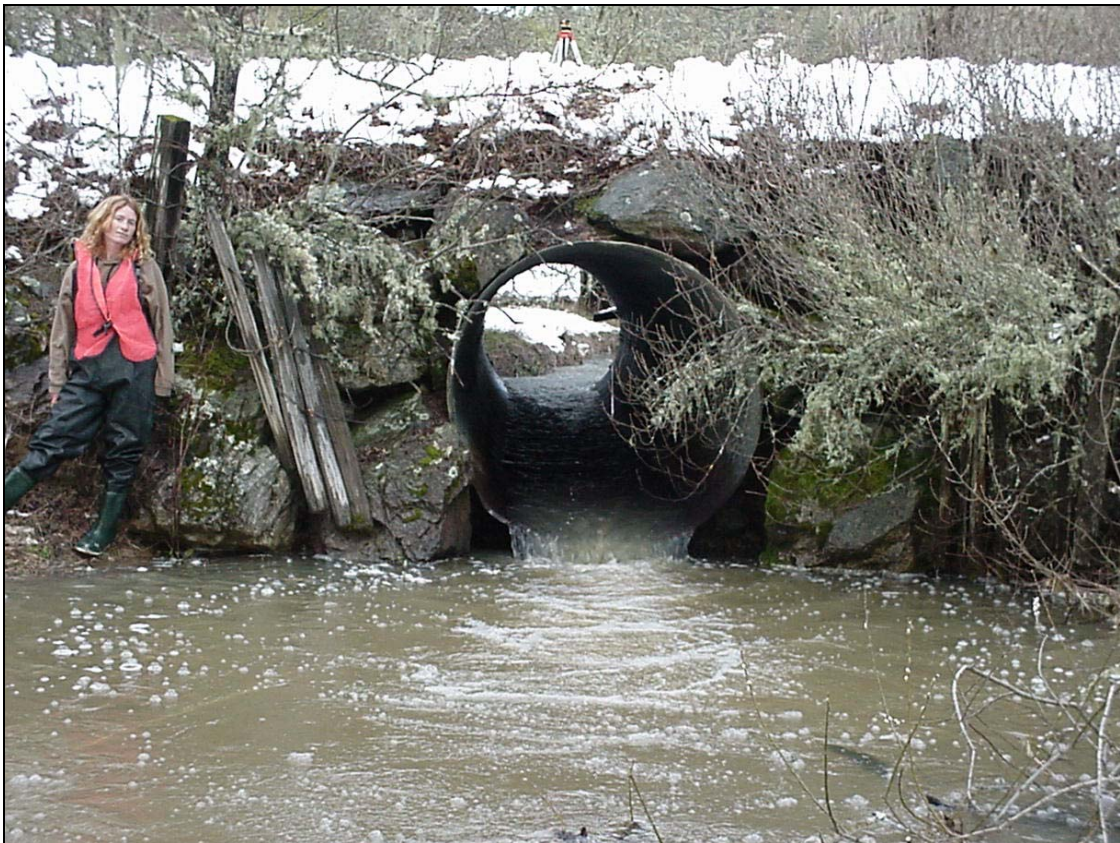
Site #10: Fulweiler Creek (northern fork) /Eastside Road; Outlet Creek/South Fork Eel River

Modifications: None **Fill Estimate:** 1,044 cubic yards **Overall condition:** Poor; floor rusted through in several locations.

Preferred Treatment: When current crossing fails, replace with a properly-sized bridge or arch-culvert set on concrete footings.

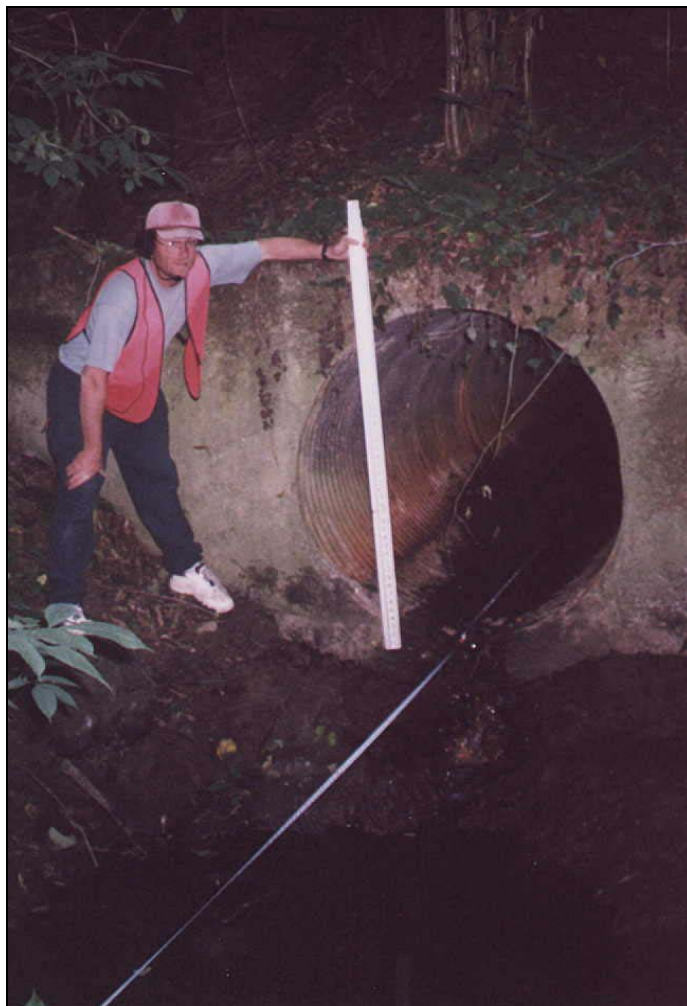
Site #11: Mill Creek tributary/ Westwood Drive; Coastal/Lake Cleone

Fill Estimate: 6,605 cubic yards **Overall condition:** Poor, floor is rusted through in numerous places.

Preferred Treatment: When culvert fails, replace with a properly-sized arch-culvert set on concrete footings or countersunk pipe. Minimal potential for anadromous fisheries and high cost of fill removal make this crossing a low-priority site for restoration funding.

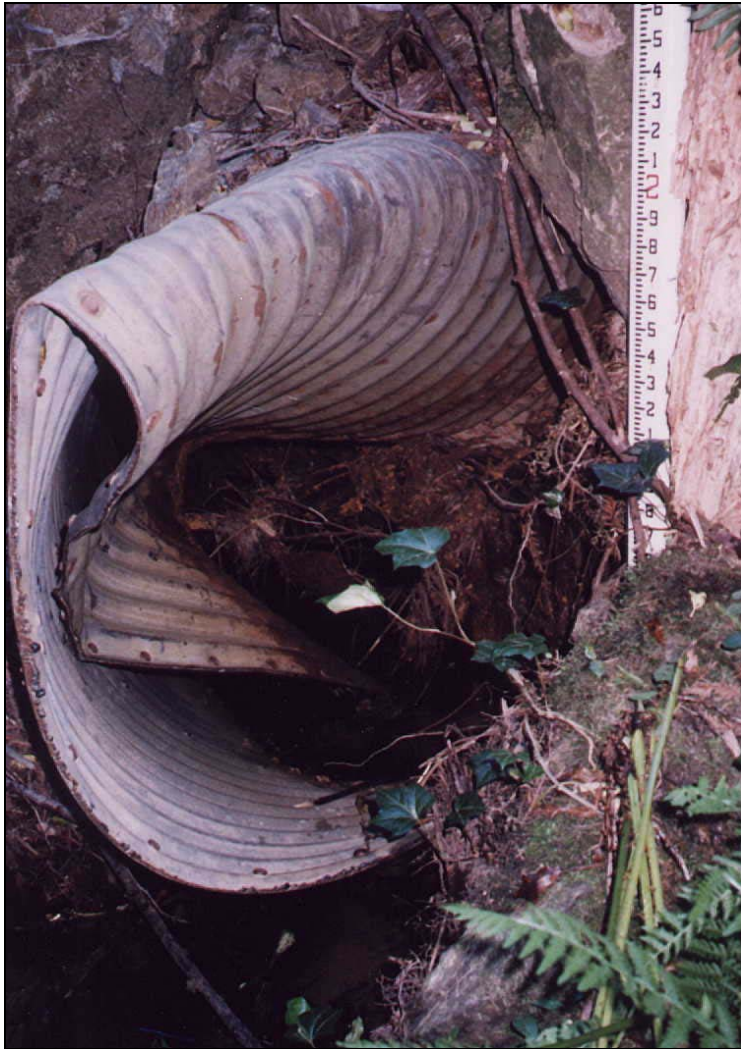
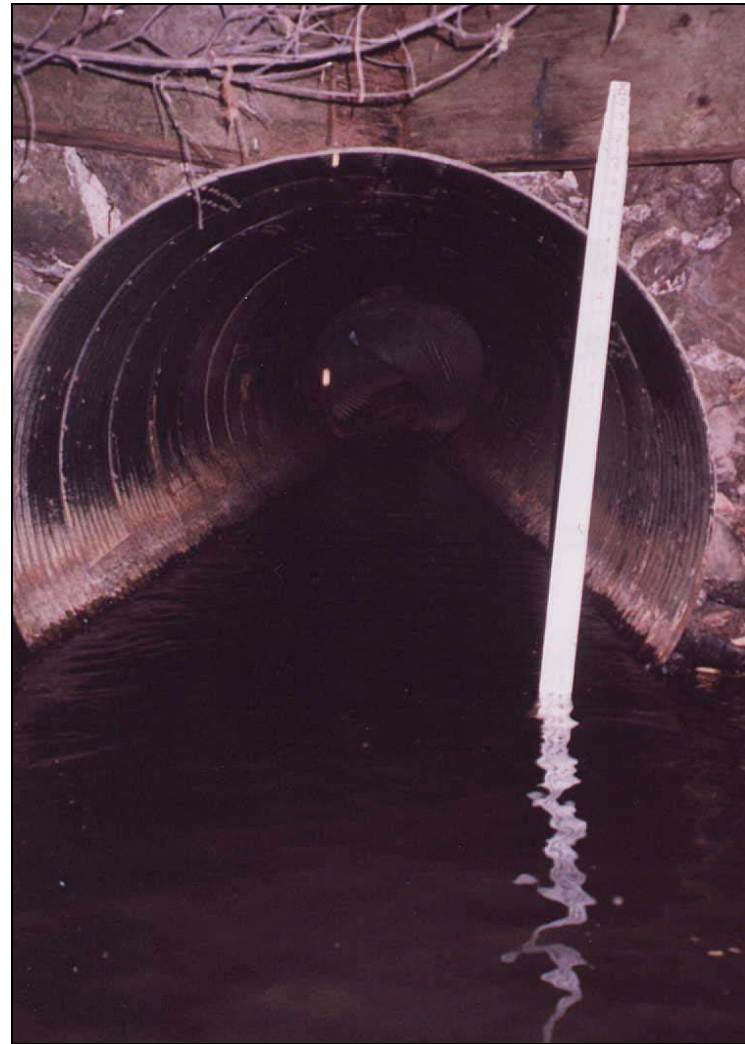
Site #12: Virgin Creek/Airport Road; Coastal

Dimensions: Diameter = 5.0' **Length:** 38.0' **Slope:** not measured, but < 2% (inlet crushed at time of survey, but was repaired 9/99). Culvert was backwatered at low summer flow and during winter visit.

Modifications: None **Fill Estimate:** 1,069 cubic yards **Overall condition:** Poor, rusted floor; inlet was crushed when initially surveyed, but fixed by Mendocino DOT.

Preferred Treatment: Properly-sized bridge or arch-culvert set on concrete footings. Lack of potential upstream habitat gains makes this site a low priority for treatment with restoration funds, but should be eventually treated with Mendocino County DOT maintenance funds.

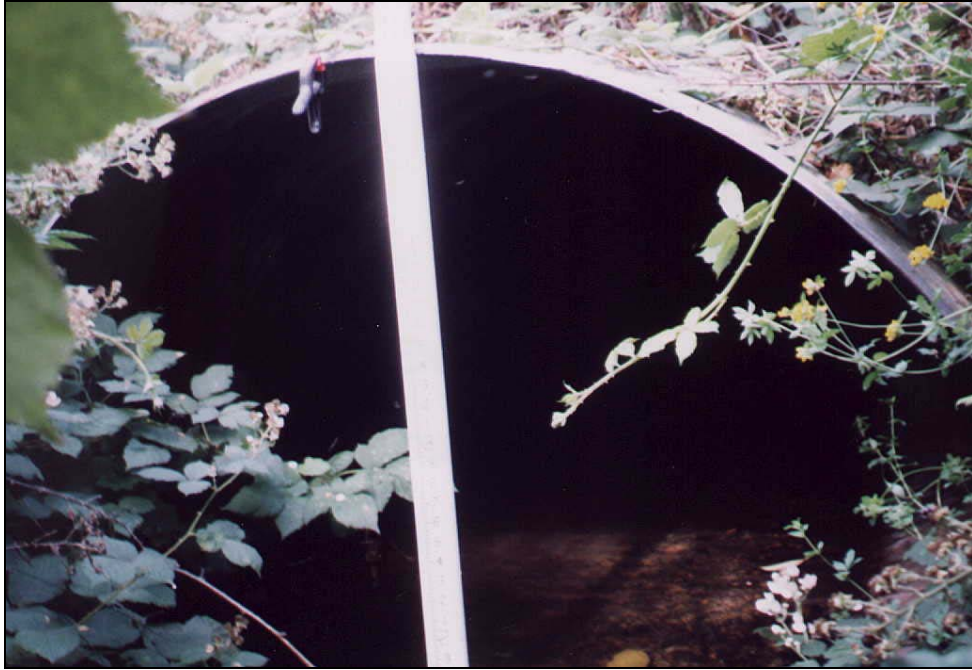
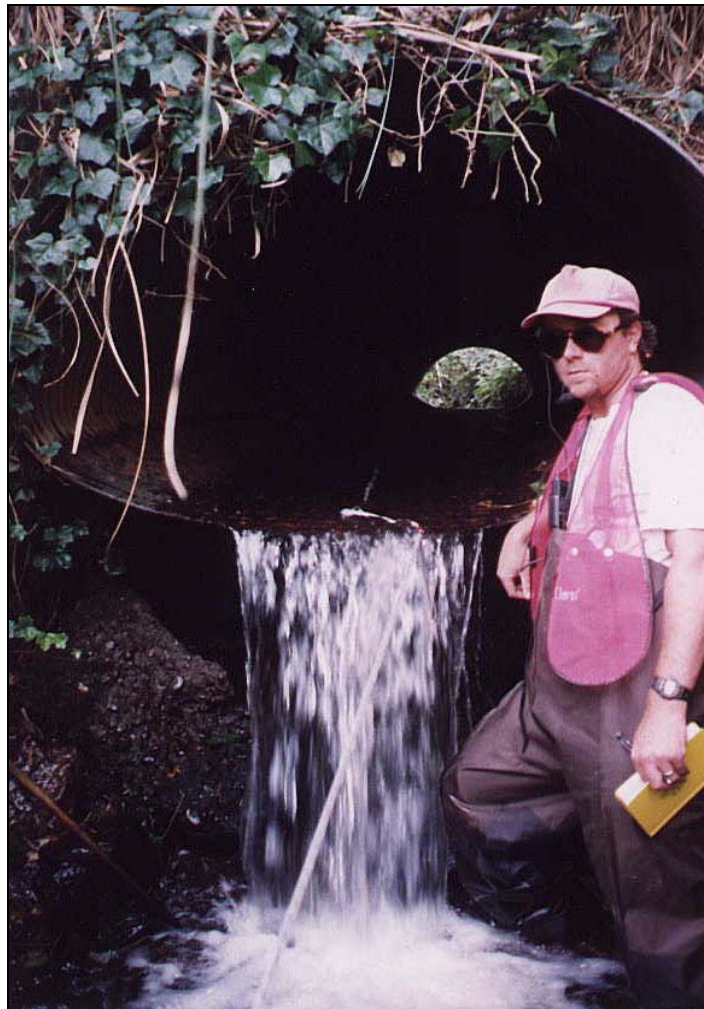
Fill Estimate: 1,443 cubic yards **Overall condition:** Poor

Preferred Treatment: Replace with a properly-sized pipe arch set on concrete footings.
