APPENDIX B:

**CATALOG OF COASTAL MENDOCINO COUNTY
CULVERTS LOCATED ON FISH-BEARING STREAM
REACHES**

NOTE: This catalog contains two pages for each culvert included inventoried. The first page consists of location information, site-specific data, habitat notes, and a map. The second page has inlet and outlet photographs, with the inlet photo on the left side (or top) and the outlet photo on either the right side or bottom. Generally, sites are ordered in their location within Mendocino County from north to south, and from lowermost to uppermost road/stream intersection within a watershed.

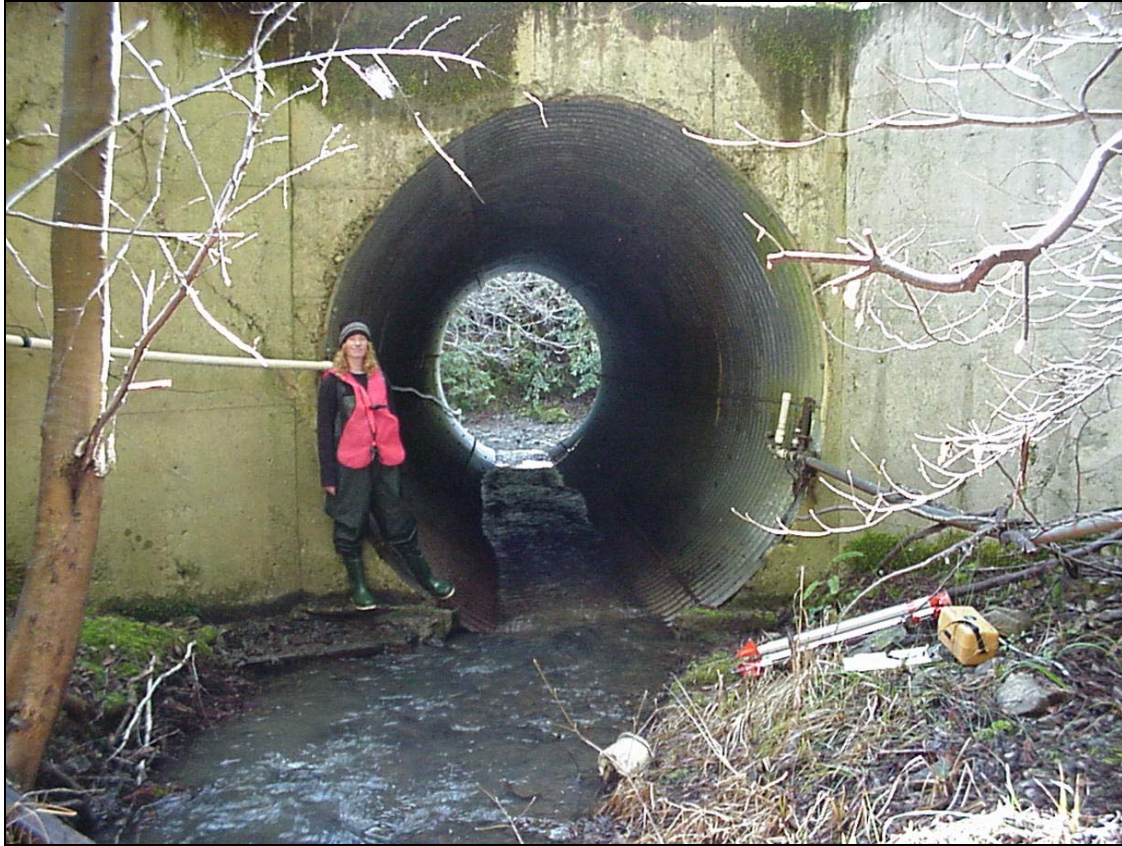
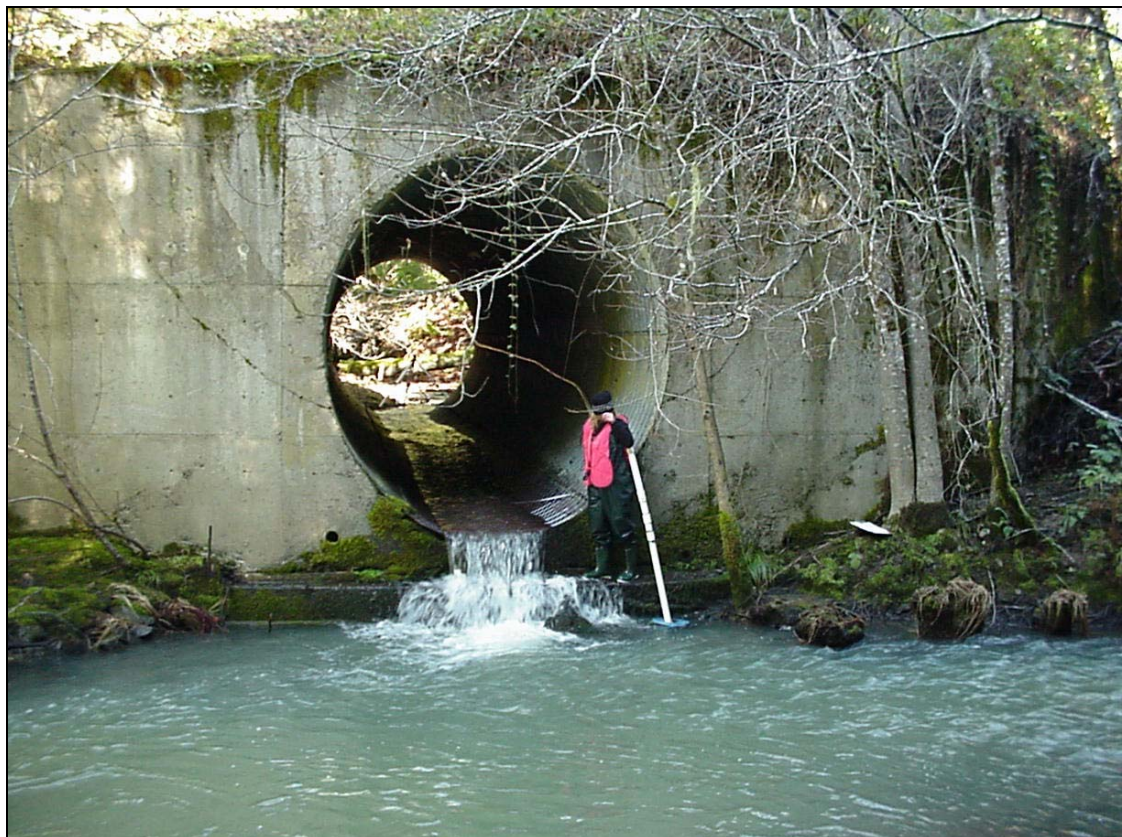
Site #15: Johnson Creek/Orr Springs Road; South Fork Big River; Big River

Fill Estimate: 906 cubic yards **Overall condition:** Good.

Preferred Treatment: Properly-sized bridge or pipe-arch set on concrete footings.

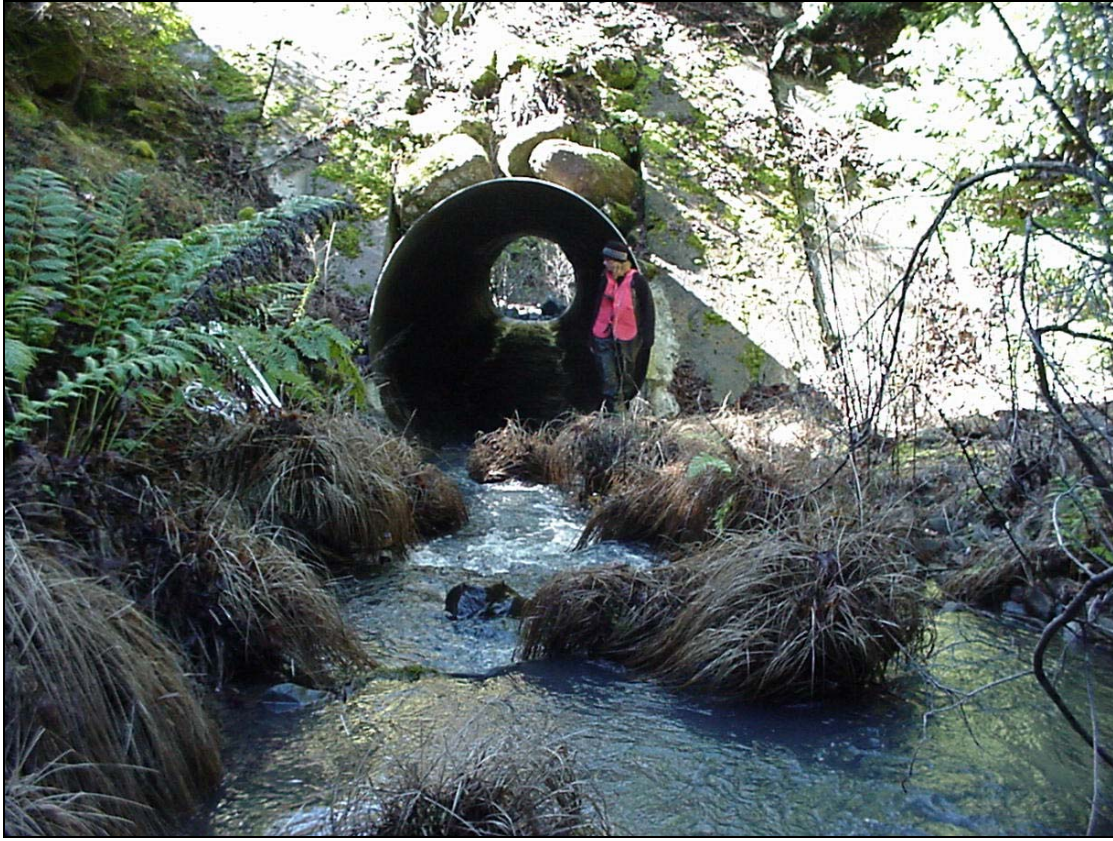
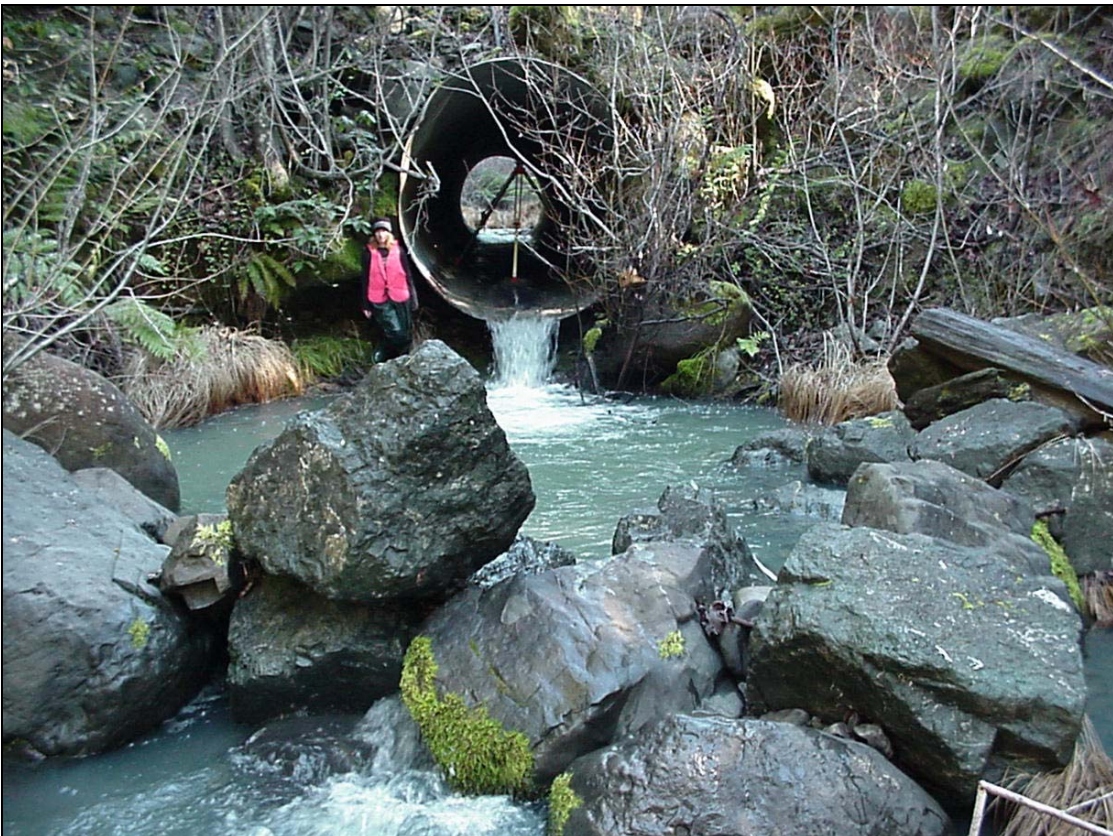
Site #16: Dark Gulch/Orr Springs Road; So.Fk. Big River; Big River

Fill Estimate: 3,200 cubic yards **Overall condition:** Poor, culvert floor is rusted through in numerous places.

Preferred Treatment: Properly-sized bridge or pipe-arch set on concrete footings.

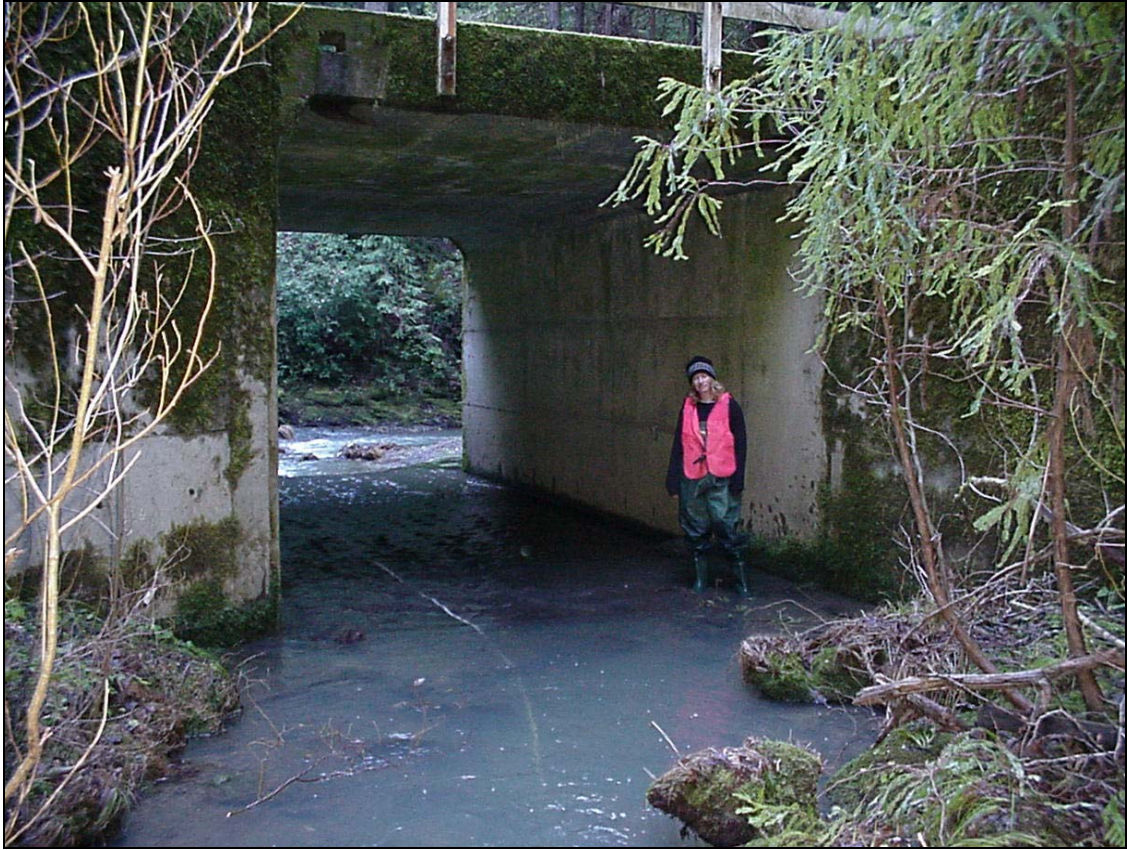
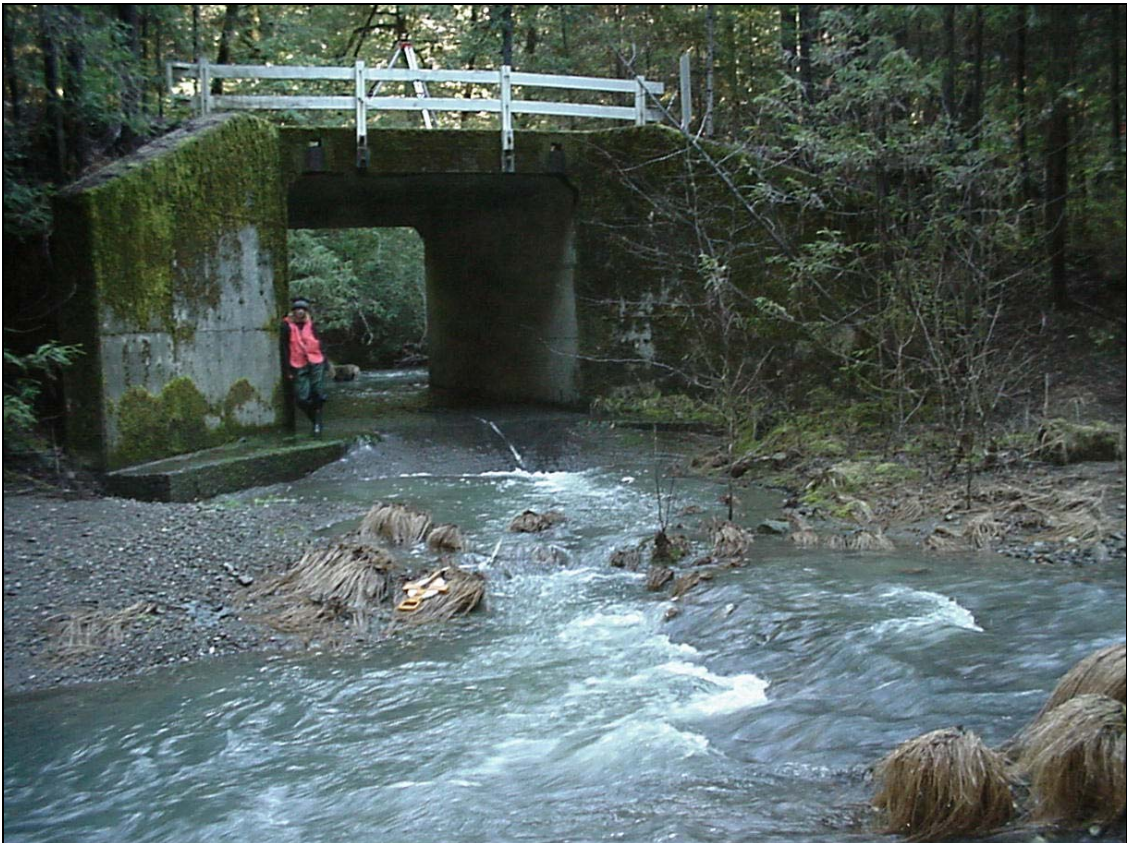
Site #17: Unnamed tributary/Orr Springs Road; South Fork Big River; Big River

Modifications: None. **Fill Estimate:** No fill material. **Overall condition:** Good.

Preferred Treatment: Properly-sized bridge or pipe-arch set on concrete footings.

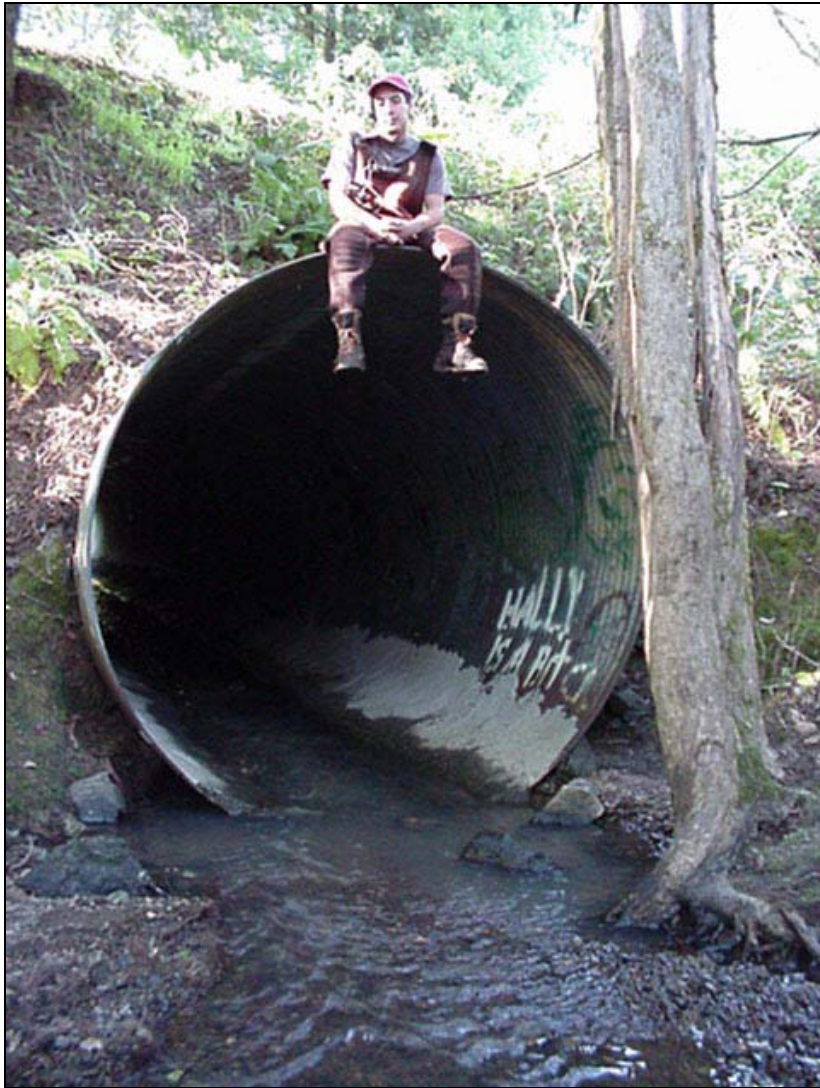
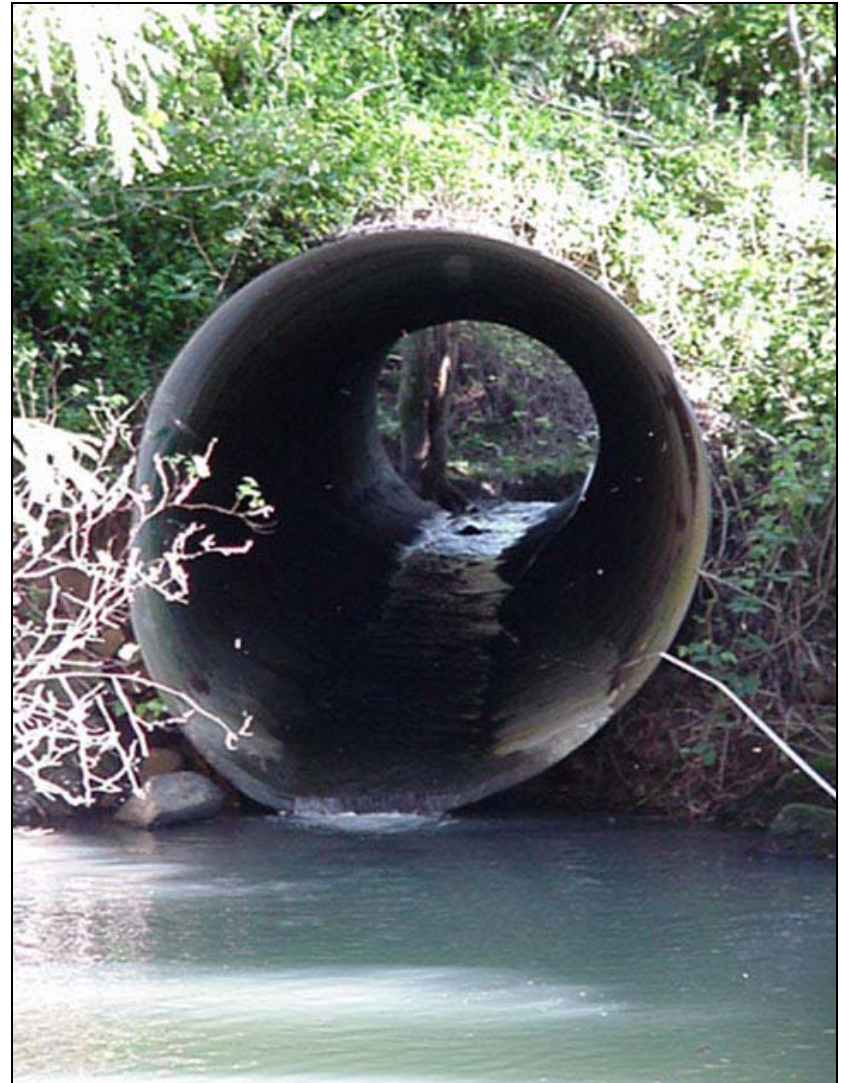
Site #18: Marsh Creek/ Flynn Creek Road; Albion River

Fill Estimate: 2,955 cubic yards **Overall condition:** Poor, concrete used to patch rusted-out floor. Culvert is poorly aligned with stream channel; flow takes about 45° turn (left) at inlet.

Preferred Treatment: Properly-sized bridge or pipe-arch set on concrete footings.

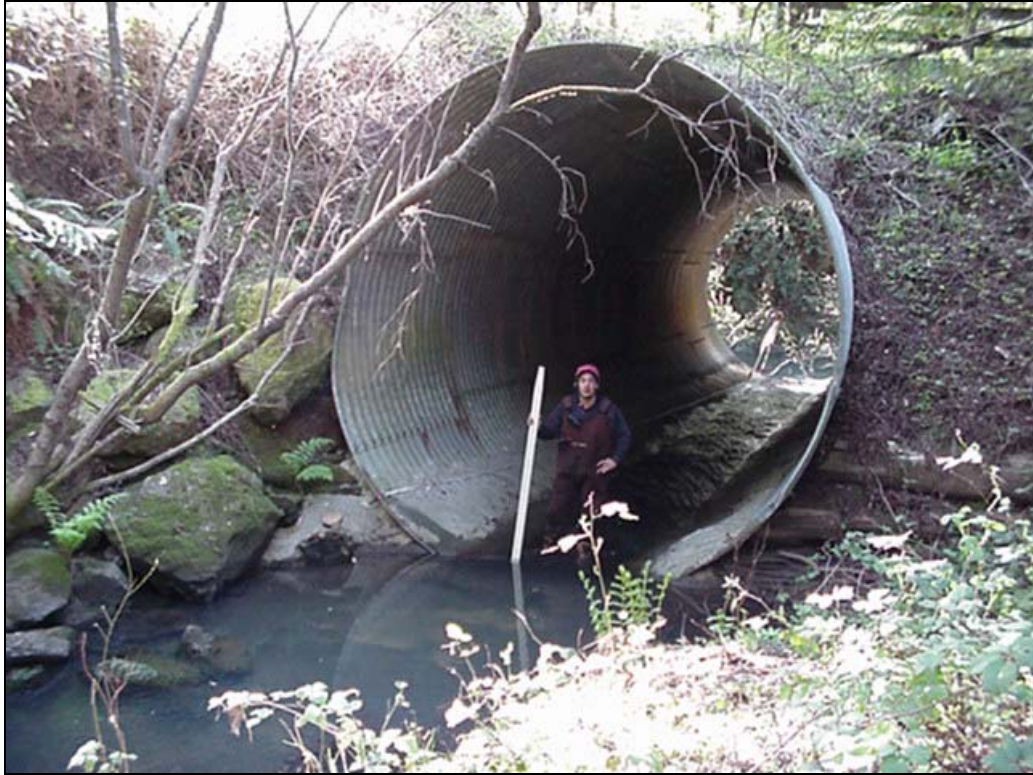
Site #19: Albion River/Flynn Creek Road; Albion River

Fill Estimate: 2,663 cubic yards **Overall condition:** Fair, floor rusted-out, but the lined with concrete.

Barrier Status: For the range of migration flows ($Q_{lp} - Q_{hp}$), FishXing determined culvert is a total barrier to adult coho salmon and steelhead and all age classes of juveniles due primarily to excessive velocities over the smooth concrete lining, lack of depth at lower migration flows, and leap required to enter culvert. On 2/24/00, observed moderate velocities, 4" depth in culvert and 1.5' drop at outlet. However, on 3/30/00 observed numerous newly-emerged fry in channel margins above and below Flynn Creek Road.

Preferred Treatment: Properly-sized bridge or pipe-arch set on concrete footings.

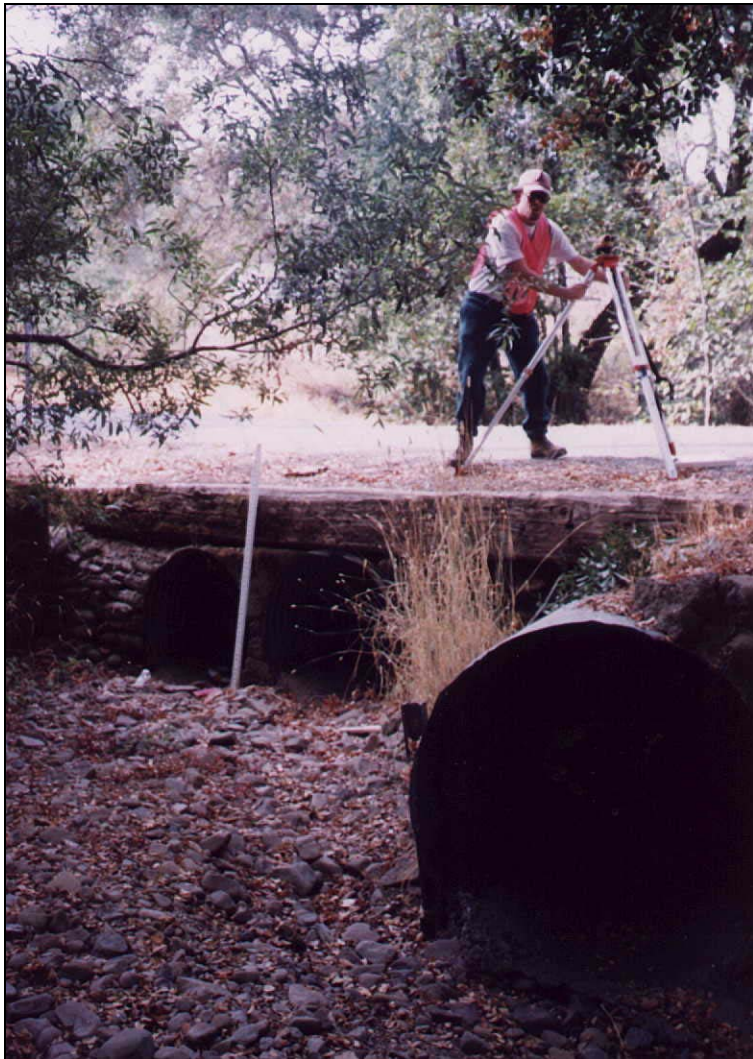
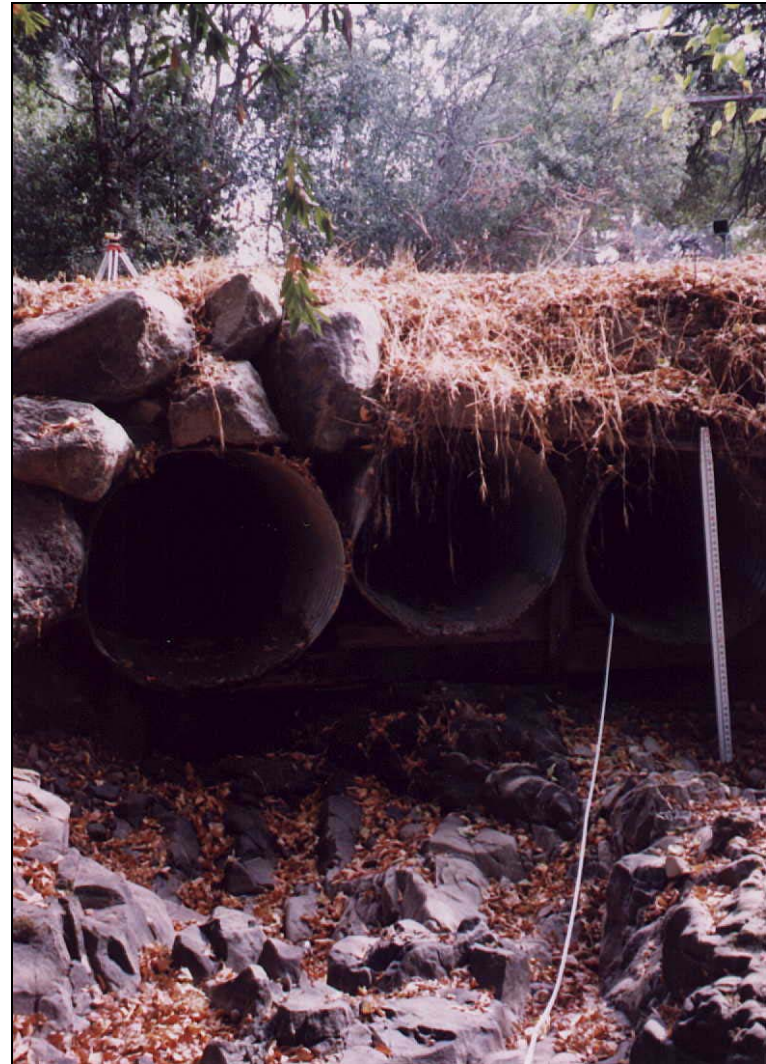
Site #21: Ornbaun Creek #1/Ornbaun Road; Anderson Ck., Navarro River

Modifications: None. **Fill Estimate:** 284 cubic yards **Overall condition:** Poor, all pipes rusted through.

Preferred Treatment: Properly-sized pipe-arch set on concrete footings. Lack of fisheries benefits makes this site a low-priority to treat with restoration funds. Mendocino County DOT should conduct regular maintenance of this crossing and replace crossing when culvert wears out.

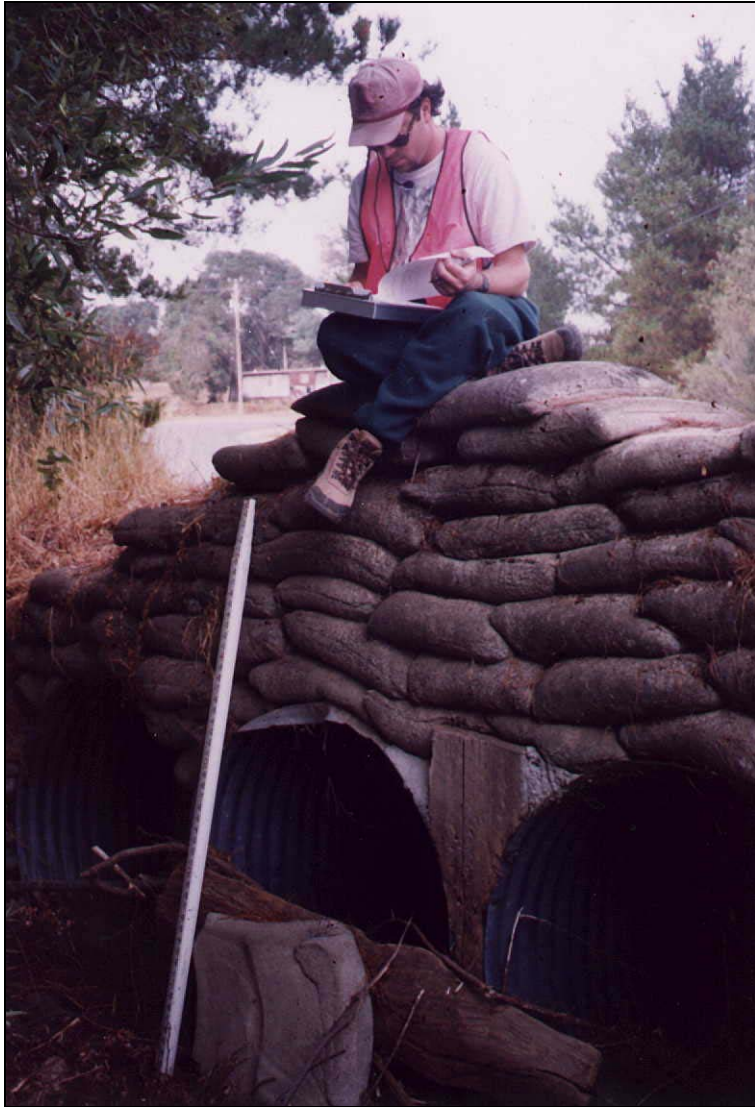
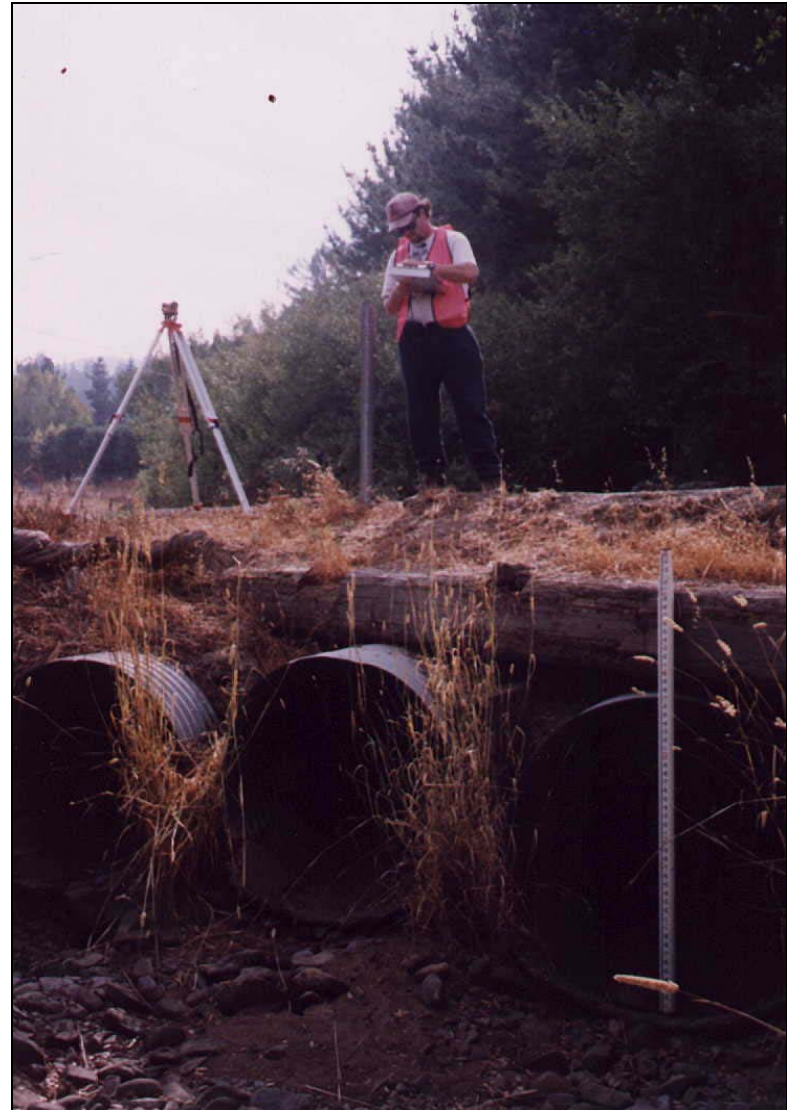
Site #22: Ornbaun Creek #2/Ornbaun Road; Anderson Ck., Navarro River

Modifications: None. **Fill Estimate:** 400 cubic yards **Overall condition:** Poor, all pipes have rusted through and been lined with concrete.

Preferred Treatment: Properly-sized pipe-arch set on concrete footings. Lack of fisheries benefits makes this site a low-priority to treat with restoration funds. Mendocino County DOT should conduct regular maintenance of this crossing and replace crossing when culvert wears out.

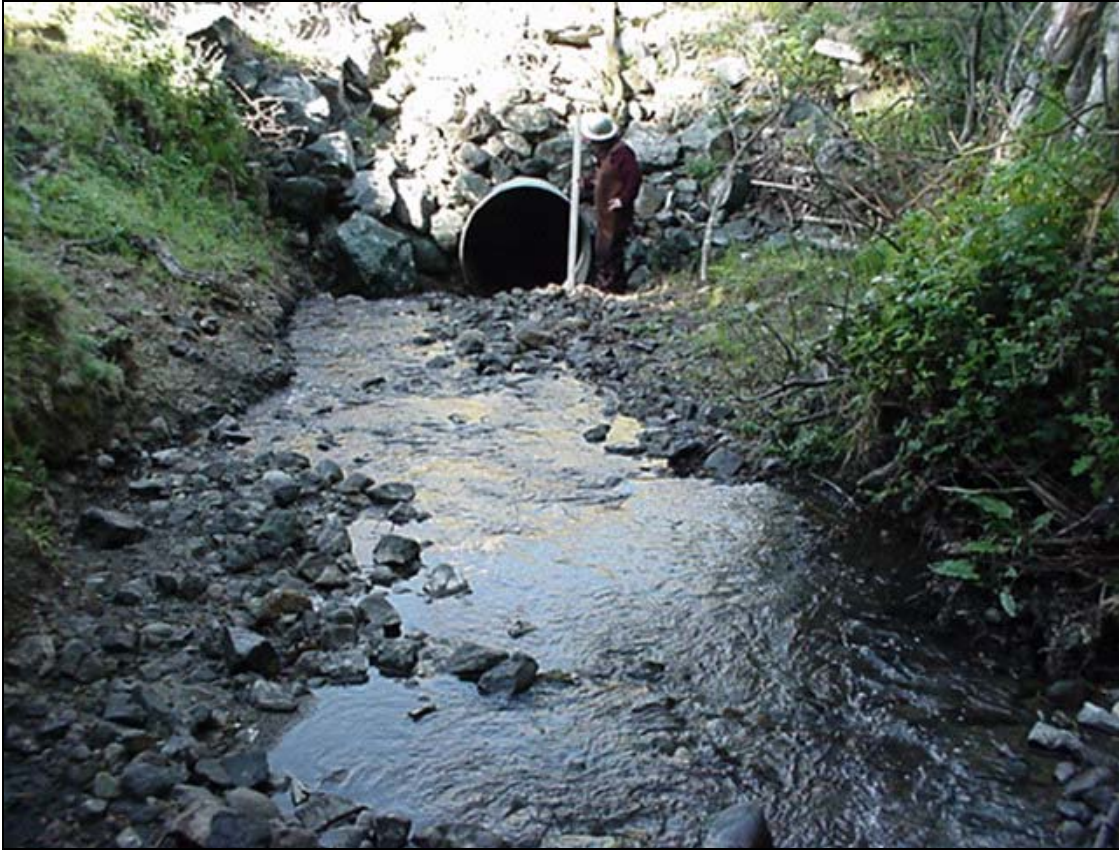
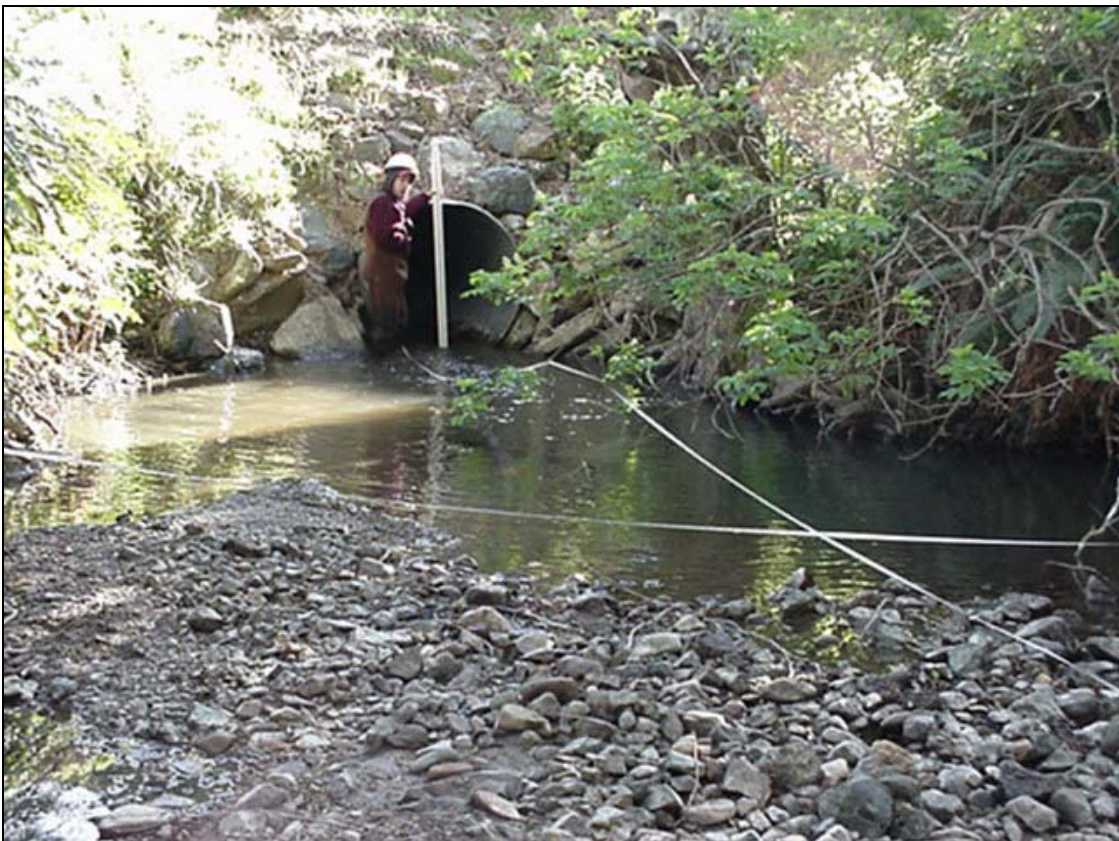
Site #23: Spanish Creek/Crispen Lane; Brush Creek, Coastal

Fill Estimate: 2,353 cubic yards **Overall condition:** Good, relatively new installation.

Preferred Treatment: Properly-sized bridge or pipe-arch set on concrete footings.

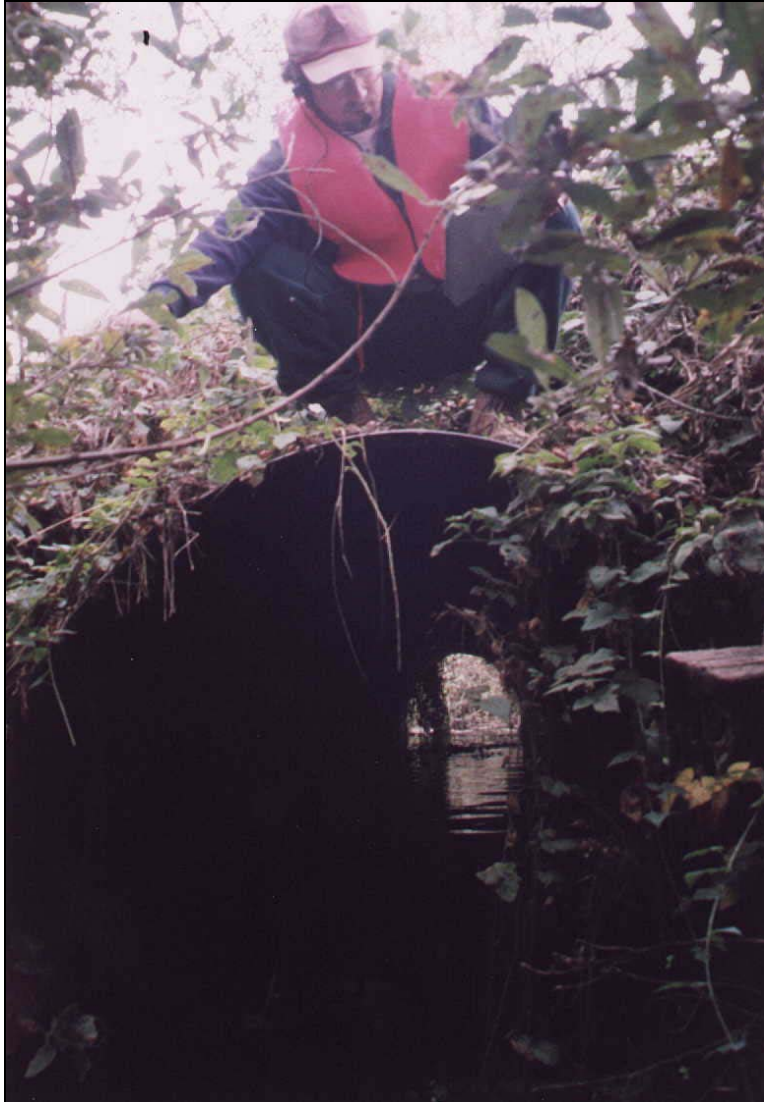
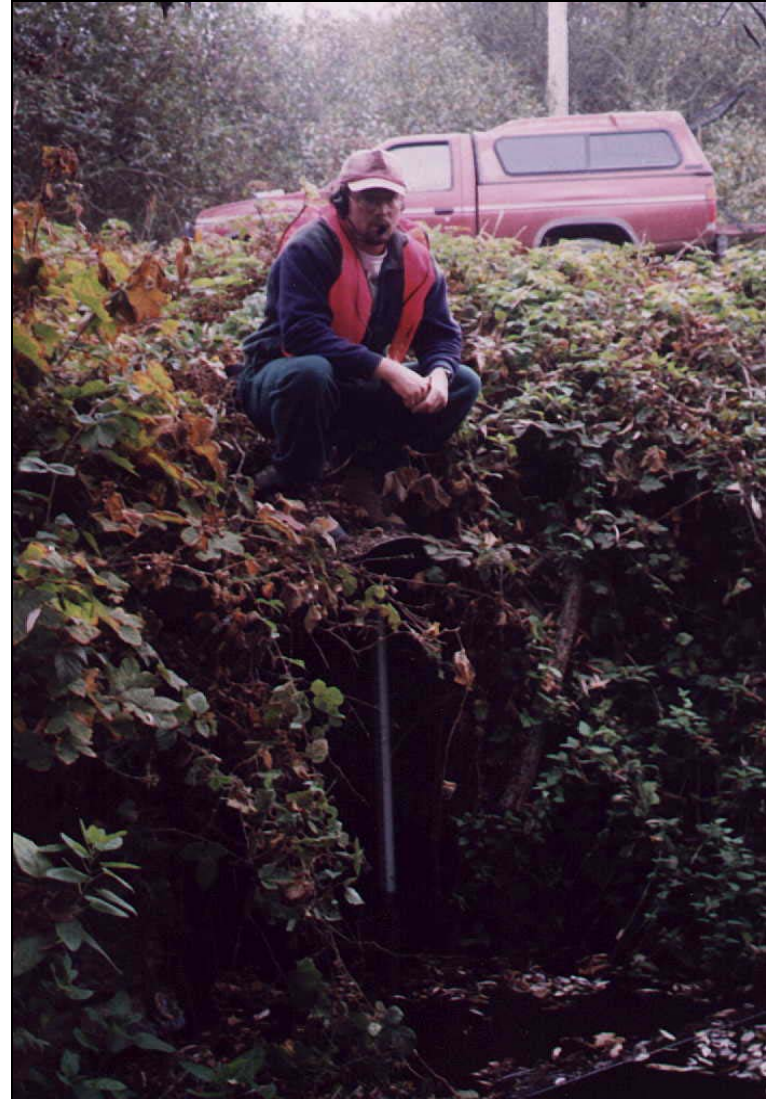
Site #24: Hathaway Creek/Windy Hollow Road; Garcia River

Fill Estimate: 2,353 cubic yards **Overall condition:** Poor, culvert floor is rusted through.

Preferred Treatment: Properly-sized bridge or pipe-arch set on concrete footings. Because current culvert provides fish passage this site is not a restoration priority; however poor condition of culvert means replacement should occur relatively soon.

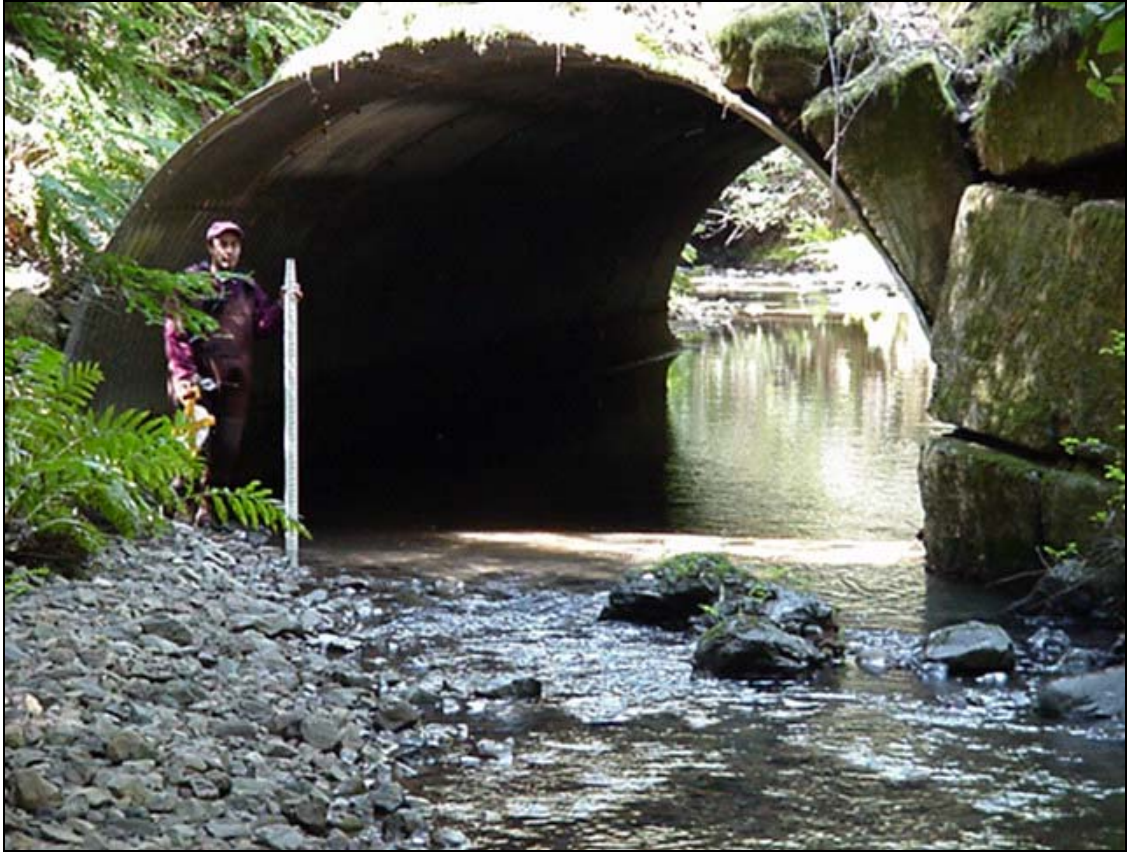
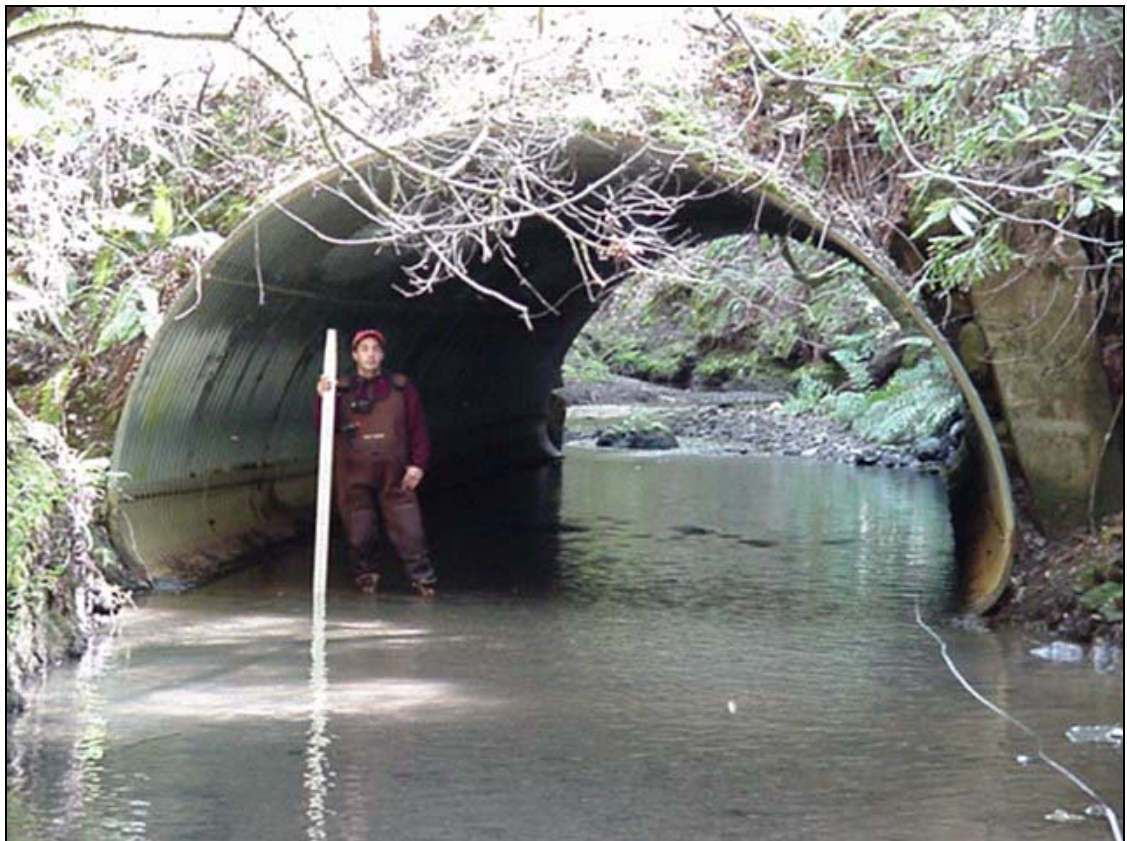
Site #25: Mill Creek #1/Fish Rock Road; Garcia River

Fill Estimate: 920 cubic yards **Overall condition:** Good.

Preferred Treatment: None required, current crossing provides passage and is properly-sized.

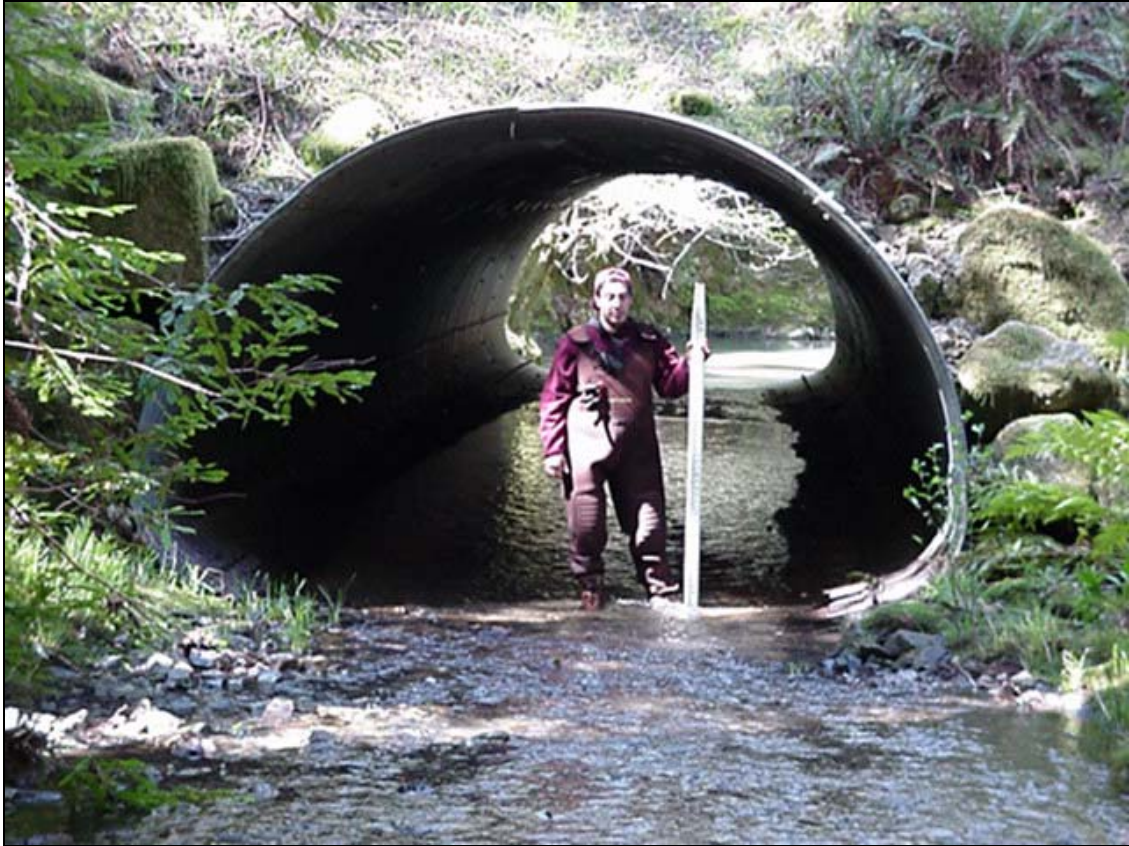
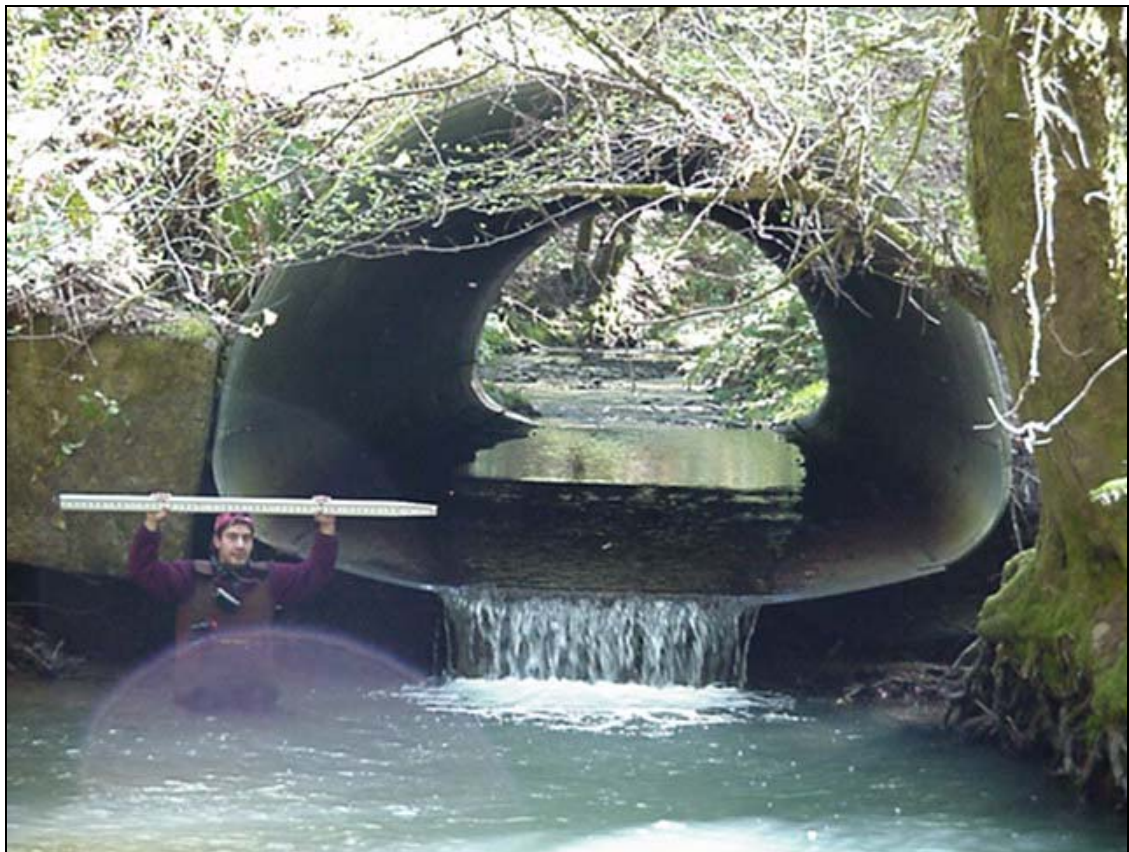
Site #26: Mill Creek #2/Fish Rock Road; Garcia River

Fill Estimate: 690 cubic yards **Overall condition:** Good.

Preferred Treatment: Least expensive option is to modify current crossing with an outlet beam, baffles, and/or outlet pool weirs to increase depth and reduce velocities. A series of weirs may backwater crossing. However, current pipe-arch is undersized by NMFS guidelines and agencies may not grant necessary permits.
