APPENDIX B:
CATALOG OF SISKIYOU COUNTY CULVERTS LOCATED ON
FISH-BEARING STREAM REACHES

Prepared for the Siskiyou County Public Works Department

By
Ross Taylor and Associates
1254 Quail Run Court
McKinleyville, CA. 95519
(707)-839-5022
rtaylor@humboldt1.com

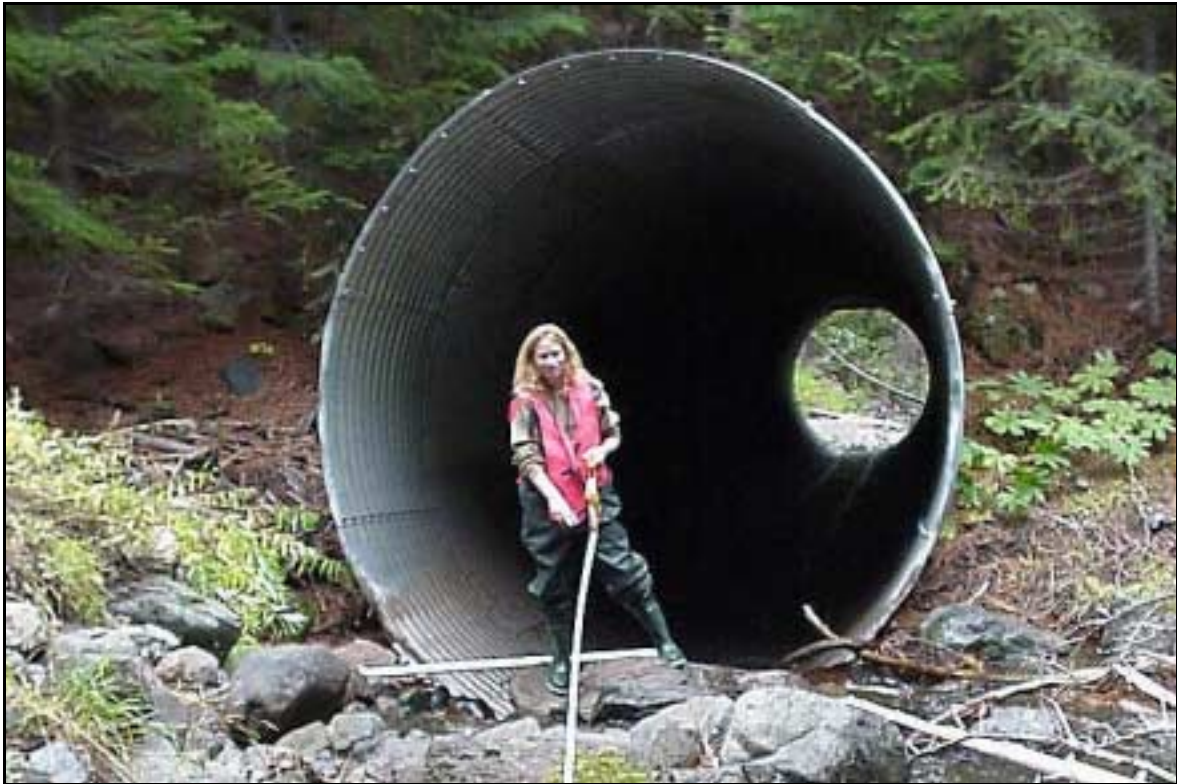
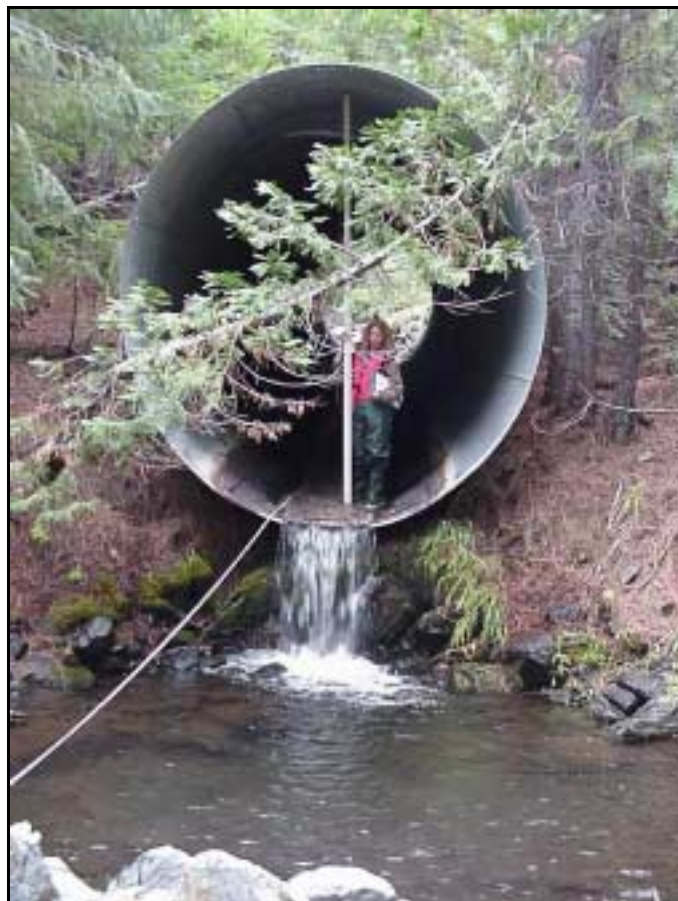
Site #5: Cronan Gulch/Sawyer's Bar Road; North Fork Salmon River; Salmon River; Klamath River.

Slope: 17.55%. **Modifications:** None. **Fill Estimate:** 891 cubic yards. **Overall condition:** Good.

Barrier Status: **RED:** the Green-Gray-Red filter determined this crossing fails to meet passage criteria for all species of adult salmonids and all age classes of juveniles. Excessive slope and lack-of-depth are crossing features that create migration barrier.

Preferred Treatment: None recommended. This adequately sized crossing is a migration barrier, yet there is insignificant fisheries habitat upstream due to the steep natural channel slope.

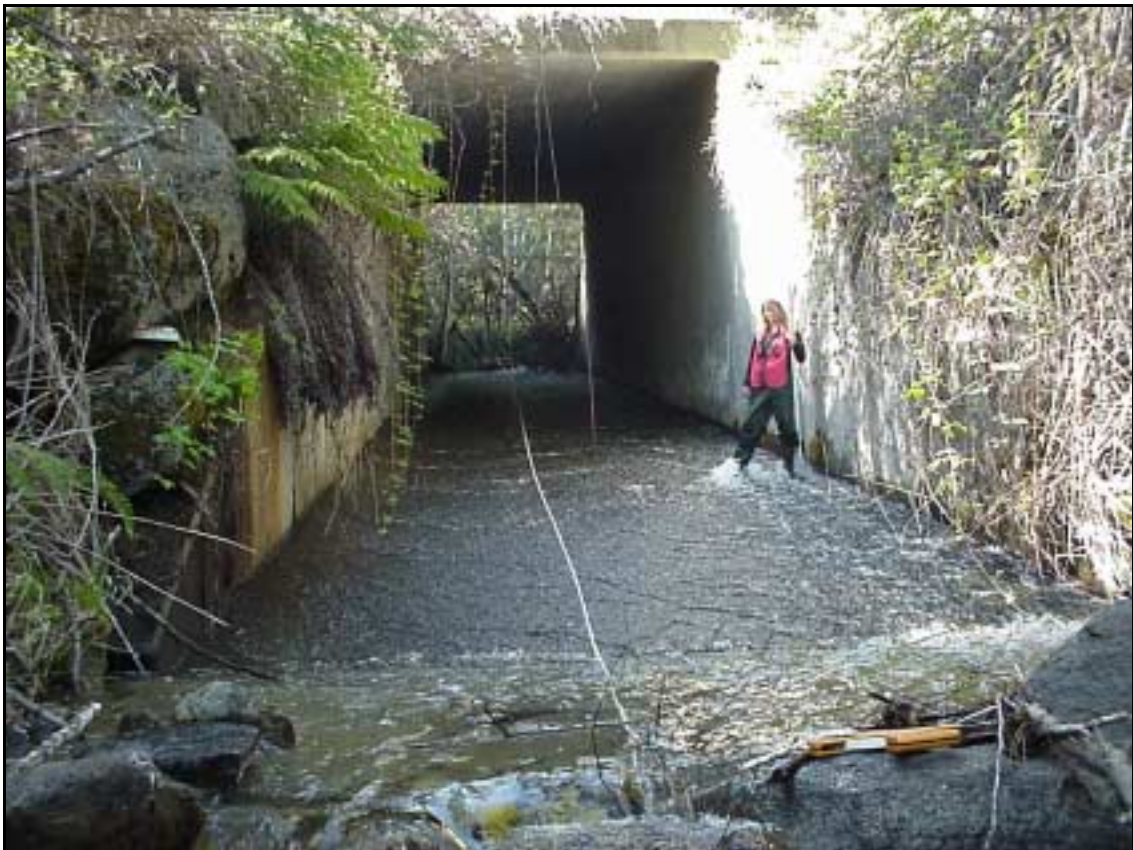
Site #5: Cronan Gulch/Sawyer's Bar Road; North Fork Salmon River; Salmon River; Klamath River

Modifications: None. **Fill Estimate:** 243 cubic yards. **Overall condition:** Fair, culvert floor is abraded.

Barrier Status: **RED:** the Green-Gray-Red filter determined this crossing fails to meet passage criteria for all species of adult salmonids and all age classes of juveniles. Excessive slope and lack-of-depth are the crossing's features that create migration barrier.

Preferred Treatment: Properly-sized bridge or arch-culvert set on concrete footings. Treatment project should also address the Forest Service spur road immediately downstream of the county road and reconstruction of the downstream channel to reconnect Kelly Gulch with the North Fork Salmon River.

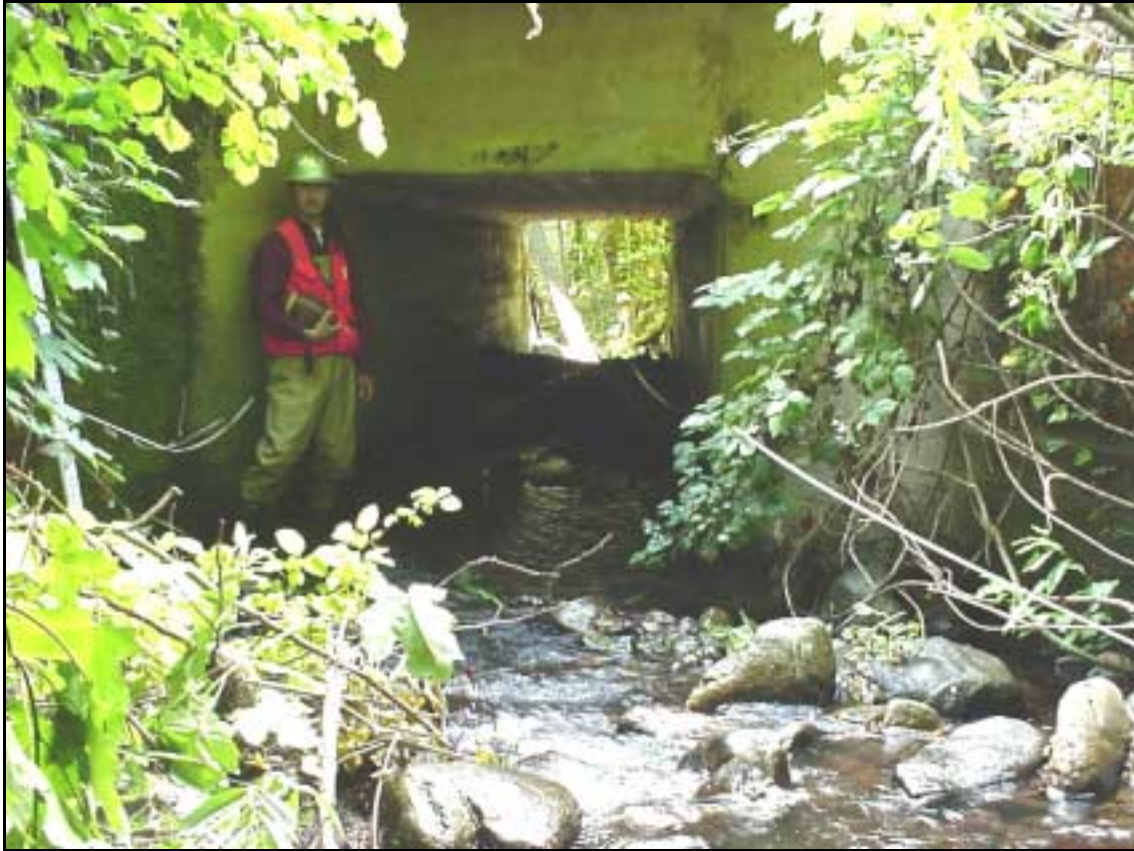
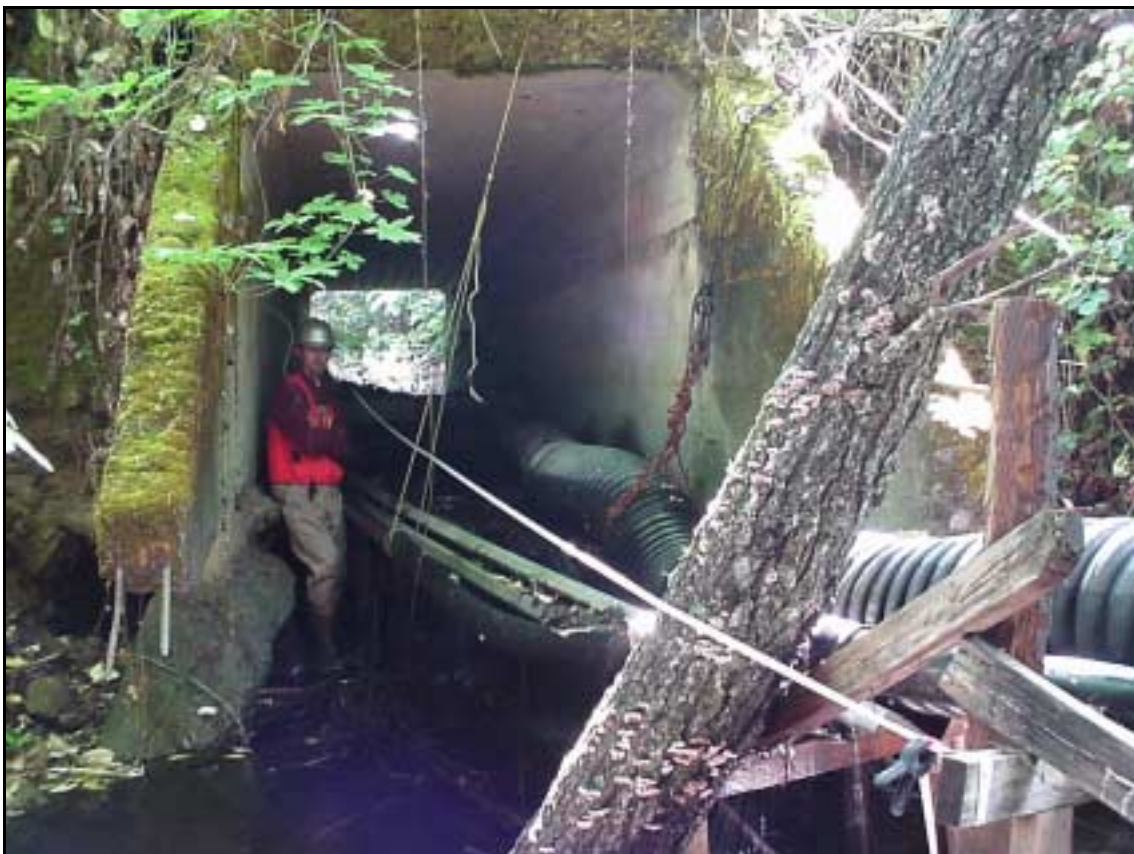
Site #13: Luther Creek/Indian Creek Road; Indian Creek; Klamath River

Overall condition: Poor, culvert floor is rusted through in numerous places.

Barrier Status: **RED:** the Green-Gray-Red filter determined this crossing fails to meet passage criteria for all species of adult salmonids and all age classes of juveniles. Excessive slope and perched outlet are the crossing's features that create a migration barrier.

Preferred Treatment: Current culvert is extremely undersized, in poor condition, and probably due for replacement. Replace with a properly-sized embedded circular SSP pipe or an arch-culvert set on concrete footings. Lack of upstream fisheries benefit makes this site a poor candidate for replacement with restoration funds.

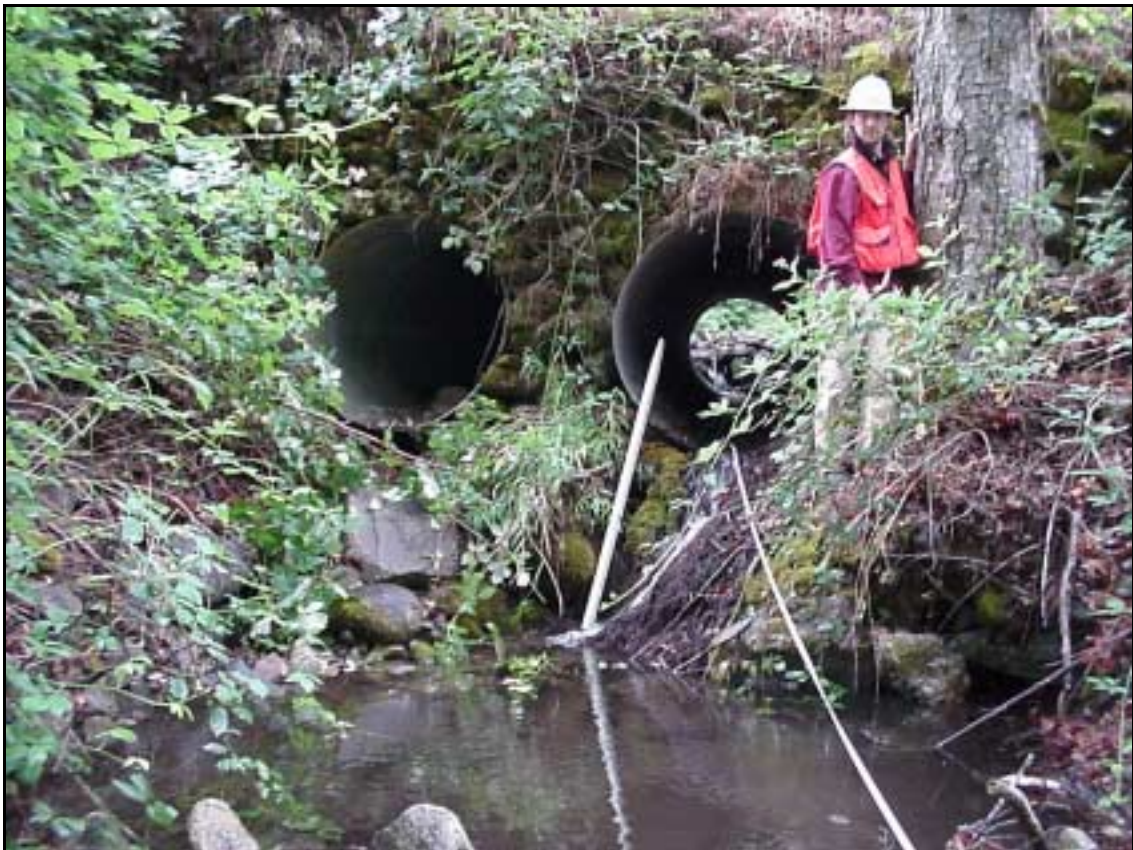
Site #15: Walker Gulch/Ladd Road; Klamath River.

Modifications: None. **Fill Estimate:** 313 cubic yards. **Overall condition:** Fair, culvert floors abraded.

Preferred Treatment: Current crossing provides passage on most migration flows, but is extremely undersized for the large drainage area upstream (22.2 mi.²). Bridge is most appropriate long-term treatment.
