Solider Creek Migration Barrier Removal Project 2002-2005

**Evans Bar Road—
Crossing #1**

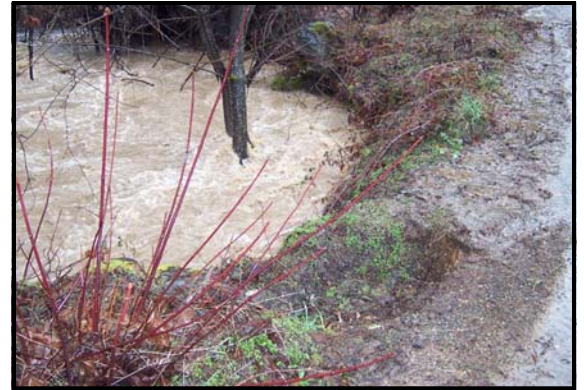
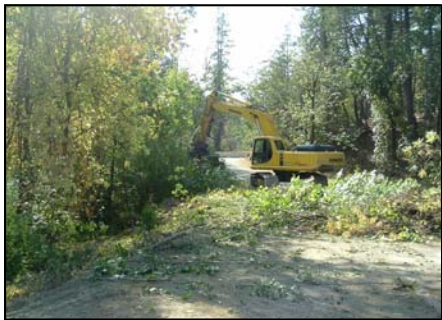
Right Photos—Inlet (top)
and outlet (bottom) during
February 2004 storm flows

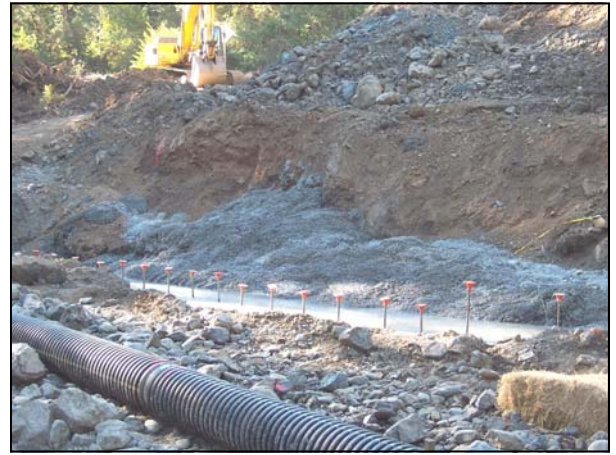
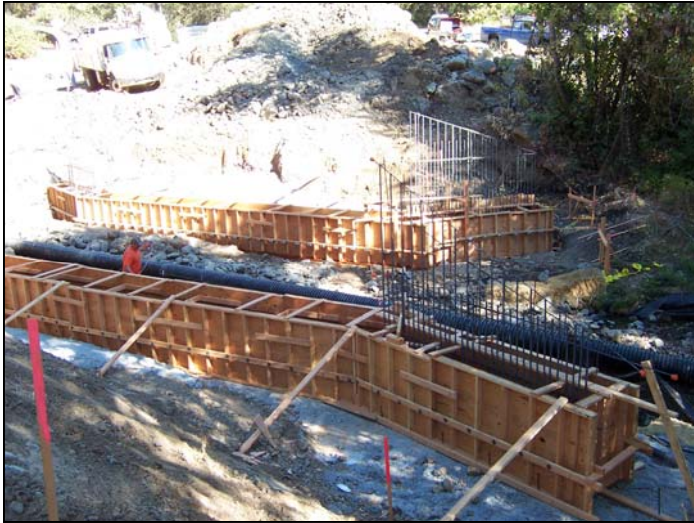
Additional concrete was required below the footing areas to stabilize the bedrock due to an error in the geotechnical investigation report

Left —6 foot depth of extra concrete below surface.

Right Photo—3 feet depth of extra concrete below surface.

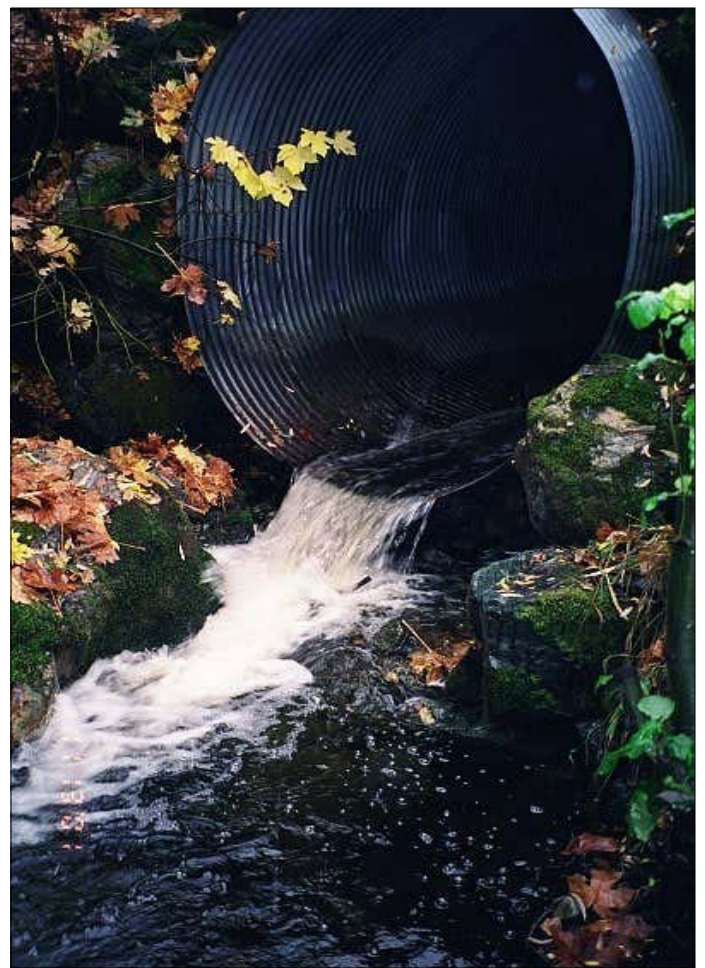
Dutch Creek Road—Crossing #2

Upper Photo—Inlet of the 8-foot diameter culvert showing velocity in the culvert and the inlet drop that poses another barrier for juveniles moving upstream

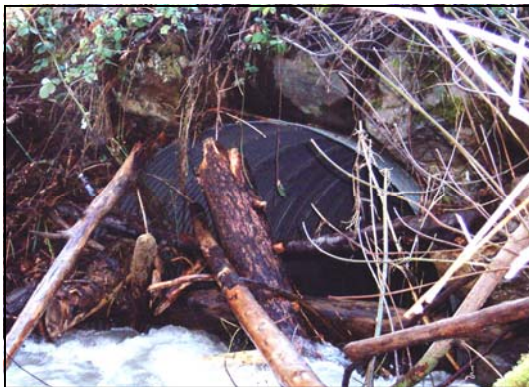
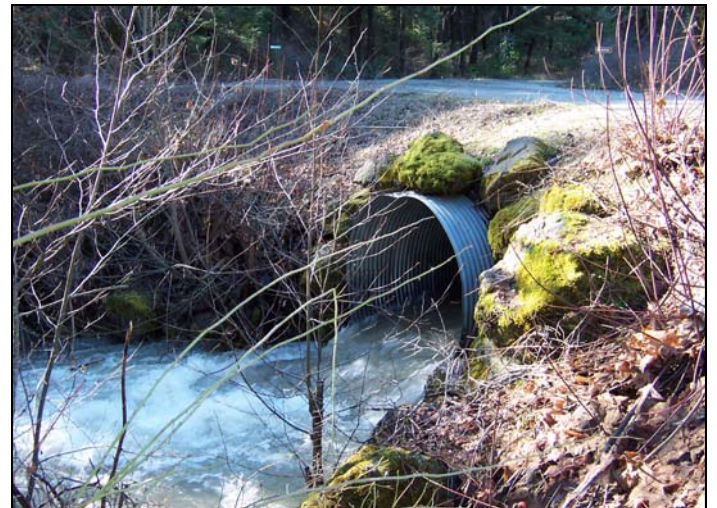
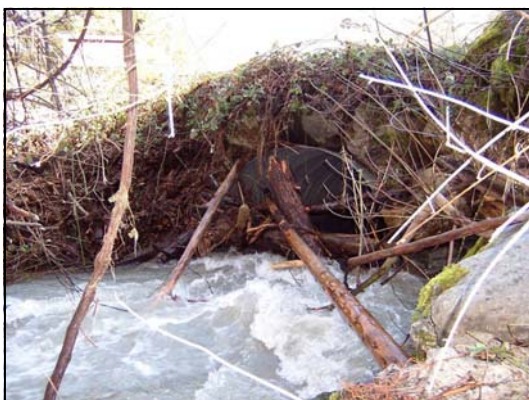
Lower Photos—Inlet area of the 8-foot culvert showing debris loading and plugging during a February 2004 winter storm event.

The Trinity County Department of Transportation maintenance crews would spend multiple hours at this, and Crossing #1, during heavy rains and flood events

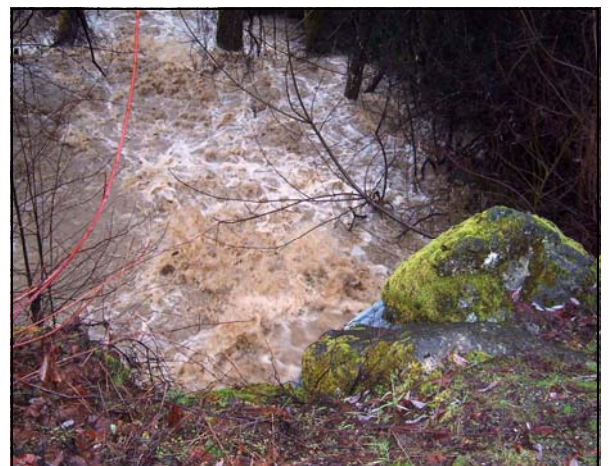
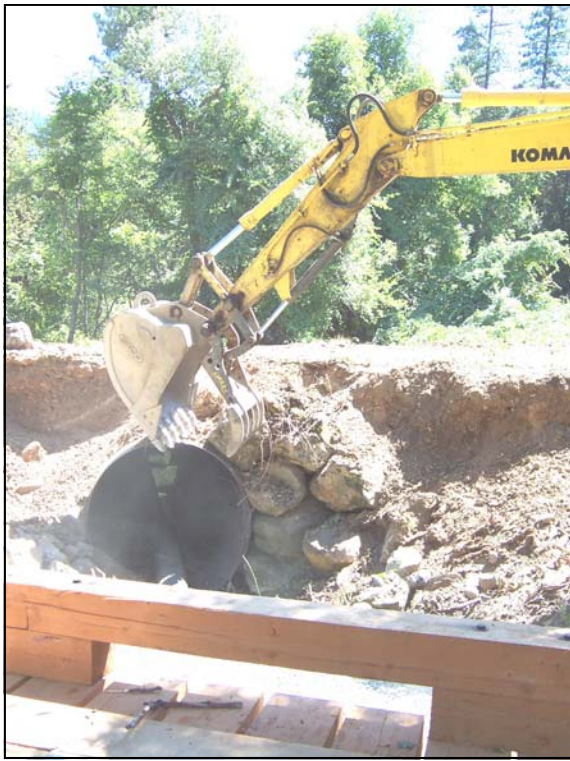
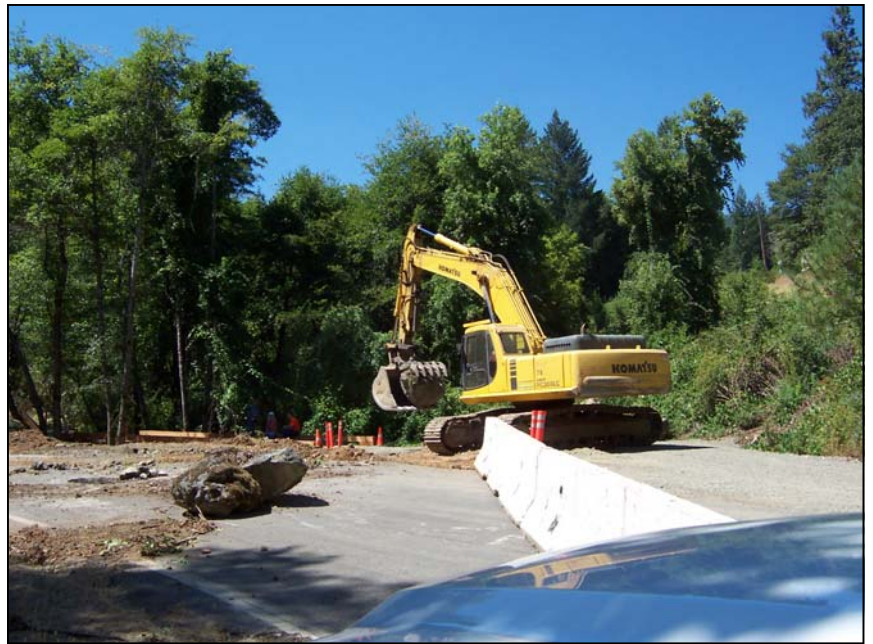
Outlet at Various Flows

Upper Right —
Low flow with outlet jump

Middle Right—
Moderate Flows

Lower Right—
High flows during
February 2004 storm
event

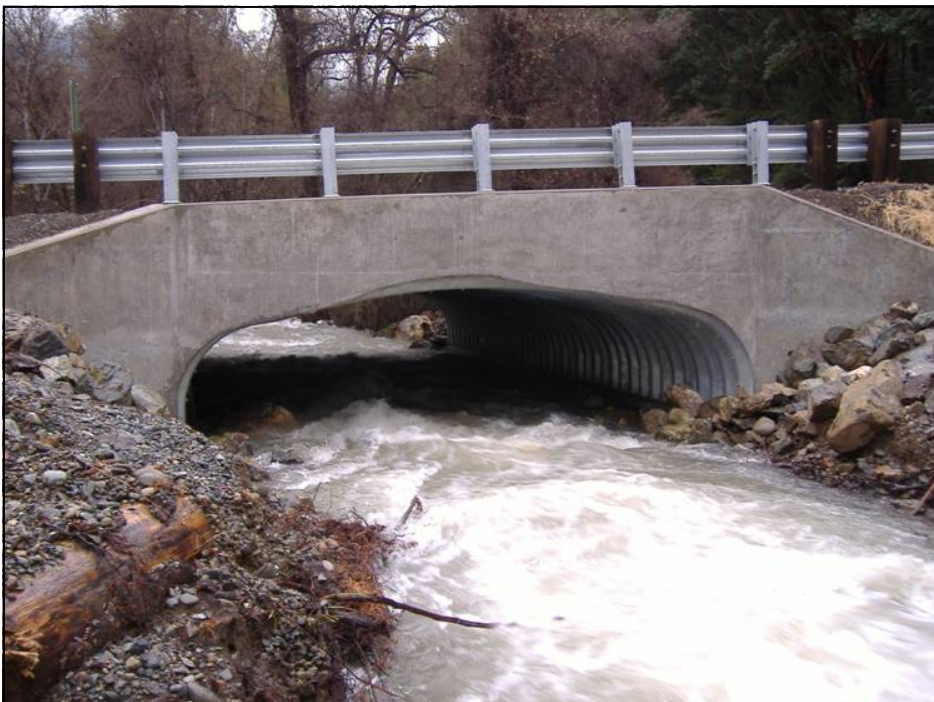
Left Photo—Winter Storm 2005

Dutch Creek Road arch (Crossing #2) during the December 2005 winter storm.

In past storm and high flow events, this crossing would have been blocked and flooded (see Pages 3 & 4).

This new arch structure, as well as at Crossing #1, handled the storm flows without problem, allowing the Trinity County Department of Transportation's emergency crews to concentrate on other areas within the County.
