APPENDIX B:

CATALOG OF TRINITY COUNTY CULVERTS LOCATED ON FISH-BEARING STREAM REACHES

Site ID #1: Unnamed tributary/South Fork Road; South Fork Trinity River; Trinity River

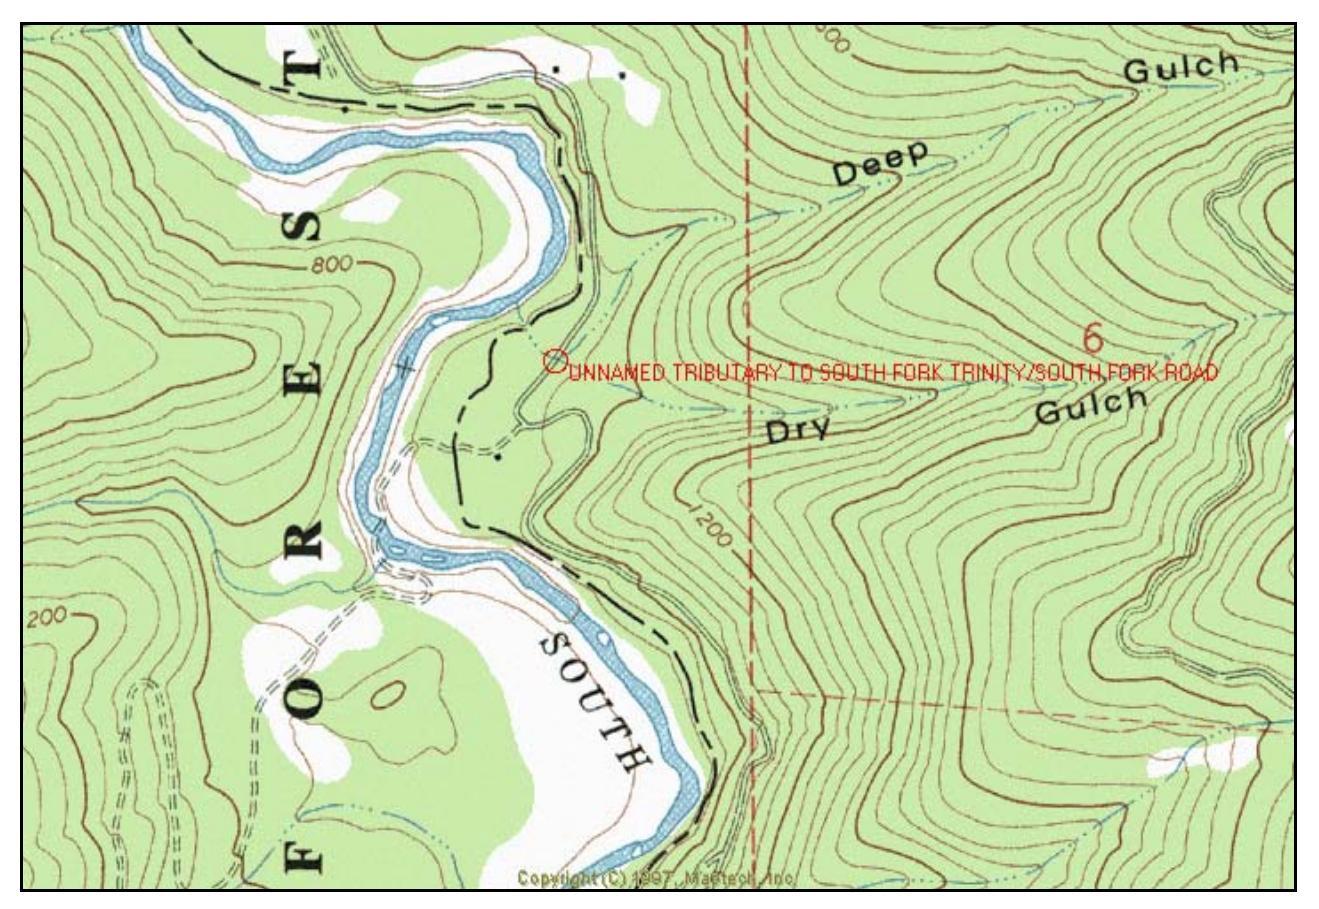
Fill Estimate: 231 cubic yards Overall condition: Fair, culvert has abraded bottom.

Sizing: Extremely undersized; HW/D = 1 on a storm flow with approximately a two-year recurrence interval. South Fork Road is overtopped on approximately a two-year storm flow.

Barrier Status: RED: the Green-Gray-Red filter determined this crossing fails to meet passage criteria for all species of adult salmonids and all age classes of juveniles.

Preferred Treatment: When crossing is due for replacement (or fails) replace with a properly-sized embedded circular SSP pipe or an open-bottom arch set on concrete footings. Lack of upstream fisheries benefit makes this site a poor candidate for replacement with restoration funds.

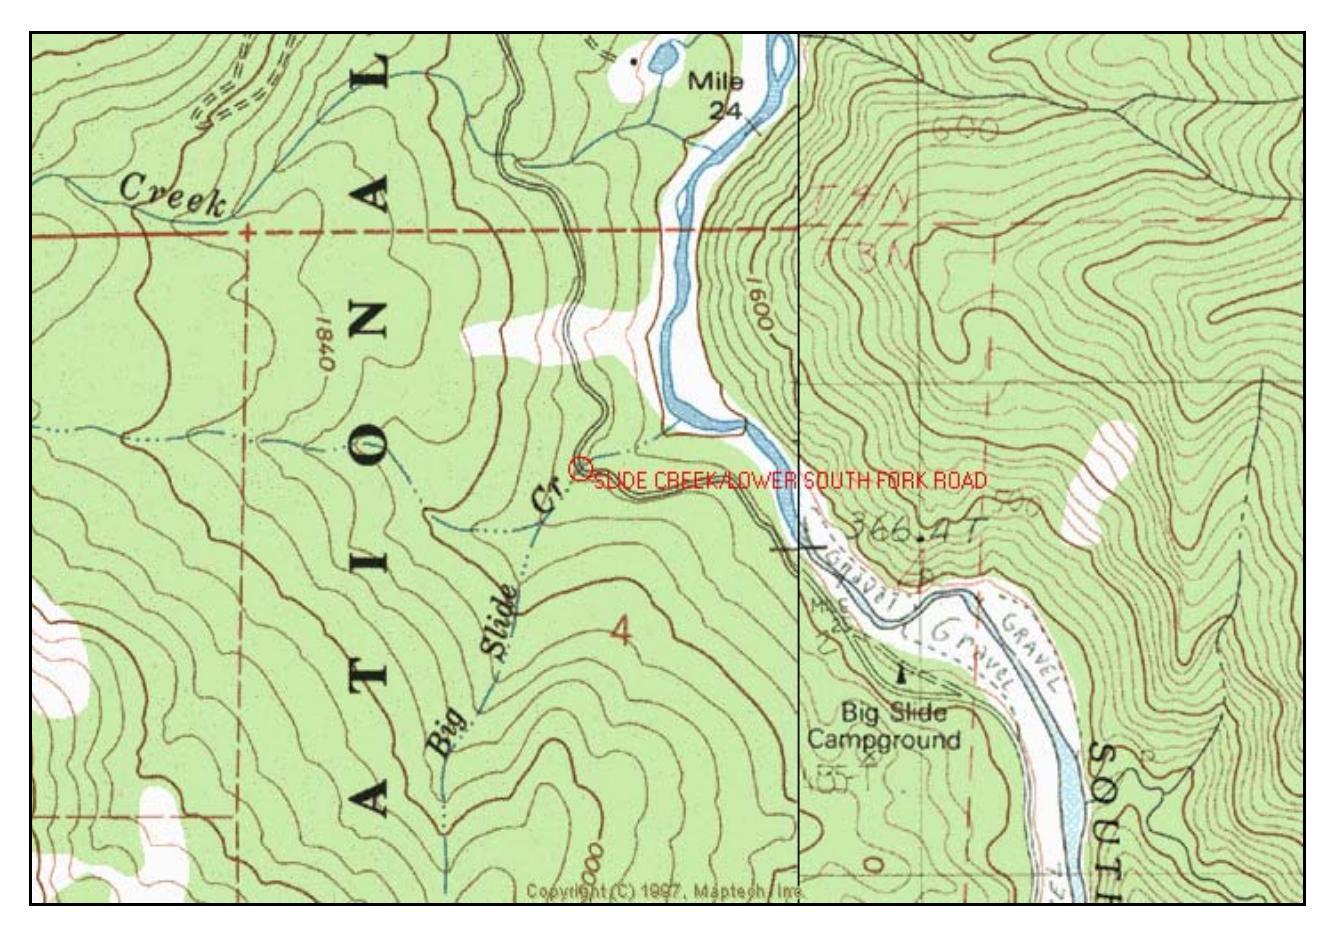
Fill Estimate: 606 cubic yards Overall condition: Abraded.

Barrier Status: RED: the Green-Gray-Red filter determined this crossing fails to meet passage criteria for all species of adult salmonids and all age classes of juveniles.

Preferred Treatment When crossing is due for replacement (or fails) replace with a properly-sized circular SSP pipe with grade control weirs or a bridge. The steep slope of the stream channel below the crossing would require a series of weirs to provide fish passage (if deemed necessary). Lack of upstream fisheries benefit makes this site a poor candidate for replacement with restoration funds.

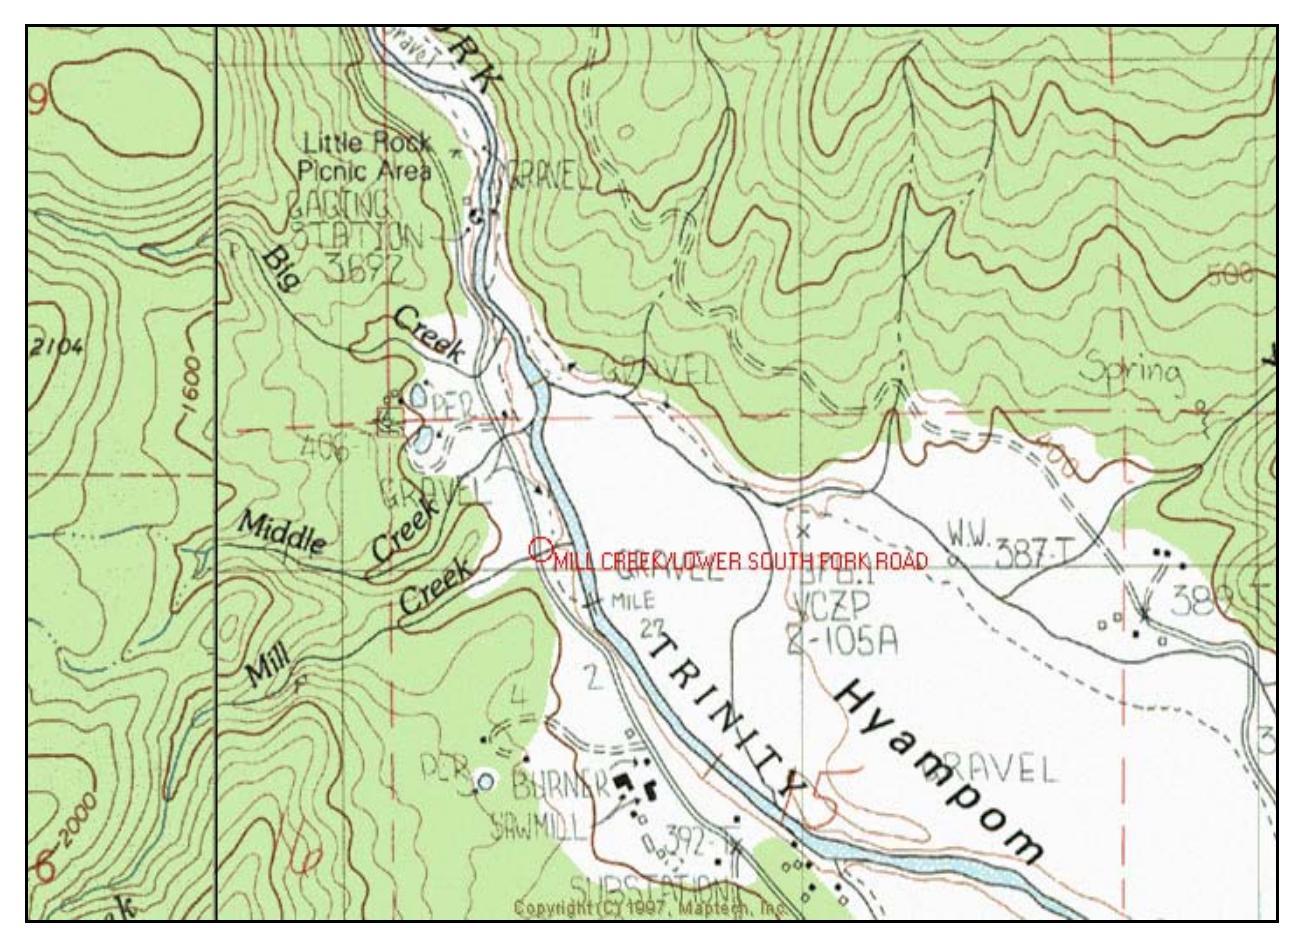
Fill Estimate: 456 cubic yards Overall condition: Fair, culvert floor is abraded.

Preferred Treatment: When crossing is due for replacement (or fails) replace with a properly-sized embedded circular SSP pipe or an open-bottom arch set on concrete footings to maintain the GREEN status of this crossing. Lack of upstream fisheries benefit makes this site a poor candidate for replacement with restoration funds.

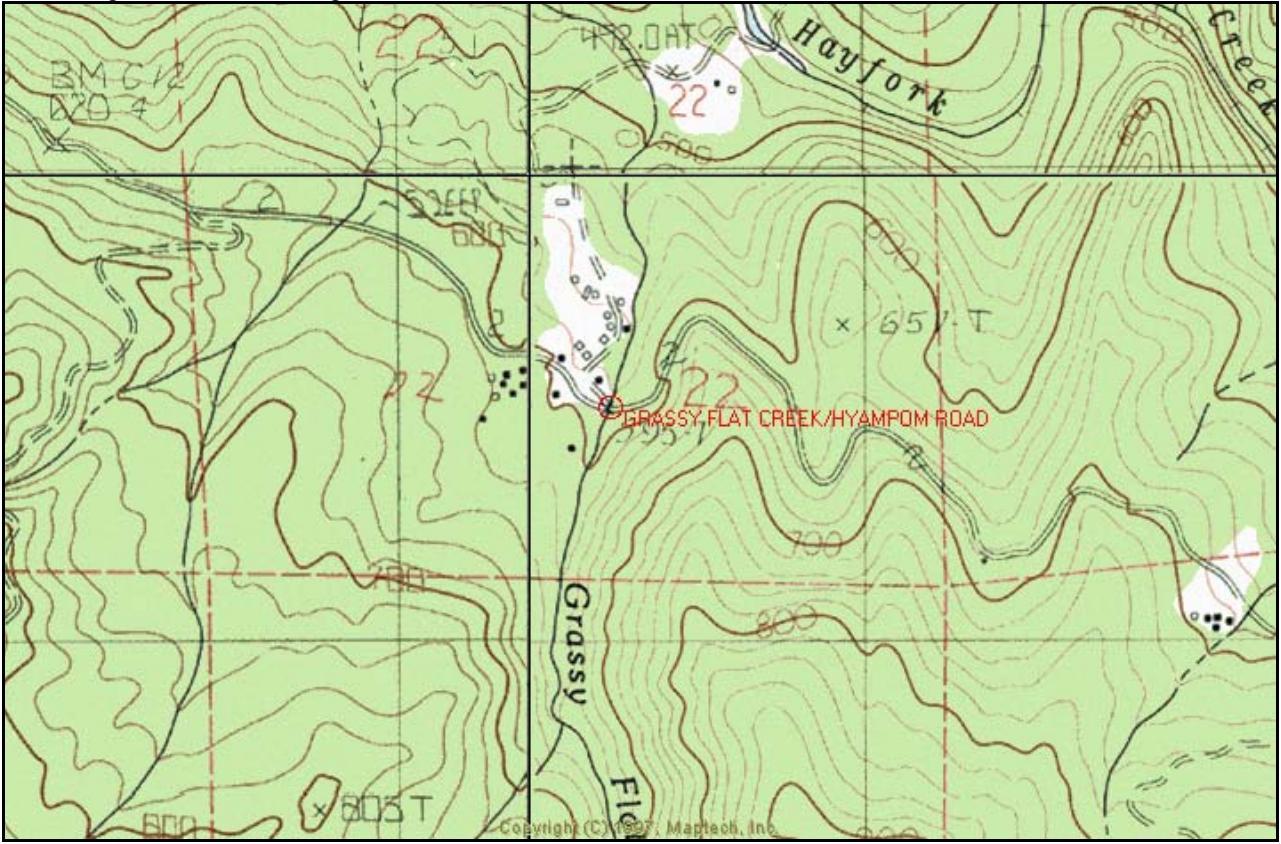
Fill Estimate: 1,607 cubic yards **Overall condition:** Poor, rusted through – at low flow, all of the flow seeps through holes before reaching the culvert outlet.

Barrier Status: RED: the Green-Gray-Red filter determined this crossing fails to meet passage criteria for all species of adult salmonids and all age classes of juveniles.

Preferred Treatment: When crossing is due for replacement (or fails) replace with a properly-sized circular SSP pipe with grade control weirs or a bridge. The steep slope of the stream channel below the crossing would require a series of weirs to provide fish passage (if deemed necessary). Lack of upstream fisheries benefit makes this site a poor candidate for replacement with restoration funds.

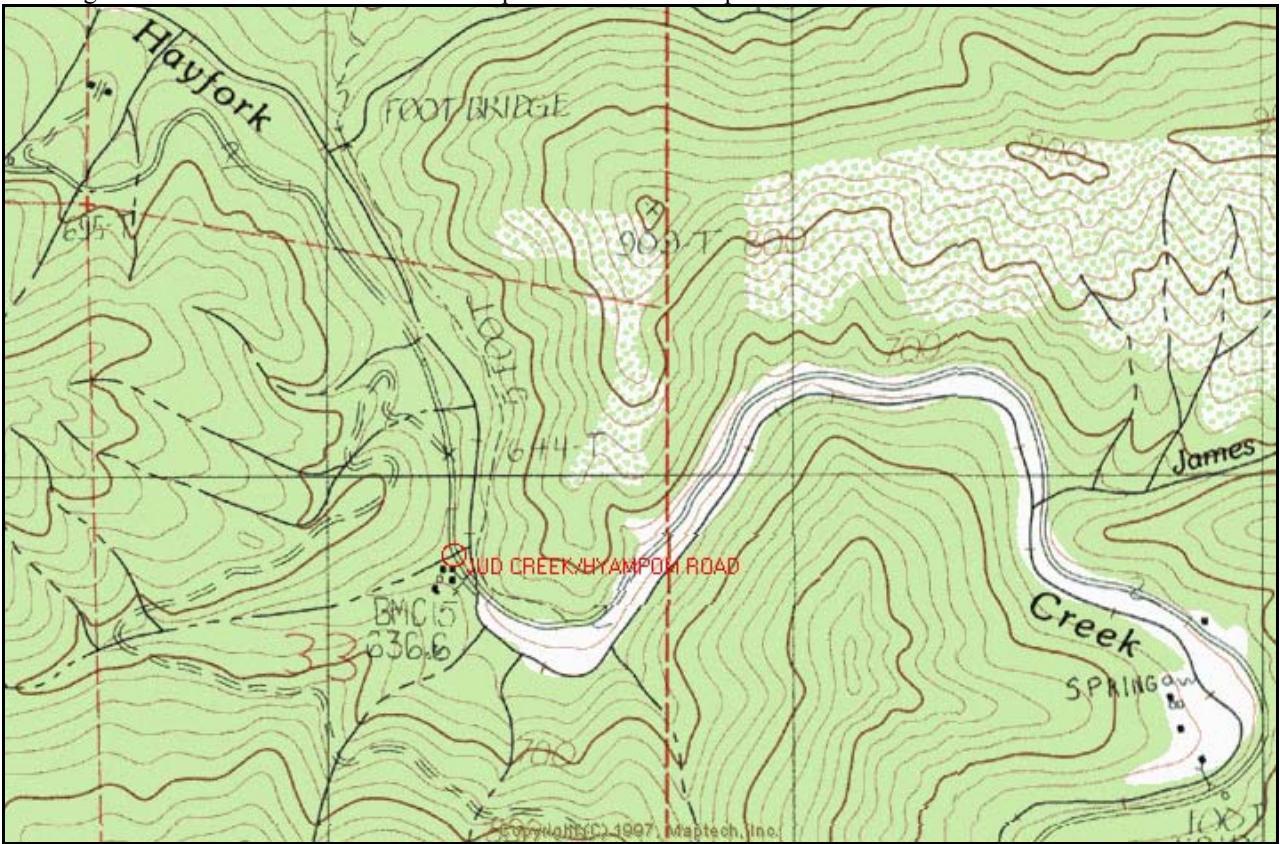
Average Active Channel Width: 9.5' Fill Estimate: 621 cubic yards Overall condition: Good.

Barrier Status: RED: the Green-Gray-Red filter determined this crossing fails to meet passage criteria for all species of adult salmonids and all age classes of juveniles.

Preferred Treatment: When crossing is due for replacement (or fails) replace with a properly-sized circular SSP pipe with grade control weirs or a bridge. The steep drop of the stream channel below the crossing would require a series of weirs to provide fish passage (if deemed necessary). The minimal fisheries benefit of restoring access to Jud Creek makes this site a poor candidate for replacement with restoration funds.

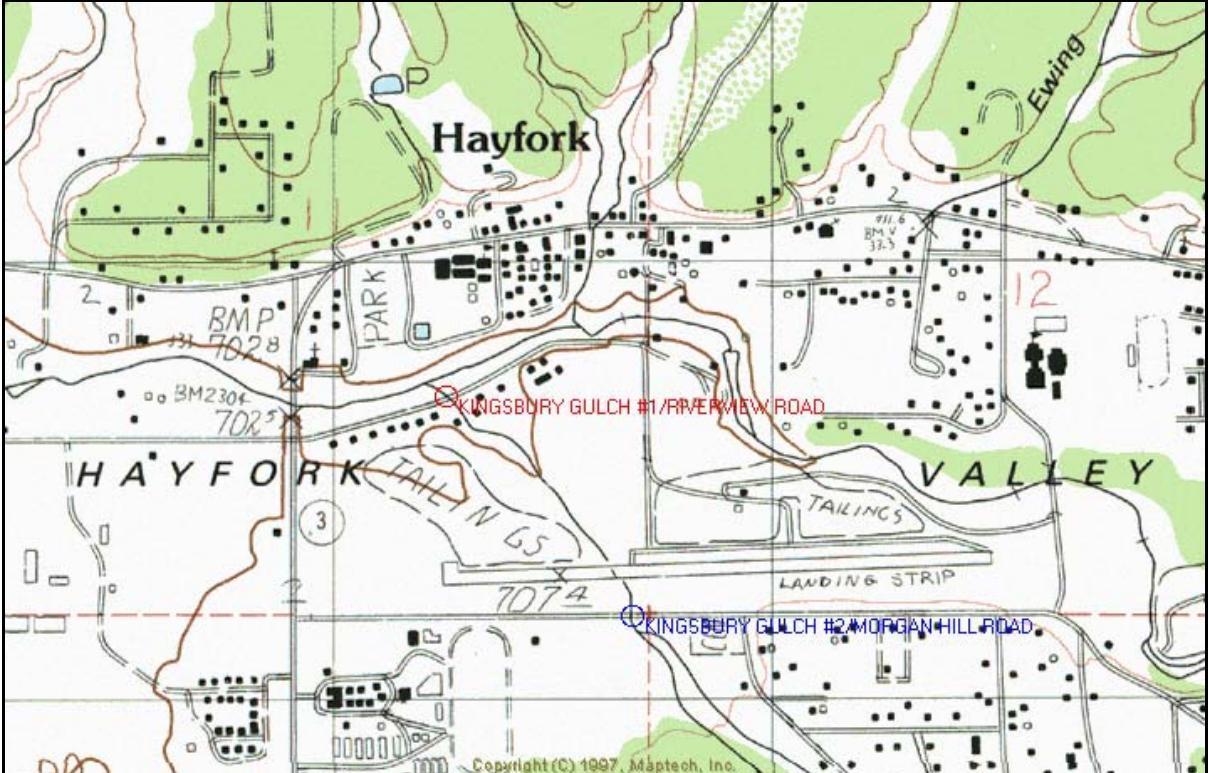
Average Active Channel Width: 7.8' Fill Estimate: 196 cubic yards Overall condition: Poor, both pipes are abraded, slightly crushed and slumping.

Barrier Status: LB= **GREY**: the Green-Gray-Red filter determined this crossing fails to meet passage criteria for all species of adult salmonids and all age classes of juveniles. RB= **RED**: The Green-Gray-Red filter determined this crossing fails to meet passage criteria for all species of adult salmonids and all age classes of juveniles.

Preferred Treatment: Replace with a properly-sized open-bottom arch set on concrete footings or a bridge.

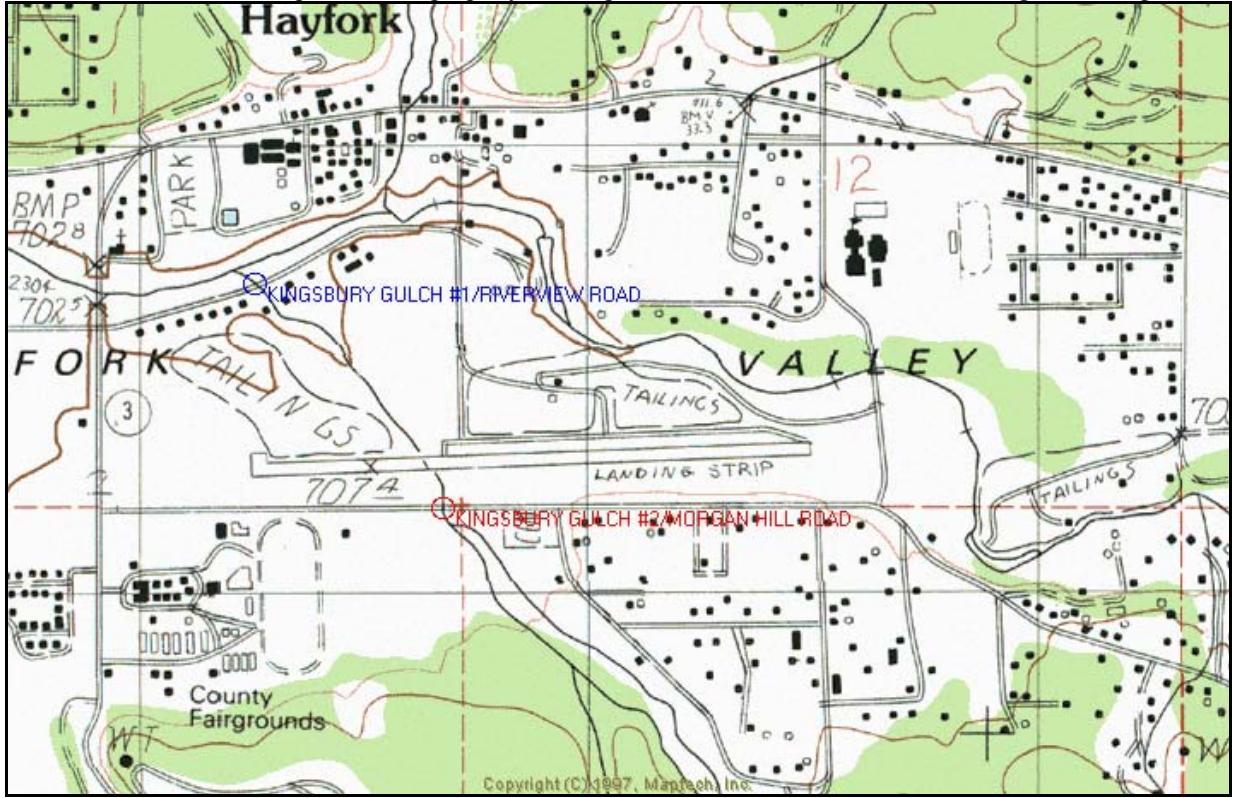
Modifications: Wooden offset baffles 0.6' high. Four placed on LB perpendicular to flow, three on RB diagonal to flow - angled in a downstream direction. NOTE: the diagonal baffles are placed improperly and probably increase velocities through culvert. Trash rack at inlet of culvert.

Overall condition: Fair, culvert is abraded.

Barrier Status: RED: the Green-Gray-Red filter determined this crossing fails to meet passage criteria for all species of adult salmonids and all age classes of juveniles.

Preferred Treatment: Replace with a properly-sized open-bottom arch set on concrete footings or a bridge.

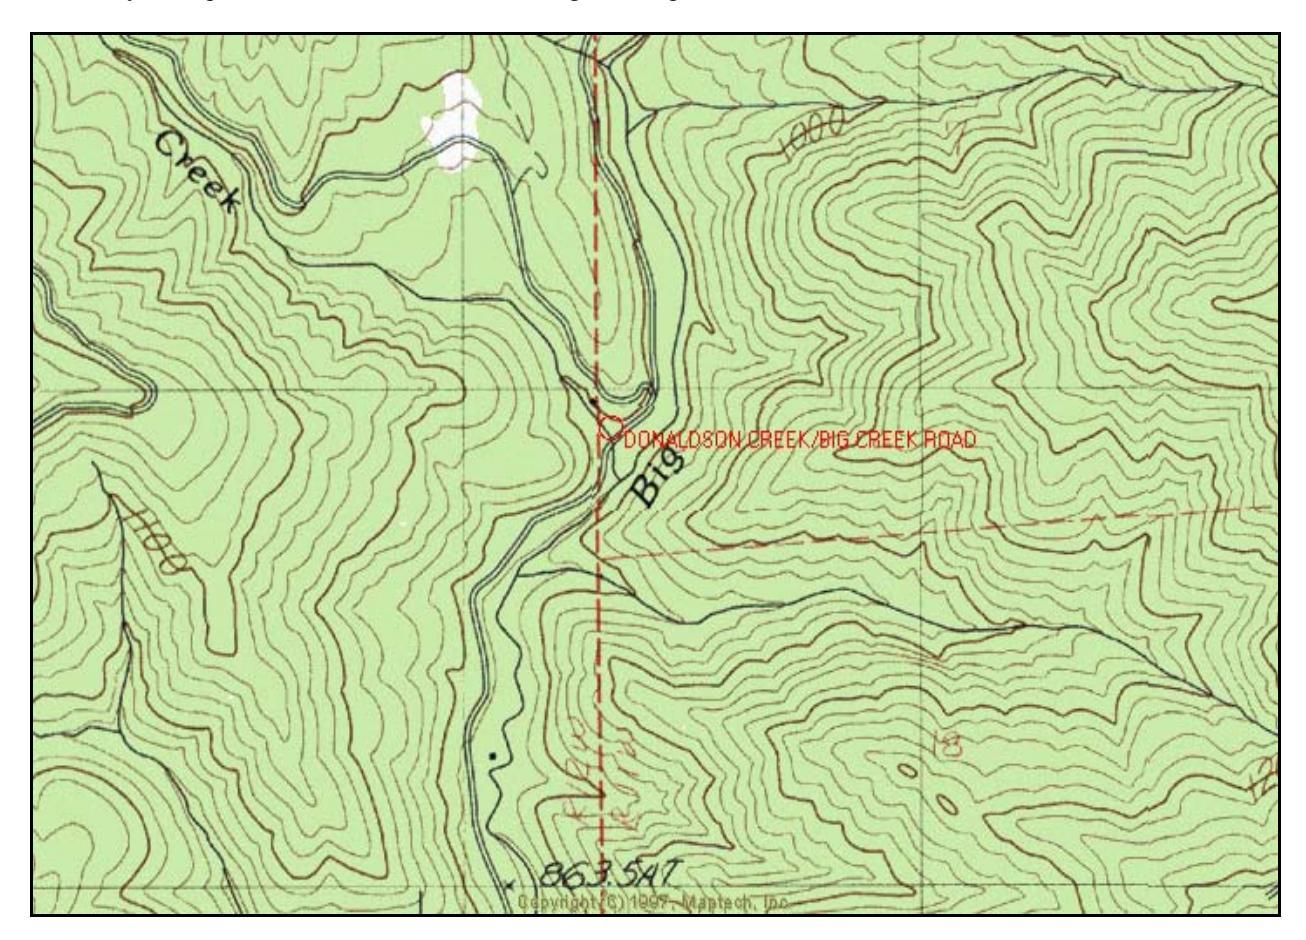
Width: 11.9' Fill Estimate: 805 cubic yards Overall condition: Good.

Barrier Status: RED: the Green-Gray-Red filter determined this crossing fails to meet passage criteria for all species of adult salmonids and all age classes of juveniles. Steep slope (4.5%) and drop at outlet are the features creating the migration barrier.

Preferred Treatment: When crossing is due for replacement (or fails) replace with a properly-sized openbottom arch set on concrete footings or a bridge. Because of the large drop at the outlet, a series of boulder weirs may be required to minimize the head-cutting of the upstream channel.

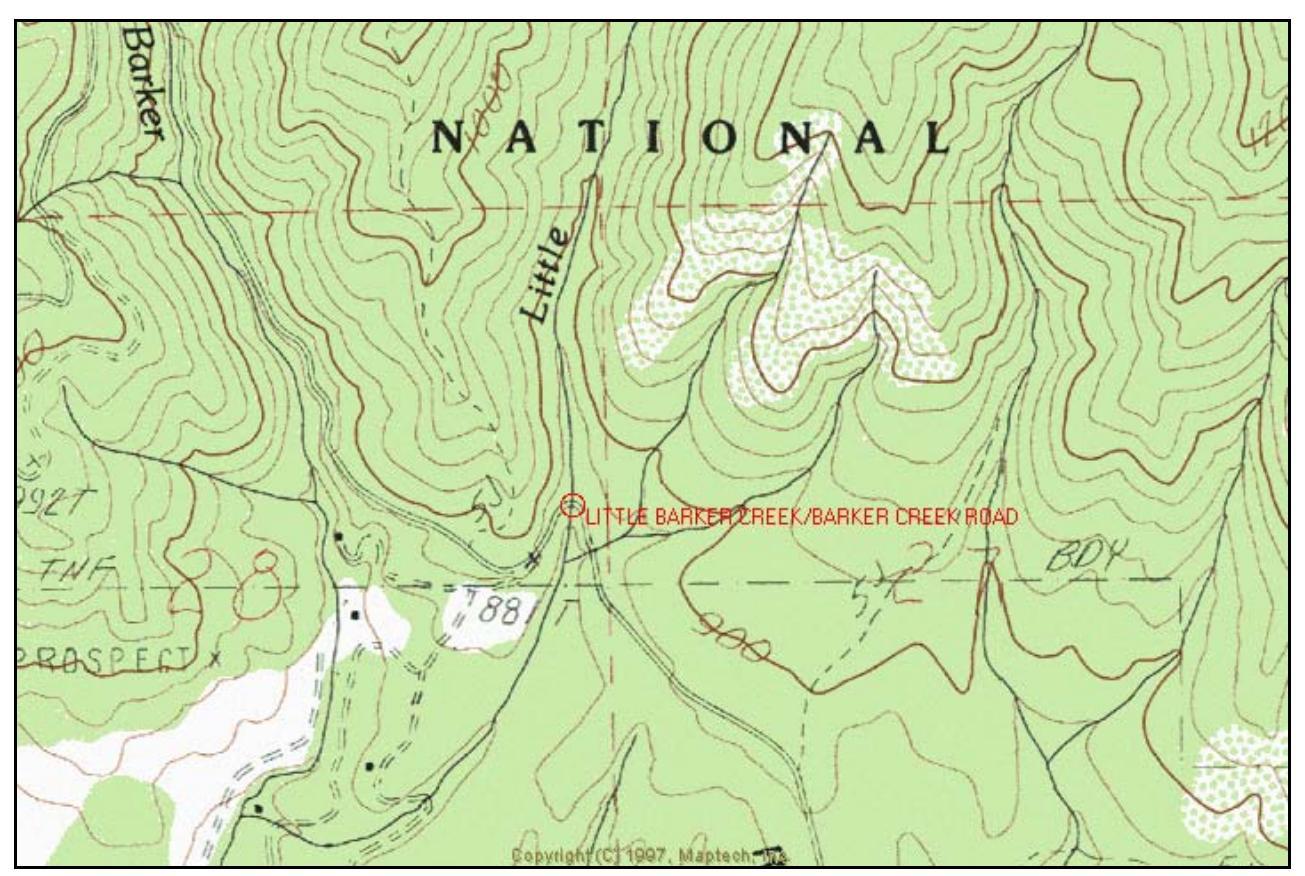
Fill Estimate: 574 cubic yards Overall condition: Good.

Barrier Status: RED: the Green-Gray-Red filter determined this crossing fails to meet passage criteria for all species of adult salmonids and all age classes of juveniles. Steep slope (4.2%) was the main feature creating the migration barrier.

Preferred Treatment: When crossing is due for replacement (or fails) replace with a properly-sized openbottom arch set on concrete footings or a bridge. The privately-owned crossings below the county-maintained site should be assessed for fish passage prior to treating the Barker Creek Road crossing.

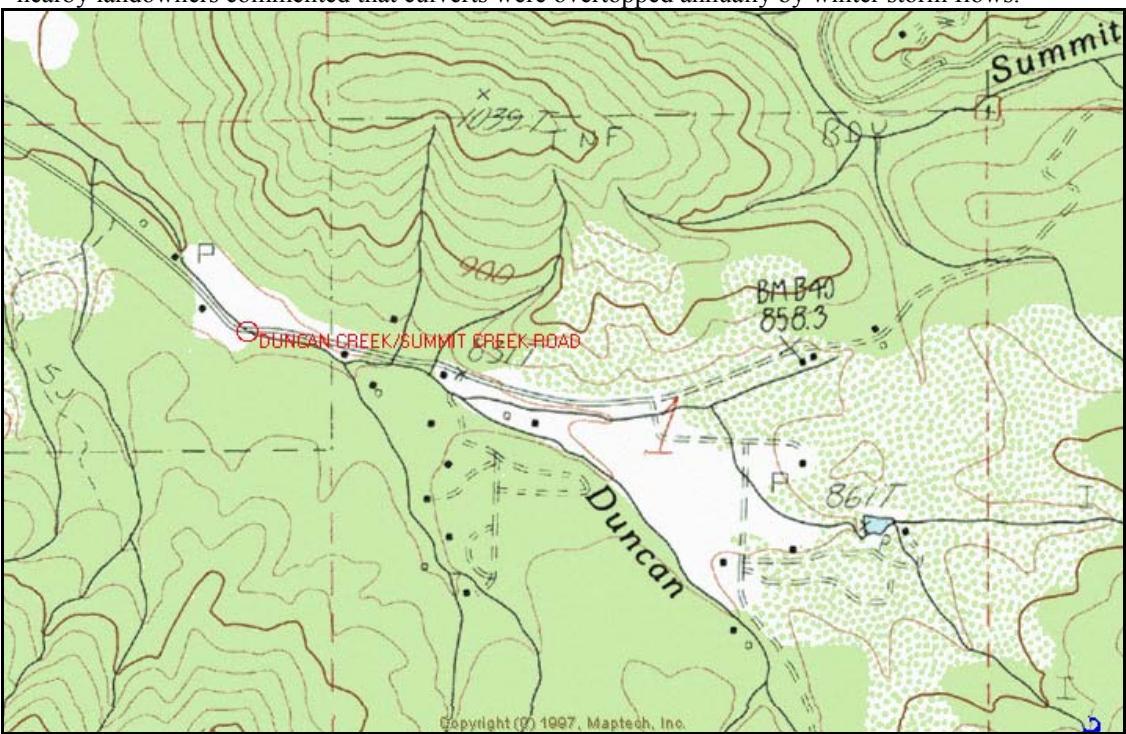
Rustline Height: LB=1.0'; RB=1.6' Average Active Channel Width: 7.1' Fill Estimate: 207 cubic yards **Overall condition:** Fair – abraded.

Barrier Status: LB= **RED**: the Green-Gray-Red filter determined this crossing fails to meet passage criteria for all species of adult salmonids and all age classes of juveniles. RB= **GREY**: the Green-Gray-Red filter determined this culvert meets passage criteria on 80% of migration flows for adult salmonids and 25% of migration flows for juveniles.

Preferred Treatment: When crossing is due for replacement (or fails) replace with a properly-sized openbottom arch set on concrete footings or a bridge. This site should be periodically inspected because of its sizing - nearby landowners commented that culverts were overtopped annually by winter storm flows.

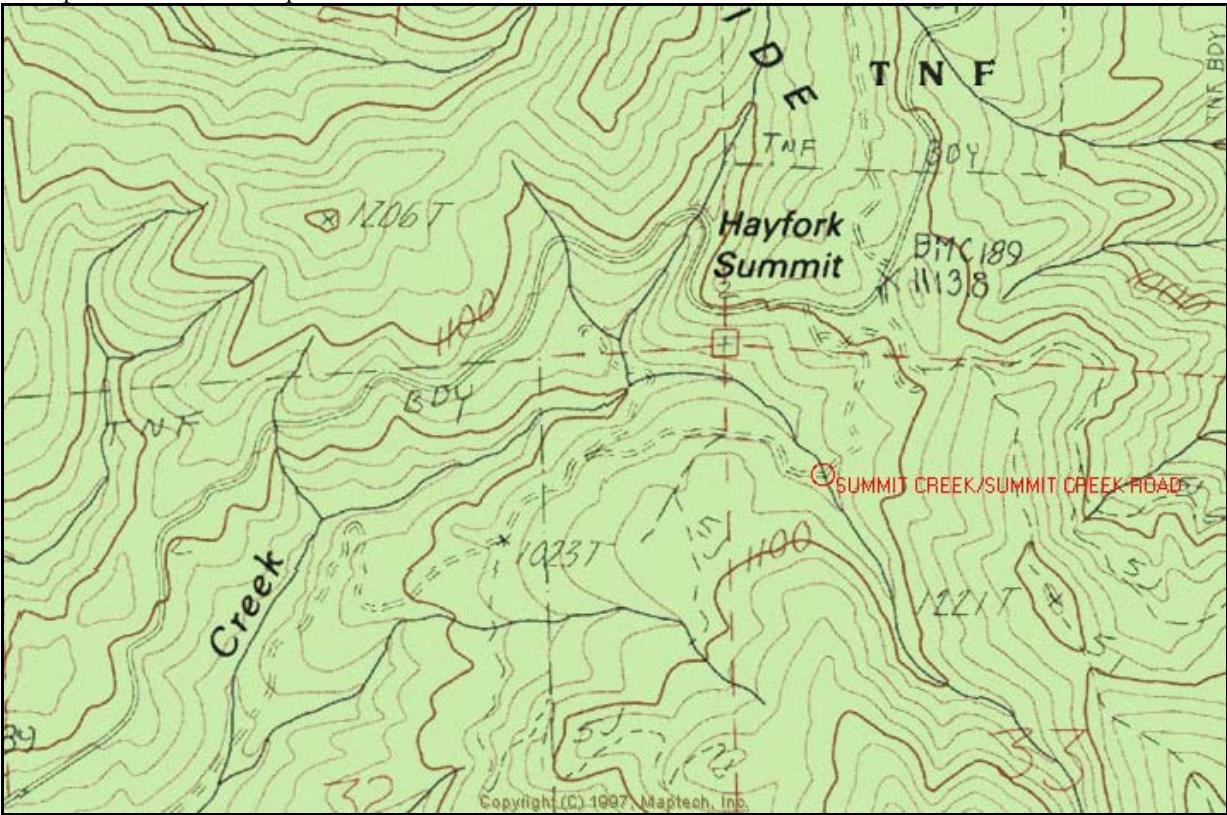
Fill Estimate: 221 cubic yards Overall condition: Fair – culvert floor is abraded.

Barrier Status: RED: the Green-Gray-Red filter determined this crossing fails to meet passage criteria for all species of adult salmonids and all age classes of juveniles.

Preferred Treatment: When crossing is due for replacement (or fails) replace with an embedded properlysized circular SSP pipe or a pipe-arch set on concrete footings. Lack of upstream fisheries benefit makes this site a poor candidate for replacement with restoration funds.

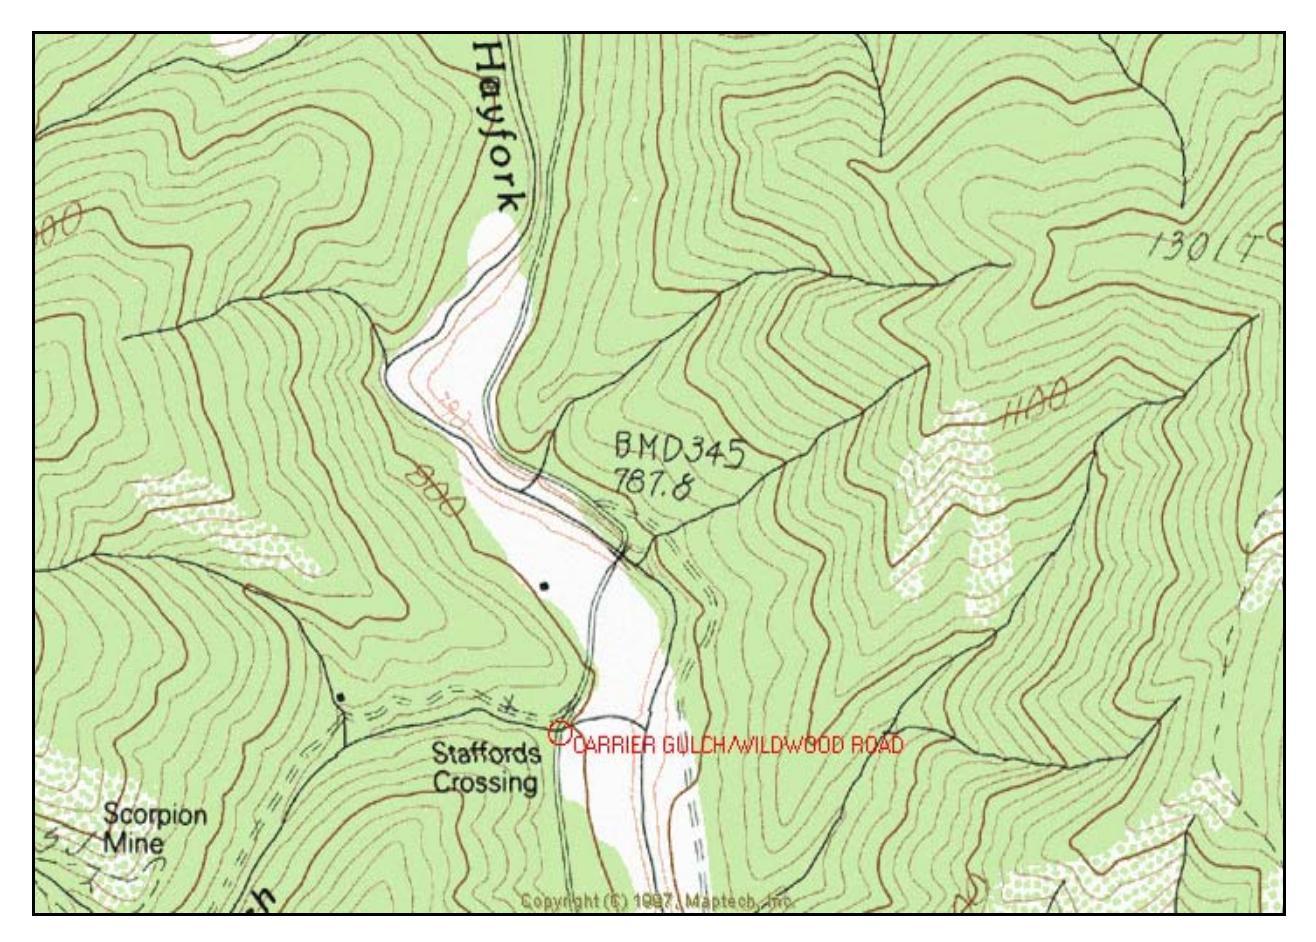
Fill Estimate: 227 cubic yards Overall condition: Abraded.

Barrier Status: RED: the Green-Gray-Red filter determined this crossing fails to meet passage criteria for all species of adult salmonids and all age classes of juveniles.

Preferred Treatment: When crossing is due for replacement (or fails) replace with an embedded properlysized circular SSP pipe or an open-bottom arch set on concrete footings. Lack of upstream fisheries benefit makes this site a poor candidate for replacement with restoration funds.

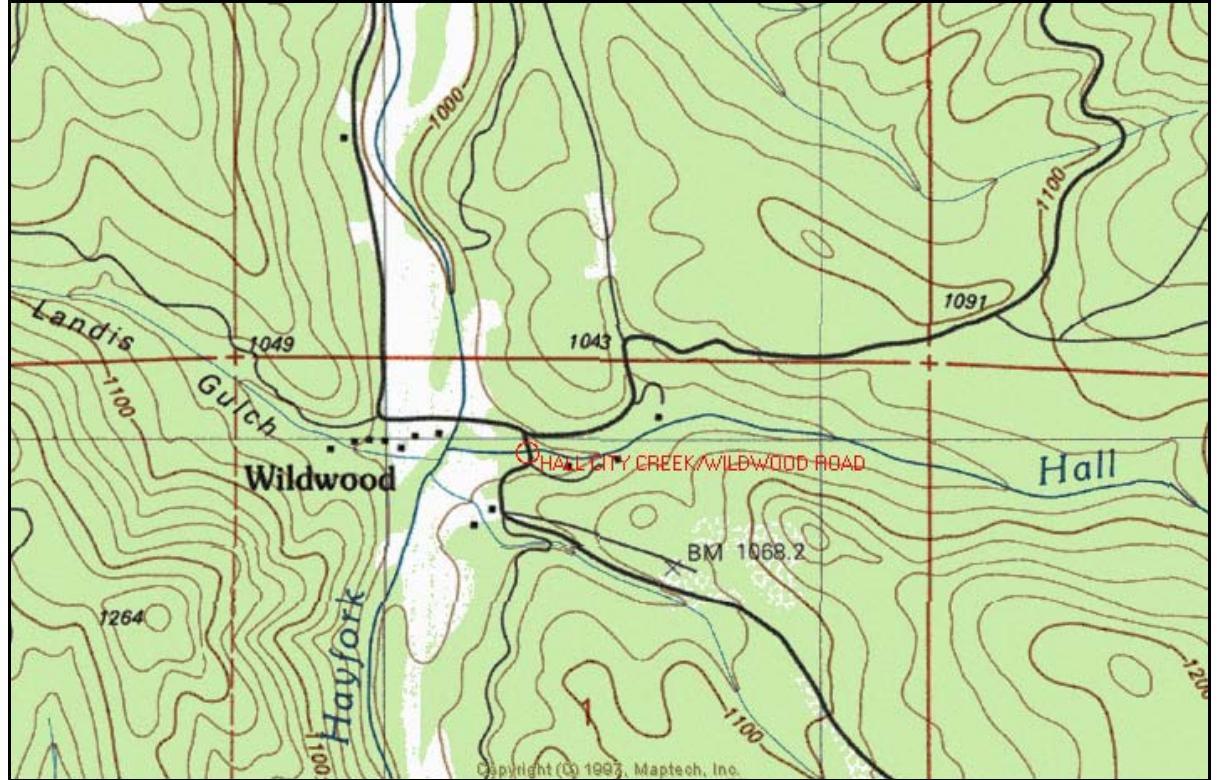
Average Active Channel Width: 5.5' Fill Estimate: 119 cubic yards Overall condition: Poor, both pipes rusted through.

Barrier Status: RED: the Green-Gray-Red filter determined this crossing fails to meet passage criteria for all species of adult salmonids and all age classes of juveniles.

Preferred Treatment: Both pipe arches are in poor condition and together are undersized. The crossing is due for replacement and should be upgraded with a properly-sized embedded circular SSP pipe or an open-bottom arch set on concrete footings. Lack of knowledge regarding upstream fisheries benefit renders this site a poor candidate for replacement with restoration funds.

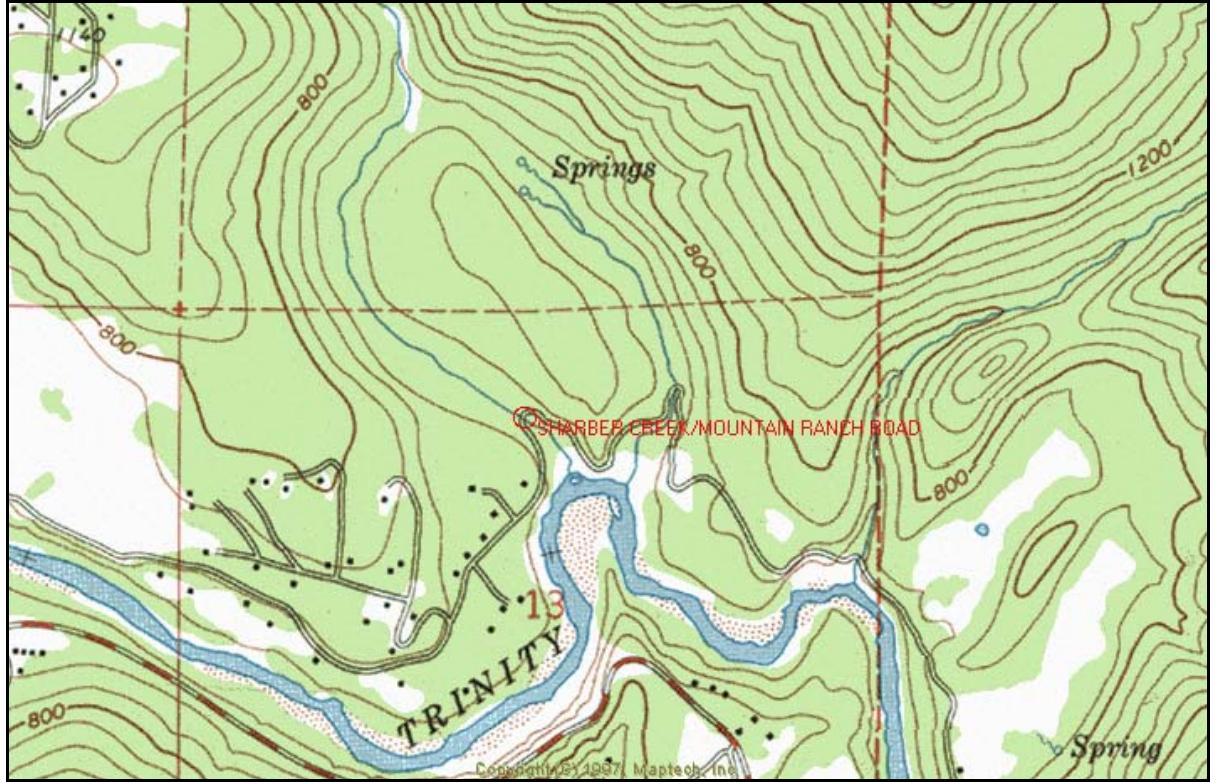
Fill Estimate: 395 cubic yards Overall condition: Fair, pipe was rusted and abraded – no holes worn through.

Preferred Treatment: When crossing is due for replacement (or fails), the landowner should replace with a properly-sized embedded circular SSP pipe or an open-bottom arch set on concrete footings. The appropriate agencies should work with the landowner to develop a fish-friendly (and legal) water diversion.
