CATALOG OF HUMBOLDT COUNTY STREAM CROSSINGS WITH CULVERTS LOCATED ON ANADROMOUS STREAM REACHES

Prepared for Humboldt County - Department of Public Works

By Ross Taylor and Associates

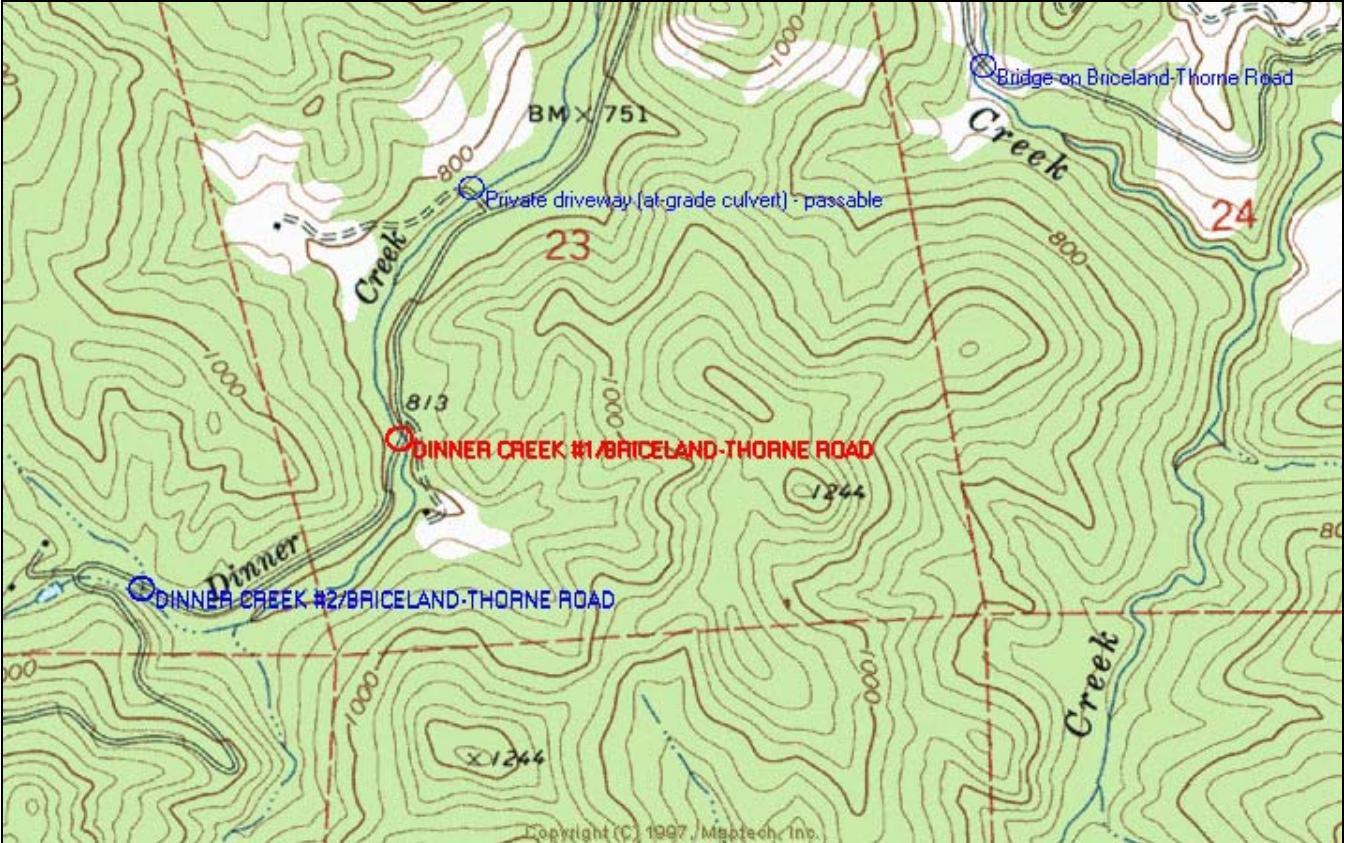
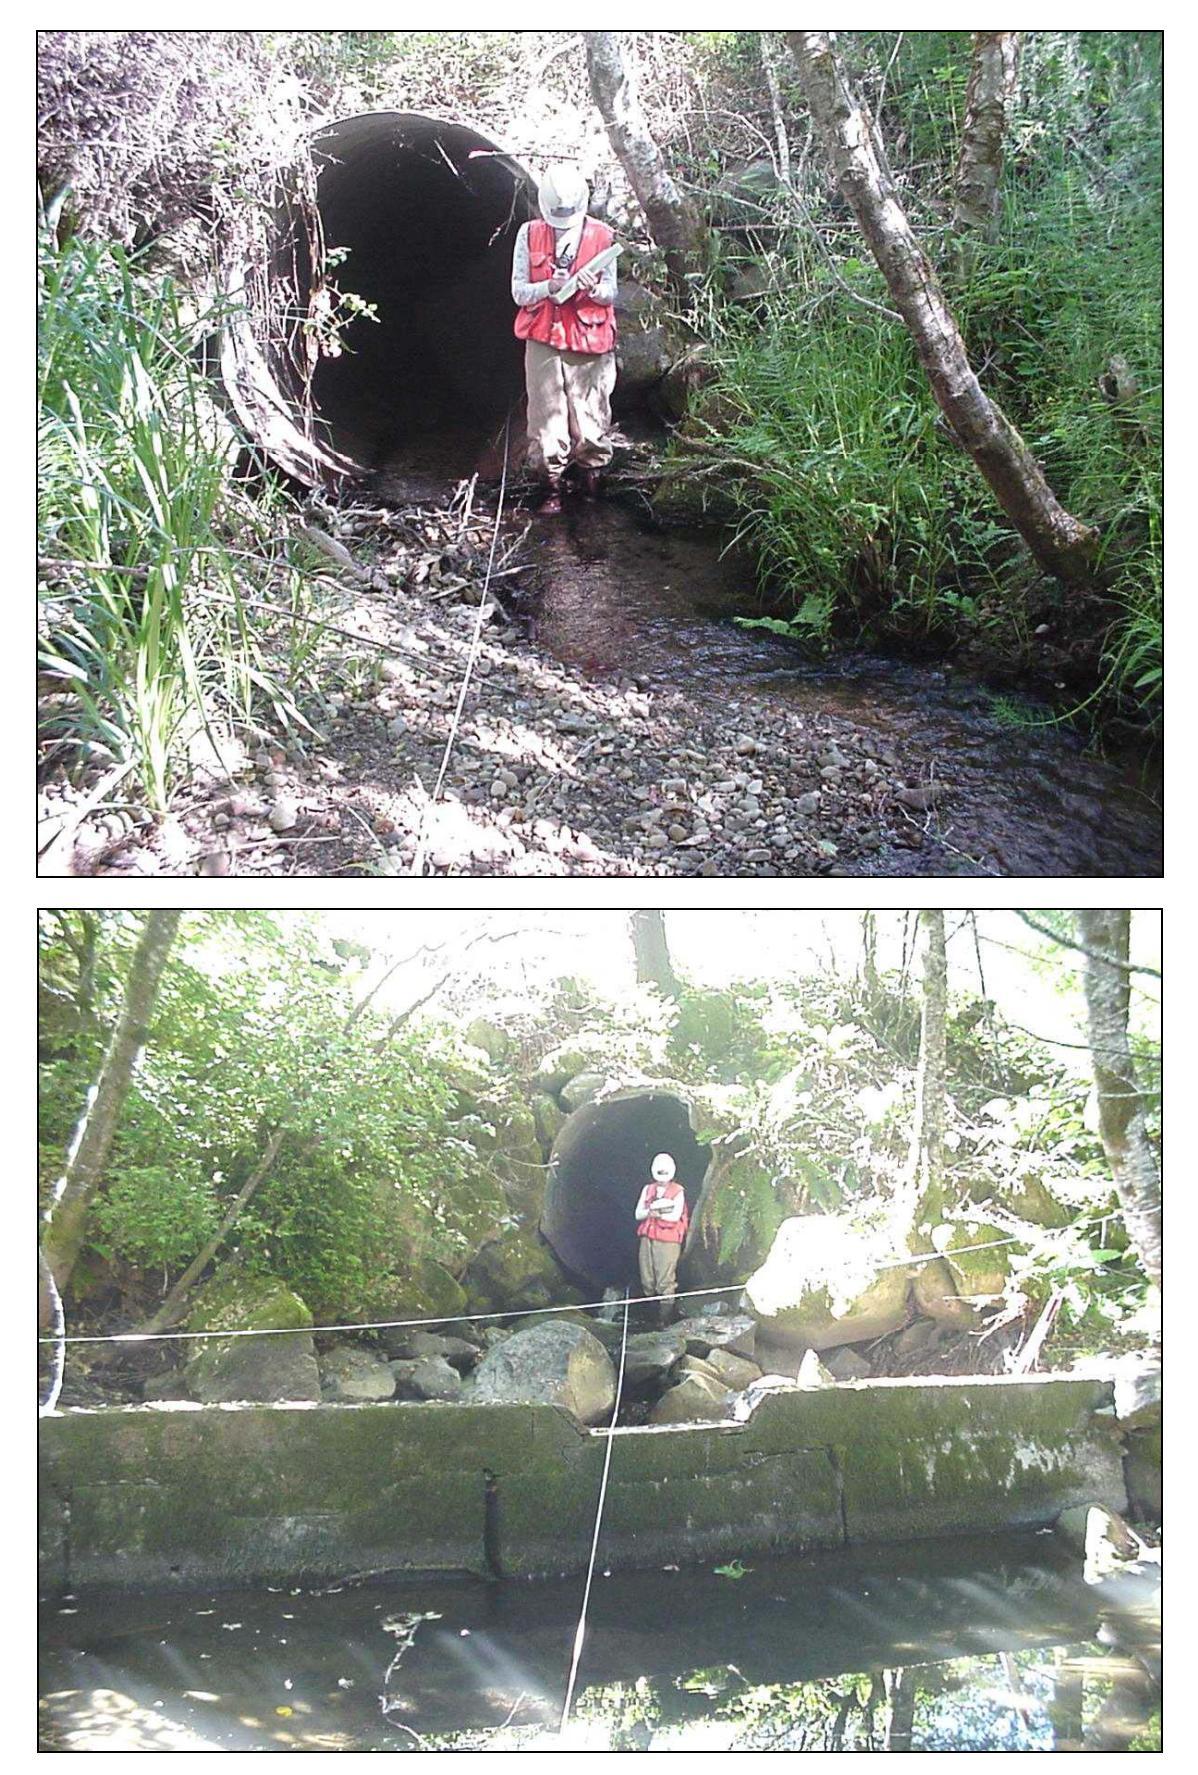
Site ID# HUM-001: Dinner Creek/Briceland-Thorne Road; China Creek; Redwood Creek; South Fork Eel River; Eel River

Culvert Type: Circular, SSP. **Corrugations:** $22/3^{\circ} x \frac{1}{2^{\circ}}$. **Dimensions: diameter = 6.0'. Length:** 91.6' **Slope:** 1.90% **Modifications:** 11 steel-ramp baffles and concrete tail-water control weir. **Rustline Height:** 2.6'. **Average Active Channel Width:** 11.6'. **Fill Estimate:** 907 cubic yards. **Overall Condition:** Poor– culvert invert is rusted-through. **Sizing:** Extremely undersized; HW/D = 1 on a storm flow with approximately a three-year recurrence interval. Briceland-Thorne Road is overtopped on approximately an 18-year storm flow. **Barrier Status:** GRAY: FishXing determined this crossing meets the 8-16-16 ft/sec passage criteria for all species of adult salmonids over 89% of the estimated range of migration flows (6.5 – 33.4 c.f.s.) and fails to meet the passage criteria for all age classes of juvenile salmonids. The FishXing analysis of adult passage assumed that the concrete weir was fully functional in controlling tail-water elevatior; however an inspection of the structure revealed that substantial leakage occurred around and under the weir. The two Hewitt-ramps downstream of the concrete weir have also failed creating a substantial drop over the weir, thus 2 points were added to the "extent of barrier" score in the initial ranking matrix.

Habitat: <u>Quantity</u> = approximately 7,400' of potential fish-bearing habitat upstream of Site ID# HUM-001. <u>Quality</u> = rated as "good" for the ranking matrix based on Taylor and Associates survey crew's field notes. CDFG conducted habitat typing survey in 1995 and confirmed the presence of juvenile coho and steelhead. The crossing was surveyed by Taylor and Associates on 6/27/03 and there was continuous surface flow in the channel. At 9:15AM the air temp = 16° C and the water temp = 13° C. The survey crew noted a dense riparian zone of conifers and hardwoods, streambed substrate of mostly gravels and cobbles, and several good-quality rearing pools adjacent to the crossing. Numerous (>100 fish) juvenile salmonids of several age classes were observed in the stream channel adjacent to Site ID# HUM-001.

Preferred Treatment: A replacement with a properly sized open-bottom arch set on concrete footings or a bridge is the best long-term solution to provide unimpeded passage.

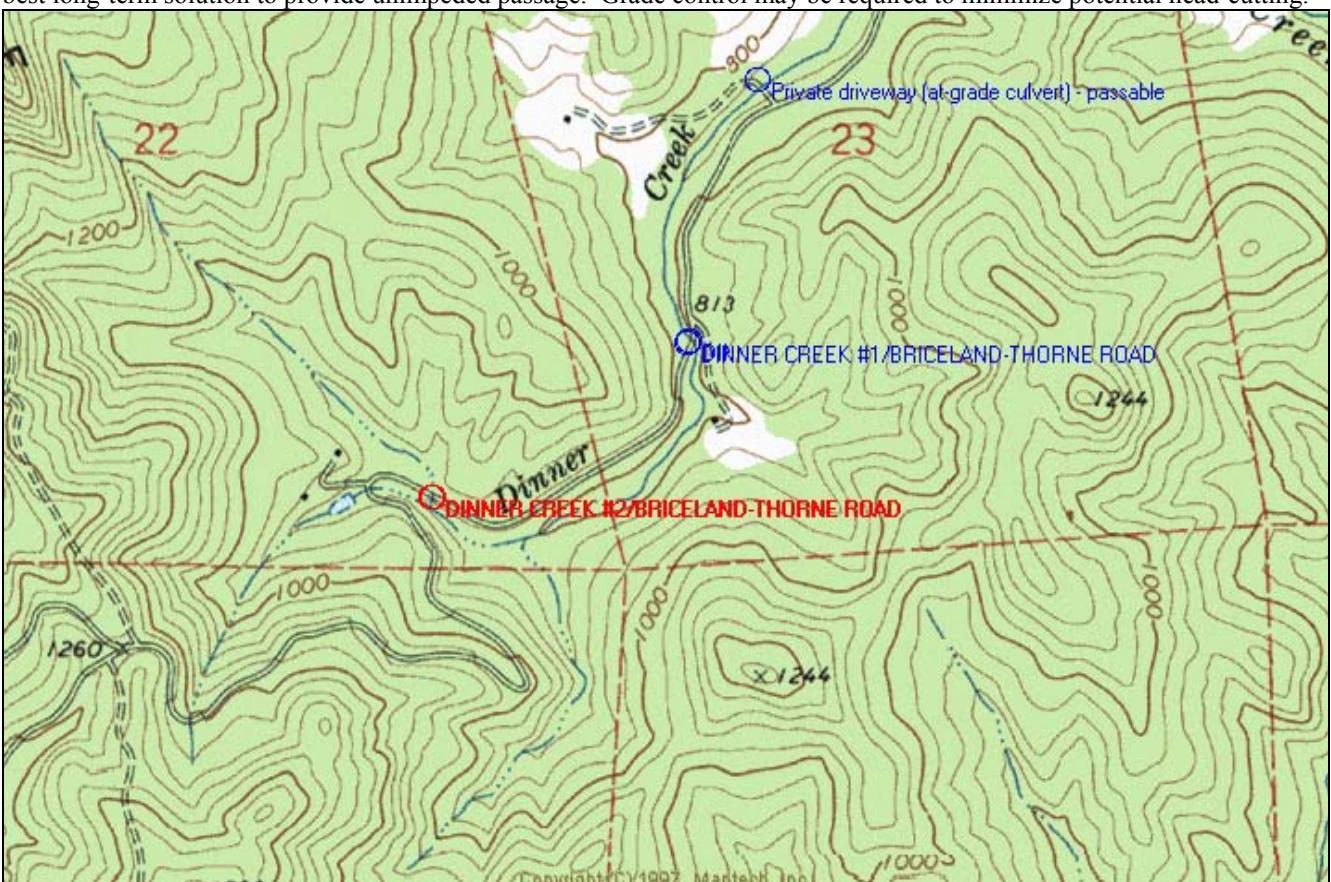
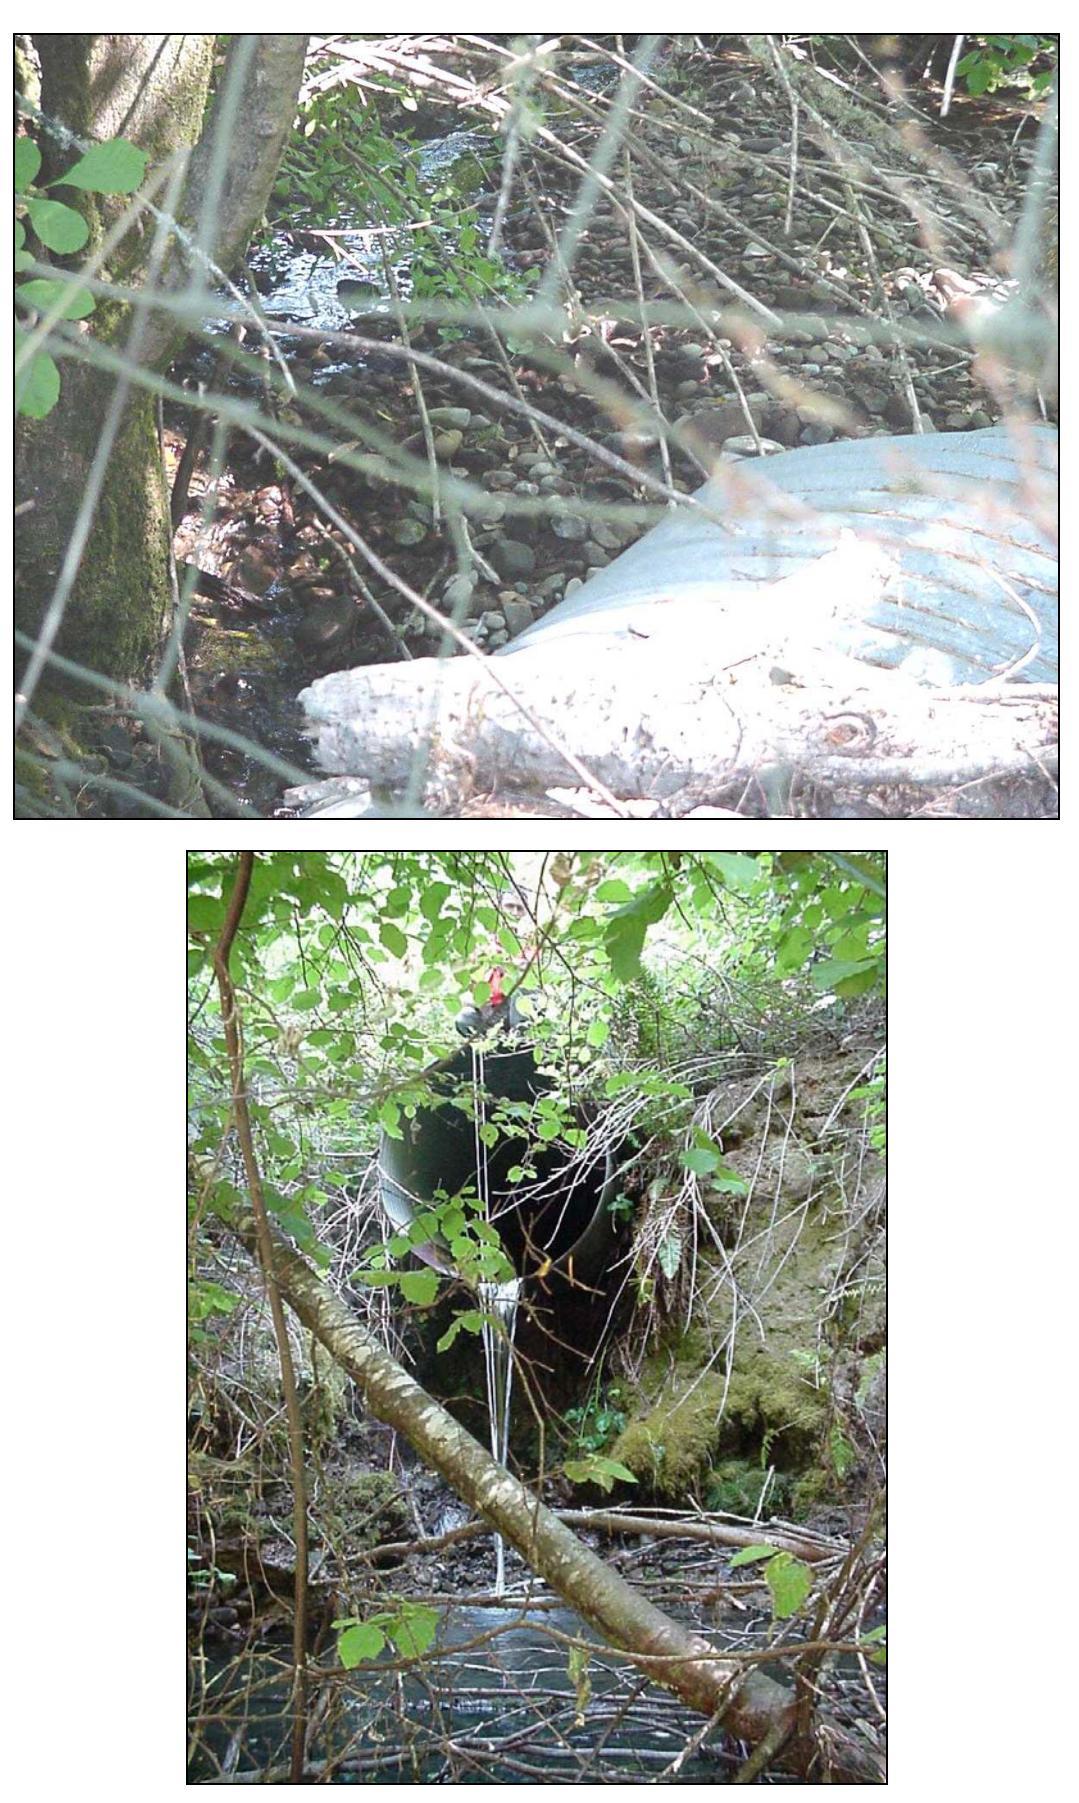
Site ID#HUM-002: Dinner Creek #2/Briceland-Thorne Road; China Ck; Redwood Creek; South Fork Eel River; Eel River

Culvert Type: Circular, SSP. **Corrugations:** 2 2/3" x $\frac{1}{2}$ ". **Dimensions:** diameter = 4.0'. **Length:** 72.0' **Slope:** 3.13% **Modifications:** None. **Rustline Height:** 1.1'. **Average Active Channel Width:** 7.9'. **Fill Estimate:** 687 cubic yards. **Overall Condition:** Fair– culvert invert is abraded and starting to rusted-through. **Sizing:** Extremely undersized; HW/D = 1 on a storm flow with approximately a two-year recurrence interval. Briceland-Thorne Road is overtopped on approximately a five-year storm flow. The Taylor and Associates field crew noted that the channel was highly aggraded on the upstream side of the crossing. **Barrier Status: RED**: the first-phase filter determined this crossing fails to meet the 8-16-16 ft/sec passage criteria for all age classes of salmonids over the entire range estimated of migration flows (for adults = 3.0 – 12.3 c.f.s.). The extremely perched outlet (approximately five feet) is the crossing's main feature that creates a migration barrier for all salmonids. **Additional Stream Crossings:** Downstream – (\approx 3,000') to Site ID #HUM-001, (\approx 5,000') to at-grade culvert on private driveway that appears passable, (\approx 7,900') to at-grade SSP arch-culverts (two pipes) on private road that appears passable, (\approx 10,600') to crossing on private road to Blue Slide Creek – status unknown , (\approx 12,800') to bridge on Briceland-Thorne Road, and (\approx 15,500') to confluence of Dinner Creek and Redwood Creek. <u>Upstream</u> – none indicated on the USGS topographic map within the fish-bearing stream reach.

Habitat: <u>Quantity</u> = approximately 2,000' of potential fish-bearing habitat upstream of Site ID# HUM-002. <u>Quality</u> = rated as "good" for the ranking matrix based on Taylor and Associates survey crew's field notes. CDFG conducted habitat typing survey in 1995 and confirmed the presence of juvenile coho salmon and steelhead. The crossing was surveyed by Taylor and Associates on 6/27/03 and there was continuous surface flow in the channel. At 11:30AM the air temp = 25° C and the water temp = 13° C. The survey crew noted a dense riparian zone of conifers and hardwoods, streambed substrate of mostly gravels and cobbles, and several good-quality rearing pools adjacent to the crossing. A moderate abundance (10-50 fish) of juvenile salmonids of two age classes was observed in the stream channel downstream of Site ID# HUM-002.

Preferred Treatment: A replacement with a properly sized open-bottom arch set on concrete footings or a bridge is the best long-term solution to provide unimpeded passage. Grade control may be required to minimize potential head-cutting.

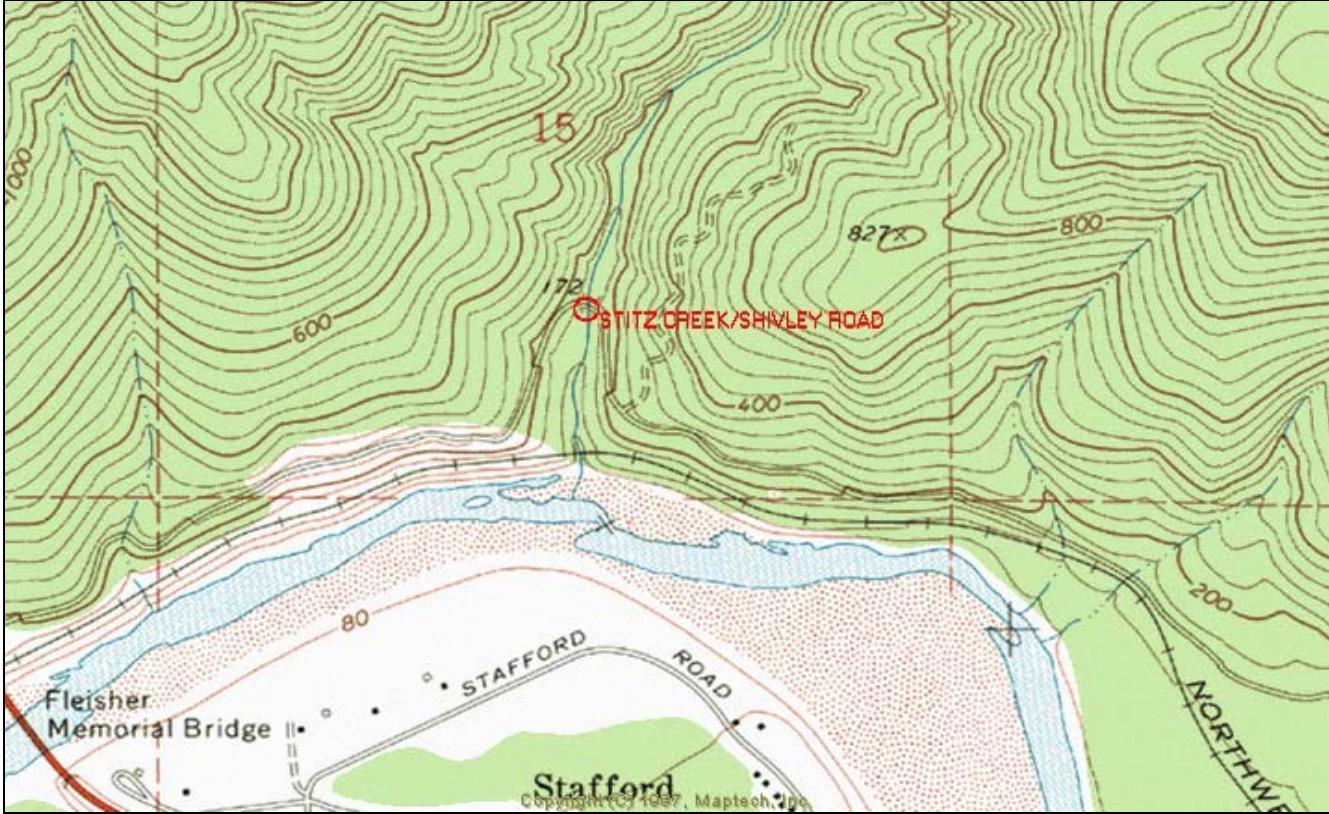
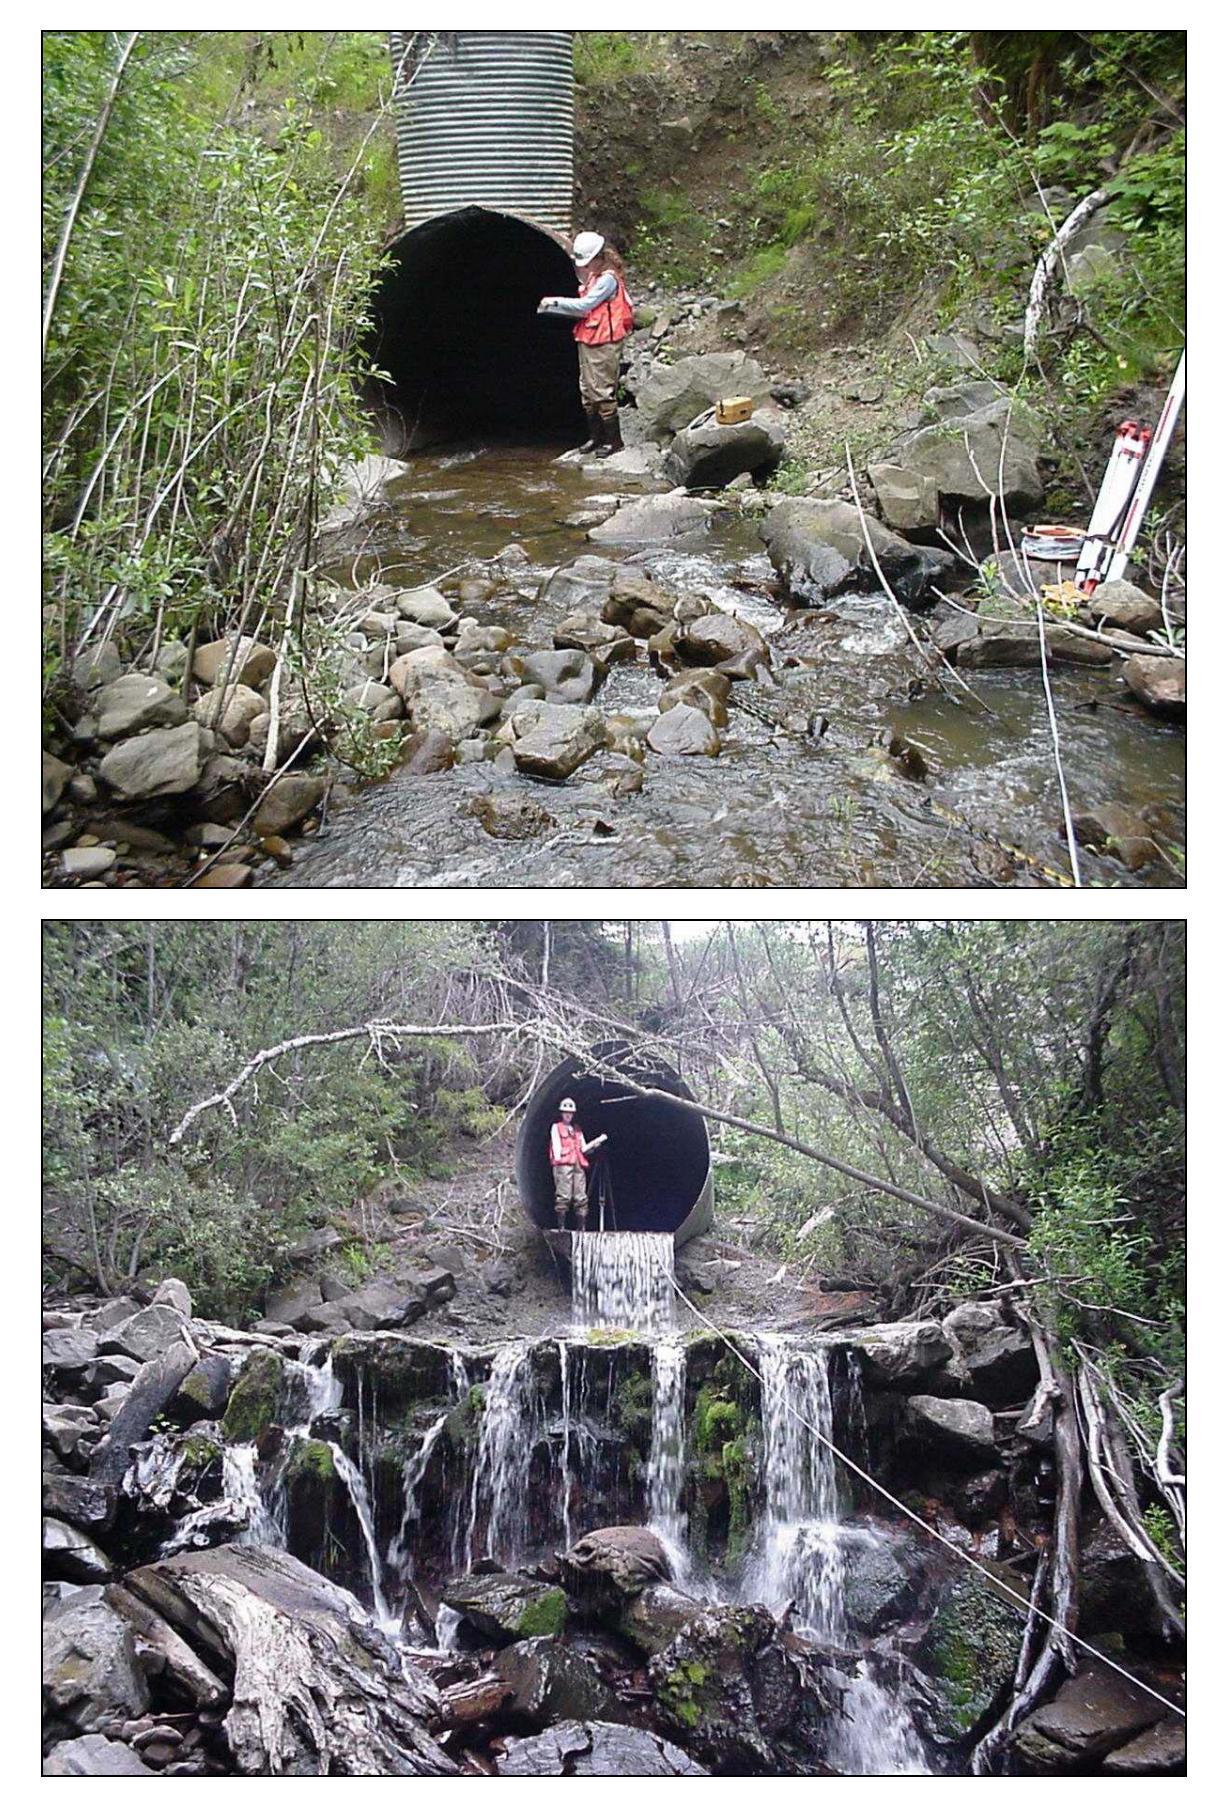
Site ID#HUM-003: Stitz Creek/Shivley Road; Eel River Road Ownership: Humboldt County

Culvert Type: Circular, SSP. **Corrugations:** 2 2/3" x $\frac{1}{2}$ ". **Dimensions:** diameter = 8.0'. **Length:** 119.8' **Slope:** 2.43% **Modifications:** None. **Rustline Height:** 3.1'. **Average Active Channel Width:** 20.7'. **Fill Estimate:** 6,274 cubic yards. **Overall Condition:** Fair– culvert invert rusted-through and then re-lined with concrete. **Sizing:** Extremely undersized; HW/D = 1 on a storm flow with approximately a two-year recurrence interval. Shivley Road is overtopped on approximately a 28-year storm flow. The Taylor and Associates field crew noted that the channel was highly aggraded on the upstream side of the crossing. **Barrier Status: RED**: the first-phase filter determined this crossing fails to meet the 8-16-16 ft/sec passage criteria for all age classes of salmonids over the entire range estimated of migration flows (for adults = 3.0 - 89.3 c.f.s.). The extremely perched outlet (approximately five feet) is the crossing's main feature that creates a migration barrier for all salmonids; and if adult salmonids were able to access the culvert it would encounter excessive velocities within the moderately-sloped concrete invert.

Habitat: <u>Quantity</u> = approximately 8,900' of potential fish-bearing habitat upstream of Site ID# HUM-003. <u>Quality</u> = rated as "fair" for the ranking matrix based on Taylor and Associates survey crew's field notes. CDFG conducted habitat surveys in 1997, 1992, 1990, 1988, 1987, and 1979. Each survey noted numerous potential barriers at the railroad crossing, Shivley Road, and numerous debris jams throughout the lower several thousand feet of channel. The 1997 survey noted that most of the available spawning gravels were highly embedded. The crossing was surveyed by Taylor and Associates on 6/12/03 and there was continuous surface flow in the channel. At 8:30AM the air temp = 12° C and the water temp = 11° C. The survey crew noted a dense riparian zone of conifers and hardwoods, streambed substrate of mostly cobbles and small boulders, and several good-quality rearing pools adjacent to the crossing. Several juvenile salmonids (<10 fish) were observed in the stream channel downstream of Site ID# HUM-003.

Preferred Treatment: A replacement with a properly sized open-bottom arch set on concrete footings or a bridge is the best long-term solution to provide unimpeded passage. Grade control may be required to minimize probable head-cutting.

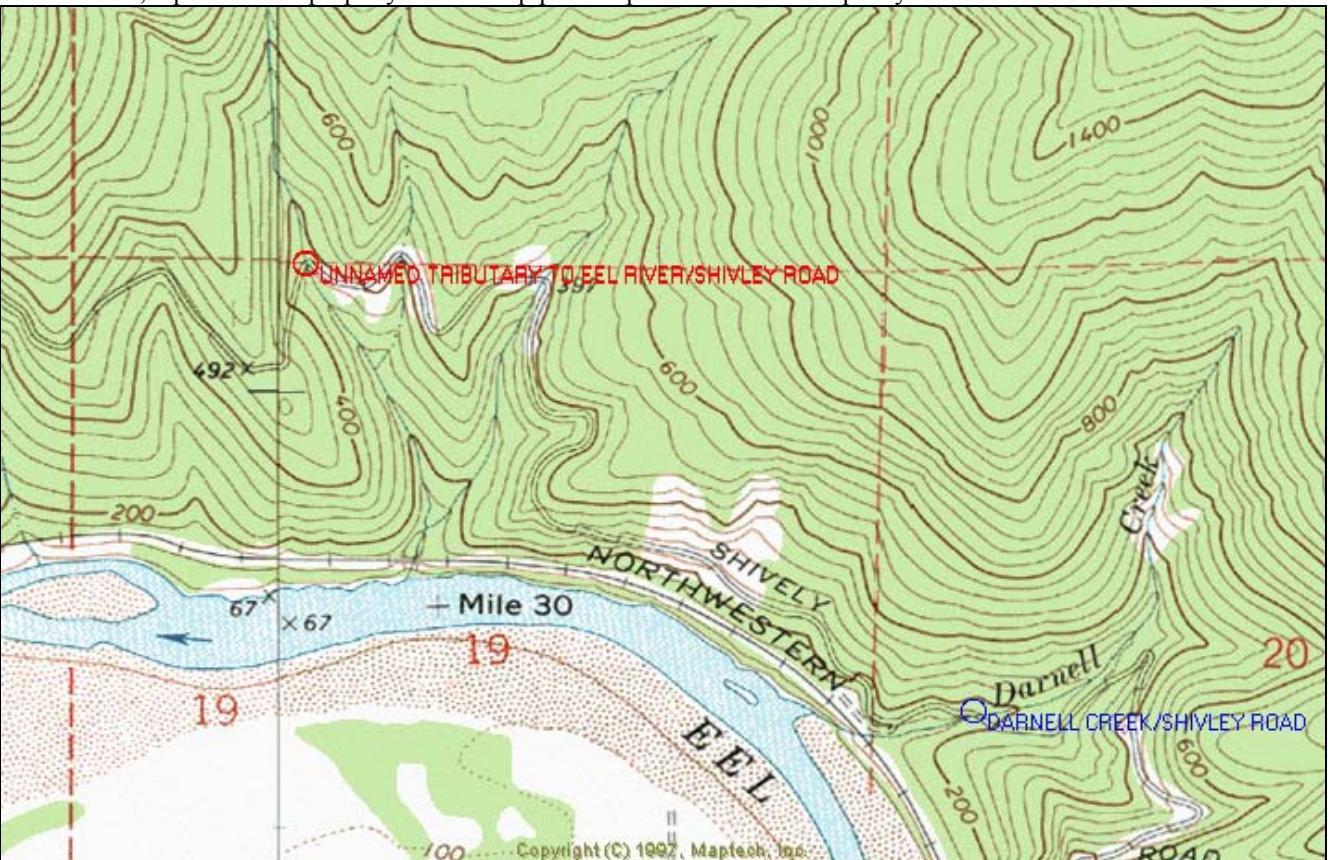
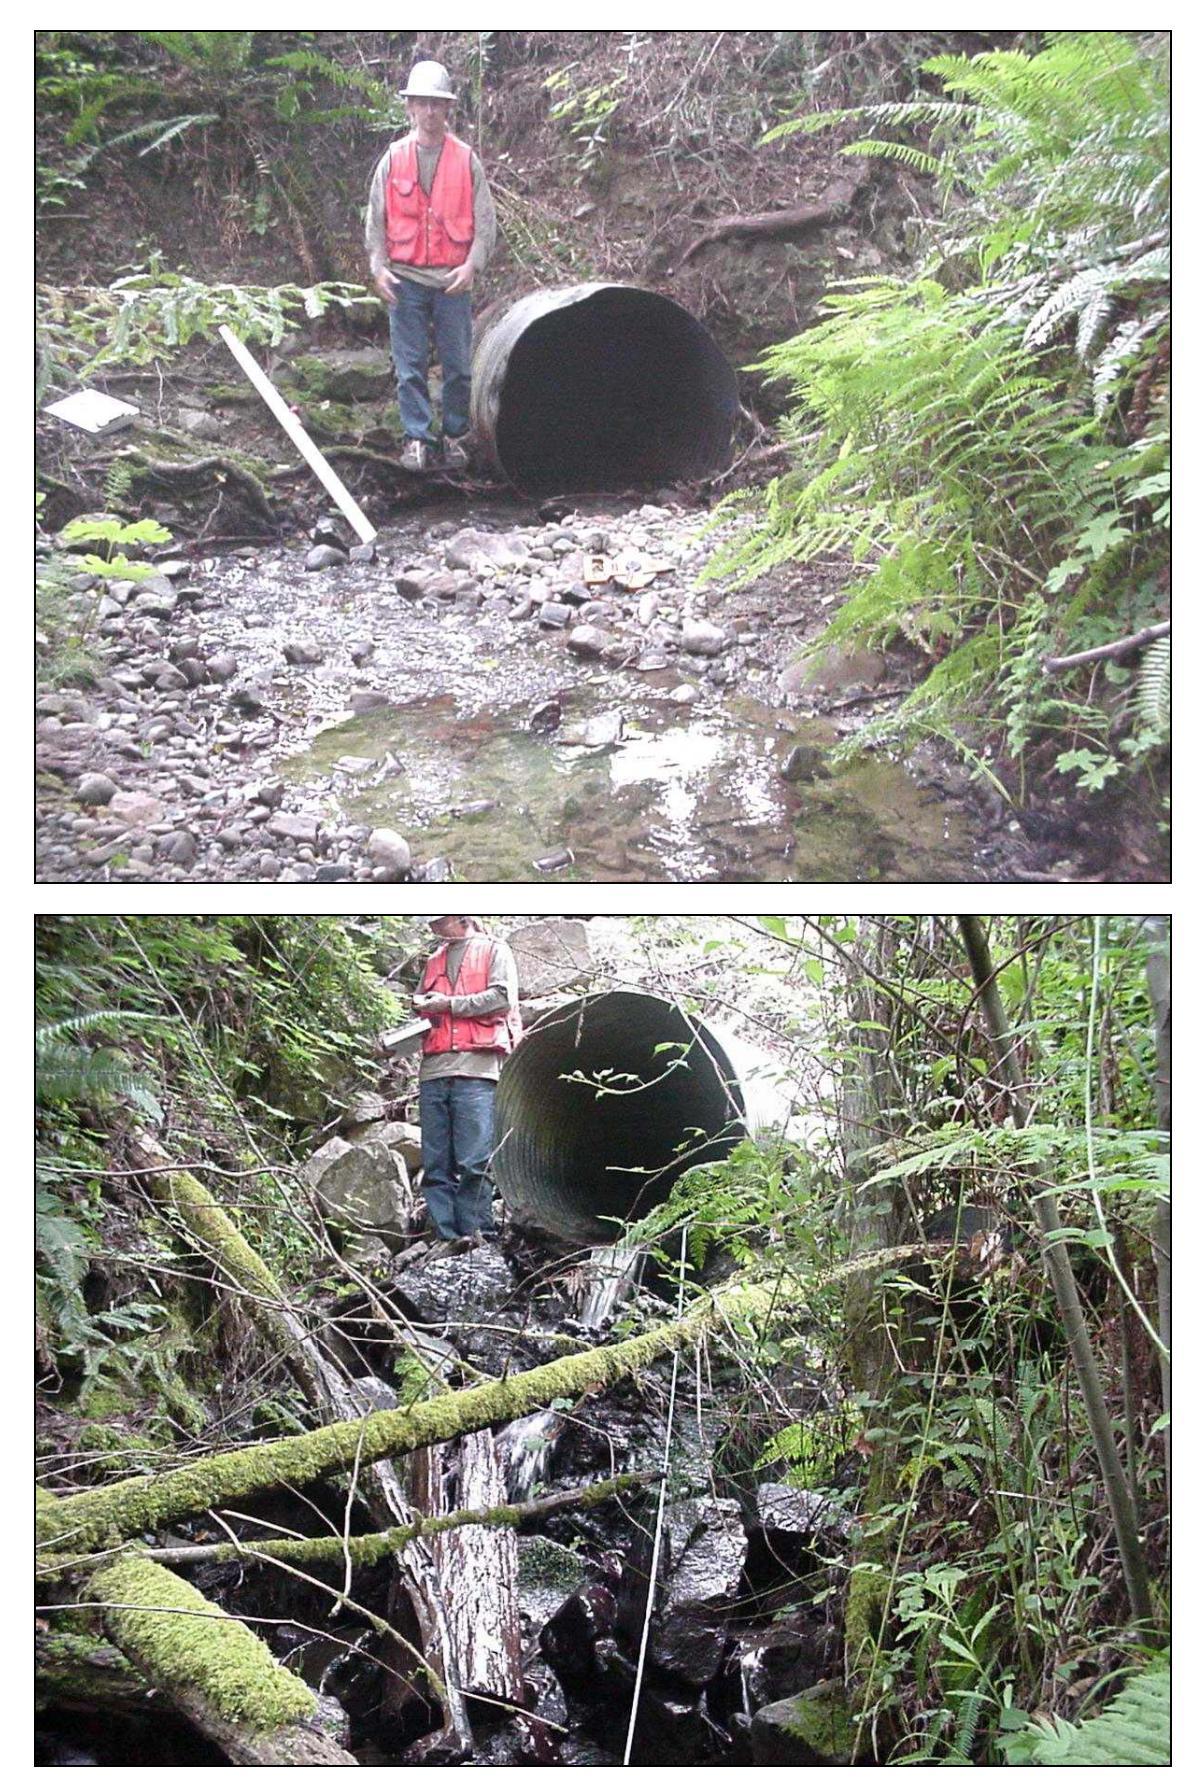
Site ID#HUM-004: Unnamed Tributary to the Eel River/Shivley Road; Eel River Road Ownership: Humboldt County

Culvert Type: Circular, SSP. **Corrugations:** 2 2/3" x $\frac{1}{2}$ ". **Dimensions:** diameter = 4.0'. **Length:** 81.0' **Slope:** 6.47% **Modifications:** None. **Rustline Height:** 1.4'. **Average Active Channel Width:** 20.7'. **Fill Estimate:** 758 cubic yards. **Overall Condition:** Fair– culvert invert rusted-through and then re-lined with 0.5' layer of concrete. **Sizing:** Extremely undersized; HW/D = 1 on a storm flow with approximately a two-year recurrence interval. Shivley Road is overtopped on approximately a nine-year storm flow. The Taylor and Associates field crew noted that the channel was highly aggraded on the upstream side of the crossing. **Barrier Status: RED**: the first-phase filter determined this crossing fails to meet the 8-16-16 ft/sec passage criteria for all age classes of salmonids over the entire range estimated of migration flows (for adults = 3.0 - 11.7 c.f.s.). The extremely perched outlet (approximately six feet) is the crossing's main feature that creates a migration barrier for all salmonids; and if adult salmonids were able to access the culvert it would encounter excessive velocities over the steeply-sloped concrete invert.

Habitat: <u>Quantity</u> = probably less than 500' of potential fish-bearing habitat upstream of Site ID# HUM-004. The channel slope downstream of Shivley Road is >8% and is probably not an anadromous stream reach. <u>Quality</u> = rated as "poor" for the ranking matrix based on Taylor and Associates survey crew's field notes due primarily to the steep channel slope. No fisheries or habitat information was available in CDFG's files. The crossing was surveyed by Taylor and Associates on 6/12/03 and there was continuous surface flow in the channel. At 9:00AM the air temp = 16° C and the water temp = 10° C. The survey crew noted a dense riparian zone of conifers and hardwoods, streambed substrate of mostly gravel and cobble. However; the surrounding hill-slopes were heavily logged with numerous fresh clear-cuts. No fish were observed in the stream channel adjacent to Site ID# HUM-004.

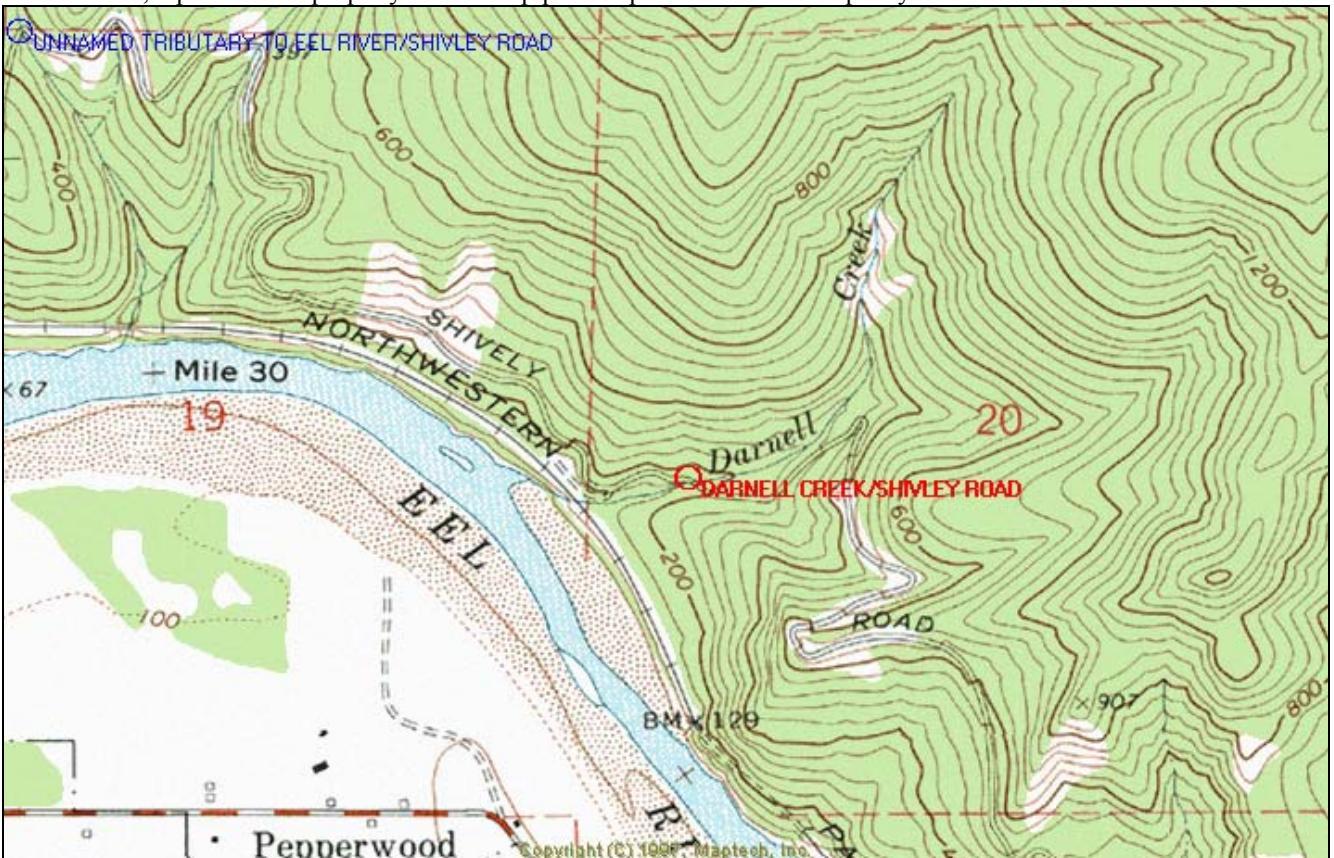
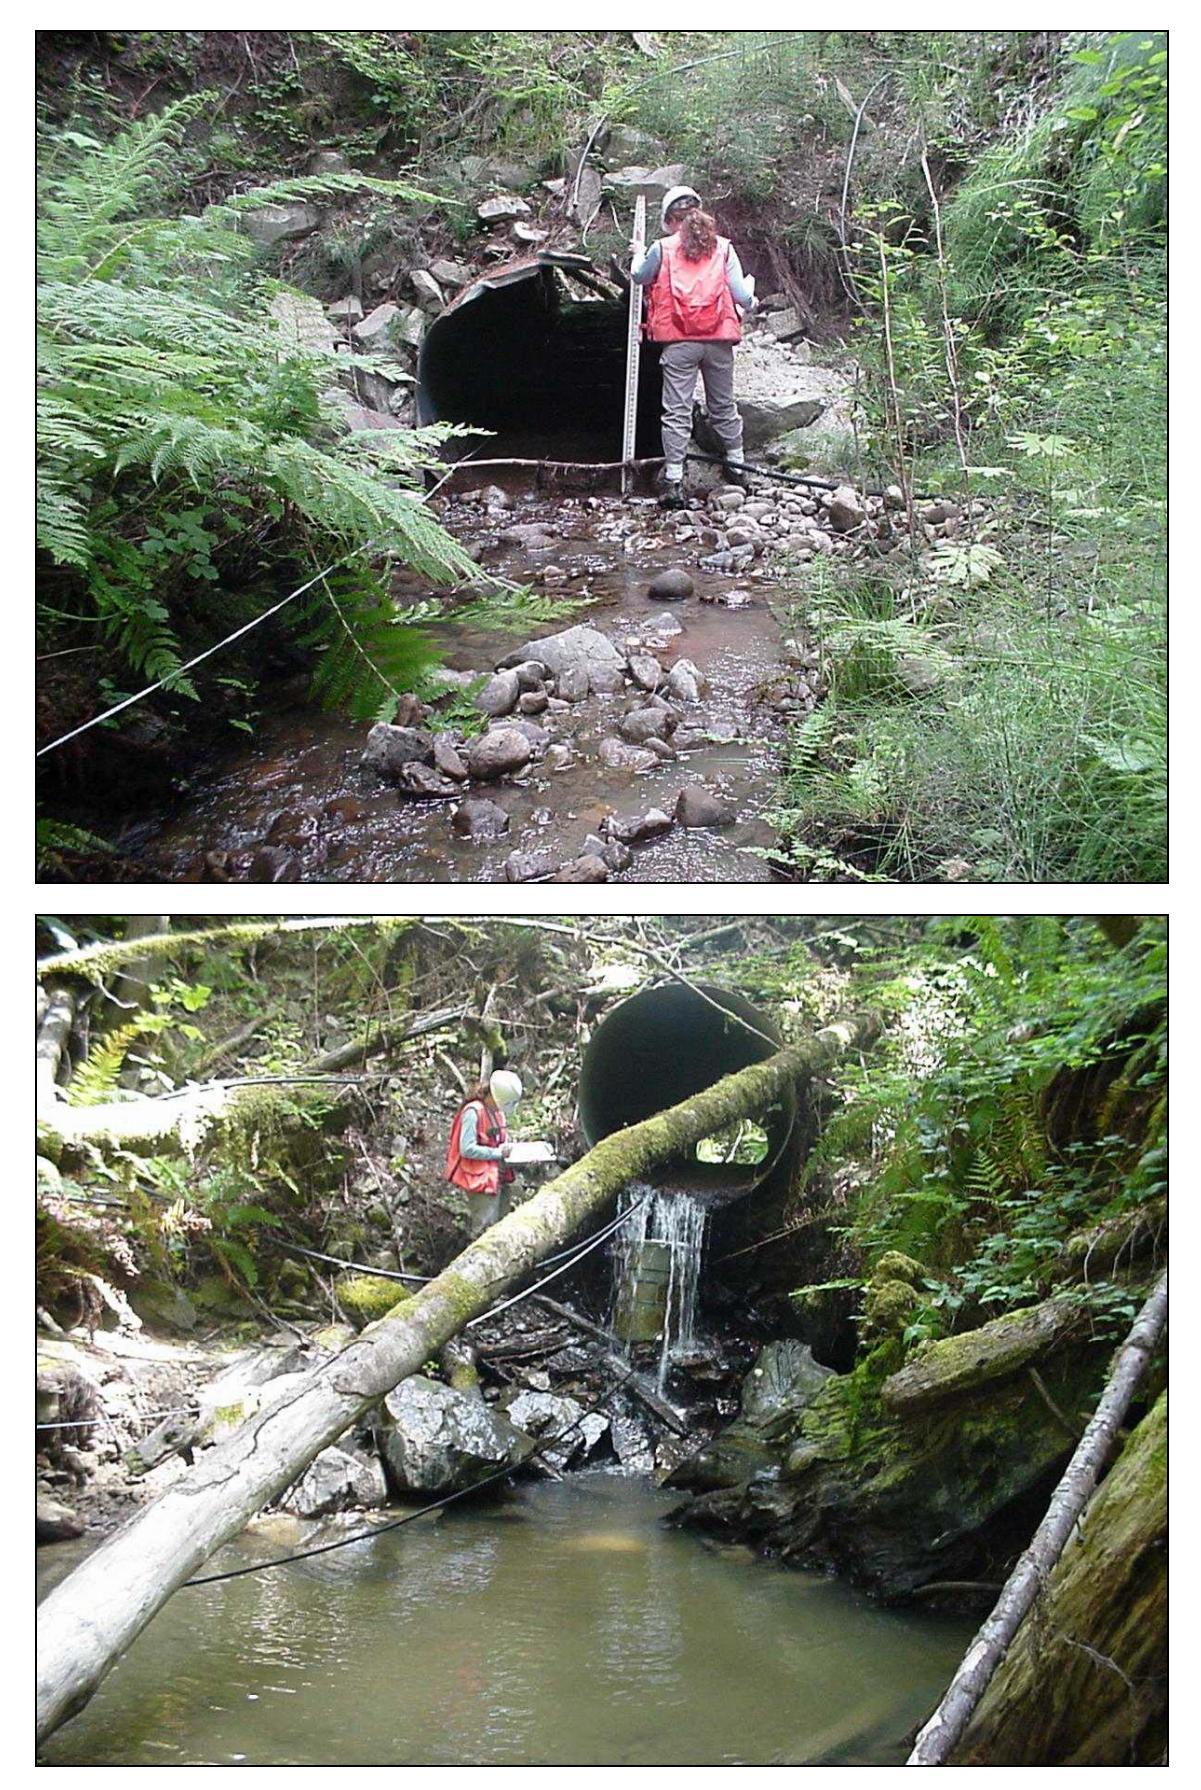
Site ID#HUM-005: Darnell Creek/Shivley Road; Eel River Road Ownership: Humboldt County

Culvert Type: Circular, SSP. **Corrugations:** 2 2/3" x $\frac{1}{2}$ ". **Dimensions:** diameter = 5.0°. **Length:** 60.6° **Slope:** 4.83% **Modifications:** None. **Rustline Height:** 1.4°. **Average Active Channel Width:** 20.7°. **Fill Estimate:** 521 cubic yards. **Overall Condition:** Fair– culvert invert rusted-through and then re-lined with 0.6° layer of concrete. **Sizing:** Extremely undersized; HW/D = 1 on a storm flow with approximately a two-year recurrence interval. Shivley Road is overtopped on approximately a 12-year storm flow. The Taylor and Associates field crew noted that the channel was highly aggraded on the upstream side of the crossing. **Barrier Status: RED**: the first-phase filter determined this crossing fails to meet the 8-16-16 ft/sec passage criteria for all age classes of salmonids over the entire range estimated of migration flows (for adults = 3.0 - 11.7 c.f.s.). The extremely perched outlet (approximately six feet) that cascades over rip-rap is the crossing's main feature that creates a migration barrier for all salmonids; and if adult salmonids were able to access the culvert it would encounter excessive velocities over the steeply-sloped concrete invert.

Habitat: <u>Quantity</u> = approximately 1,300' of potential fish-bearing habitat upstream of Site ID# HUM-005. <u>Quality</u> = rated as "fair" for the ranking matrix based on Taylor and Associates survey crew's field notes due primarily to the steep channel slope. Approximately 1,300' of Darnell Creek was habitat-typed by CDFG in 1992. The CDFG survey noted highly embedded gravels, moderate shelter ratings in pool habitats, and several juvenile steelhead in the lower survey reach. The crossing was surveyed by Taylor and Associates on 6/12/03 and there was continuous surface flow in the channel. At 9:00AM the air temp = 16° C and the water temp = 10° C. The survey crew noted a dense riparian zone of conifers and hardwoods, streambed substrate of mostly gravel and cobble. However; the surrounding hill-slopes were heavily logged with numerous fresh clear-cuts. No fish were observed in the stream channel adjacent to Site ID# HUM-005.
