CATALOG OF HUMBOLDT COUNTY STREAM CROSSINGS WITH CULVERTS LOCATED ON ANADROMOUS STREAM REACHES

Prepared for Humboldt County - Department of Public Works

By Ross Taylor and Associates

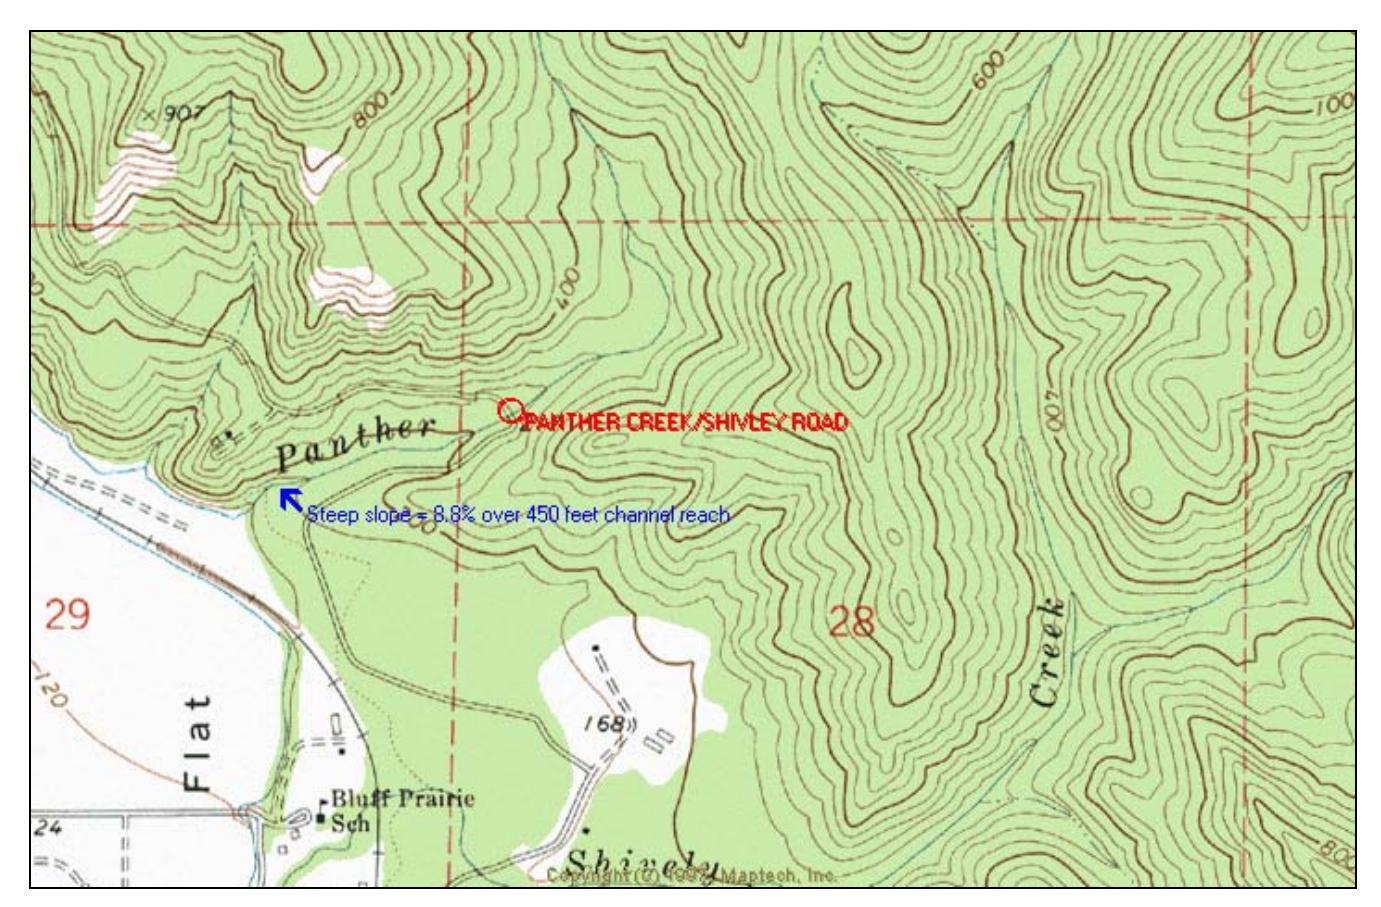
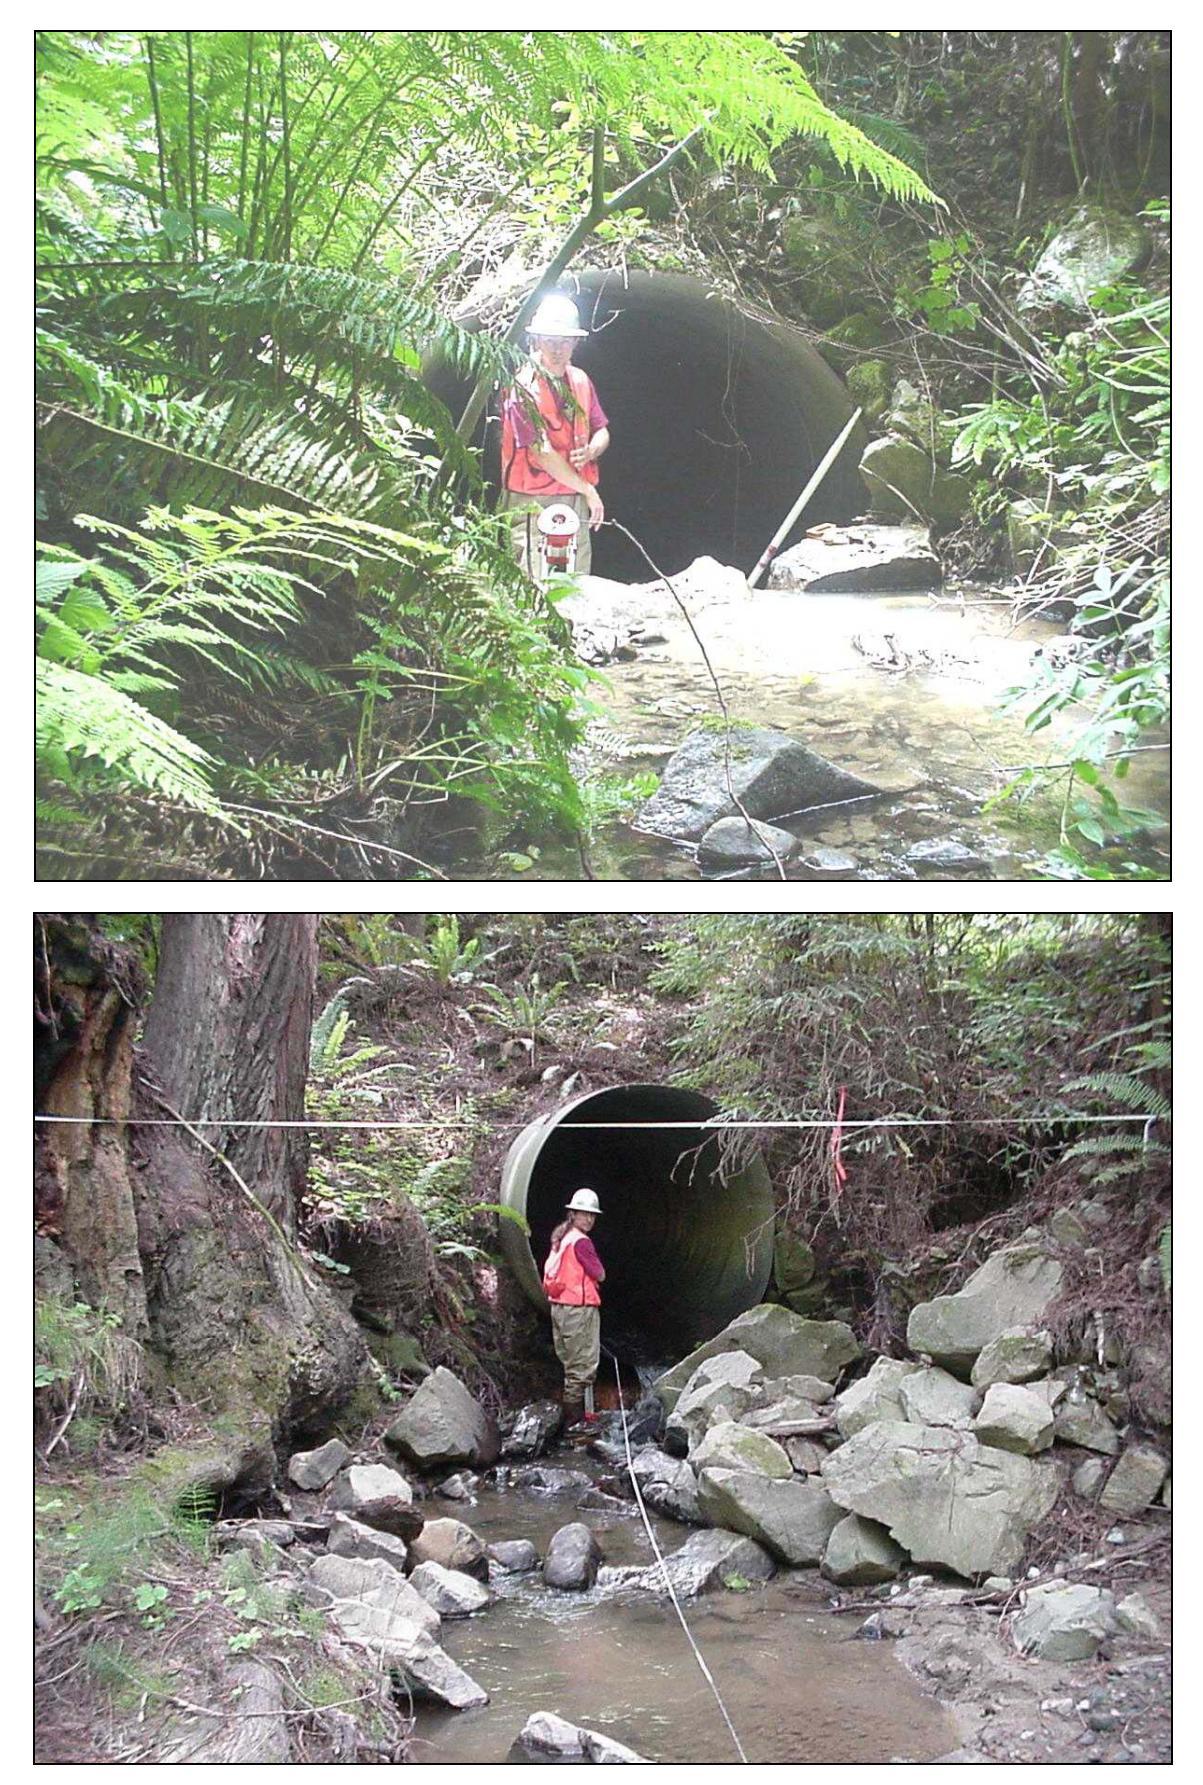
Site ID#HUM-006: Panther Creek/Shivley Road; Eel River Road Ownership: Humboldt County

Culvert Type: Circular, SSP. **Corrugations:** $2 \frac{2}{3}$ " x $\frac{1}{2}$ ". **Dimensions:** diameter = 7.0'. **Length:** 77.2' **Slope:** 8.98% **Modifications:** None. **Rustline Height:** 1.4'. **Average Active Channel Width:** 12.0'. **Fill Estimate:** 521 cubic yards. **Overall Condition:** Fair– culvert invert is rusted/abraded and sections of pipe starting to bow and separate. **Sizing:** Undersized; HW/D = 1 on a storm flow with approximately a 33-year recurrence interval. However, Shivley Road is overtopped on approximately more than a 250-year storm flow.

Barrier Status: RED: the first-phase filter determined this crossing fails to meet the 8-16-16 ft/sec passage criteria for all age classes of salmonids over the entire range estimated of migration flows (for adults = 3.0 - 17.4 c.f.s.). The culvert's steep slope is the crossing's main feature that creates a migration barrier for all salmonids.

Habitat: <u>Quantity</u> = approximately 2,100' of potential fish-bearing habitat upstream of Site ID# HUM-006. However; there is a steep channel reach approximately 1,500' downstream of Shivley Road that may prevent anadromous salmonids from even reaching the County-maintained crossing. <u>Quality</u> = rated as "fair" for the ranking matrix based on Taylor and Associates survey crew's field notes. No fisheries or habitat information was available in CDFG's files. The crossing was surveyed by Taylor and Associates on 6/12/03 and there was continuous surface flow in the channel. At 3:00PM the air temp = 19° C and the water temp = 13° C. The survey crew noted a dense riparian zone of conifers and hardwoods, streambed substrate of mostly gravel and cobble. No fish were observed in the stream channel adjacent to Site ID# HUM-006.

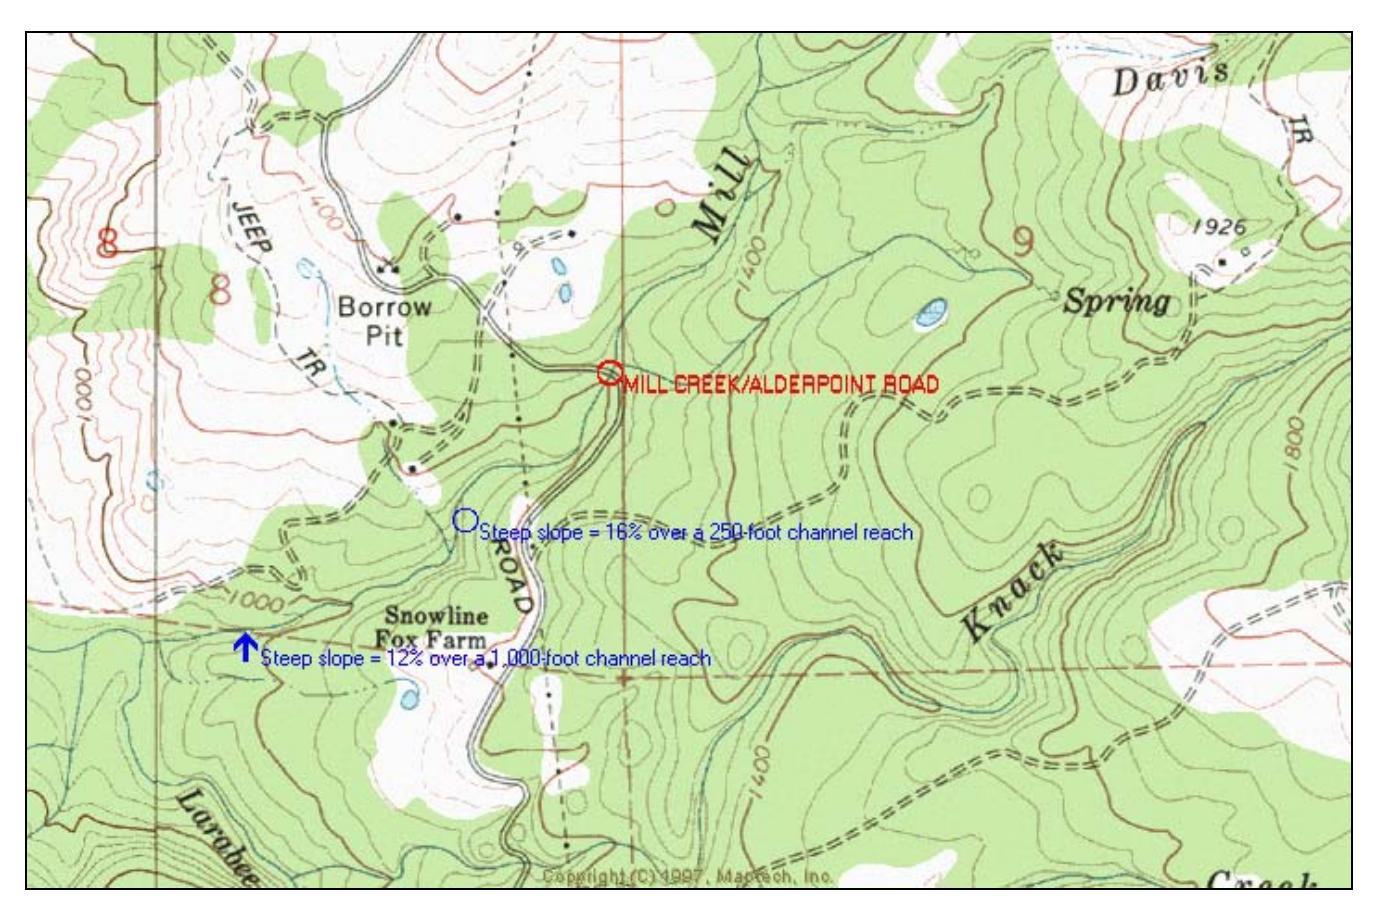
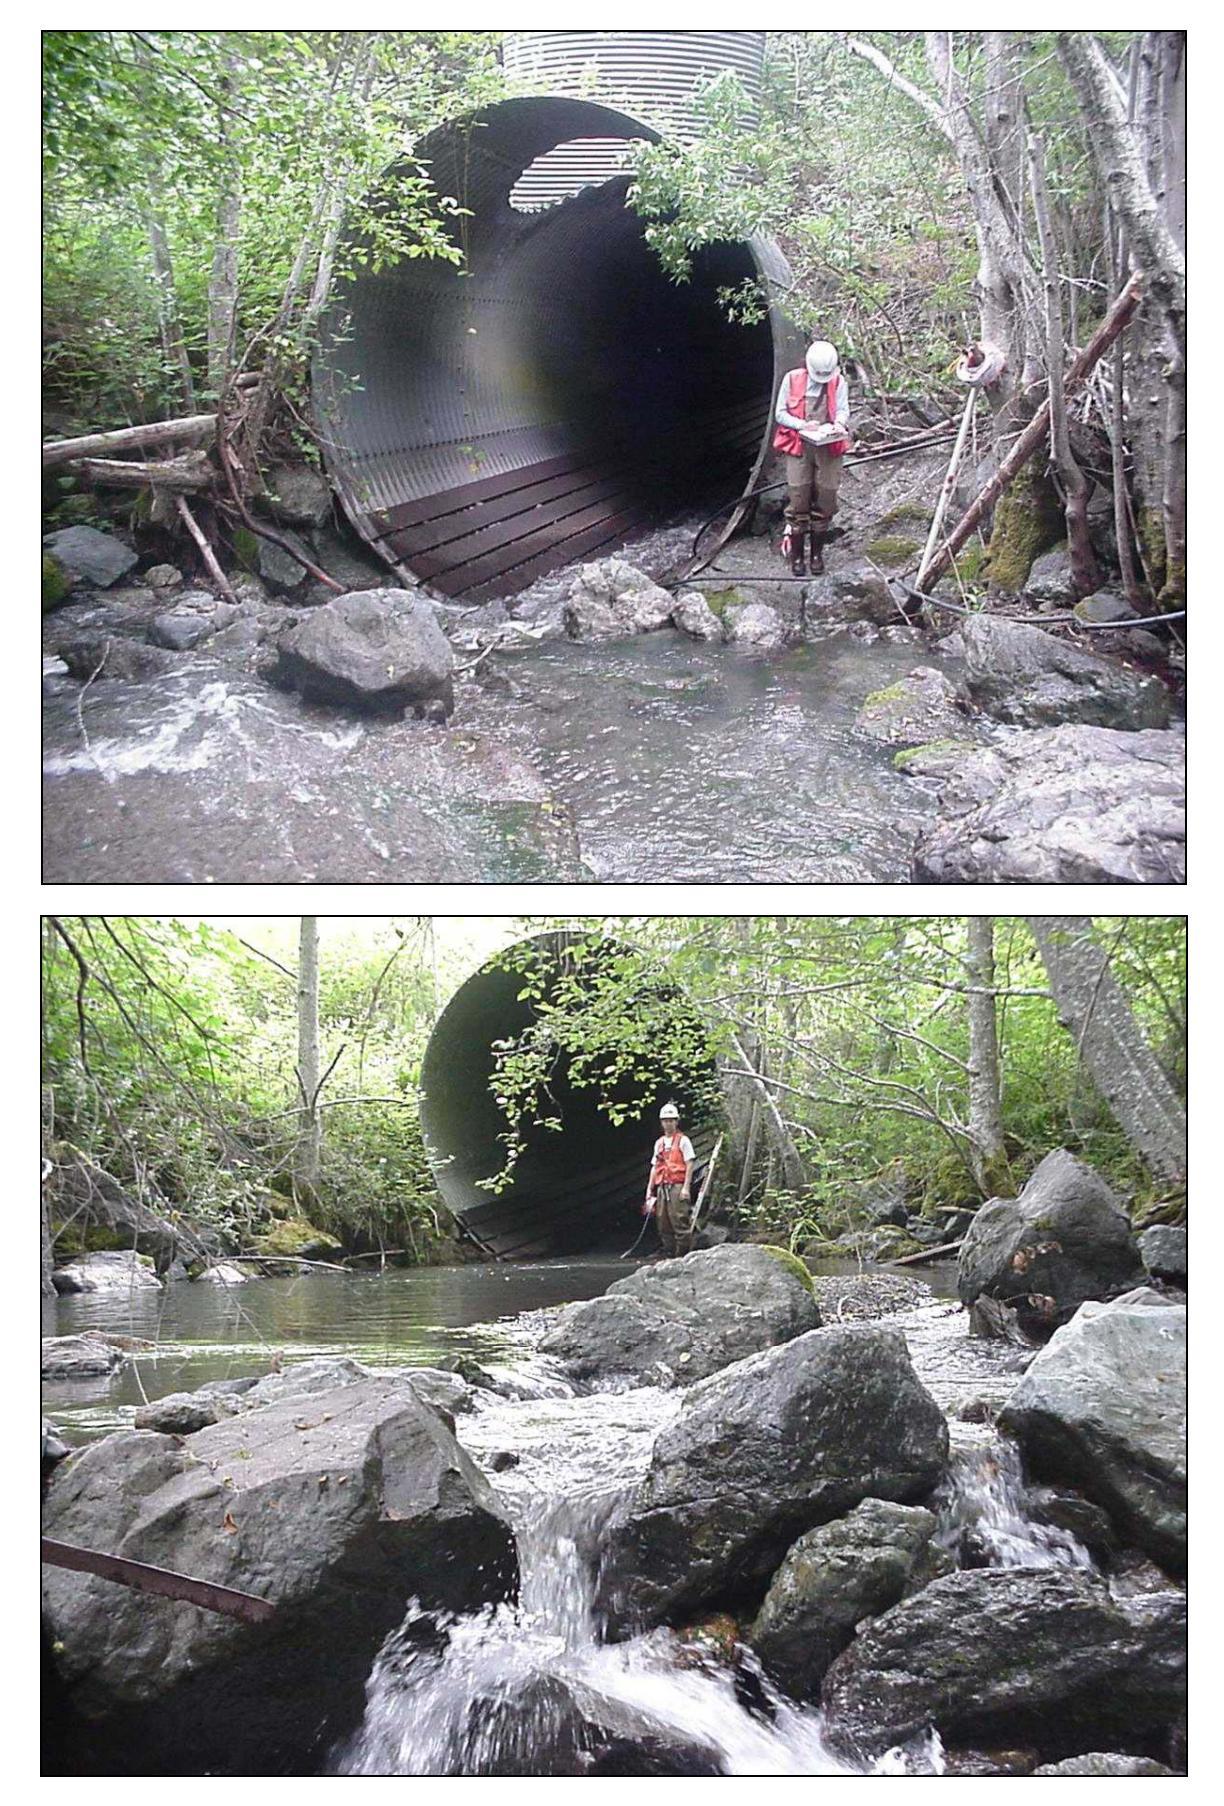
Site ID#HUM-007: Mill Creek/Alderpoint Road; Larabee Creek; Eel River Road Ownership: Humboldt County

Culvert Type: Circular, SSP. **Corrugations:** 6" x 2". **Dimensions:** diameter = 13.0'. **Length:** 144.7' **Slope:** 10.35% **Modifications:** Steel plates installed to protect invert from abrasion during bedload transport. **Rustline Height:** 1.4'. **Average Active Channel Width:** 17.6'. **Fill Estimate:** 4,604 cubic yards. **Overall Condition:** Poor– culvert invert is rusted-through. **Sizing:** Undersized; HW/D = 1 on a storm flow with approximately a 40-year recurrence interval. However, Alderpoint Road is overtopped on approximately more than a 250-year storm flow.

Barrier Status: RED: the first-phase filter determined this crossing fails to meet the 8-16-16 ft/sec passage criteria for all age classes of salmonids over the entire range estimated of migration flows (for adults = 3.0 - 113.9 c.f.s.). The culvert's extremely steep slope is the crossing's main feature that creates a migration barrier for all salmonids.

Habitat: <u>Quantity</u> = approximately 1,300' of potential fish-bearing habitat upstream of Site ID# HUM-007. However; there is are two steep channel reaches (16% and 12%) downstream of Alderpoint Road that may prevent anadromous salmonids from even reaching the County-maintained crossing. <u>Quality</u> = rated as "fair to poor" for the ranking matrix based on Taylor and Associates survey crew's field notes due primarily to steep channel slope. No fisheries or habitat information was available in CDFG's files. The crossing was surveyed by Taylor and Associates on 6/17/03 and there was continuous surface flow in the channel. At 10:45AM the air temp = 15°C and the water temp = 12°C. The survey crew noted a dense riparian zone of mostly hardwoods and a steep, boulder-strewn channel. Several (<10 fish) juvenile fish of unknown species were observed in the stream channel downstream of Site ID# HUM-007.

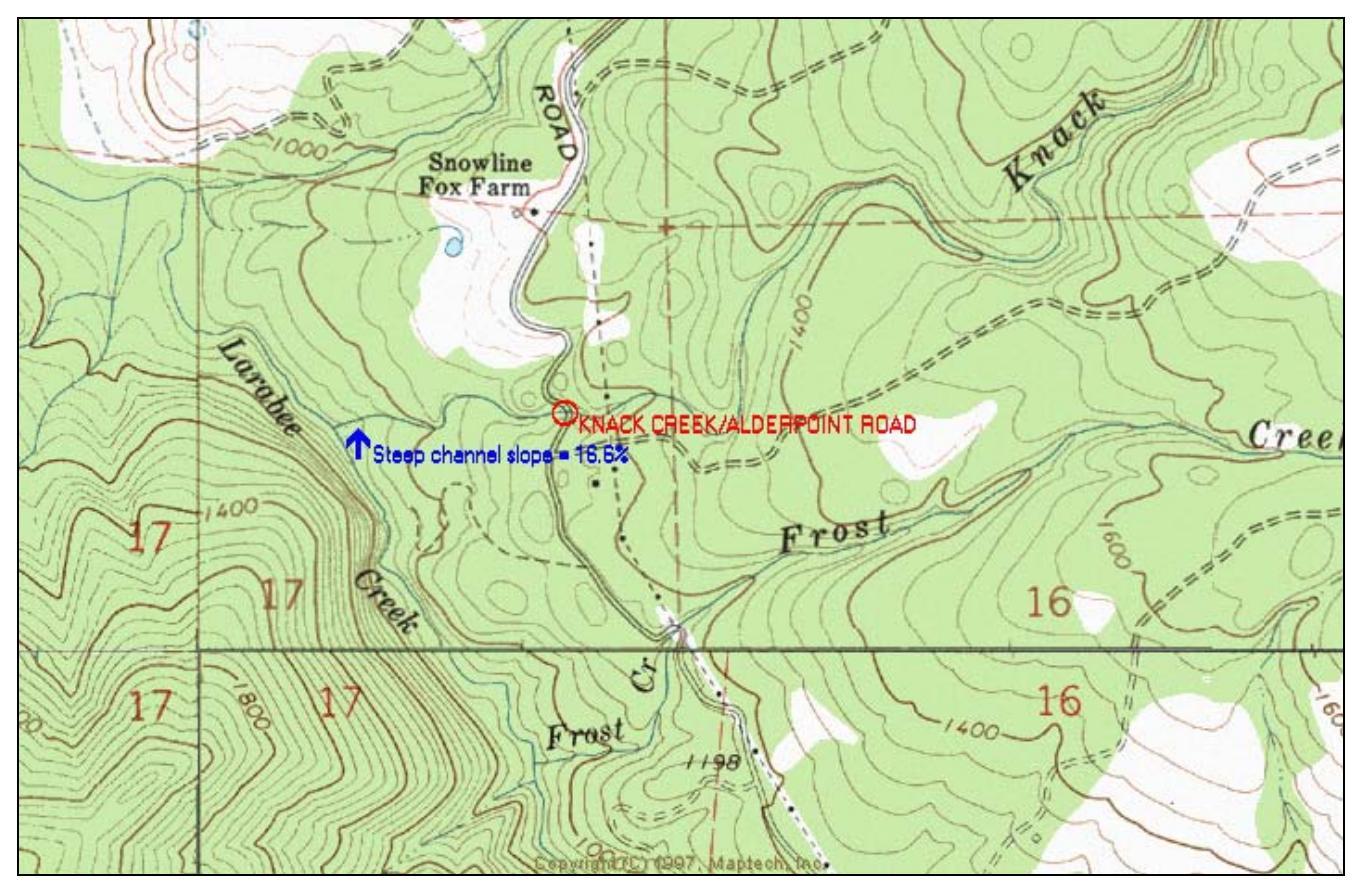
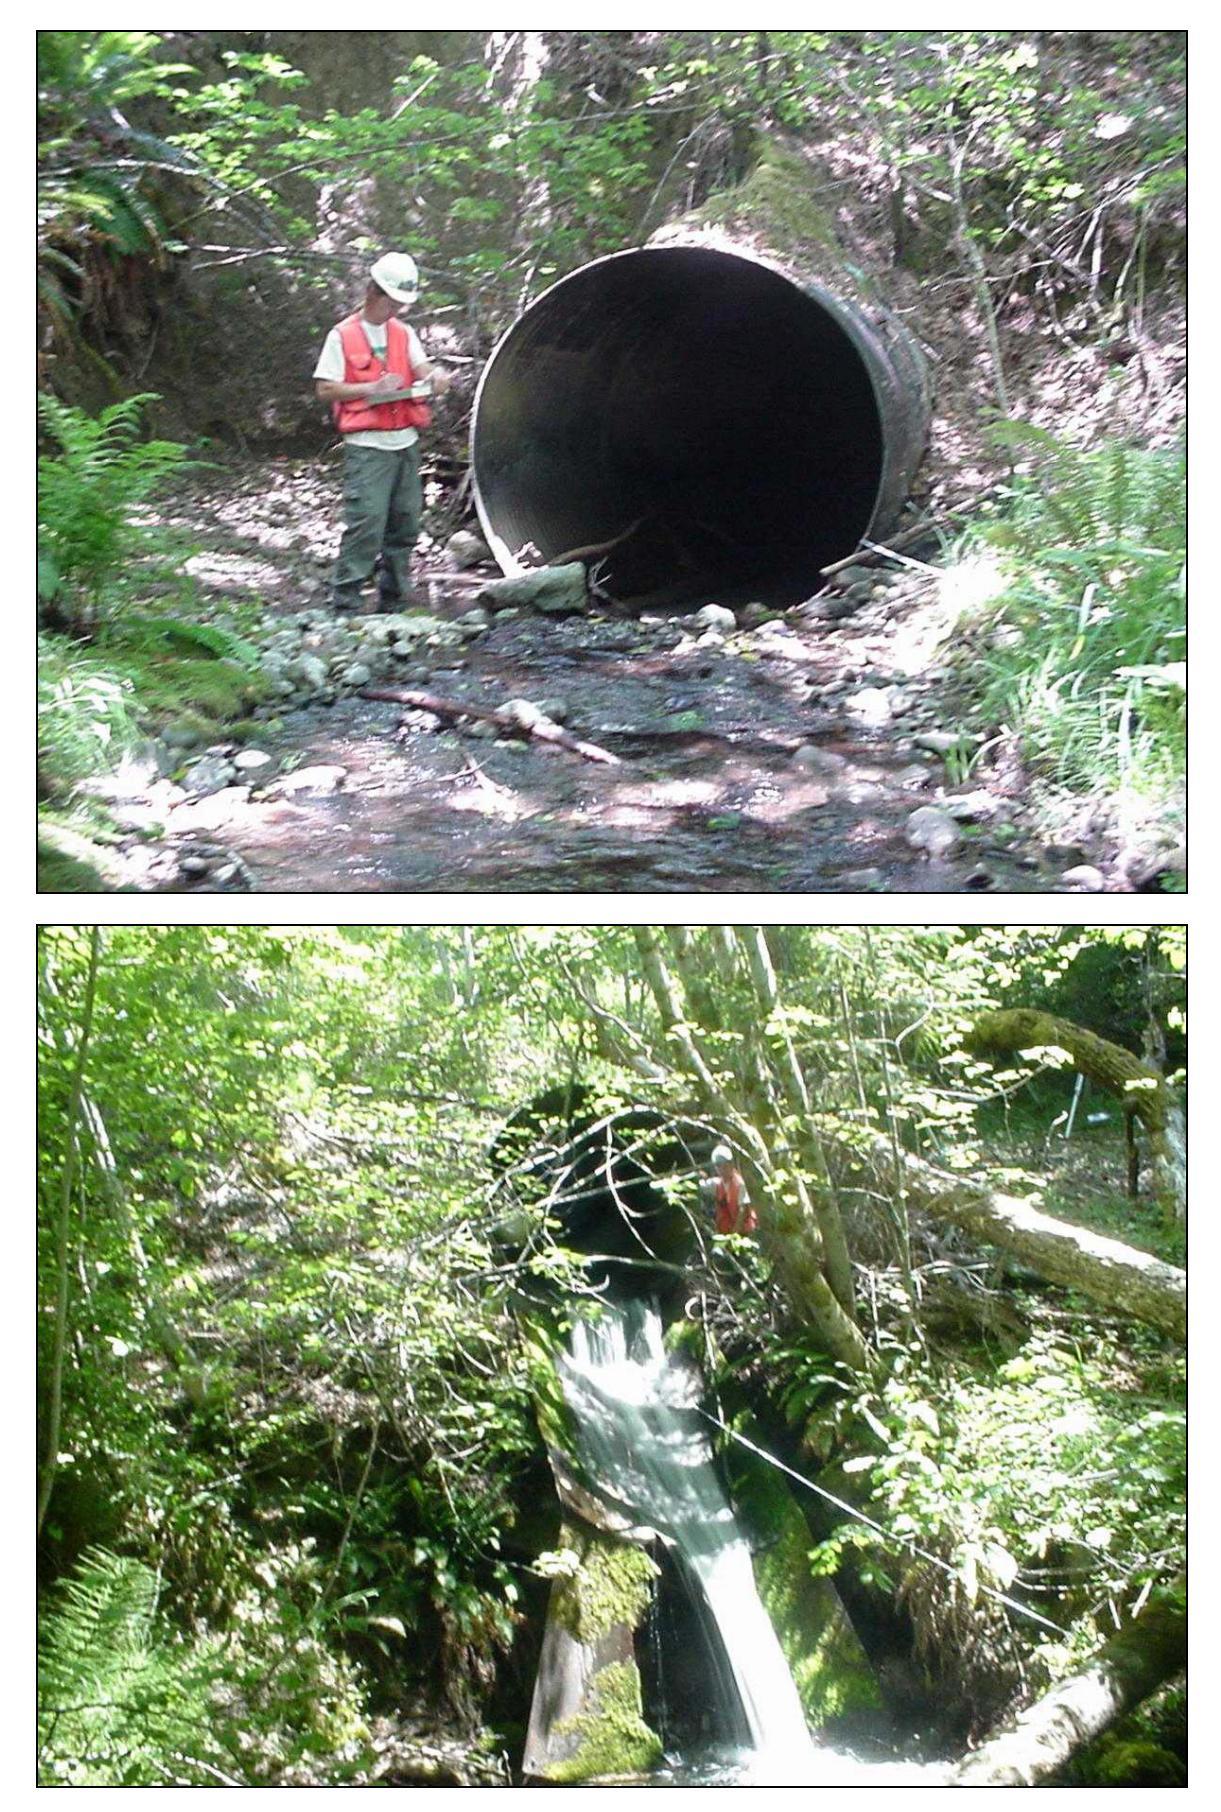
Site ID#HUM-008: Knack Creek/Alderpoint Road; Larabee Creek; Eel River Road Ownership: Humboldt County

Culvert Type: Circular, SSP. **Corrugations:** 2 - 2/3" x 1/2". **Dimensions:** diameter = 7.0'. **Length:** 103.7' **Slope:** 10.71% **Modifications:** None. **Rustline Height:** 2.5'. **Average Active Channel Width:** 8.7'. **Fill Estimate:** 7,625 cubic yards. **Overall Condition:** Poor– culvert invert is rusted-through and has a new floor weldedin. **Sizing:** Undersized; HW/D = 1 on a storm flow with approximately a 11-year recurrence interval. However, Alderpoint Road is overtopped on approximately a 137-year storm flow.

Barrier Status: RED: the first-phase filter determined this crossing fails to meet the 8-16-16 ft/sec passage criteria for all age classes of salmonids over the entire range estimated of migration flows (for adults = 3.0 - 33.1 c.f.s.). The culvert's perched inlet and extremely steep slope are the crossing's two main features that create a migration barrier for all age classes of salmonids.

Habitat: <u>Quantity</u> = less than 500 feet of potential fish-bearing habitat upstream of Site ID# HUM-008 and there is a steep channel reach (slope = 16.6%) downstream of Alderpoint Road that probably prevents anadromous salmonids from even reaching the County-maintained crossing. <u>Quality</u> = rated as "fair to poor" for the ranking matrix based on Taylor and Associates survey crew's field notes due primarily to steep channel slope. No fisheries or habitat information was available in CDFG's files. The crossing was surveyed by Taylor and Associates on 6/17/03 and there was continuous surface flow in the channel. At 2:00PM the air temp = 15° C and the water temp = 12° C. The survey crew noted a dense riparian zone of mostly hardwoods and a steep, boulder-strewn channel. No fish were observed in the stream channel adjacent to Site ID# HUM-008.

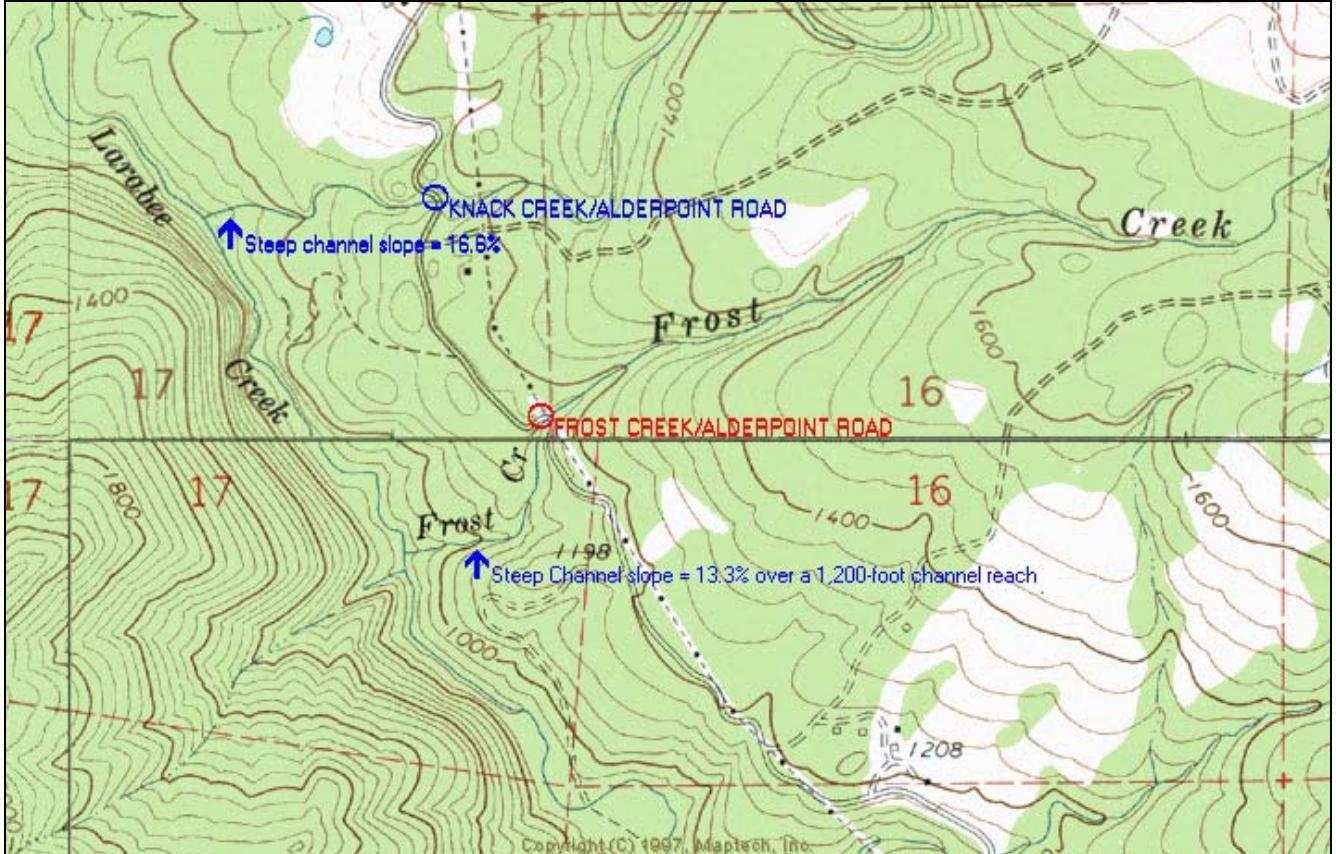
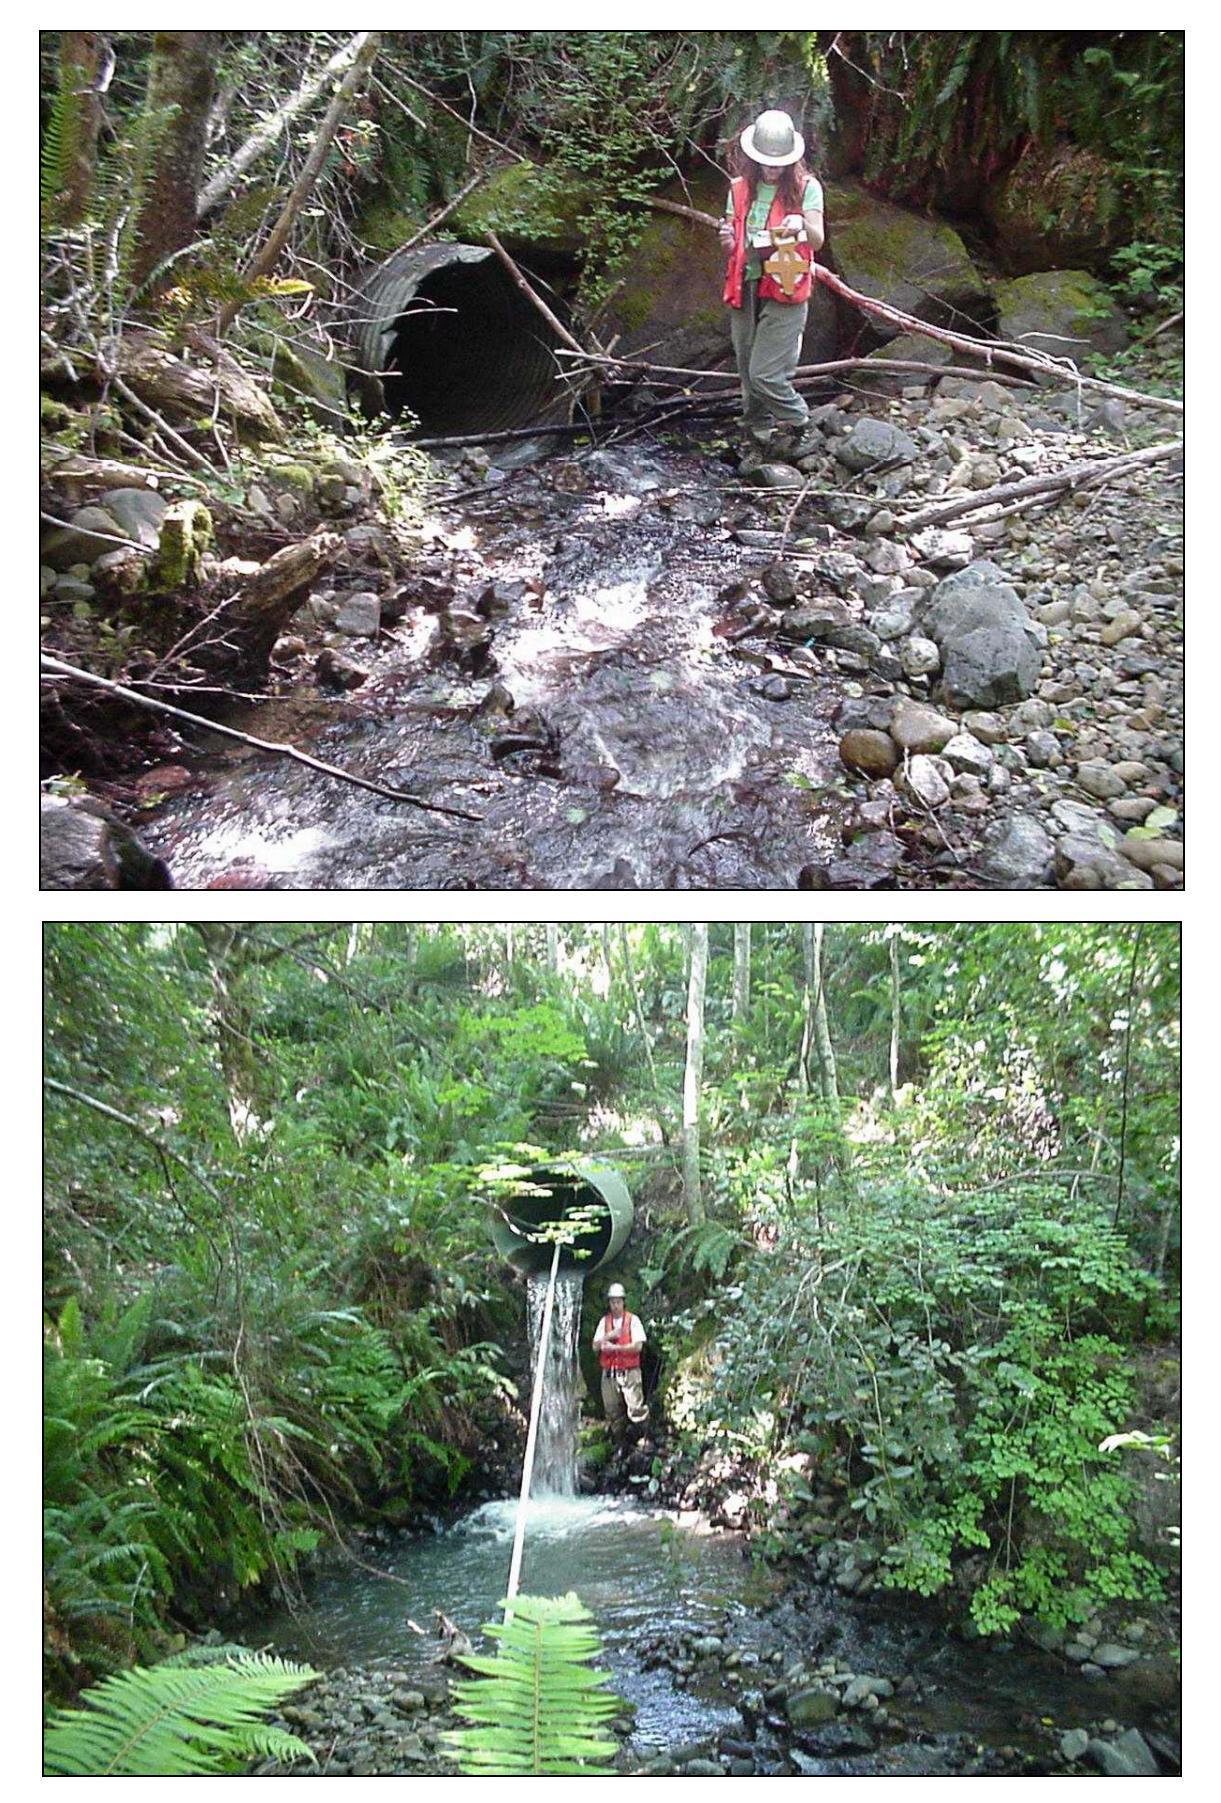
Site ID#HUM-009: Frost Creek/Alderpoint Road; Larabee Creek; Eel River Road Ownership: Humboldt County

Culvert Type: Circular, CSP. **Corrugations:** $2 - 2/3^{\circ} \times 1/2^{\circ}$ with spiral corrugations. **Dimensions:** diameter = 4.0'. **Length:** 121.2' **Slope:** 3.99% **Modifications:** None. **Rustline Height:** 2.5'. **Average Active Channel Width:** 8.7'. **Fill Estimate:** 7,625 cubic yards. **Overall Condition:** Fair– invert is abraded in several areas. **Sizing:** Extremely Undersized; HW/D = 1 on a storm flow with approximately a three-year recurrence interval. However, Alderpoint Road is overtopped on approximately a 26-year storm flow. **Barrier Status: RED**: the first-phase filter determined this crossing fails to meet the 8-16-16 ft/sec passage criteria for all age classes of salmonids over the entire range estimated of migration flows (for adults = 3.0 - 21.3 c.f.s.). The culvert's perched inlet (at least seven feet) is the crossing's main feature that creates a migration barrier for all age classes of salmonids.

Habitat: <u>Quantity</u> = less than 500 feet of potential fish-bearing habitat upstream of Site ID# HUM-009 and there is a steep channel reach (slope = 13.3%) downstream of Alderpoint Road that probably prevents anadromous salmonids from even reaching the County-maintained crossing. <u>Quality</u> = rated as "fair to poor" for the ranking matrix based on Taylor and Associates survey crew's field notes due primarily to steep channel slope. No fisheries or habitat information was available in CDFG's files. The crossing was surveyed by Taylor and Associates on 6/17/03 and there was continuous surface flow in the channel. At 3:25PM the air temp = 20° C and the water temp = 14° C. The survey crew noted a dense riparian zone of mostly hardwoods and a steep boulder-strewn channel. No fish were observed in the stream channel adjacent to Site ID# HUM-009.

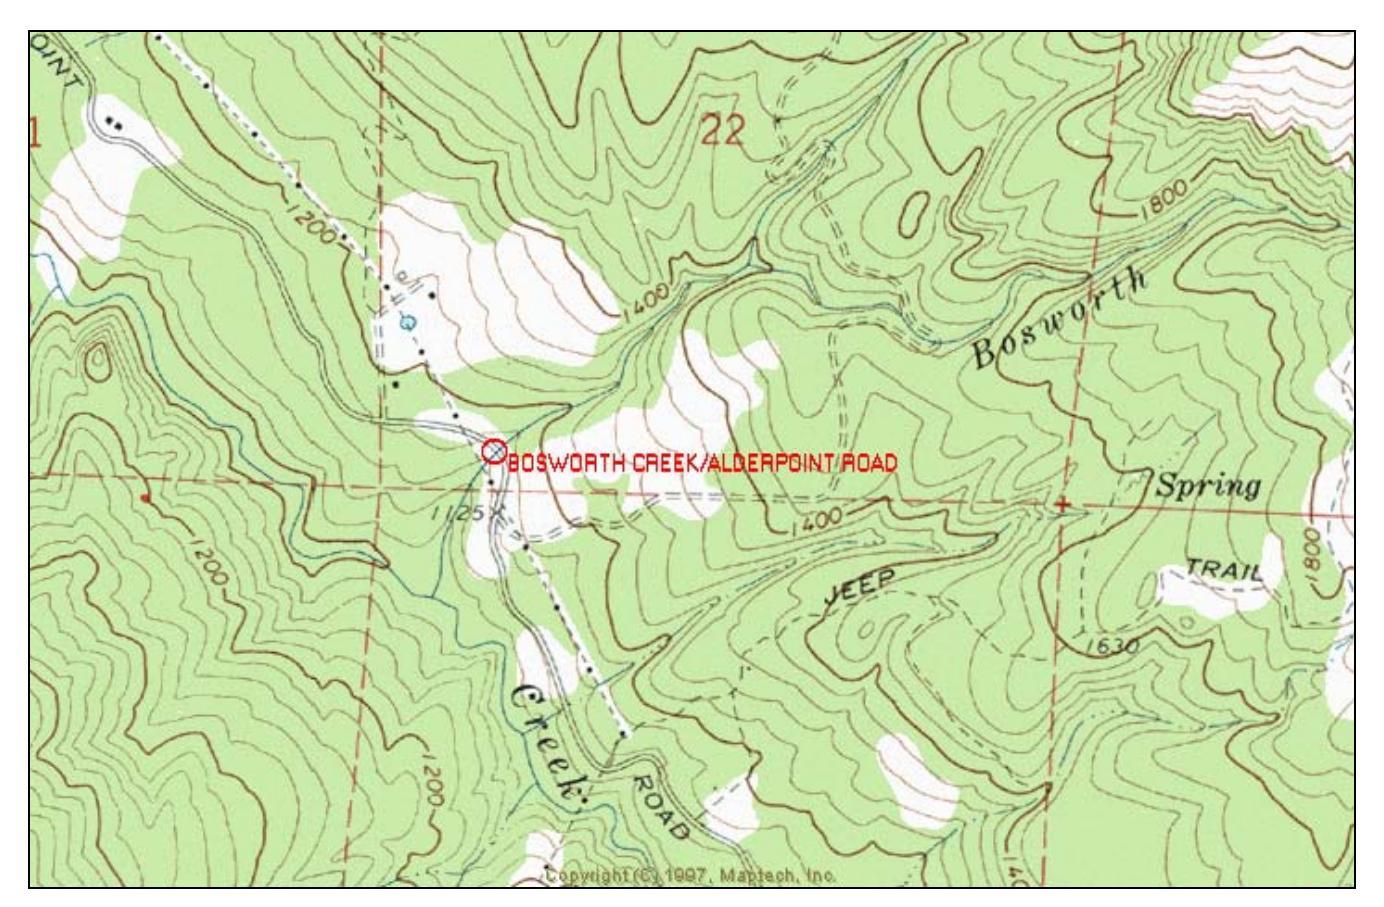
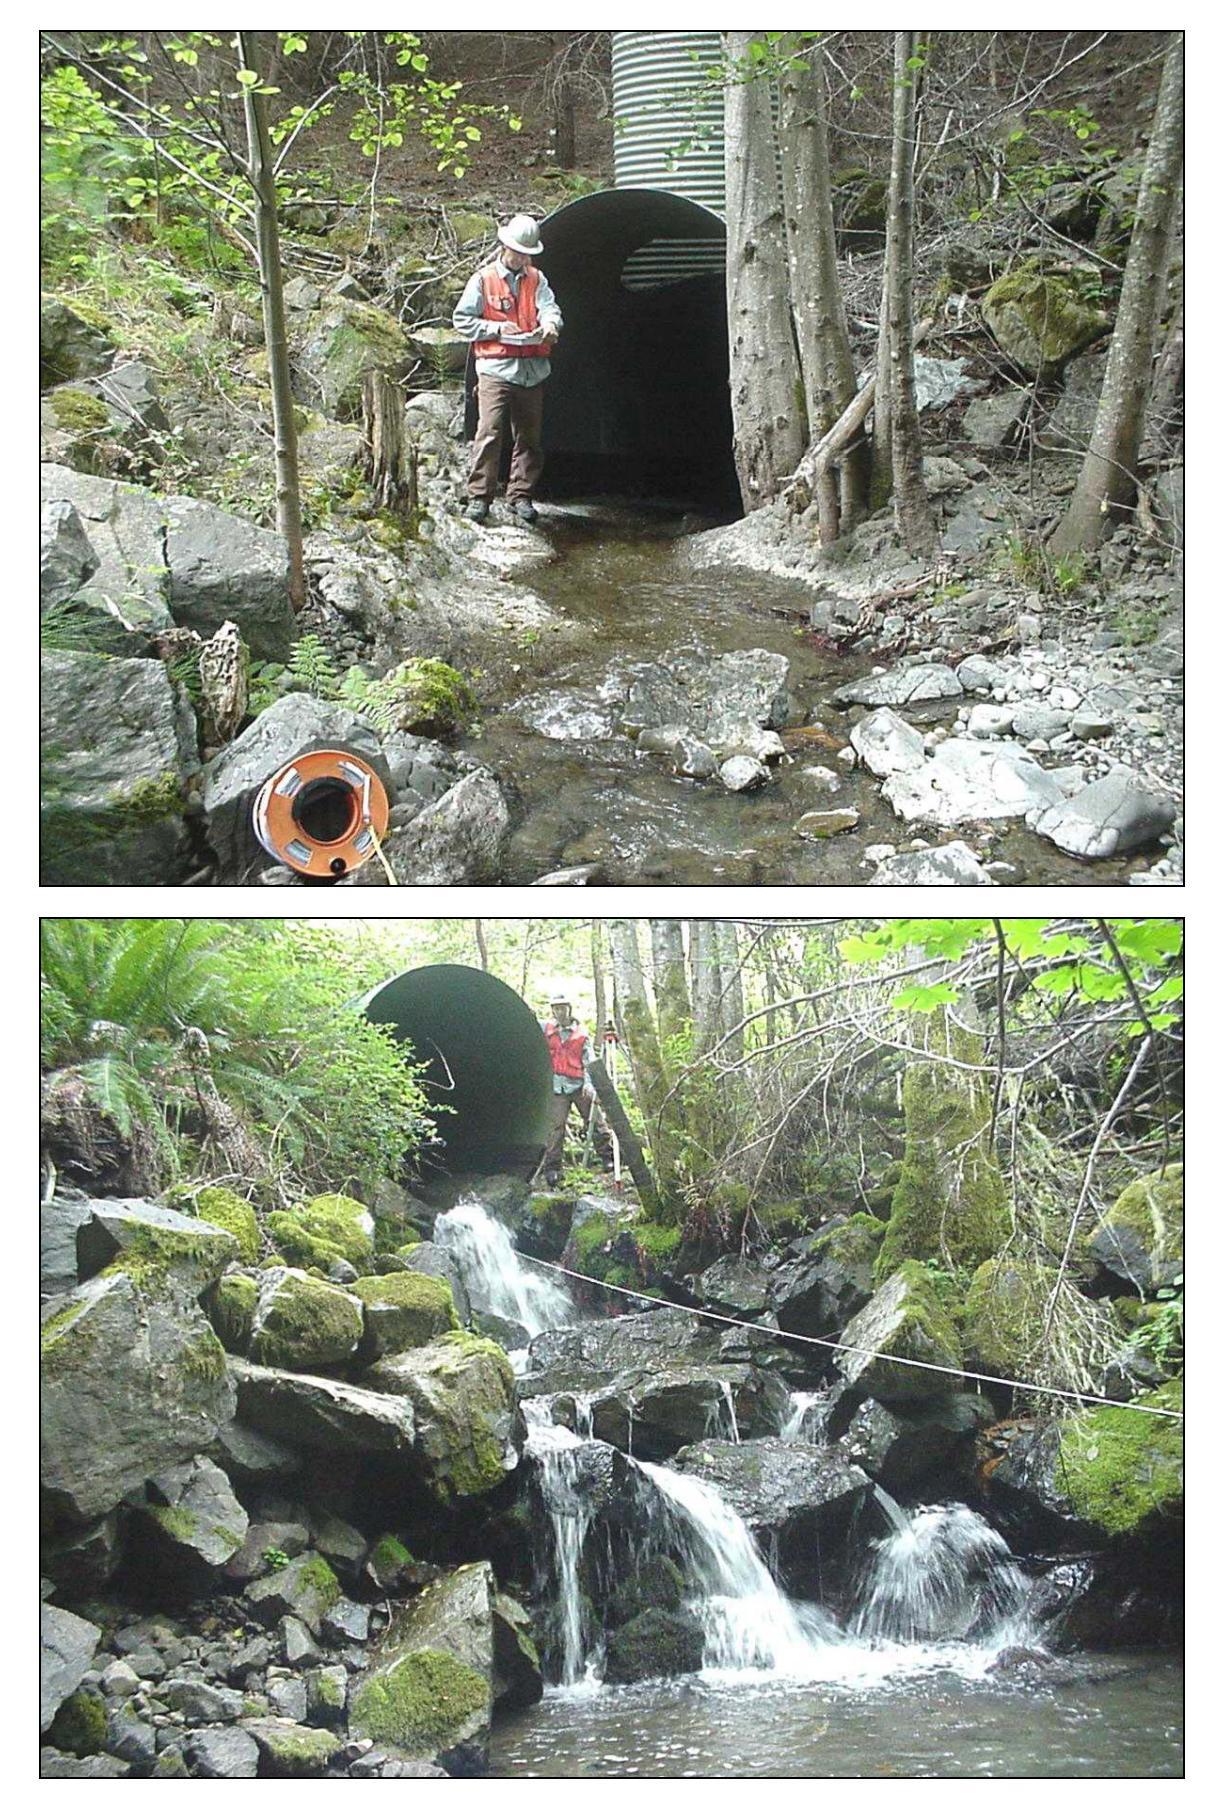
Site ID#HUM-010: Bosworth Creek/Alderpoint Road; Larabee Creek; Eel River Road Ownership: Humboldt County

Culvert Type: Circular, SSP. **Corrugations:** 2 -2/3" x 1/2". However, invert is lined with 0.8' of concrete **Dimensions:** diameter = 7.0'. **Length:** 191.8' **Slope:** 18.15% **Modifications:** None. **Rustline Height:** no observable rustline. **Average Active Channel Width:** 10.9'. **Fill Estimate:** 2,074 cubic yards. **Overall Condition:** Fair– invert is abraded in several areas. **Sizing:** Undersized; HW/D = 1 on a storm flow with approximately an 11-year recurrence interval. However, Alderpoint Road is overtopped on approximately a 156-year storm flow.

Barrier Status: RED: the first-phase filter determined this crossing fails to meet the 8-16-16 ft/sec passage criteria for all age classes of salmonids over the entire range estimated of migration flows (for adults = 3.0 - 34.3 c.f.s.). The culvert's extremely steep slope (>18%) is the crossing's main feature that creates a migration barrier for all age classes of salmonids.

Habitat: <u>Quantity</u> = less than 500 feet of potential fish-bearing habitat upstream of Site ID# HUM-010 and there is a steep channel reach (slope = 16.3%) downstream of Alderpoint Road that probably prevents anadromous salmonids from even reaching the County-maintained crossing. <u>Quality</u> = rated as "fair to poor" for the ranking matrix based on Taylor and Associates survey crew's field notes due primarily to steep channel slope. No fisheries or habitat information was available in CDFG's files. The crossing was surveyed by Taylor and Associates on 6/18/03 and there was continuous surface flow in the channel. At 9:00AM the air temp = 14°C and the water temp = 12°C. The survey crew noted a dense riparian zone of mostly hardwoods and a steep boulder-strewn channel. Several (<10 fish) juvenile salmonids were observed in the stream channel downstream of Site ID# HUM-010.
