CATALOG OF HUMBOLDT COUNTY STREAM CROSSINGS WITH CULVERTS LOCATED ON ANADROMOUS STREAM REACHES

Prepared for Humboldt County - Department of Public Works

By Ross Taylor and Associates

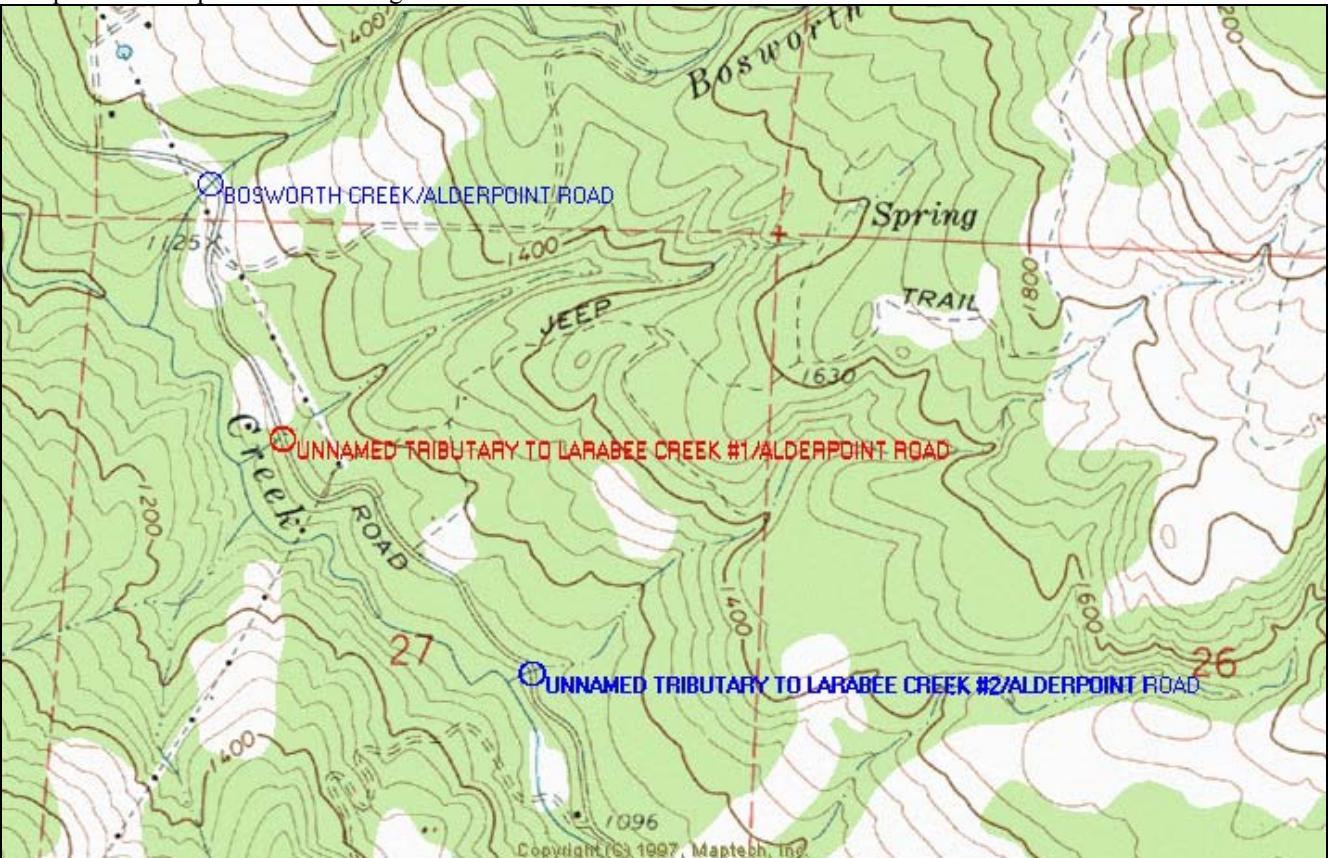
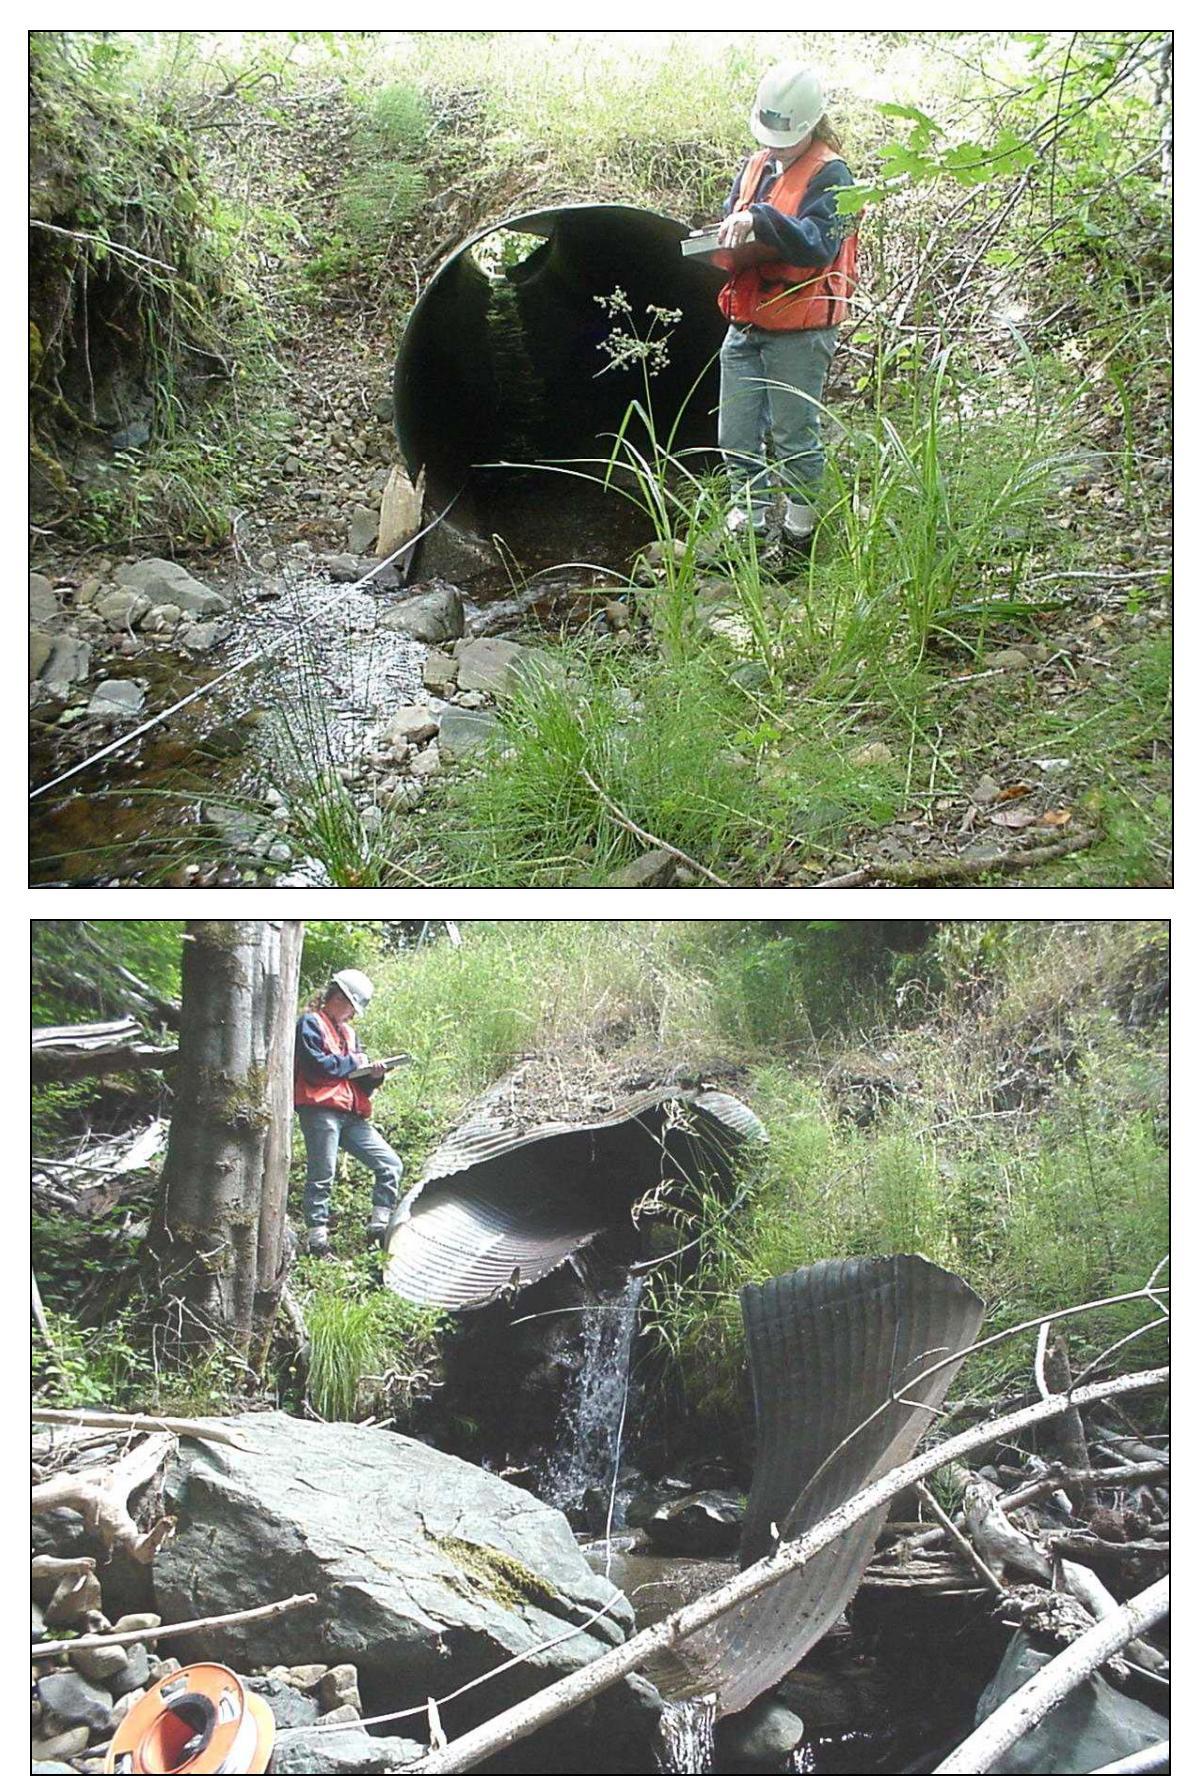
Site ID#HUM-011: Unnamed Tributary #1 to Larabee Creek/Alderpoint Road; Larabee Creek; Eel River

Culvert Type: Circular, SSP. **Corrugations:** 2 -2/3" x 1/2". However, invert is lined with 0.3' of concrete **Dimensions:** diameter = 5.0'. **Length:** 57.9' **Slope:** 5.91% **Modifications:** None. **Rustline Height:** 1.3'. **Average Active Channel Width:** 9.2'. **Fill Estimate:** 406 cubic yards. **Overall Condition:** Extremely Poor – sections at outlet have broken-off. **Sizing:** Undersized; HW/D = 1 on a storm flow with approximately an nine-year recurrence interval and Alderpoint Road is overtopped on approximately a 20-year storm flow.

Barrier Status: RED: the first-phase filter determined this crossing fails to meet the 8-16-16 ft/sec passage criteria for all age classes of salmonids over the entire range estimated of migration flows (for adults = 3.0 - 13.0 c.f.s.). The culvert's steep slope (>5%) is the crossing's main feature that creates a migration barrier for all age classes of salmonids.

Habitat: <u>Quantity</u> = less than 500 feet of potential fish-bearing habitat upstream of Site ID# HUM-011 and the crossing is located in a steep channel reach (slope = 14%). <u>Quality</u> = rated as "fair to poor" for the ranking matrix based on Taylor and Associates survey crew's field notes due primarily to steep channel slope. No fisheries or habitat information was available in CDFG's files. The crossing was surveyed by Taylor and Associates on 6/18/03 and there was continuous surface flow in the channel. At 11:15AM the air temp = 16°C and the water temp = 13°C. The survey crew noted a dense riparian zone of mostly hardwoods and a steep, boulder-strewn channel. No fish were observed in the stream channel adjacent to Site ID# HUM-011.

Preferred Treatment: Although the upstream channel has limited,, if any, salmonid habitat the crossing is in very poor condition and should be replaced before it fails. Recommend replacement with a properly sized SSP pipe to improve storm-flow capacity. The stream should be surveyed for fish presence to determine if meeting fish-passage design criteria is required for a replacement crossing.

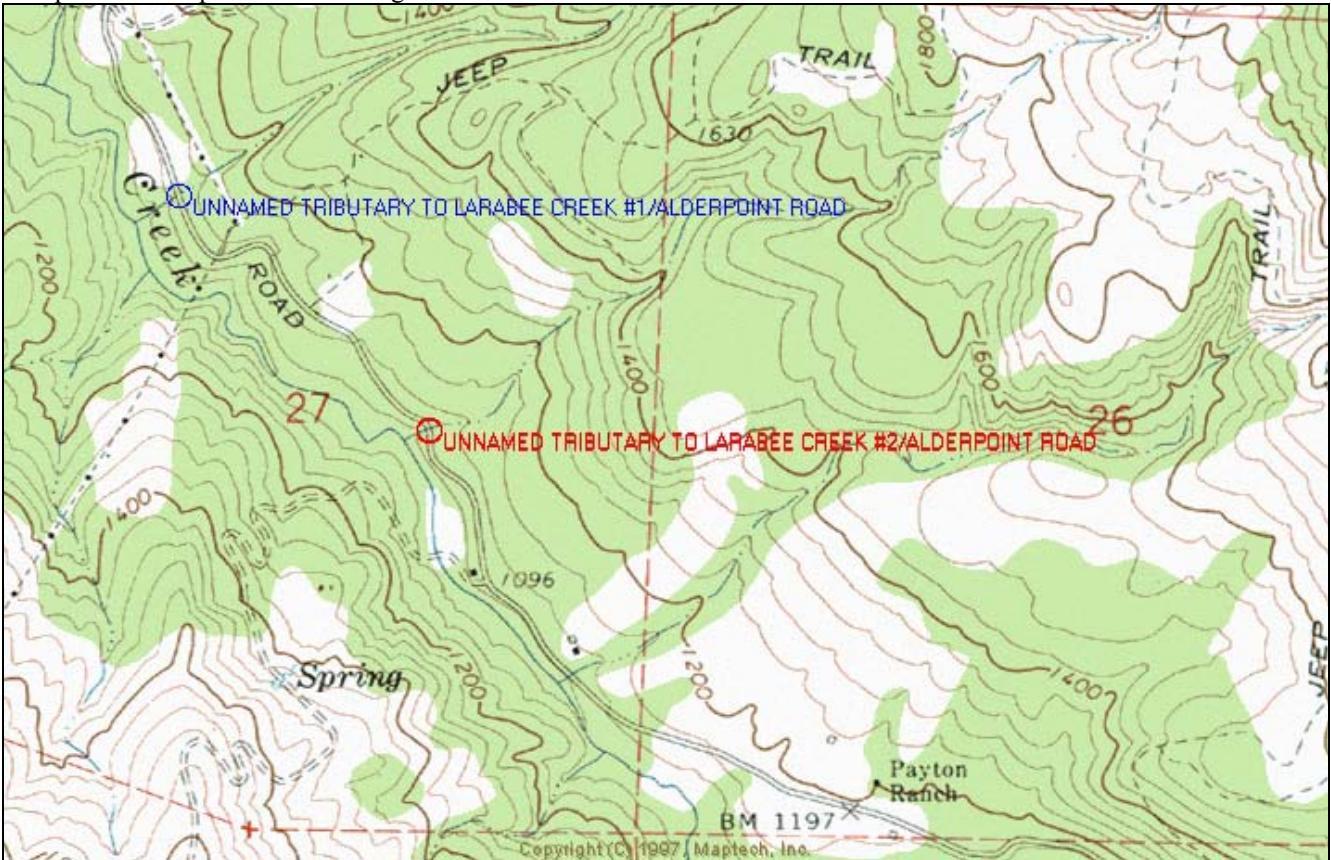
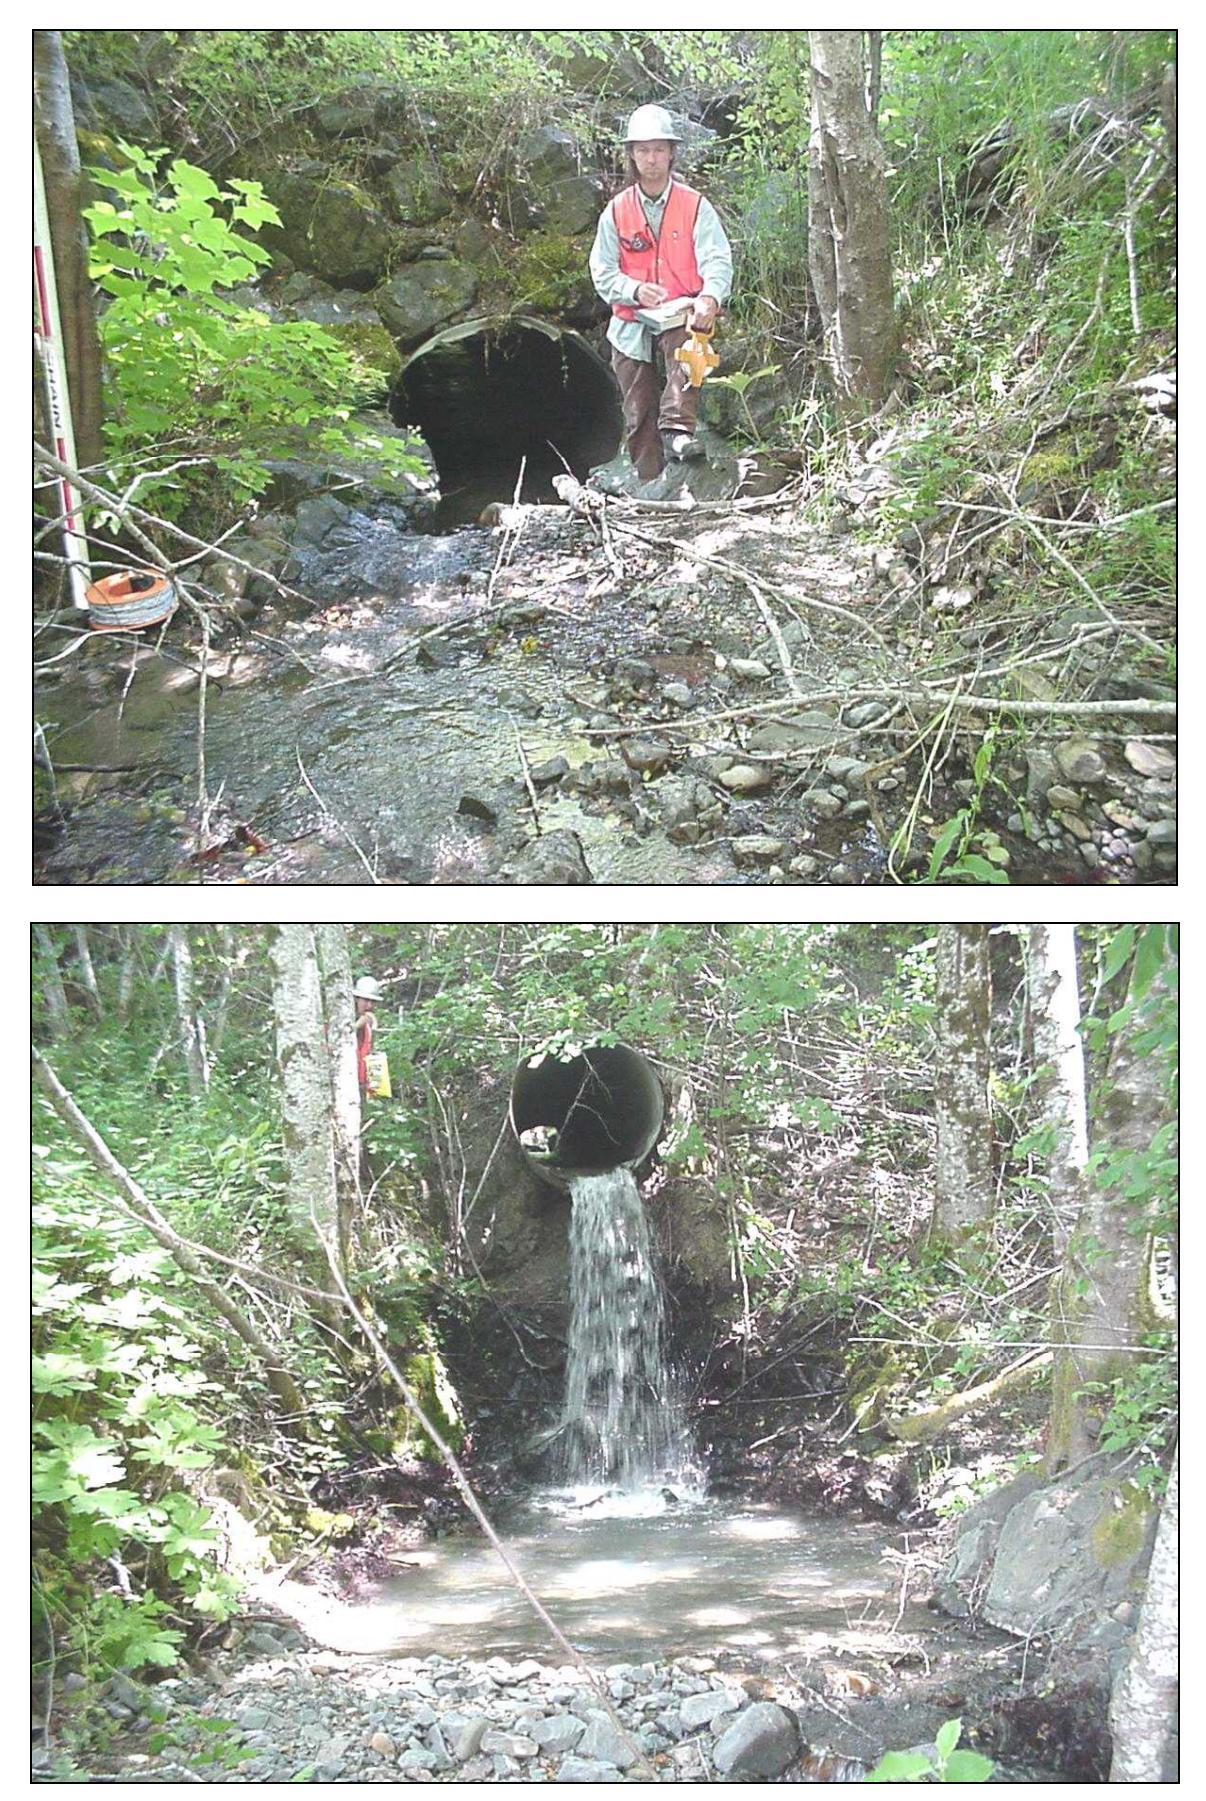
Site ID#HUM-012: Unnamed Tributary #2 to Larabee Creek/Alderpoint Road; Larabee Creek; Eel River

Culvert Type: Circular, CSP. **Corrugations:** $2 - 2/3^{\circ} \times 1/2^{\circ}$. However, invert is lined with 0.3' of concrete **Dimensions:** diameter = 4.0'. **Length:** 81.8' **Slope:** 11.98% **Modifications:** None. **Rustline Height:** 1.6'. **Average Active Channel Width:** 11.4'. **Fill Estimate:** 1,452 cubic yards. **Overall Condition:** Poor – culvert is squashed and invert is rusted-through. **Sizing:** Extremely Undersized; HW/D = 1 on a storm flow with approximately an four-year recurrence interval and Alderpoint Road is overtopped on approximately a 18-year storm flow.

Barrier Status: RED: the first-phase filter determined this crossing fails to meet the 8-16-16 ft/sec passage criteria for all age classes of salmonids over the entire range estimated of migration flows (for adults = 3.0 - 13.0 c.f.s.). The culvert's extremely steep slope (>11%) is the crossing's main feature that creates a migration barrier for all age classes of salmonids.

Preferred Treatment: Although the upstream channel has limited, if any, salmonid habitat the crossing is in very poor condition and should be replaced before it fails. Recommend replacement with a properly sized SSP pipe to improve storm-flow capacity. The stream should be surveyed for fish presence to determine if meeting fish-passage design criteria is required for a replacement crossing.

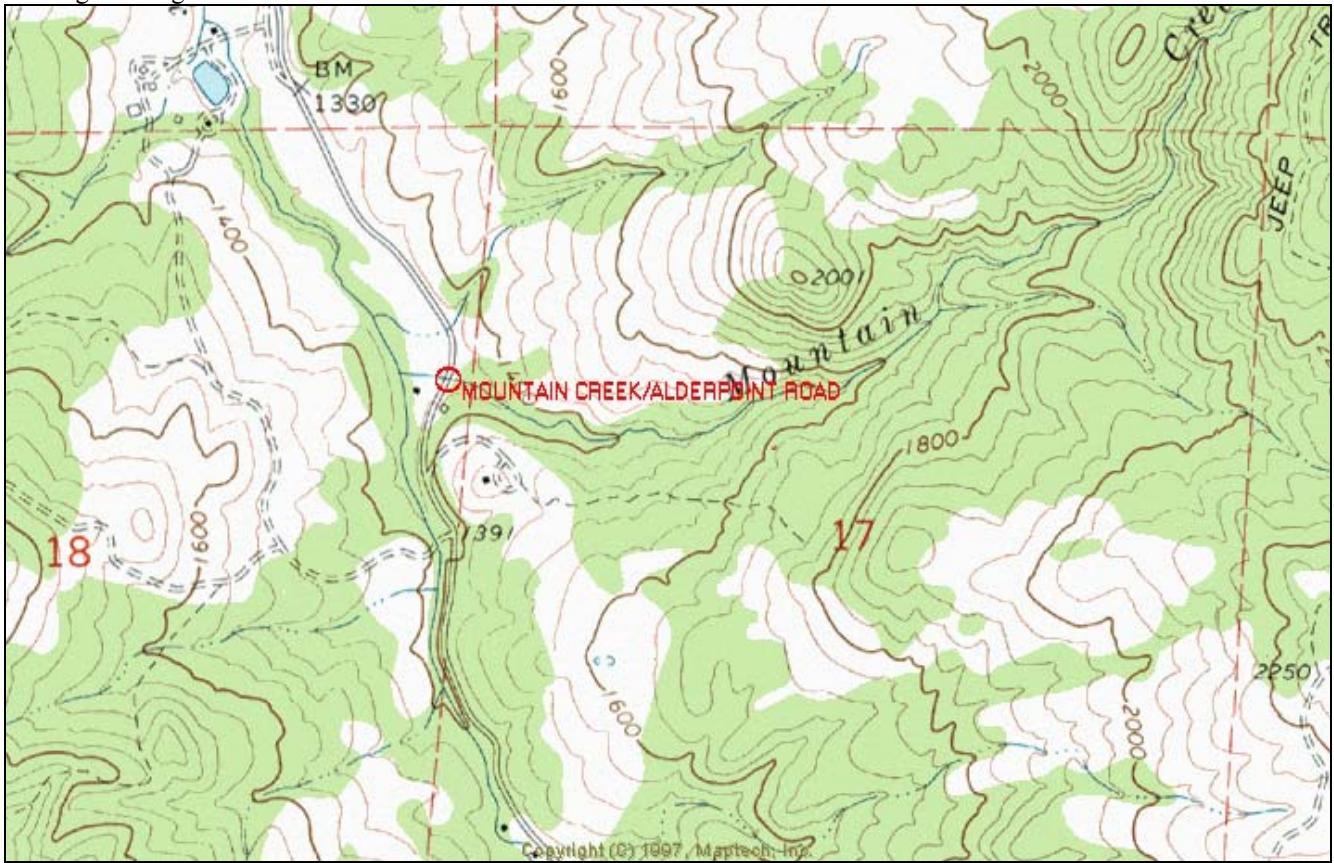
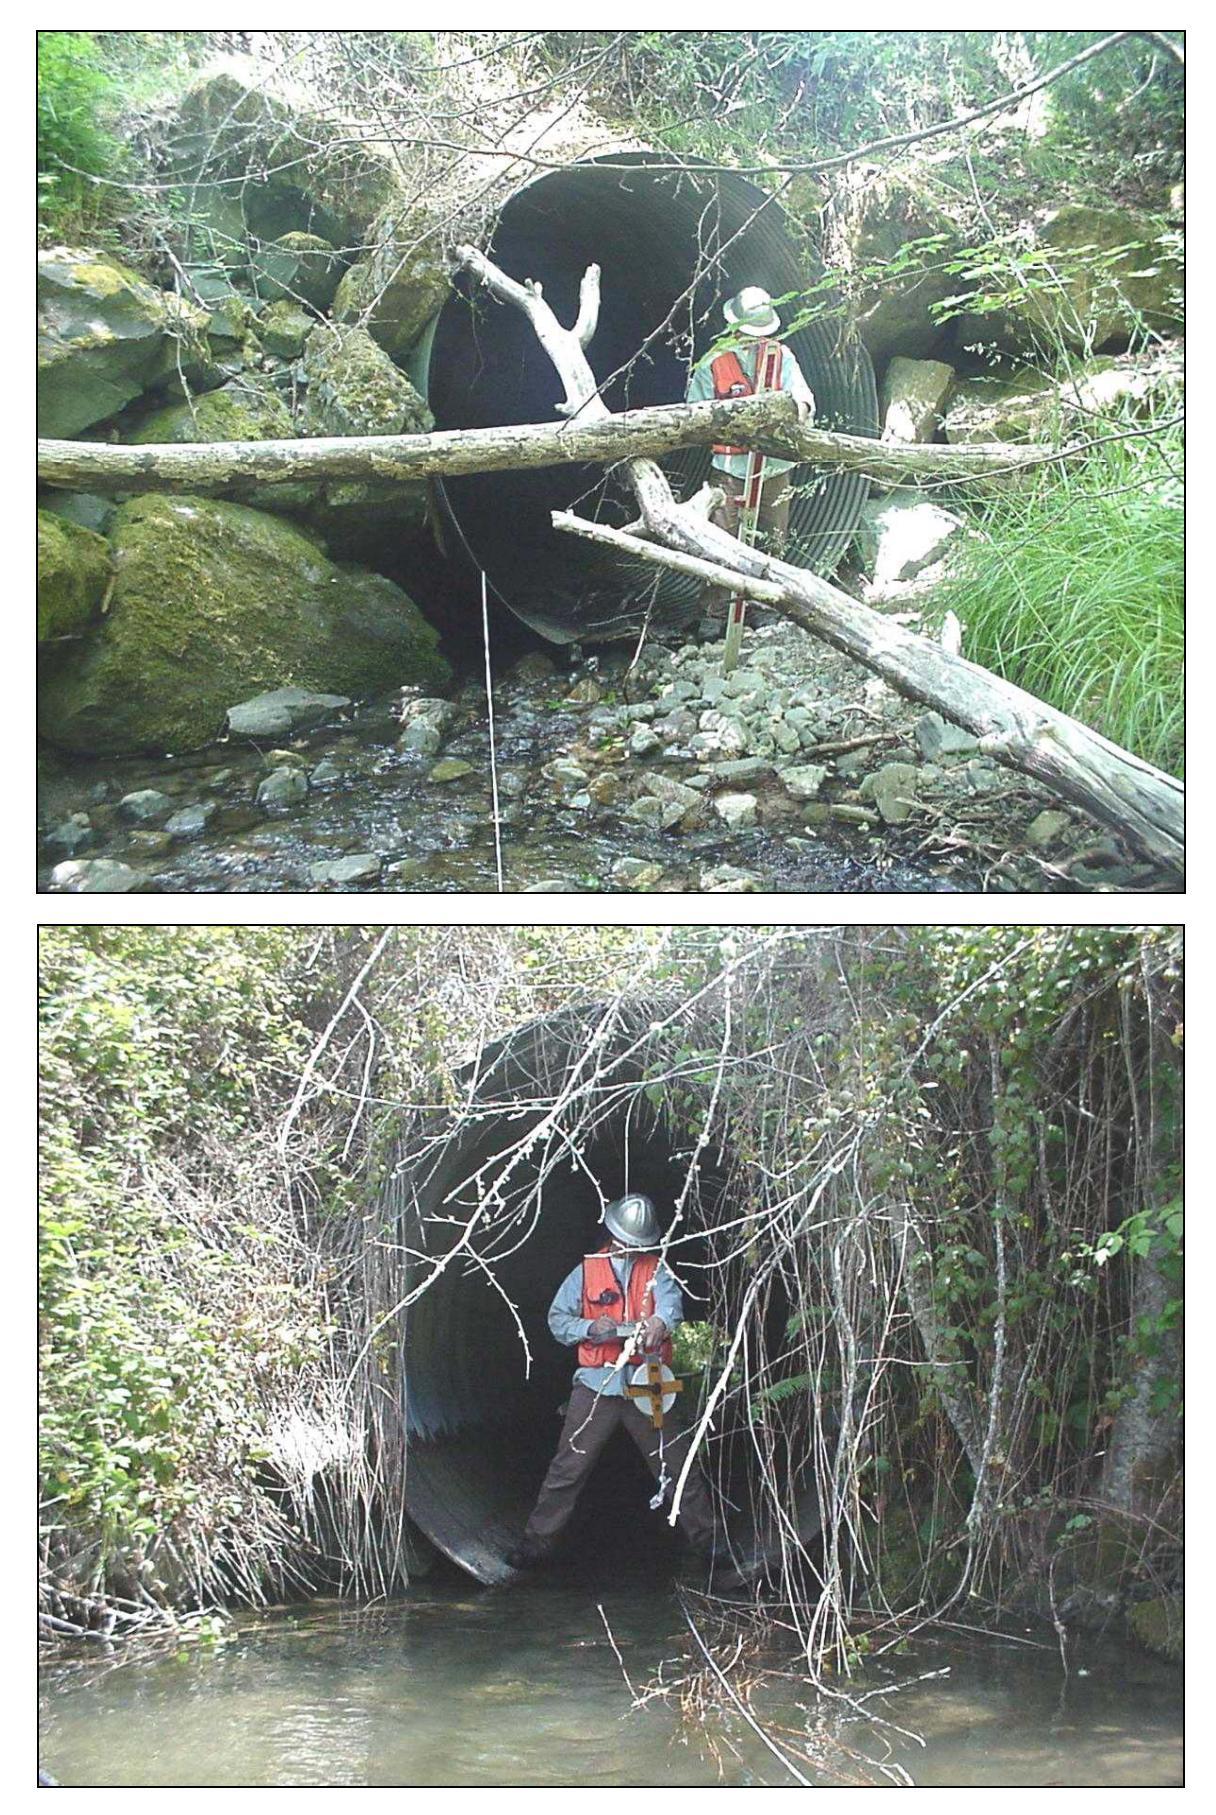
Site ID#HUM-013: Mountain Creek/Alderpoint Road; Larabee Creek; Eel River

Culvert Type: Circular, SSP. **Corrugations:** $2 - 2/3^{\circ} \times 1/2^{\circ}$. However, invert is lined with 0.3' of concrete **Dimensions:** diameter = 8.0'. **Length:** 81.0' **Slope:** 1.31% **Modifications:** None. **Rustline Height:** 2.2'. **Average Active Channel Width:** 13.6'. **Fill Estimate:** 755 cubic yards. **Overall Condition:** Poor – culvert invert is rusted-through and torn in several places. **Sizing:** Undersized; HW/D = 1 on a storm flow with approximately a 10-year recurrence interval and Alderpoint Road is overtopped on approximately a 33-year storm flow.

Barrier Status: GRAY: FishXing determined this crossing meet the 8-16-16 ft/sec passage criteria for all adult salmonids over 33% of the range of estimated of migration flows (between 11.7 - 29.0 c.f.s.). At lower migration flows FishXing predicted a lack-of-depth and between 30 and 55 c.f.s. FishXing predicted excessive velocities through the culvert. FishXing determined this crossing failed to meet the passage criteria for all age classes of juvenile salmonids.

Habitat: <u>Quantity</u> = approximately 2,400 feet of potential fish-bearing habitat upstream of Site ID# HUM-013. <u>Quality</u> = rated as "good" for the ranking matrix based on Taylor and Associates survey crew's field notes. No fisheries or habitat information was available in CDFG's files. The crossing was surveyed by Taylor and Associates on 6/19/03 and there was continuous surface flow in the channel. At 2:00PM the air temp = 19°C and the water temp = 14° C. The survey crew noted a moderately dense riparian zone of mostly hardwoods through agricultural fields on both sides of the road. Extremely abundant numbers (>100 fish) of juveniles salmonids were observed in the stream channel both upstream and downstream of Site ID# HUM-013. Two fish appeared to be in the 3"-6" size class and the rest were young-of-year fry.

Preferred Treatment: Recommend replacement with a properly sized open-bottom arch set on concrete footings provide unimpeded passage and to improve storm-flow capacity. The replacement should also correct the poor alignment the existing crossing has with the stream channel.

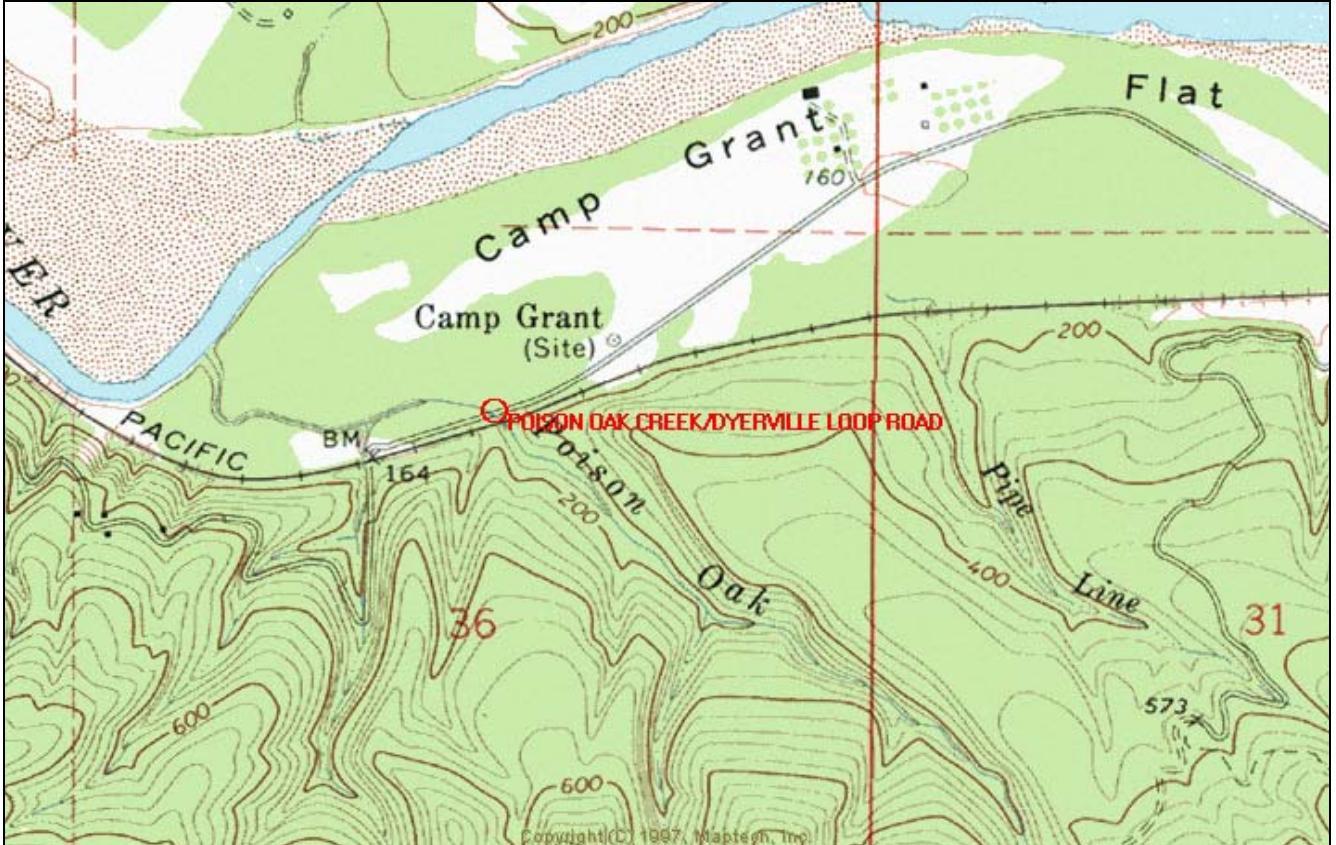
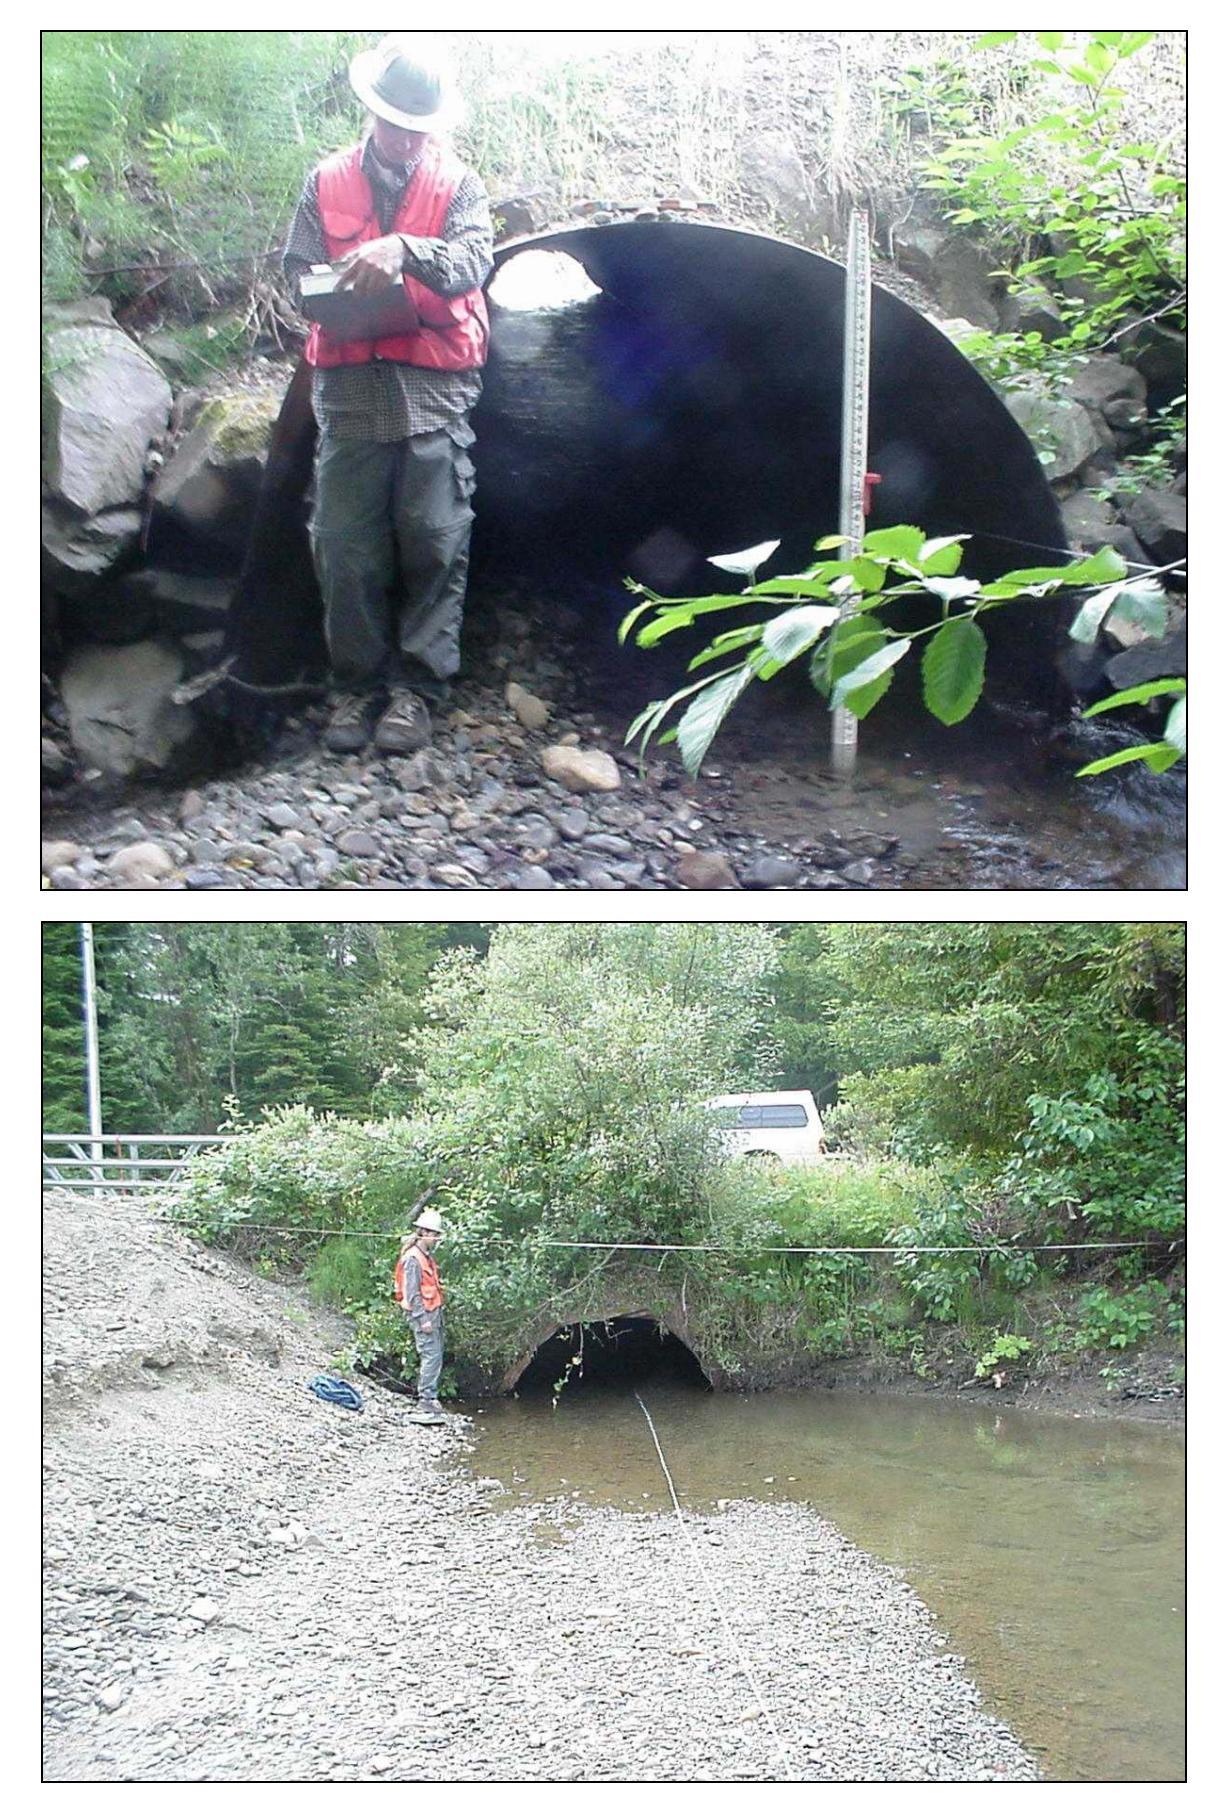
Site ID#HUM-014: Poison Oak Creek/Dyerville Loop Road; Eel River

Culvert Type: Circular, SSP. **Corrugations:** 2 - 2/3" x 1/2". **Dimensions:** diameter = 7.0'. **Length:** 71.2' **Slope:** -0.17% **Modifications:** None. **Rustline Height:** 5.0'. **Average Active Channel Width:** 14.2'. **Fill Estimate:** 345 cubic yards. **Overall Condition:** Poor – culvert invert is rusted-through. **Sizing:** Extremely Undersized; HW/D = 1 on a storm flow with approximately a three-year recurrence interval and Dyerville Loop Road is overtopped on approximately a four-year storm flow. **Barrier Status: GRAY:** FishXing determined this crossing meet the 8-16-16 ft/sec passage criteria for all adult salmonids over 86% of the range of estimated of migration flows (meets criteria between 9.0 - 46.3 c.f.s.), meets passage criteria for resident trout and 2+ year-old juvenile salmonids over 52% of the range of estimated migration flows (meets criteria between 3.5 - 12.5 c.f.s.), and meets passage criteria for 1+ year old and young-of-the-year juvenile salmonids over 16% of the range of estimated migration flows (meets 1.0 - 2.5 c.f.s.). For adults, at lower migration flows, FishXing predicted a lack-of-depth; thus actual passage may be higher.

Habitat: <u>Quantity</u> = approximately 3,200 feet of potential fish-bearing habitat upstream of Site ID# HUM-014. <u>Quality</u> = rated as "good" for the ranking matrix based on Taylor and Associates survey crew's field notes. No fisheries or habitat information was available in CDFG's files. The crossing was surveyed by Taylor and Associates on 6/10/03 and there was continuous surface flow in the channel. At 9:00AM the air temp = 19° C and the water temp = 13° C. The survey crew noted a moderately dense riparian zone of redwood and alder. Upstream land-use appeared to be commercial timber harvest. The survey crew talked to local landowners who said the lower reach of the creek dries-up later in the summer on a regular basis. This person also the outlet area of the crossing is dredged on an annual basis. A moderate abundance (10 - 50 fish) of juveniles salmonids (<3" in length) were observed in the stream channel downstream of Site ID# HUM-014.

Preferred Treatment: None immediately recommended because crossing provides ample fish passage. However, the crossing is severely undersized and is in poor condition. The recommended replacement is a properly sized open-bottom arch set on concrete footings to provide unimpeded passage and improve storm-flow capacity.

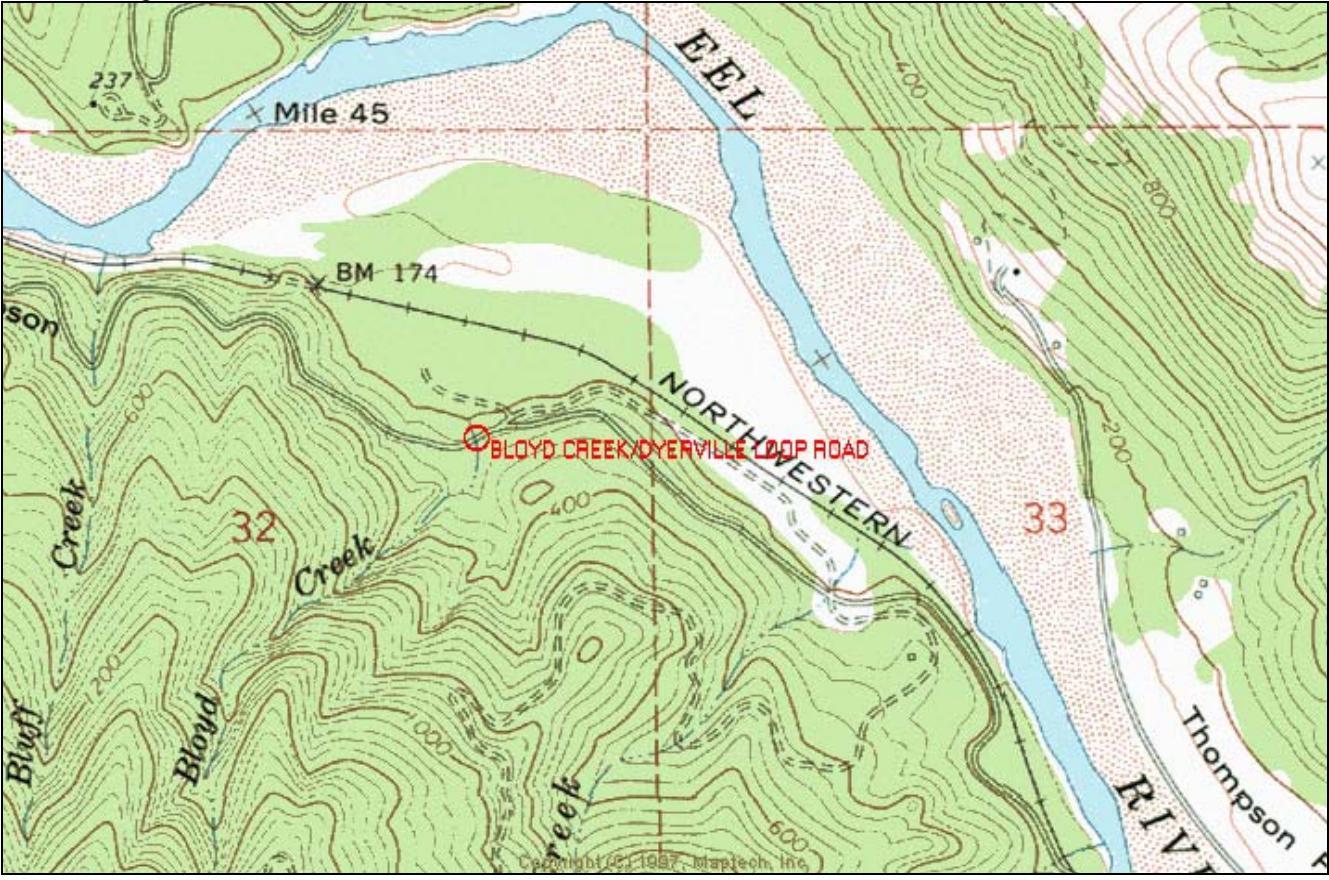
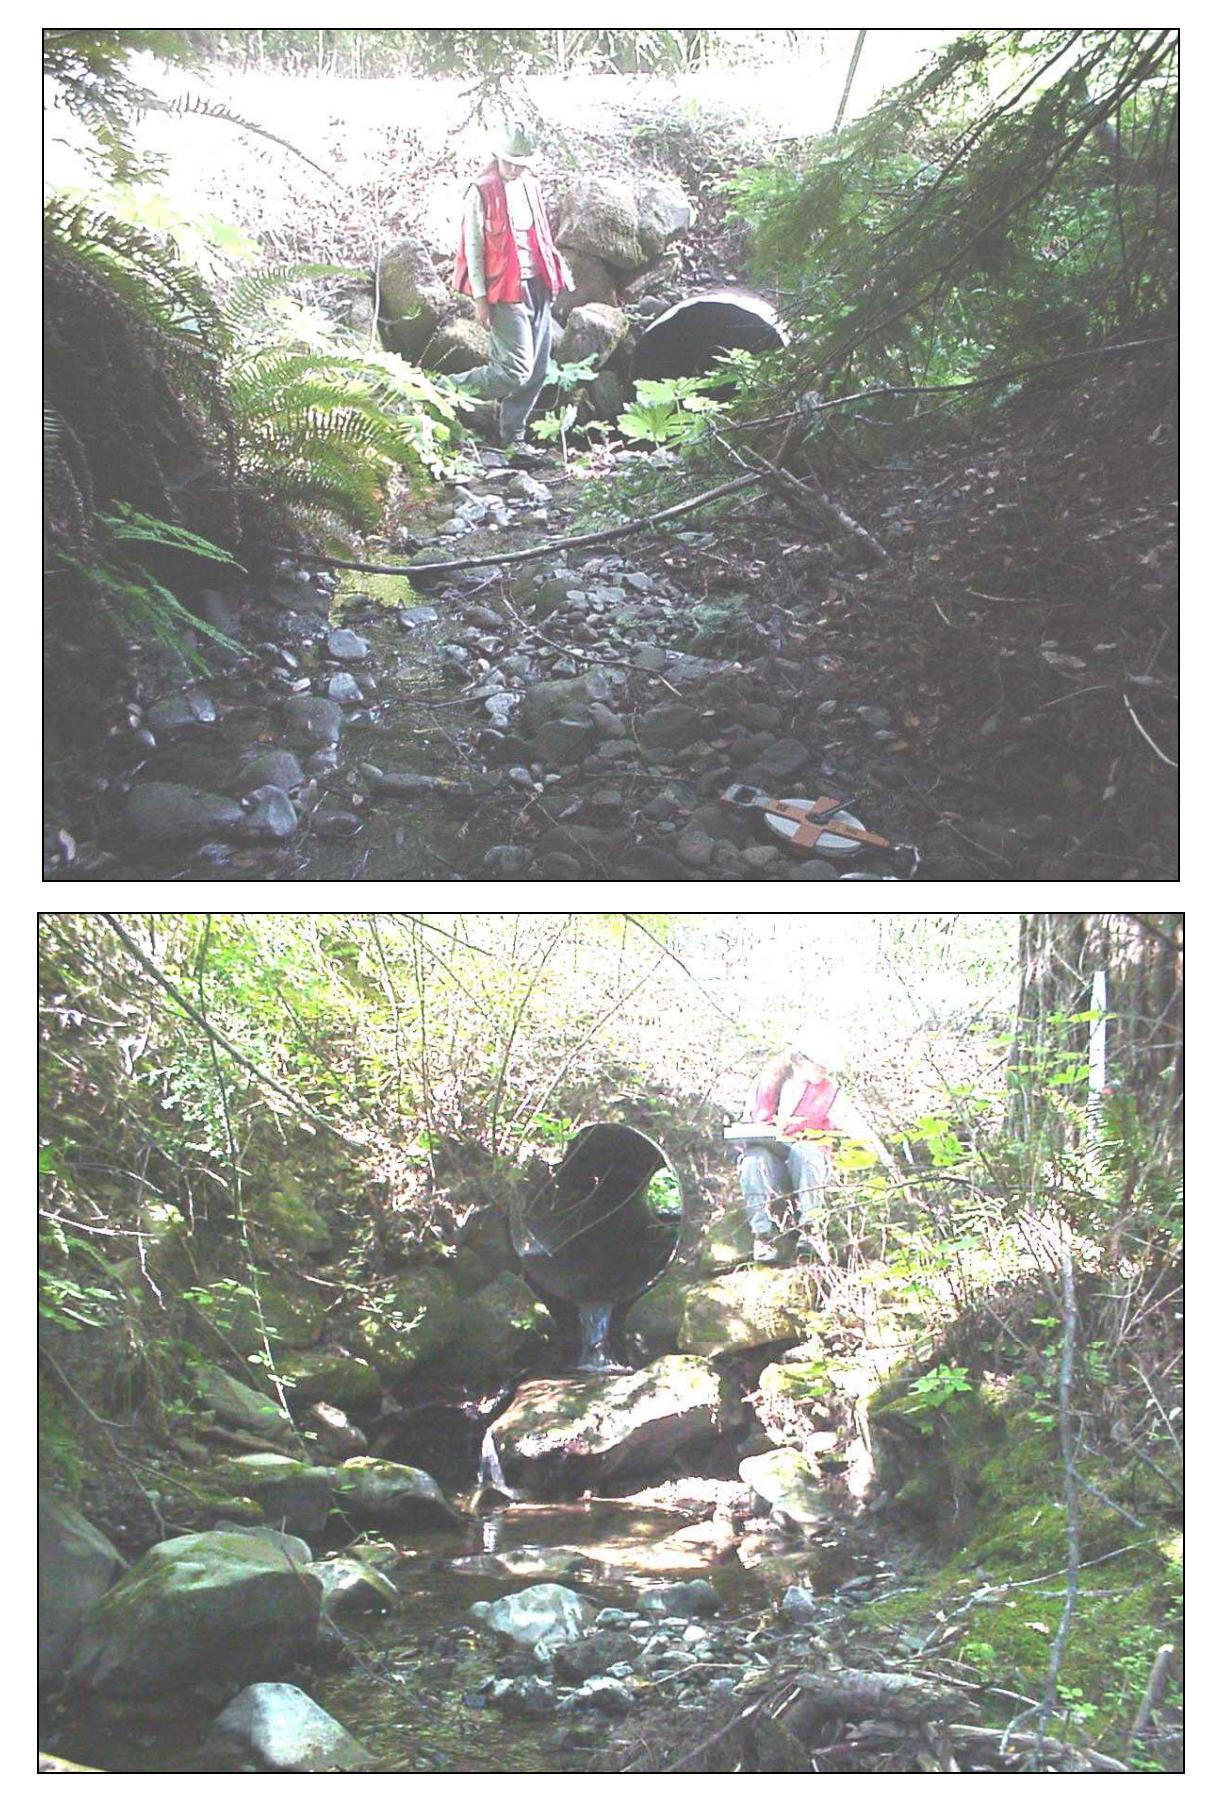
Site ID#HUM-015: Bloyd Creek/Dyerville Loop Road; Eel River

Culvert Type: Circular, SSP. **Corrugations:** 2 - 2/3" x 1/2". **Dimensions:** diameter = 3.0'. **Length:** 40.8' **Slope:** 5.51% **Modifications:** None. **Rustline Height:** 1.2'. **Average Active Channel Width:** 6.9'. **Fill Estimate:** 180 cubic yards. **Overall Condition:** Good. **Sizing:** Extremely Undersized; HW/D = 1 on a storm flow with approximately a two-year recurrence interval and Dyerville Loop Road is overtopped on approximately a four-year storm flow. **Barrier Status: RED**: the first-phase filter determined this crossing fails to meet the 8-16-16 ft/sec passage criteria for all age classes of salmonids over the entire range estimated of migration flows (for adults = 3.0 - 7.3 c.f.s.). The culvert's steep slope (>5%) is the crossing's main feature that creates a migration barrier for all age classes of salmonids. The perched outlet that cascades over rip-rap and a shallow outlet also makes entering the culvert problematic.

Habitat: <u>Quantity</u> = approximately 750 feet of potential fish-bearing habitat upstream of Site ID# HUM-015. <u>Quality</u> = rated as "fair to poor" for the ranking matrix based on Taylor and Associates survey crew's field notes. No fisheries or habitat information was available in CDFG's files. The crossing was surveyed by Taylor and Associates on 6/26/03 and there was continuous surface flow in the channel. At 9:30AM the air temp = 15° C and the water temp = 13° C. The survey crew noted a dense riparian zone of redwood and alder and the streambed was comprised of gravel and cobble. Upstream land-use appeared to be commercial timber harvest. No fish were observed in the stream channel adjacent to Site ID# HUM-015.

Preferred Treatment: The crossing is severely undersized and is in poor condition and should be upgraded with properly sized embedded SSP culvert or an open-bottom arch set on concrete footings to provide unimpeded passage and improve storm-flow capacity. Prior to treatment, the County should conduct a thorough field survey to assess the potential fisheries benefit (if any) within Bloyd Creek – including the highly-aggraded, intermittent lower channel between the Dyerville Loop Road crossing and the Eel River.
