Conner Creek Migration Barrier Removal Project

Red Hill Road – Conner Creek - December 2012

CA DEPARTMENT OF FISH AND GAME FINAL REPORT

Red Hill Road Project Description

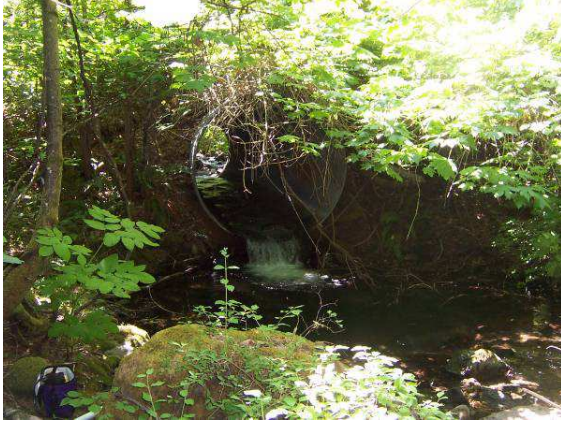
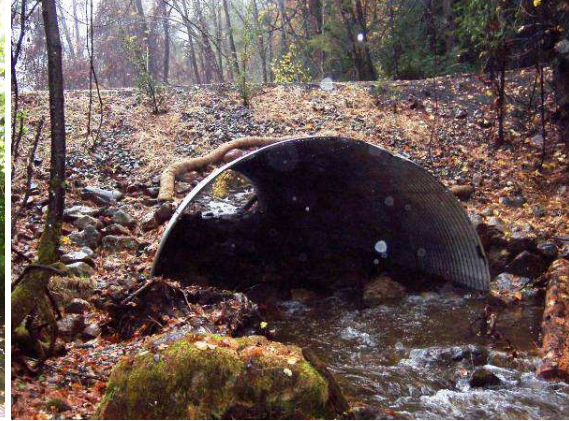
Red Hill Road Project before with 10' metal pipe culvert looking upstream (left) and restored channel with 18' multi-plate arch (right).

In 2012 the 10' diameter corrugated metal pipe (CMP) culvert was removed and replaced with an 80 foot long 18-foot span corrugated metal multi-plate arch, implementing a full stream simulation design through the road crossing. The old culvert created a 2' jump at the outlet that did not allow for almost fish passage. Also the undersized crossing reduced passage of bedload and debris associated with the high flows. The full stream simulation design complies with the *NMFS Guidelines for Salmonid Passage at Stream Crossings* (September 2001 as amended), allowing for the 100-year flood flows and associated bedload and debris to pass safely through replacement structures. This treatment minimized the potential for future culvert failures in larger storms (<100 year storms). The pre-existing culvert at Conner Creek Road and the existing structure on Red Hill Road overtopped on relatively small storms and the roads overtopped on 18-year and 43-year storm flows. The new crossings reduce maintenance costs associated with storm flows and culvert plugging and/or weir clearing, and eliminate the potential for delivery of approximately 2,189 cubic yards of road fill material into the downstream reaches of Conner Creek and the Trinity River.

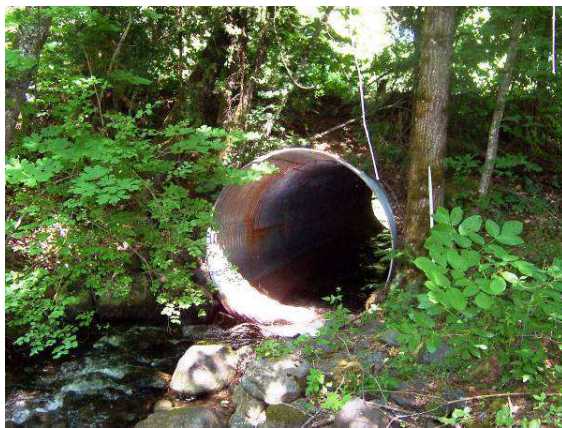
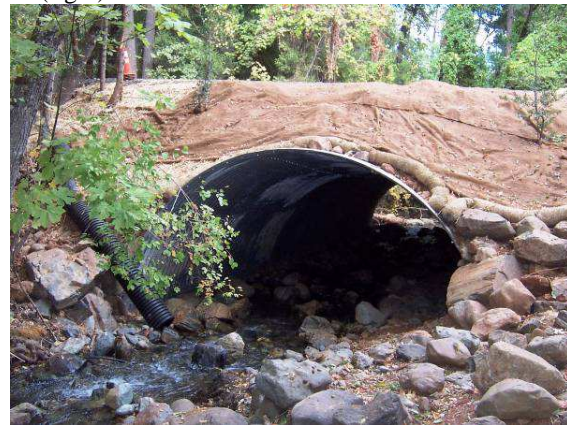
Red Hill Road Project before with 10' metal pipe culvert looking downstream (left) and restored channel with 18' multi-plate arch (right).

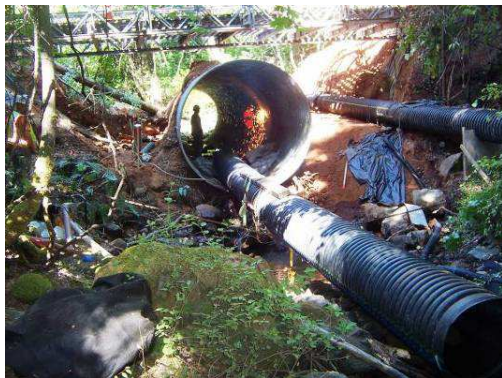
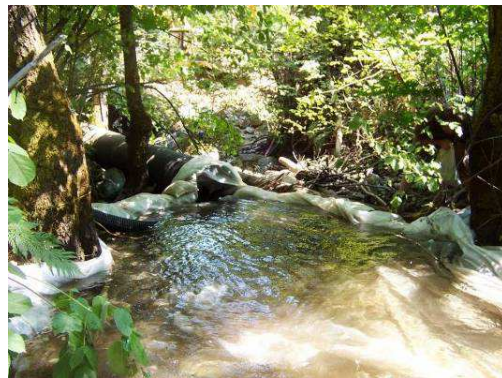
Left: The initial water diversion pipe placed within the old culvert was used to allow excavation of the road fill and installation of the main diversion pipe, which is visible in the right side of the photo. Once the main diversion pipe was installed, the initial diversion pipe in the 10' diameter CMP was removed. Right: Diversion Dam upstream of the project

The stream which had a consistent 2-3 cfs flow was dewatered by running it through the project site in a pipe prior to excavation of the old culvert. The initial stage of dewatering required an approximately 3 foot dam to be constructed out of plastic sand bags and plastic sheeting inside the old culvert. The water was diverted into a 40' long by 24" wide double-walled HDPE culvert

in order to carry the creek flow beyond the tailwater control of the plunge pool and out of the project area. The diversion pipe was comprised of two sections chained together and stabilized with 4" by 4" wood beams below and on top of the culvert joint. A chain was strung between two trees and put under tension with a come-along to further support the diversion pipe and the weight of the water flowing through it. Once the fill surrounding the old culvert had been excavated and the second diversion pipe installed, the first diversion was removed in order to extricate the old culvert.

The second creek diversion was constructed of an approximately 3 foot high dam made out of plastic sand bags, rocks and plastic sheeting at the upper end of the project. It was located at the downstream side of a natural pool below the upper fish exclusion screen. Flows were diverted through a 120' long by 24" wide HDPE culvert with a 20' section of 24" single-walled flexible pipe at the outlet end. The flexible pipe section at the bottom end of the diversion pipe was required in order to allow the creek water to reenter the creek channel with a drop of less than 12" inches and avoid excessive scour of the creek bank. The dewatering culvert was chained together with lever binders at each pipe segment to assure that it would not come apart during construction and to minimize leakage. Having the dewatering pipe to the side of the construction site did slow some excavation work as it impinged on the crews ability to place fill material and required the need to cut a trench.

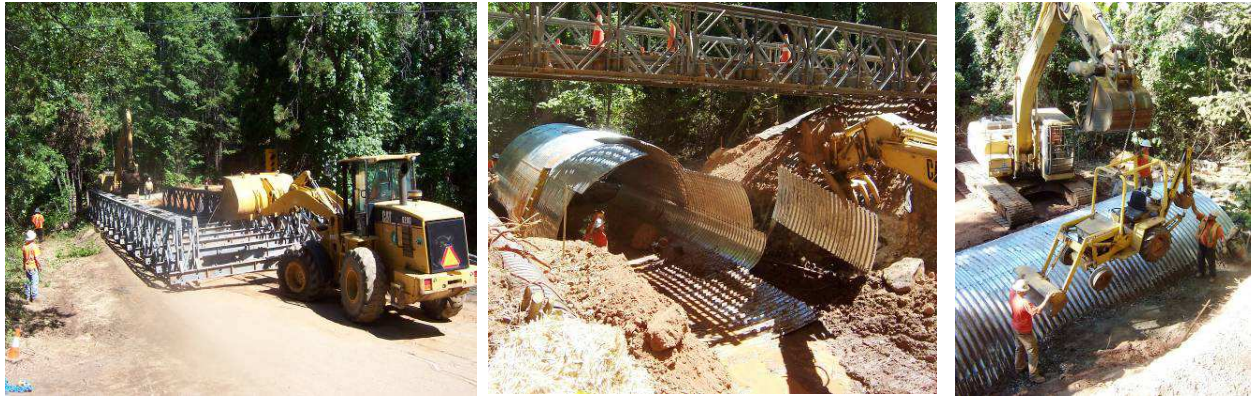
Half width construction was possible with the use of a bailey bridge. Left: Bailey bridge installation, Middle: construction of the multiplate in place, underneath the bridge, Right: lowering the small backhoe into place alongside the newly constructed pipe.

One of the goals of the project was to minimize construction disturbance to only the area necessary for project construction access and to remove only those trees and vegetation necessary for safety and access. To accomplish that goal the half-width construction was utilized and detour design had to be flexible enough to allow to minimize vegetation disturbance and road access. The initial excavation began at the downstream side of the project in order to allow one lane of residential access along the upstream half of the road. TCDOT installed two solar power traffic light trailers, set to blink red light, at either end with construction signage. A Bailey bridge was installed for a detour and remained in place for most of the project construction time. The use of the Bailey bridge allowed TCDOT to lower a small 20 hp Terramite T5 backhoe onto the fill material in order to work under the bridge.

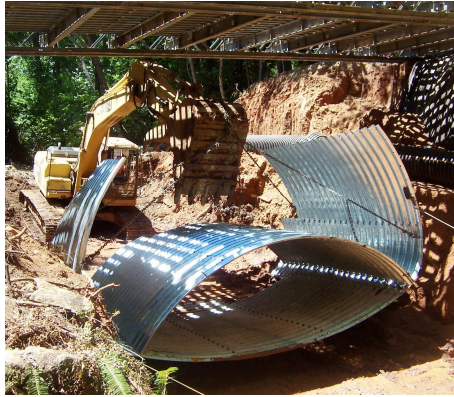
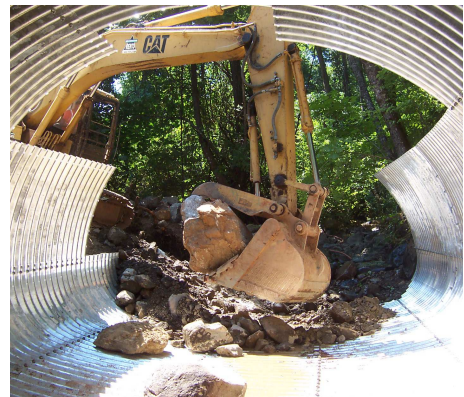
TCDOT pre constructed the first multi-plate section and set it in place (left) before the installing remaining sections (middle). Large boulders were placed as the multi-plate was constructed (right).

The downstream 12-foot section of the multi-plate culvert was constructed off-site at the Weaverville DOT maintenance yard before being trucked in and installed at the project site. The remaining sections of the pipe were stored at the second staging area and were constructed in place one section at a time. The bottom pieces were installed first by lifting the bottom, upstream lip of the culvert and bolting the bottom panels together. The remaining side and overhead pieces were then installed before the next bottom piece was attached. Large rocks, from 3 to 4 tons, were placed in the culvert (2 every 10 feet) with the excavator as the culvert was constructed. The alignment of the pipe was finalized before the remaining sections were put together and large rock added.

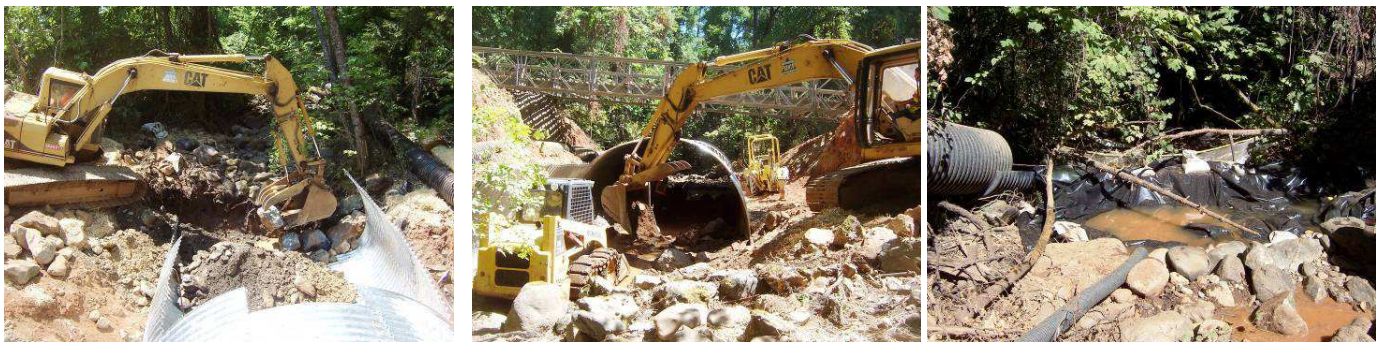
TCDOT constructed the upstream rock ribbon at the inlet of the culvert (left) before the streambed mix was installed in the pipe (middle). A temporary sediment basin was constructed downstream of the former plunge pool (right)

The total length of stream channel treated was 100 feet consisting almost entirely of the section within the newly constructed culvert. The remaining roughened channel consists of the filled in plunge pool at the outlet and the two rock ribbon grade-control structures constructed with 2 ton rock, buried 2 layers deep and keyed together and into the banks. The plunge pool below the replaced culvert was installed first. A natural rock ribbon that acted as the tail water control of the plunge pool was left in place. A single 1.5 – 2 ton boulder was added to the river left side along with streambed material to assure erosion protection along the full creek width. The first engineered rock ribbon was installed before the first section of the multi-plate culvert was installed due to limited downstream excavator access after the culvert was in place. The second rock ribbon was installed upstream after the final bottom sections of the multi-plate culvert were installed and before Trinity crews moved the streambed material in to place.

Engineered streambed material designed to be stable up to the 100-year flows was placed in the channel and jetted to compaction using a both the upstream electric pump and the TCDOT trash pump downstream. Streambed material was mixed on site at the staging area using a combination of native and purchased material. Initial streambed material proved to be too fine and was amended with sand, crushed gravel and cobble. A ¼ inch smooth bore brass nozzle and ½ inch fire nozzle supplied sufficient water pressure to jet the streambed material and fill interstitial gaps. Jetting occurred as material was added and while the remaining culvert pieces were installed. During jetting, turbid water was pumped from the lower end of the project and recirculated into the jetted material. A sump hole at the downstream river left side of the culvert

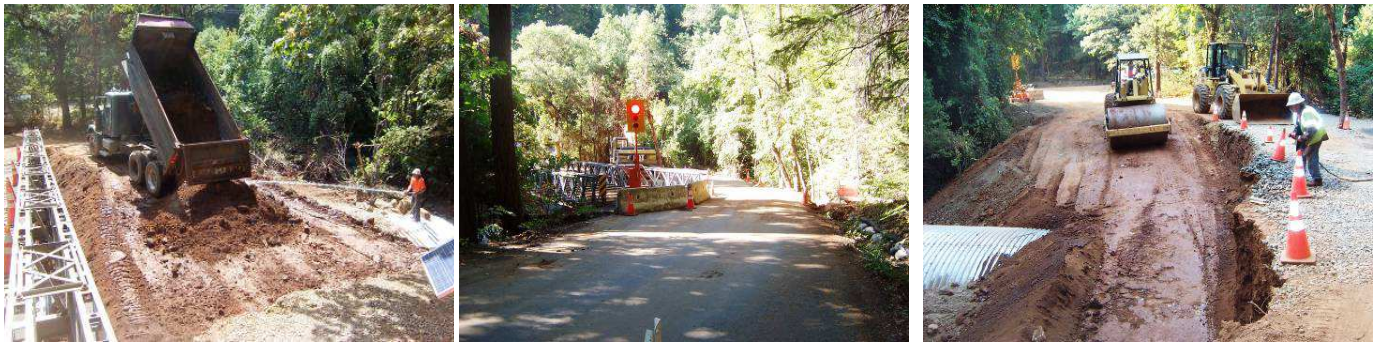
Constructing the upstream fill material (left), the detour road and traffic control lights (middle), constructing the downstream fill (right).

As the streambed material was installed, as described above, TCDOT crews began backfilling around the pipe. The 20 hp Terramite T5 backhoe, supplied by LanMark Forestry, was used to place fill material in preparation for compaction with a plate compactor. Once the engineered streambed material was fully set and full creek flows were returned to the channel, the diversion pipe was removed and the remaining upstream fill material was constructed and compacted. A detour road was reinstalled on the upstream fill slope in order to provide access while the Bailey bridge was deconstructed and removed. The TCDOT crews then reconstructed the downstream portion of the fill, installing an alder rootwad on the river right side of the creek at the same time. An approximately 25-foot section of 20" diameter ponderosa pine was installed on the river left side of the creek downstream of the culvert outlet. The butt of the tree section was anchored into the left bank with large rock outside of the fill material in order to avoid compromise of the fill material. The tree section was angled downstream at approximately forty-five degrees from the stream channel. Both pieces of LWD were placed to promote scour and deposition of streambed material during high flows in order to create and maintain fish habitat.

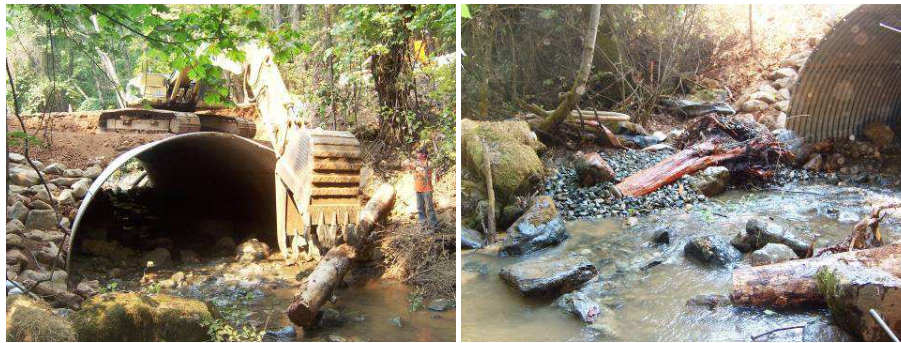
Installing large wood at the culvert outlet (left) and completed LWD (right)

Large rock slope protection material was placed at the inlet and outlet of the multi-plate culvert for bank stabilization and project from high flows. Due to the large size of the culvert, rock slope projection was only required to cover approximately half the height of the culvert.

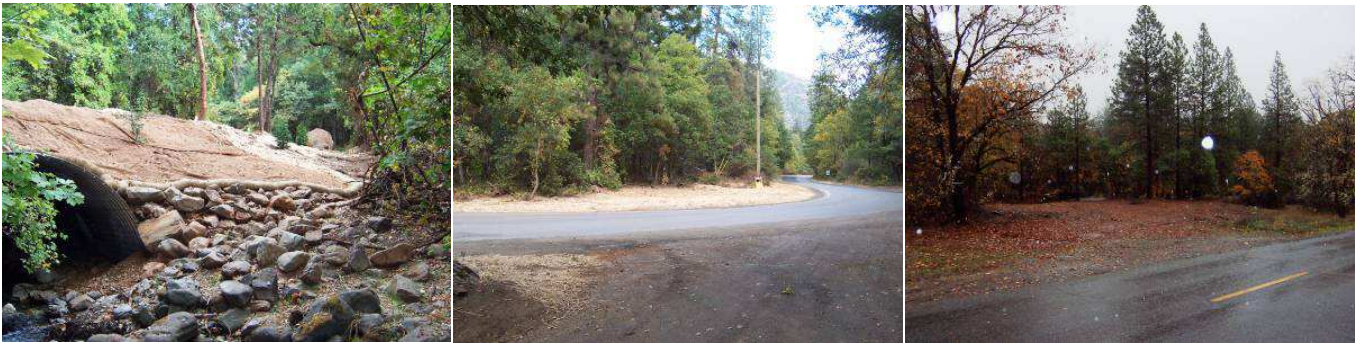
Native pine mulch, certified weed-free straw, grass seed, straw wattle, tree plantings and jute matt (left) were applied to the site. Native mulch, straw and grass seed were applied to the equipment staging area (middle). Mulch, seed and acorns were used at the large staging area (right).

On November 1st the site final erosion control and temporary reseeding effort was completed. 20 pounds of native grass (Blue Wild Rye: (*Elymus glaucus*), Meadow Barley: (*Hordeum Brachyantherum*), Beardless Wild Rye (*Leymus Triticoides*) was planted and mulched with native mulch/compost collected from forest land adjacent to the site. Seed was purchased by the Trinity County Resource Conservation District (RCD) and was a locality mix. California Brome (*Bromus carinatus*) was obtained from the Forest Service and added to the seed mix. Seeded portions included sections of Red Hill Road adjacent to the bridge that were disturbed during construction as well as all disturbed soil along Conner Creek, the riparian area and the staging area at the barrier site. Five larger diameter (2") incense cedars (*Calocedrus decurrens*), 5- 1" diameter Douglas-fir (*Pseudotsuga menziesii*), and 3- 1" interior live oak (*Quercus chrysolepis*) were planted along the road side and in the access road. Jute mat was laid across the steepest sections of fill slope and stapled in place in order to provide added protection from rain impact. The large spoils staging area was mulched, reseeded with the described mix and locally collected acorns were planted. All silt fences and wattles were removed.
