Attachment 2

Deadwood Fish Passage Improvement Project Photo Log

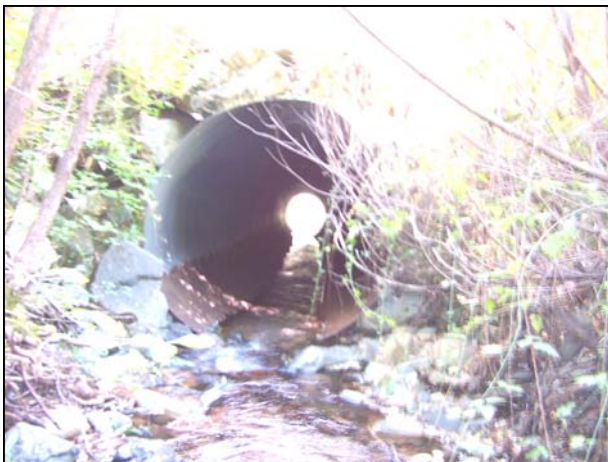
Above: Pre-project view of outlet pool looking downstream

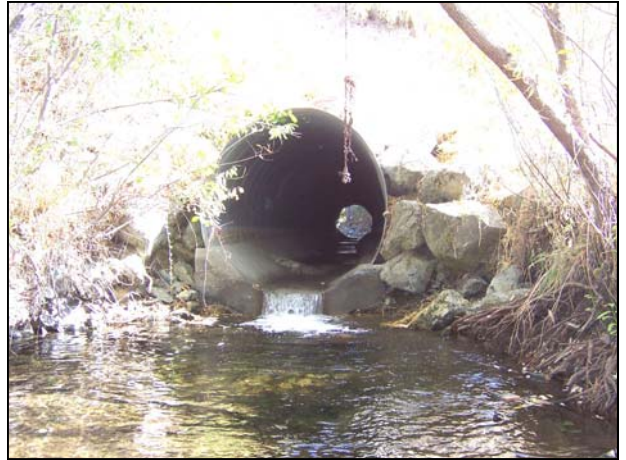
Below: Pre-project view looking downstream into culvert

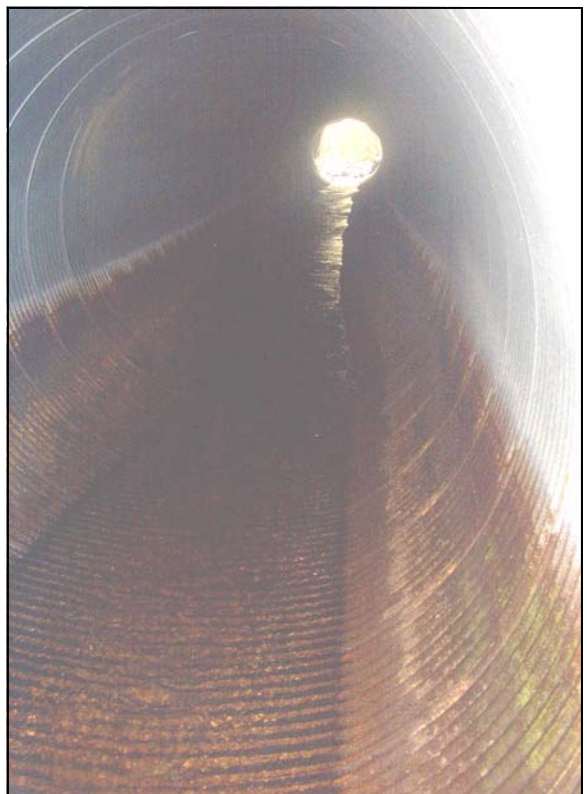
Above: Post Project view of outlet pool looking upstream into the culvert

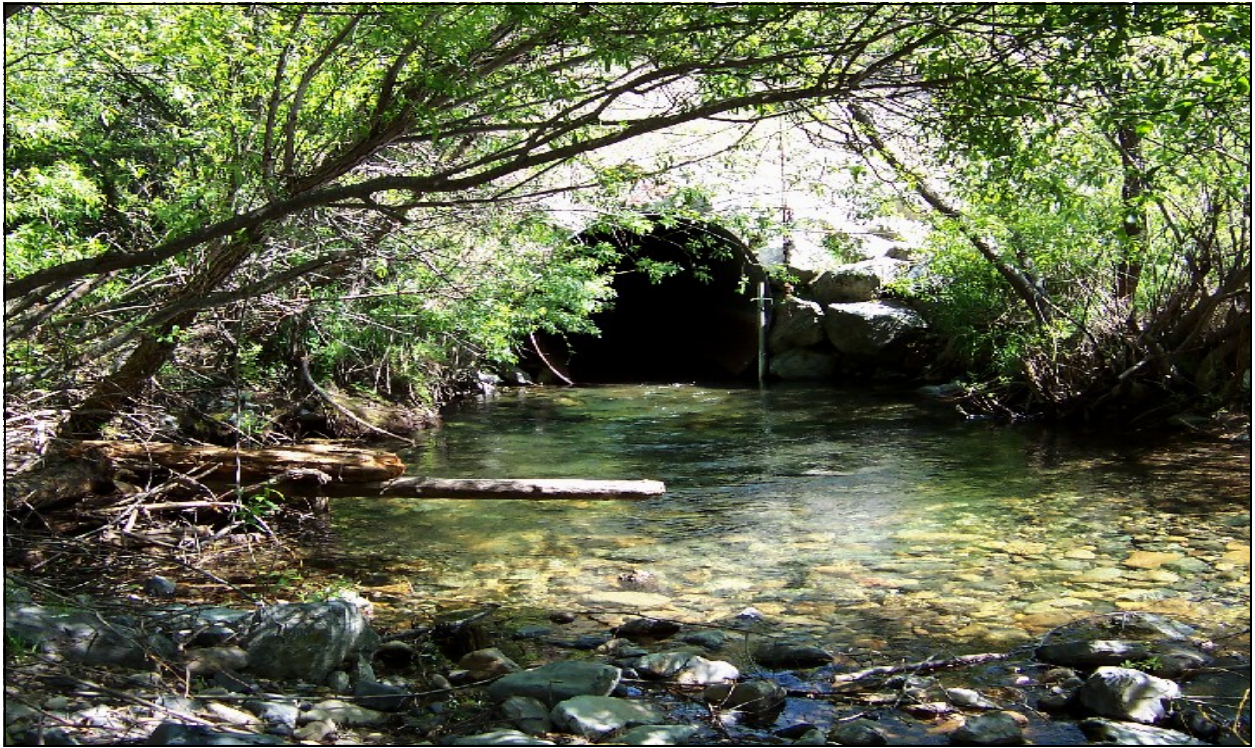
Below: Pre-project view looking upstream into the culvert

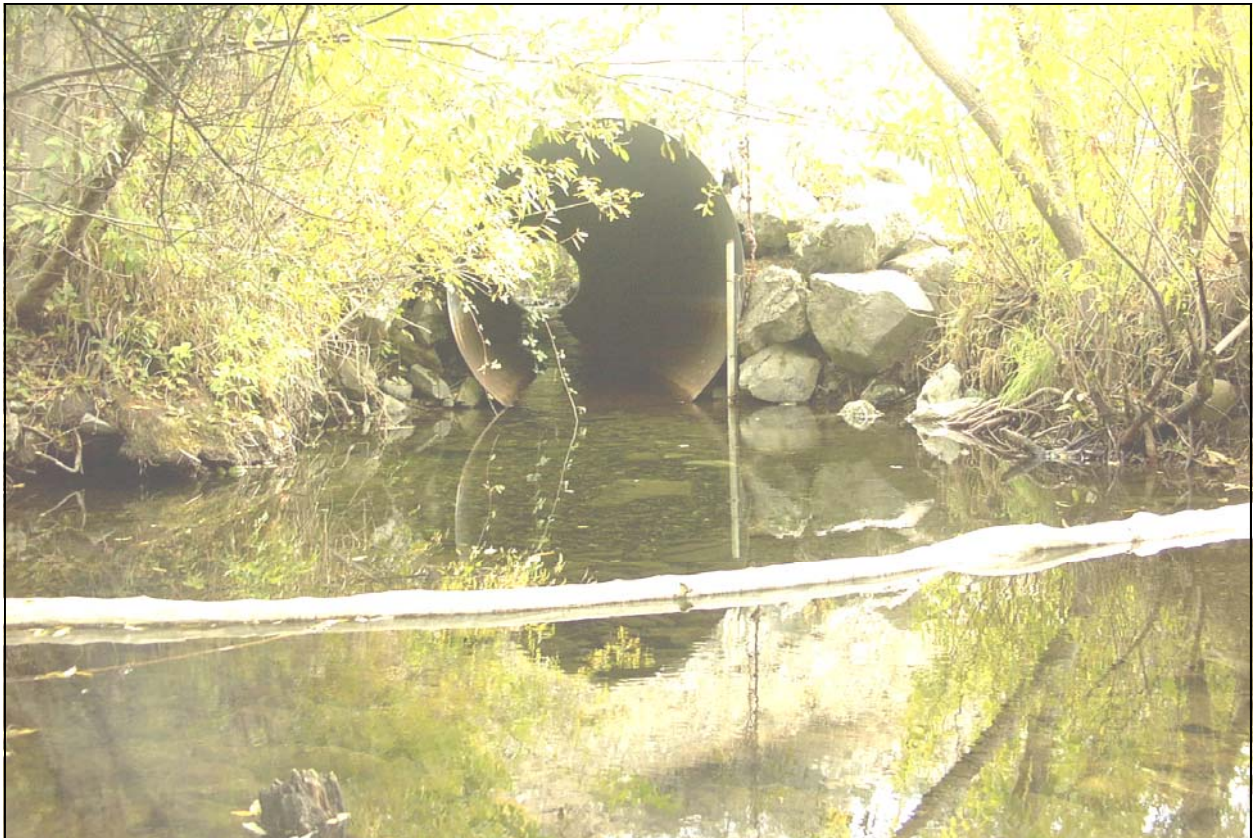
Above: Looking upstream toward the culvert outlet prior to Phase 1 and 2 work

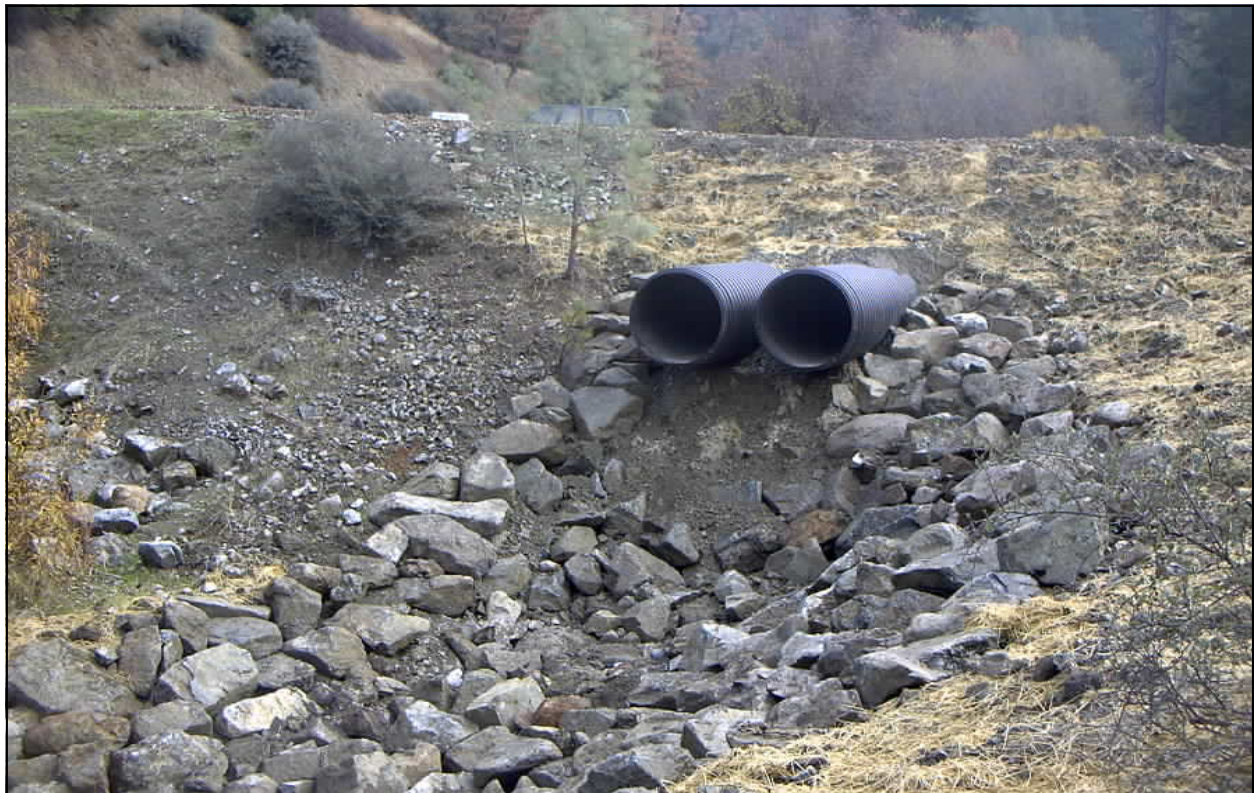
Above: 4-foot diameter overflow culverts installed (rock slope protection is on the road awaiting placement—Phase 2)

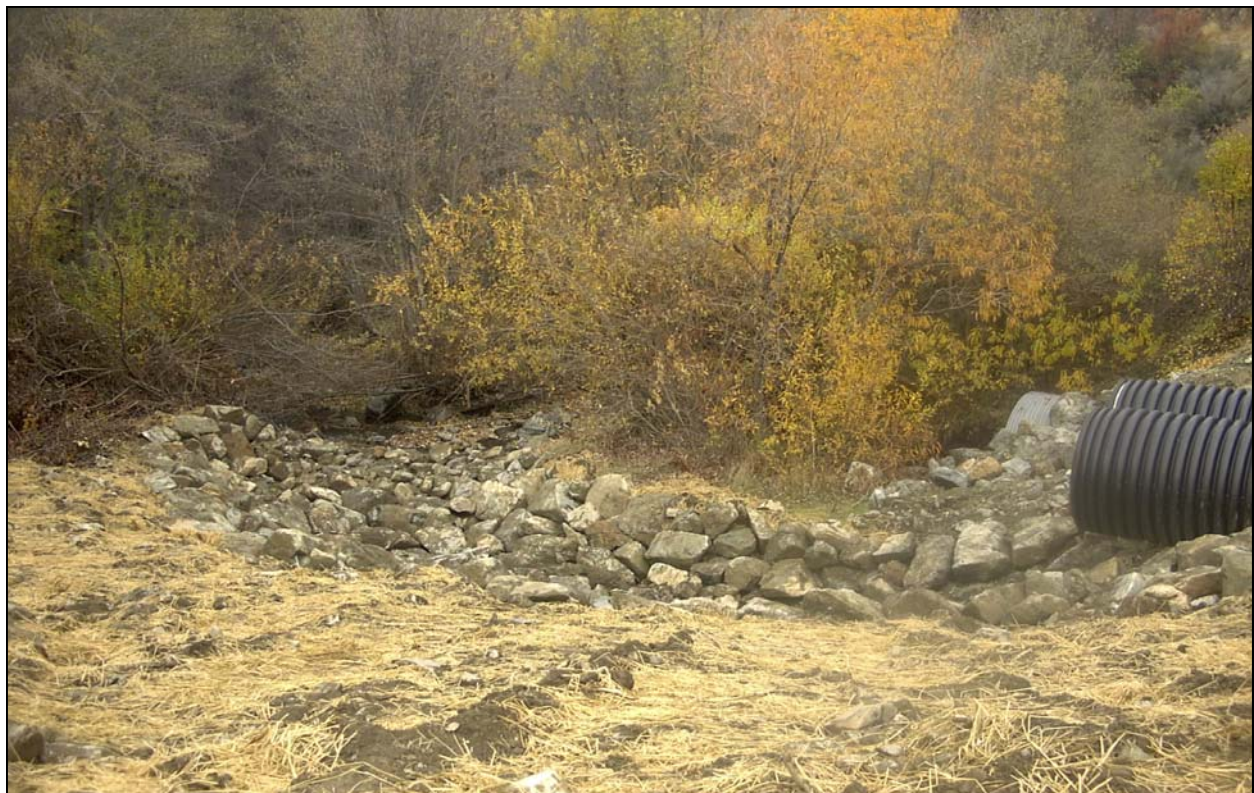
Above: Side view of overflow culvert outlets without rock slope protection (Phase 2)

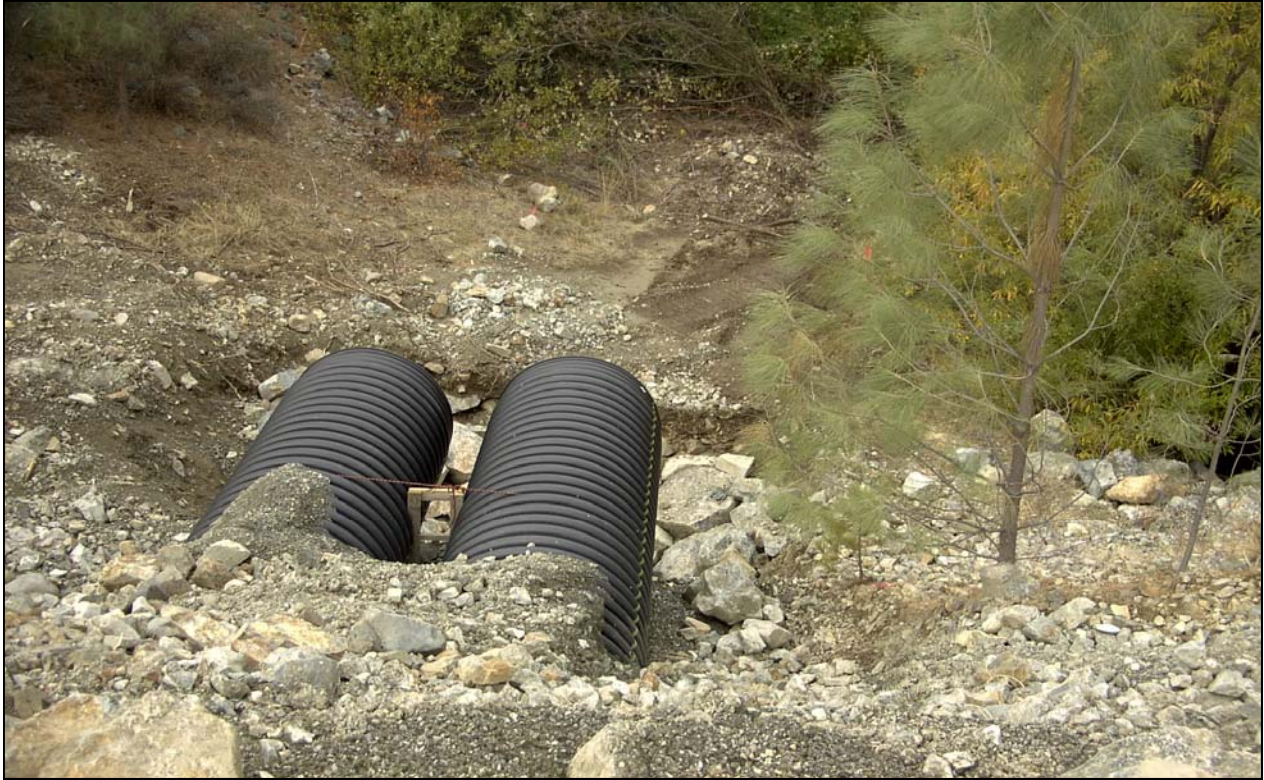
Below: Same view of overflow culvert outlets with rock slope protection and revegetation

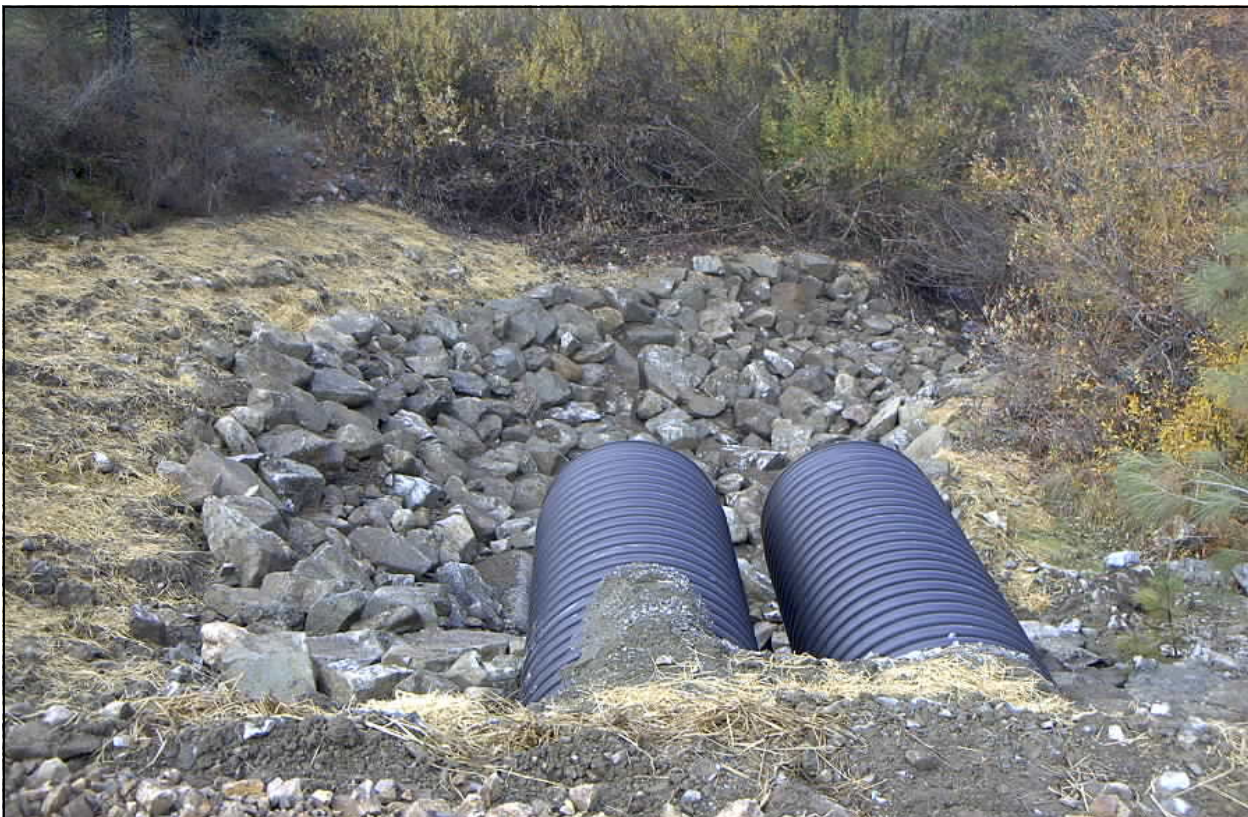
Above: Outlet fillslope of 4-foot diameter HDPE overflow culverts without rock slope Protection (Phase 2)

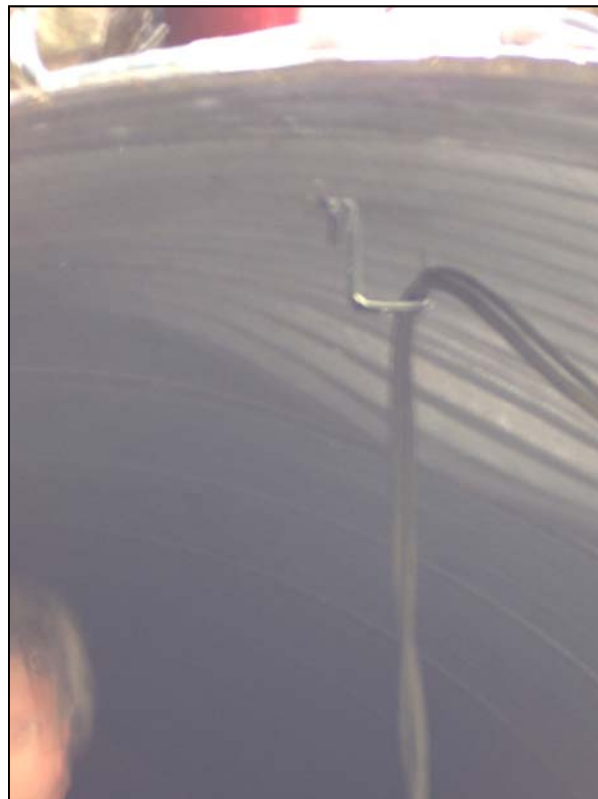
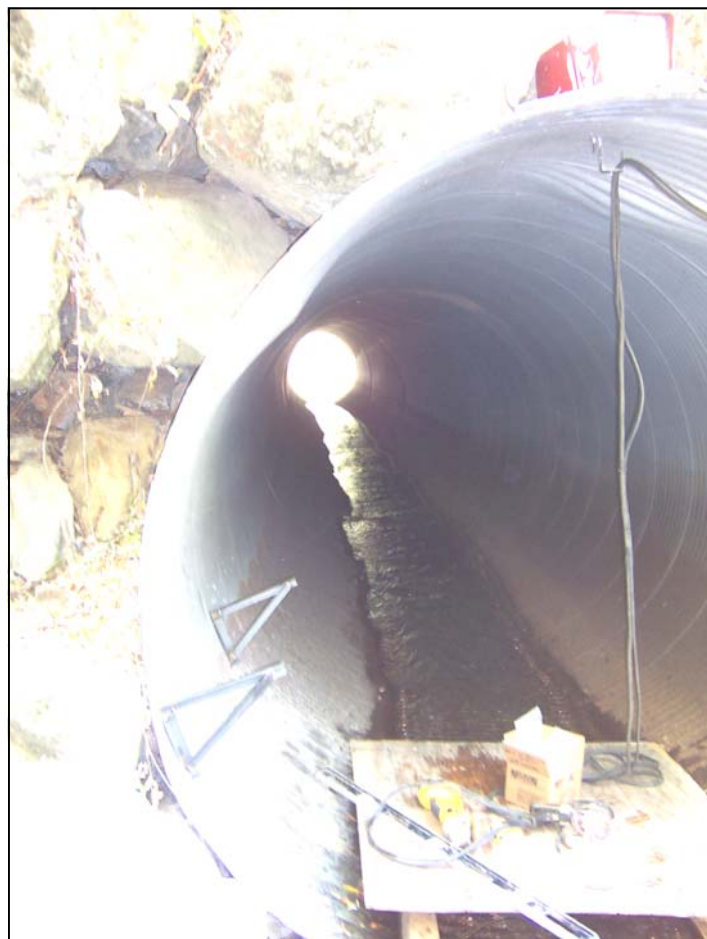
Utilizing a stud gun to weld bolts to the inner walls of the culvert in order to suspend the diversion pipe and hang lighting and cordage from above (Phase 3)

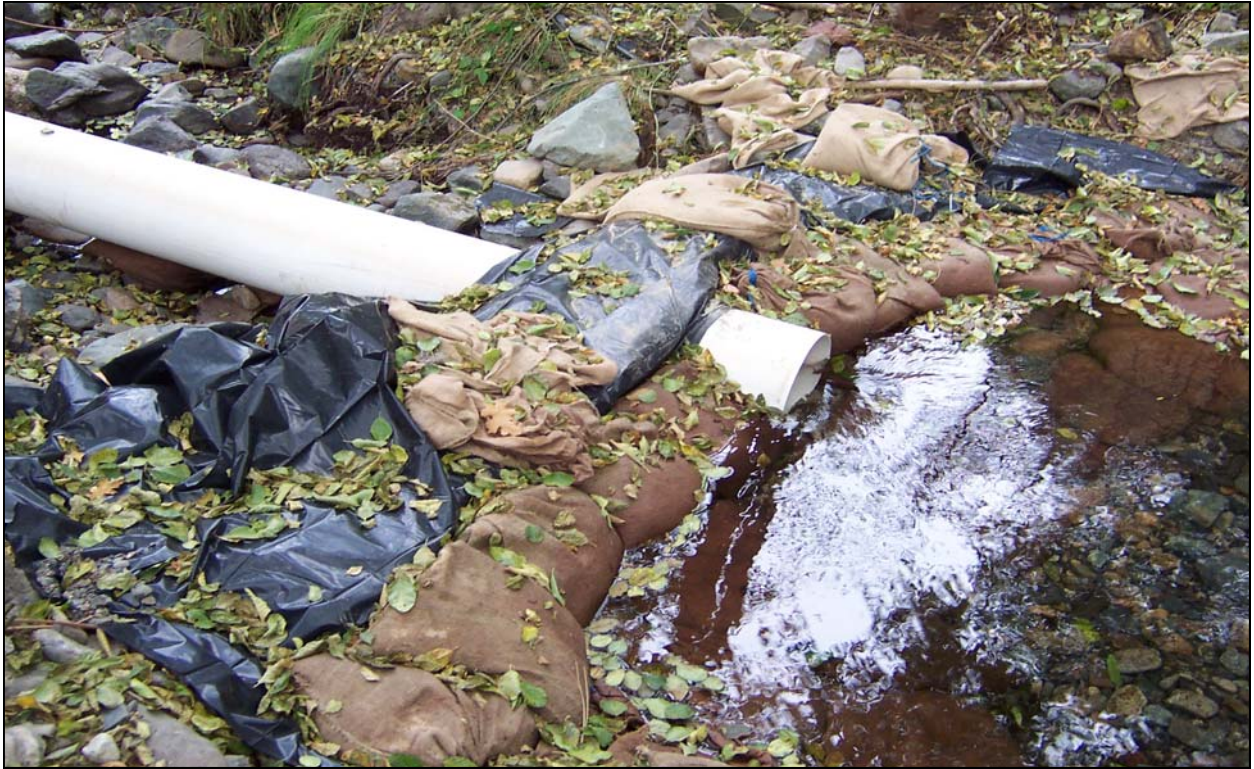
Above: Cofferdam & 15"-inch diversion pipe set approximately 40-feet upstream of the culvert inlet

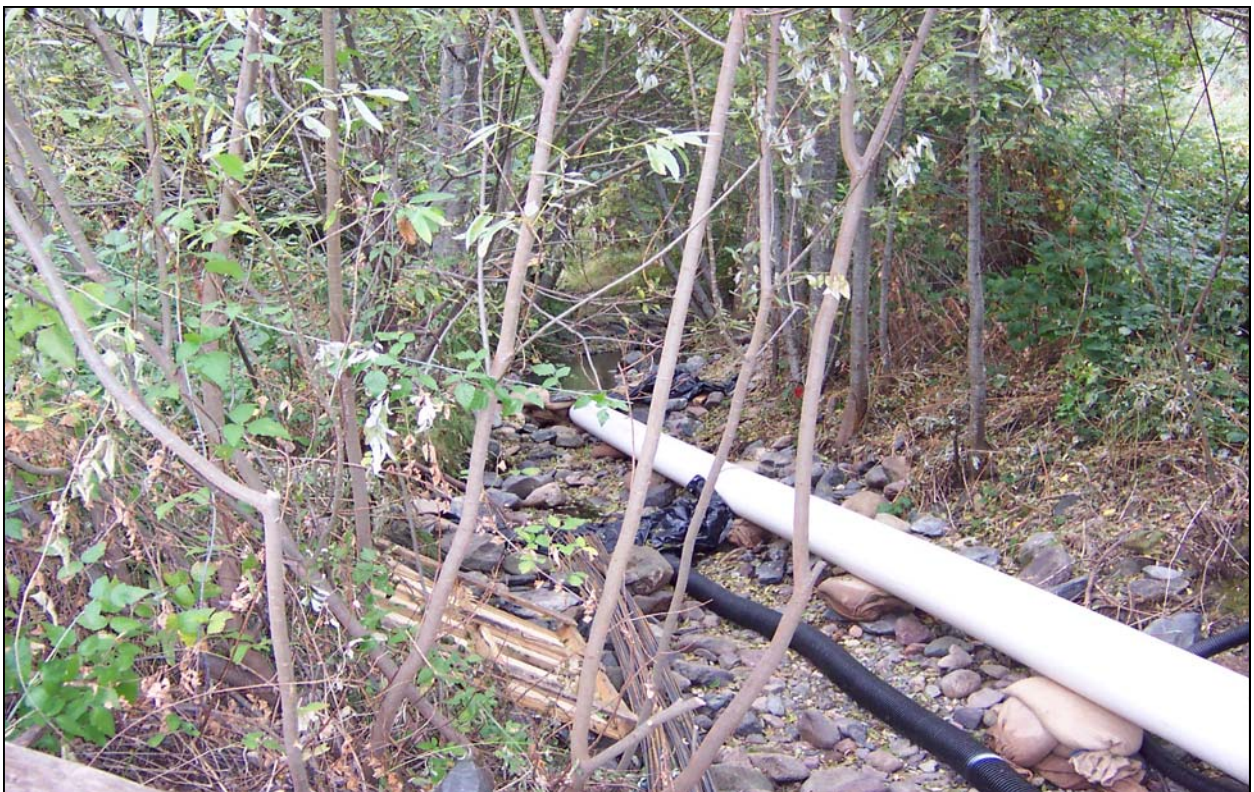
Below: Diversion pipes extending from cofferdam to culvert inlet

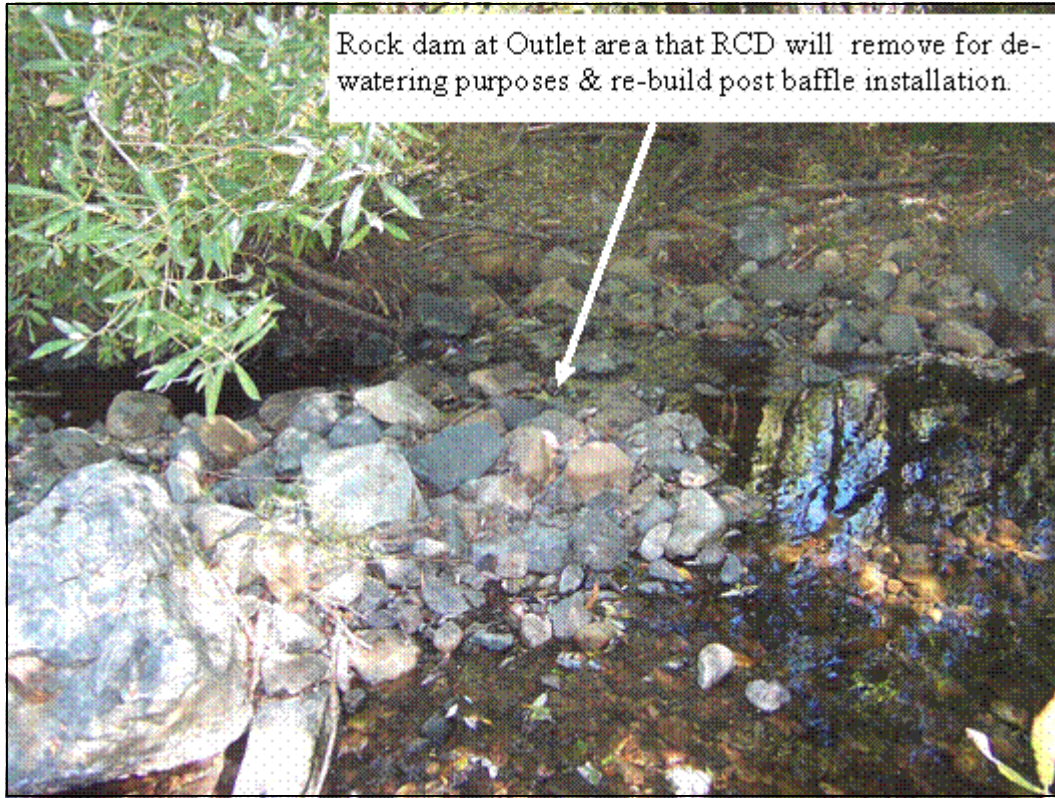
Outlet area rock weir and roughened riffle channel extending from outlet down to confluence with the Trinity River

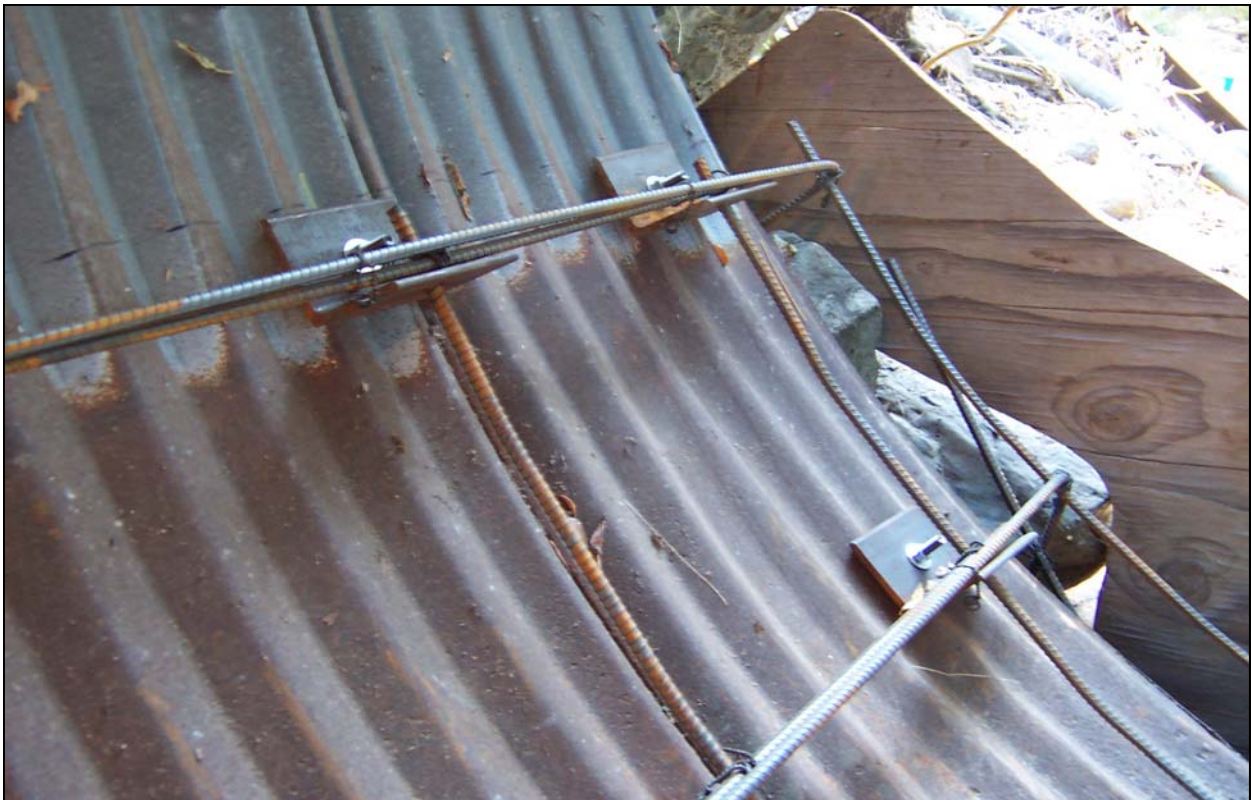
Above: One baffle set in the concrete—view looking upstream from culvert outlet

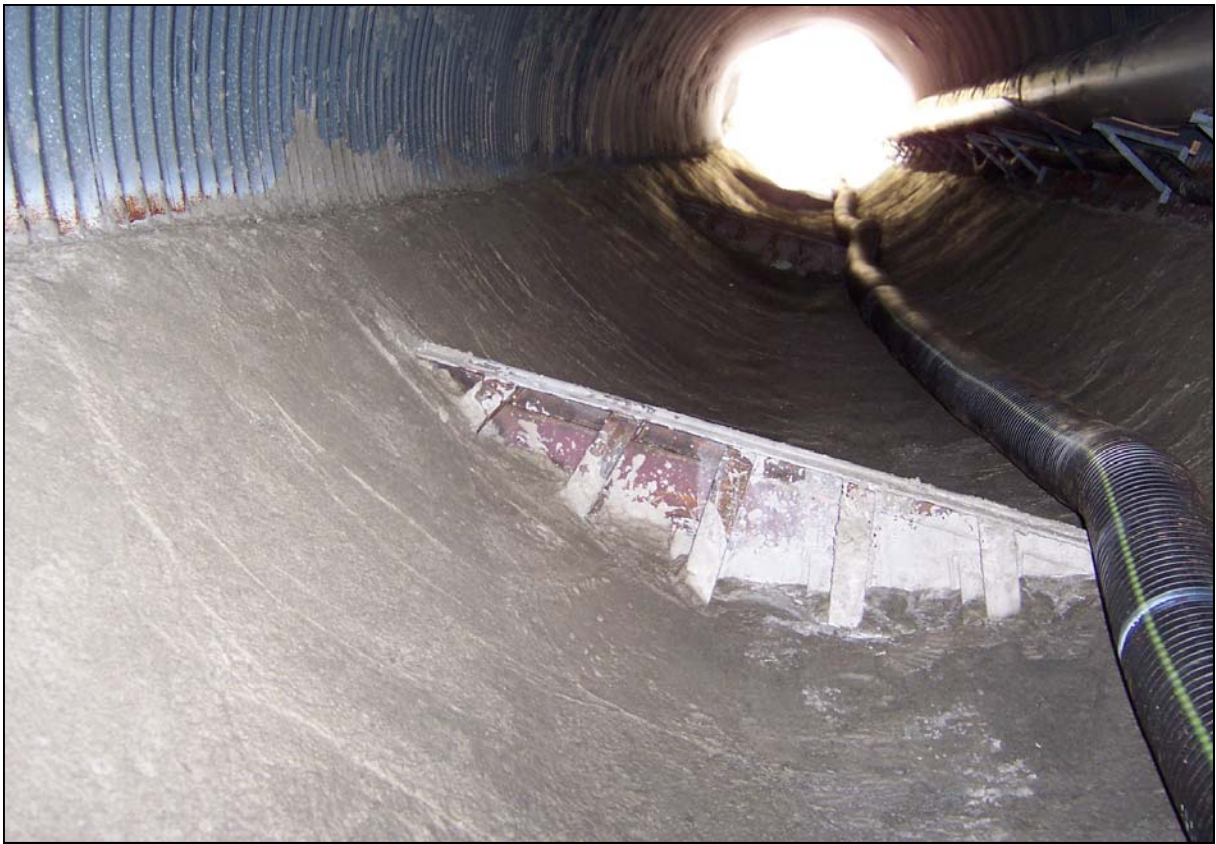
Below: Looking downstream through the culvert at the six baffles set in concrete

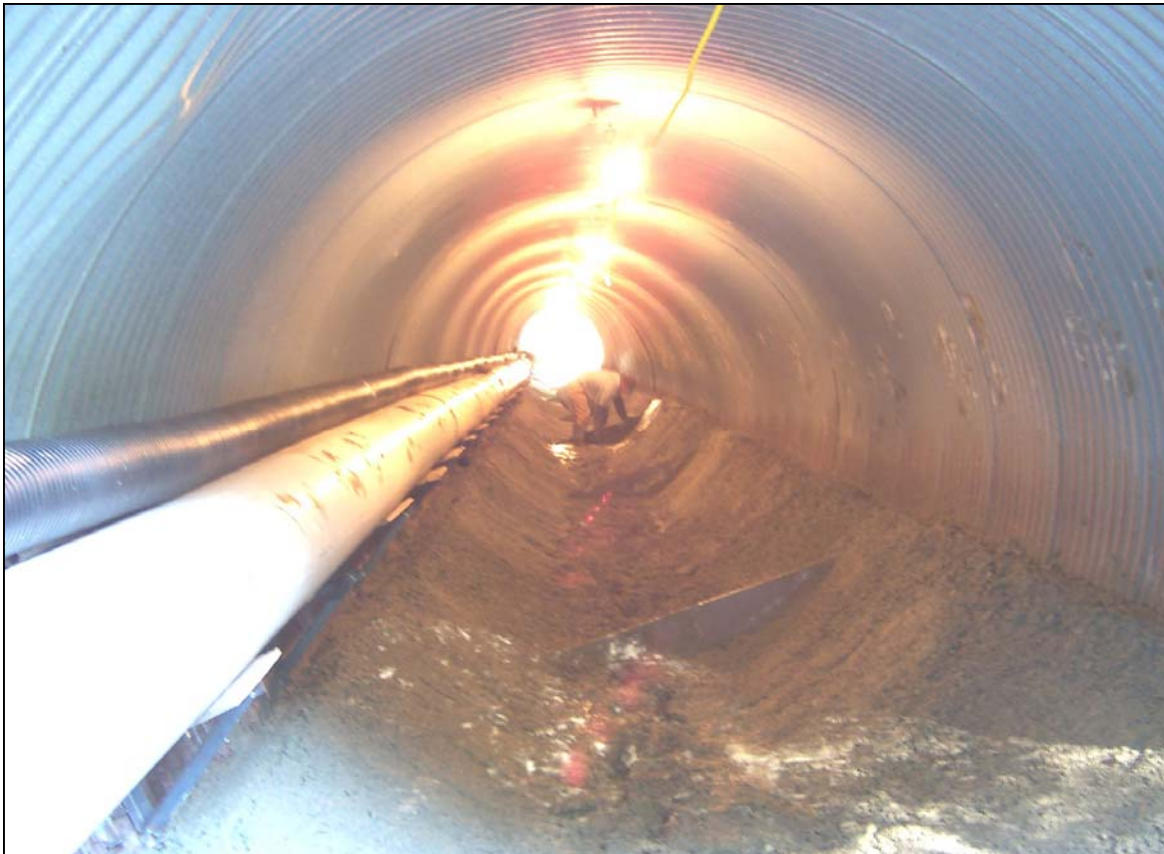
Upper Left: Low flows around and over a baffle after installation.

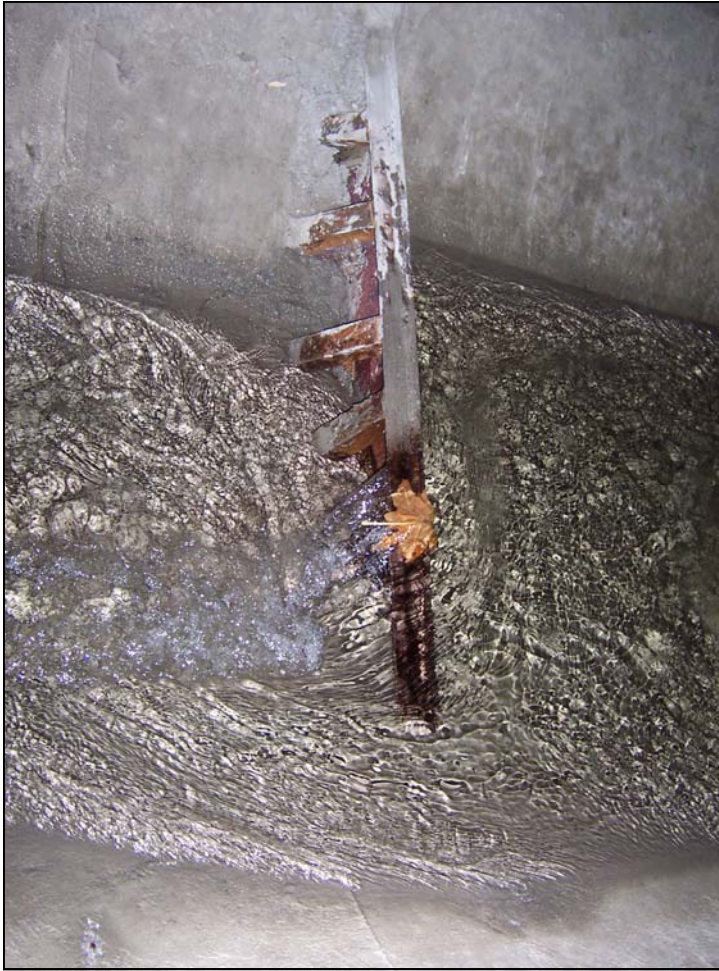
Lower Left: View of outlet after baffle installation and diversion removal. The outlet pool control will be restored to backwater the culvert inlet at lower flows.

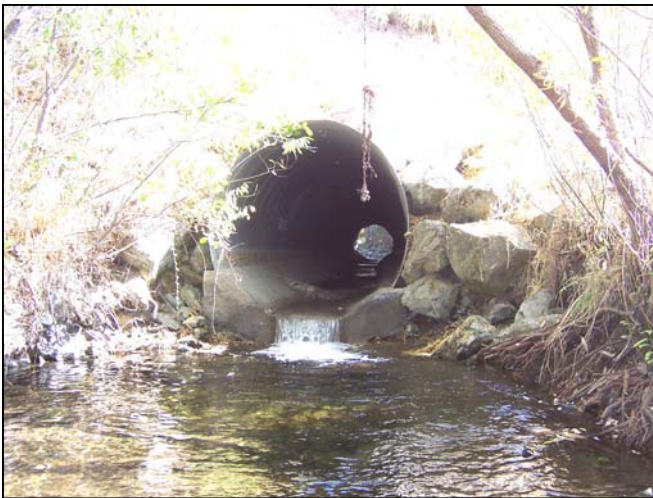
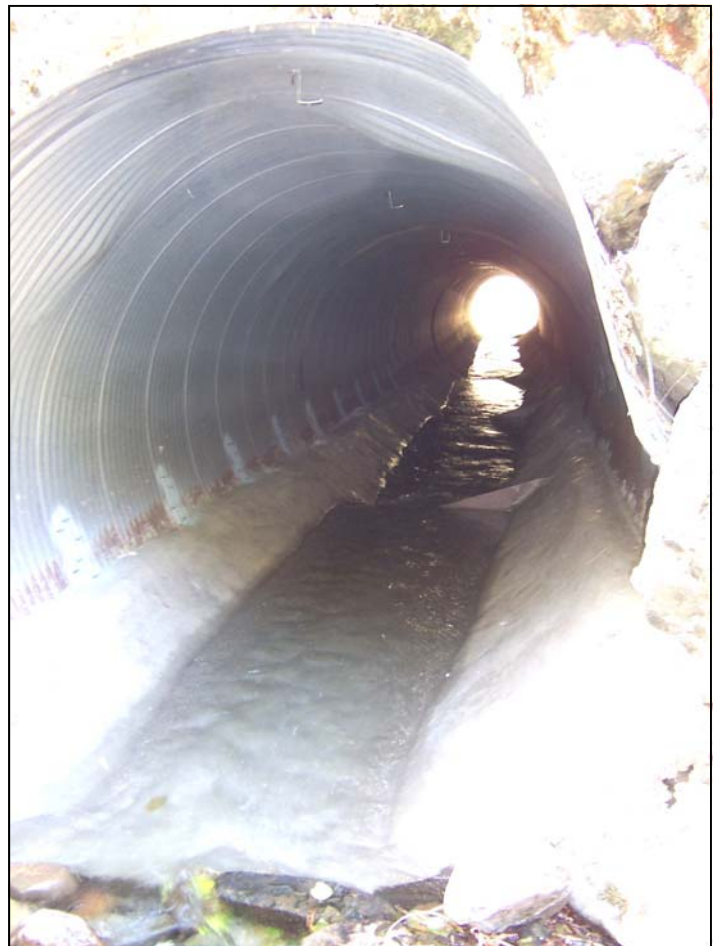
Lower Right: Looking downstream through culvert after baffle installation
