**Little Browns Creek Migration Barrier Removal Project
Five Counties Salmonid Conservation Program
Roundy Road—Trinity County**

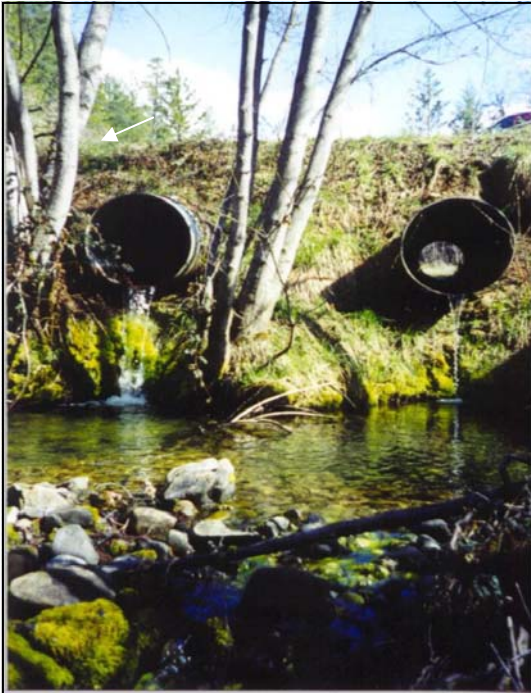
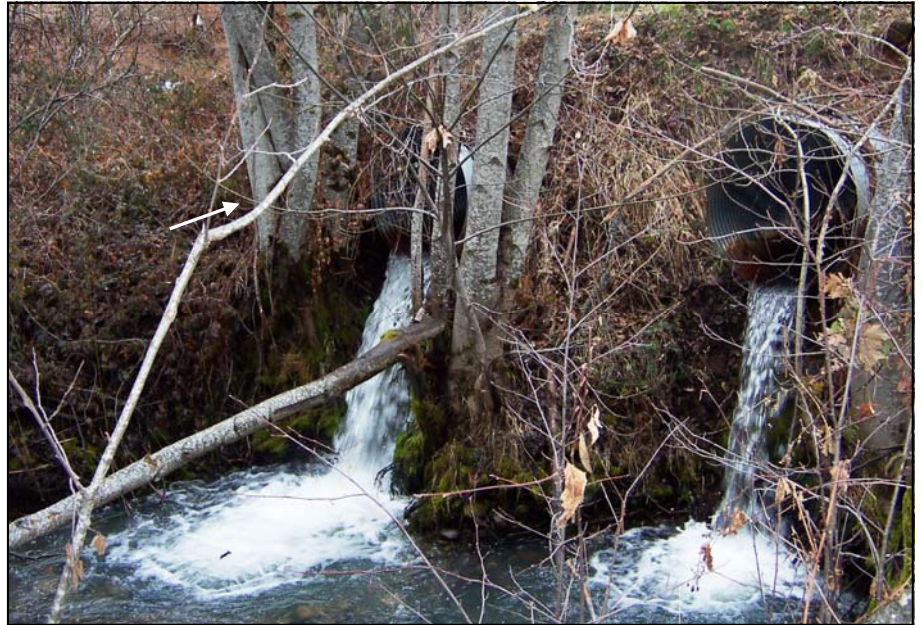
Top Left: Outlet of 2 of the 3, 48" x 50' long culverts at Roundy Road in 2000

Top Right: Outlets in February 2007

*Note cottonwood tree at left with arrows

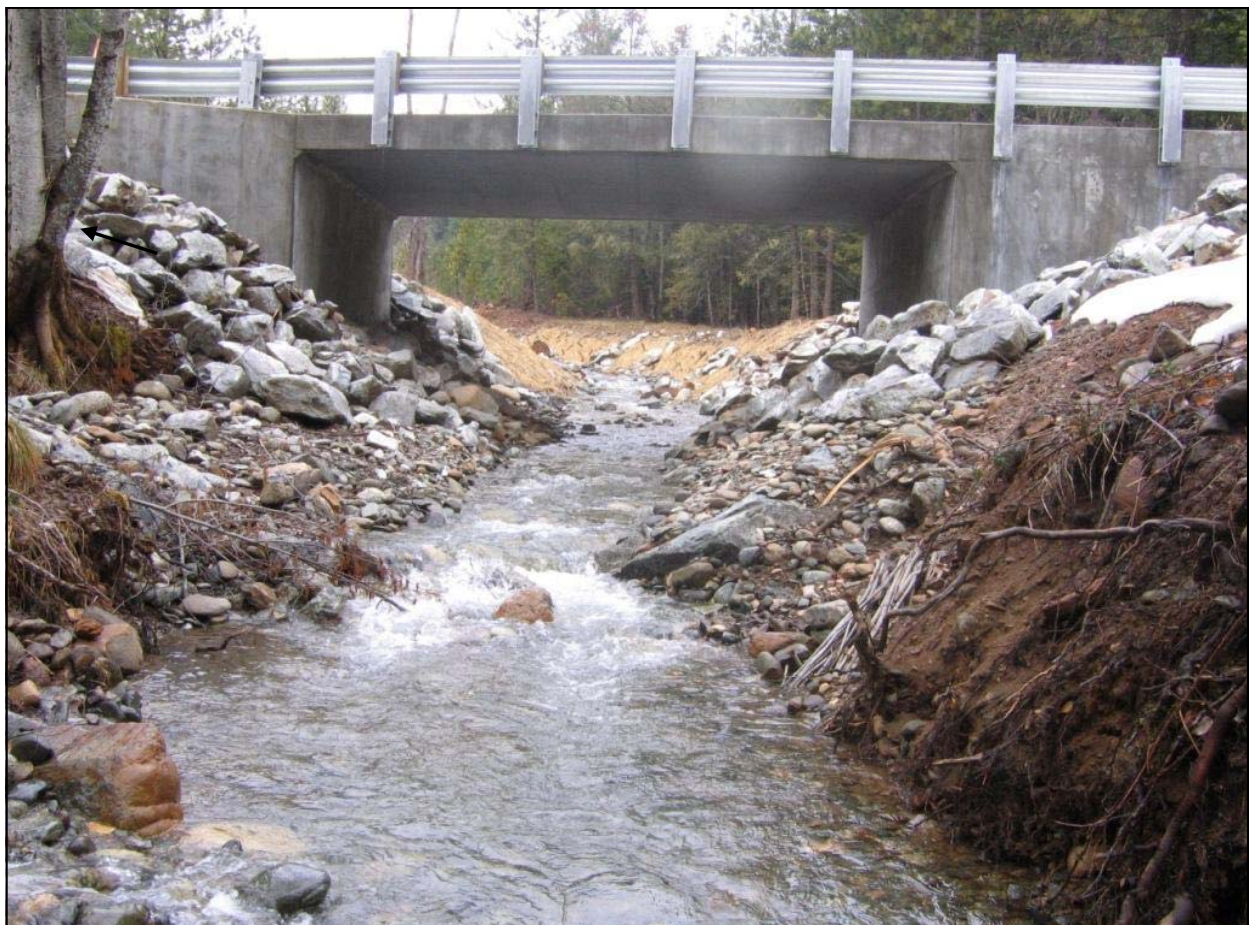
Bottom: View upstream to constructed bridge—March 2008*

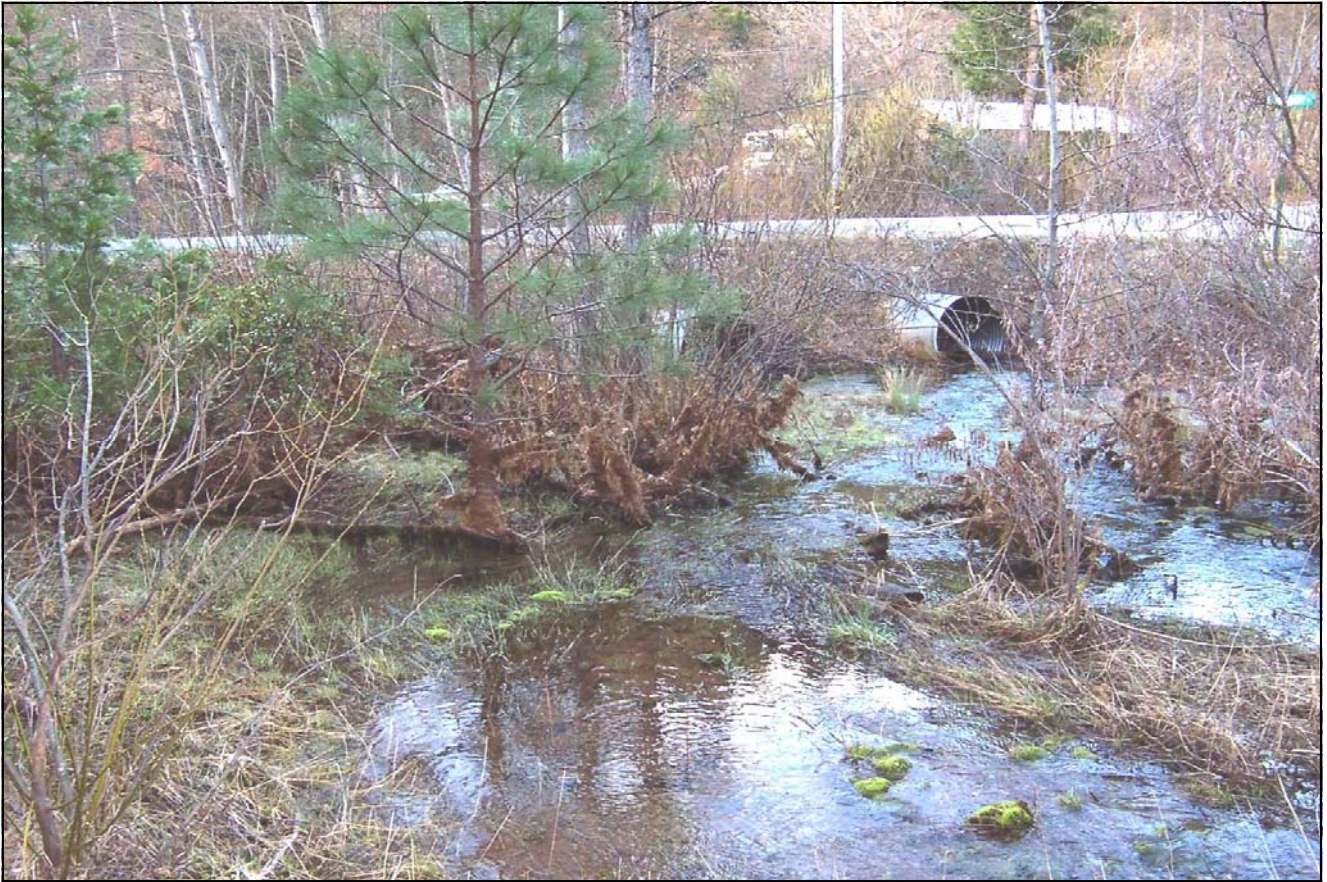
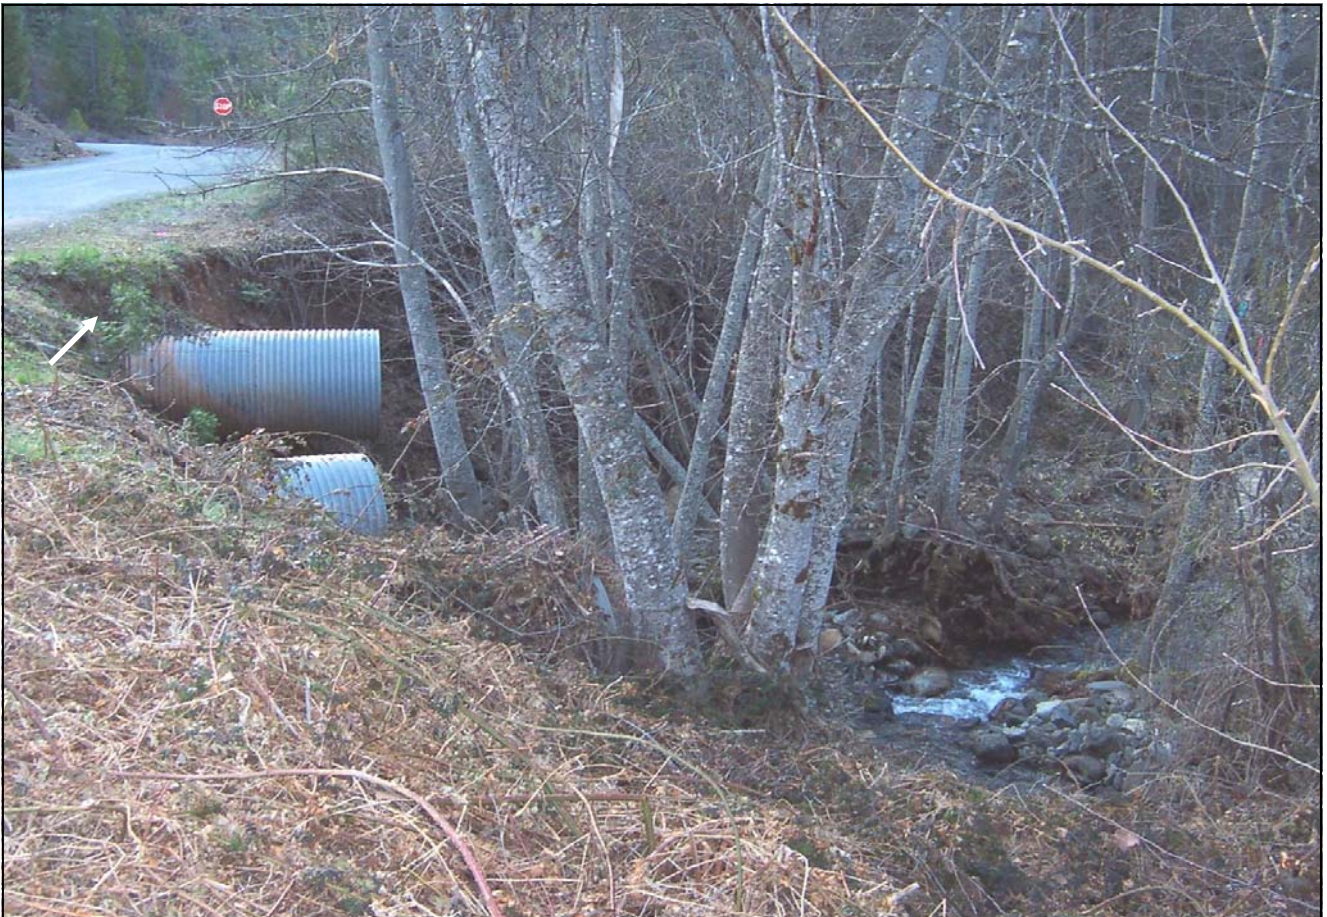
Pre-Project Conditions

Top: Upstream of the 3, 48" Culverts ~1,400 cyds of Aggraded Sediment Resulted in a Flat, Widened Stream Channel Condition for ~200 Feet
Bottom: View of the 3 Perched Outlets & Progressing Outboard Fill Failure

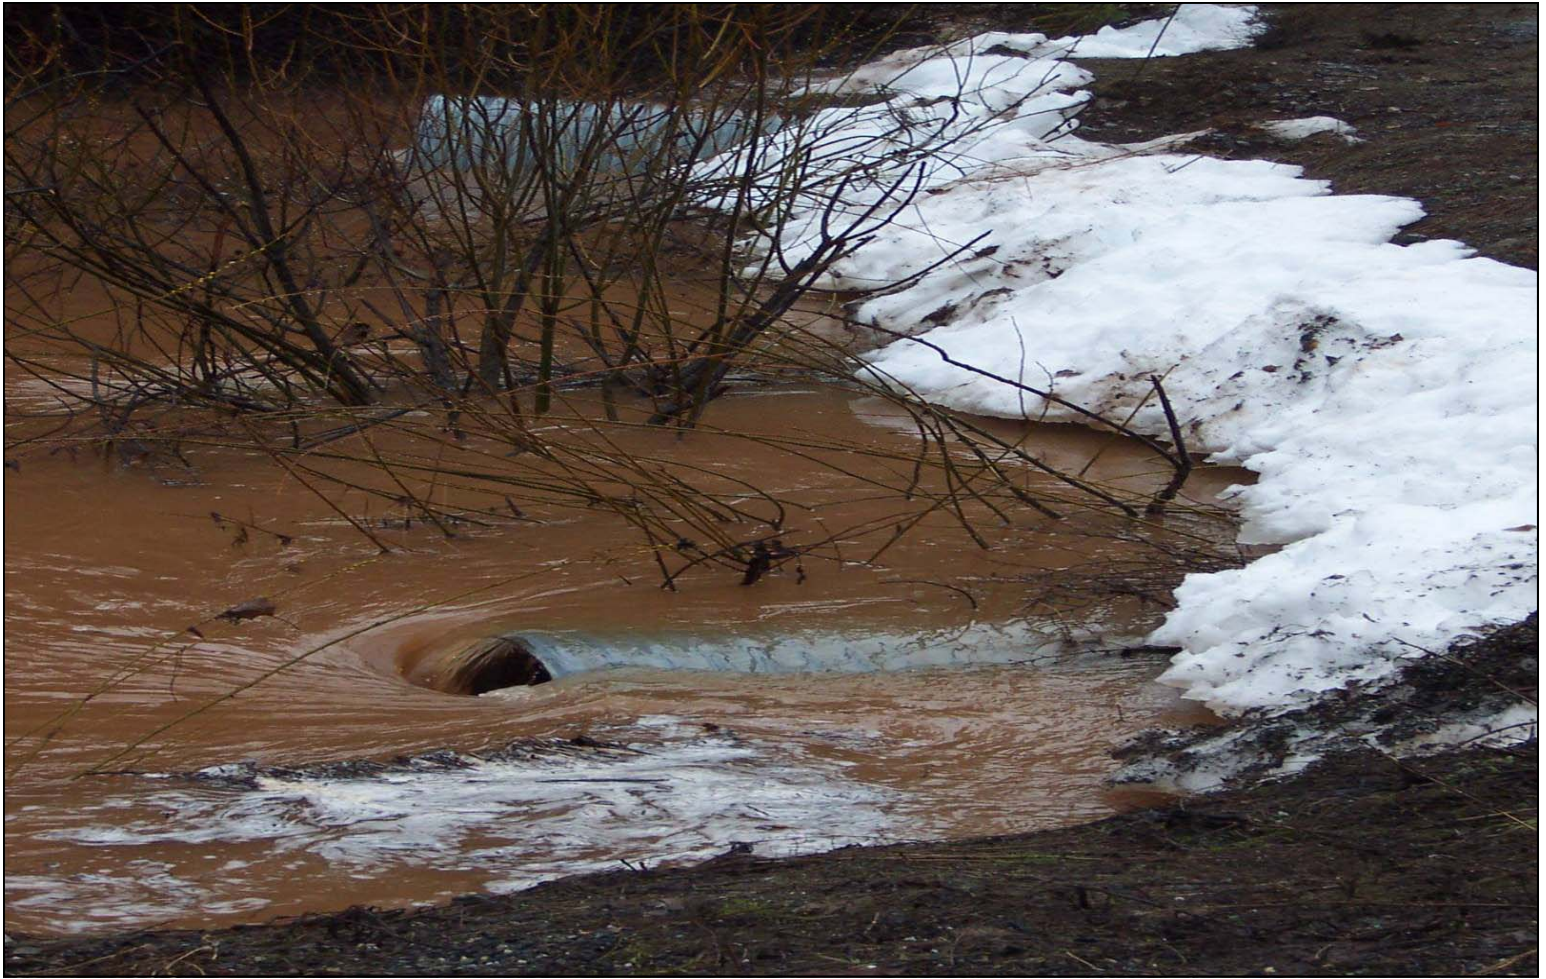
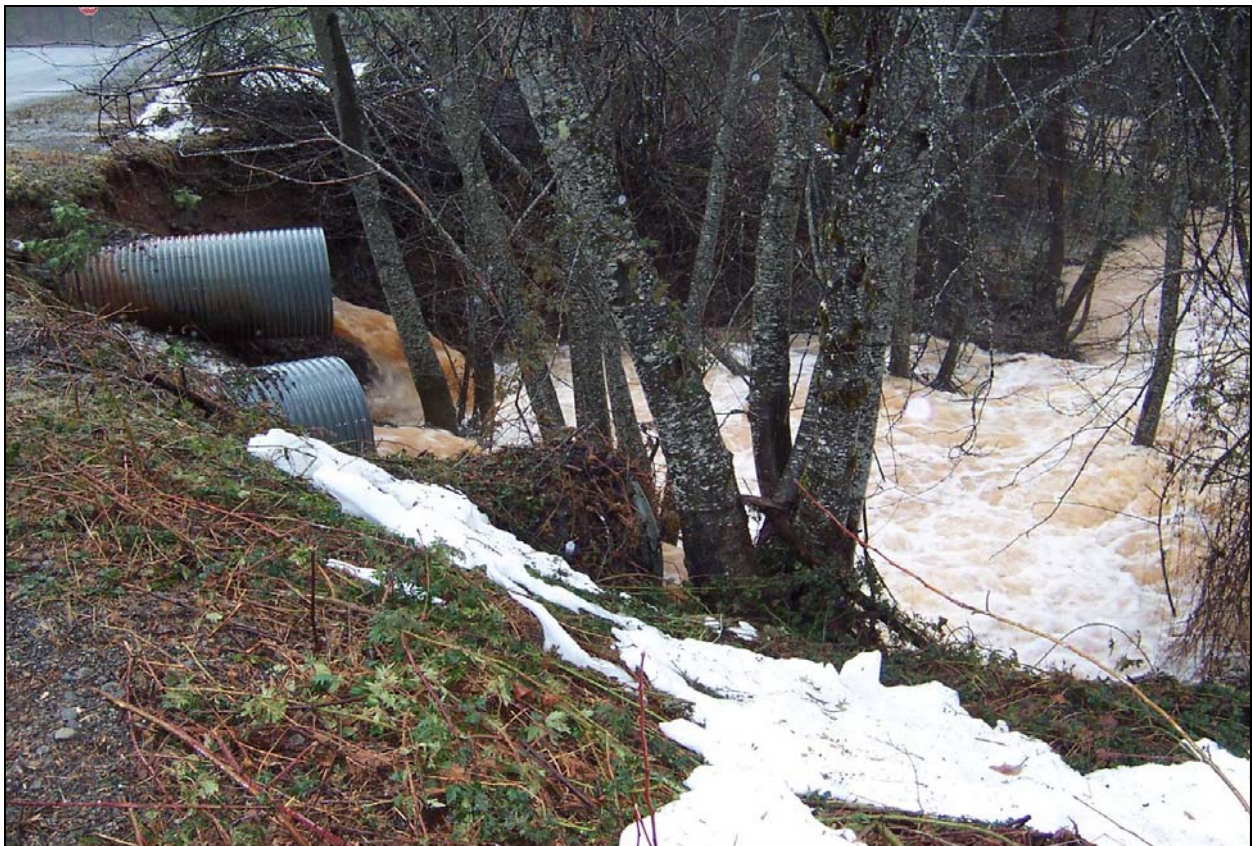
Pre-Project Conditions

Top: Inlet During High Flow with Submergence & Flooding of Upstream Channel
Bottom: Outlet During High Flows

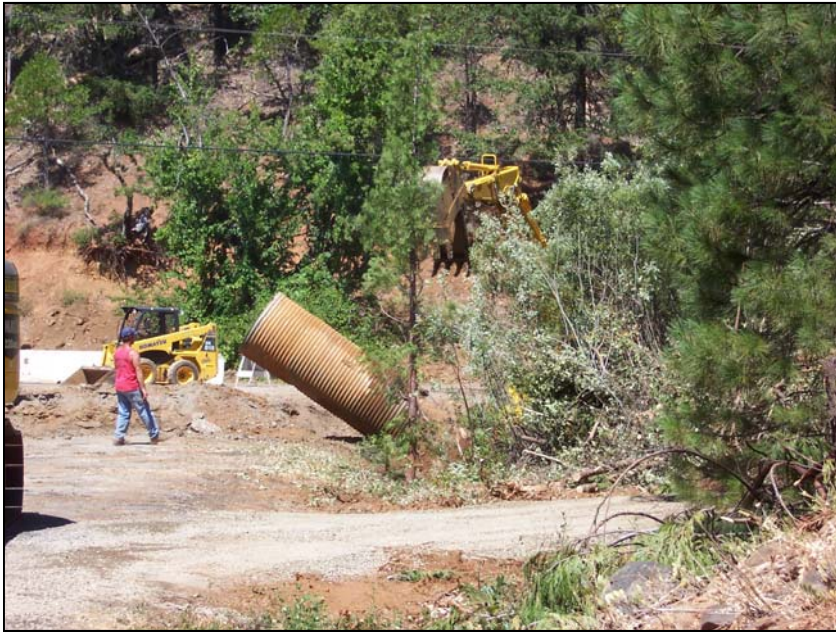
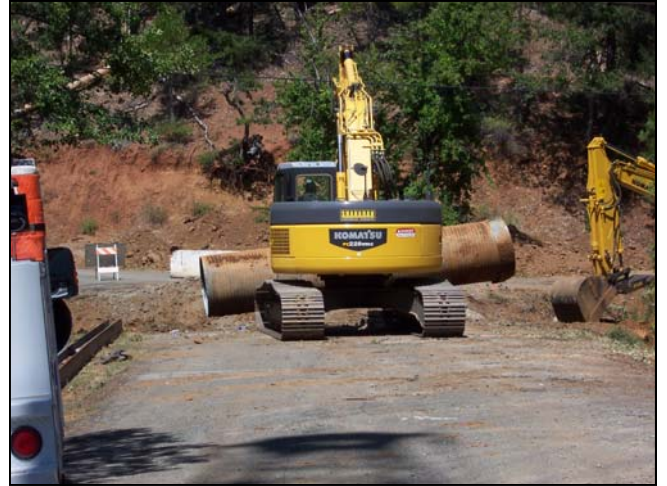
Top: Excavating the 3, 48” Culverts from Roundy Road

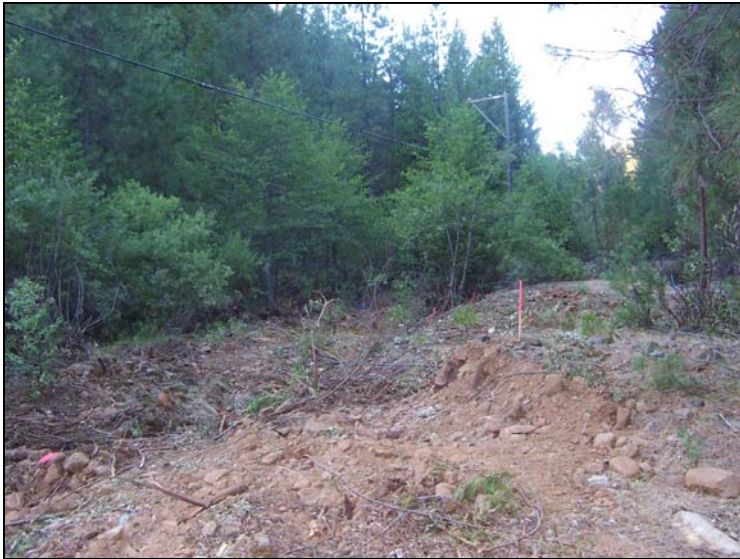
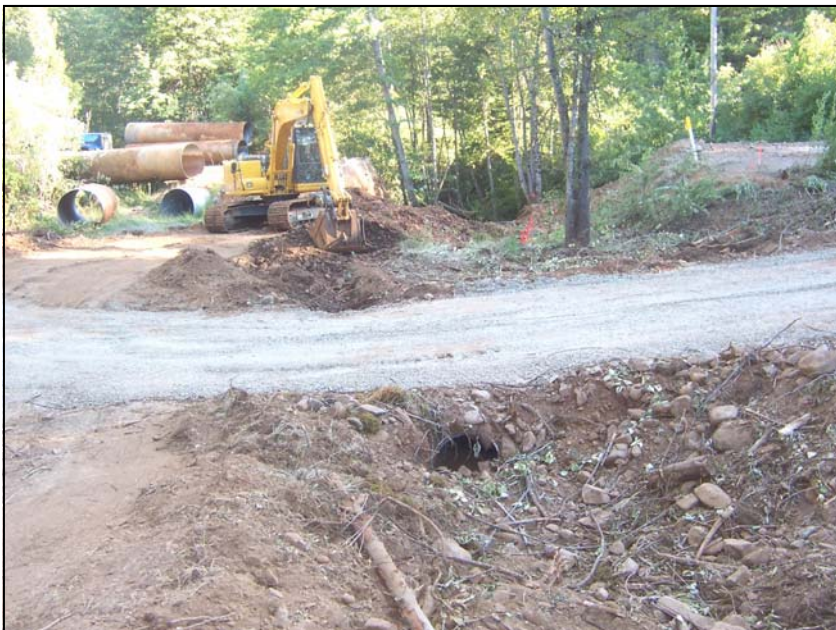
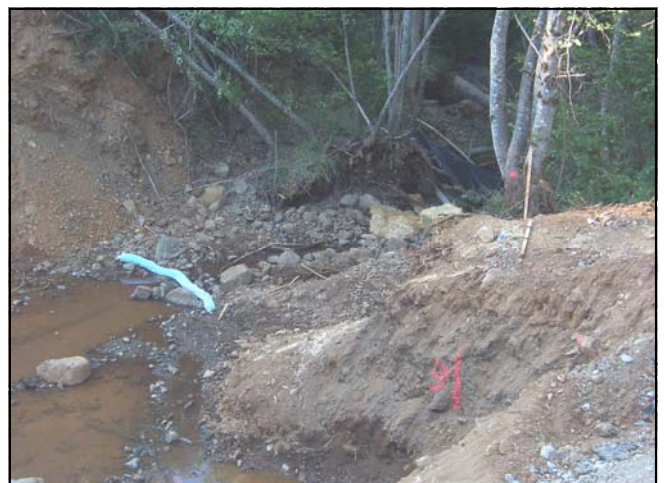
Left: Upstream Channel Vegetation Clearing for Detour & Roughened Channel Construction

Bottom Left: Detour Road Installed Upstream of Roundy Road

Bottom Right: Straw Bales, Silt Fence & Oil Absorbing Boom Installed below Project

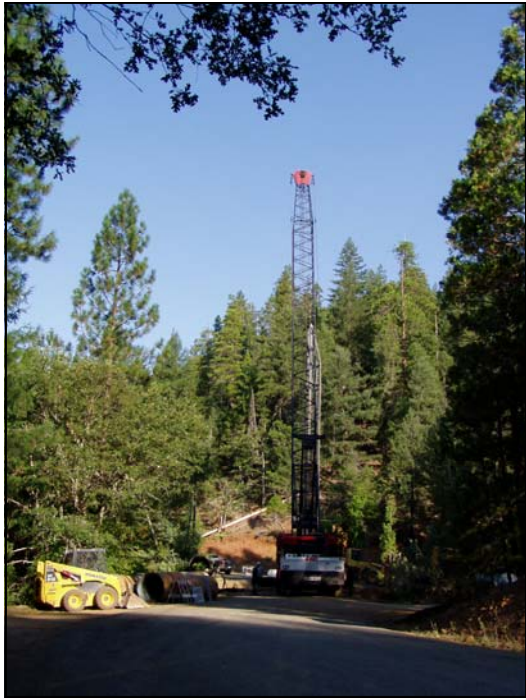
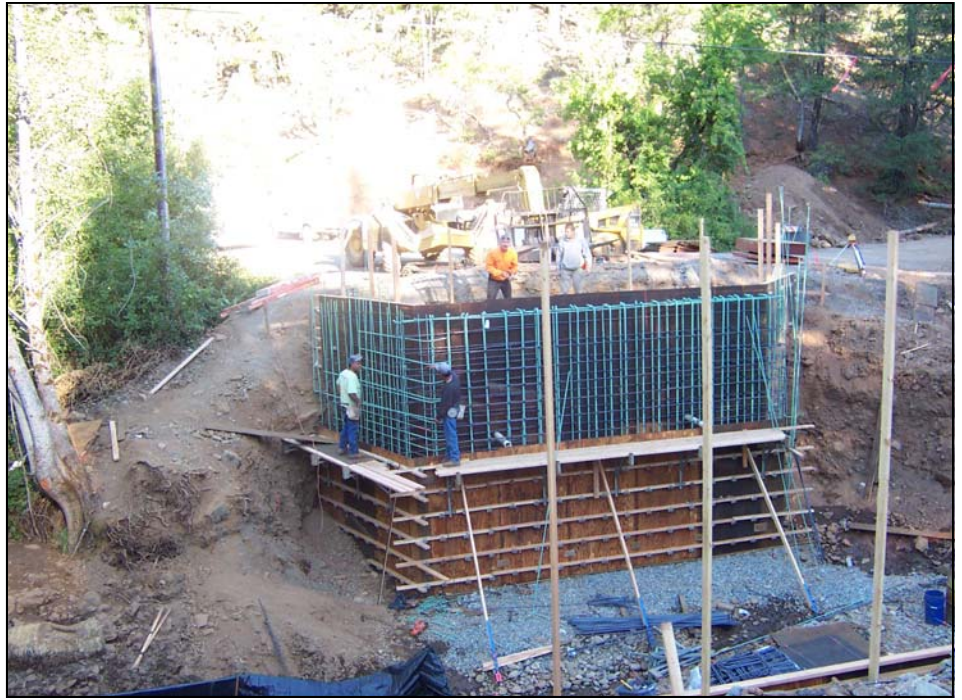
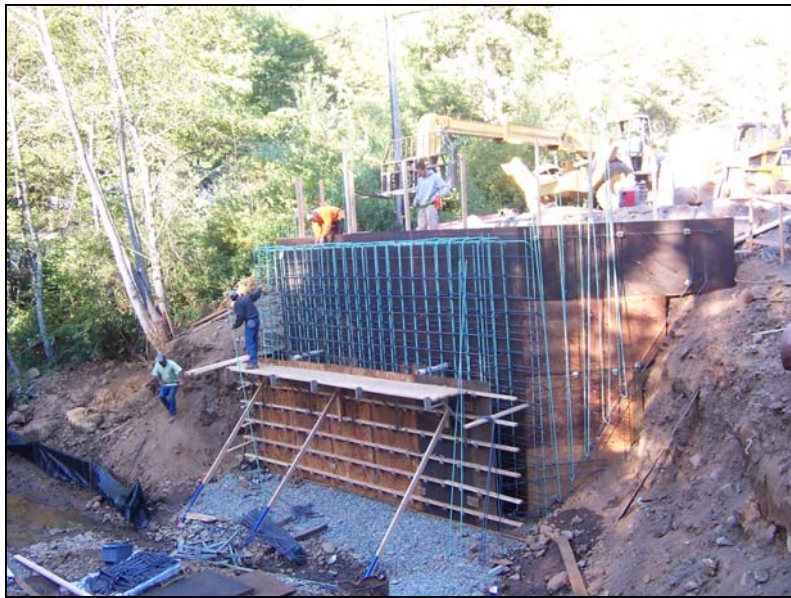
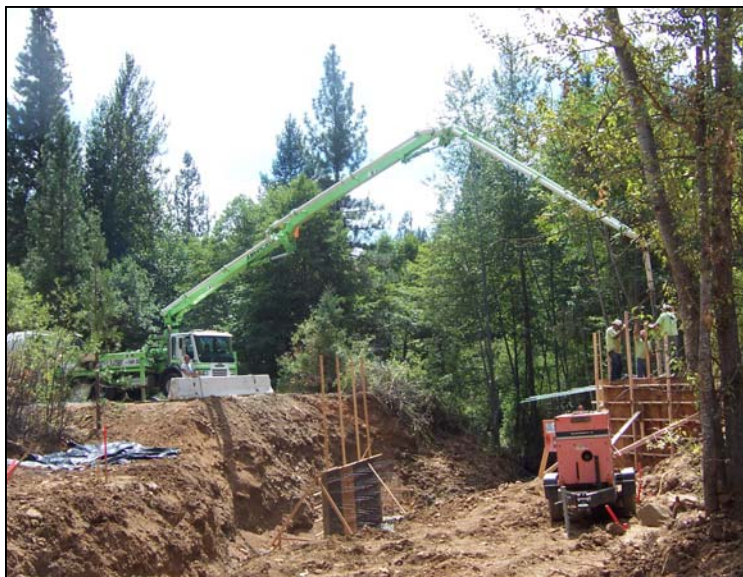
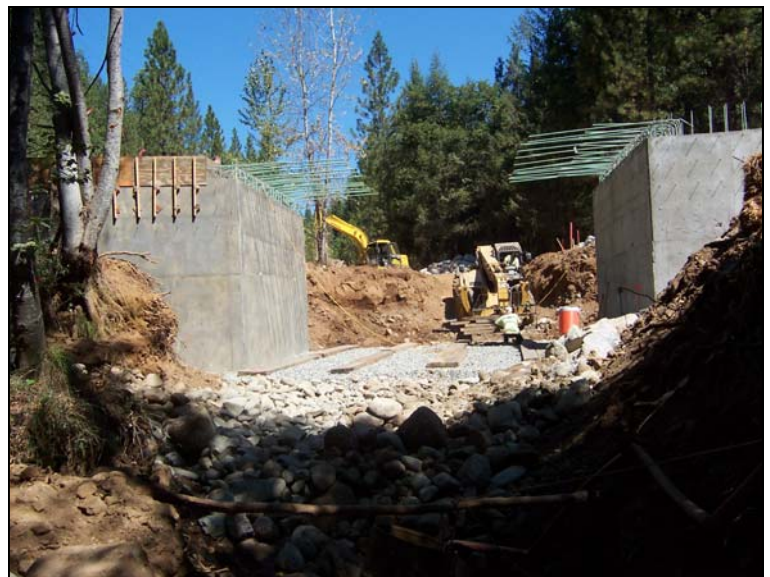
Top Left: Pile Driver for 8 Steel Piles that Comprise the Abutment Foundation (4 per Abutment)

Top Right & Middle Left: Forming the Left & Right Abutments

Bottom Left: Placing the Left & Right Abutments (concrete pours)

Bottom Right: Abutments Placed & Forms Removed

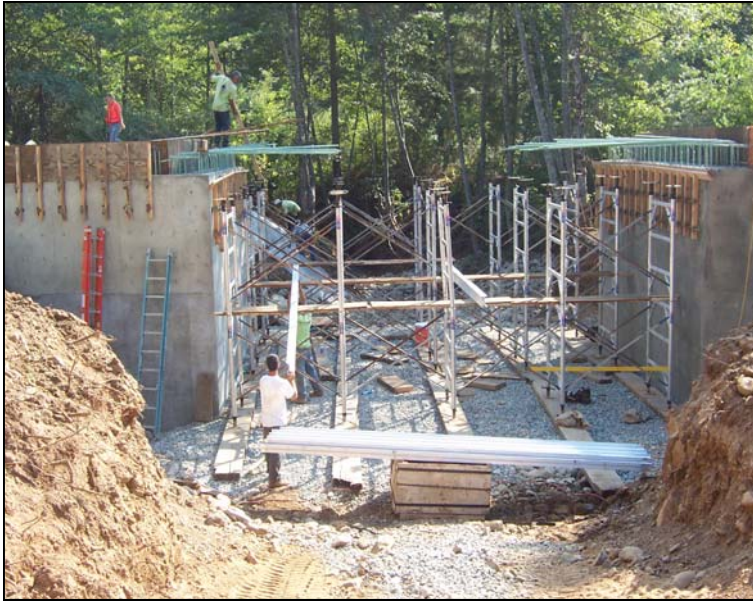
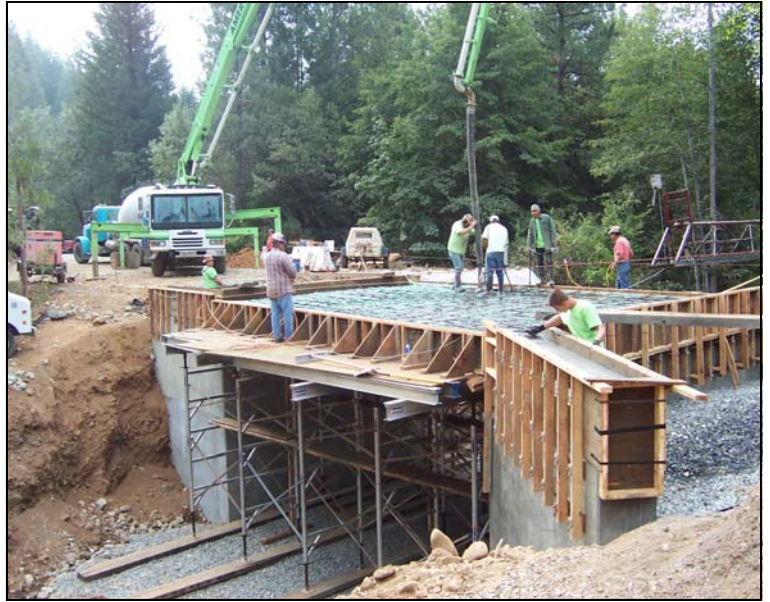
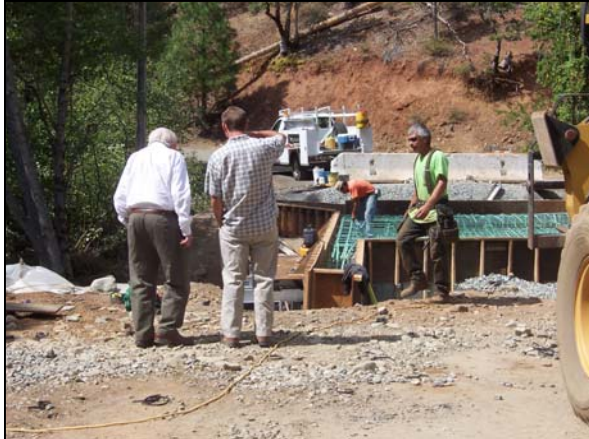
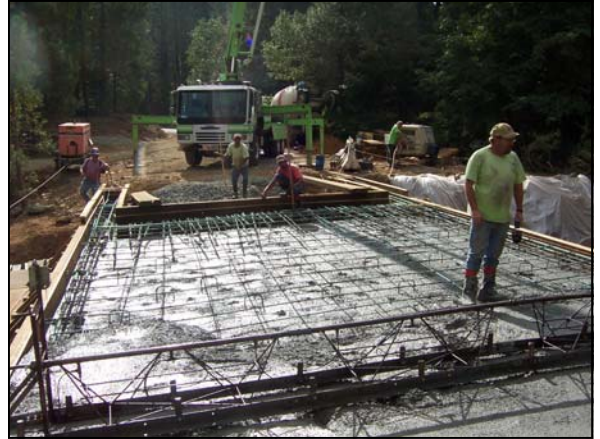
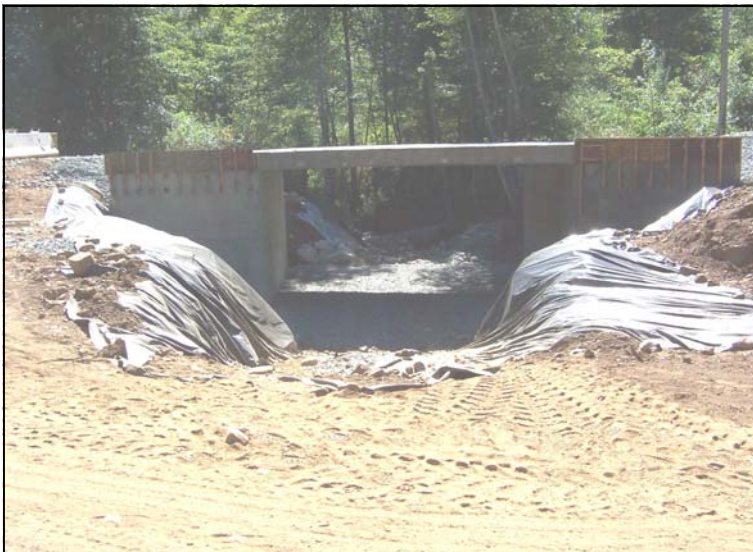
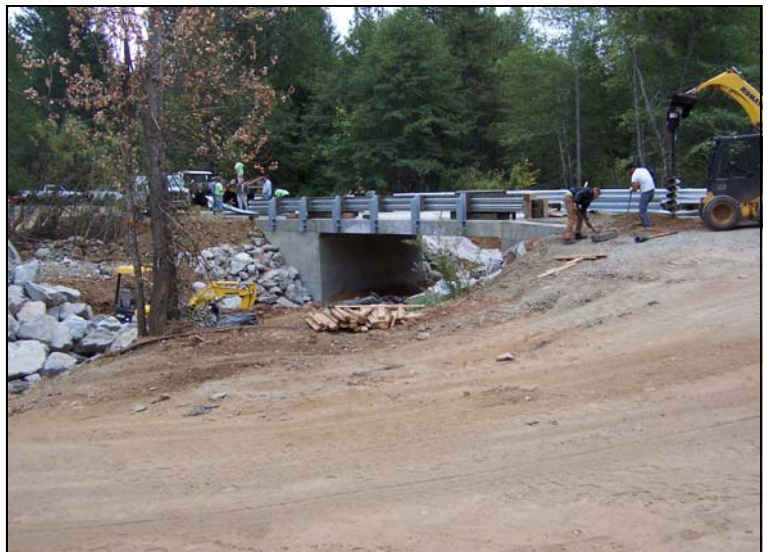
Top Left & Right: Bridge Deck Falsework Construction & Deck Framing/Placing

Middle Left & Right: On Site with Upstream Landowner & Bridge Deck Placed

Bottom Left & Right: View of Bridge from Upstream with Falsework Removed & Guardrail Installation

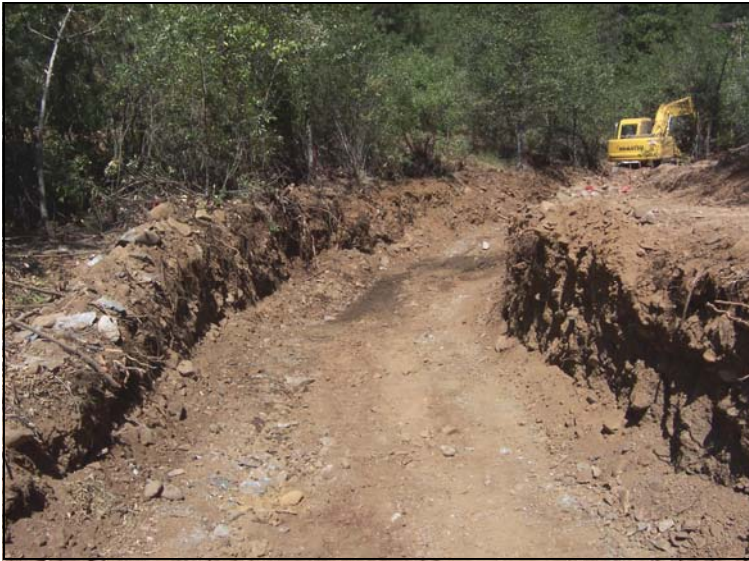
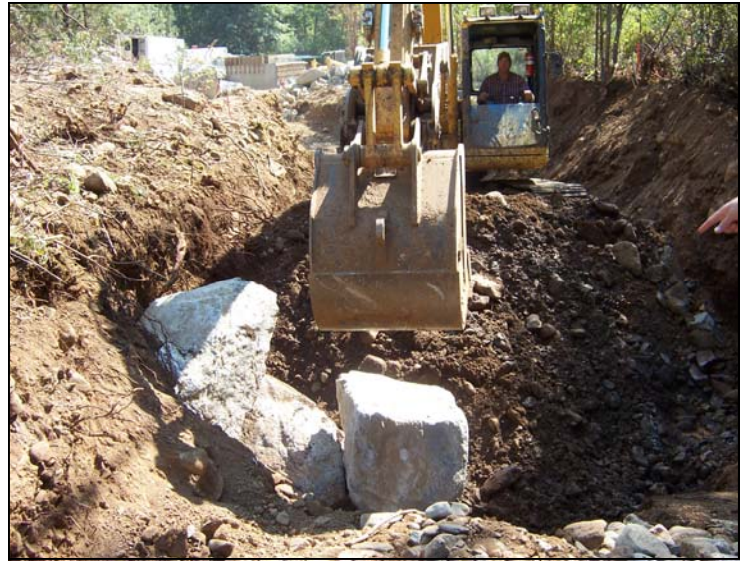
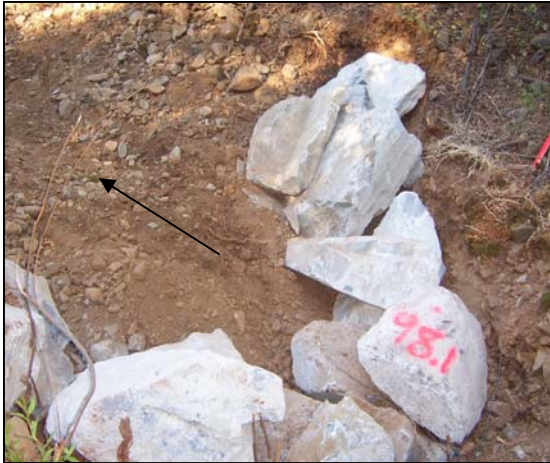
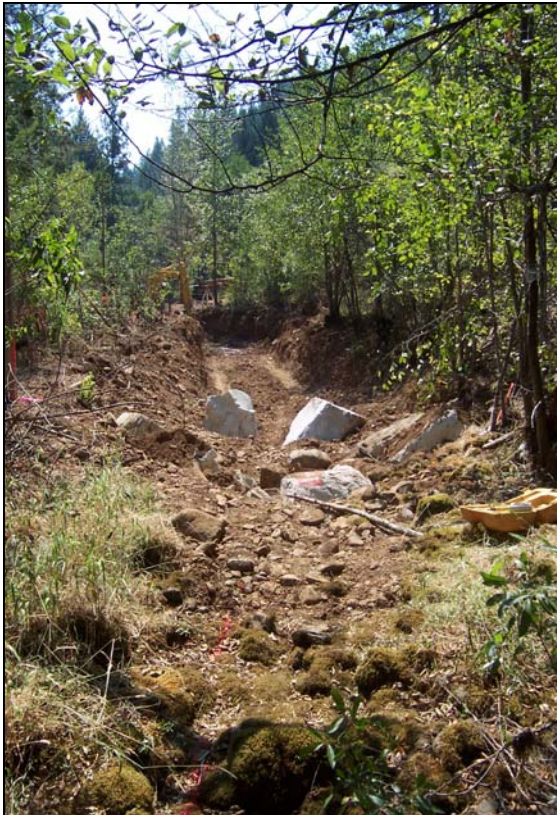
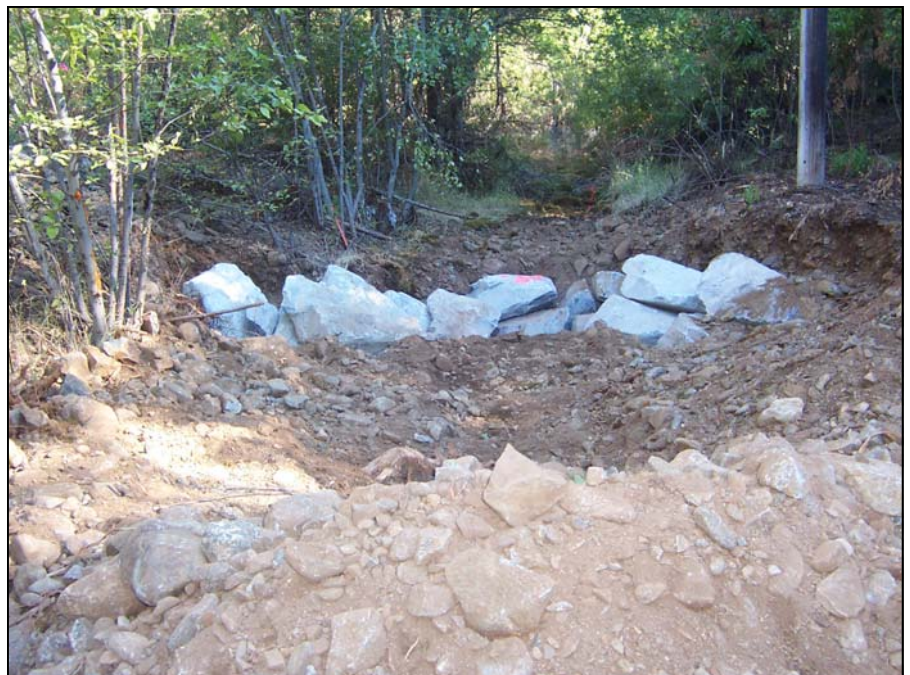
Top Left : 300' of Upstream Channel Excavated to 5% Grade—Banks to be Shaped as Channel is Constructed

Top Right: Installing the 2 Layers of 1.5 Ton Rock Ribbon at Station 13+00 (Top of Project—See Plans)

Left : 13+00 Ribbon Constructed with Inserted Arrow Pointing Downstream

Bottom Left & Right: Looking Downstream at Constriction Rocks Installed at 12+90 & Looking Upstream to 13+00 Ribbon

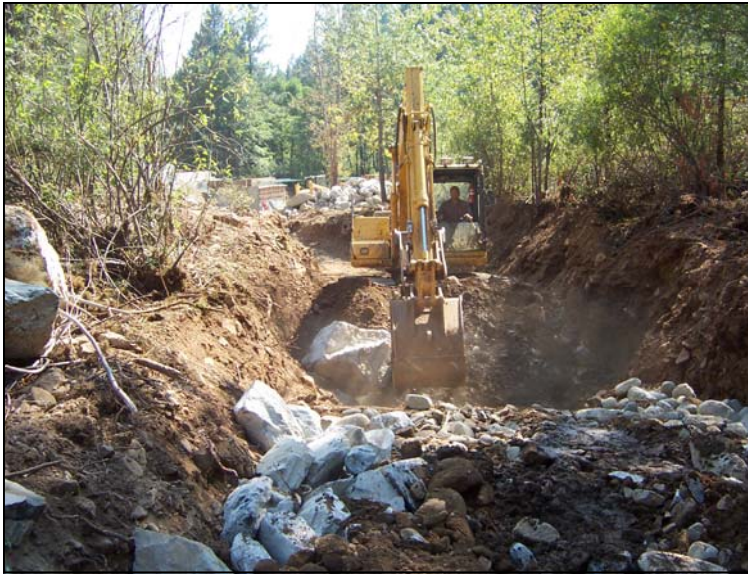
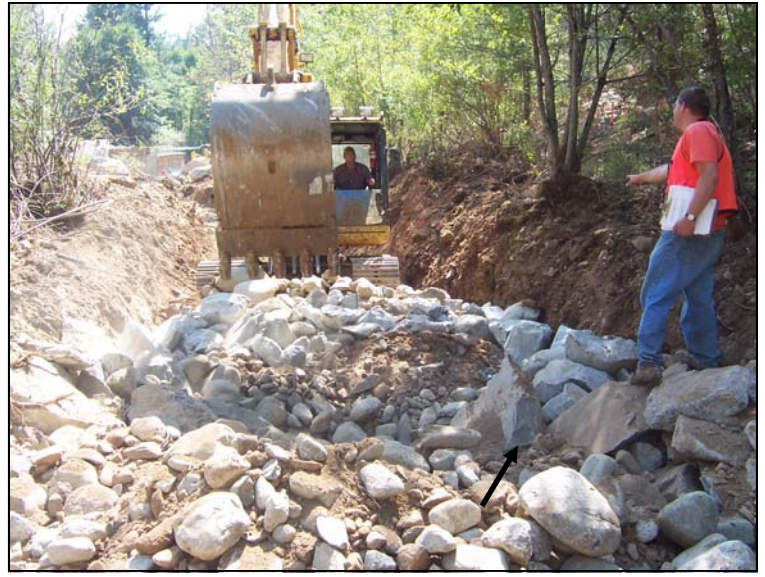
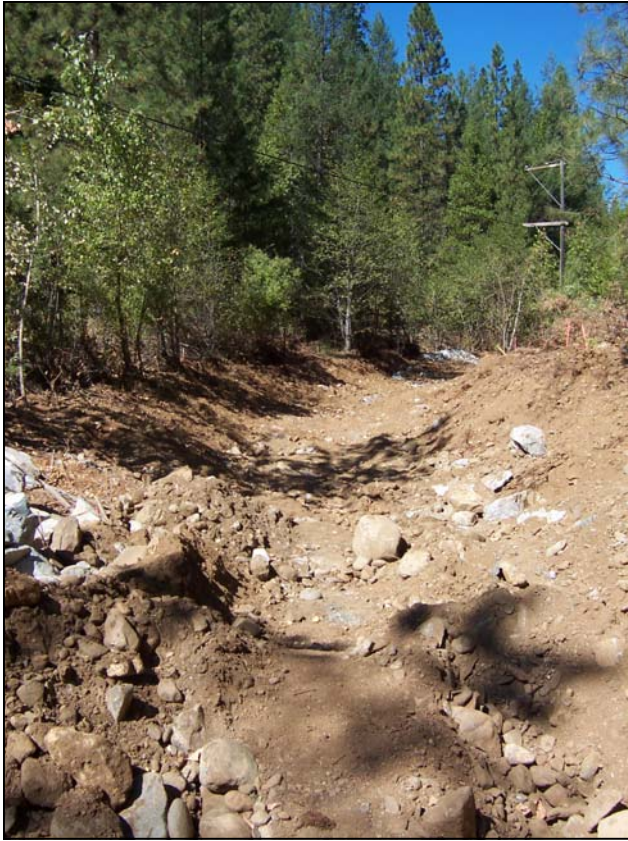
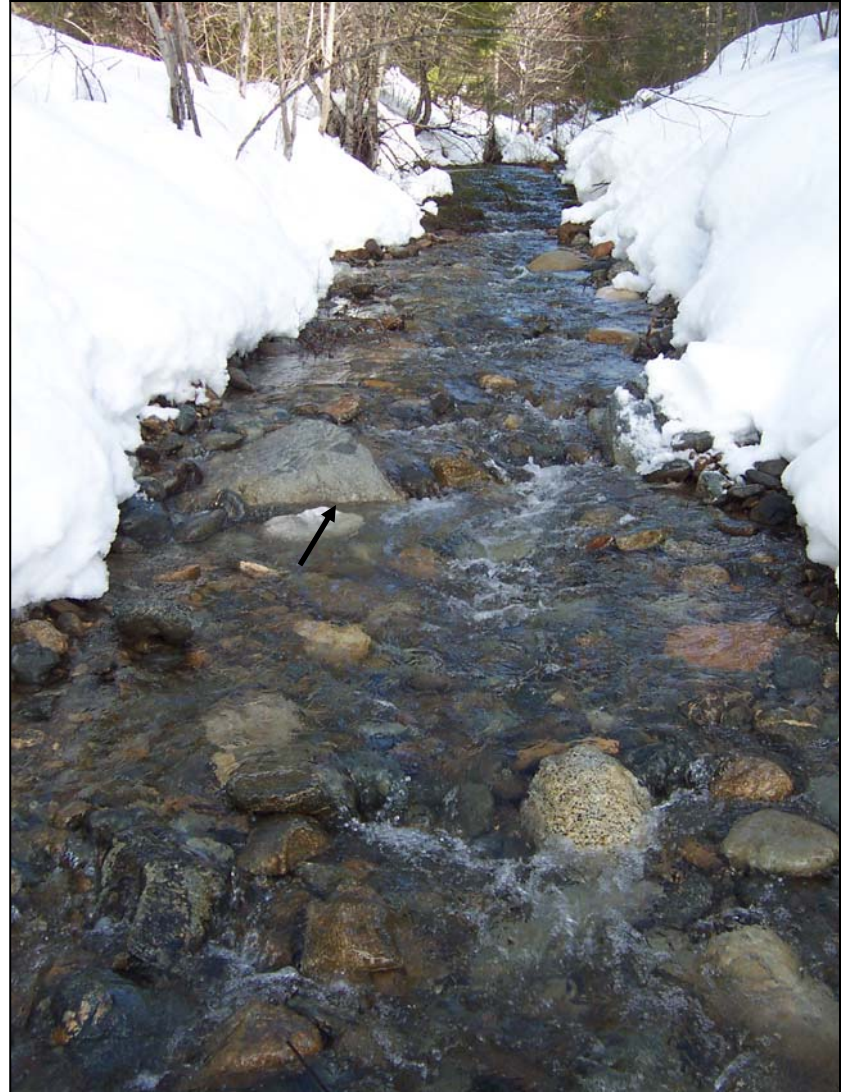
Top: Installing Engineered Streambed

Left : View upstream from Station 11+20 of Completed & Shaped Roughened Channel

Right: February 2008 Flows to Compare Constriction Rocks at 12+90 . The Top Right Photo is the View Downstream with the Constriction Rock Installed (arrow on rock). The Bottom Photo is the View Upstream of the Same Constriction Rock (arrow on rock).

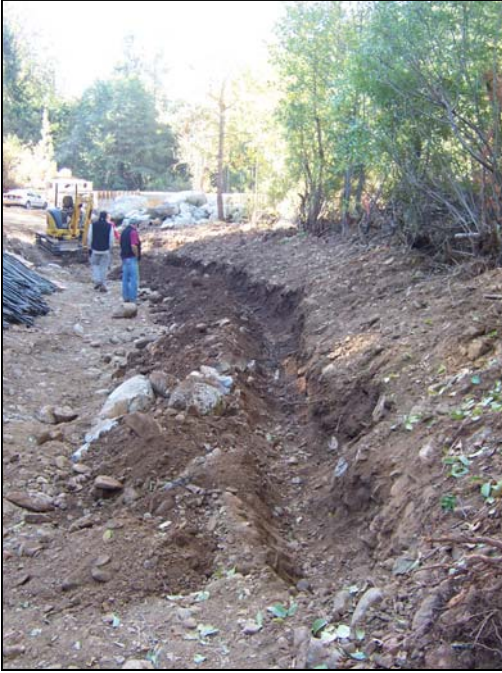
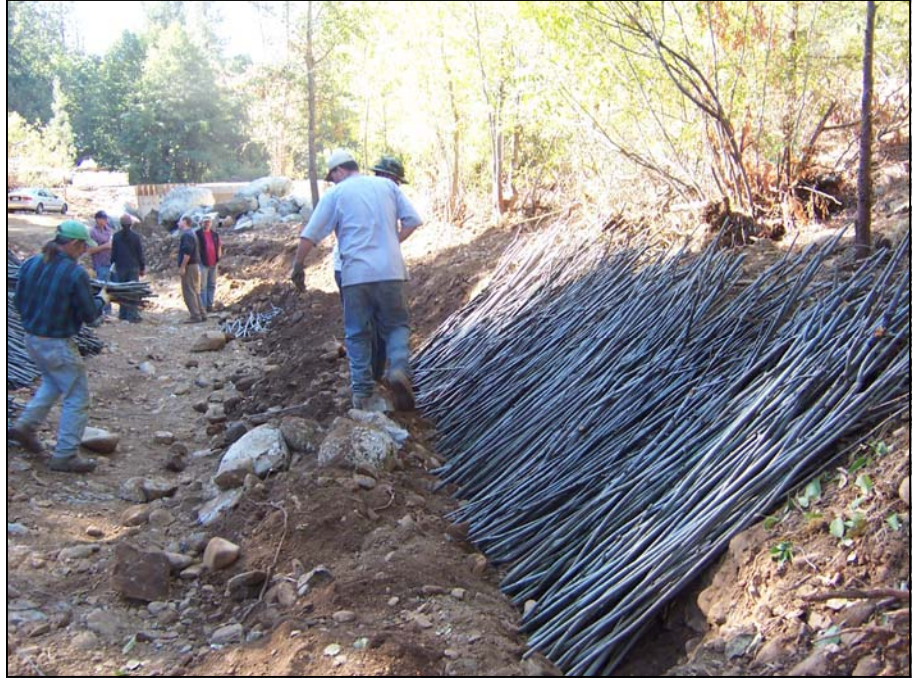
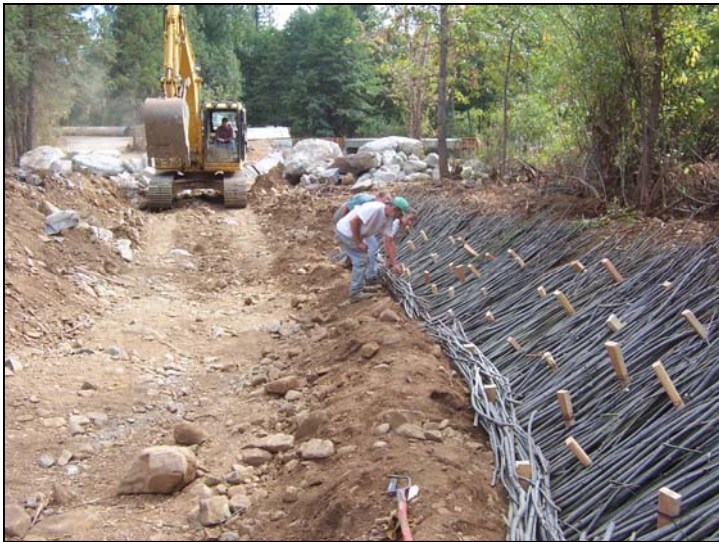
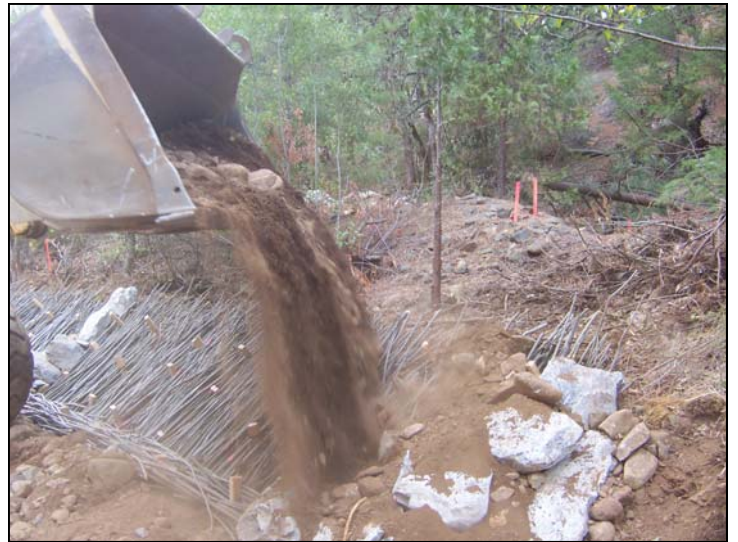
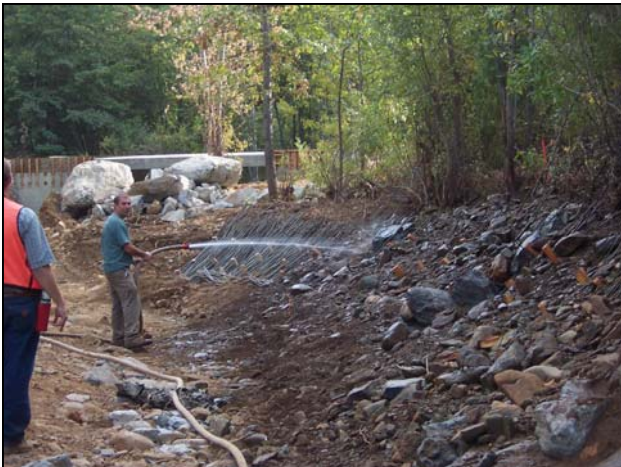
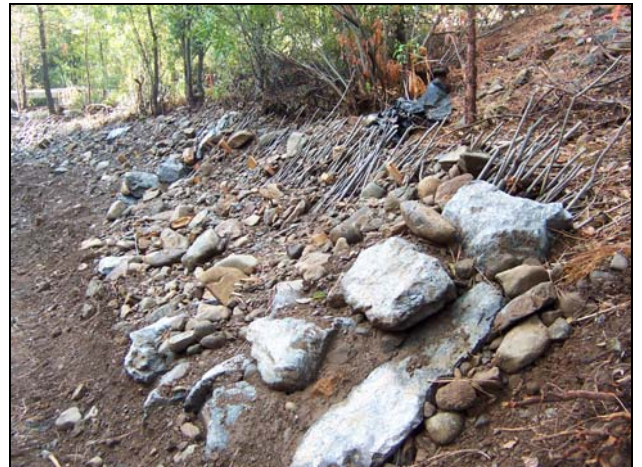
9-27-07: Upstream Bank Bioengineering Installed at Section 11+80 to 12+40
Photos Show Toe Trench Excavation, Willow Fascine & Brushmattress
Installation, Backfilling of Brushmattress, Watering & View Downstream After
Work Completed by Trinity County RCD & 5C staff
