**Little Browns Creek Migration Barrier Removal Project
Five Counties Salmonid Conservation Program
Roundy Road—Trinity County**

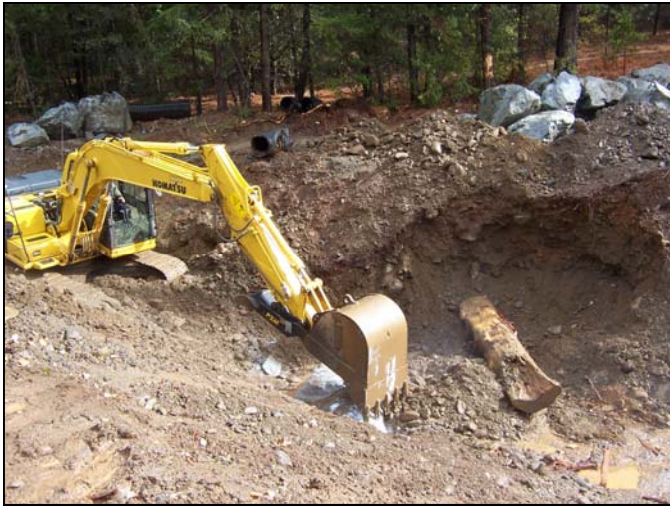
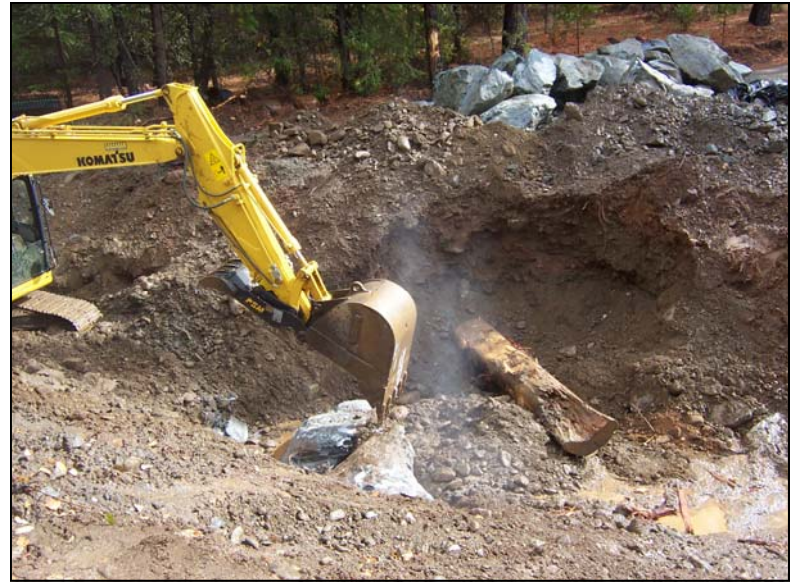
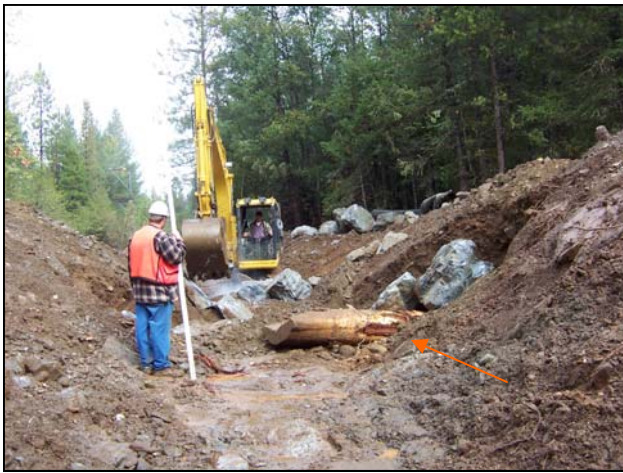
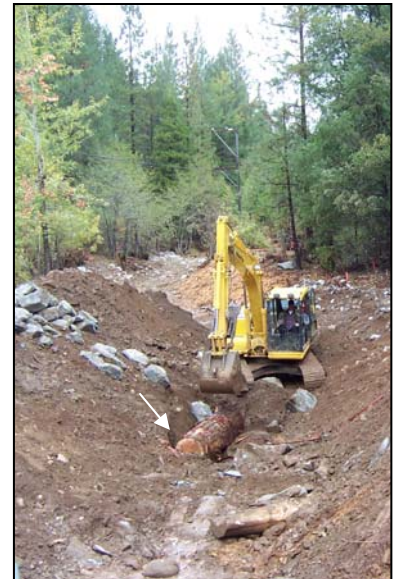
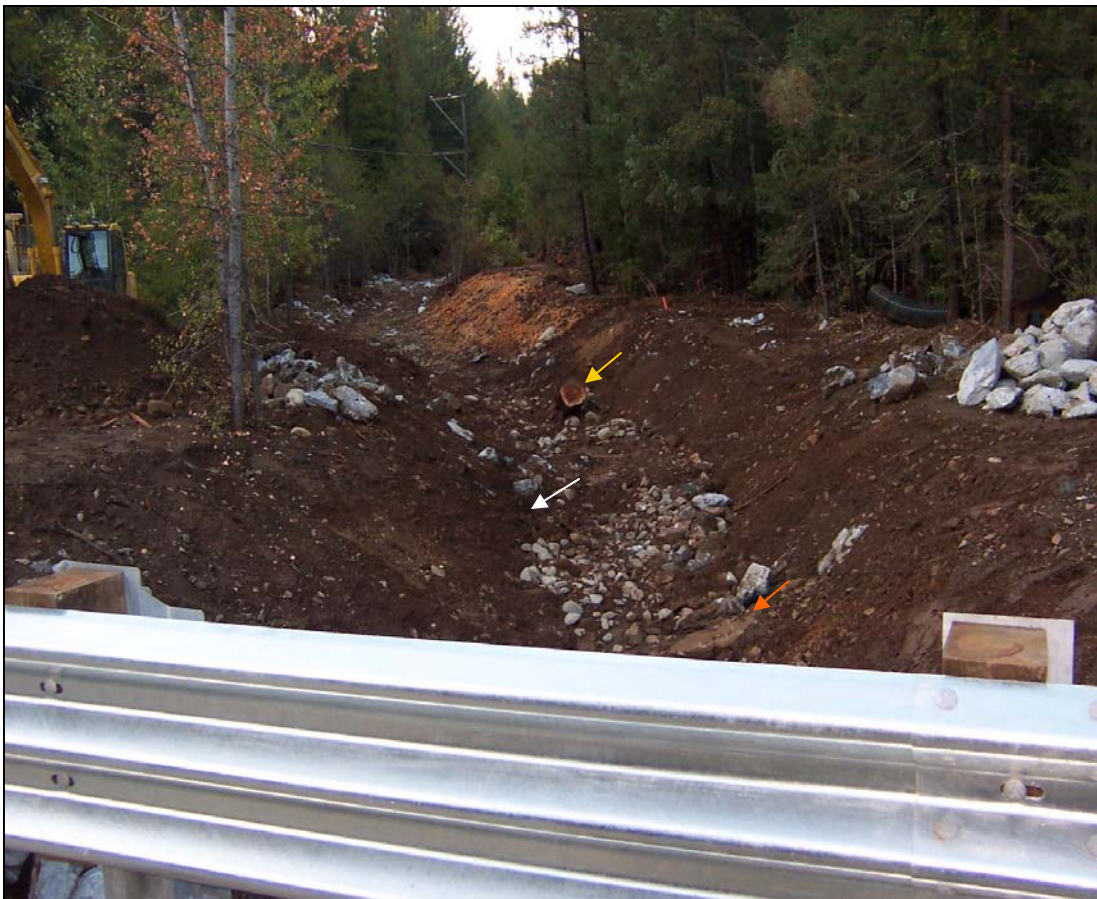
10-12-07:
Three sections of
Incense cedar,
Measuring ~ 36"
diameter & 12-feet
long were Installed
Upstream of the
Bridge between
Section 10+60 &
11+50 in place of 3
Constriction
Rocks—See Arrows

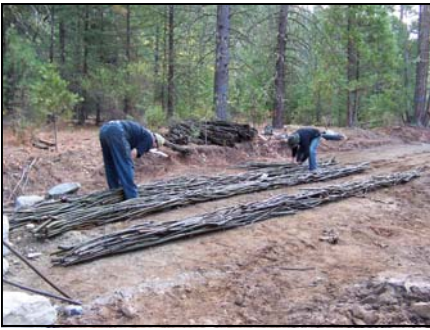
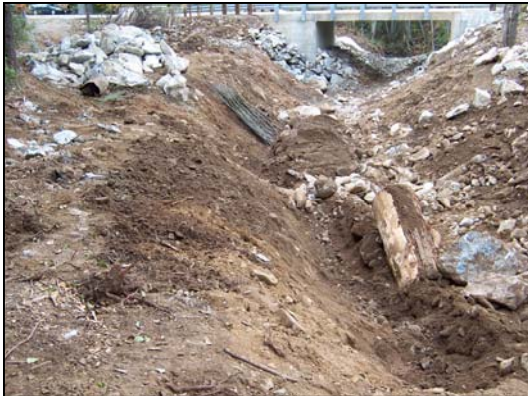
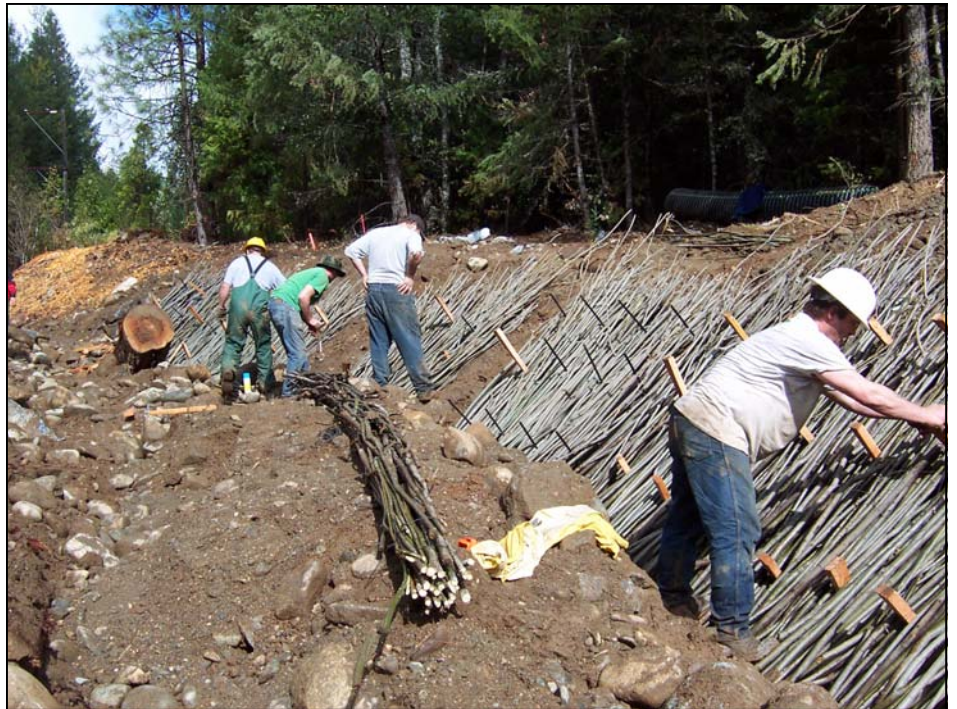
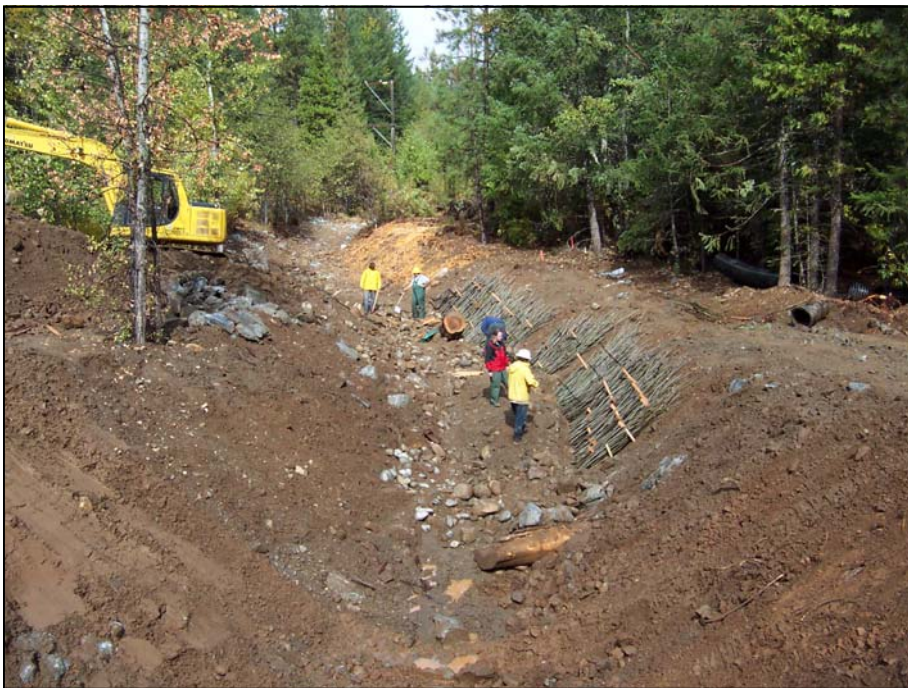
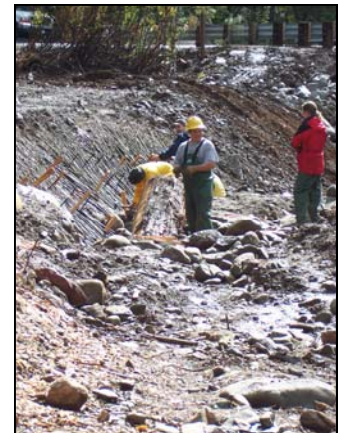
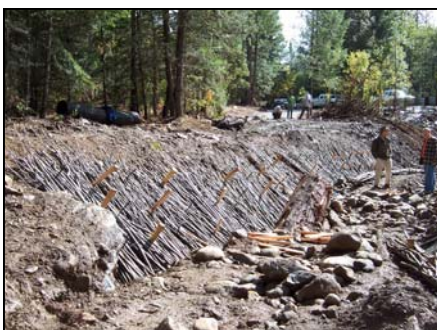
10-15-07: Upstream Bank
Bioengineering Installed at
Section 11+00 to 11+50

Willow Brushmattress &
Fascine Installation
Work Completed by Trinity
County RCD

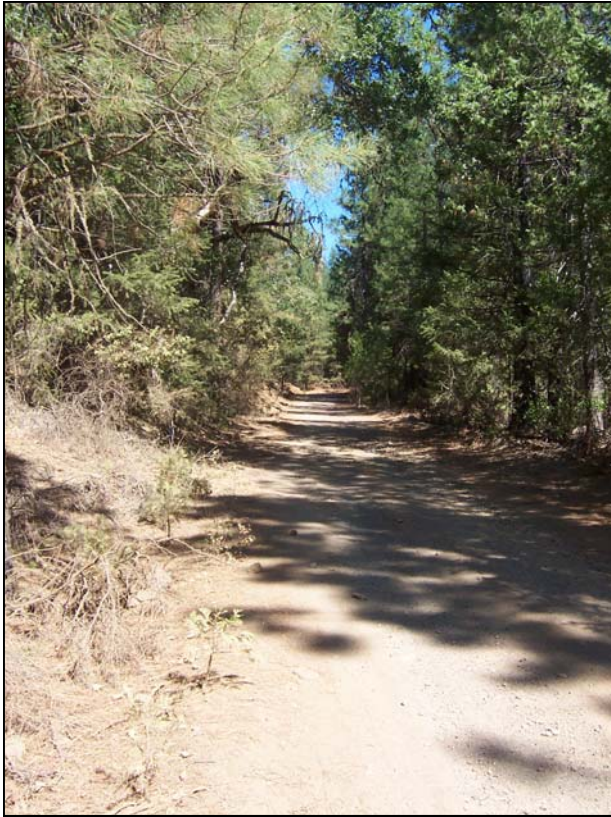
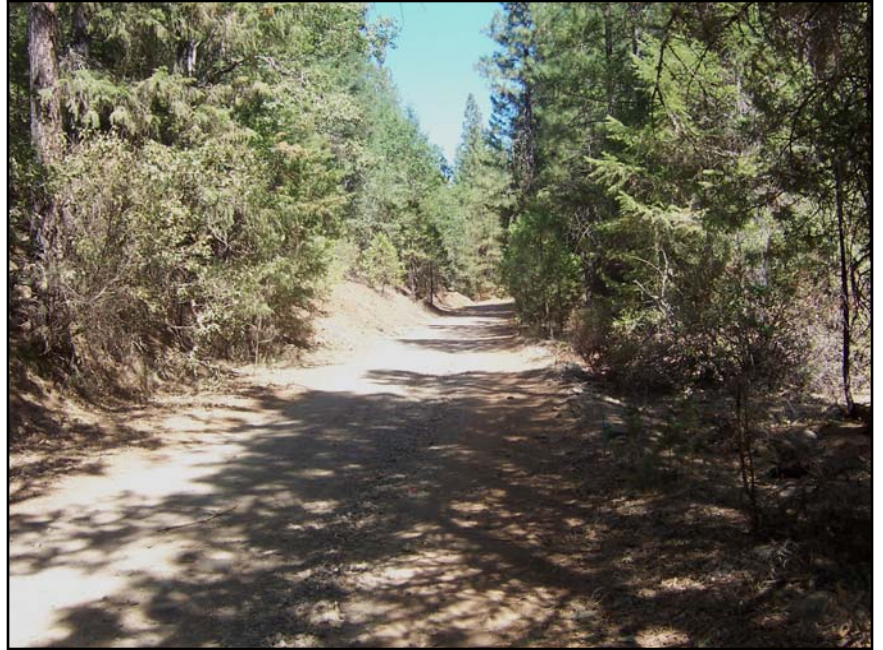
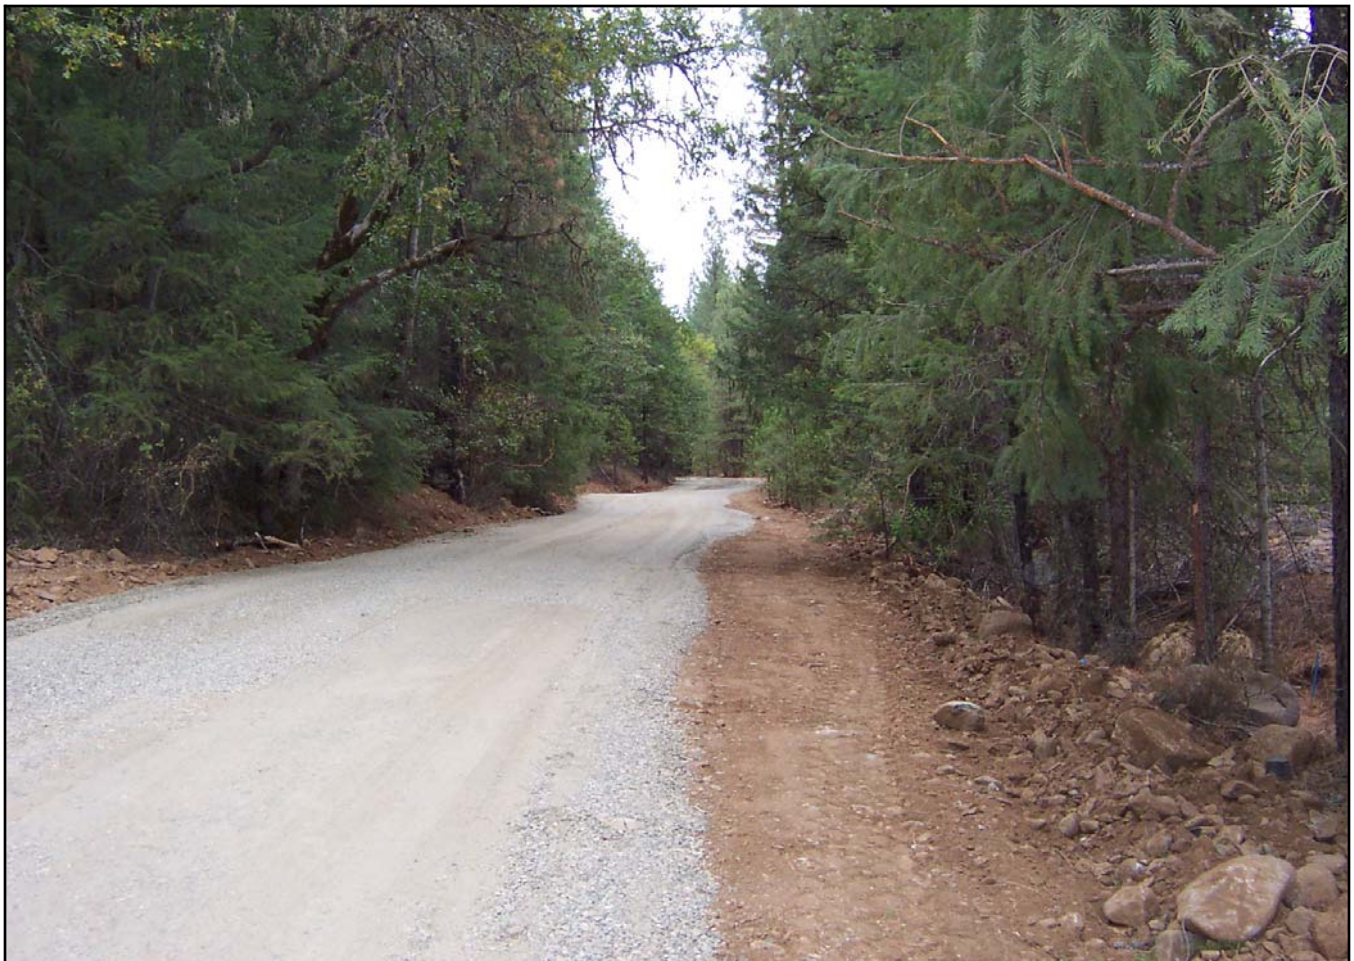
North Roundy Road: Through-Cut Road with no Drainage Structures that would Deliver Sediment to Little Browns Creek upstream of the Crossing (top photos). The Road was Outsloped with the Surplus Excavated Channel Material & Rocked (bottom photo). Road accesses USFS & Pvt Lands

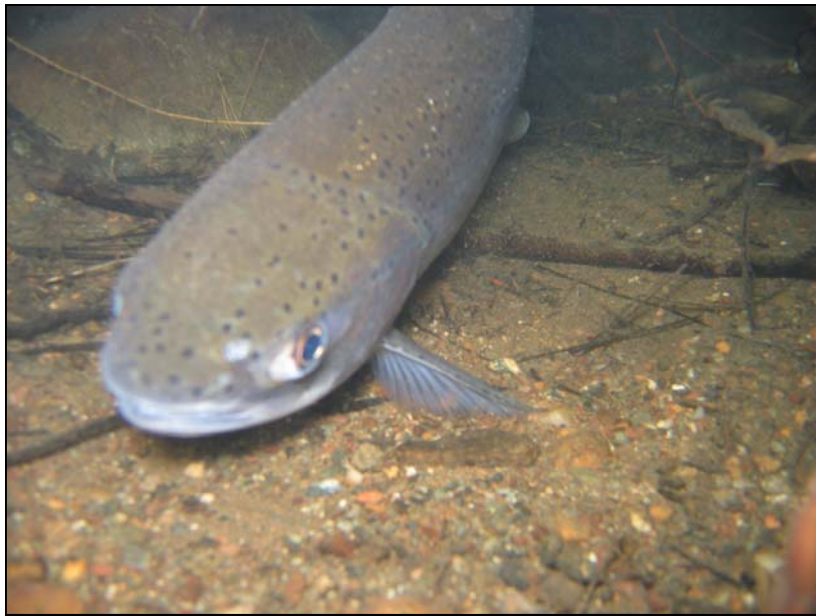
The USFS Weaverville Ranger District, Shasta-Trinity National Forest photographed this steelhead downstream of the Highway 3 culvert in early July 2007. The Highway 3 crossing is located ~1 mile below the Project & is not a barrier to juveniles or adults.

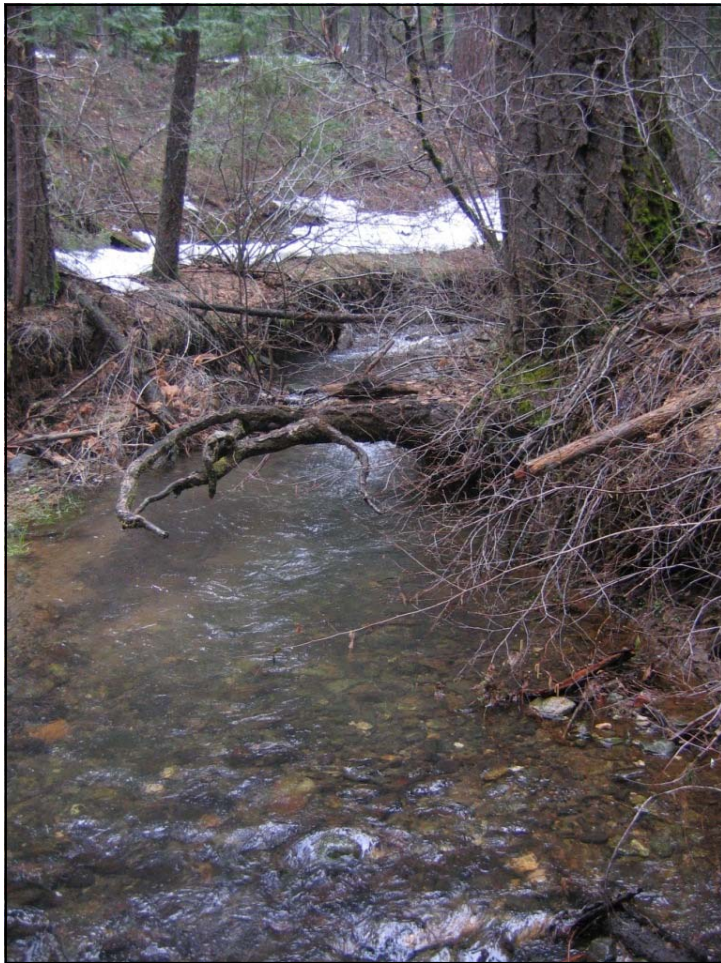
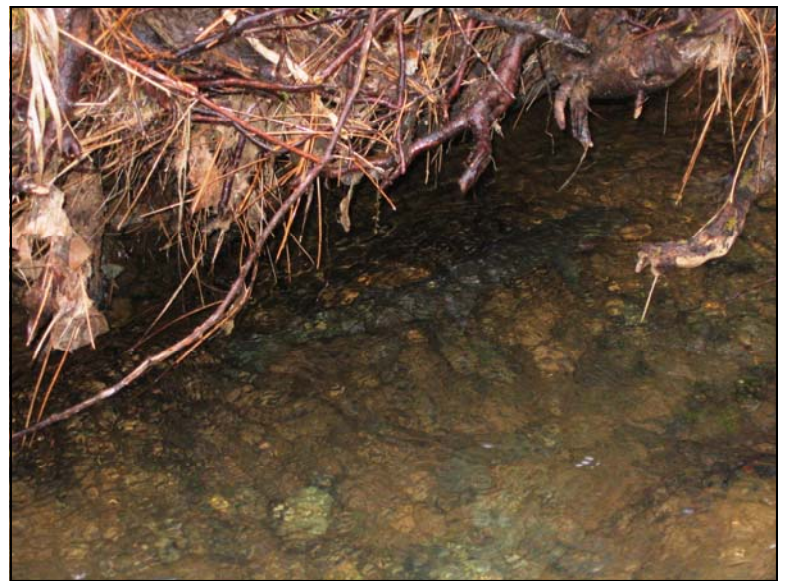
The initial spawning survey for the Project was conducted on March 19, 2008. Five redds were located below the Project site, one with a wild female steelhead (photos below). In addition to spawning surveys, an out-migrant trapping program will be implemented to monitor the biological response to the Project.

3-19-08: Good quality spawning habitat upstream of the Project & a wild female steelhead on a redd just below the Highway 3 crossing

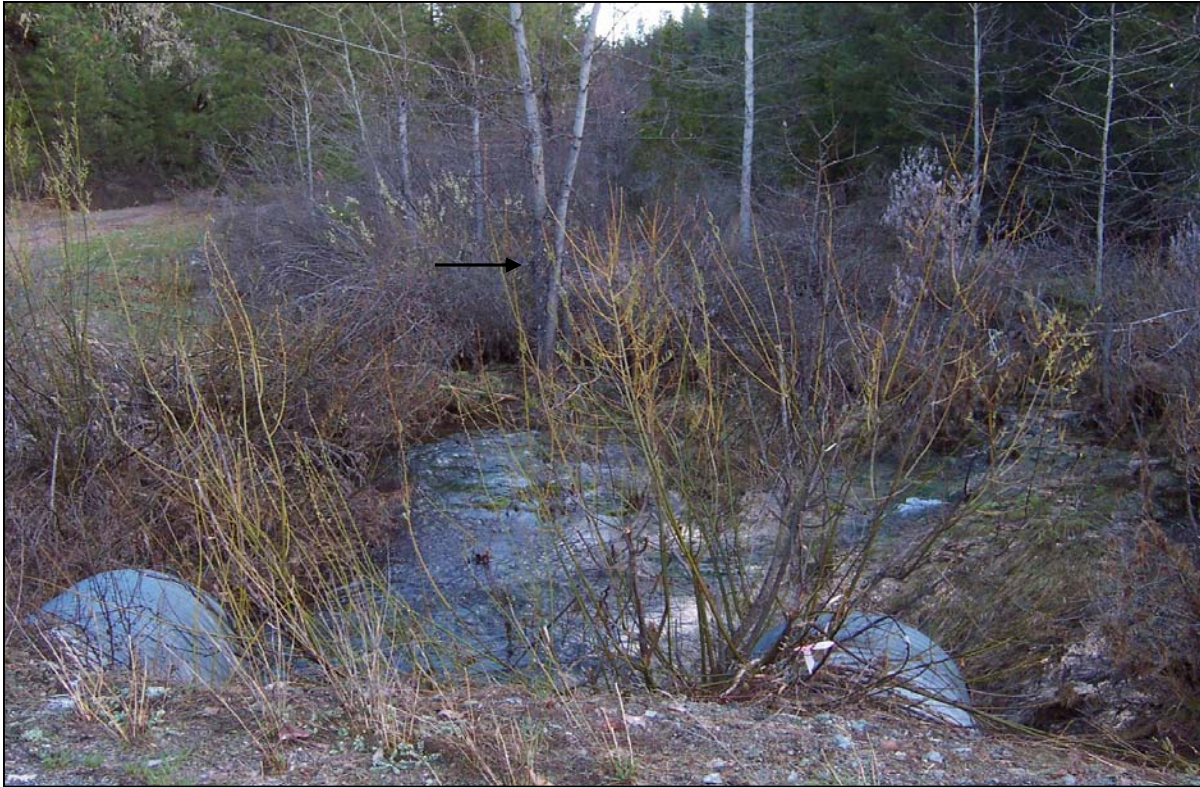
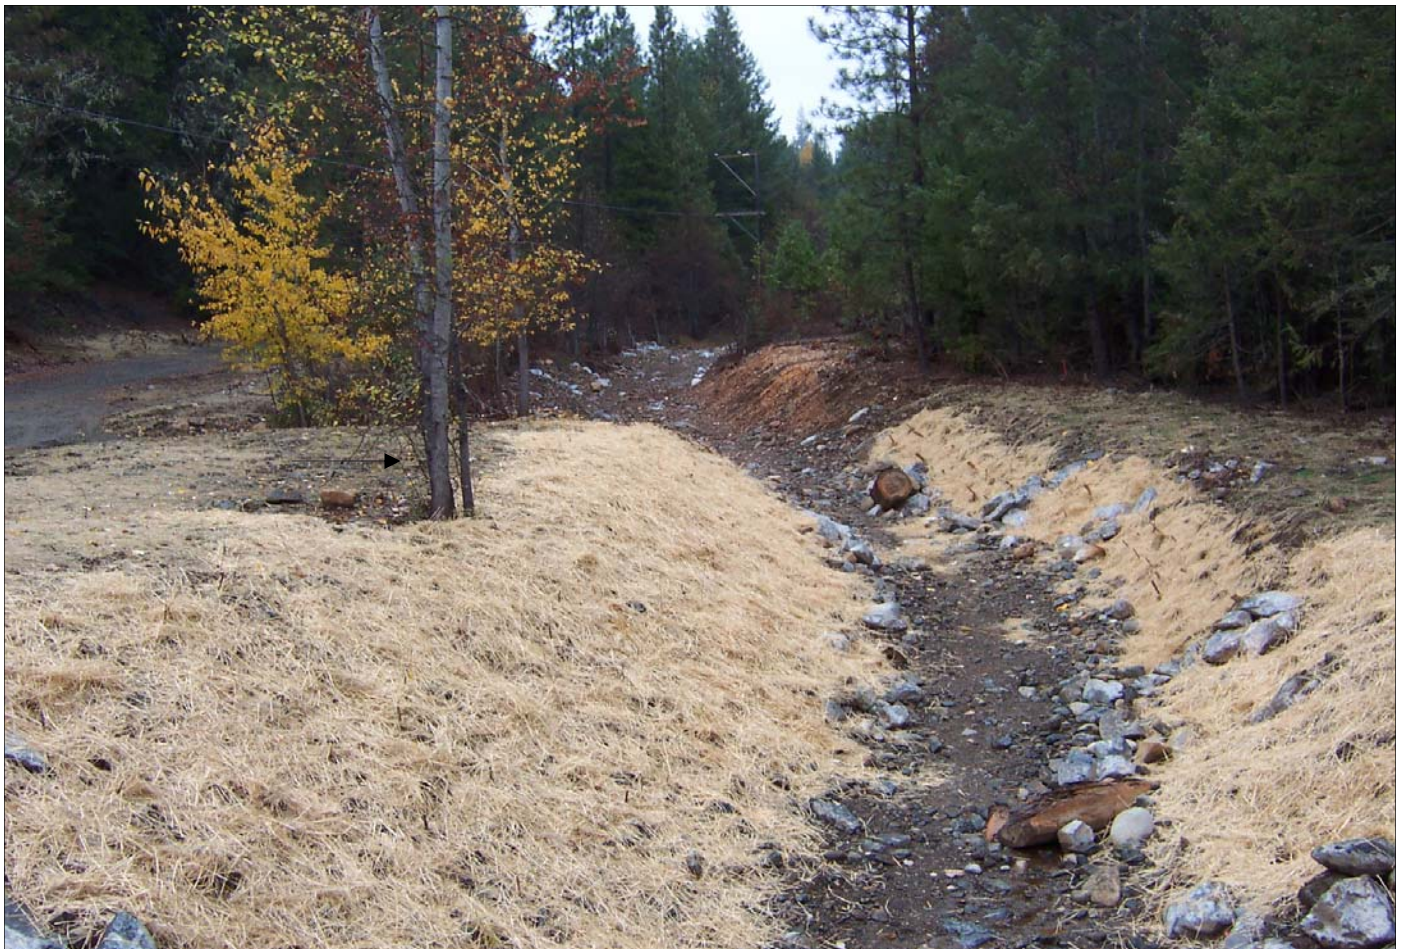
Top: View of Upstream Widened Channel in February 2007*

Bottom: View of Upstream Constructed Roughened Channel & Streambank Bioengineering in November 2007
- Note Cottonwood Tree with Arrow

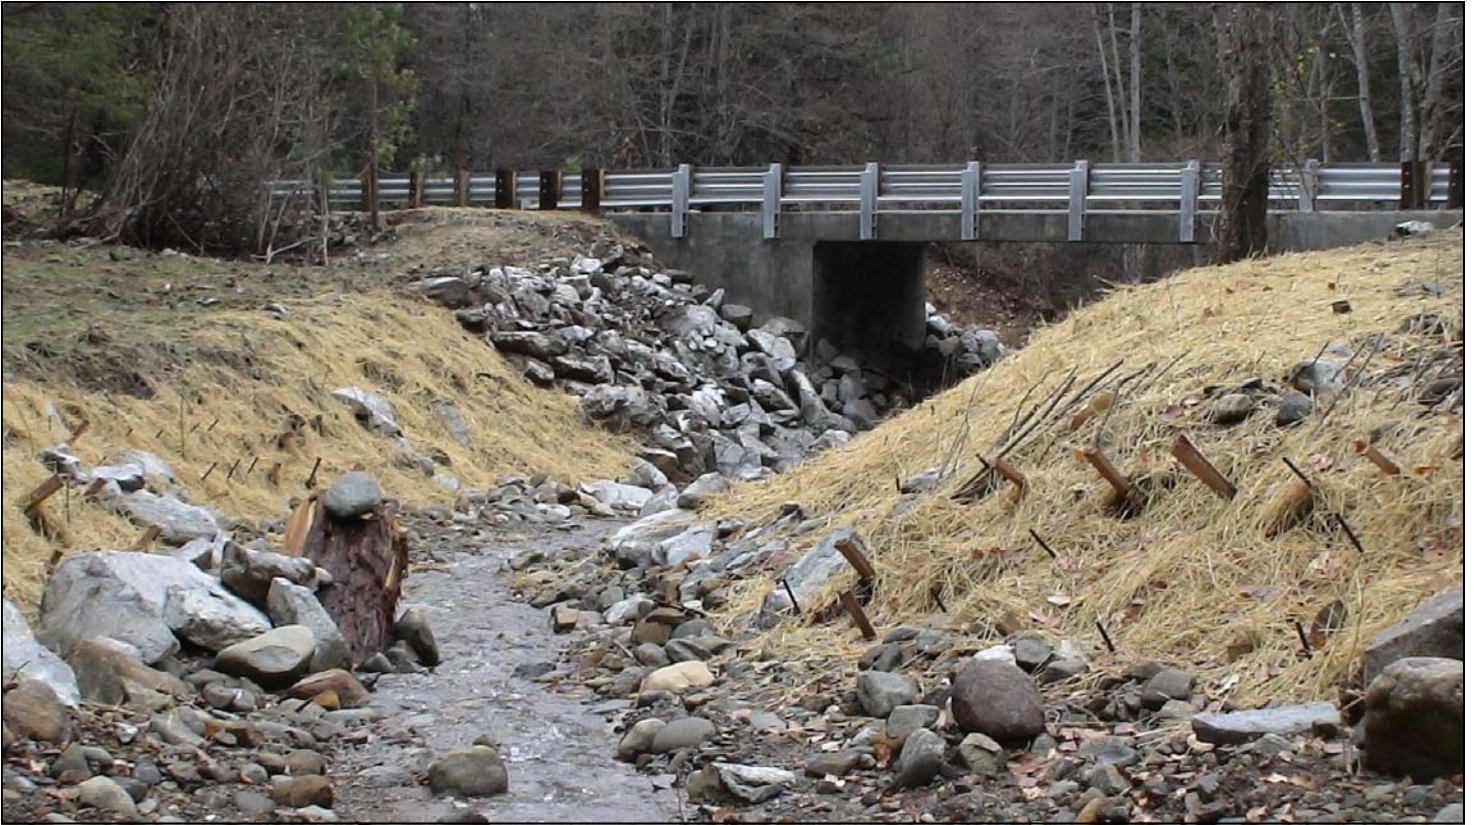
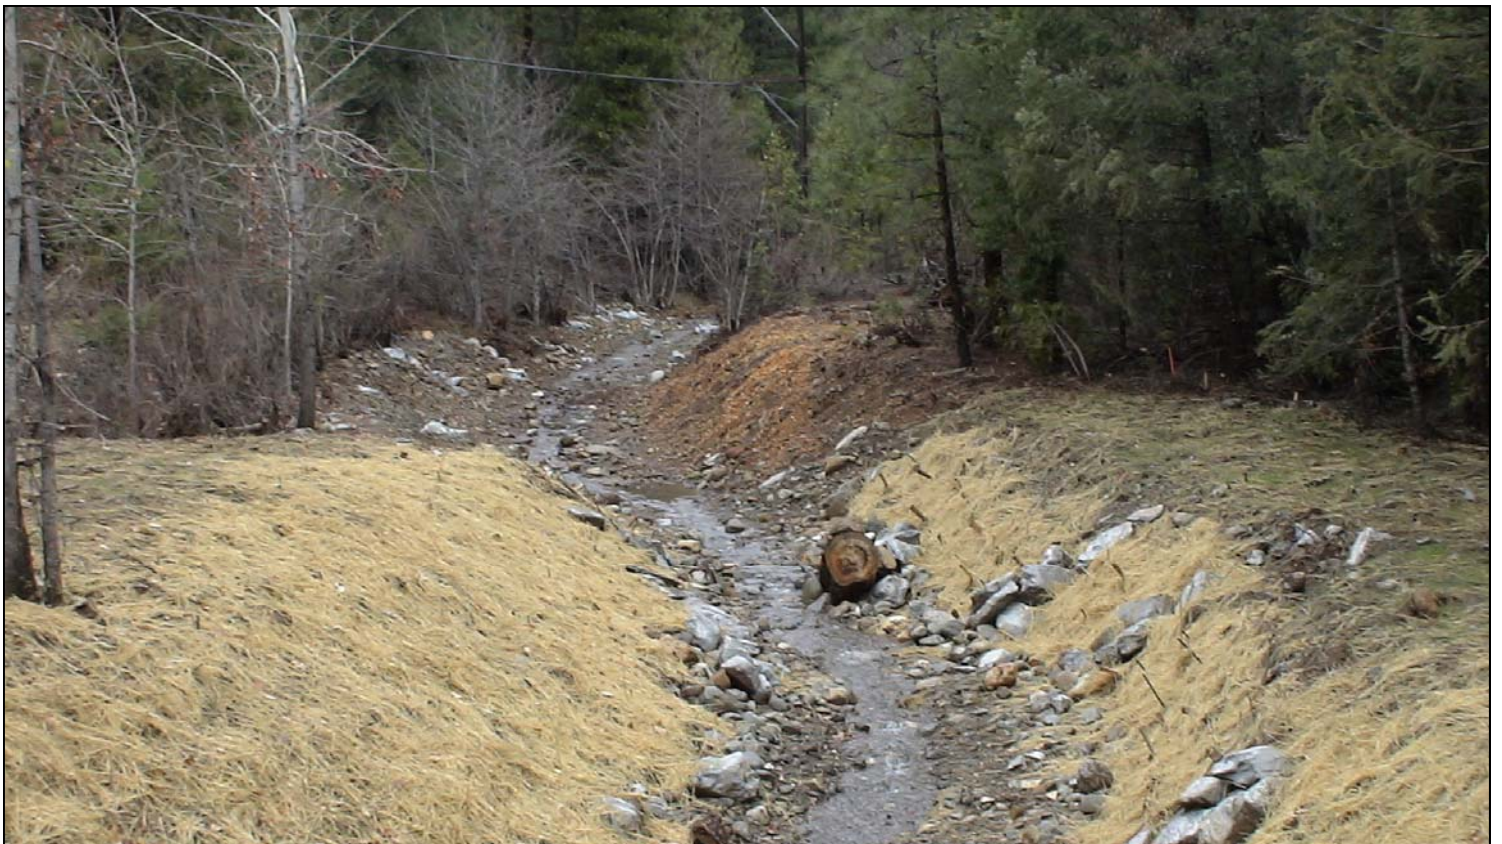
Top: Looking Downstream from approximately 150 feet Upstream of Bridge, note Large Wood Installation at Left

Bottom: Looking Upstream at Constructed Roughened Channel & Streambank Bioengineering—December 2007 (first flows post construction)

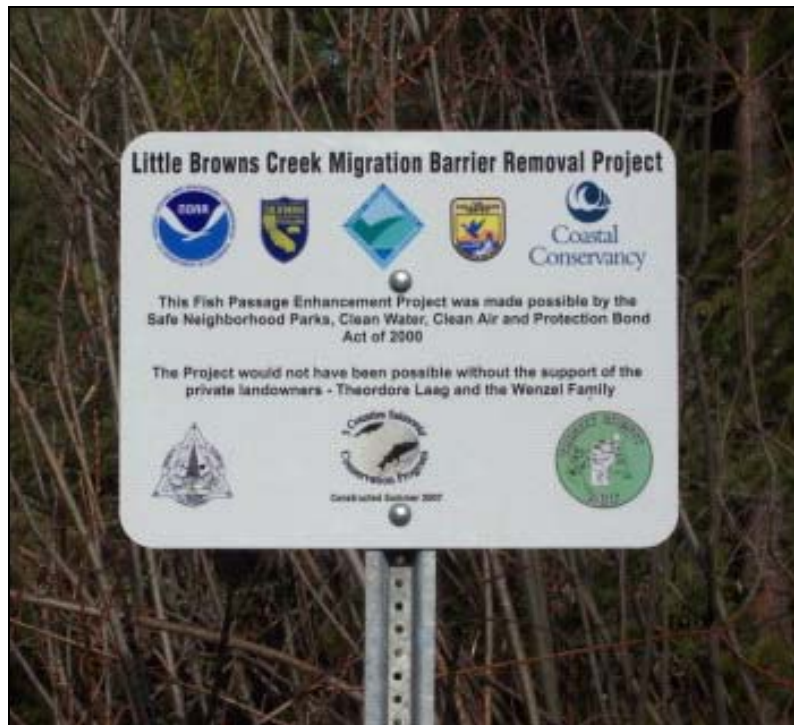
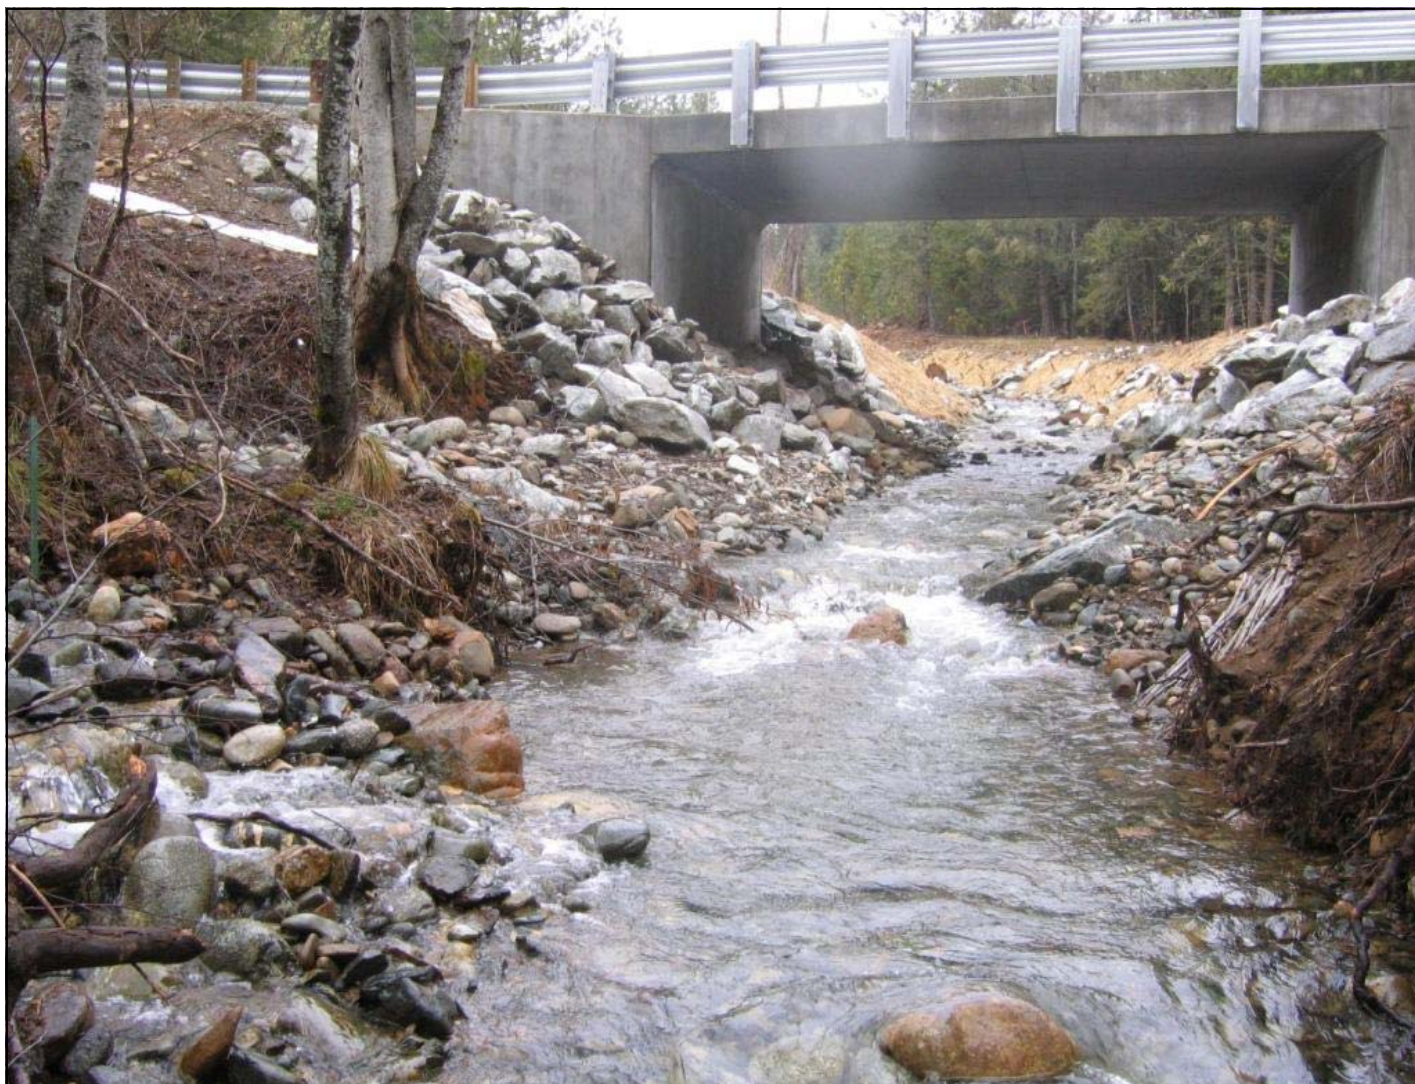
Sign constructed at the Project Site with Partners—March 2008 Site Photos of Upstream Channel & Bridge
