Lower Sidney Gulch Urban Stream Restoration: Phase I Final Report

Summary

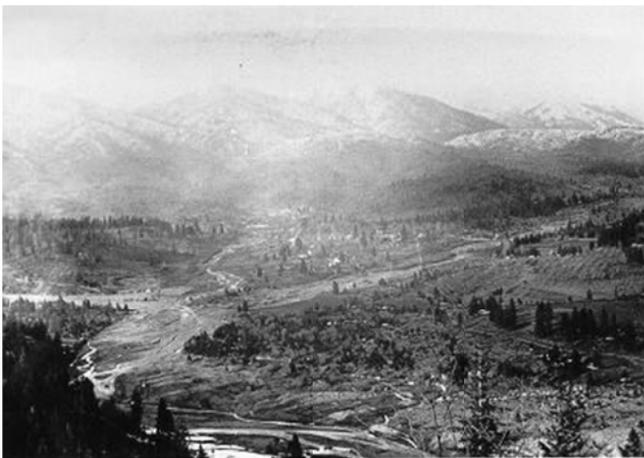
Photo 1 (left): Sidney Gulch (Center of photo). A small ridge (~200' high) once separated East Weaver Creek from Sidney Gulch. This mountain was hydraulically mined and washed away in the late 1800's. Photo 2 (right): A welded wire wall at the Joss House State Park confines the natural stream channel. A building and parking lot are located behind the wall.

Sidney Gulch and the mountain ridge that formed it were hydraulically mined and washed away from the mid 1880's thru the first quarter of the 1900's (photo 1). Over the next 60 years, the first 1.5 miles of the creek were reconstructed, channelized and confined to a series of straight runs. The stream banks were narrowed, simplified, and hardened as follows:

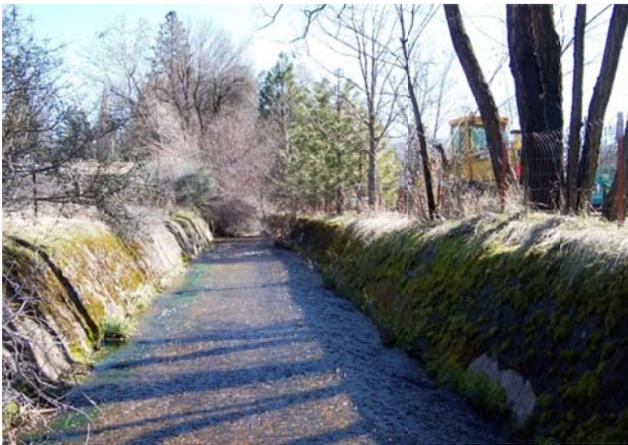
Photo 3 (left): Forest Service compound before installation of fish resting structures (left).

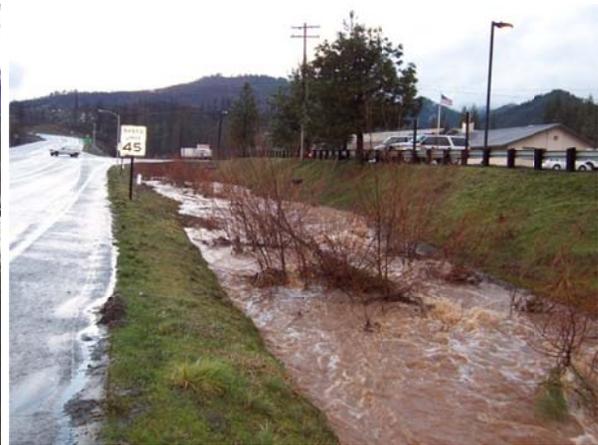
Photo 4 (right): Sidney Gulch between Highway 299 and the Memorial Drive crossing (February, 2004).

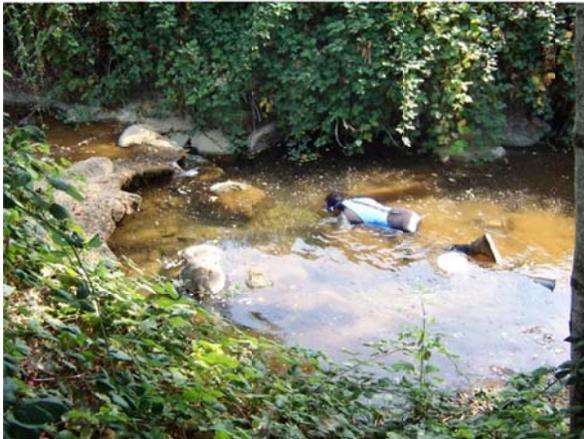
Photo 5 (left): Fisheries biologist Patrick Garrison snorkels the pool immediately downstream of the Forest Service compound (note concrete apron at upstream end that scours pool).

While no systematic surveys of the stream have been conducted for fish use, empirical monitoring of the pool at the downstream end of the USFS compound (Photo 5) has occurred since 1988. Sampling of the pool has consistently documented a minimum of two age classes of coho salmon and three age classes of steelhead. Steelhead up to 22" in diameter were observed in the pool during one survey. The 1989 stream assessment reported coho in reaches within Lee Fong Park as well. Between 2000 and 2004, spawning coho were observed upstream of Lorenz Road and in 2001, a few migrating adult coho, under nearly "ideal" flows, were able to migrate above the Forest Service reach (Photo 6) and spawn in the upper portions of the watershed. Most however, could not make it through the concrete lined channel.

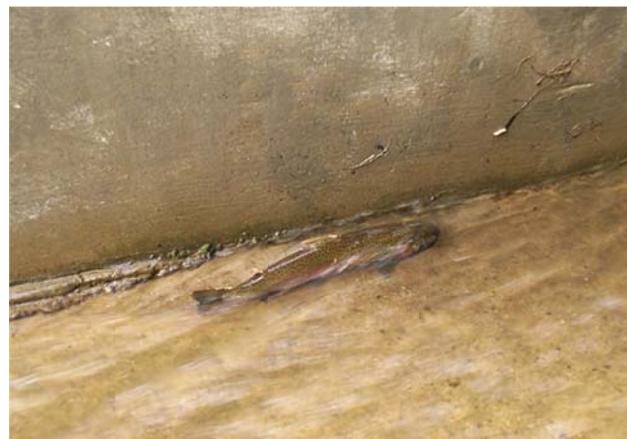
Photo 6 (right): Adult coho attempting to migrate through Forest Service compound (2001).

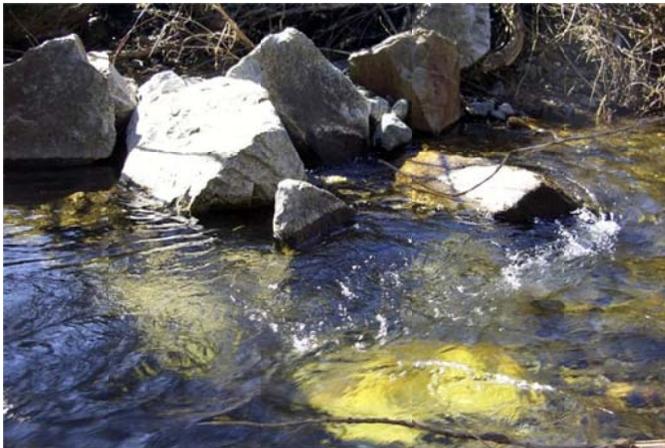
Photo 7 (left): Boulder cluster in Lee Fong Park constructed in 1991 as part of Trinity County's Urban Stream Project (photo taken in 2006). Photo 8 (right): Resting structures within the Forest Service compound.

In 1991, the County subcontracted the installation of boulder clusters in the stream at Lee Fong, creating pool habitat (Photo 7). In 2004, storm water retention basins were constructed into parking lot upgrades at both Lee Fong Park and Sam Lee Ranch house properties. In 2006, the Forest Service installed concrete structures in the stream within its compound to create resting habitat to help fish move upstream (Photo 8).

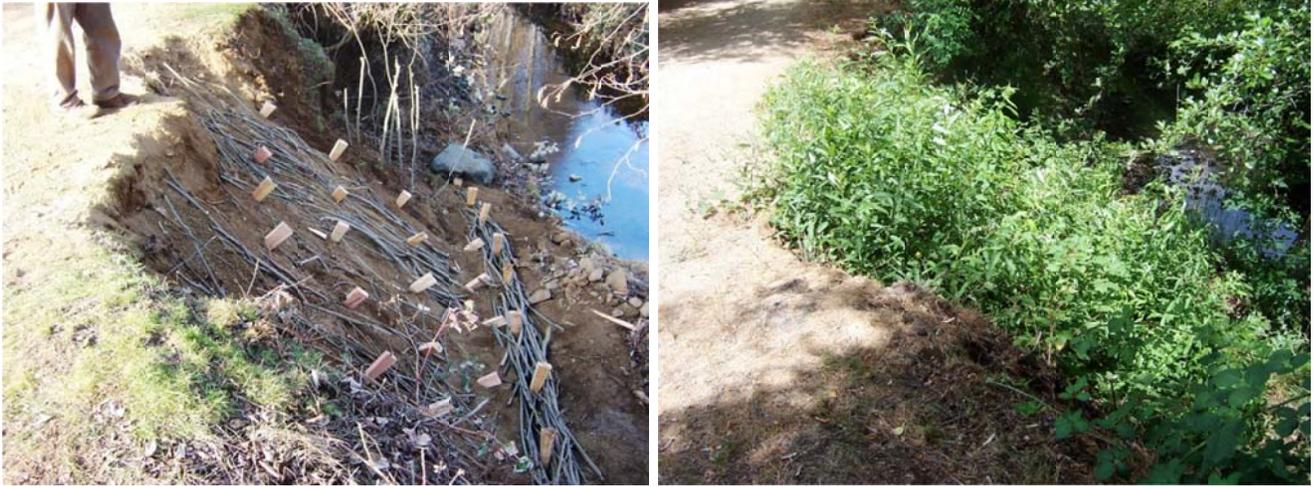
Photos 9 and 10: A stream bank undercut in the January 2006 storms had been proposed to be rip-rapped, but willow mattress bio-engineering techniques were used instead.

In 2006, the 5C Program utilized bioengineering techniques to stabilize a stream bank instead of using the traditional boulder rip-rap (Photos 9 and 10).

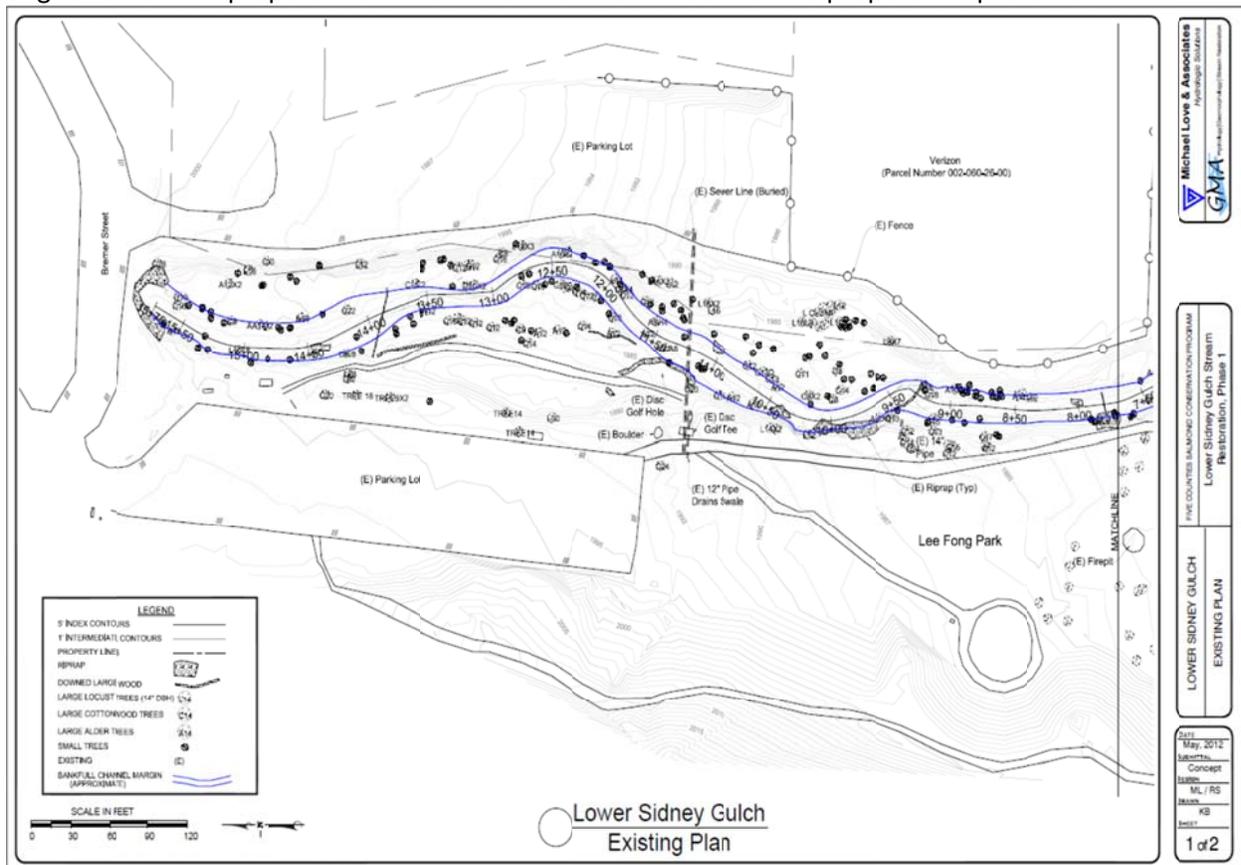
Figure 1 (above): Upper section of stream targeted for restoration.

The existing condition and proposed condition illustrates the locations of the proposed improvements.

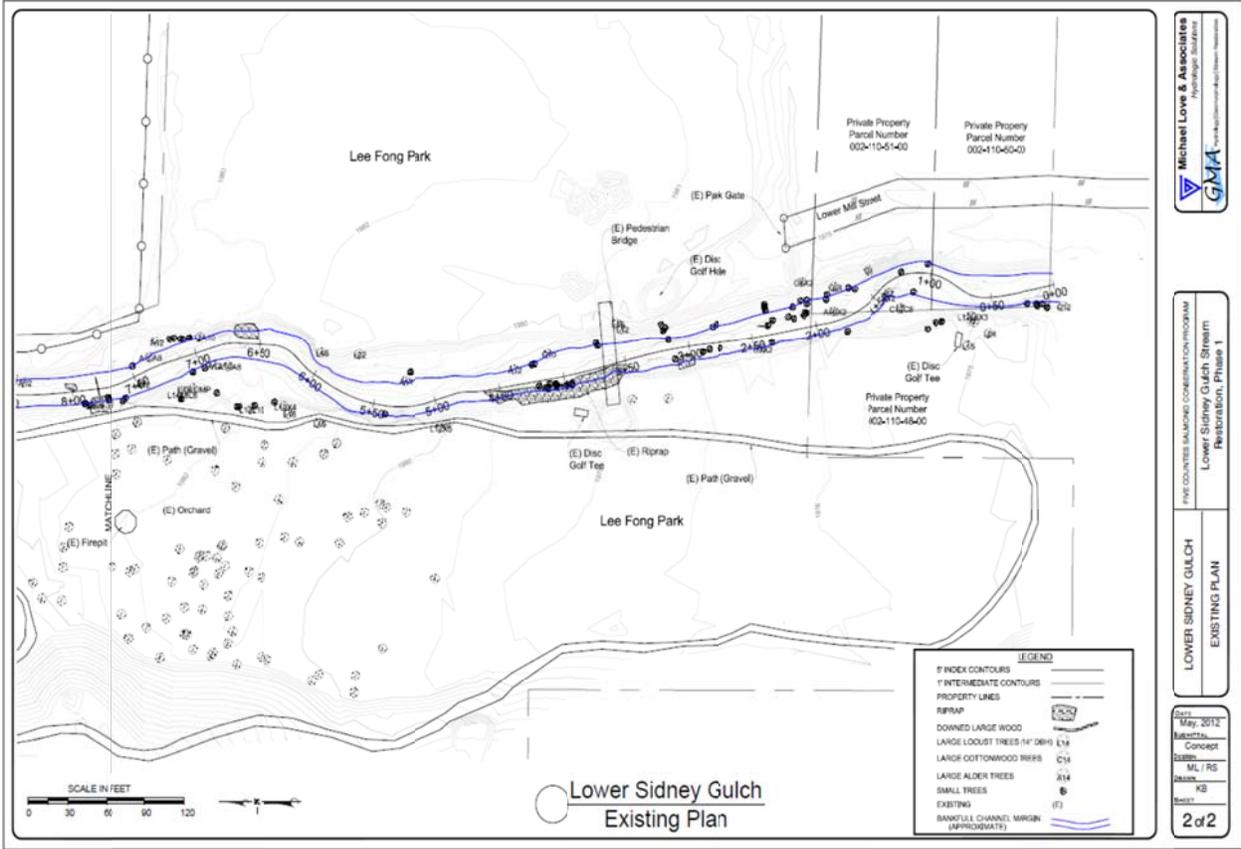
Figure 2 (below): Lower section of stream targeted for restoration.

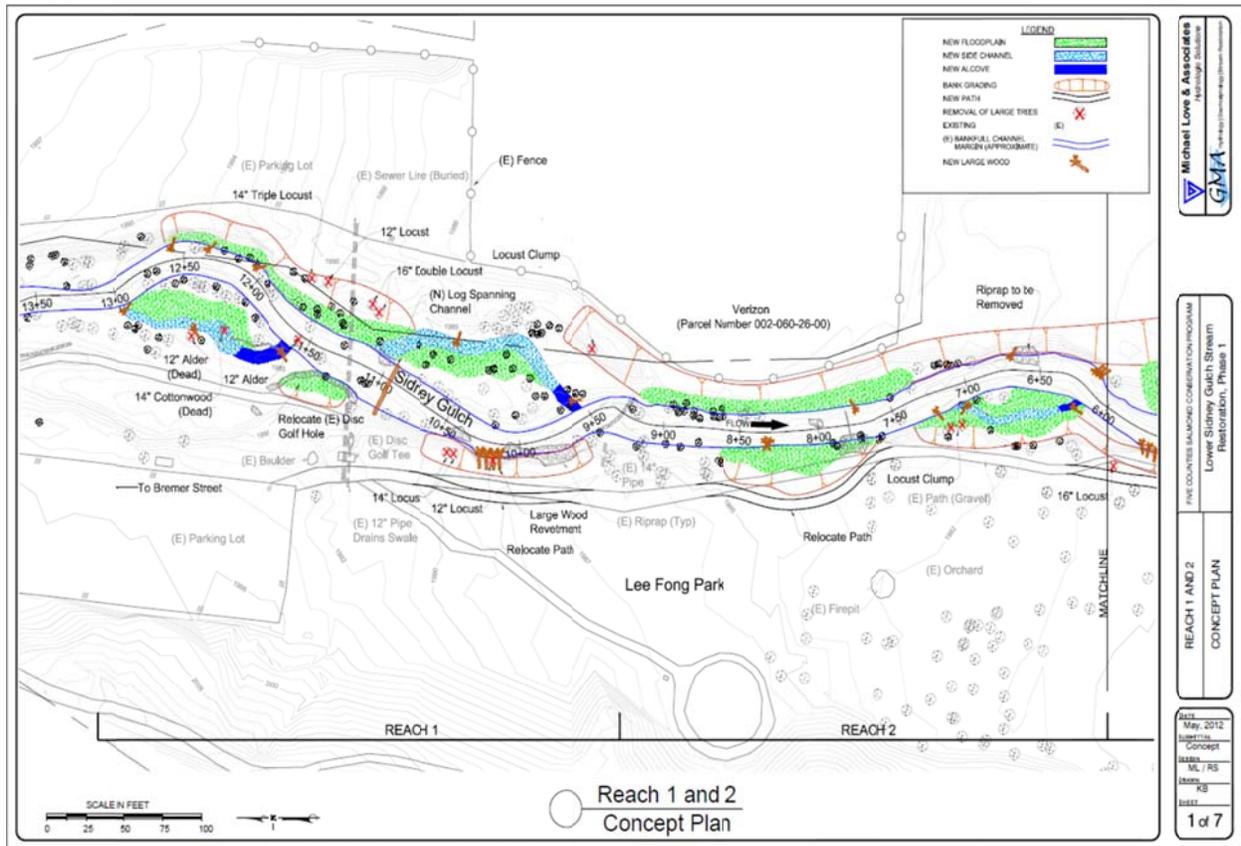
Figure 3 (above): Upper section of stream proposed restoration.
 Figure 4 (below): Lower section of stream proposed restoration.

The conceptual design developed by this project features these proposed improvements:

- Creating more complex instream habitat (large wood, boulders)
- Allowing more space for the channel to naturally meander and creating more of a meander in some places
- Removing blackberries, scotch broom, mullein, and other invasive species
- Removing non-native locust trees
- Replanting with suitable native, riparian species
- Preservation of important heritage orchard trees
- Relocating pedestrian path to allow for stream meander in some sections
