2011-12 FIVE COUNTIES WORK SUMMARY

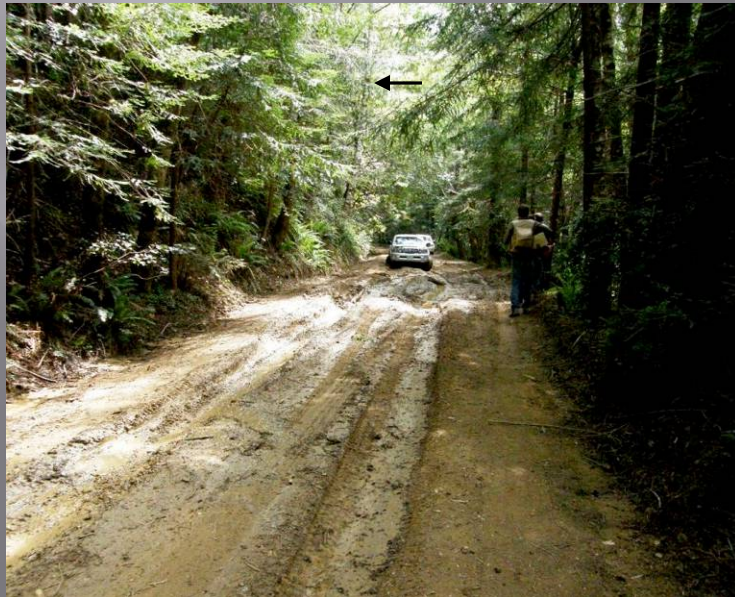
USAL ROAD AT WATERFALL GULCH

Fill the In Board Ditch, Outslope the Road, Remove the Berm, Breach the Berm, Add Geo Fabric & Rock Surface
