Solider Creek Migration Barrier Removal Project 2002-2005

**Evans Bar Road—
Crossing #1**

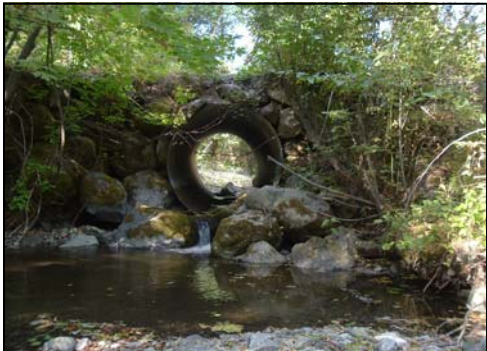
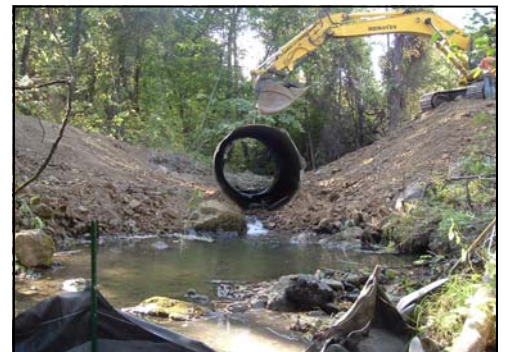
Right Photos—The culvert exposed

Excavating the 8-Foot Culvert in 2004

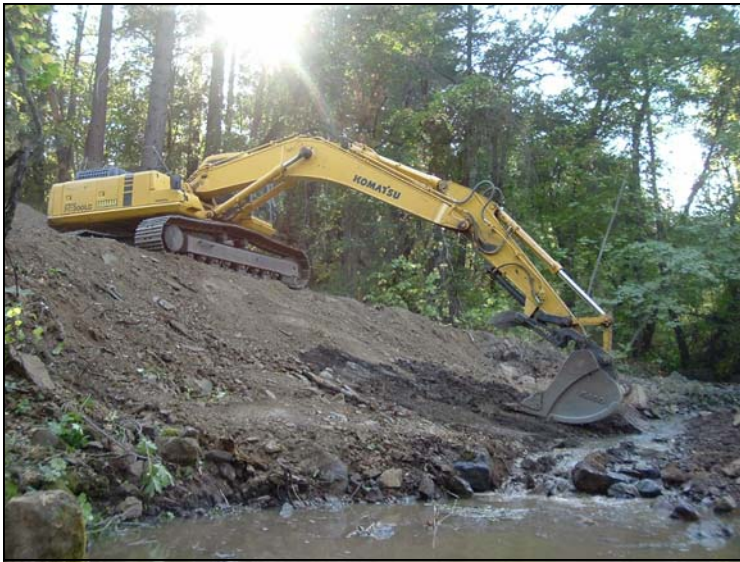
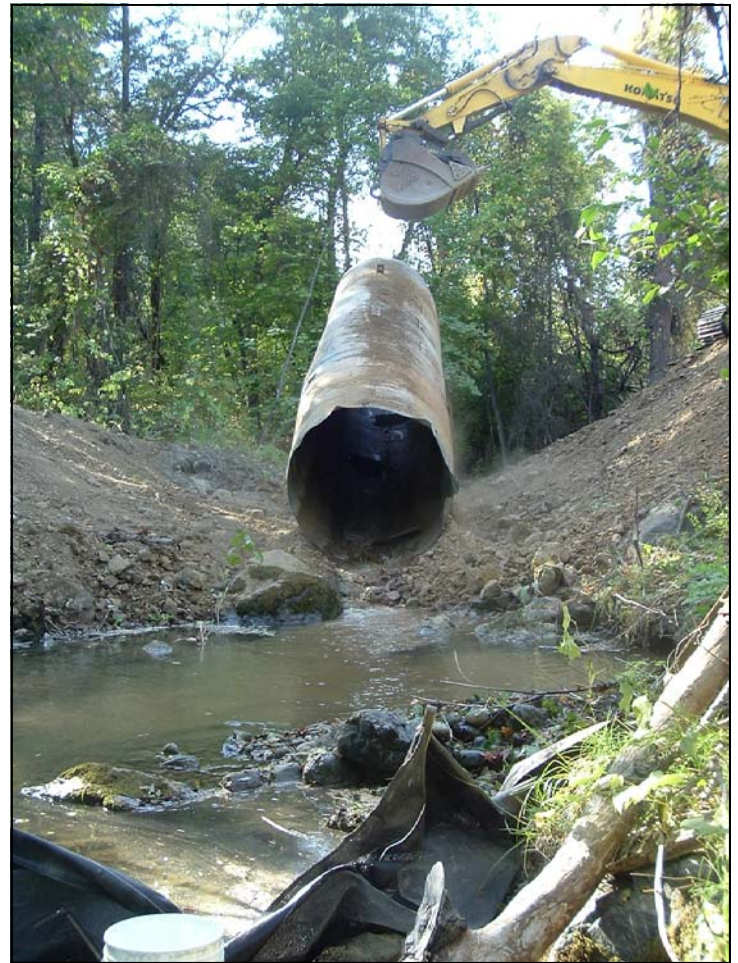
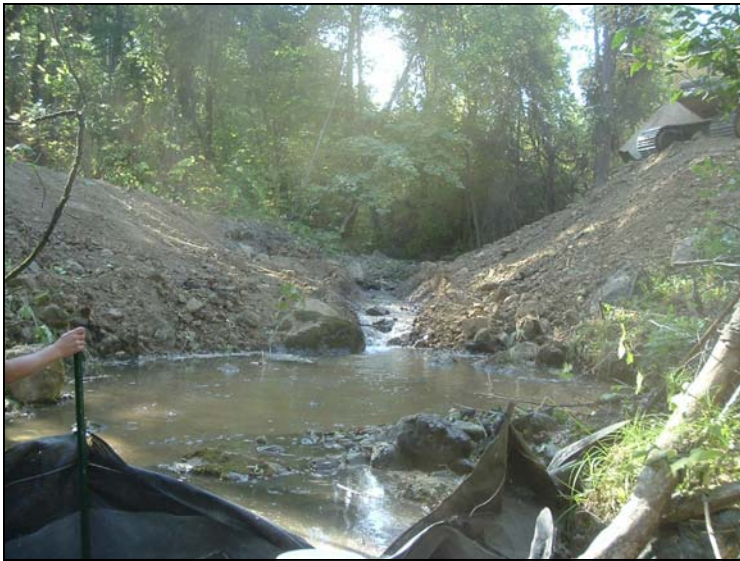
Above—Removing the culvert

Upper Left—Excavating back the slopes

Middle Left—Channel after pipe excavation

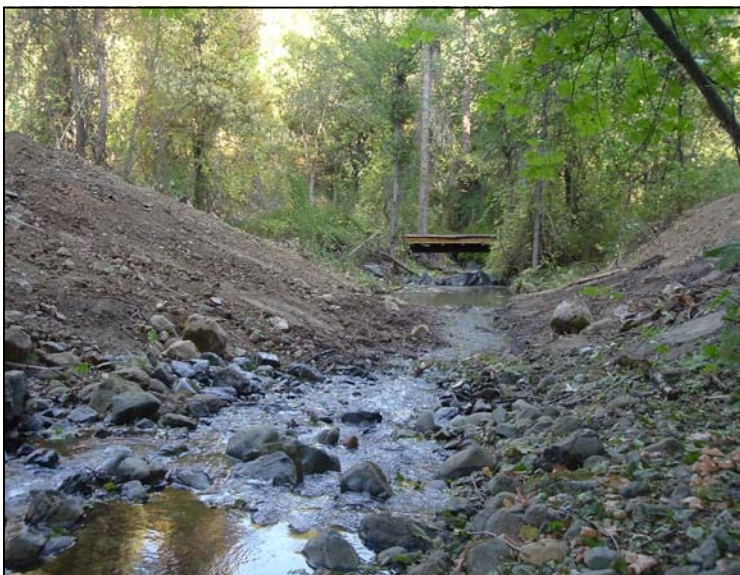
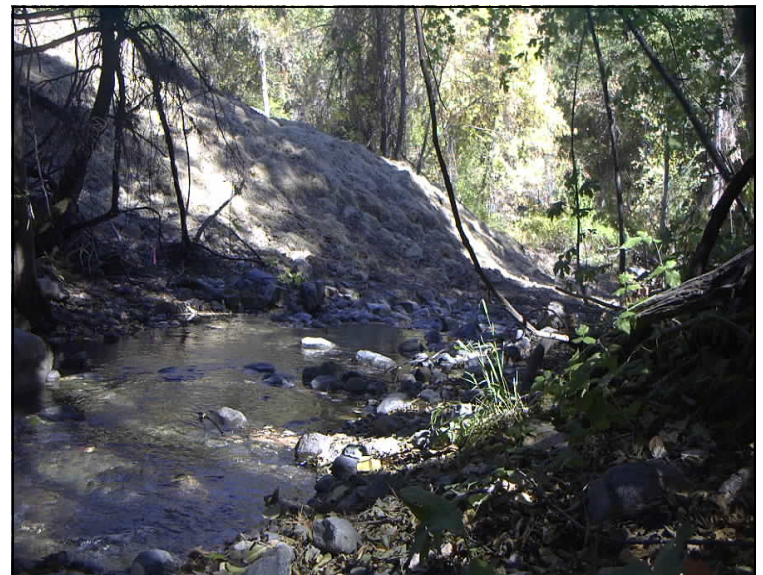
Left Photo—Looking downstream at installed detour bridge on Crossing #1, Fall 2004

Right Photo—Erosion control with mulching after culvert removal and detour installation, Fall 2004

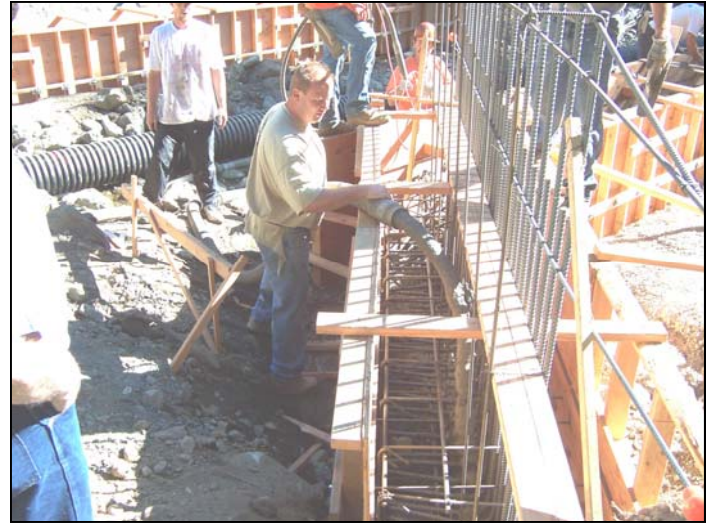
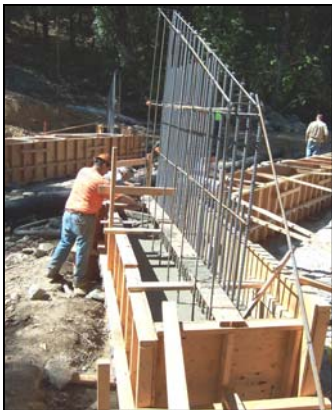
Additional concrete was required below the footing areas to stabilize the bedrock due to an error in the geotechnical investigation report

Left —6 foot depth of extra concrete below surface.

Right Photo—3 feet depth of extra concrete below surface.

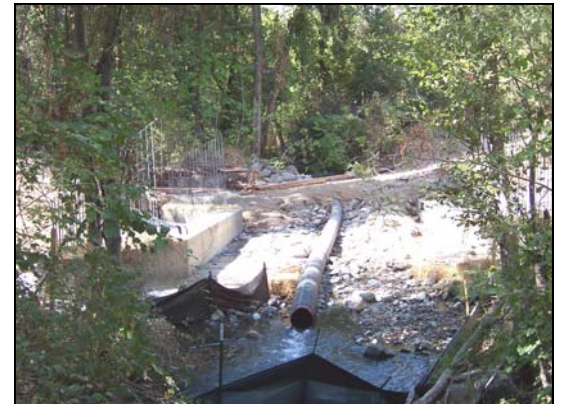
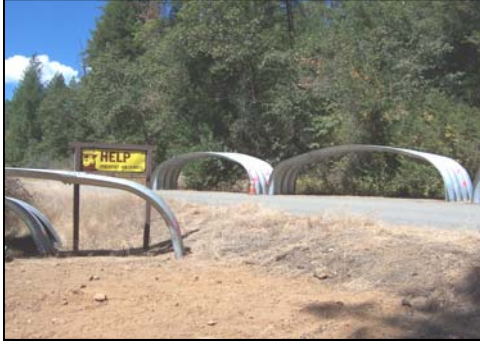
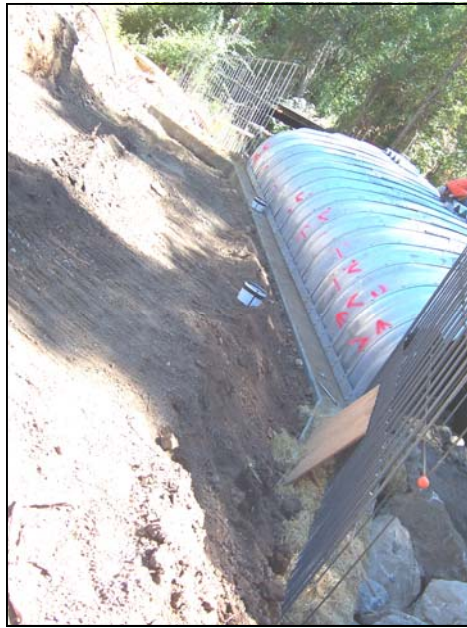
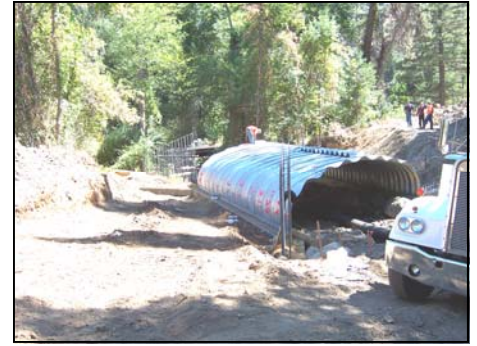
Concrete Pour at Crossing #1

Upper Left—empty forms for footings with interior rebar and wingwall rebar exposed

Upper Right—concrete pour with extension hoses. A 6-sack mix was utilized to assure faster curing time

Middle Photos—vibrating the poured slurry and the cured north and south footings

Lower Right—overall view of work area showing 15" diversion culvert outlet and fish screening

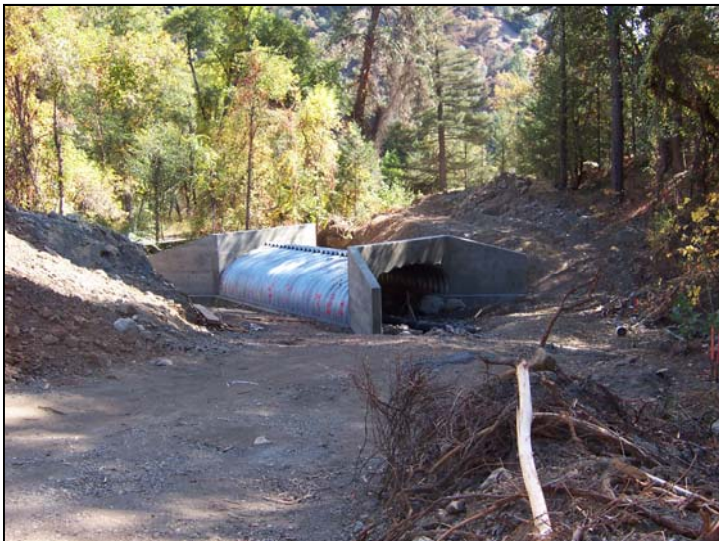
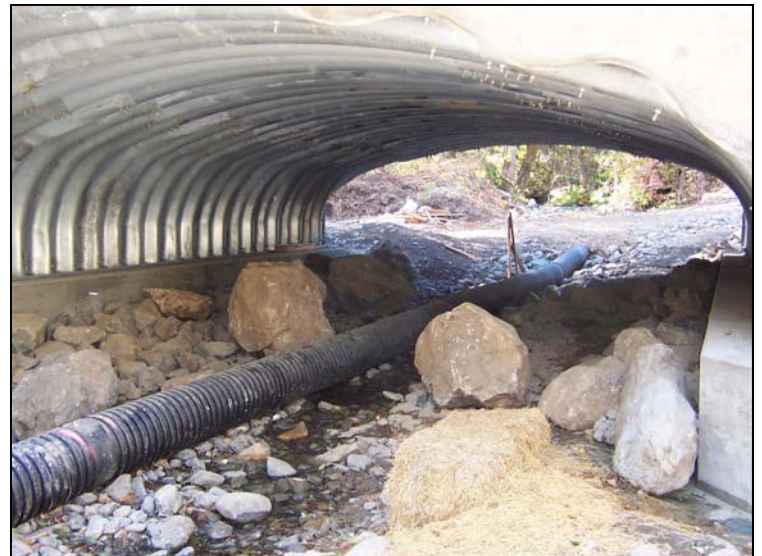
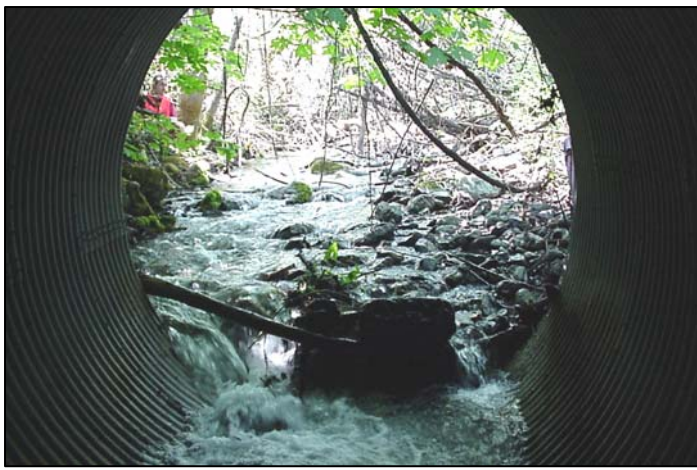
Crossing # 1—Arch Assembly and Installation

Upper Left—arch delivered in sections

Upper Middle—arch installed, backfilled & compacted to Engineering standards

Upper Right—Checking bolt tightness and overall view of the crossing area

Left—framing for wingwalls and headwalls

Lower Left—view of arch installed with cured wingwall & headwall concrete

Lower Right—View within arch showing rip-rap placement

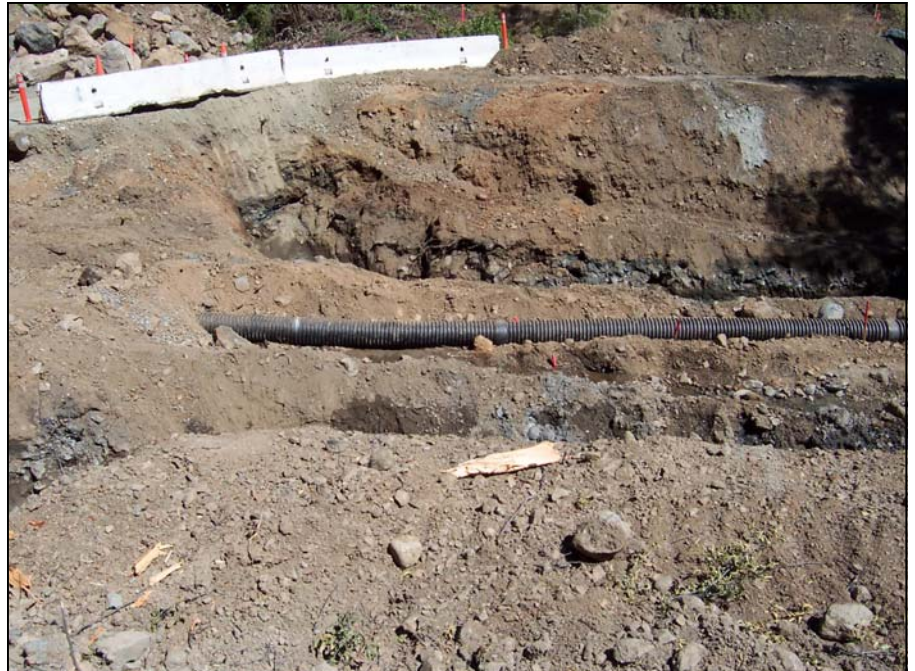
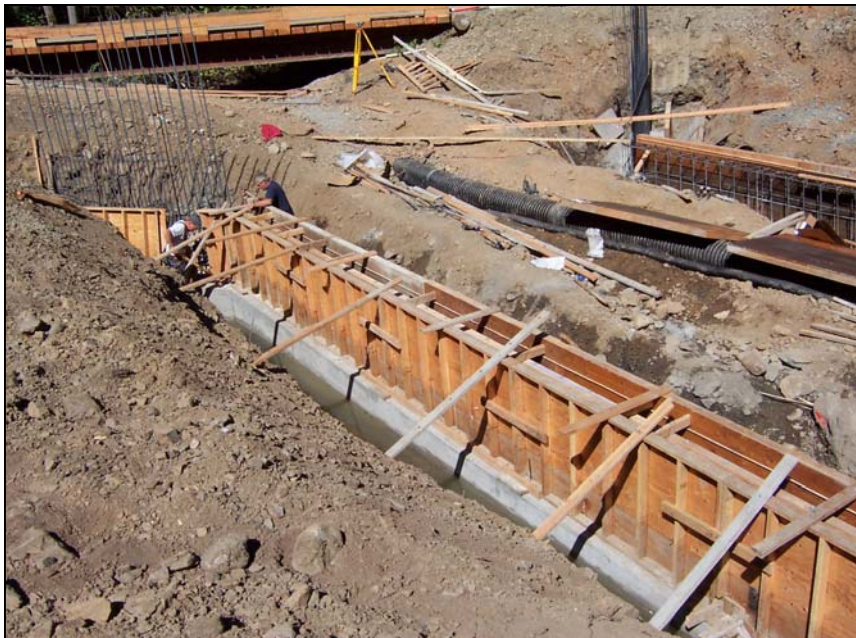
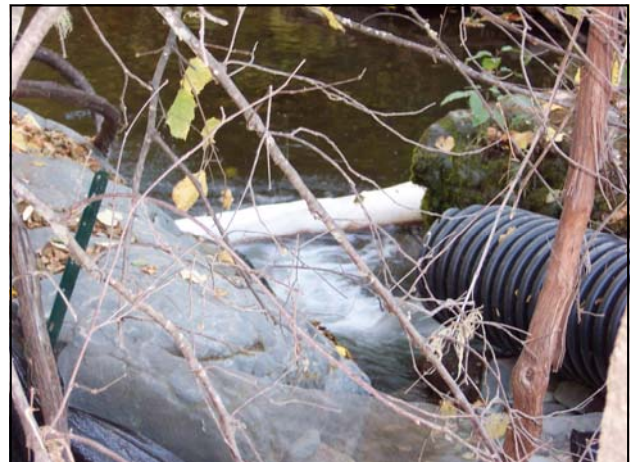
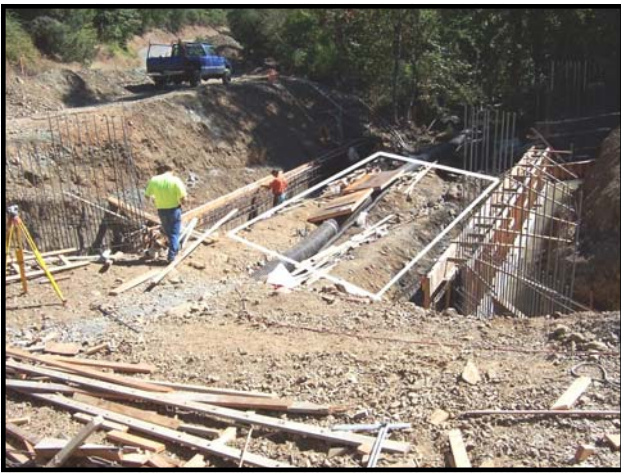
Crossing #2

Upper Photos—excavation of 8-foot culvert and rock to be used as rock slope protection

Right—Overall work area showing 15" diversion culvert and footing areas excavated

Lower Left—concrete footing poured and stemwall forming with wood frames

Lower Right—oil absorbing boom at outlet of 15" diversion culvert

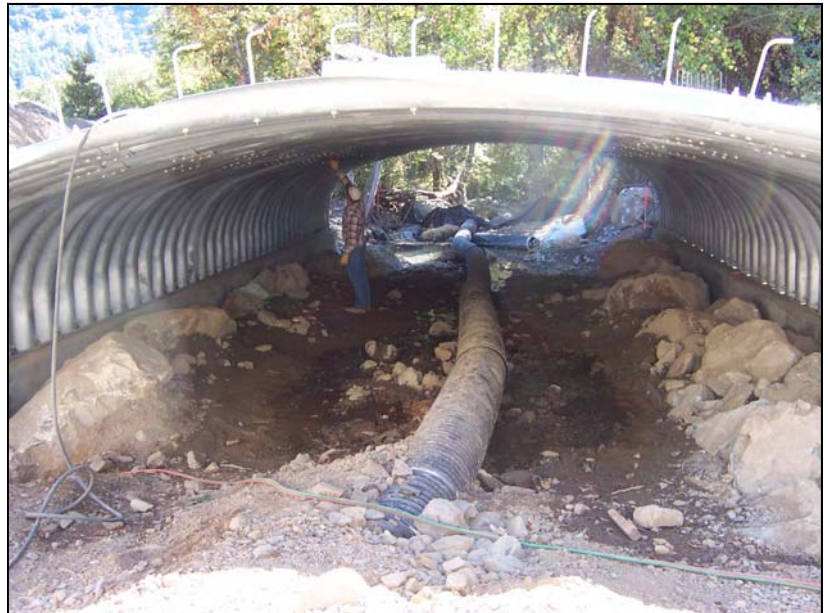
The concrete footings on Crossing #2 were set below ground level and backfilled. Shorter stemwalls (right) are exposed and the arch is attached to the stemwall surface

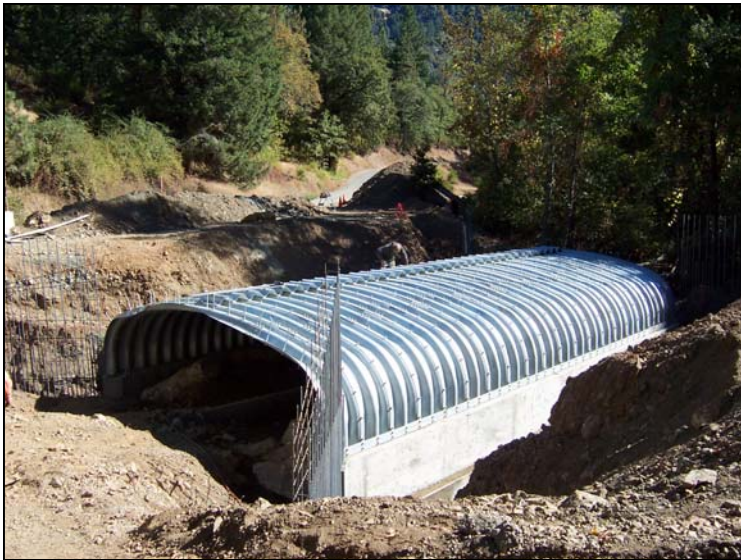
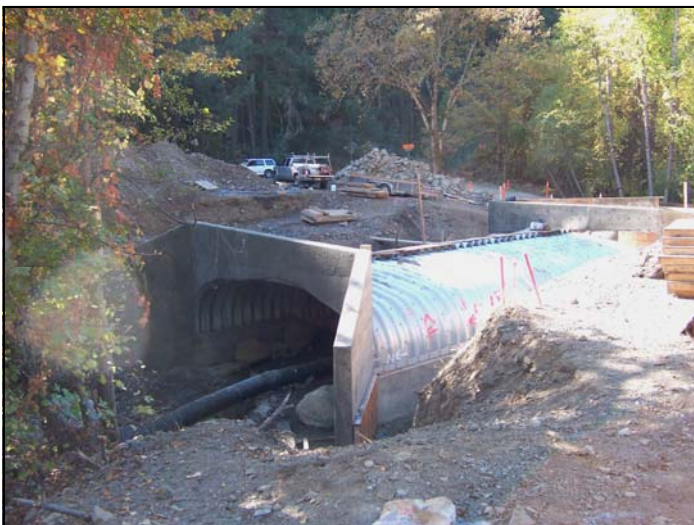
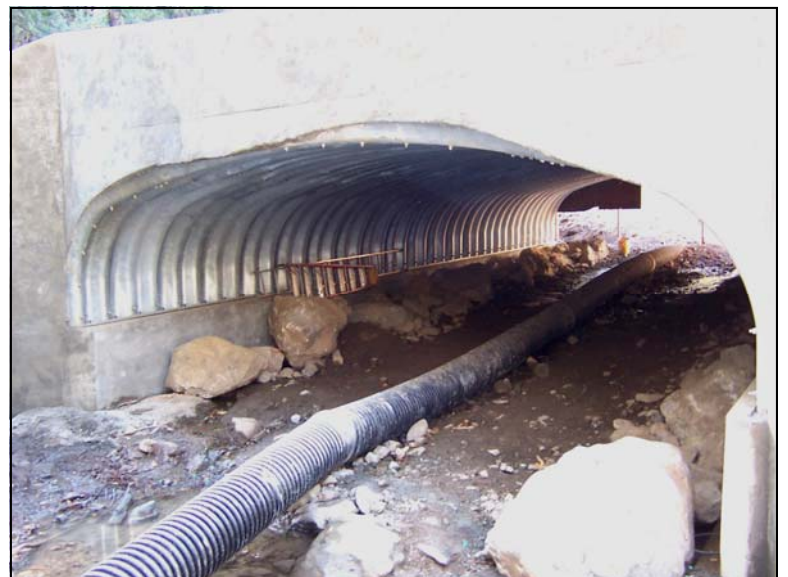
Crossing #2

Upper Left—footings poured and stemwall framing in place with wingwall rebar exposed

Upper Right—Tightening bolts during arch assembly

Middle Left—Arch assembled

Lower Left—Overall view with wingwall and headwall concrete cured

Lower Right—Interior view of arch showing rip-rap placement

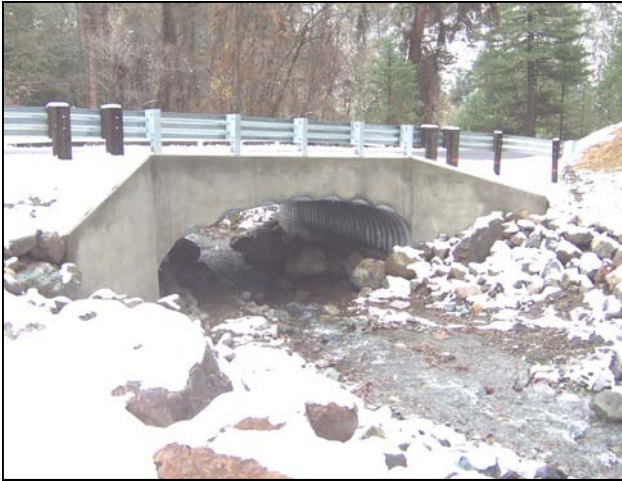
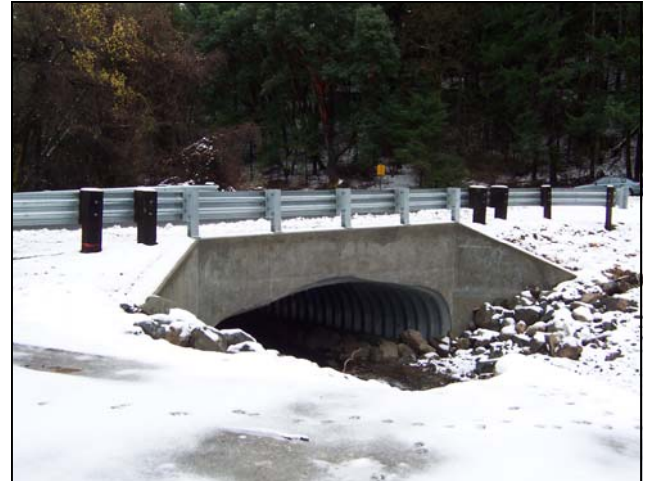
Roadway surfaces and guardrails installed at Crossing #1 (left) and Crossing #2 (right)

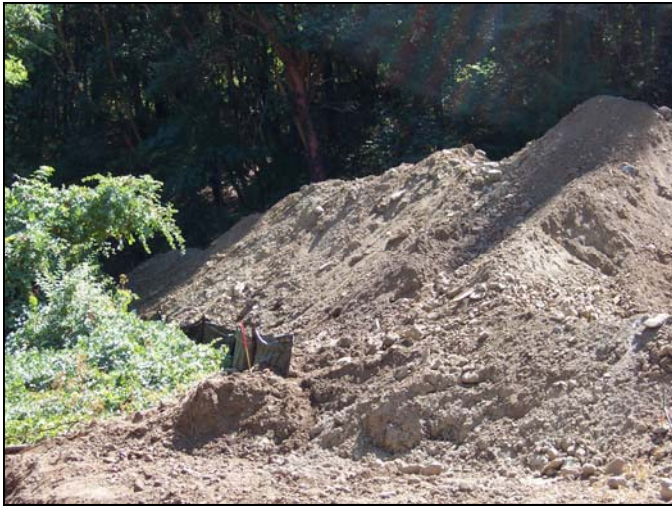
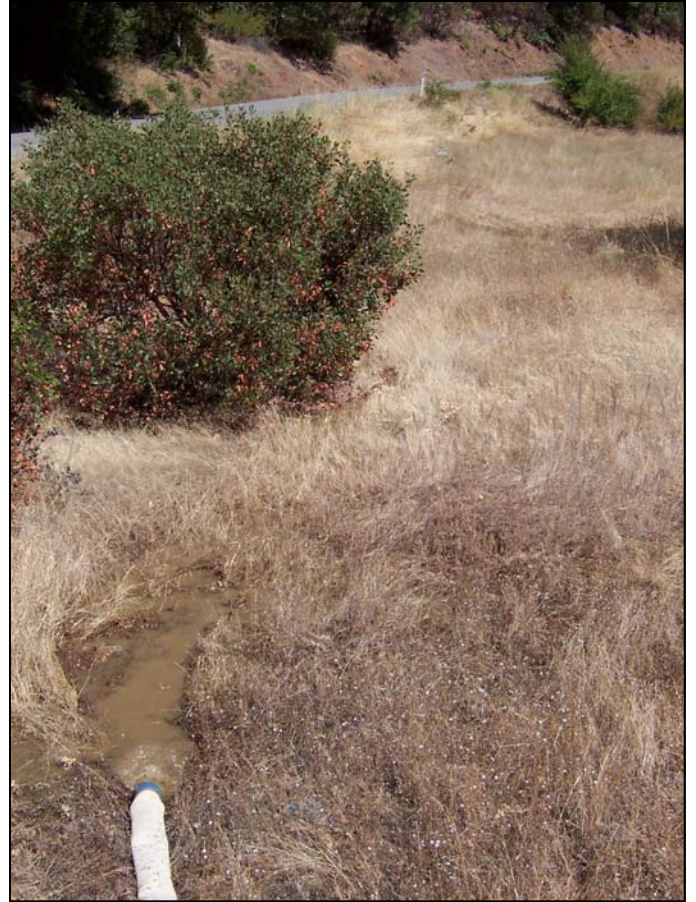
Top & Left—
Silt fencing on fill material to be re-used as structural backfill on the arches

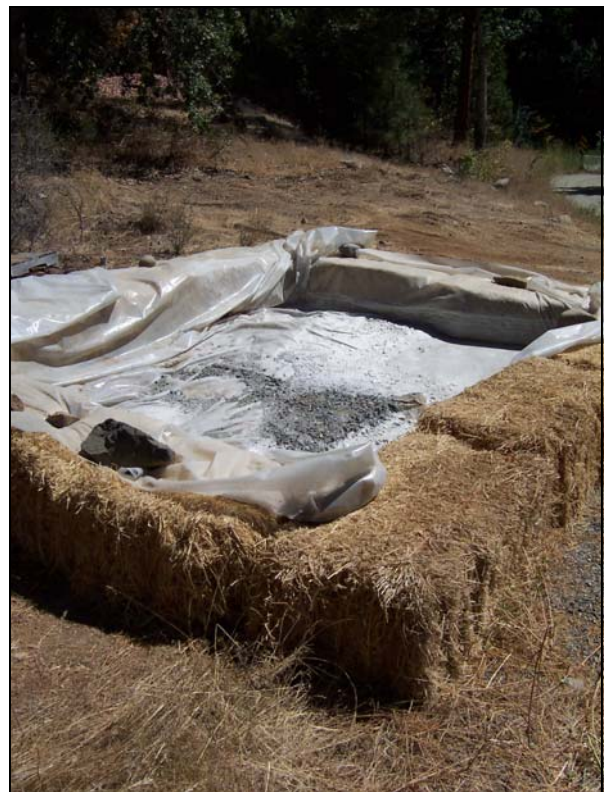
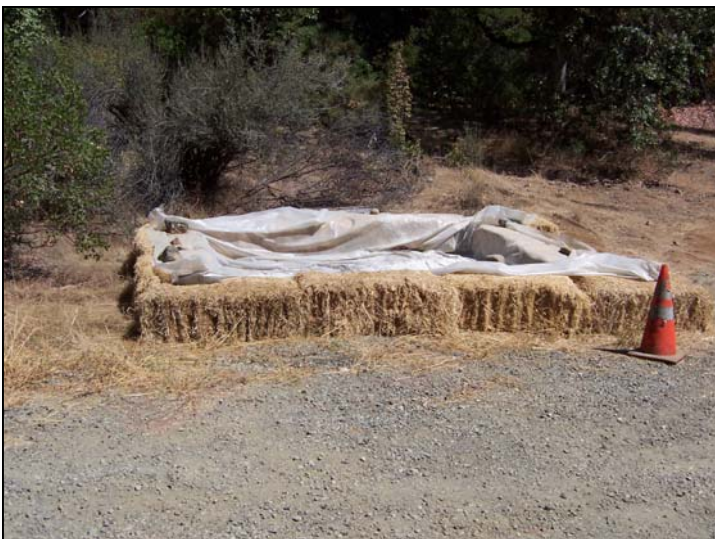
Bottom—
Straw bale concrete wash stations for tools and concrete pump trucks
