**APPENDIX B:**

**CATALOG OF DEL NORTE COUNTY CULVERTS LOCATED  
ON FISH-BEARING STREAM REACHES**

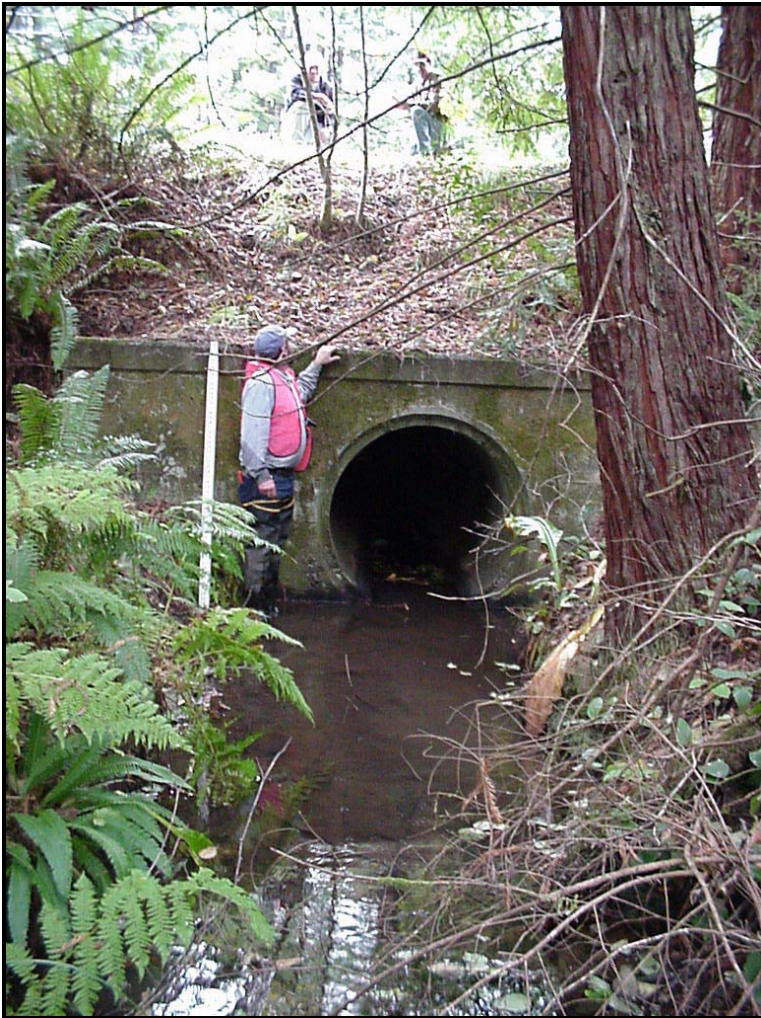
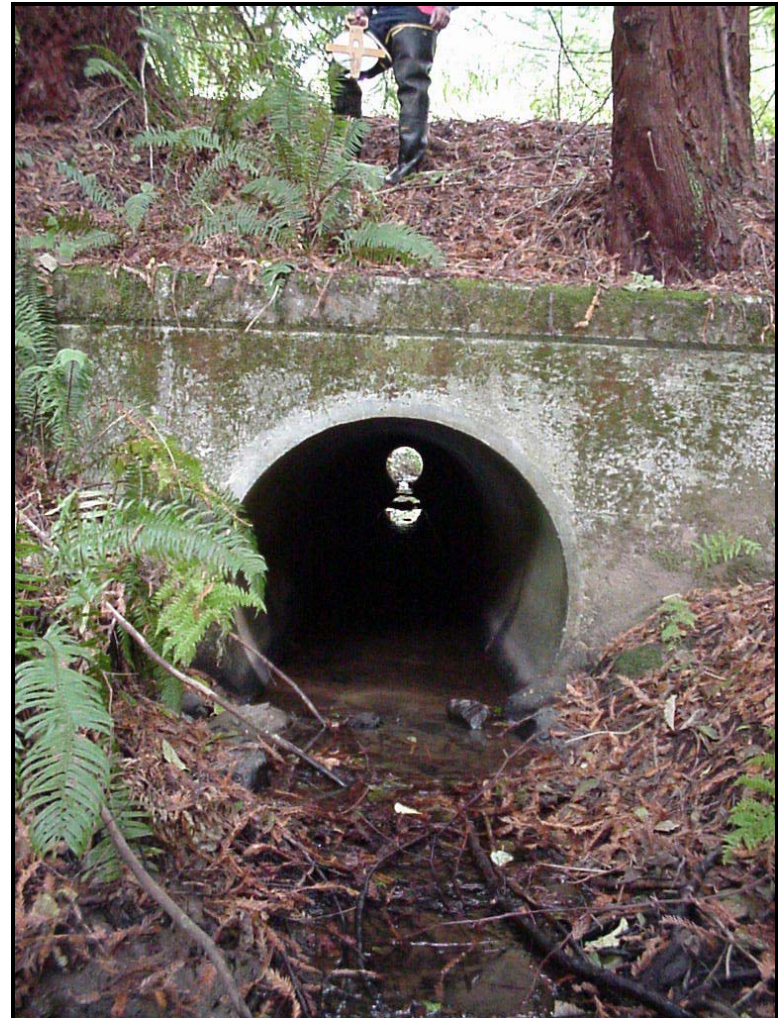
Site #20: Jordan Creek Trib. #8/English Lane; tributary to Lake Earl

**Habitat:** Quantity = approximately 800' of potential fish-bearing habitat above English Lane. Quality = Fair/poor: has year-round flow and riparian canopy of hardwoods, blackberries, and some conifer. Suitable spawning and rearing habitat is limited by the size of the channel. Upstream channel flows through private property; mostly residential houses.

**Preferred Treatment:** when culvert wears-out, replace with a properly-sized arch-culvert on concrete footings or pipe-arch set below stream grade. Reduce length of crossing by reducing road-width (old section of Highway 101).

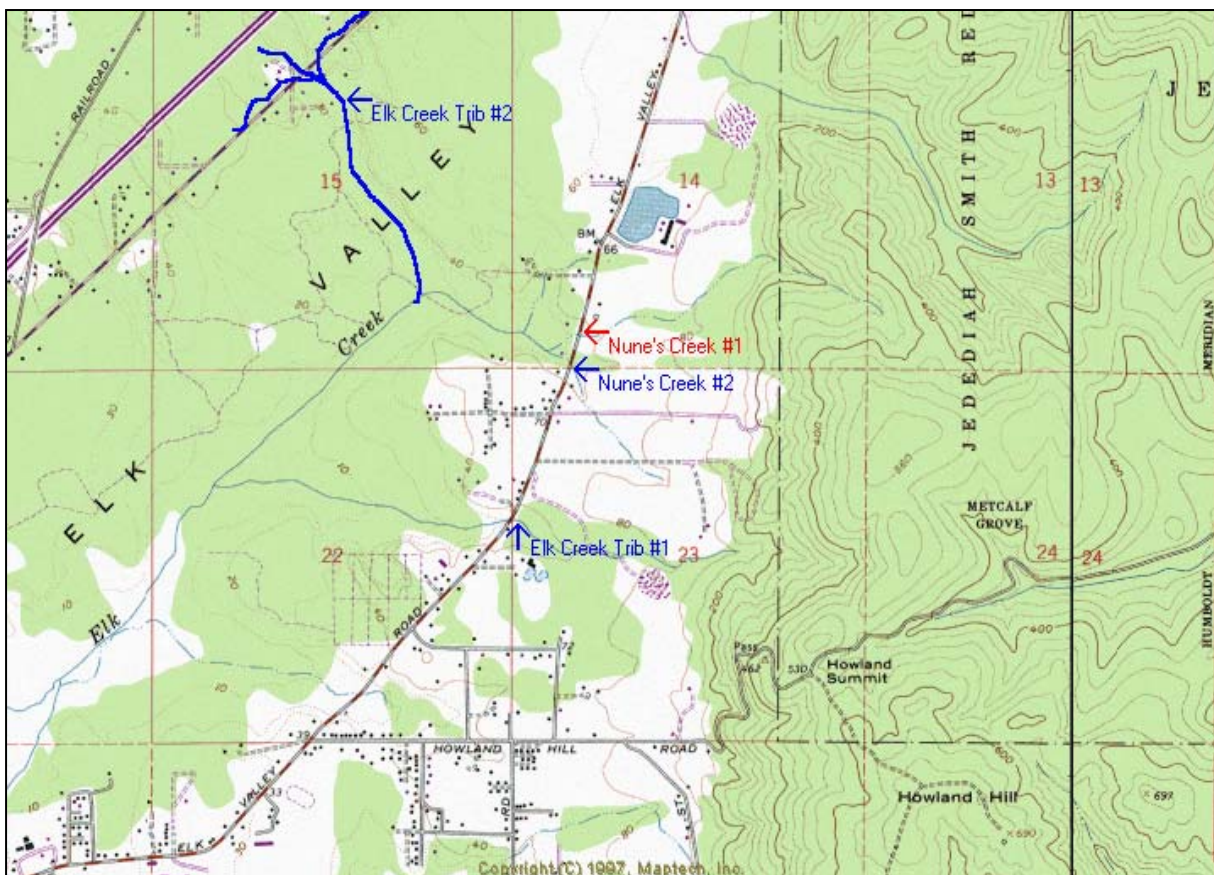
Site #22: Nune's Creek #1/Elk Valley Road; tributary to Elk Creek

**Fill Estimate:** 350 cubic yards. **Overall condition:** Fair, apparent scour and wear of pipe floor.

**Habitat:** Quantity = approximately 2,800' of potential fish-bearing habitat above Elk Valley Road. Quality = Fair. Cool flow of water during late-summer site visit. No current habitat surveys available. Several recent spawning surveys confirmed adult coho salmon and redds above Elk Valley Road (Burgess, pers. com.).

**Preferred Treatment:** when culvert wears-out, replace with a properly-sized arch-culvert on concrete footings or pipe-arch set below stream grade.

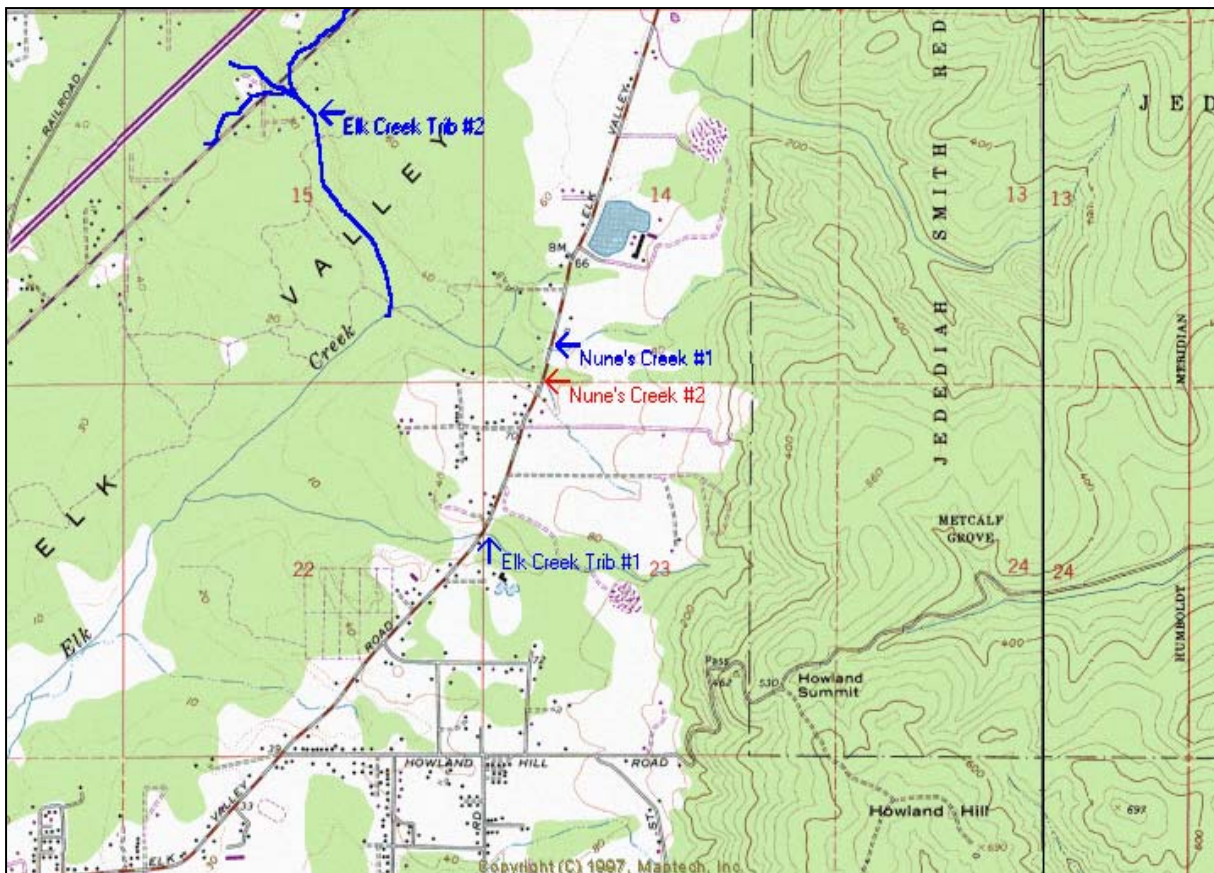
Site #23: Nune's Creek #2/Elk Valley road; tributary to Elk Creek

**Fill Estimate:** 175 cubic yards. **Overall condition:** Good, no apparent wear or damage.

**Habitat:** Quantity = approximately 4,600' of potential fish-bearing habitat above Elk Valley Road. Quality = Fair. Cool flow of water during late-summer site visit. No current habitat surveys available. Several recent spawning surveys confirmed possible coho or steelhead redds above Elk Valley Road (Burgess, pers. com.).

**Preferred Treatment:** when culvert wears-out, replace with a properly-sized arch-culvert on concrete footings or pipe-arch set below stream grade.

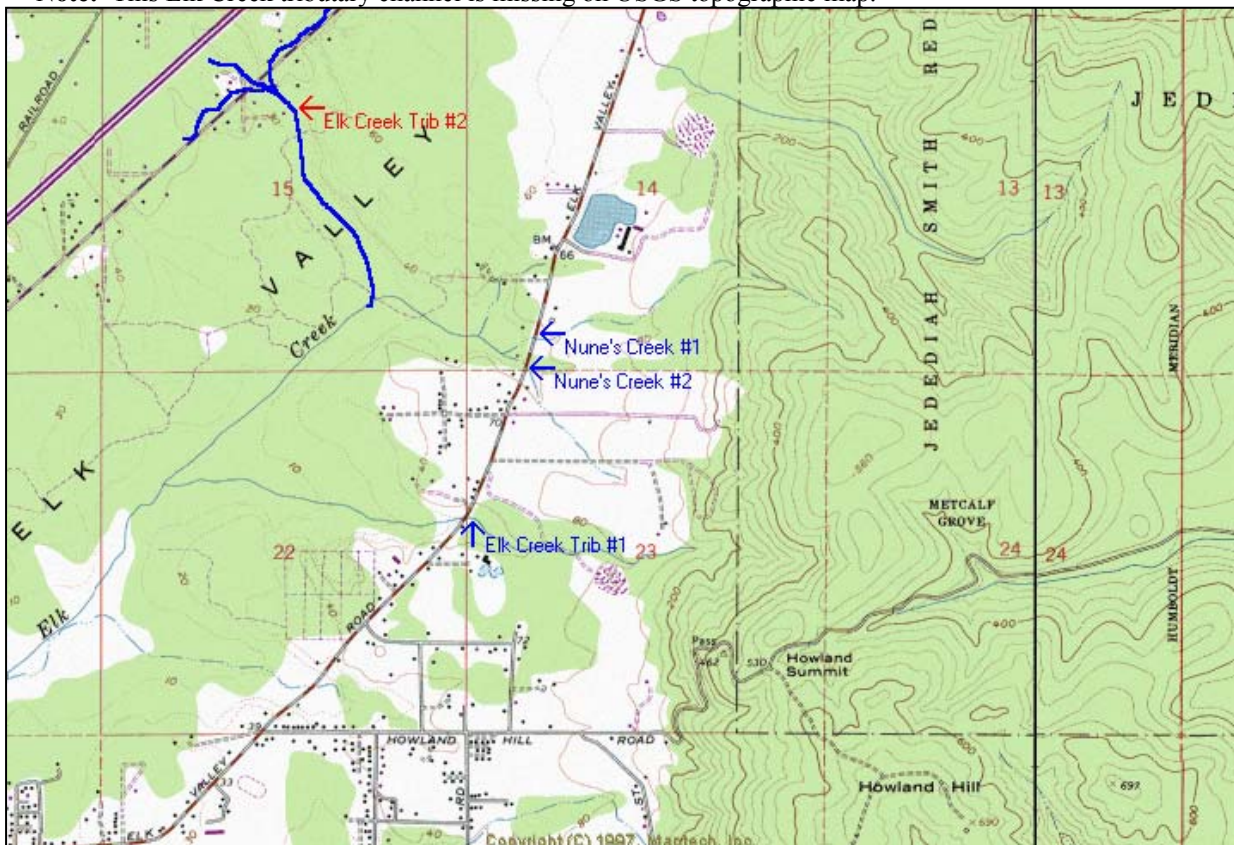
**Site #24:** Elk Creek Tributary #2/Elk View Road; tributary to Elk Creek

**Overall condition:** Good, no apparent wear or damage.

**Habitat:** Quantity = approximately 1,200' of potential fish-bearing habitat above Elk Valley Road. Quality = Fair. Cool flow of water during late-summer site visit with dense riparian zone. Limited spawning and rearing habitat. Dominant substrate is sand. No current habitat surveys available. Several recent spawning surveys confirmed possible coho or steelhead redds downstream of Elk View Road (Burgess, pers. com.). Several resident trout (most likely cutthroat) up to 7" long observed in outlet pool.

**Preferred Treatment:** when culvert wears-out, replace with a properly-sized arch-culvert on concrete footings or pipe-arch set below stream grade.

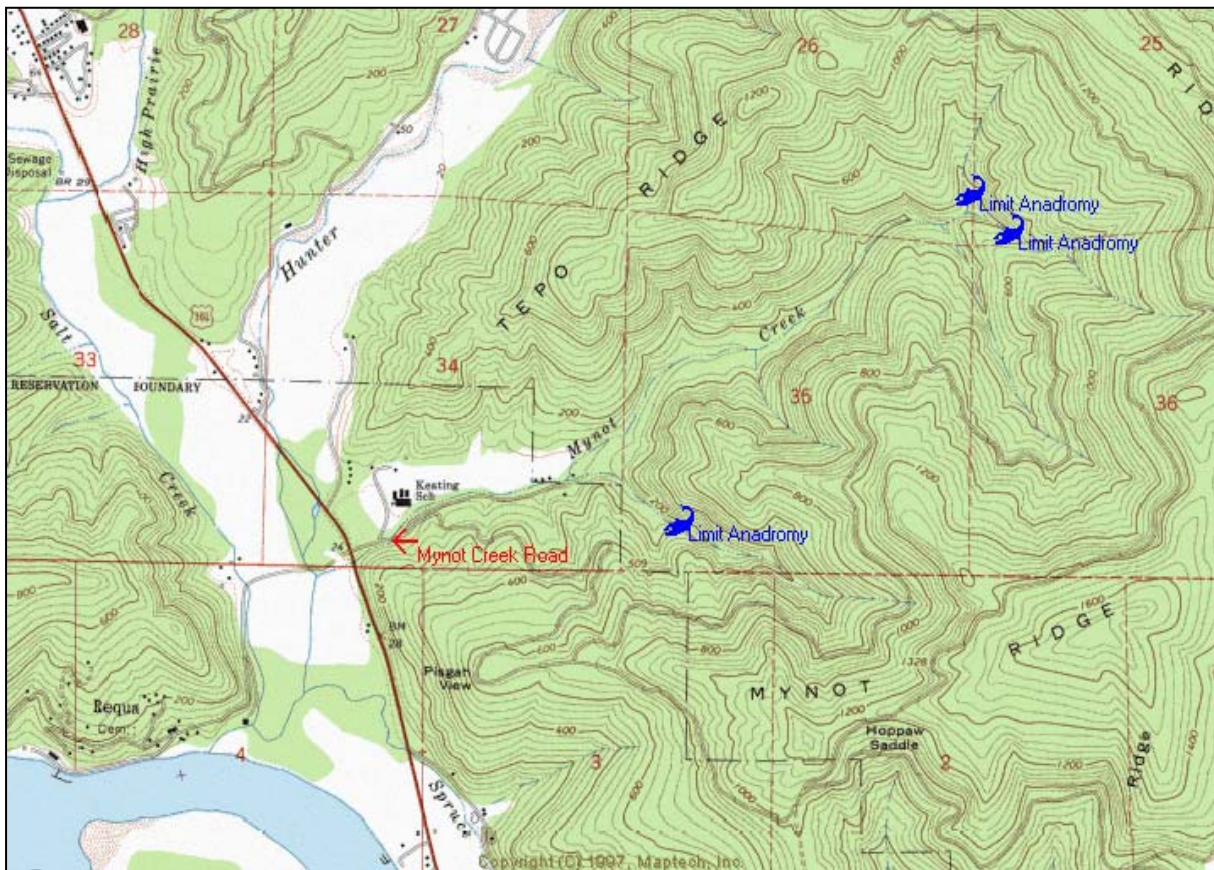
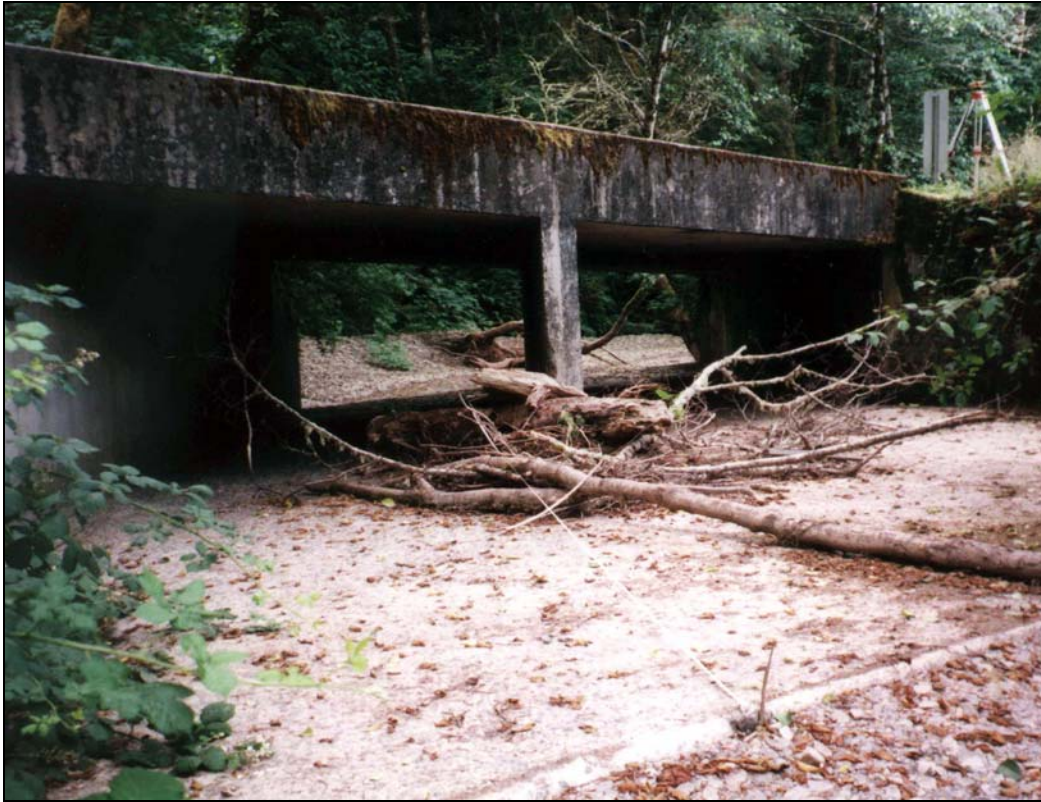
**Site #25: Mynot Creek/Mynot Creek Road; trib to Hunter Creek/ Klamath River**

**Fill Estimate:** No fill within road crossing.    **Overall condition:** Good, no apparent wear or damage.

**Barrier Status:** FishXing determined culvert to be a complete barrier to all adult and juvenile salmonids. Depending on stream flow, barrier is caused by: excessive entry jump required, lack of depth through culvert, and excessive velocities. On 12/13/99 measured velocities of 4.6 ft/sec through left bay. Flow shoots several feet out into outlet pool.

**Habitat:** Quantity = 13,600' of potential fish-bearing habitat above Mynot Creek Road. Quality = Poor; channel is highly aggraded with minimal habitat complexity. Flow is sub-surface during summer. Yurok Tribal biologists have sampled low numbers of juveniles (coho, chinook, steelhead and coastal cutthroat) up to county road crossing – the juvenile salmon were presumed to have migrated up Mynot Creek from lower Hunter Creek (Gale, per. com.). Only resident coastal cutthroat trout and steelhead juveniles were sampled (in low numbers) above Mynot Creek Road.

**Preferred Treatment:** replace with a properly-sized arch-culvert on concrete footings or a bridge.

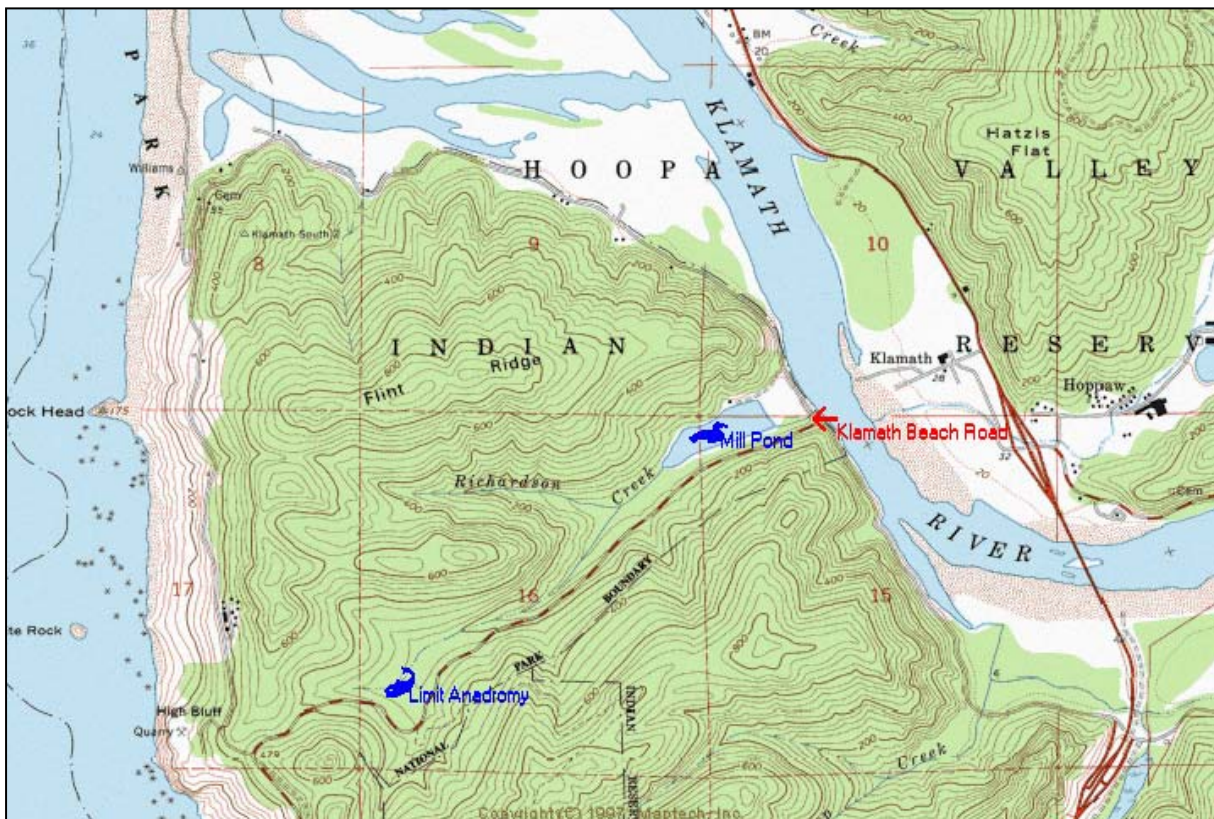
**Overall condition:** Poor, culvert floor is rusted through in places.

**Habitat:** Quantity = 8,900' of potential fish-bearing habitat above Klamath Beach Road. Quality = Poor: channel above mill pond appears in fair condition; dense riparian area and cool flow in summer. However, swamp at upper end of mill pond may prevent salmonid migration. An illegal dump was observed along Alder Camp Road that extends from road down to creek channel. Reports of exotic species (largemouth bass) in pond may impact successful rearing of juvenile salmonids. Yurok Tribal fisheries program has not yet sampled Richardson's Creek (Gale, per. com.).

**Site #26: Richardson's Creek/Klamath Beach Road: Before and After shots of blocked inlet**

**Preferred Treatment:** when culvert wears-out, replace with a properly-sized arch-culvert on concrete footings or pipe-arch set below stream grade. National Park trail located along upstream side of road fill; suggest requesting National Park share cost of upgrading this crossing.

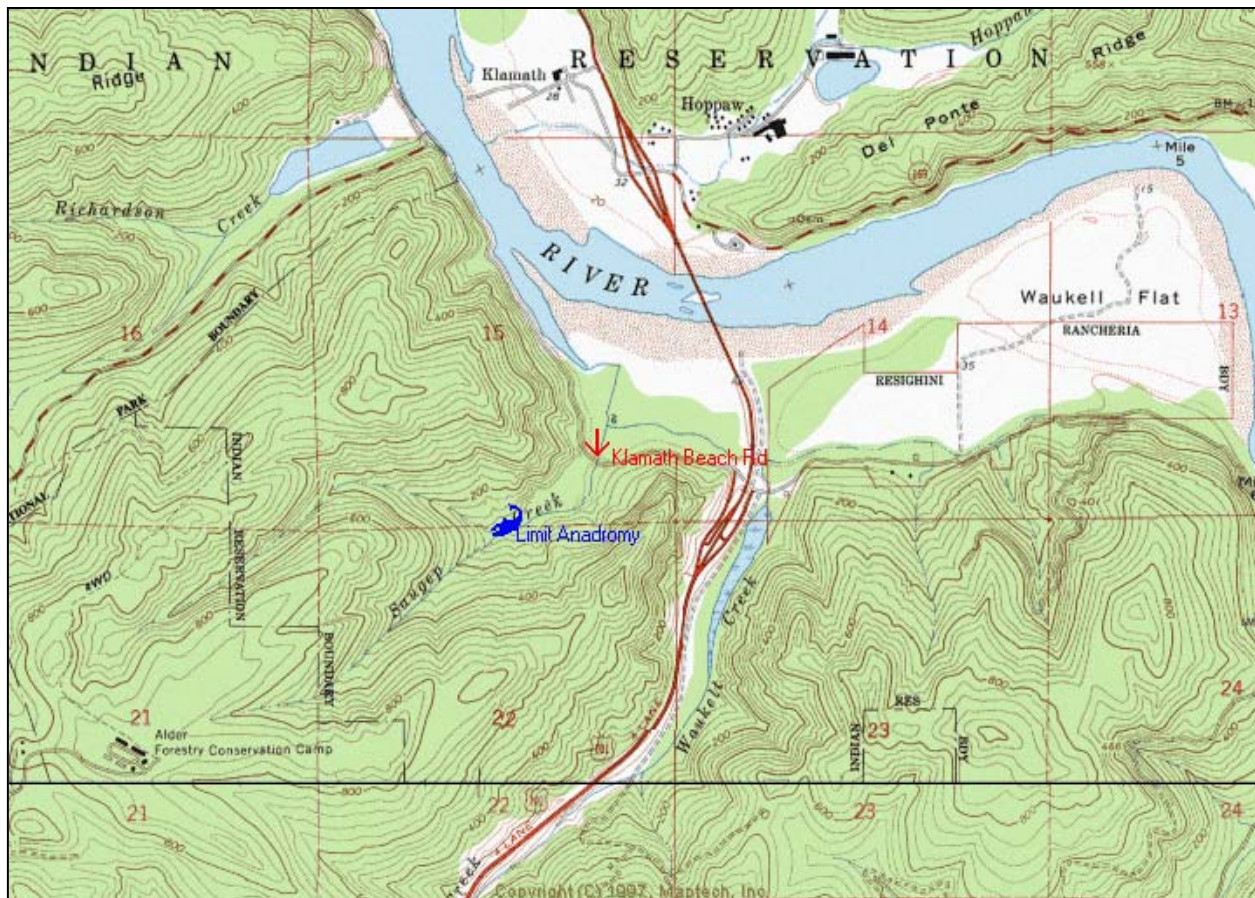
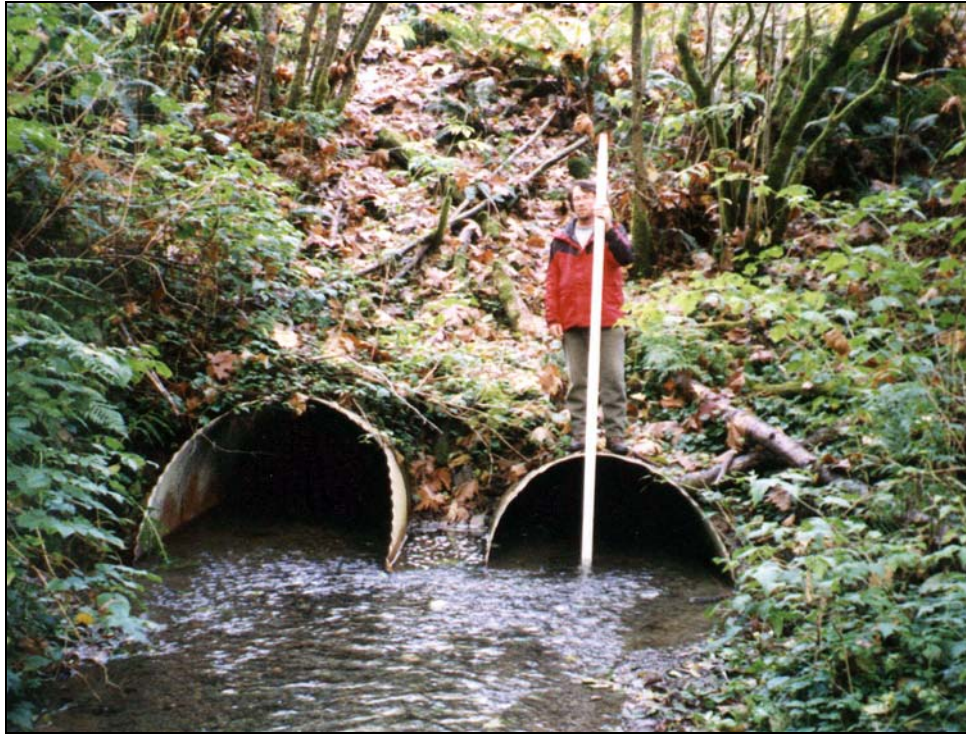
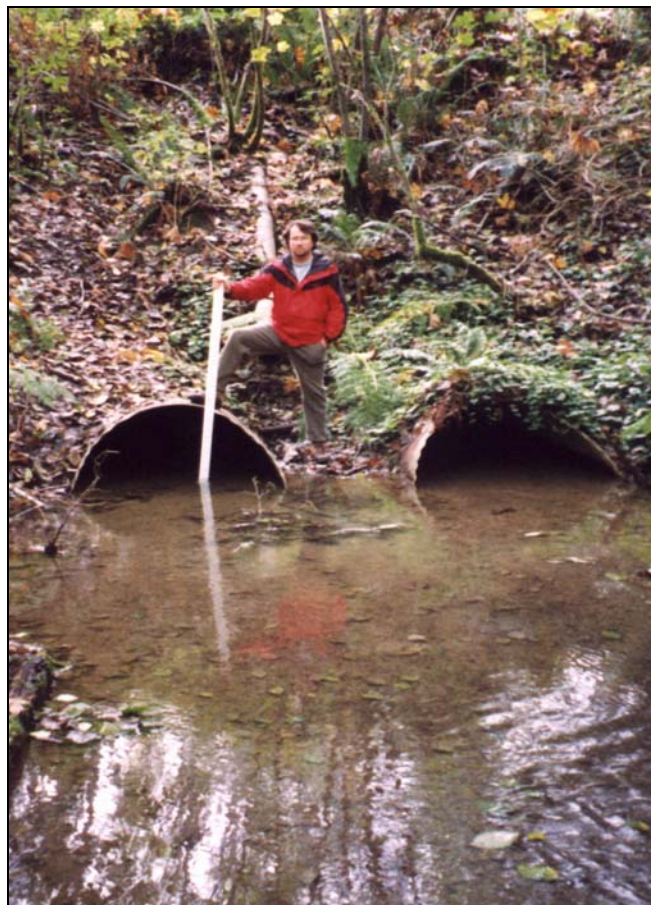
Site #27: Saugep Creek/Klamath Beach Road; trib. to lower Klamath River

**Overall condition:** Poor, pipes are crushed and starting to rust through.

**Habitat:** Quantity = 2,500' of potential fish-bearing habitat above Klamath Beach Road. Quality = Poor; channel appears aggraded with minimal habitat complexity. Has a dense riparian of hardwoods and young conifers. Yurok biologists have sampled low numbers of juvenile chinook, coho, steelhead and cutthroat up to county road crossing (Gale, per. com.). Above the county road only coho (1), steelhead and coastal cutthroat were found in low numbers. Dump adjacent to creek, upstream of Klamath Beach Road.

**Preferred Treatment:** when culvert wears-out, replace with a properly-sized arch-culvert on concrete footings or pipe-arch set below stream grade.
