APPENDIX B:

**CATALOG OF COASTAL MENDOCINO COUNTY
CULVERTS LOCATED ON FISH-BEARING STREAM
REACHES**

NOTE: This catalog contains two pages for each culvert included inventoried. The first page consists of location information, site-specific data, habitat notes, and a map. The second page has inlet and outlet photographs, with the inlet photo on the left side (or top) and the outlet photo on either the right side or bottom. Generally, sites are ordered in their location within Mendocino County from north to south, and from lowermost to uppermost road/stream intersection within a watershed.

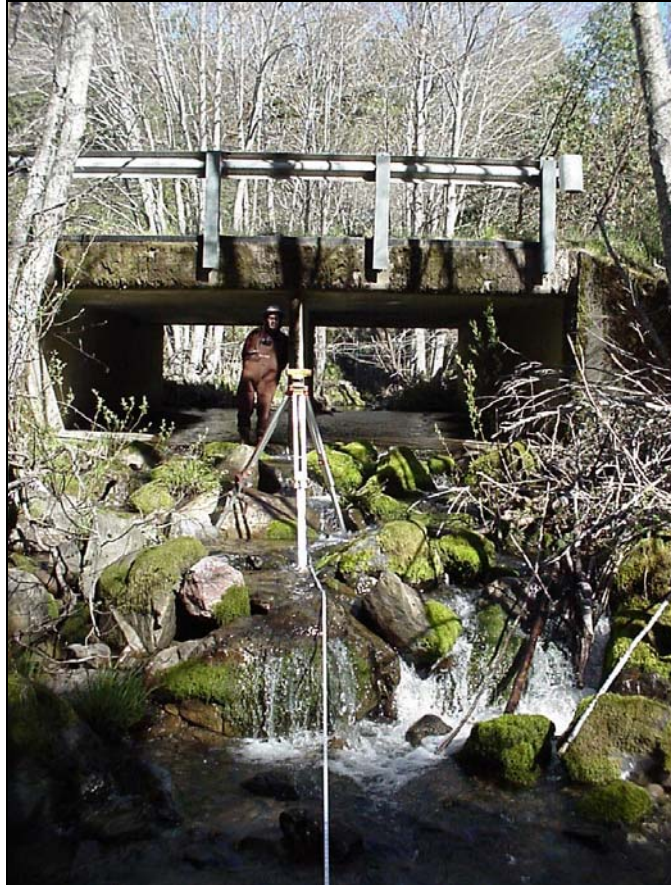
Site #8: Ryan Creek/Ryan Creek Road; Outlet Creek/South Fork Eel River **Ranking: #2 = High Priority**

Fill Estimate: 7,975 cubic yards **Overall condition:** Poor; outlet apron cracked and slumped (see photo).

Barrier Status: For the range of migration flows ($Q_{lp} - Q_{hp}$), FishXing determined crossing is 20% passable for adults (coho salmon, chinook salmon, and steelhead). For juveniles (all age classes) = 100% barrier due to excessive velocities and entry jump required at outlet. Broken concrete apron at outlet is a major impediment to fish migration (Harris, pers. comm.).

Preferred Treatment: Replace existing crossing with a properly-sized bridge or arch-culvert set on concrete footings. Removal of crossing is also an option since access to Highway 101 is possible in either direction.

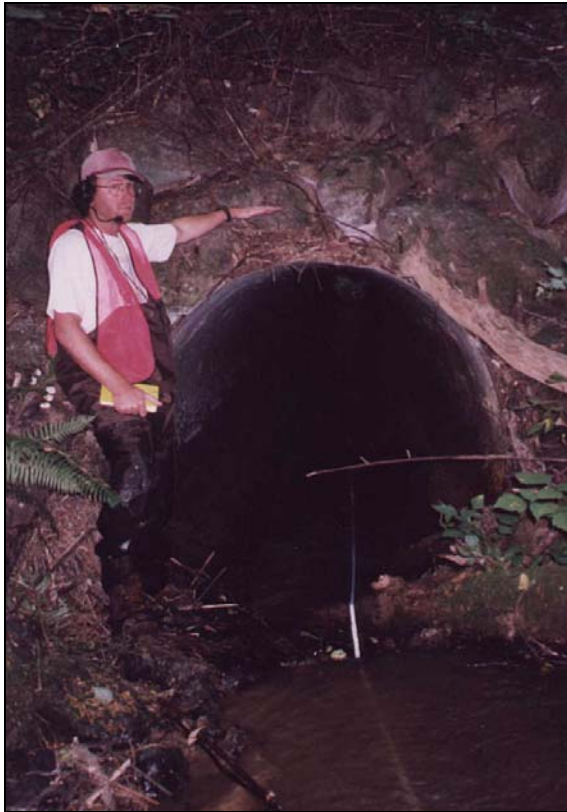
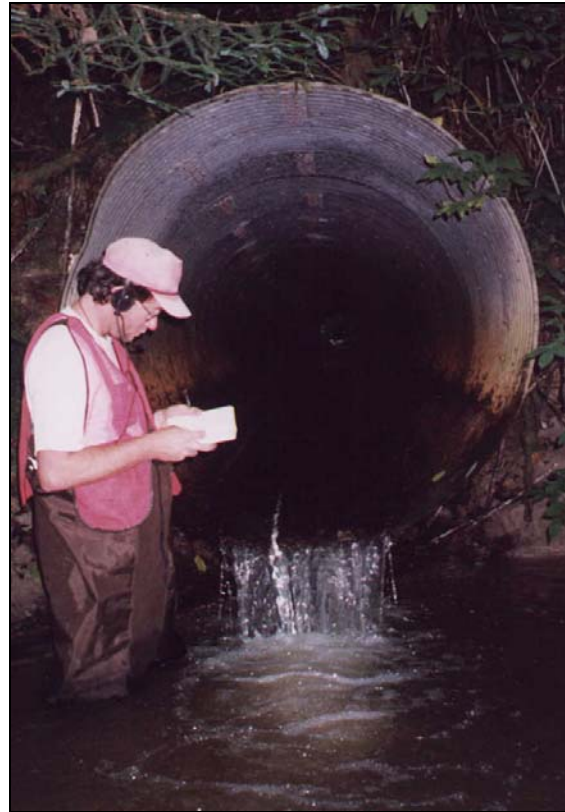
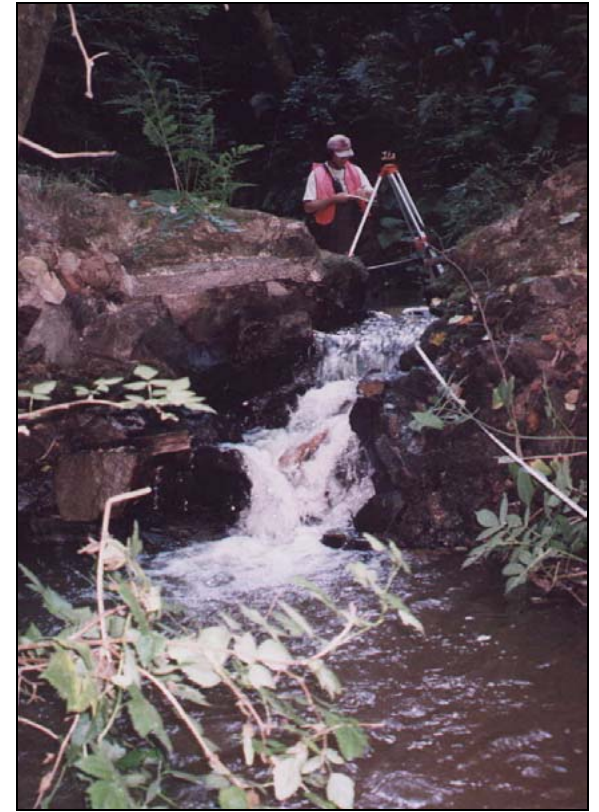
Site #14: Mitchell Creek/Mitchell Creek Road:

Overall condition: Extremely poor; floor is rusted through, heavy seepage of flow under culvert.

Preferred Treatment: Replace with bridge or properly-sized bottomless arch-culvert.

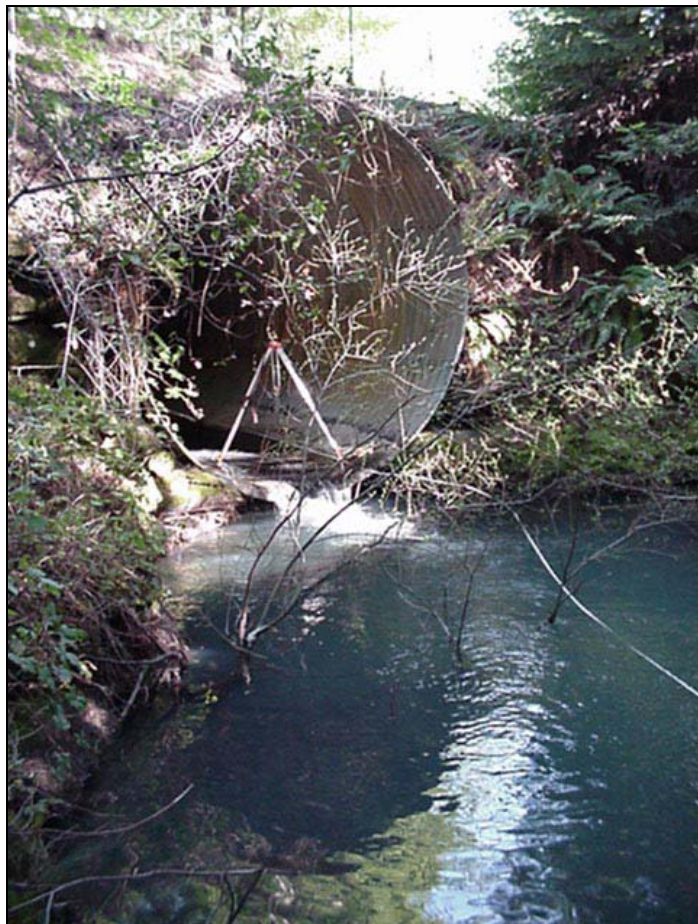
Site #19: Albion River/Flynn Creek Road; Albion River

Fill Estimate: 2,663 cubic yards **Overall condition:** Fair, floor rusted-out, but the lined with concrete.

Barrier Status: For the range of migration flows ($Q_{lp} - Q_{hp}$), FishXing determined culvert is a total barrier to adult coho salmon and steelhead and all age classes of juveniles due primarily to excessive velocities over the smooth concrete lining, lack of depth at lower migration flows, and leap required to enter culvert. On 2/24/00, observed moderate velocities, 4" depth in culvert and 1.5' drop at outlet. However, on 3/30/00 observed numerous newly-emerged fry in channel margins above and below Flynn Creek Road.

Preferred Treatment: Properly-sized bridge or pipe-arch set on concrete footings.
