APPENDIX B:
CATALOG OF SISKIYOU COUNTY CULVERTS LOCATED ON
FISH-BEARING STREAM REACHES

Prepared for the Siskiyou County Public Works Department

By
Ross Taylor and Associates
1254 Quail Run Court
McKinleyville, CA. 95519
(707)-839-5022
rtaylor@humboldt1.com

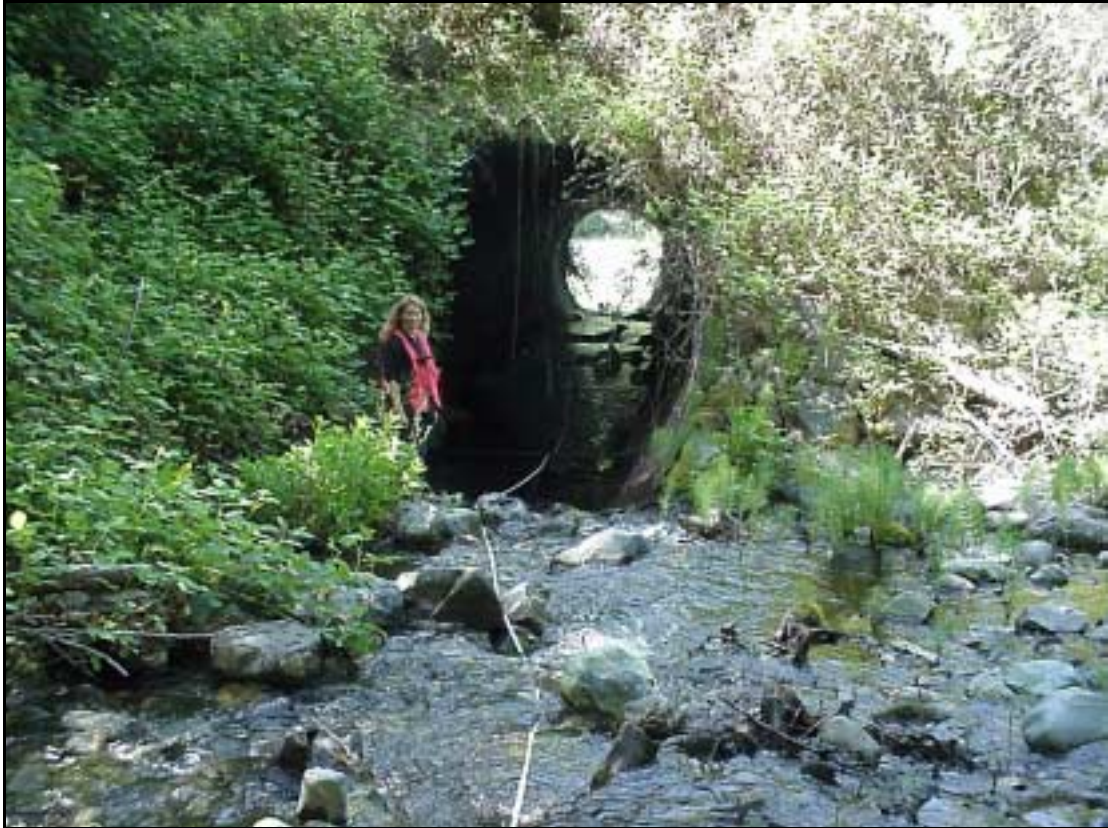
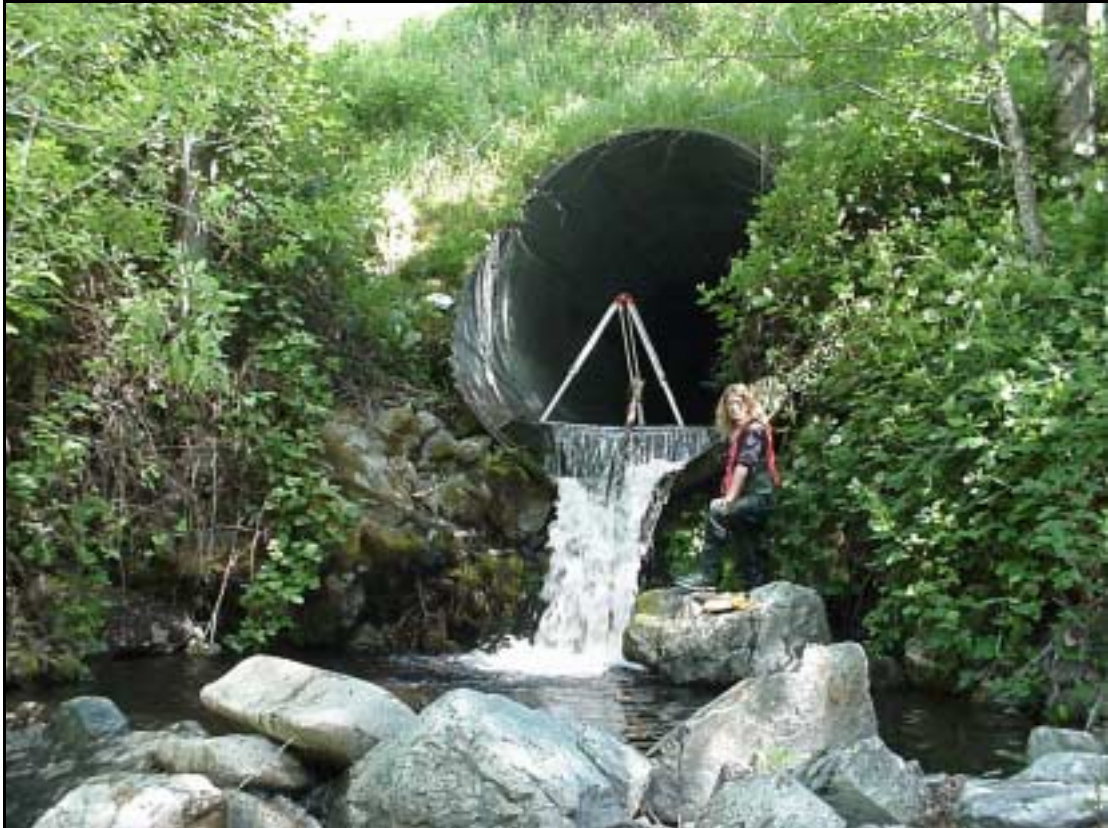
Site #1: Merrill Creek/ Salmon River Road; Salmon River; Klamath River

Modifications: notched, steel-plate weirs within culvert, mostly non-functional because of storm damage.

Fill Estimate: 3,457 cubic yards **Overall condition:** Fair, culvert has abraded bottom, and some damage to inlet.

Barrier Status: **RED:** the Green-Gray-Red filter determined this crossing fails to meet passage criteria for all species of adult salmonids and all age classes of juveniles. The extremely perched outlet is the main feature that prevents fish migration. The outlet pool also lacks depth for fish to execute a successful leap attempt.

Preferred Treatment: Properly-sized bridge or arch-culvert set on concrete footings.

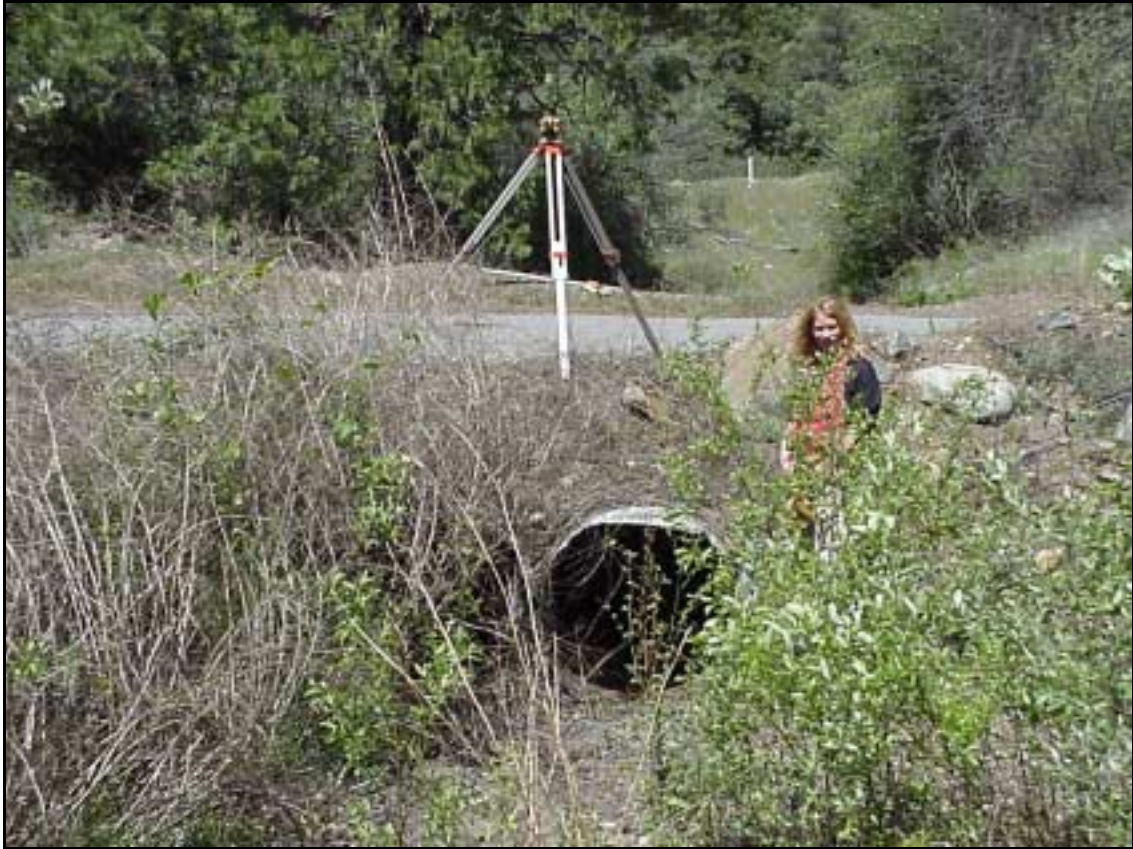
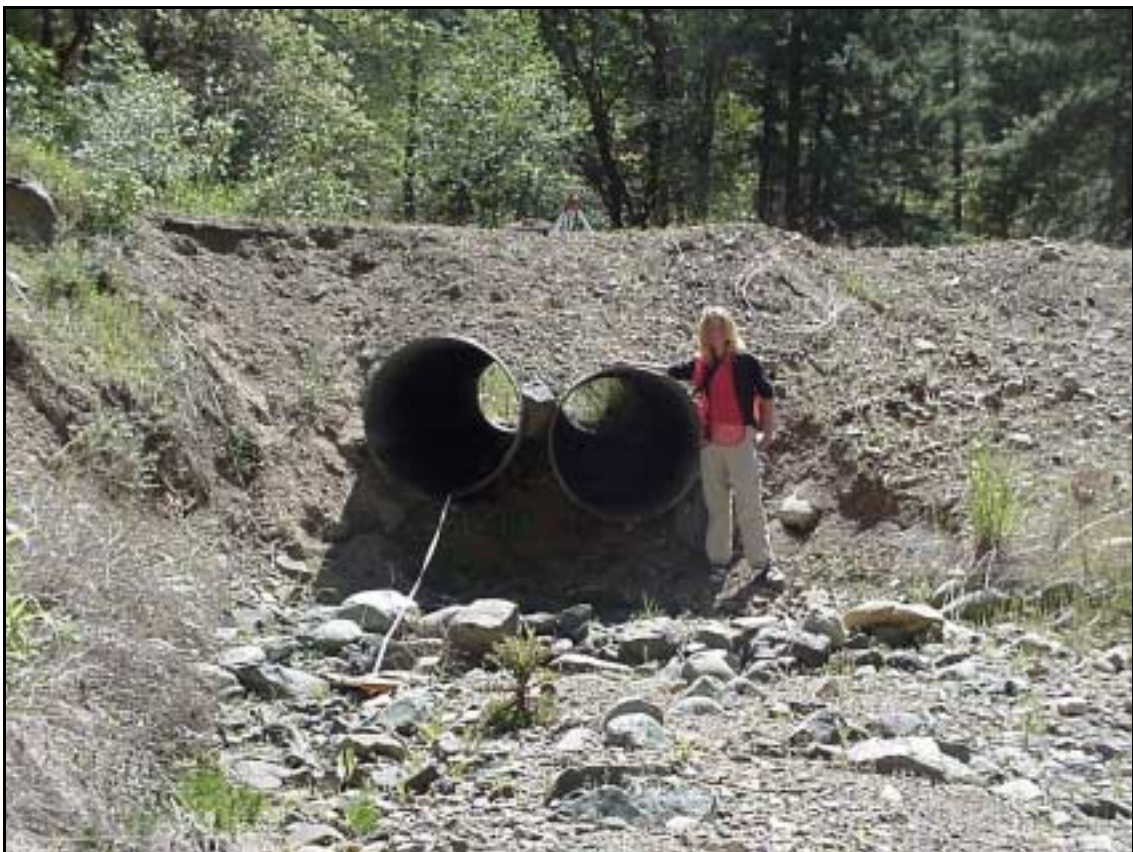
Site #2: Hotelling Gulch/Callahan-Cecilville Road; South Fork Salmon River; Salmon River; Klamath River

Modifications: None. **Fill Estimate:** 158 cubic yards **Overall condition:** Fair, both culverts have abraded bottoms.

Barrier Status: **RED:** the Green-Gray-Red filter determined this crossing fails to meet passage criteria for all species of adult salmonids and all age classes of juveniles.

Preferred Treatment: Properly-sized bridge or arch-culvert set on concrete footings. Proper treatment of this site should consider feasibility of relocating stream channel back into its natural/original location. Remains of an abandoned bridge (or box culvert) and channel are evident approximately 500' down road towards the Forks of Salmon.

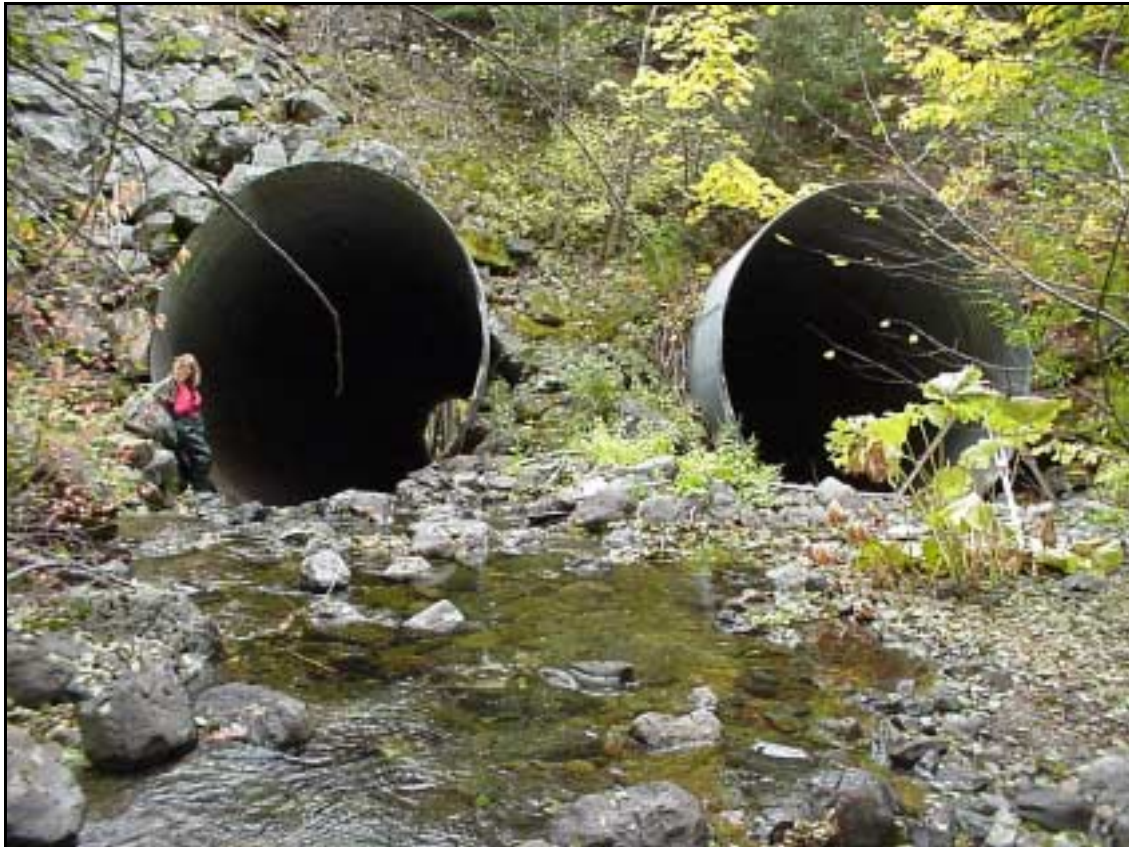
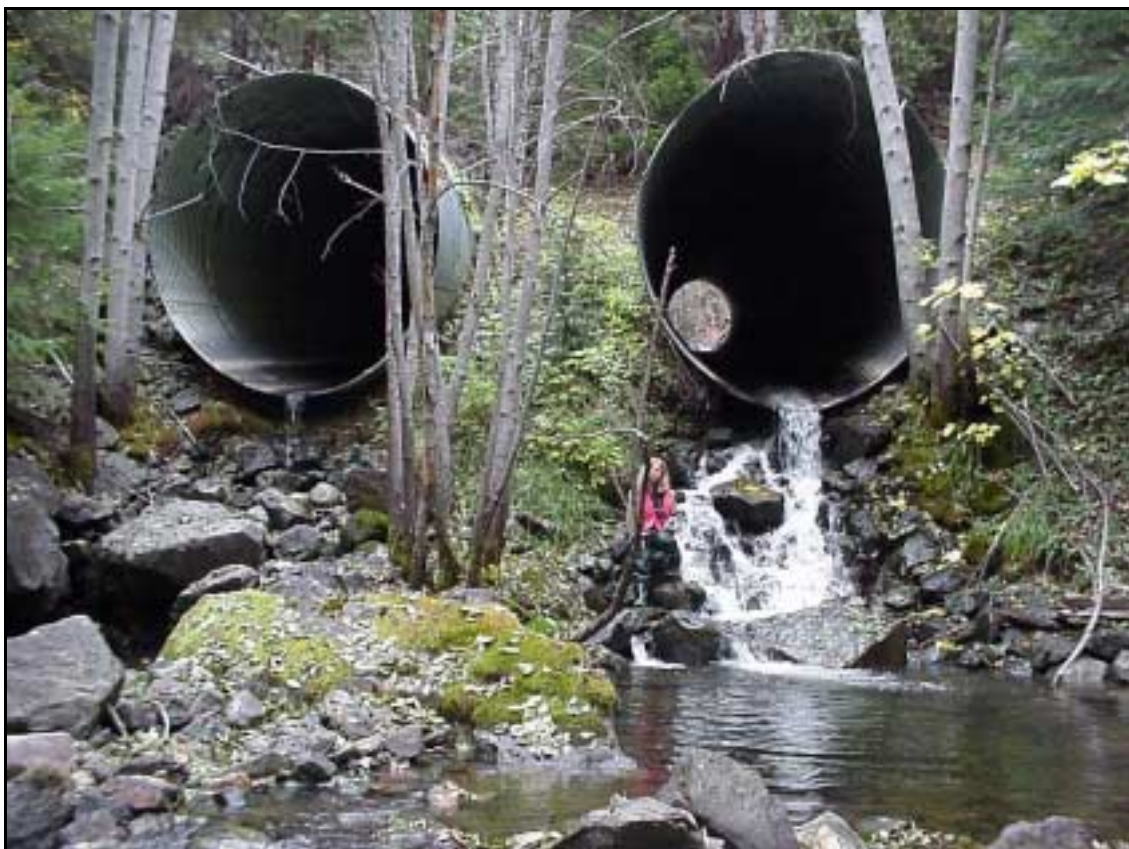
Site #3: Sixmile Creek/Callahan-Cecilville Road; South Fork Salmon River; Salmon River; Klamath River

Modifications: None. **Fill Estimate:** 8,172 cubic yards **Overall condition:** Good.

Barrier Status: **RED:** the Green-Gray-Red filter determined this crossing fails to meet passage criteria for all species of adult salmonids and all age classes of juveniles. Excessive drop at both outlets (perched about eight feet) and excessive slopes are the main features of this crossing that prevent fish migration.

Preferred Treatment: No treatment recommended because: current culverts are in good condition and properly sized; high cost and difficulty of providing passage; and stream has limited potential for anadromous fisheries.

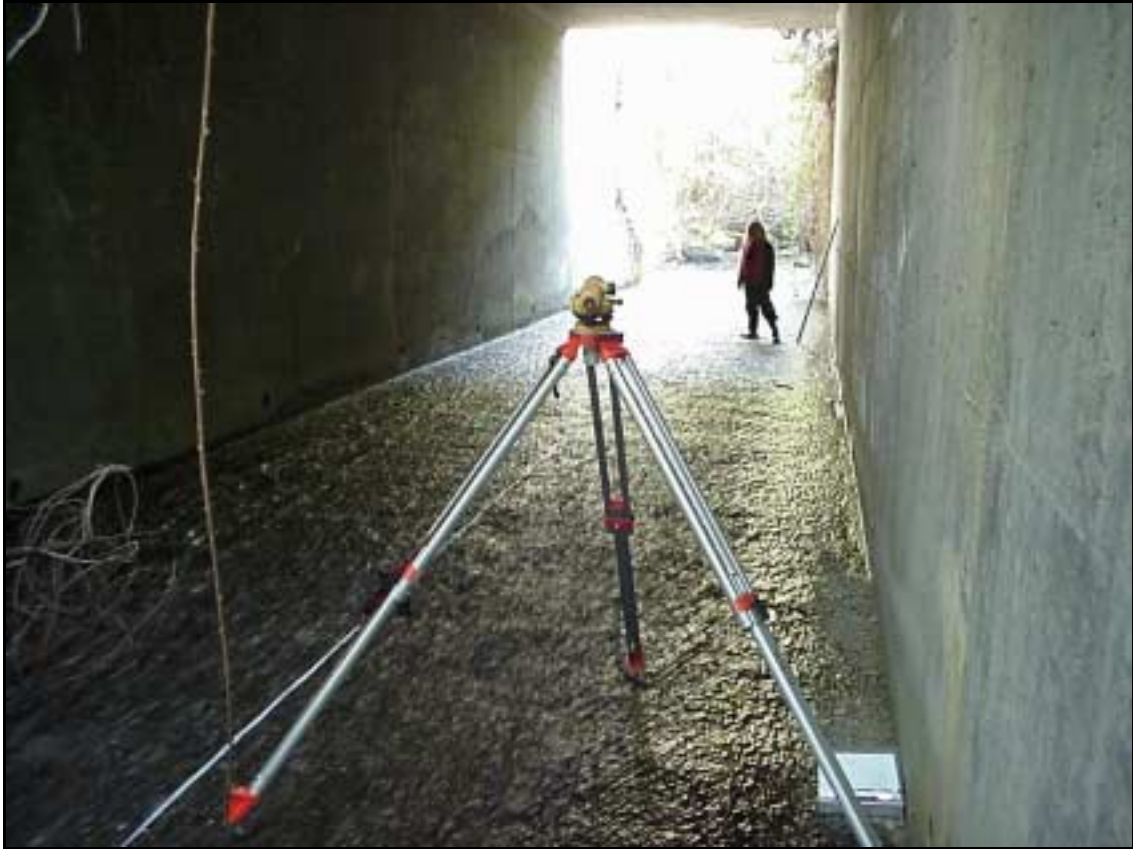
Site #5: Cronan Gulch/Sawyer's Bar Road; North Fork Salmon River; Salmon River; Klamath River

Slope: 17.55%. **Modifications:** None. **Fill Estimate:** 891 cubic yards. **Overall condition:** Good.

Barrier Status: **RED:** the Green-Gray-Red filter determined this crossing fails to meet passage criteria for all species of adult salmonids and all age classes of juveniles. Excessive slope and lack-of-depth are crossing features that create migration barrier.

Preferred Treatment: None recommended. This adequately sized crossing is a migration barrier, yet there is insignificant fisheries habitat upstream due to the steep natural channel slope.

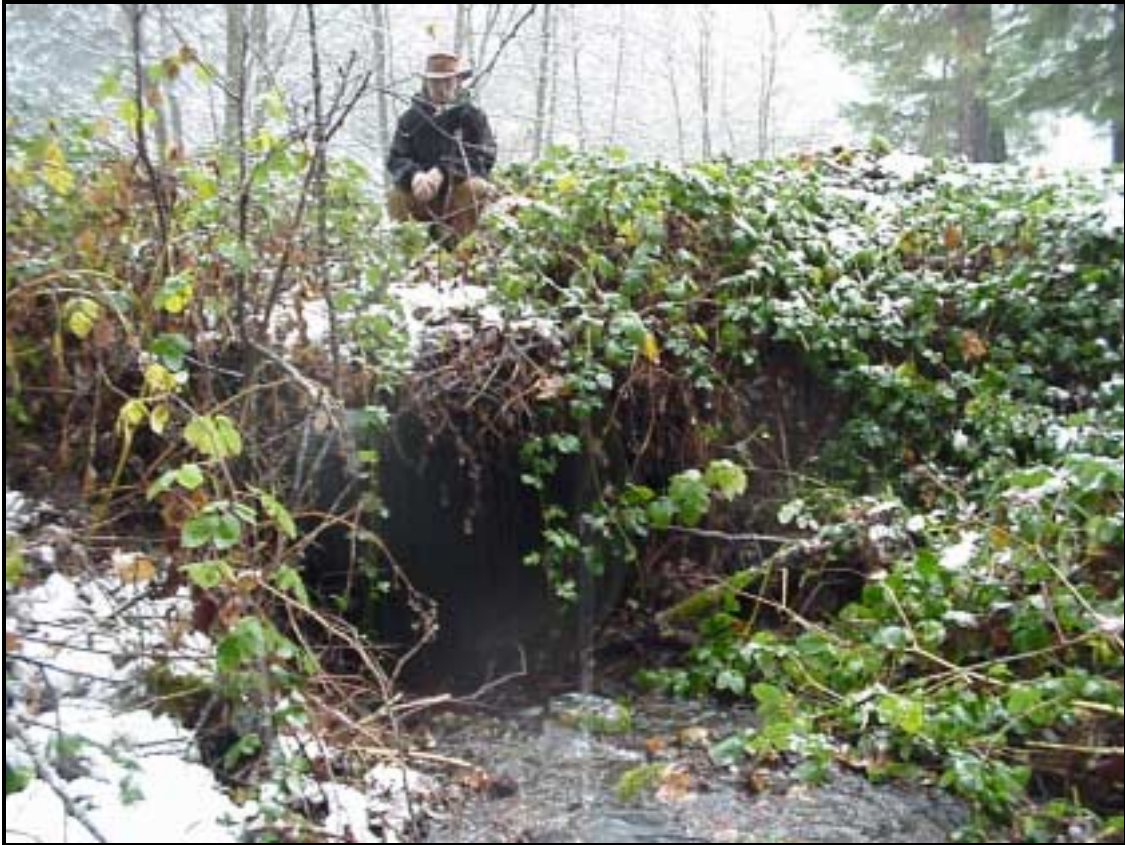
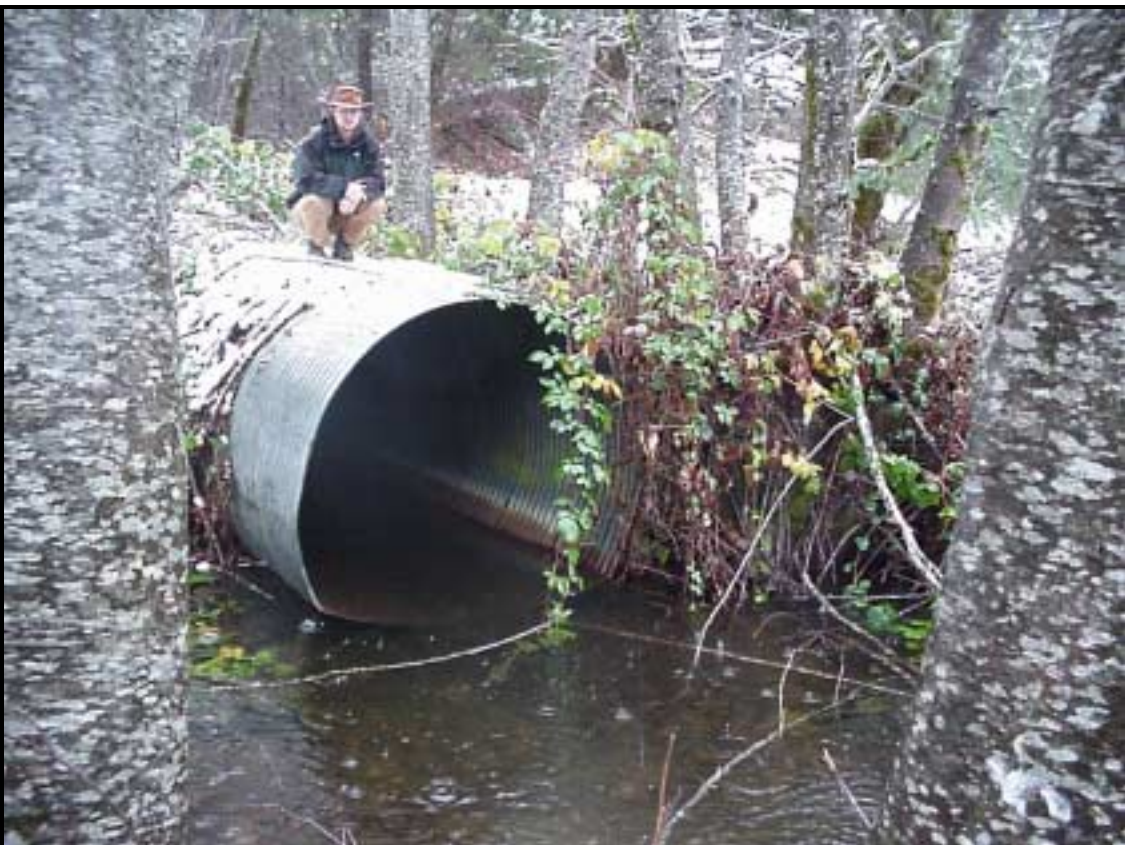
Site #6: Kelly Gulch/Sawyer's Bar Road; North Fork Salmon River; Salmon River; Klamath River

Modifications: None. **Fill Estimate:** 243 cubic yards. **Overall condition:** Fair, culvert floor is abraded.

Barrier Status: **RED:** the Green-Gray-Red filter determined this crossing fails to meet passage criteria for all species of adult salmonids and all age classes of juveniles. Excessive slope and lack-of-depth are the crossing's features that create migration barrier.

Preferred Treatment: Properly-sized bridge or arch-culvert set on concrete footings. Treatment project should also address the Forest Service spur road immediately downstream of the county road and reconstruction of the downstream channel to reconnect Kelly Gulch with the North Fork Salmon River.

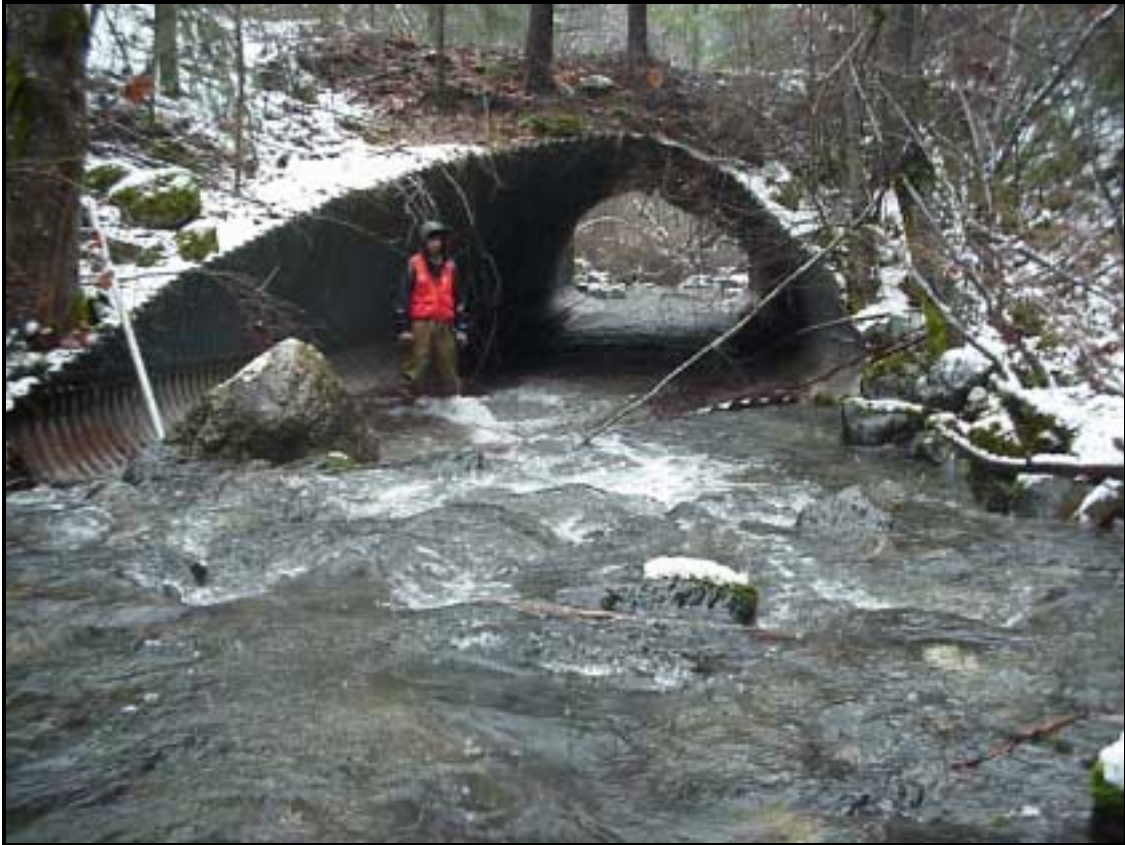
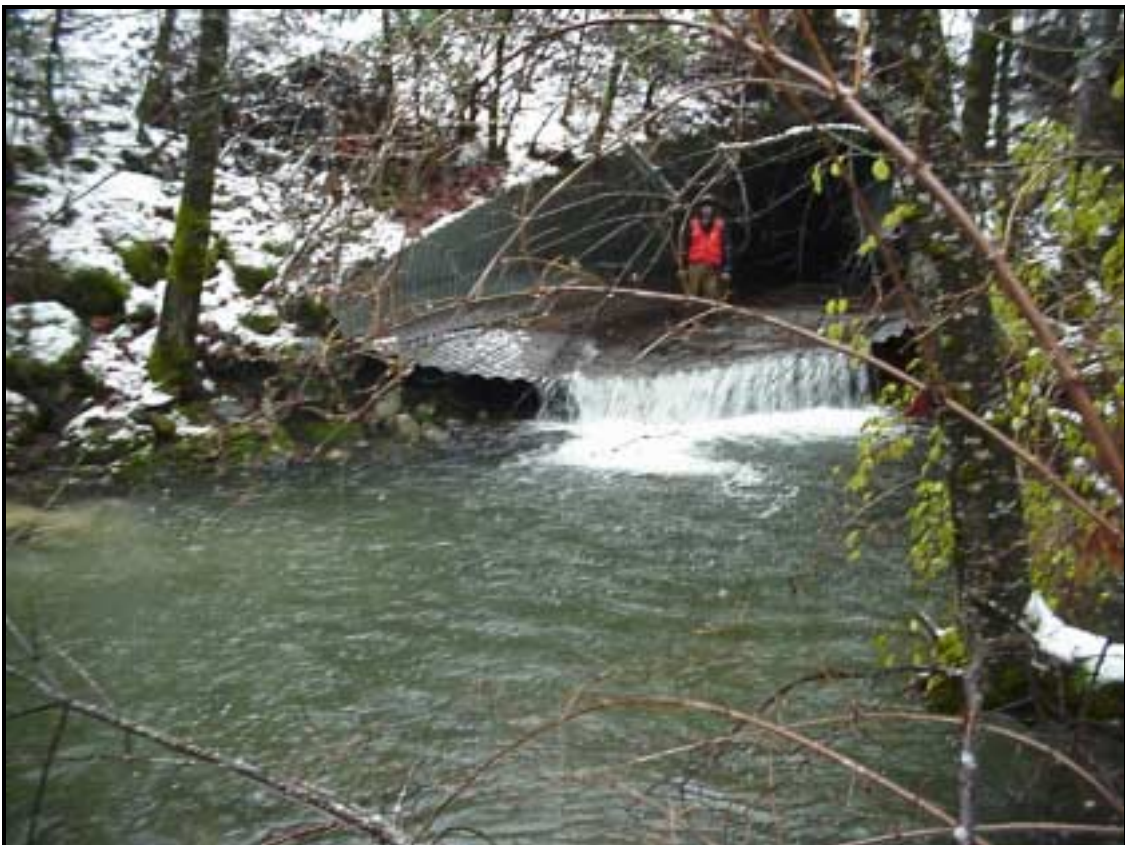
Site #7: Whites Gulch/Whites Gulch Road; North Fork Salmon River; Salmon River; Klamath River

Modifications: None. **Fill Estimate:** 1,999 cubic yards. **Overall condition:** Fair.

Barrier Status: **RED:** the Green-Gray-Red filter determined this crossing fails to meet passage criteria for all species of adult salmonids and all age classes of juveniles. Excessive slope and lack-of-depth are crossing's features that create migration barrier. Outlet is also perched.

Preferred Treatment: Due to size of drainage area above the county road, the potential for high-intensity rain and rain-on-snow events, and the remote location; a properly-sized bridge is the preferred treatment.

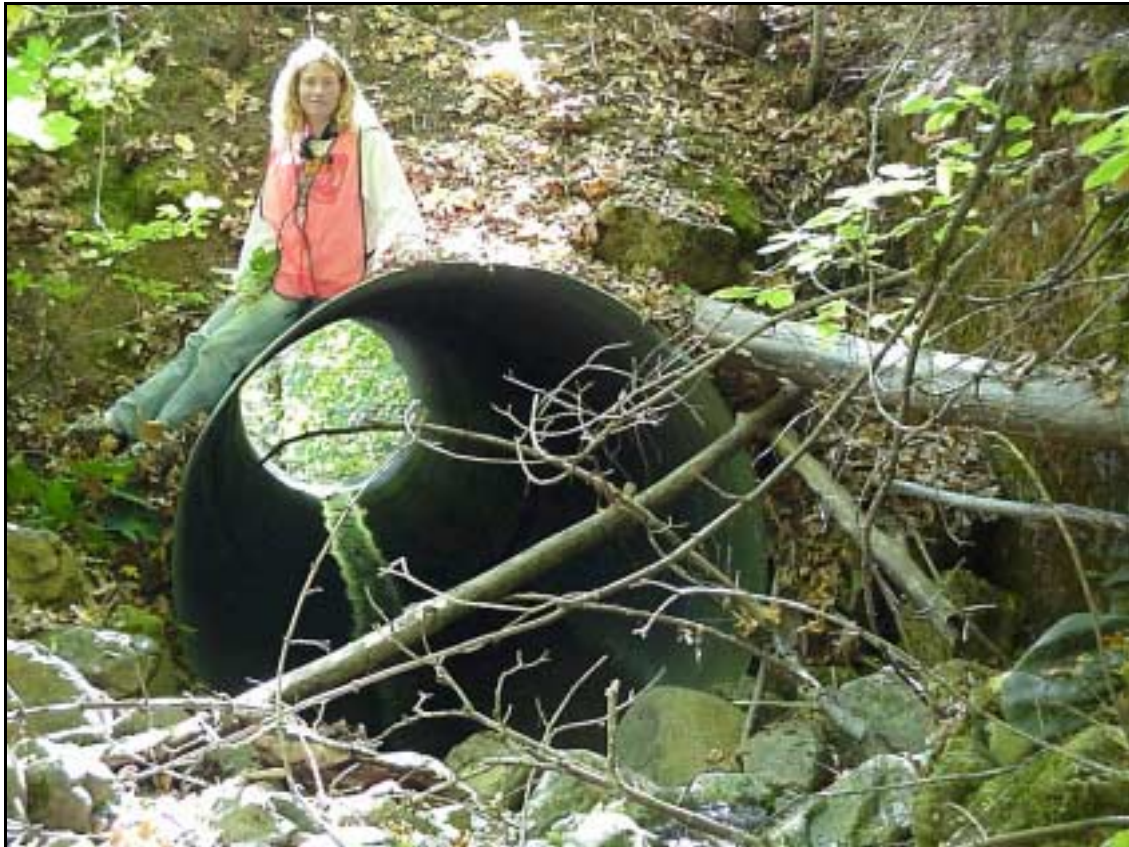
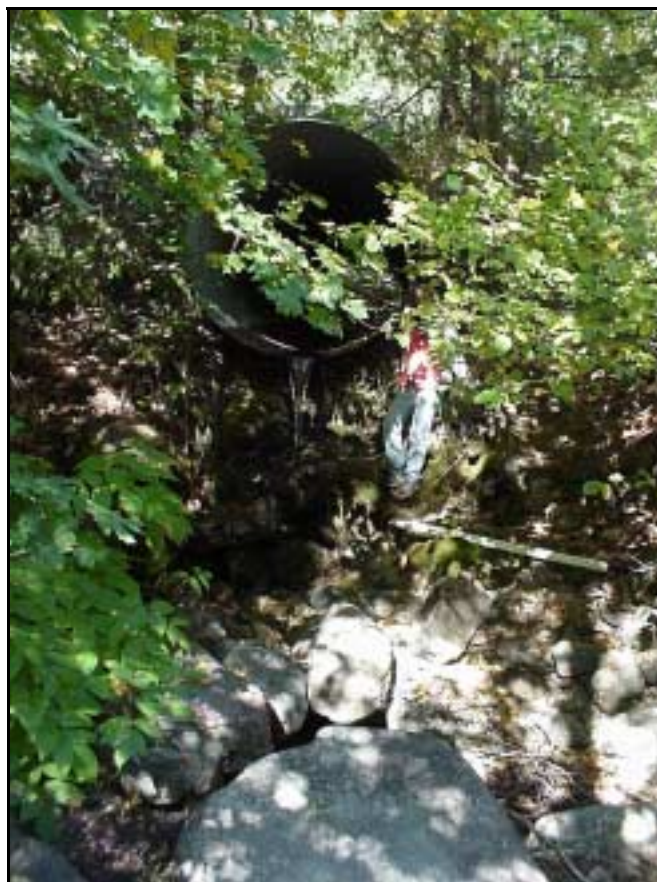
Site #8: Robinson Gulch/Sawyer's Bar Road; North Fork Salmon River; Salmon River; Klamath River

Modifications: None. **Fill Estimate:** 819 cubic yards. **Overall condition:** Good, no apparent signs of wear.

Barrier Status: **RED:** the Green-Gray-Red filter determined this crossing fails to meet passage criteria for all species of adult salmonids and all age classes of juveniles. Excessive slope and perched outlet are crossing's features that create migration barrier.

Preferred Treatment: When site is due for replacement (or fails) construct either a properly-sized bridge or arch-culvert set on concrete footings. The limited amount of upstream habitat makes this site a poor candidate for treatment with fisheries restoration funds.

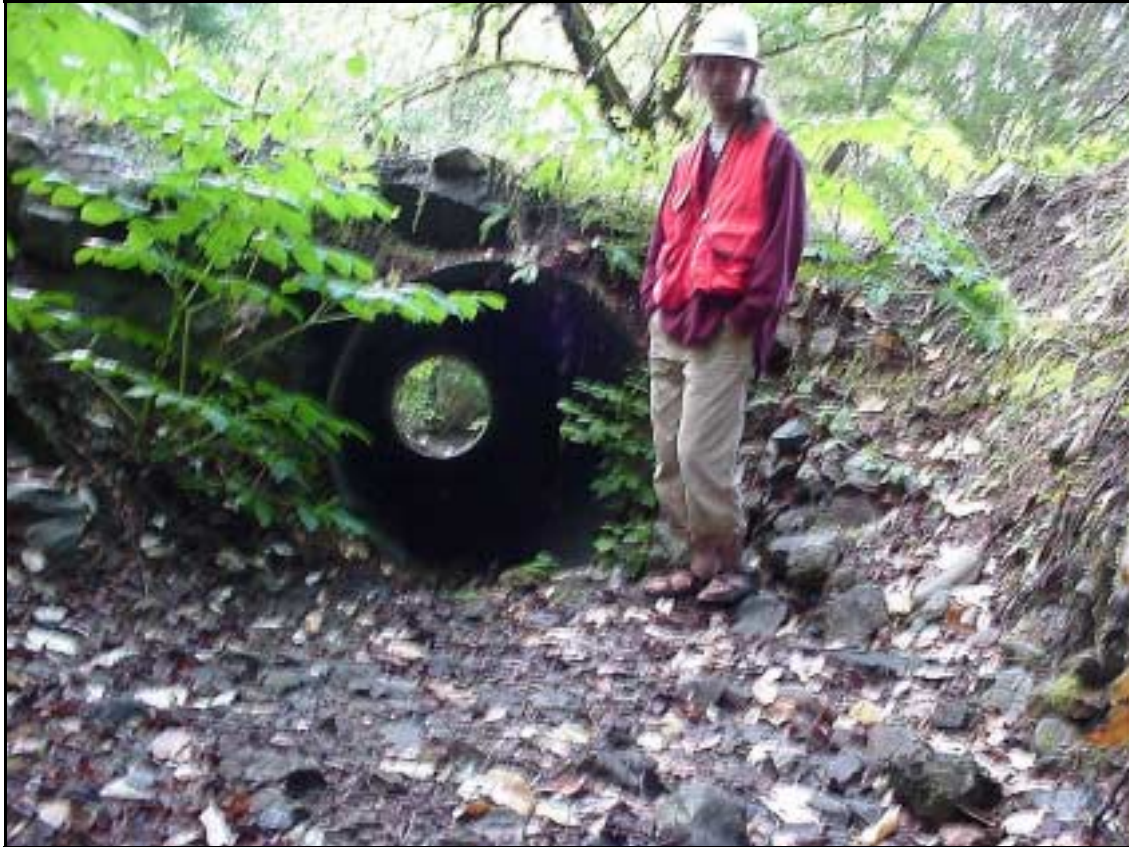
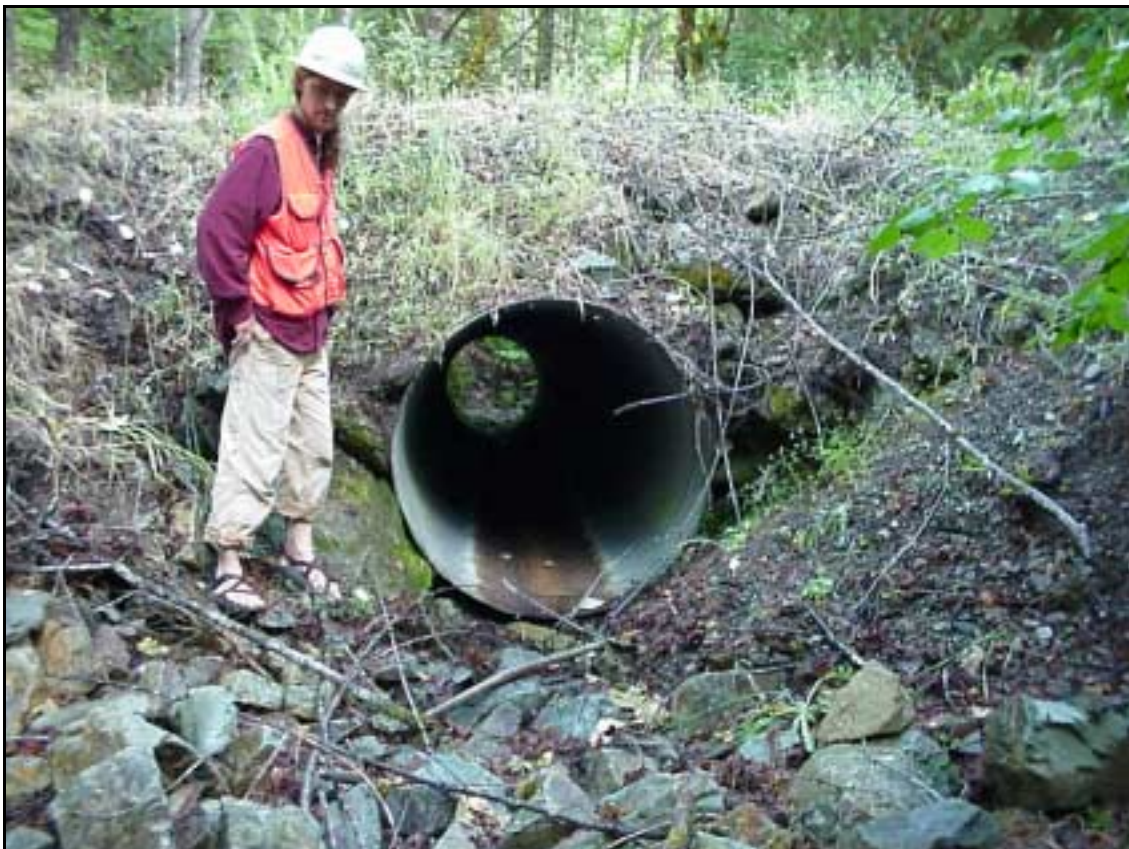
Site #9: Ottley Gulch/China Road; Klamath River.

Slope: 6.65%. **Modifications:** None. **Fill Estimate:** 110 cubic yards. **Overall condition:** Fair, culvert floor is rusted and abraded throughout.

Barrier Status: **RED:** the Green-Gray-Red filter determined this crossing fails to meet passage criteria for all species of adult salmonids and all age classes of juveniles. Excessive slope is the crossing's feature that creates a migration barrier.

Preferred Treatment: When crossing is due for replacement (or fails) replace with a properly-sized embedded circular SSP pipe or an arch-culvert set on concrete footings. Lack of upstream fisheries benefit makes this site a poor candidate for replacement with fisheries restoration funds.

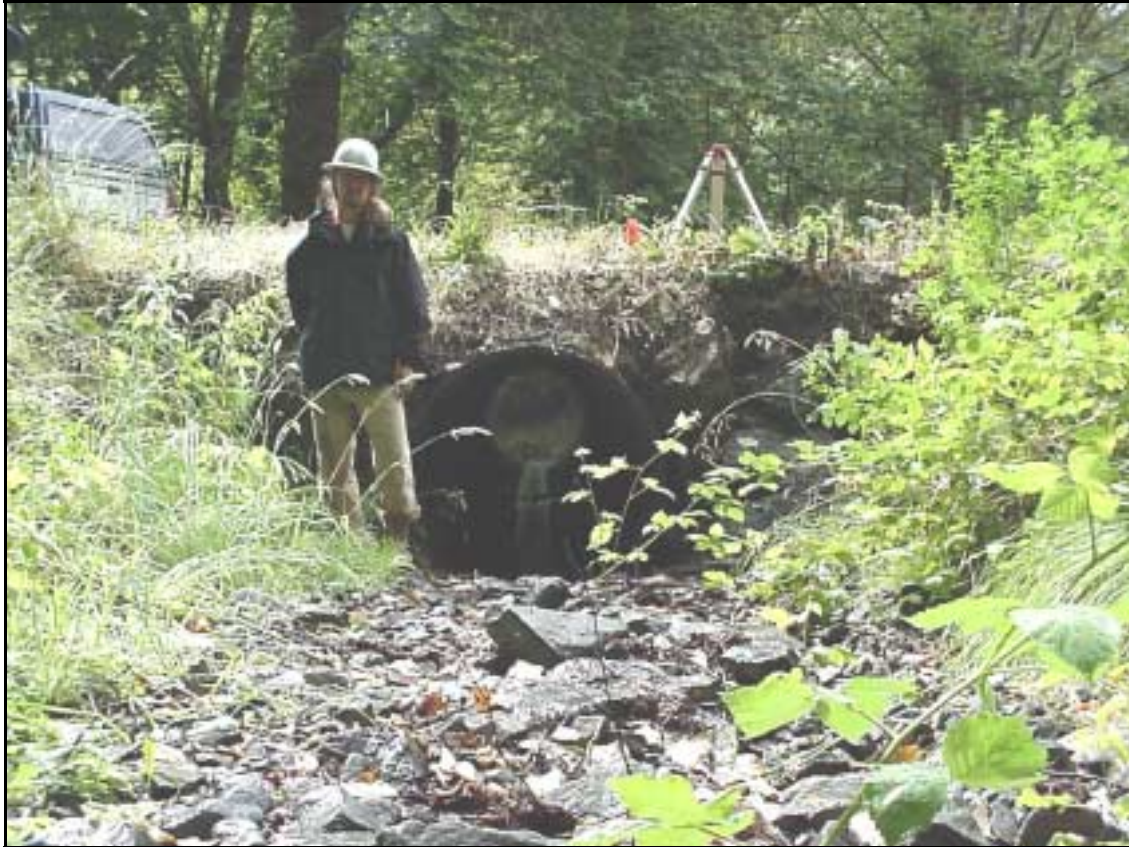
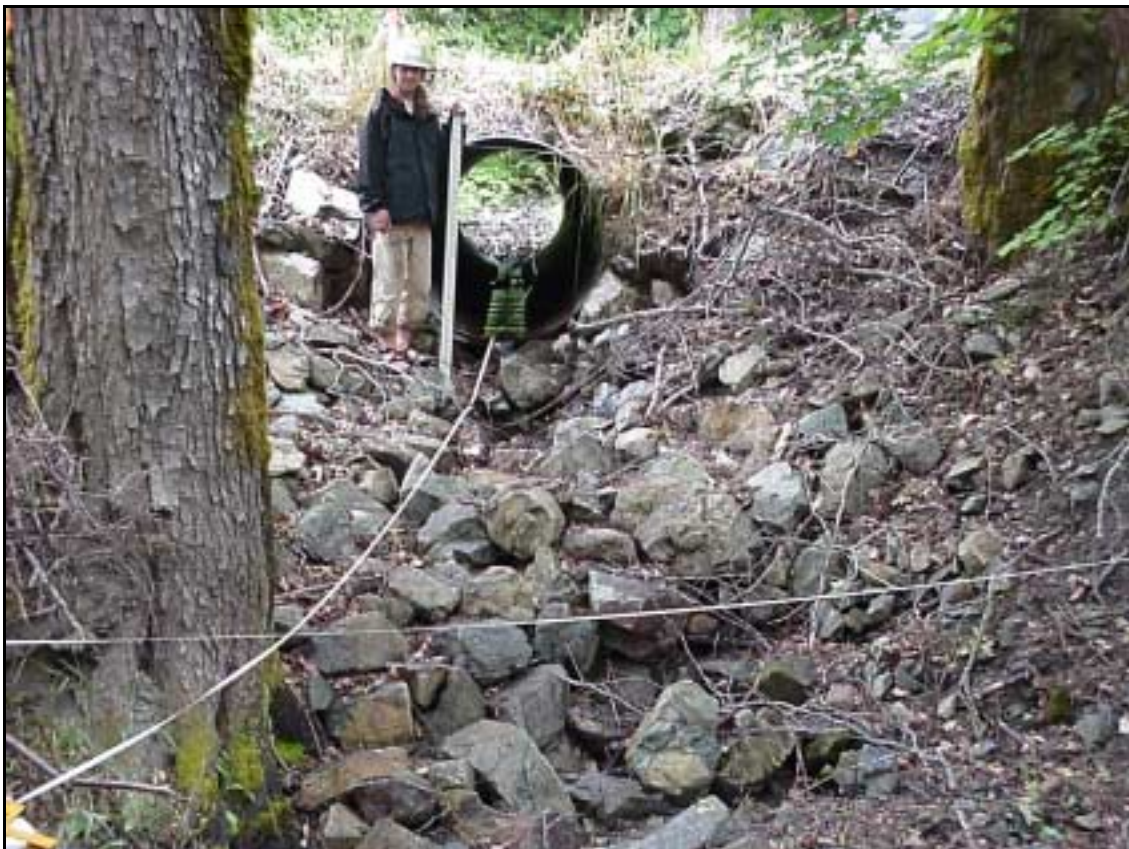
Site #10: Frying Pan Creek/China Road; Klamath River.

Overall condition: Fair, culvert floor is rusted and abraded throughout.

Barrier Status: **RED:** the Green-Gray-Red filter determined this crossing fails to meet passage criteria for all species of adult salmonids and all age classes of juveniles. Lack of depth through the culvert and the steep drop over riprap below the outlet are the crossing's features that create a migration barrier.

Preferred Treatment: When crossing is due for replacement (or fails) replace with a properly-sized embedded circular SSP pipe or an arch-culvert set on concrete footings. Lack of upstream fisheries benefit makes this site a poor candidate for replacement with restoration funds.

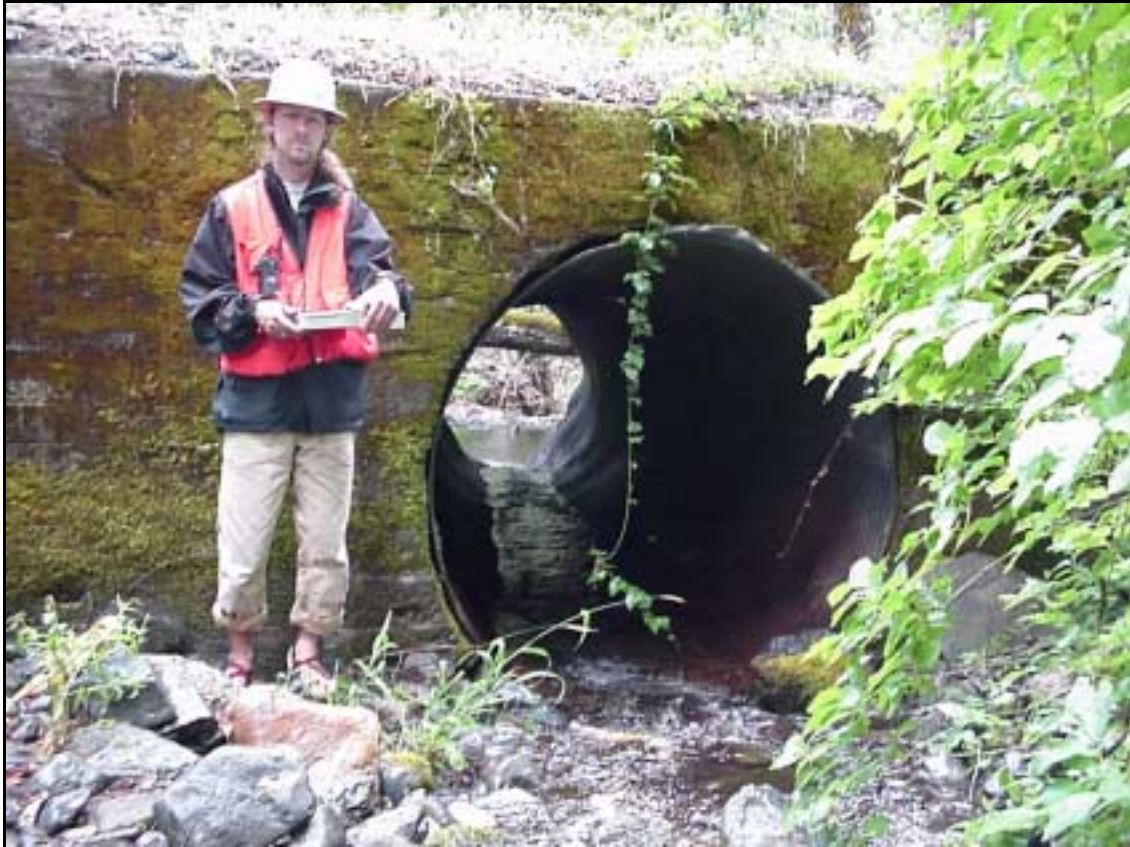
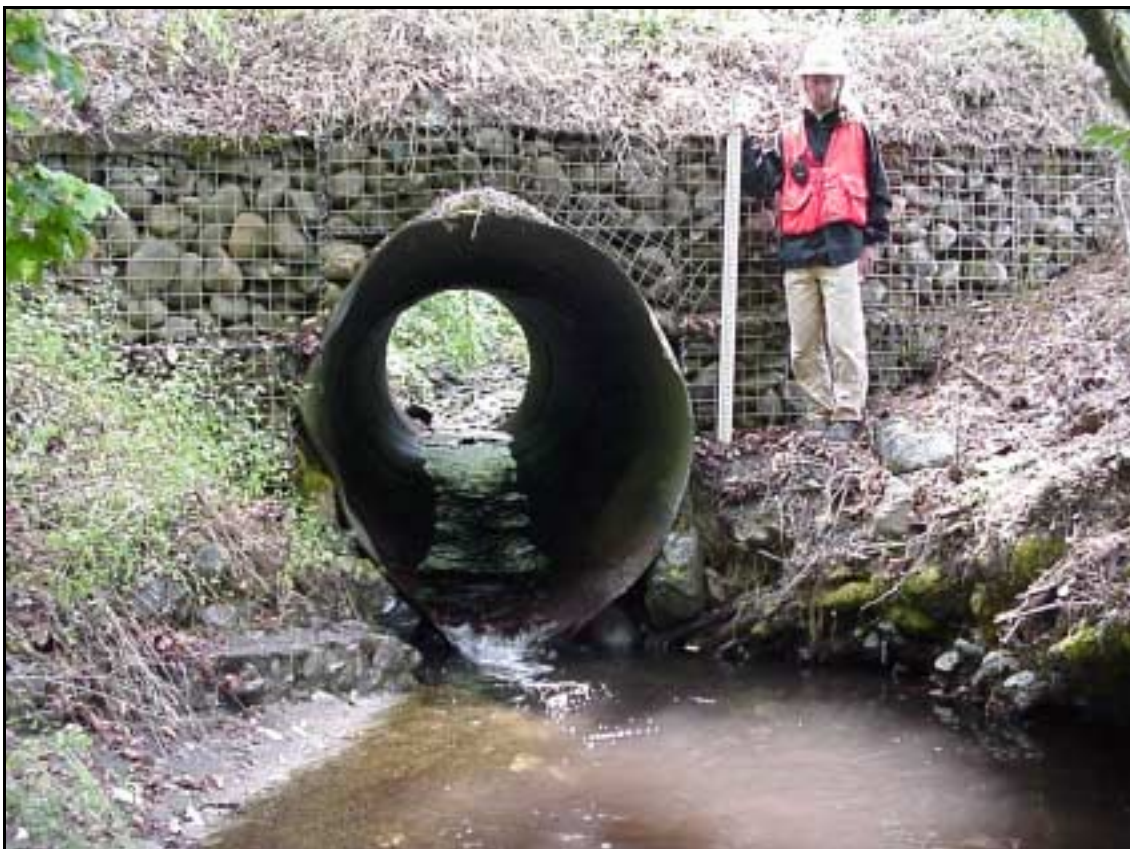
Site #11: Horse Creek/China Road; Klamath River.

Modifications: None. **Fill Estimate:** 356 cubic yards. **Overall condition:** Poor, culvert floor is rusted through in numerous places.

Barrier Status: **RED:** the Green-Gray-Red filter determined this crossing fails to meet passage criteria for all species of adult salmonids and all age classes of juveniles. Excessive slope through the culvert is the crossing's feature that creates a migration barrier.

Preferred Treatment: Properly-sized bridge or arch-culvert set on concrete footings.

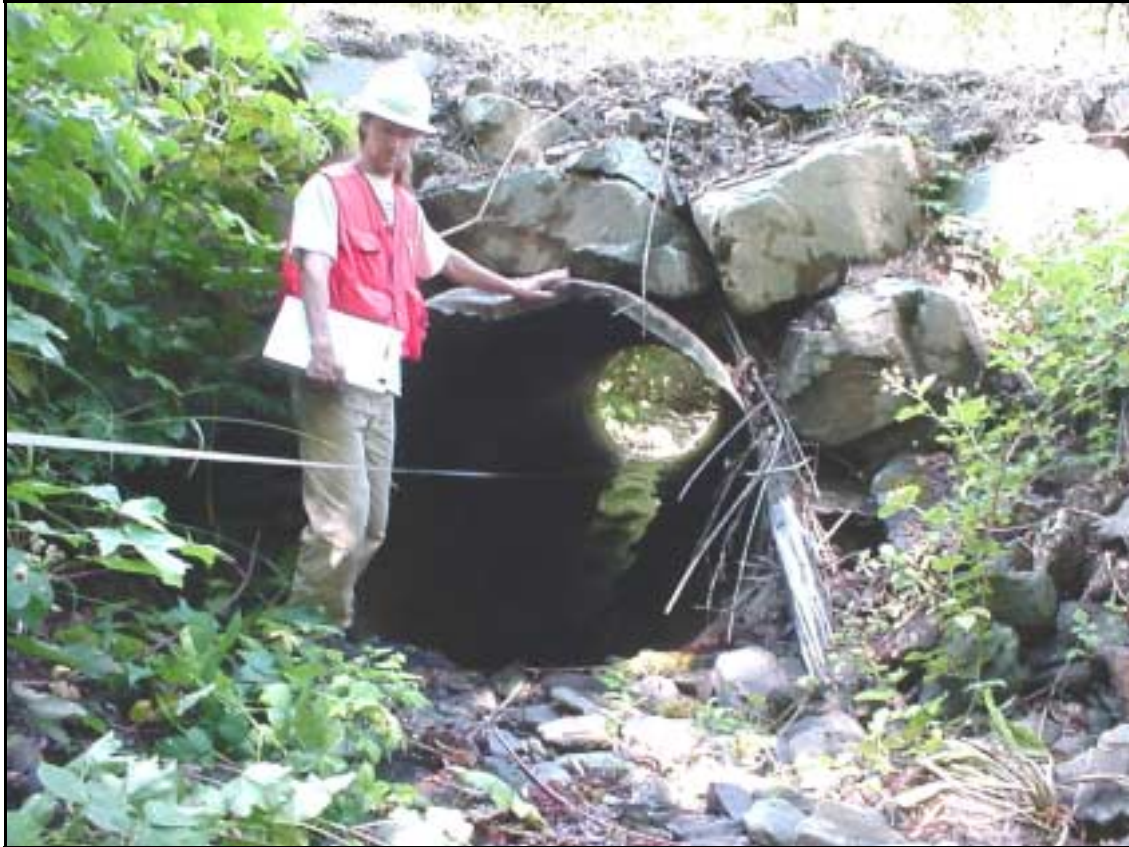
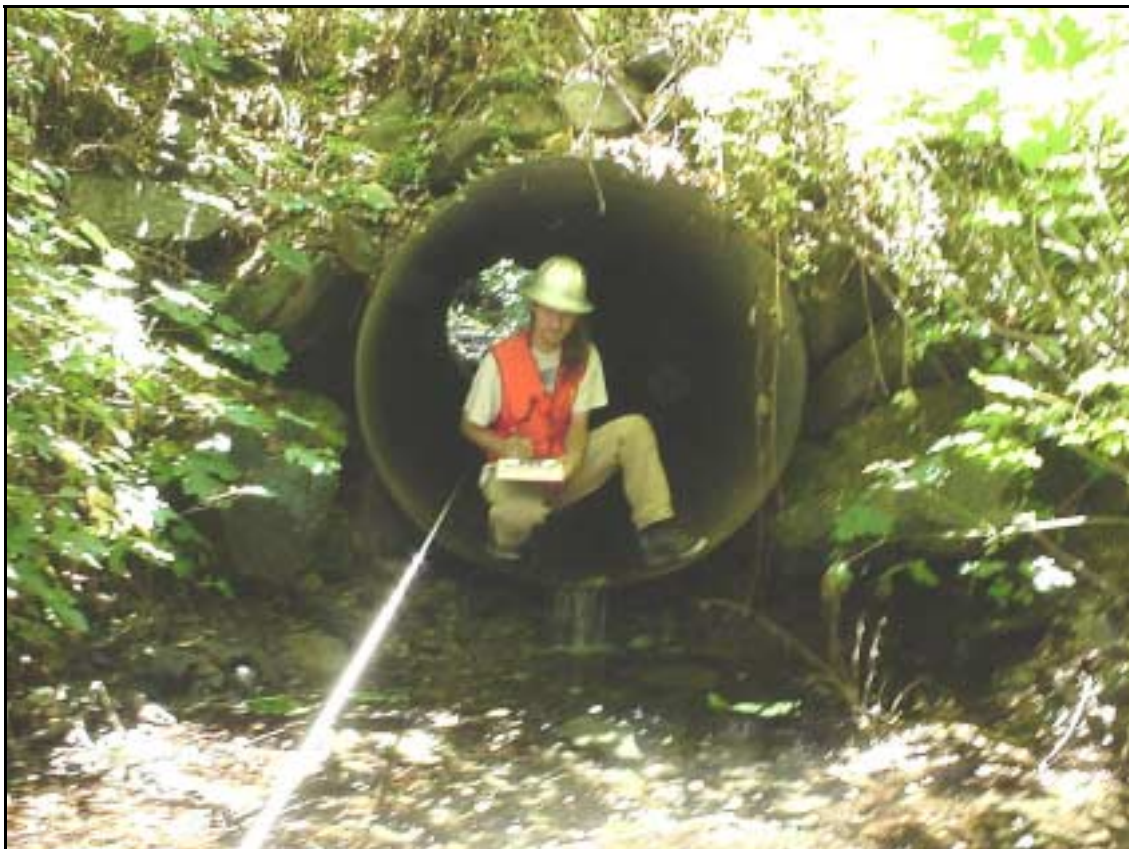
Site #12: Slater Creek a.k.a. Ikes Creek/Indian Creek Road; Indian Creek; Klamath River

Modifications: None. **Fill Estimate:** 274 cubic yards. **Overall condition:** Poor, culvert floor is rusted through.

Preferred Treatment: When crossing is due for replacement (or fails) replace with a properly-sized embedded circular SSP pipe or an arch-culvert set on concrete footings. Lack of upstream fisheries benefit makes this site a poor candidate for replacement with restoration funds.
