APPENDIX B:
CATALOG OF SISKIYOU COUNTY CULVERTS LOCATED ON
FISH-BEARING STREAM REACHES

Prepared for the Siskiyou County Public Works Department

By
Ross Taylor and Associates
1254 Quail Run Court
McKinleyville, CA. 95519
(707)-839-5022
rtaylor@humboldt1.com

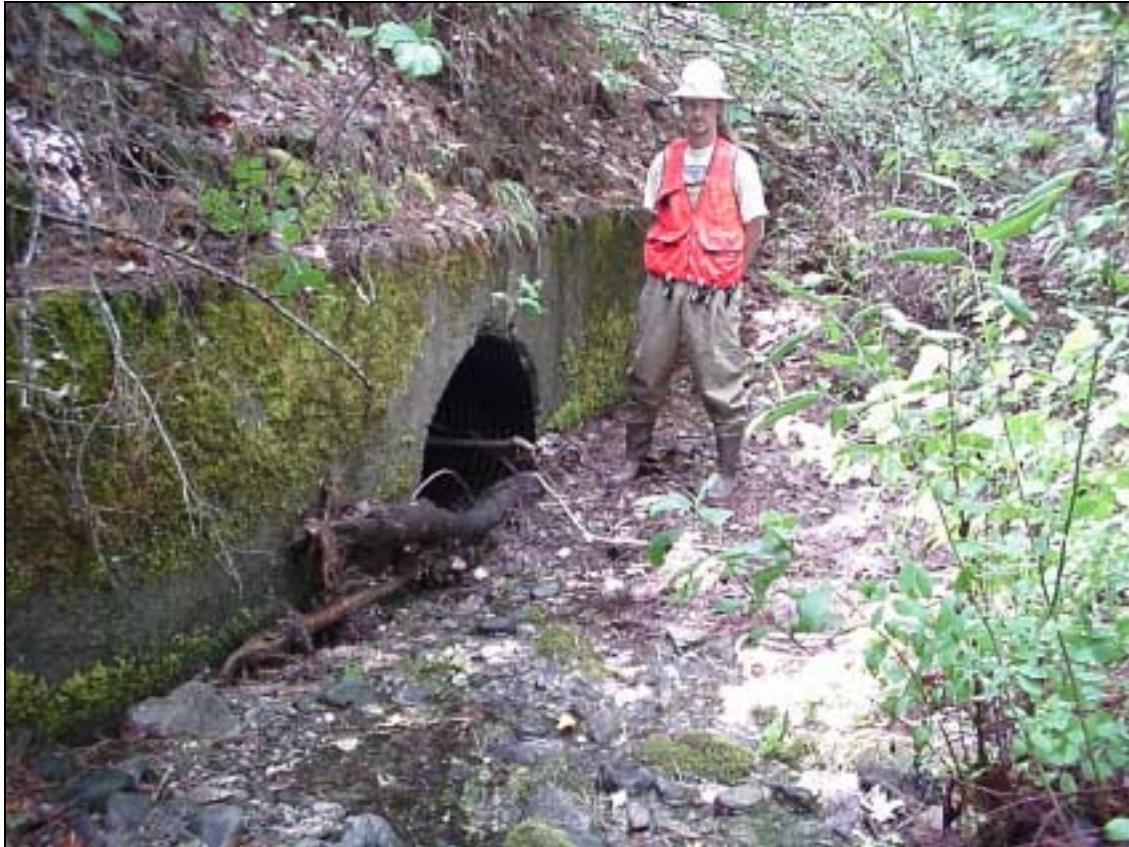
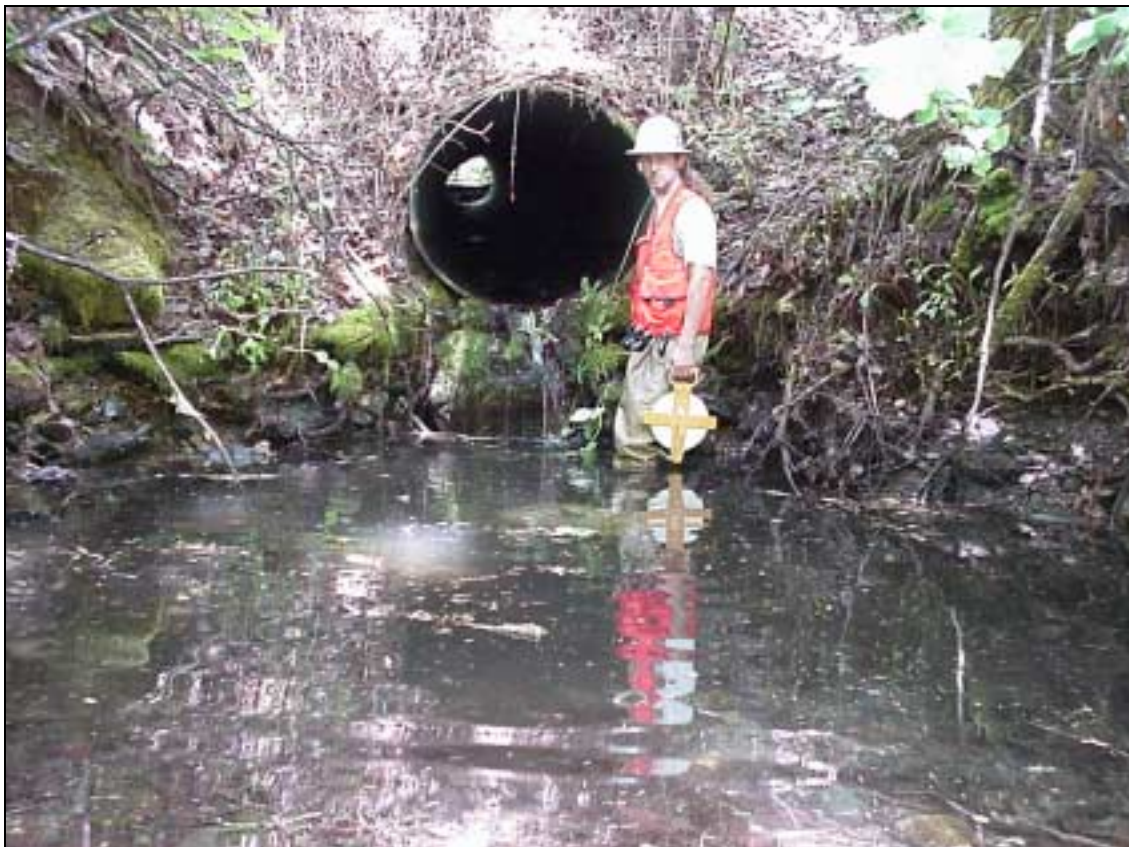
Site #14: Darkey Creek/Seiad Creek Road; Seiad Creek; Klamath River.

Overall condition: Poor, culvert floor is rusted through in numerous places.

Barrier Status: **RED:** the Green-Gray-Red filter determined this crossing fails to meet passage criteria for all species of adult salmonids and all age classes of juveniles. Excessive slope and perched outlet are the crossing's features that create a migration barrier.

Preferred Treatment: Current culvert is extremely undersized, in poor condition, and probably due for replacement. Replace with a properly-sized embedded circular SSP pipe or an arch-culvert set on concrete footings. Lack of upstream fisheries benefit makes this site a poor candidate for replacement with restoration funds.

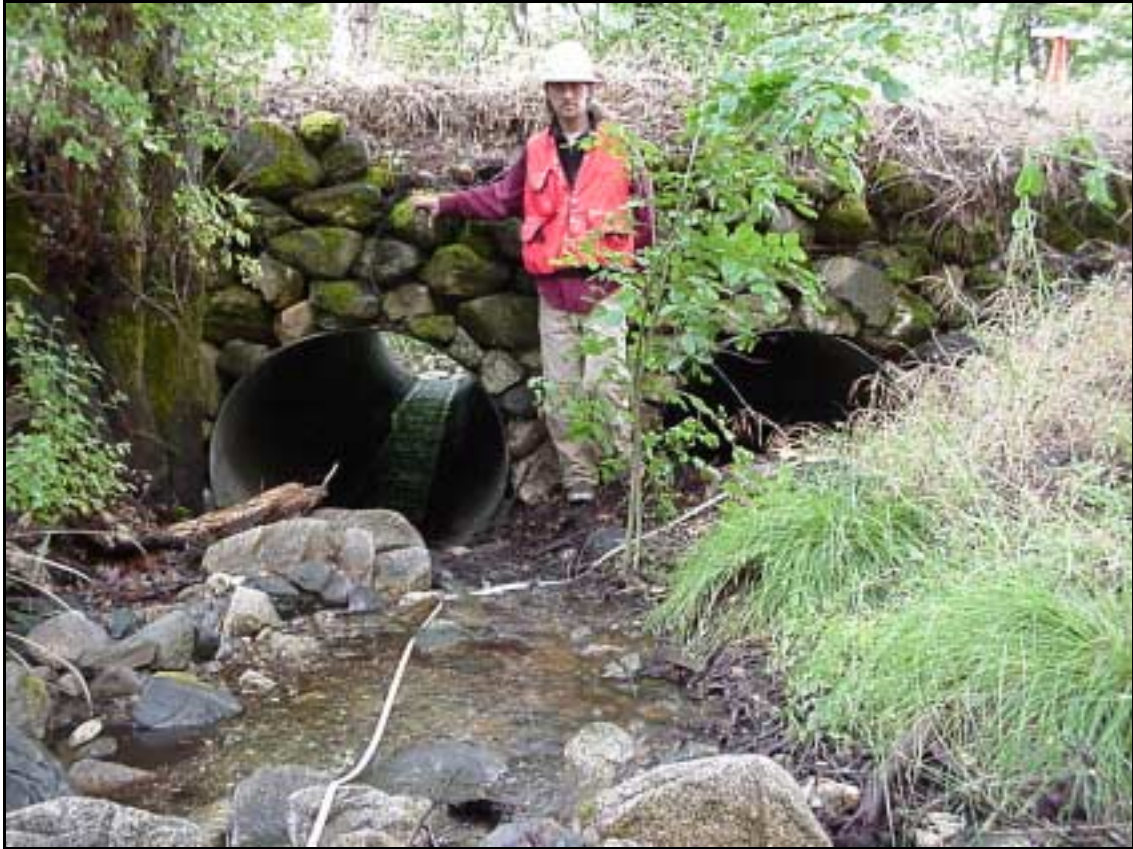
Site #15: Walker Gulch/Ladd Road; Klamath River.

Modifications: None. **Fill Estimate:** 167 cubic yards. **Overall condition:** Good.

Barrier Status: **RED:** the Green-Gray-Red filter determined this crossing fails to meet passage criteria for all species of adult salmonids and all age classes of juveniles. Excessive slope and perched outlet are the crossing's features that create a migration barrier.

Preferred Treatment: When crossing is due for replacement (or fails) replace with a properly-sized embedded circular SSP pipe or an arch-culvert set on concrete footings. Lack of upstream fisheries benefit makes this site a poor candidate for replacement with restoration funds.

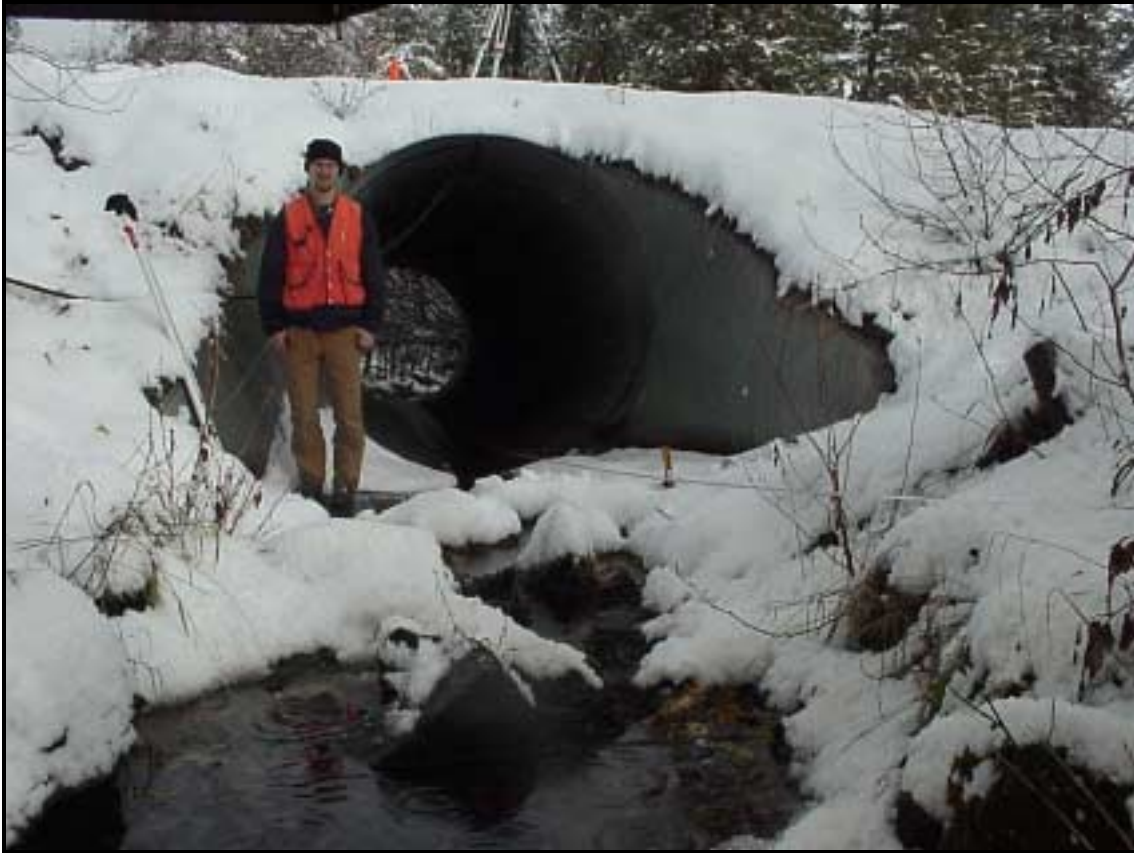
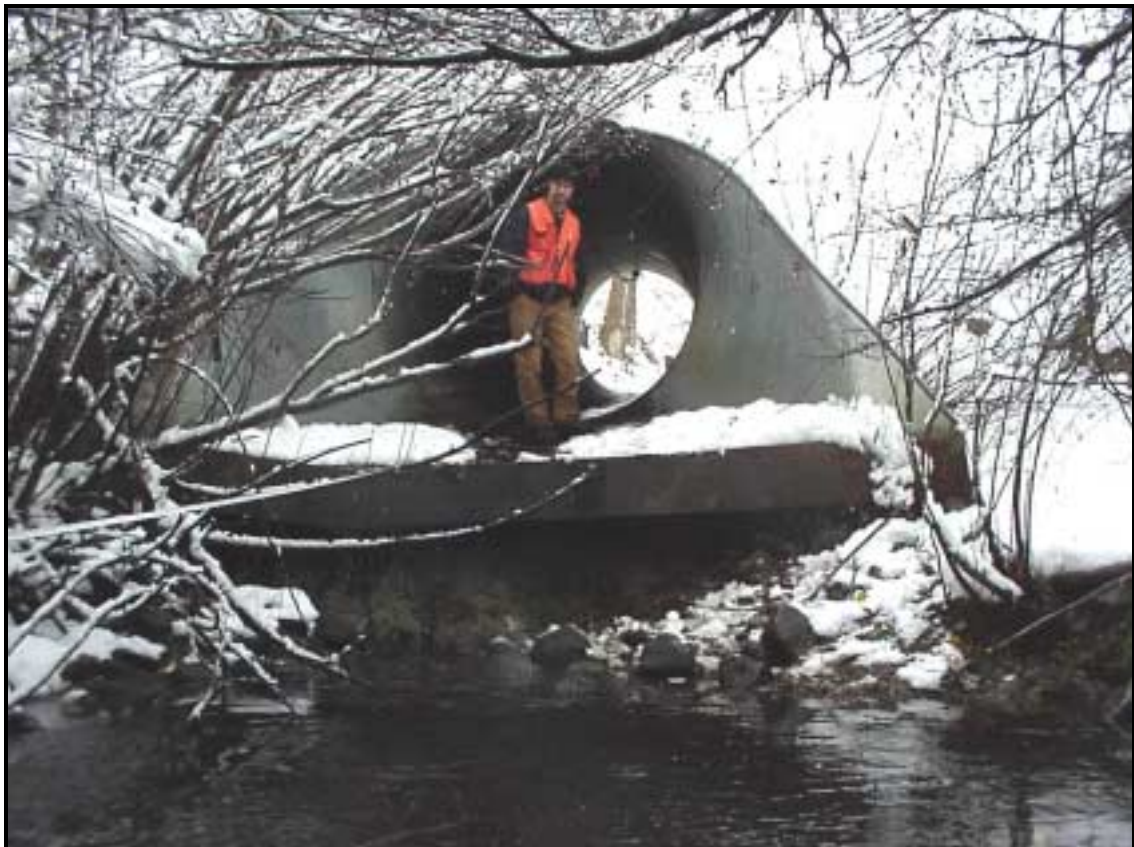
Site #18: Sniktaw Creek/Big Meadows Road; Scott River; Klamath River

Modifications: None. **Fill Estimate:** 370 cubic yards. **Overall condition:** Fair.

Barrier Status: **RED:** the Green-Gray-Red filter determined this crossing fails to meet passage criteria for all species of adult salmonids and all age classes of juveniles. Excessive slope and perched outlet are crossing's features that create migration barrier.

Preferred Treatment: Properly-sized bridge or open bottom arch-culvert set on concrete footings.

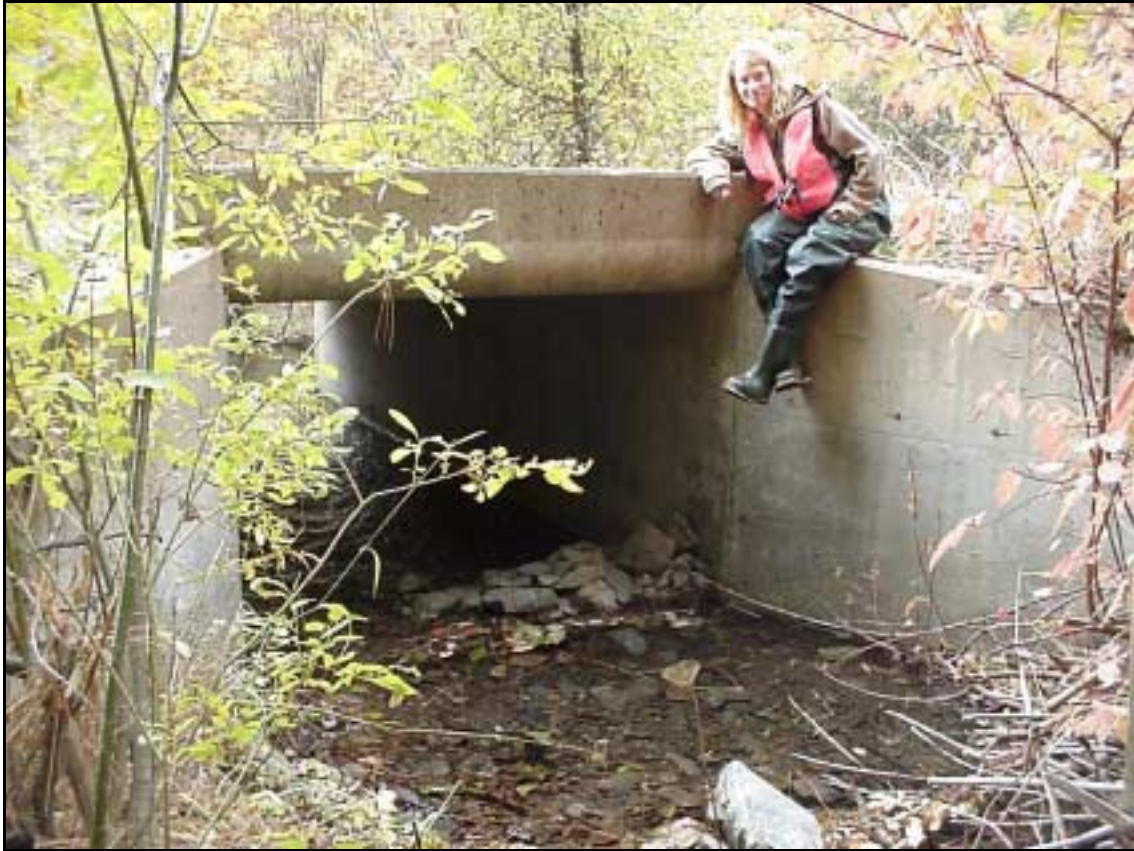
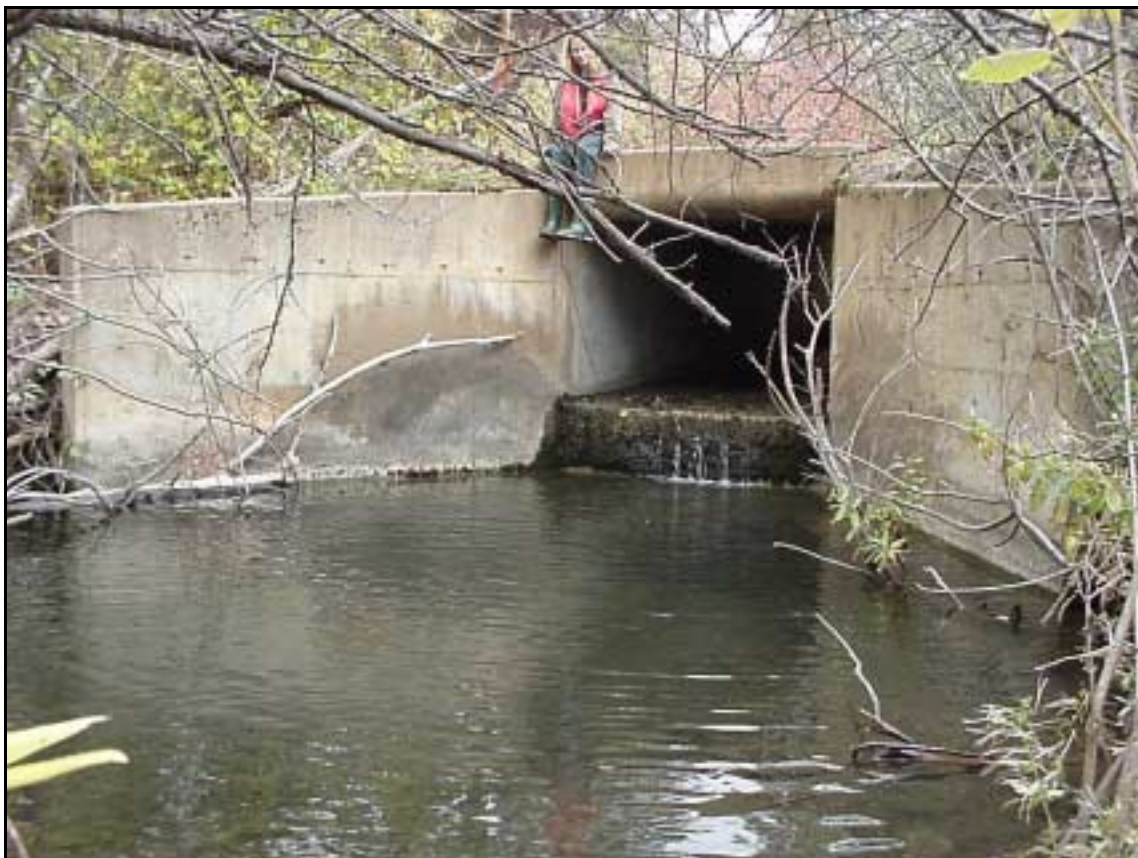
Site #19: Rattlesnake Creek/Rattlesnake Creek Road; Scott River; Klamath River.

Modifications: None. **Fill Estimate:** 131 cubic yards. **Overall condition:** Good.

Barrier Status: **RED:** the Green-Gray-Red filter determined this crossing fails to meet passage criteria for all species of adult salmonids and all age classes of juveniles. Excessive slope and perched outlet are the crossing's features that prevent fish migration.

Preferred Treatment: Properly-sized bridge or open bottom arch-culvert set on concrete footings.

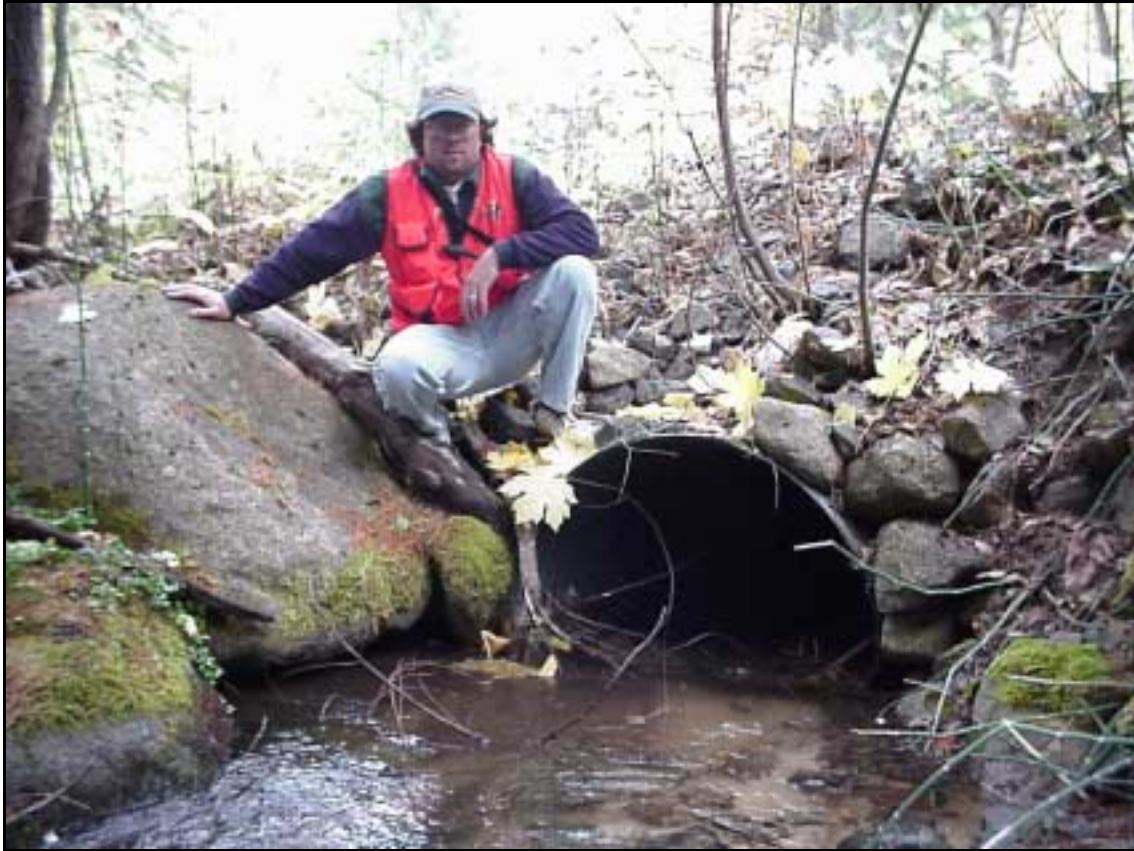
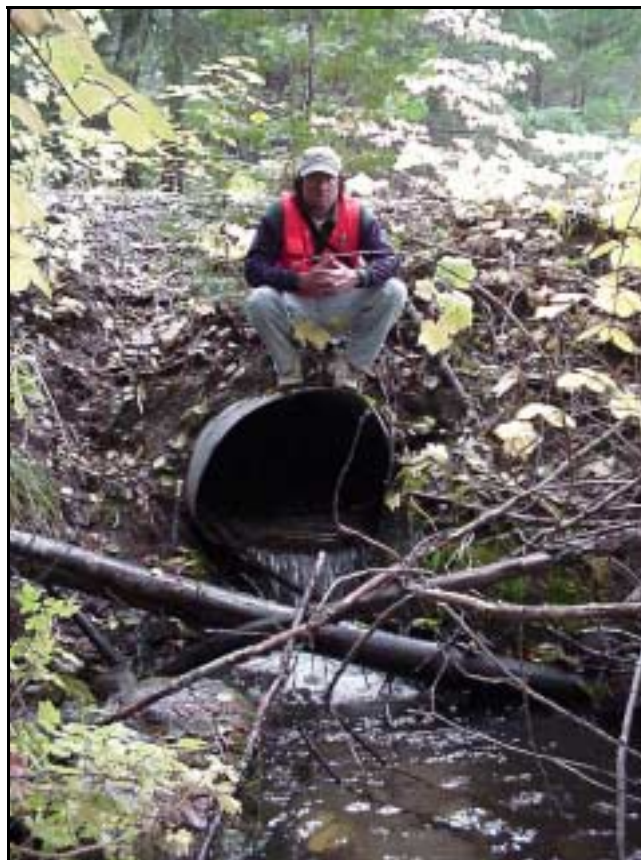
Site #20: French Creek – Eaton Lakes tributary/French Creek Road; Scott River; Klamath River.

Modifications: None. **Fill Estimate:** 109 cubic yards. **Overall condition:** Fair, culvert floor is abraded.

Preferred Treatment: Properly sized open-bottom arch culvert set on concrete footings.

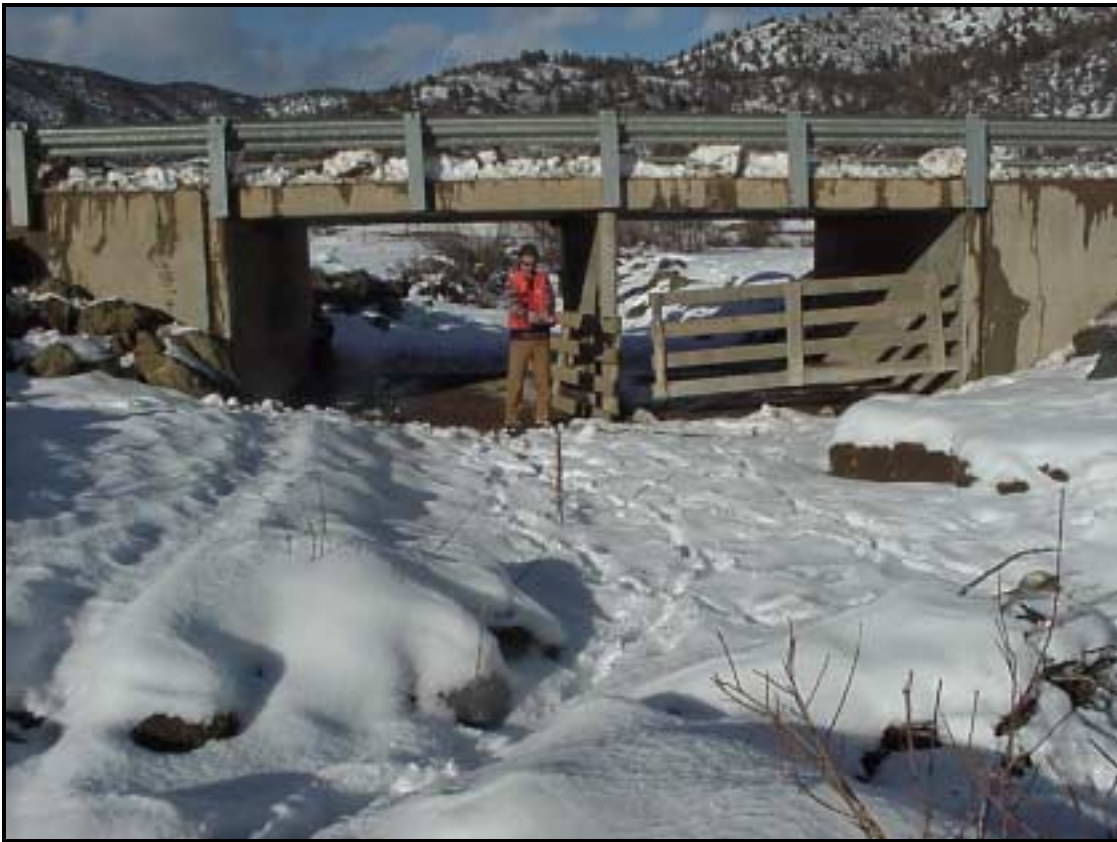
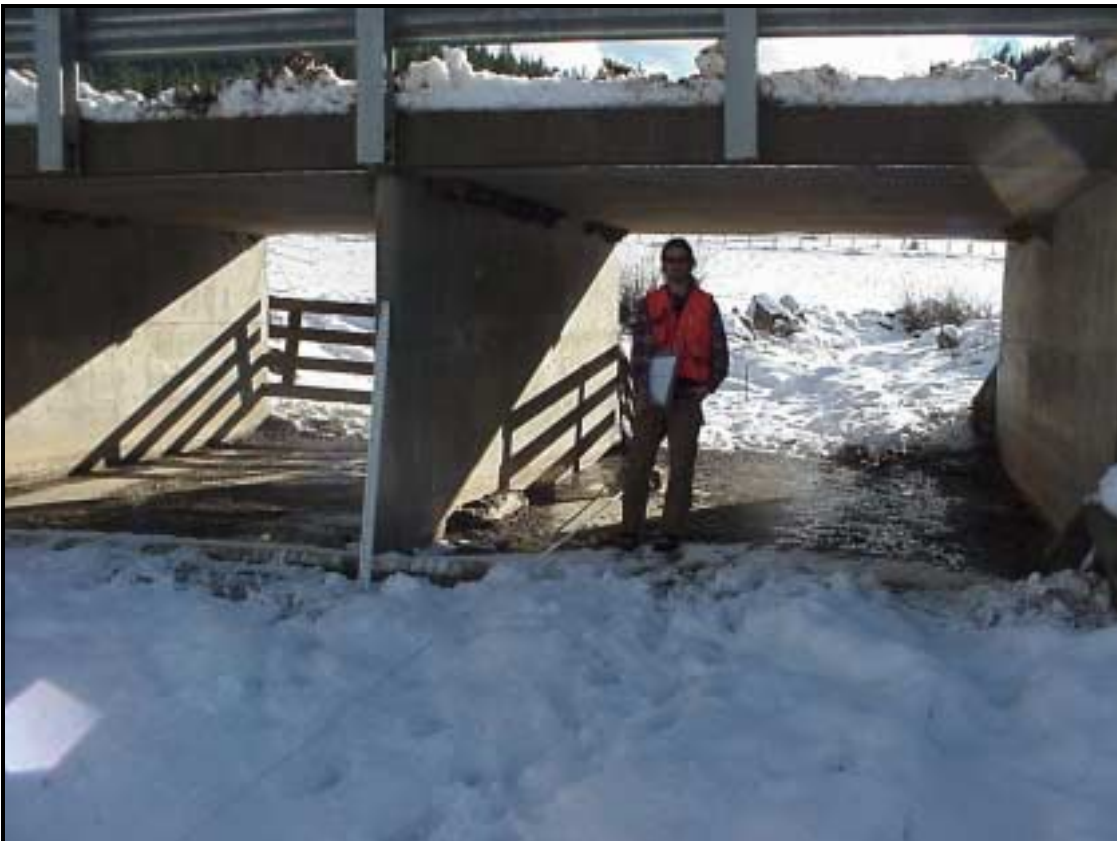
Site #21: Duzel Creek/ Duzel Creek Road; Moffett Creek; Scott River; Klamath River

Slope: 1.20%. **Modifications:** None. **Fill Estimate:** 208 cubic yards. **Overall condition:** Good.

Preferred Treatment: Offset baffles would increase depth and reduce water velocities within box culvert.

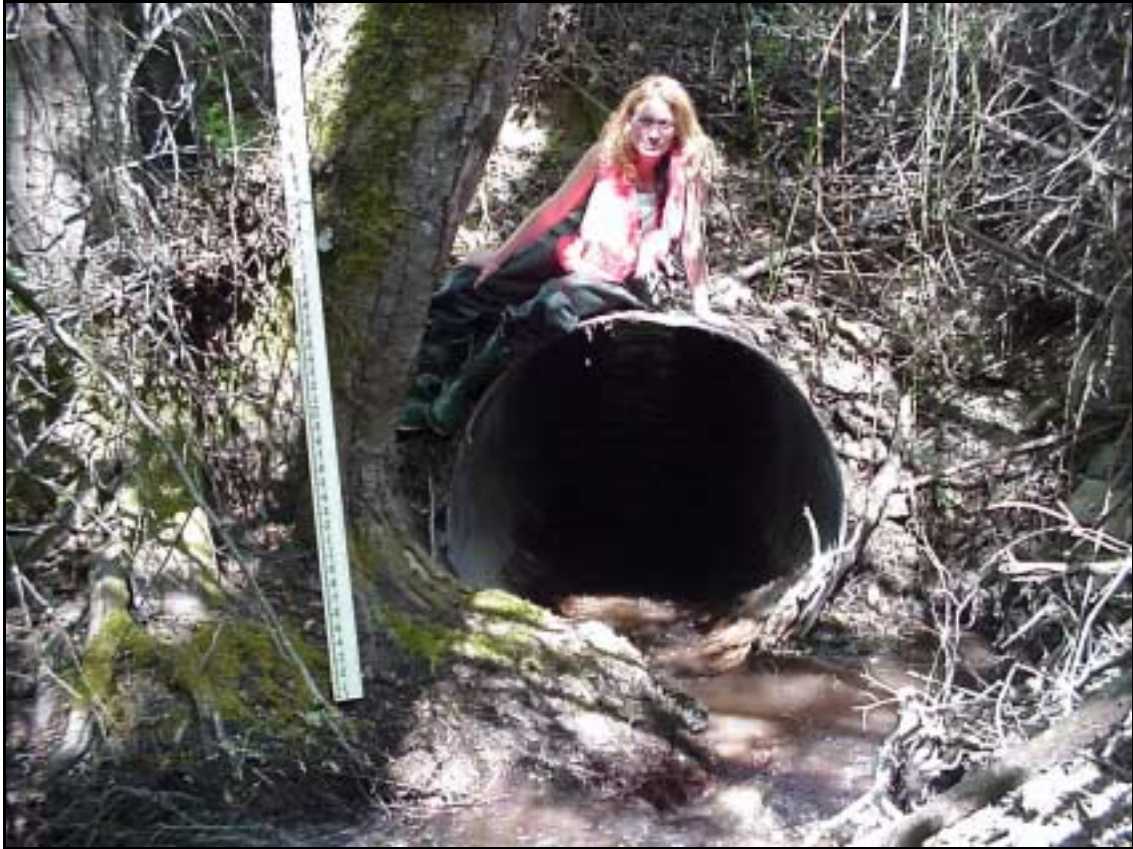
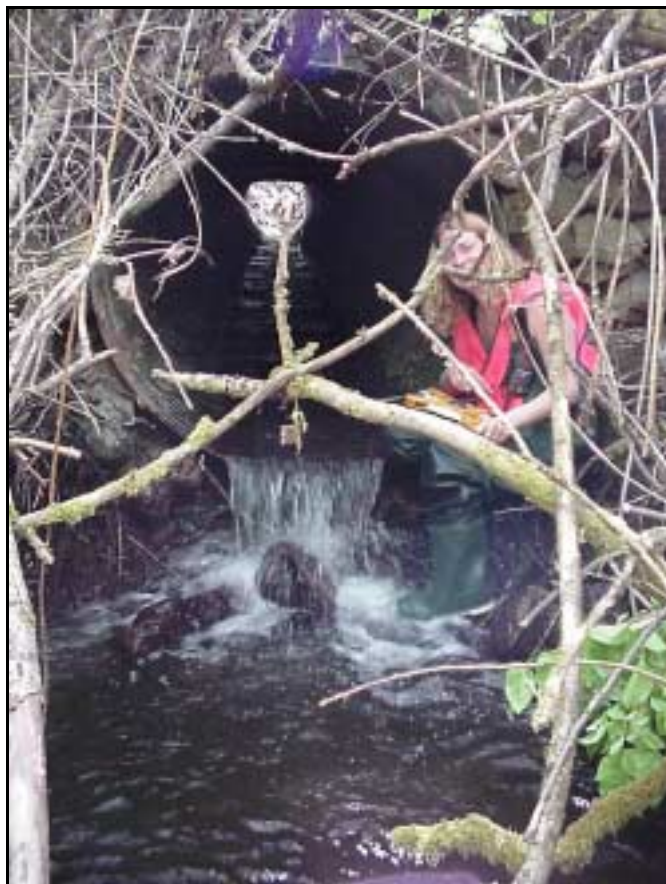
Site #22: Collins Creek/Walker Road; Klamath River.

Modifications: None. **Fill Estimate:** 297 cubic yards. **Overall condition:** Fair/poor; floor is abraded and culvert is slightly crushed and slumping under road fill.

Barrier Status: **RED:** the Green-Gray-Red filter determined this crossing fails to meet passage criteria for all species of adult salmonids and all age classes of juveniles. Excessive slope is the crossing's main feature that creates a migration barrier. The slightly perched outlet probably impedes juvenile migration too. Large tree growing right at inlet probably creates excessive turbulence that impedes fish passage.

Preferred Treatment: Replace with a properly sized open-bottom arch culvert set on concrete footings or a bridge.

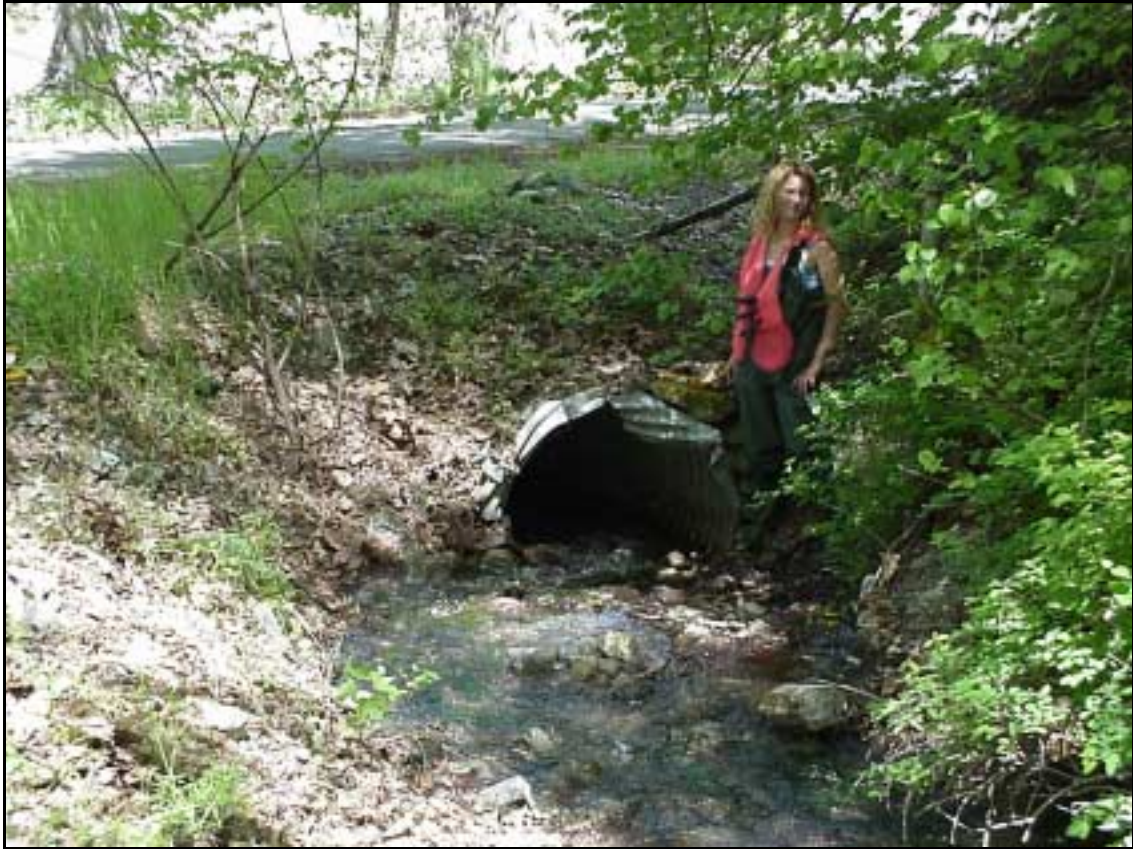
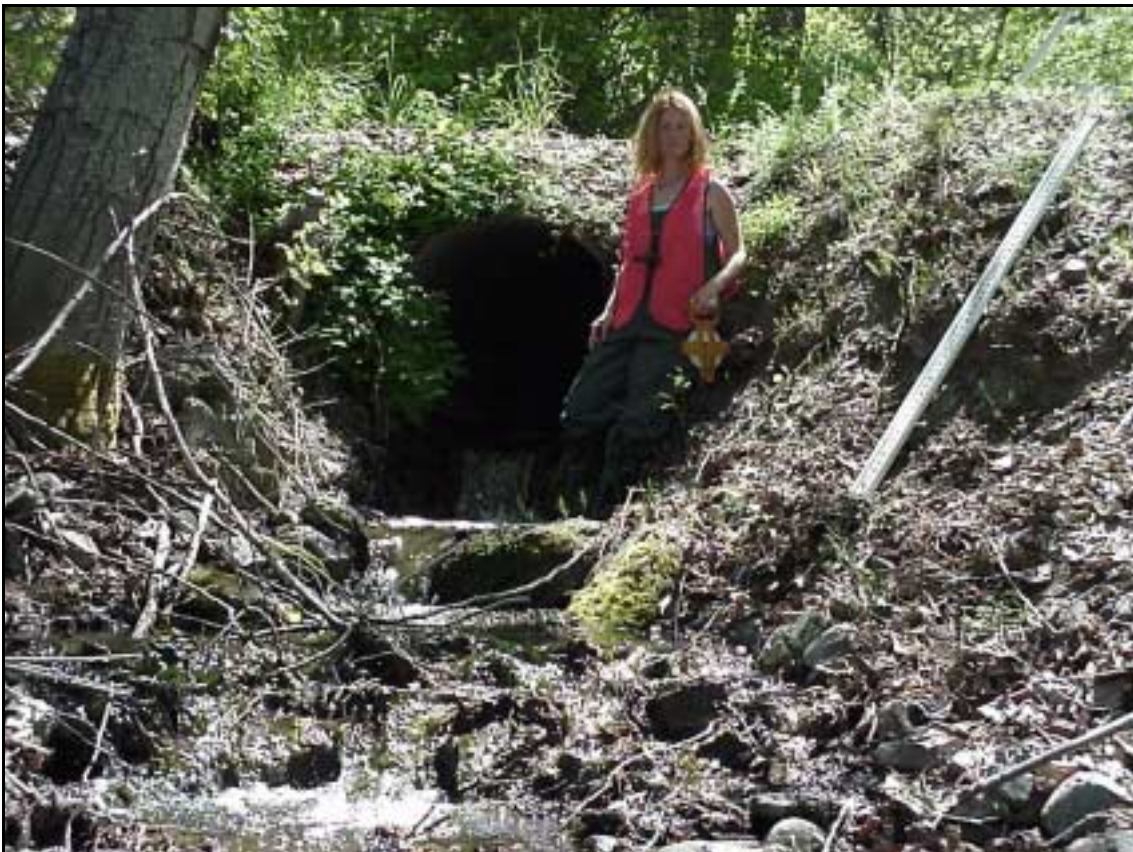
Site #23: Dona Creek/Walker Road; Klamath River.

Modifications: None. **Fill Estimate:** 67 cubic yards. **Overall condition:** Poor; culvert floor is abraded throughout and rusted through in numerous places. Inlet is slightly crushed.

Barrier Status: **RED:** the Green-Gray-Red filter determined this crossing fails to meet passage criteria for all species of adult salmonids and all age classes of juveniles. Excessive slope and perched outlet are crossing's features that create a migration barrier.

Preferred Treatment: Replace with a properly sized embedded circular or oval culvert. Although creek has minimal fisheries potential, the crossing is extremely undersized, is in poor condition, and has a high potential for failure. Site scored fairly high due to sizing and condition.

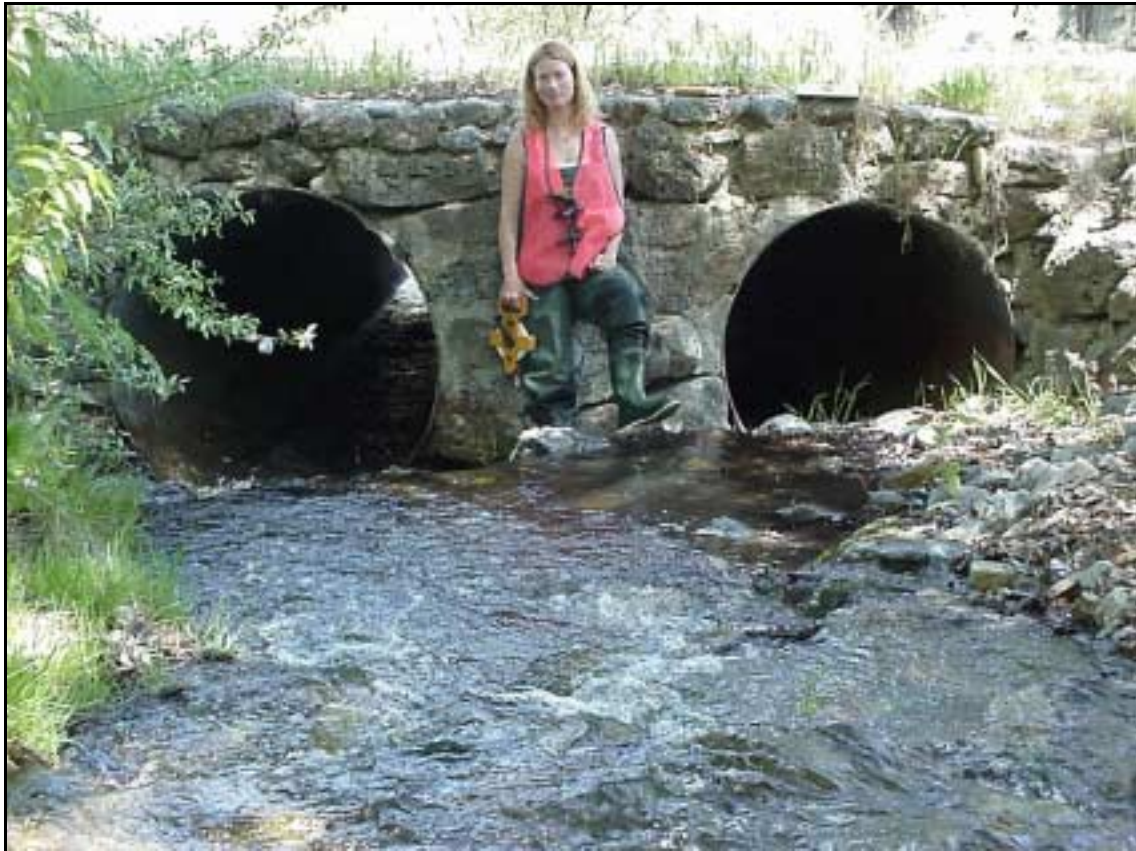
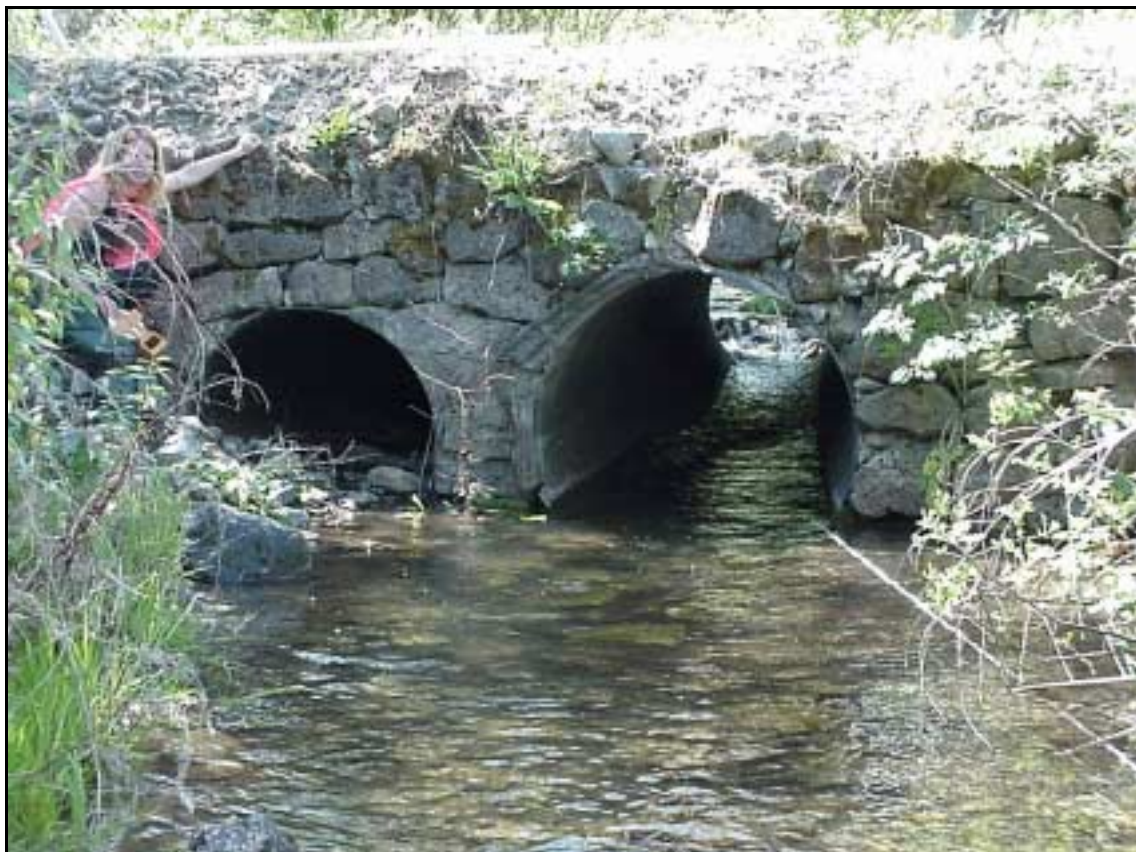
Site #24: McKinney Creek/Walker Road; Klamath River.

Modifications: None. **Fill Estimate:** 110 cubic yards. **Overall condition:** Fair; culvert floors are abraded throughout.

Barrier Status: LB= **RED**: the Green-Gray-Red filter determined this crossing fails to meet passage criteria for all species of adult salmonids and all age classes of juveniles. RB= **GREY**: although "Grey", FishXing estimated that fish passage criteria are met on 0% of the expected migration flows for adult anadromous salmonids, 0% for resident/two-year old juveniles, and 0% for one-year old and young-of-year juveniles. Excessive slope is the crossing's feature that creates a migration barrier.

Preferred Treatment: Properly sized bridge or open-bottom arch culvert set on concrete footings.

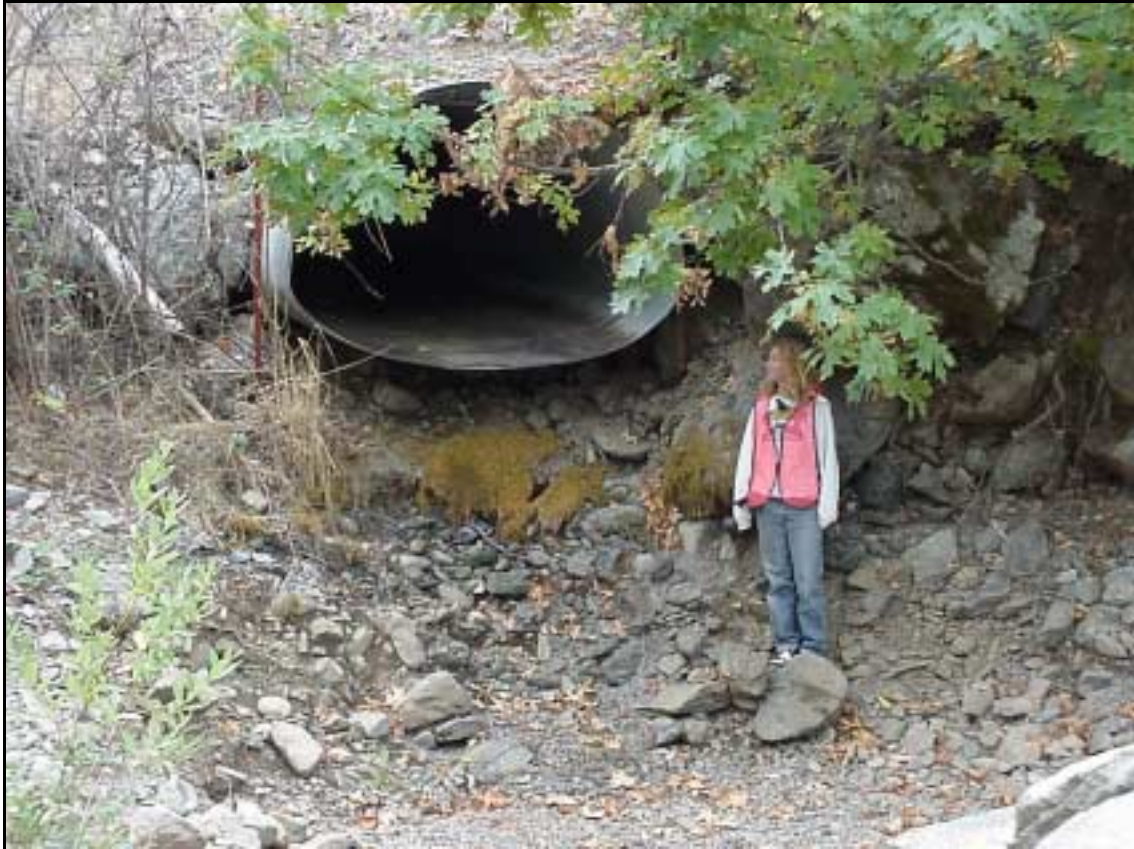
Site #25: Little Humbug Creek/Walker Road; Klamath River.

Modifications: None. **Fill Estimate:** 251 cubic yards. **Overall condition:** Fair; culvert floor is abraded throughout.

Barrier Status: **RED:** the Green-Gray-Red filter determined this crossing fails to meet passage criteria for all species of adult salmonids and all age classes of juveniles. Excessive slope and perched outlet are crossing's features that create migration barrier.

Preferred Treatment: Crossing was replaced with a properly sized bridge during the summer of 2000. See before and after photos of crossing's downstream side.

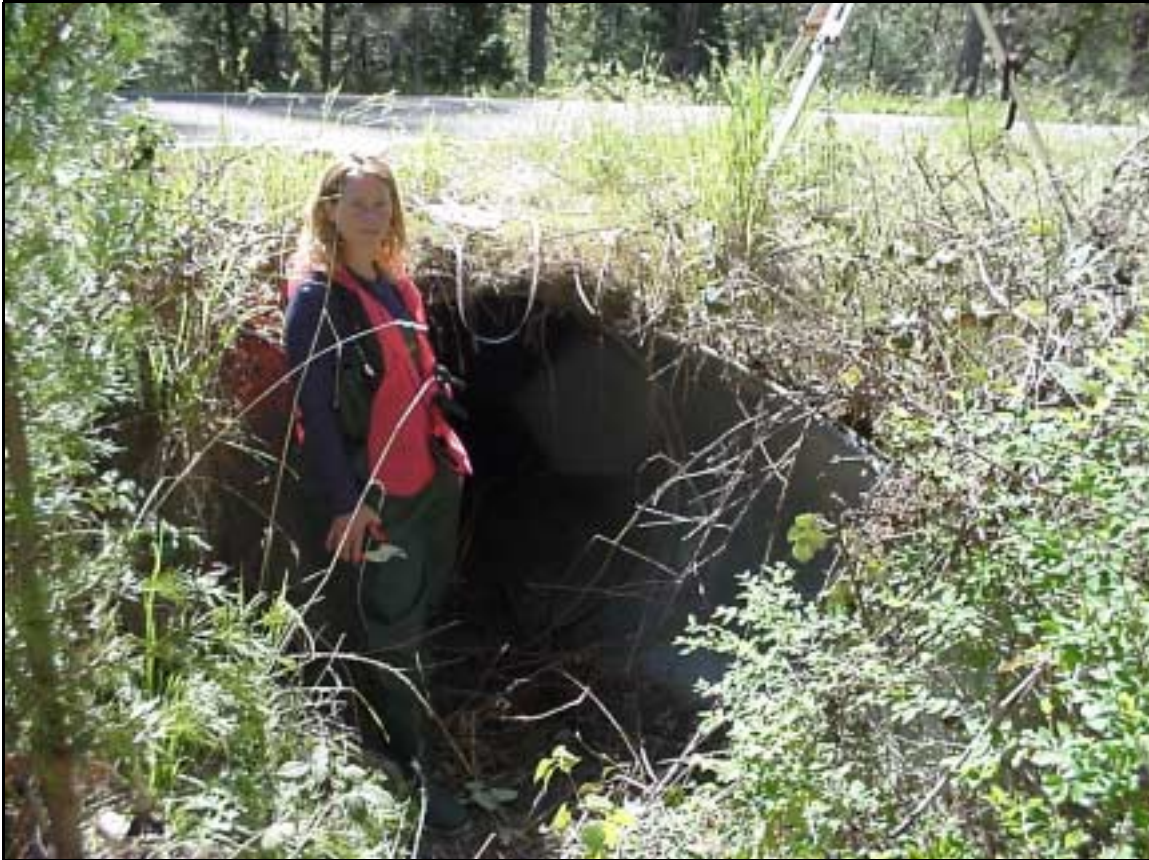
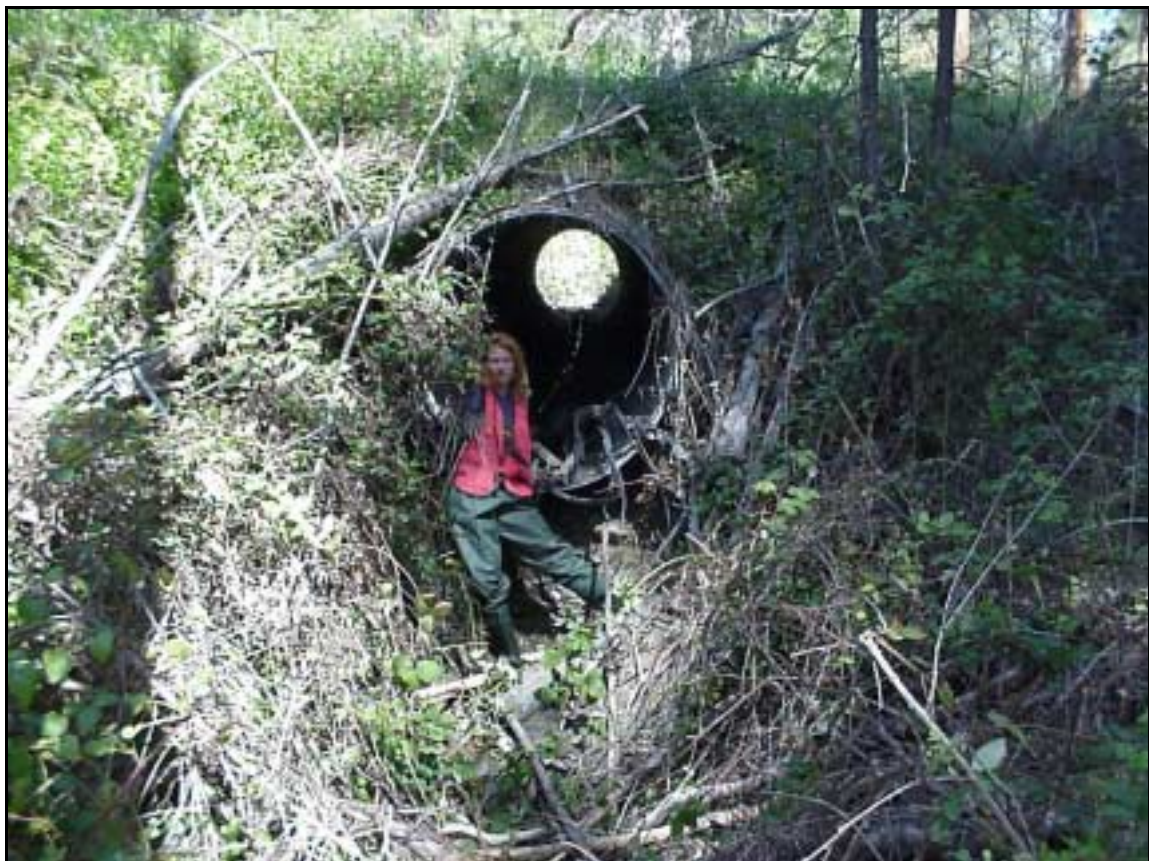
Site #26: Fish Gulch/Beaver Creek Road; Beaver Creek; Klamath River.

Modifications: None. **Fill Estimate:** 156 cubic yards. **Overall condition:** Good.

Barrier Status: **RED:** the Green-Gray-Red filter determined this crossing fails to meet passage criteria for all species of adult salmonids and all age classes of juveniles. Excessive slope and perched outlet are the crossing's features that create a migration barrier.

Preferred Treatment: Replace with a culvert that can convey at least a 50-year storm flow when the current crossing is due for replacement (or fails).

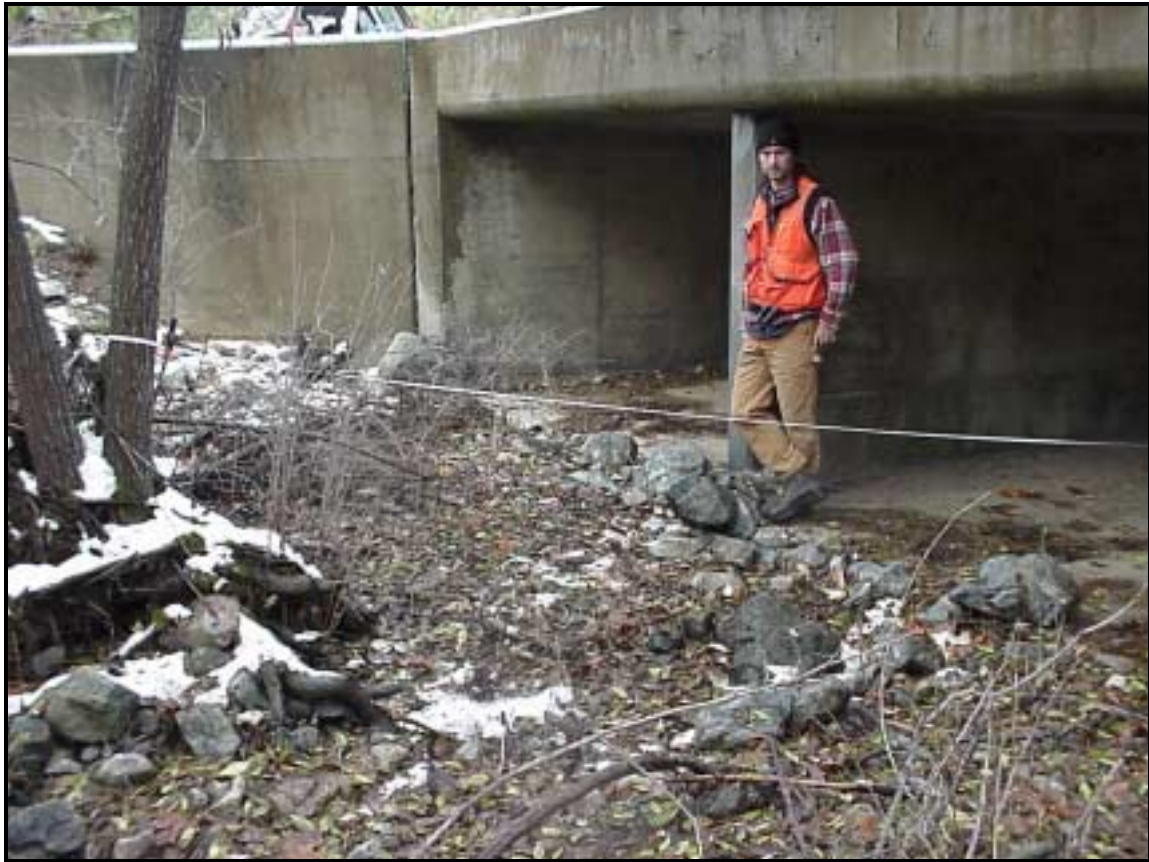
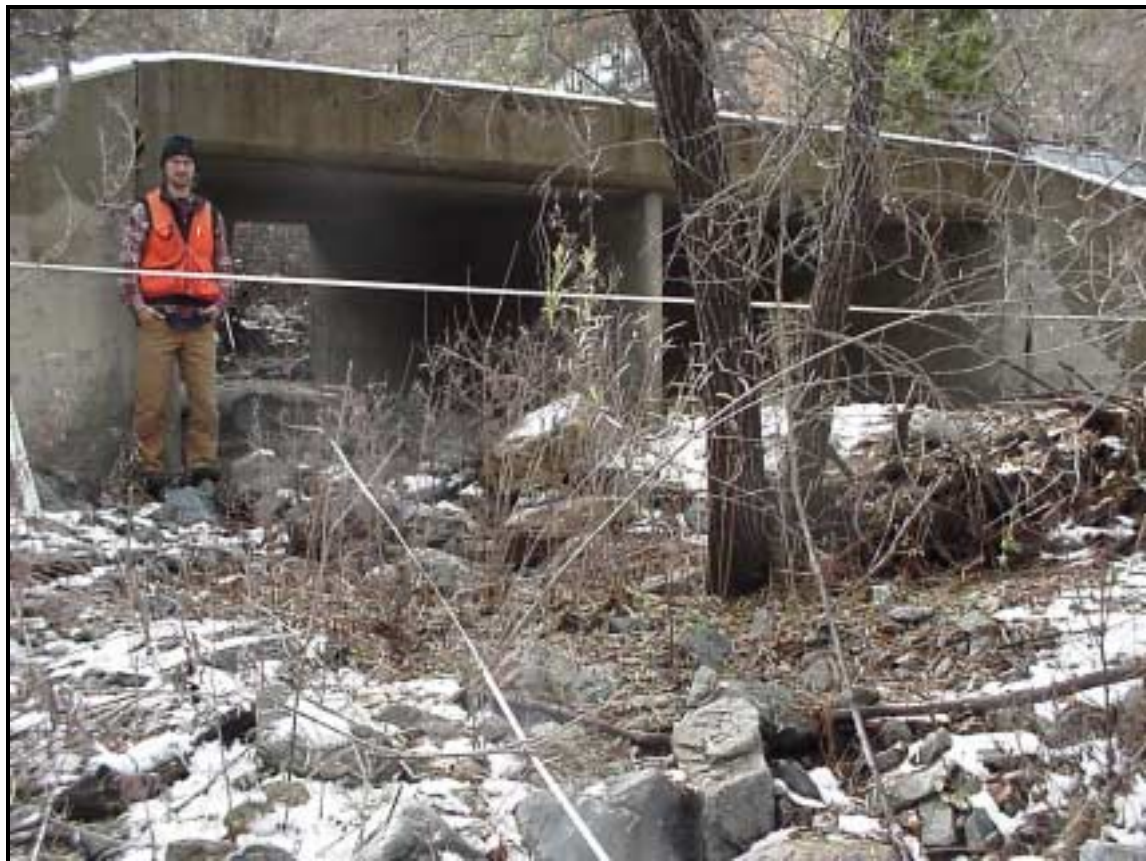
Site #27: Vesa Creek/Klamath River Road; Klamath River

Modifications: None. **Fill Estimate:** 221 cubic yards. **Overall condition:** Good.

Barrier Status: **RED:** the Green-Gray-Red filter determined this crossing fails to meet passage criteria for all species of adult salmonids and all age classes of juveniles. Excessive slope and wide shallow concrete floor are the crossing's features that create a migration barrier.

Preferred Treatment: No treatment recommended. The current crossing is sized close to NMFS guidelines and is in good condition. If upstream habitat was of significance, offset baffles could be installed to reduce water velocities and increase depths within the box culvert.
