APPENDIX B:
CATALOG OF SISKIYOU COUNTY CULVERTS LOCATED ON
FISH-BEARING STREAM REACHES

Prepared for the Siskiyou County Public Works Department

By
Ross Taylor and Associates
1254 Quail Run Court
McKinleyville, CA. 95519
(707)-839-5022
rtaylor@humboldt1.com

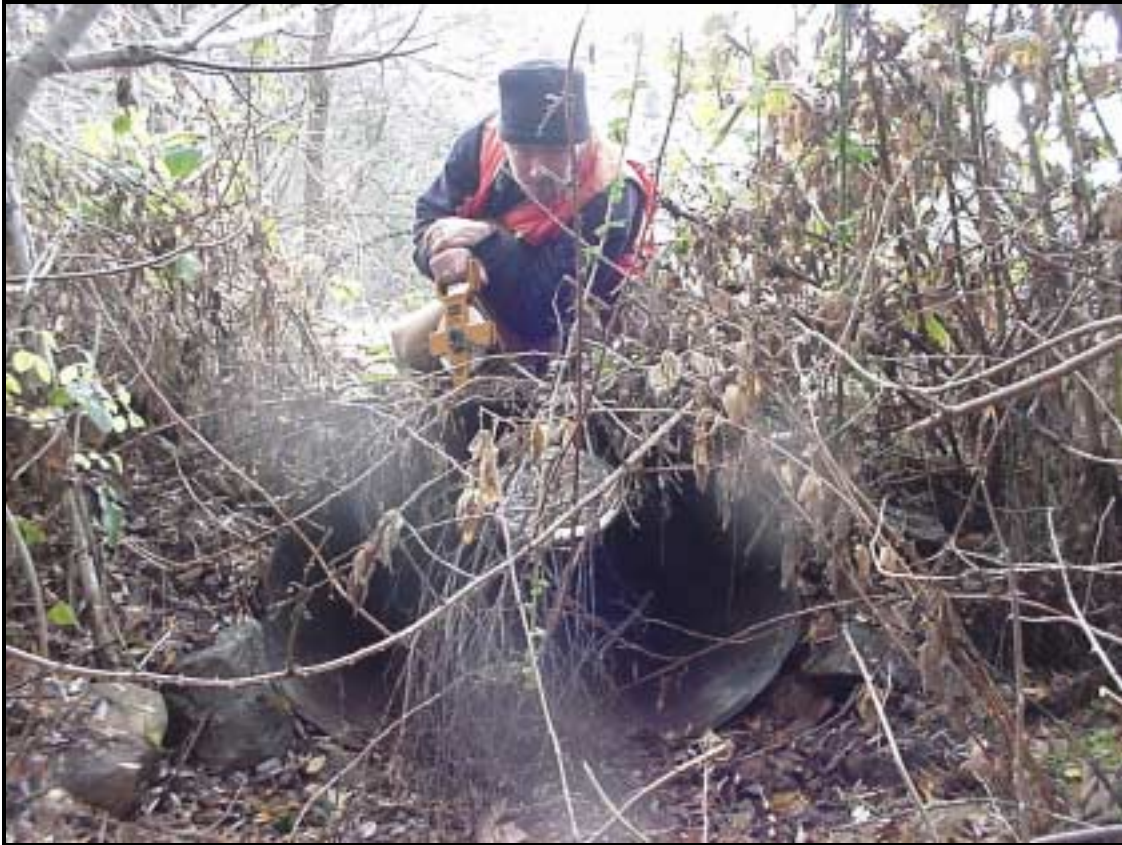
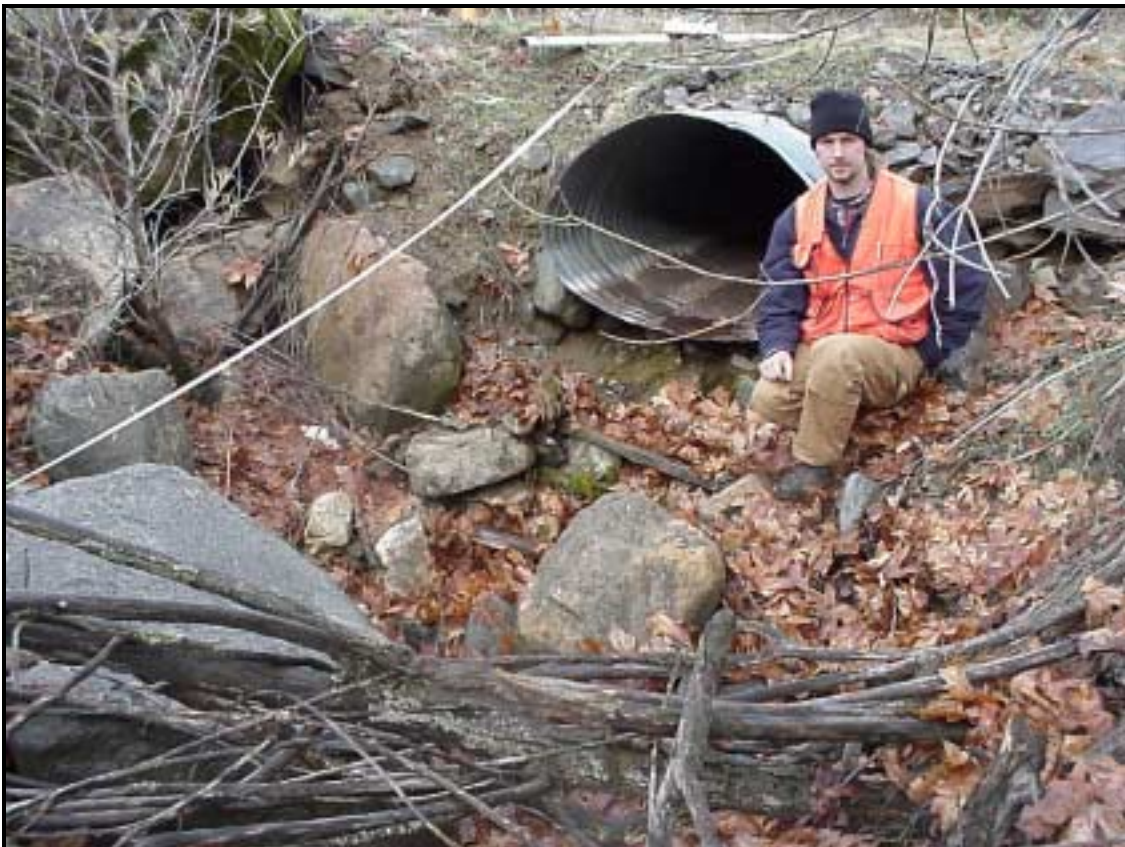
Site #28: Clear Creek/Humbug Creek Road; Humbug Creek; Klamath River

Modifications: None. **Fill Estimate:** 75 cubic yards. **Overall condition:** Fair, culvert is abraded.

Barrier Status: **RED:** the Green-Gray-Red filter determined this crossing fails to meet passage criteria for all species of adult salmonids and all age classes of juveniles. Excessive slope and perched outlet are crossing's features that create migration barrier. Riprap and boulders at outlet probably create unfavorable, turbulent conditions during migration flows.

Preferred Treatment: Properly sized bridge or open-bottom arch culvert set on concrete footings.

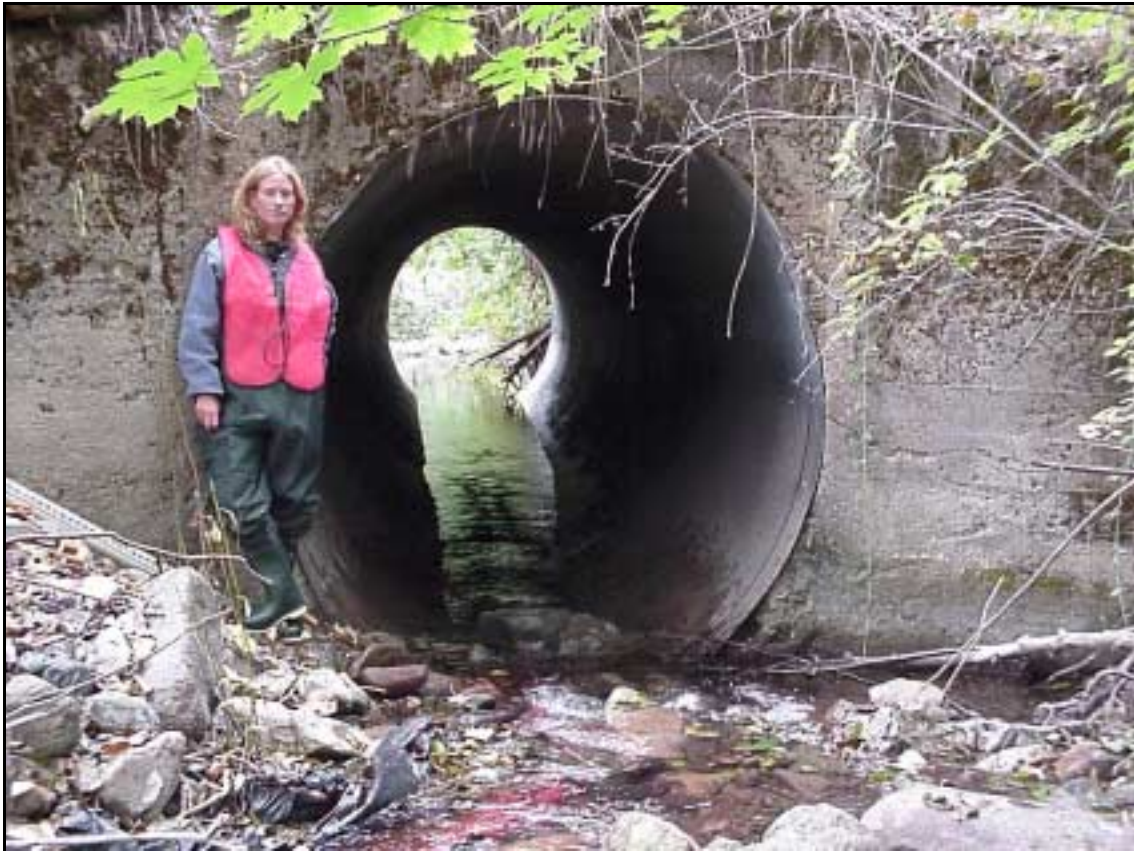
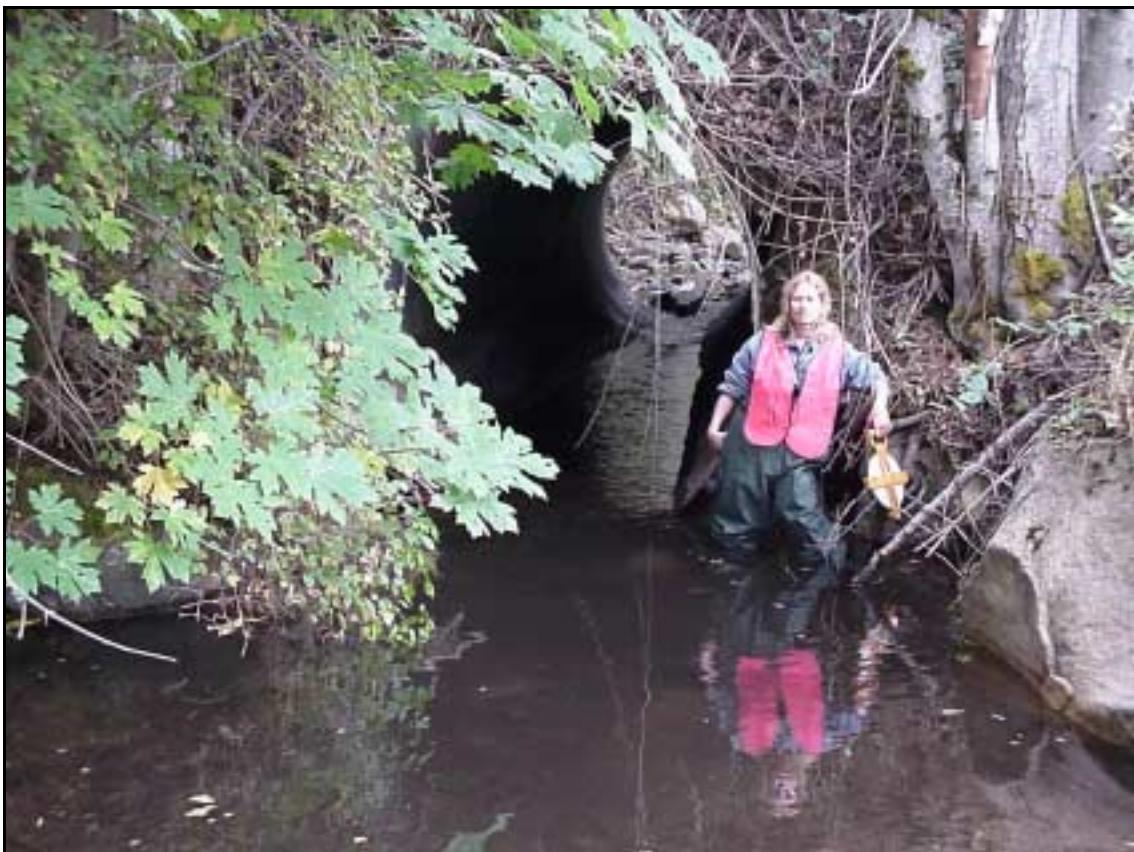
Site #29: Middle Fork Humbug Creek/Yreka-Walker Road; Humbug Creek; Klamath River.

Modifications: None. **Fill Estimate:** 346 cubic yards. **Overall condition:** Fair; culvert floor is abraded throughout.

Preferred Treatment: Although the current culvert allows for partial passage it is undersized and starting to wear-out. A properly sized bridge or open-bottom arch culvert set on concrete footings is the best long-term solution. This site should be treated concurrently with the replacement of the South Fork Humbug Creek culvert, located approximately 150' to the east.

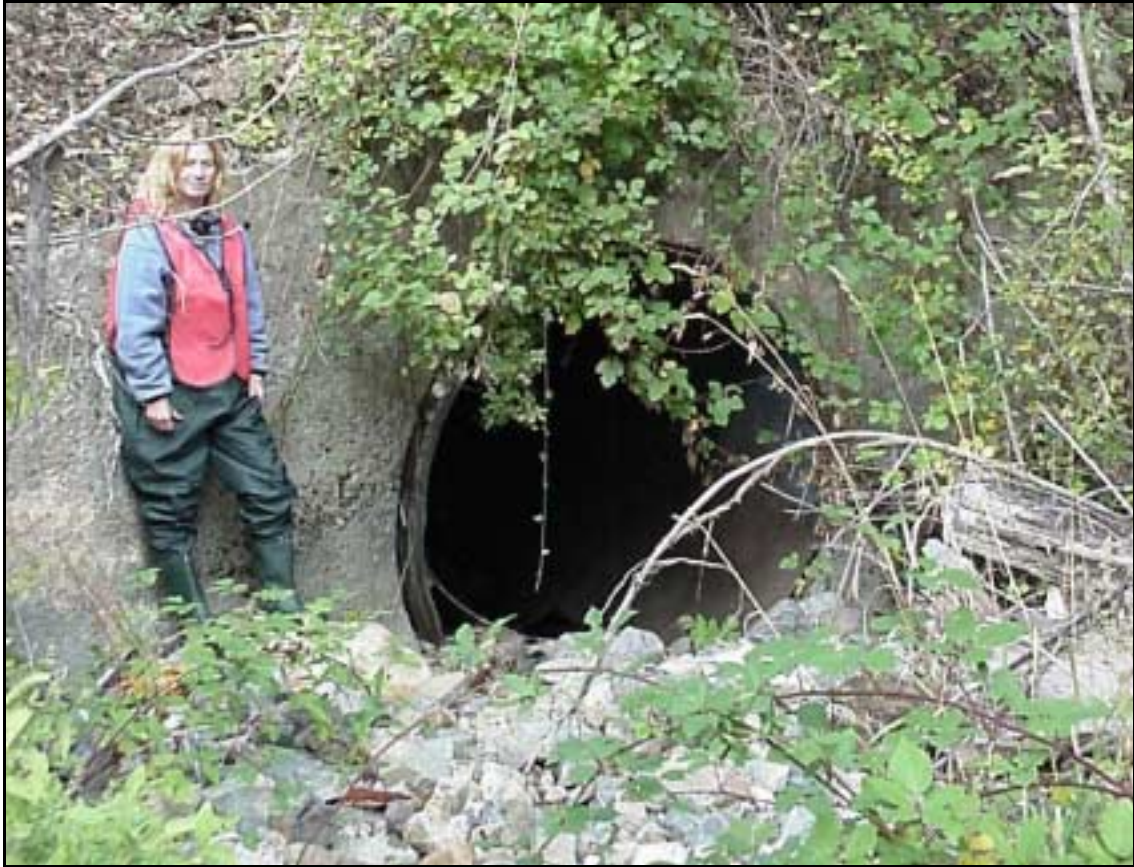
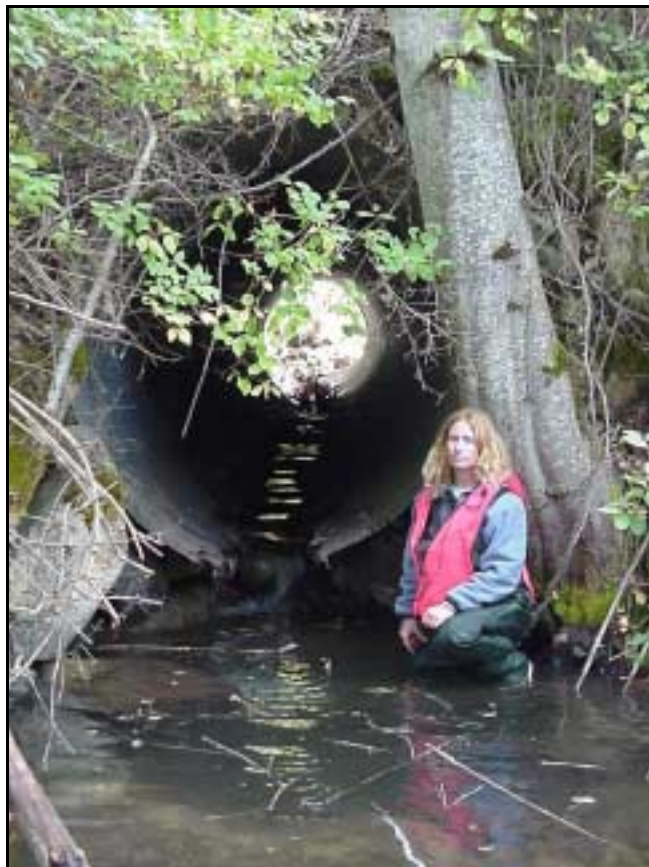
Site #30: South Fork Humbug Creek/Yreka-Walker Road; Humbug Creek; Klamath River.

Modifications: None. **Fill Estimate:** 324 cubic yards. **Overall condition:** Extremely poor; culvert floor is rusted through and torn apart.

Barrier Status: **RED:** the Green-Gray-Red filter determined this crossing fails to meet passage criteria for all species of adult salmonids and all age classes of juveniles. Excessive slope and slightly perched outlet are the crossing's features that create a migration barrier. Also, the steep inlet drop caused by the severe aggradation of substrate on the upstream side of the culvert (see photo) is probably a velocity barrier too.

Preferred Treatment: Replace with a properly sized bridge or open-bottom arch culvert set on concrete footings. This crossing ranked high (in part) because it is extremely undersized and in very poor condition.

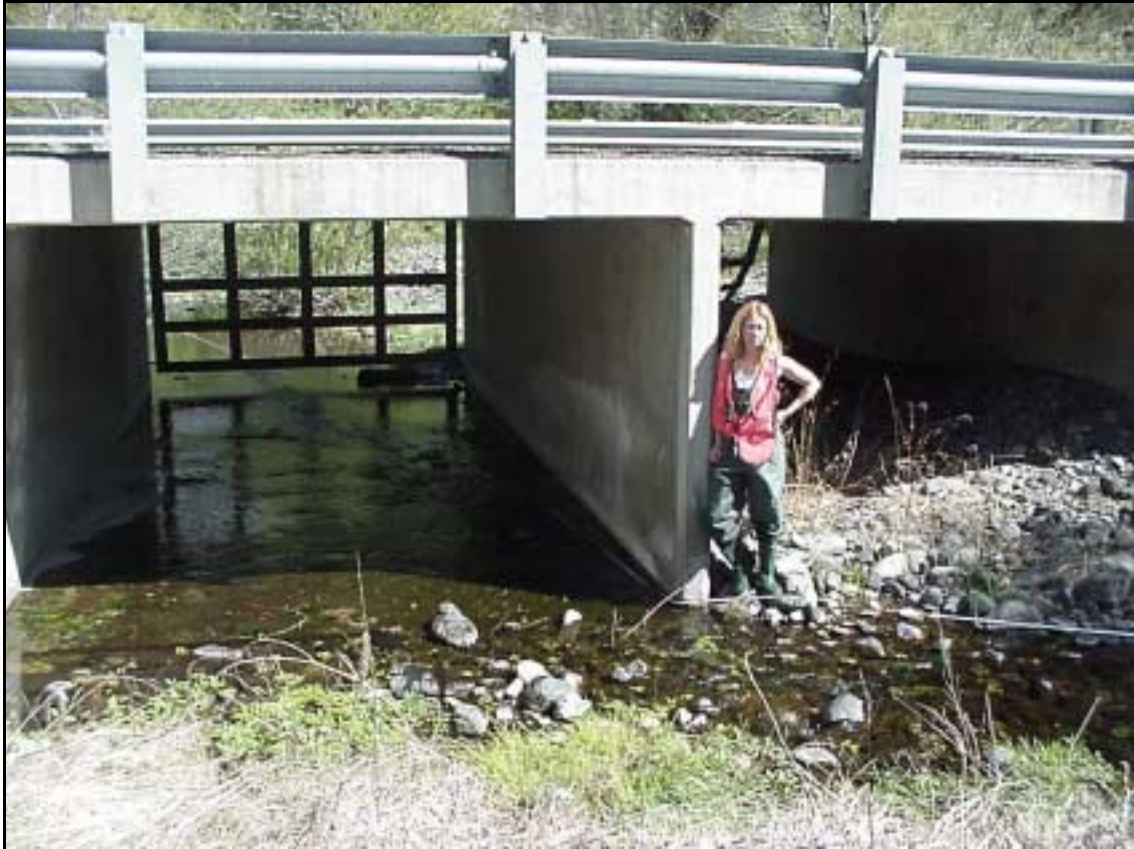
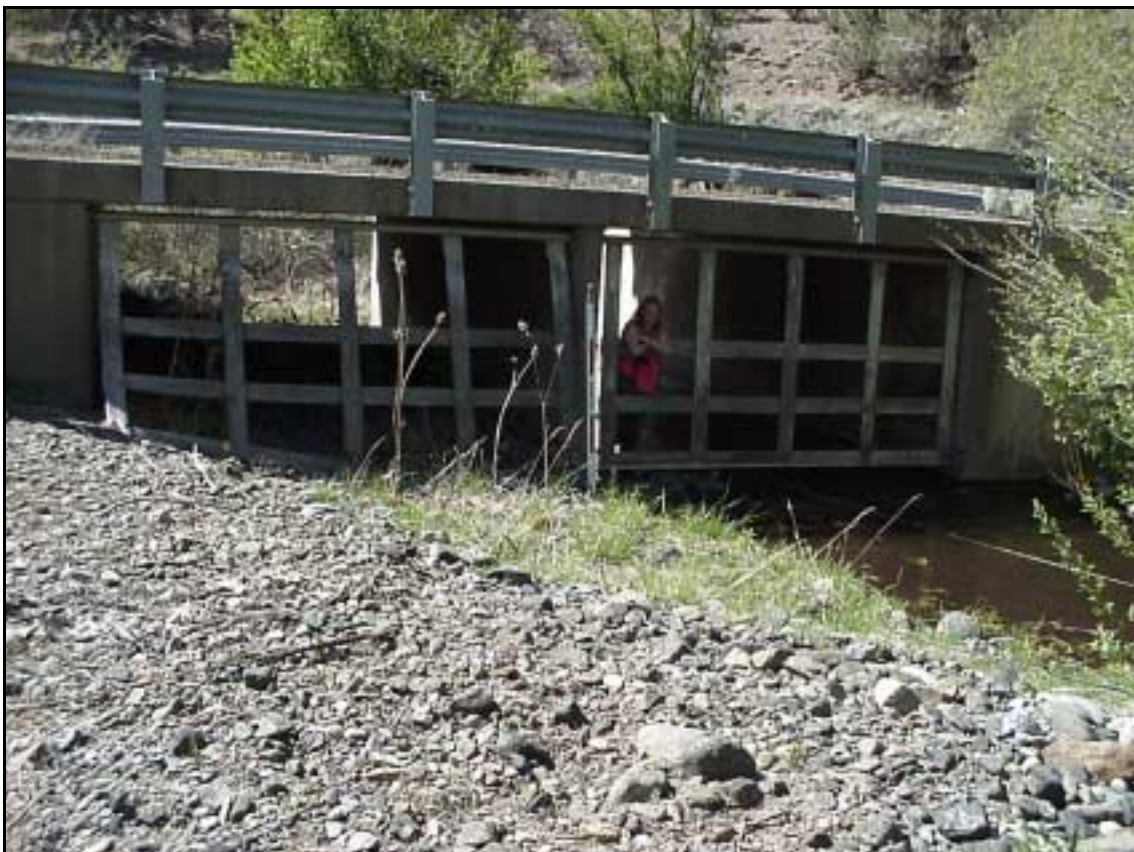
Site #31: Willow Creek #1/Gazelle-Callahan Road; Shasta River; Klamath River.

Slope: 0.95%. **Modifications:** None. **Fill Estimate:** 190 cubic yards. **Overall condition:** Good.

Habitat: Quantity = approximately 6.5 miles of potential anadromous fish-bearing habitat. Quality = Poor. No habitat typing or fisheries surveys or memos were found at the CDFG or USFS offices. Lower Willow Creek is diverted for irrigation and runs through a series of irrigation canals. When the site was surveyed, the lower channel was dry, however it was wetted at this crossing with several juvenile salmonids observed upstream of the box culvert. Overall, the channel appears to lack pool habitat and is aggraded with fine sediment. The riparian consists of a sparse band of willows and alders. The stream banks appear subjected to unfenced grazing and are in poor condition.

Preferred Treatment: No treatment is recommended due to the poor quality of habitat and the high probability of downstream migration barriers at private crossings and diversion structures. However, if the crossing were to fail Siskiyou County should replace with a properly sized bridge or open-bottom arch culvert set on concrete footings that is better aligned with the upstream channel.

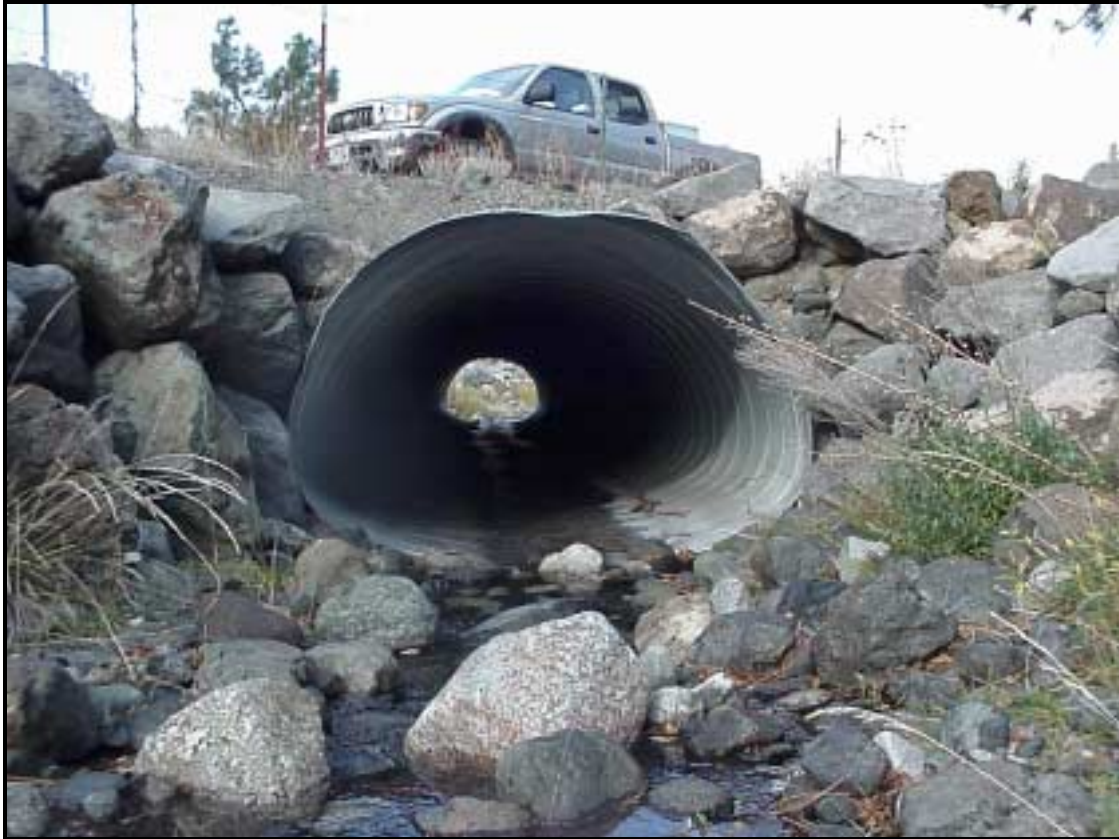
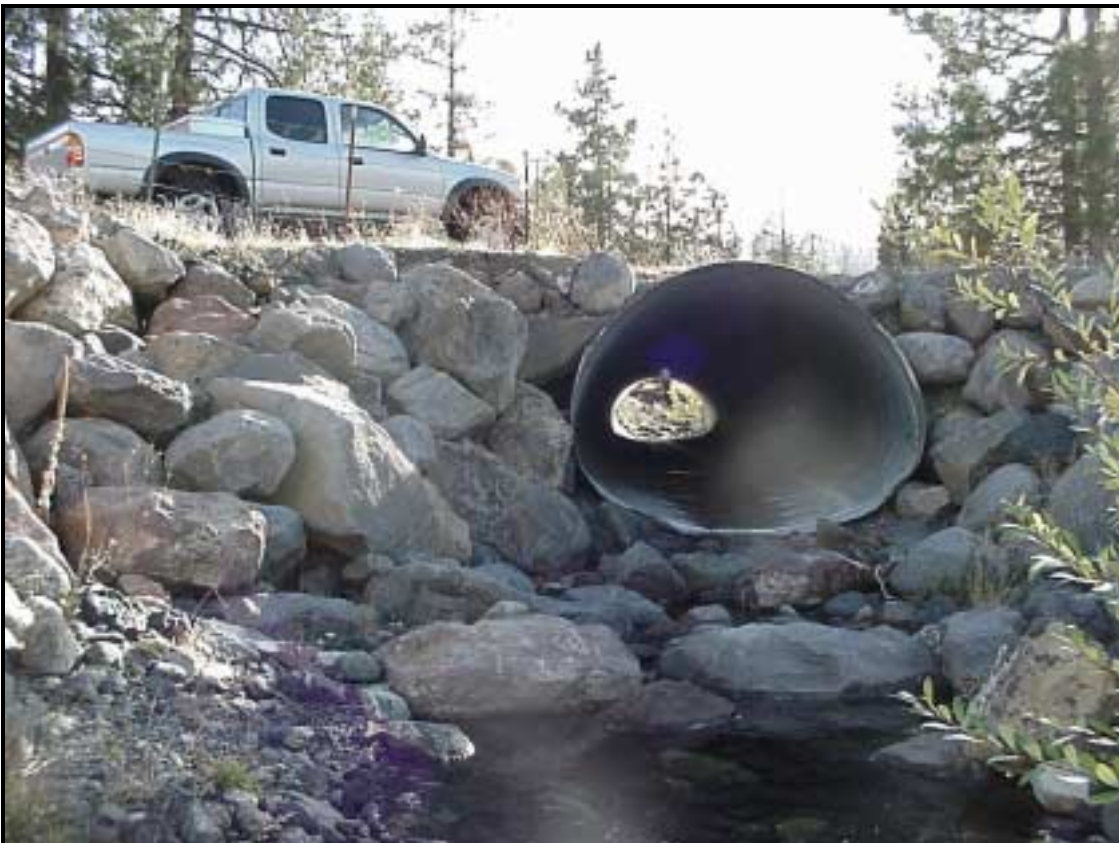
Site #32: South Fork Willow Creek/Gazelle-Callahan Road; Shasta River; Klamath River.

Slope: 3.80%. **Modifications:** None. **Fill Estimate:** 605 cubic yards. **Overall condition:** Good, new installation.

Barrier Status: **RED:** the Green-Gray-Red filter determined this crossing fails to meet passage criteria for all species of adult salmonids and all age classes of juveniles. Excessive slope and perched outlet are crossing's features that create a migration barrier. The riprap placed at the culvert outlet probably creates excessive turbulence at migration flows.

Preferred Treatment: Properly sized bridge or open-bottom arch culvert set on concrete footings.

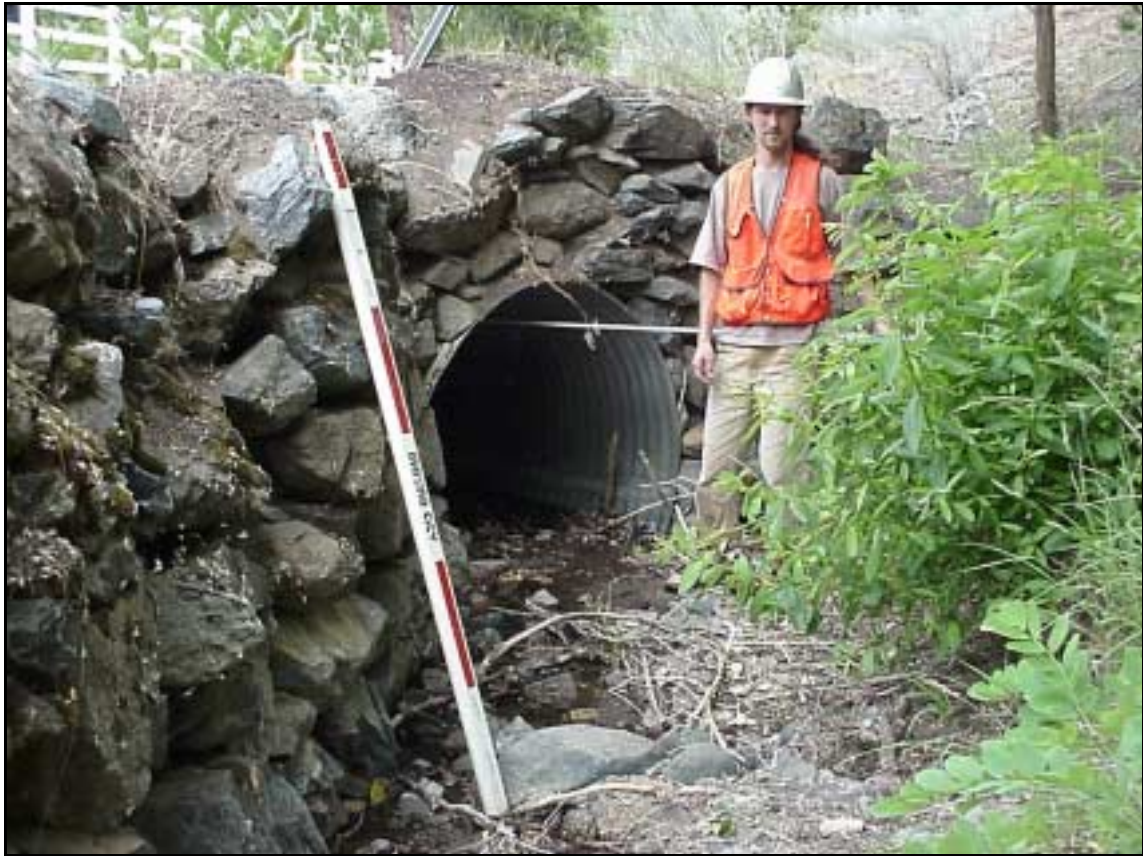
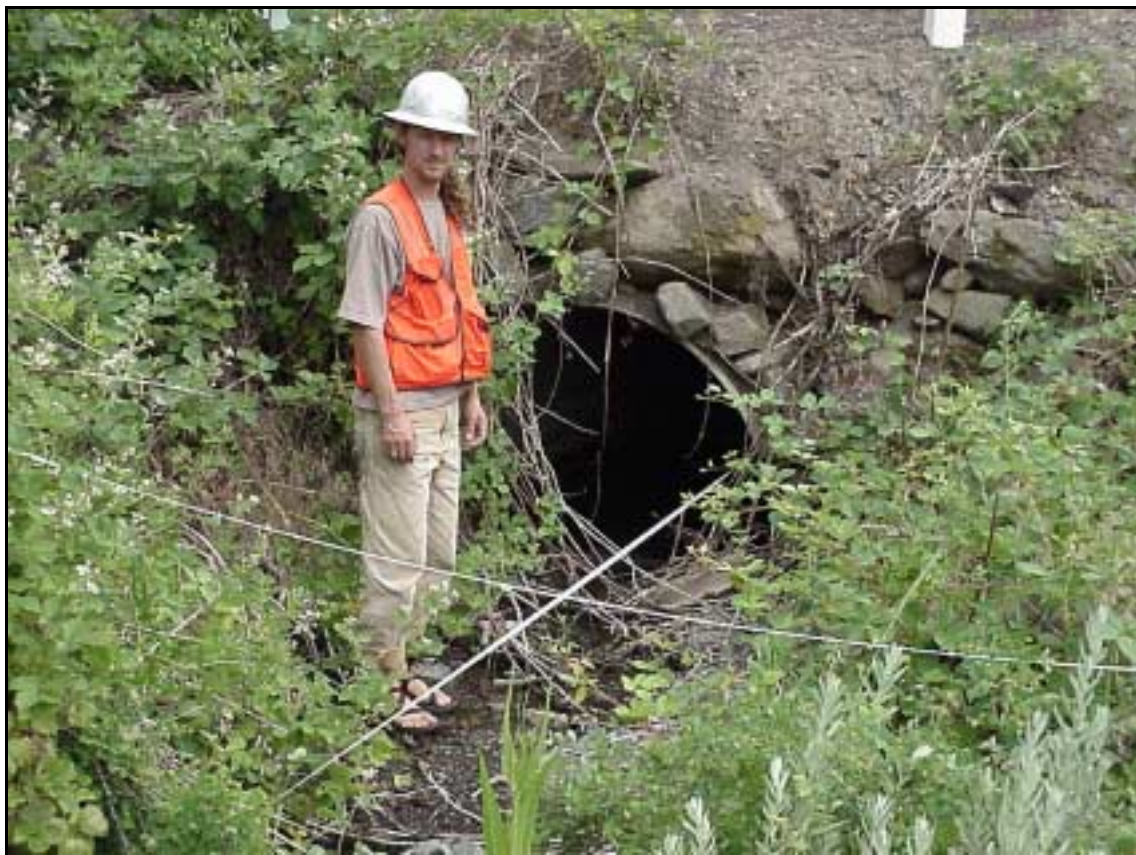
Site #33: Willow Creek #2/Gazelle-Calahan Road; Shasta River; Klamath River.

Slope: 0.77%. **Modifications:** None. **Fill Estimate:** 149 cubic yards. **Overall condition:** Good.

Habitat: Quantity = approximately 3,400' of potential anadromous fish-bearing habitat. Quality = Poor. No habitat typing or fisheries surveys, notes, or memos were found in CDFG and USFS files. The channel above the County culvert was spotted checked in numerous places along the road. Overall, the channel is narrow and confined to the inboard ditch of the road with limited pool habitat for rearing and suitable gravels for spawning.

Preferred Treatment: No treatment recommended because the current culvert meets fish passage criteria. However, the current culvert is undersized and should be replaced with a properly-sized embedded circular or oval culvert when the current structure is due for replacement (or fails). The new installation should also be properly aligned with the upstream channel.

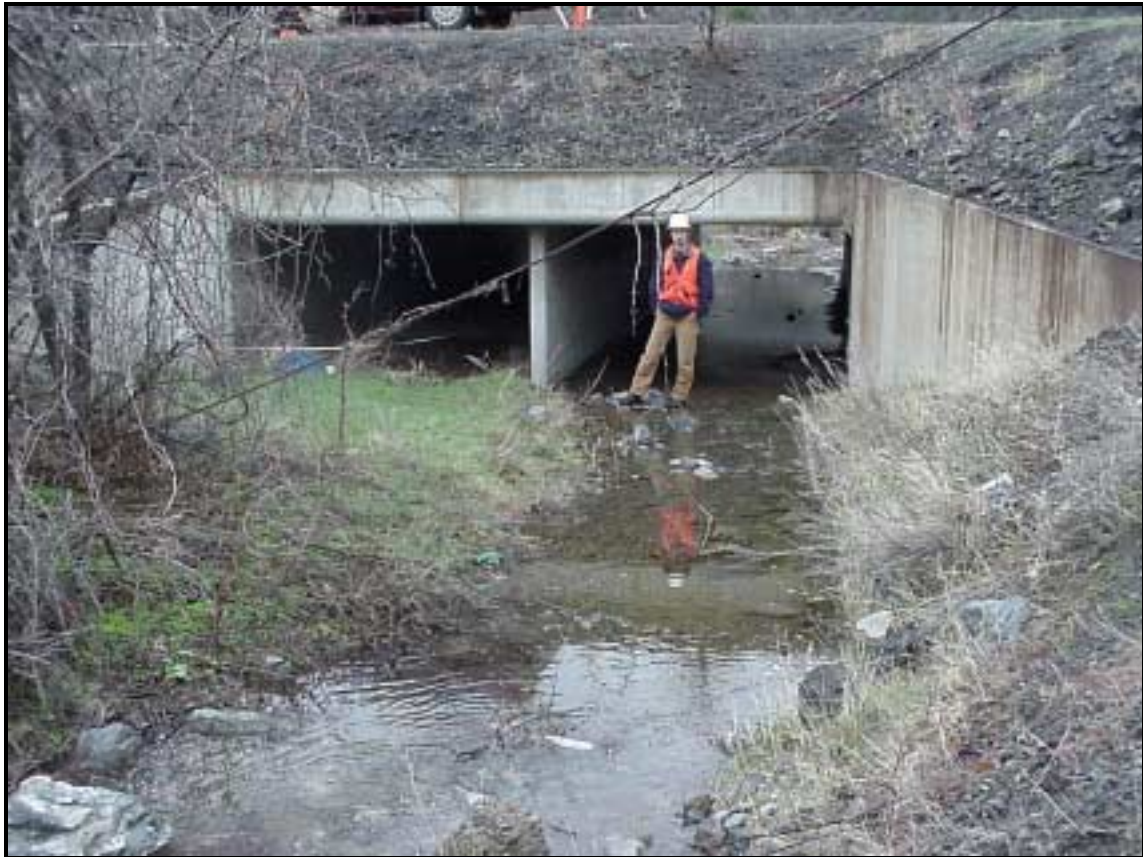
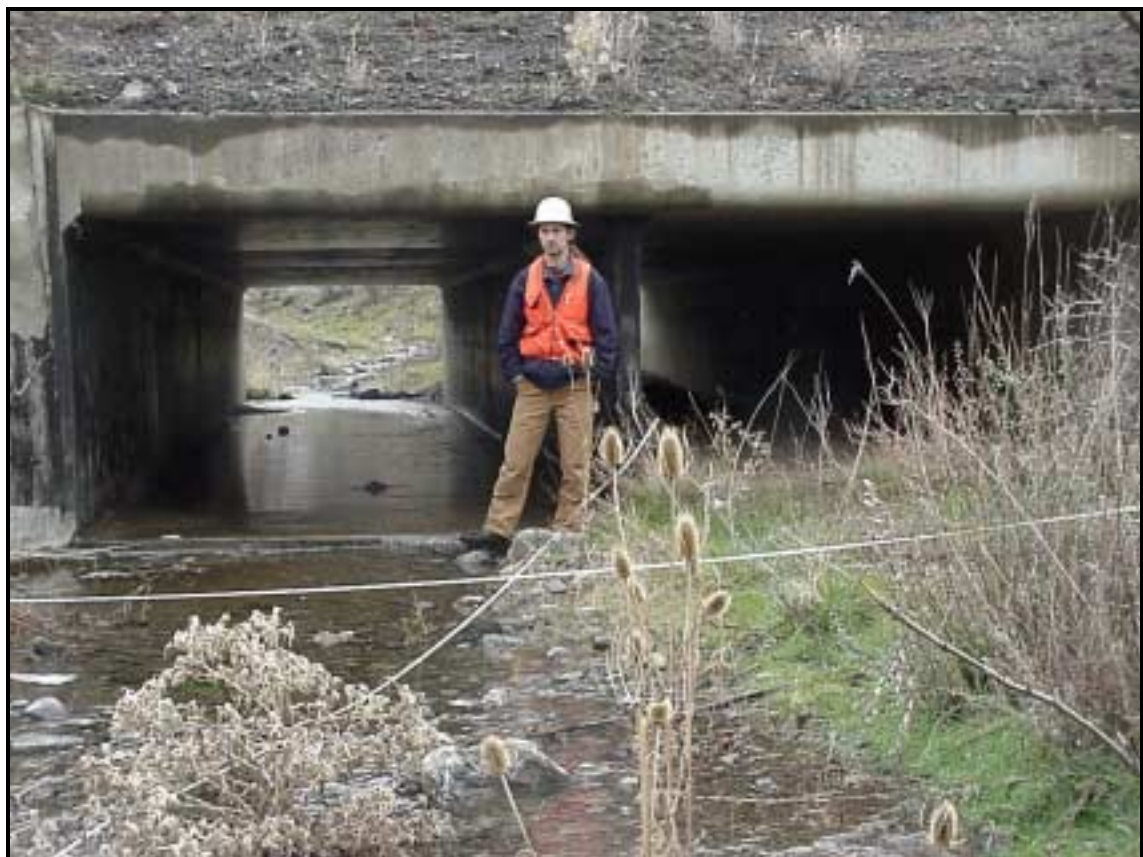
Site #34: Williams Creek/Klamathon Road; Klamath River

Slope: LB=0.05%; RB=0.20%. **Modifications:** None. **Fill Estimate:** 522 cubic yards. **Overall condition:** Good.

Barrier Status: LB= Due to the large amounts of embedded substrate, this bay of the culvert may provide conditions suitable for adult passage when Williams Creek is flowing at a discharge higher than the expected high-passage flow. RB=GREY: although "Grey", FishXing estimated that fish passage criteria are met on 0% of the expected migration flows for adult anadromous salmonids, 0% for resident/two-year old juveniles, and 0% for one-year old and young-of-year juveniles. Lack of depth is the crossing's feature that creates a migration barrier.

Preferred Treatment Passage can be improved by installing corner baffles and an outlet beam in both bays of box culvert to increase depth and reduce velocities. Periodic maintenance (prior to and during period of expected steelhead migration, Jan-March) is recommended to ensure the baffles are clear of debris and performing properly.

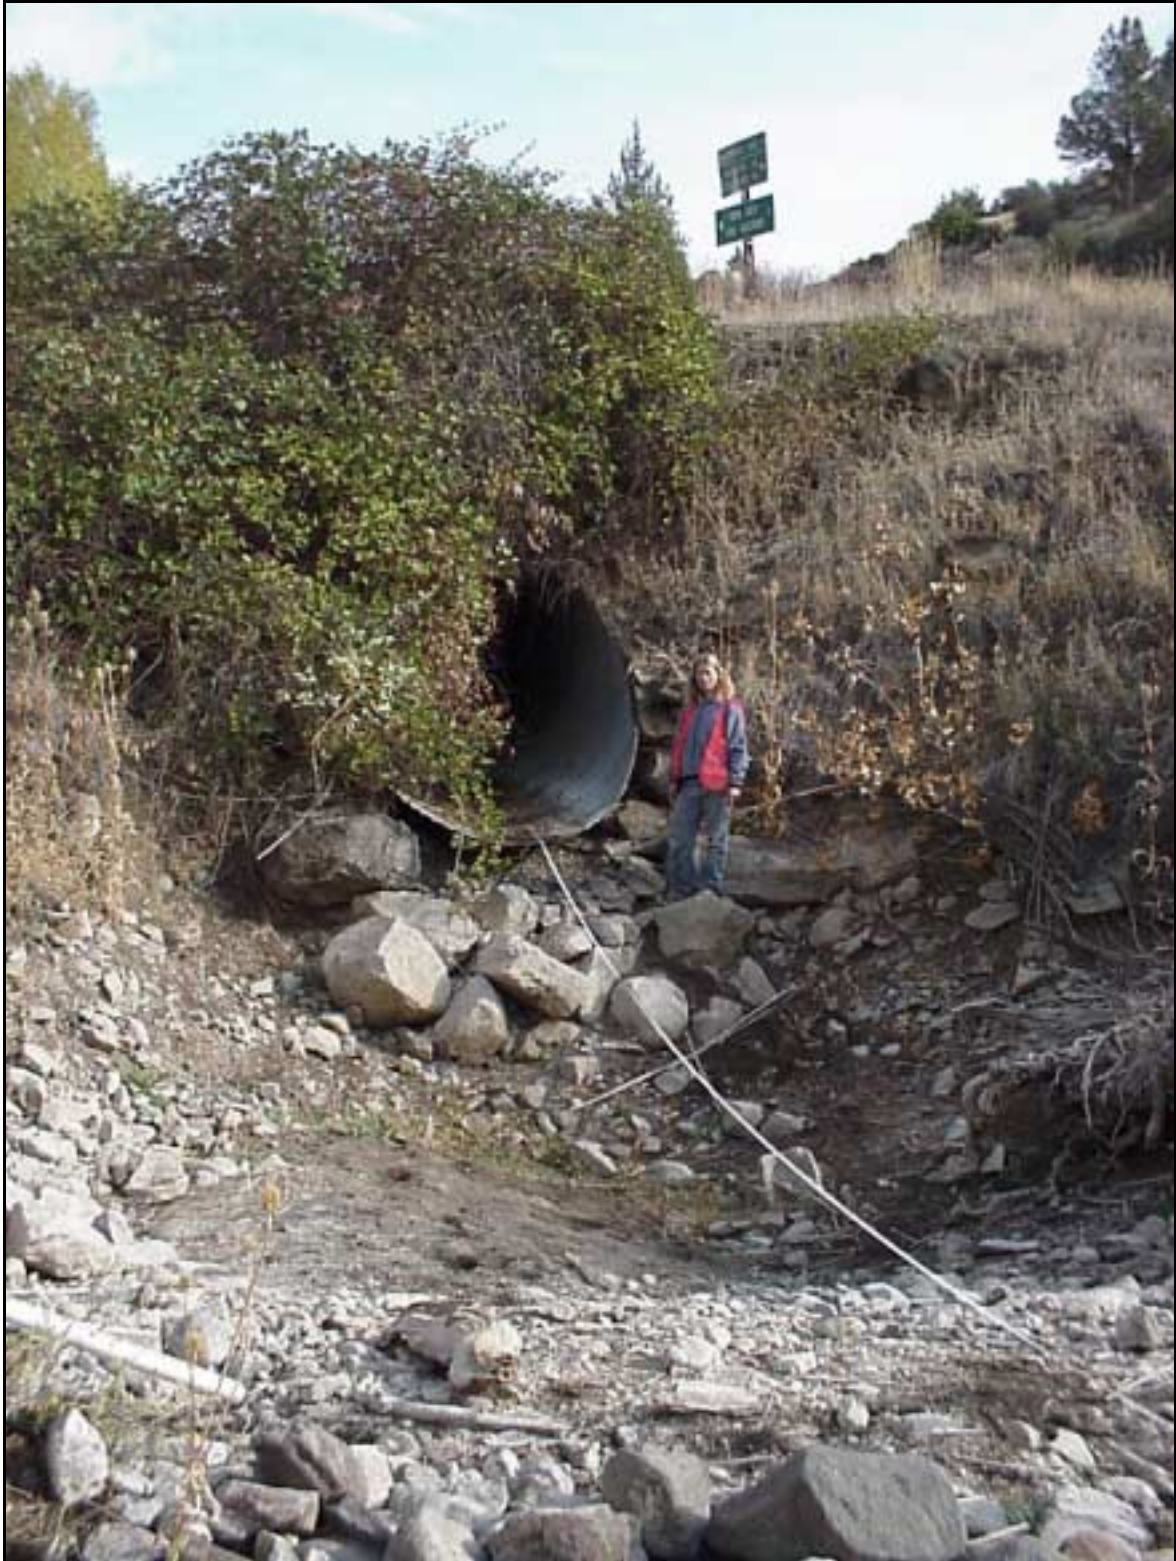
Site #35: Cape Horn Creek/Copco Road; Klamath River.

Modifications: None. **Fill Estimate:** 659 cubic yards. **Overall condition:** Fair, culvert floor is abraded and rusted.

Preferred Treatment: No treatment recommended because of the limited benefit of upstream habitat gains. However, the current culvert is undersized and should be replaced with a properly-sized embedded circular or oval culvert when the current structure is due for replacement (or fails).
