APPENDIX B:

CATALOG OF TRINITY COUNTY CULVERTS LOCATED ON FISH-BEARING STREAM REACHES

Site ID #1: Unnamed tributary/South Fork Road; South Fork Trinity River; Trinity River

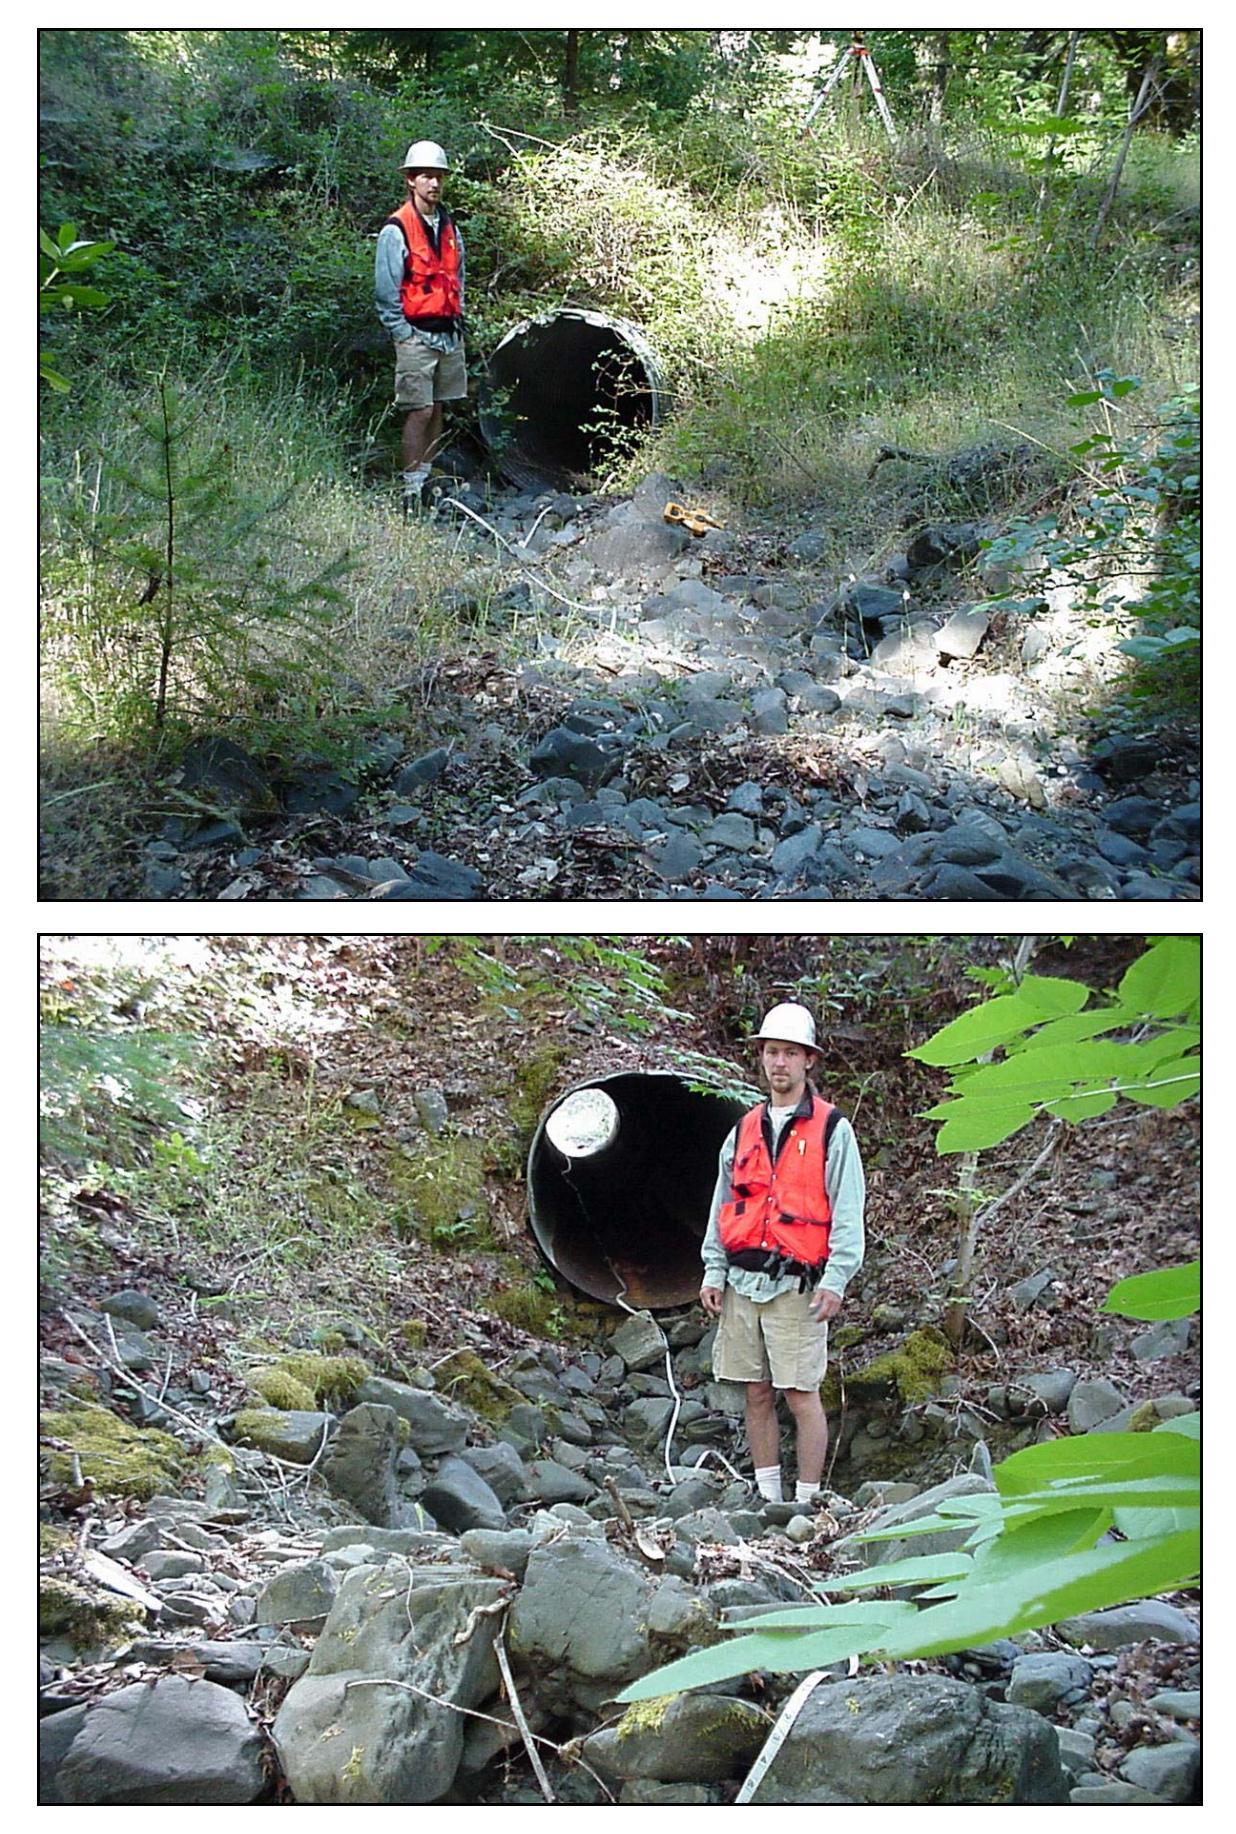
Fill Estimate: 231 cubic yards Overall condition: Fair, culvert has abraded bottom.

Sizing: Extremely undersized; HW/D = 1 on a storm flow with approximately a two-year recurrence interval. South Fork Road is overtopped on approximately a two-year storm flow.

Barrier Status: RED: the Green-Gray-Red filter determined this crossing fails to meet passage criteria for all species of adult salmonids and all age classes of juveniles.

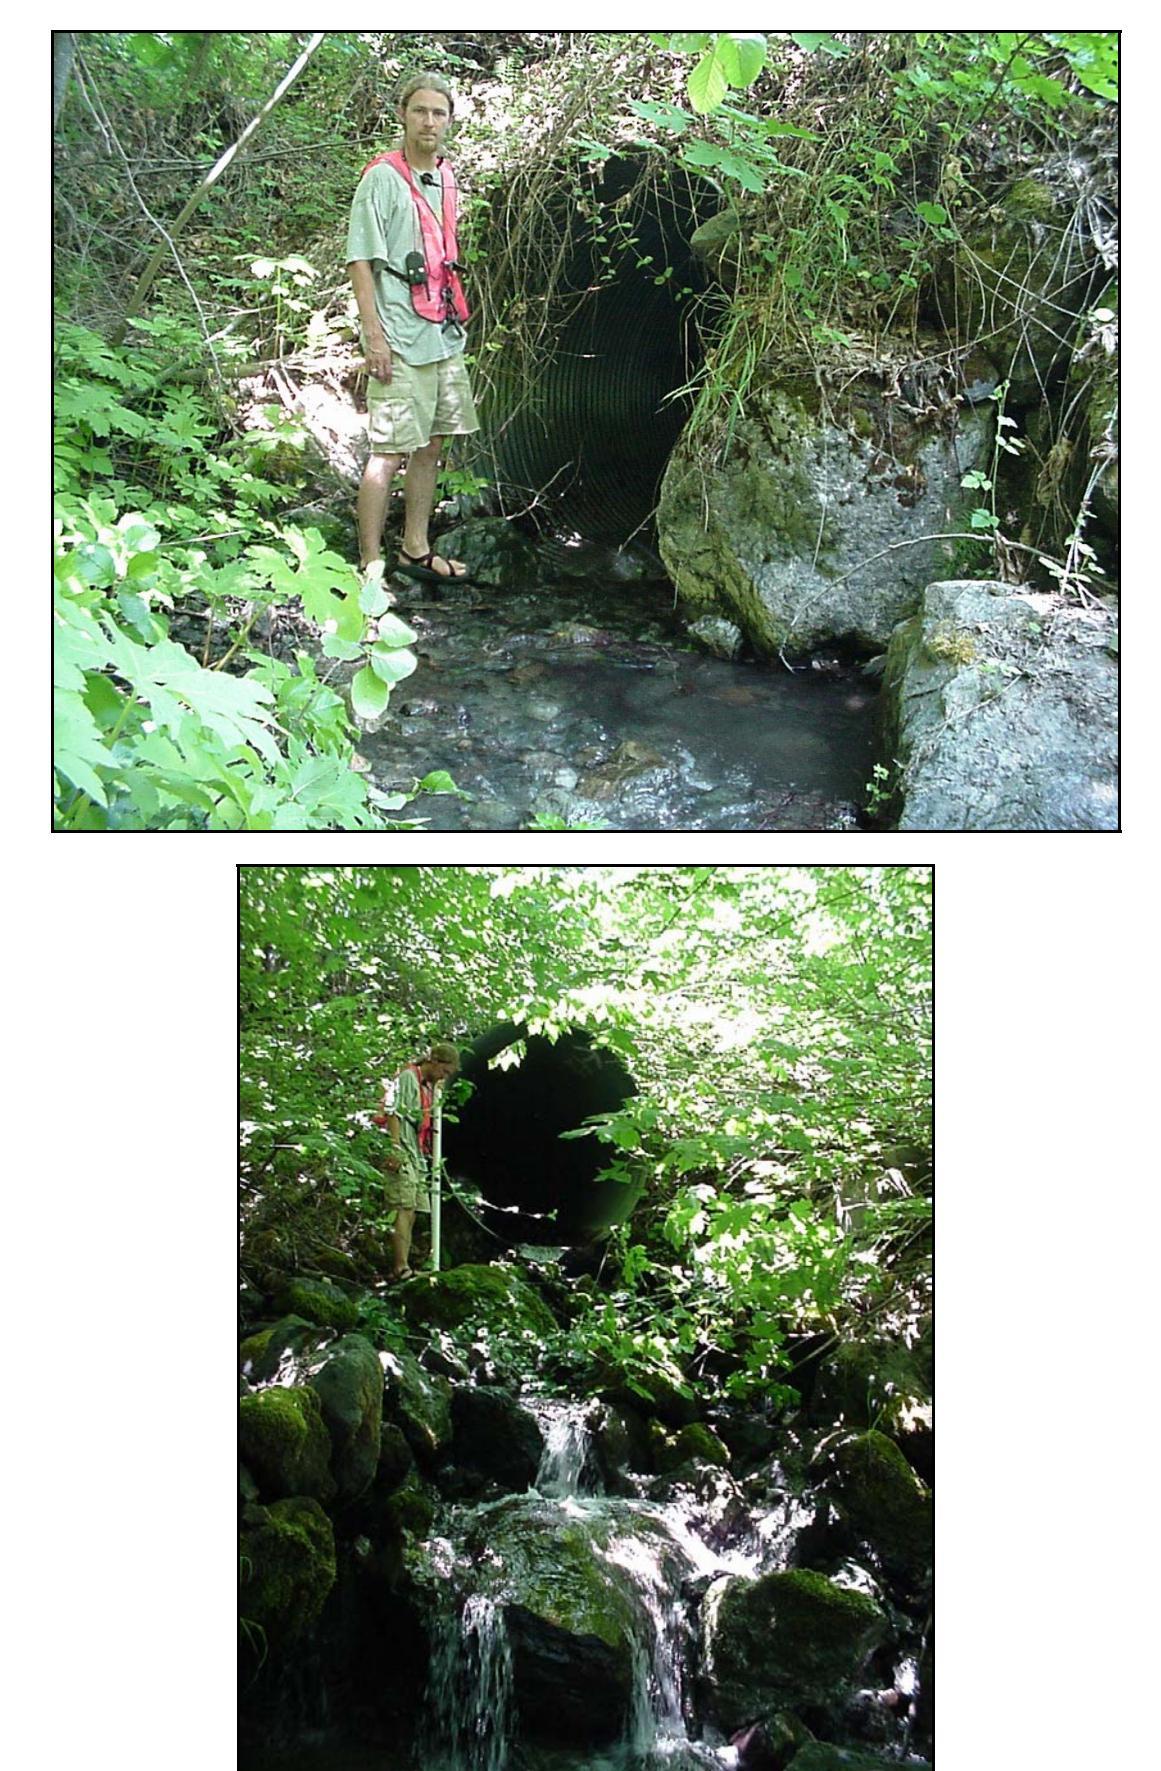
Site ID #2: Slide Creek/Lower South Fork Road; Hayfork Creek; South Fork Trinity River; Trinity River

Fill Estimate: 606 cubic yards Overall condition: Abraded.

Barrier Status: RED: the Green-Gray-Red filter determined this crossing fails to meet passage criteria for all species of adult salmonids and all age classes of juveniles.

Preferred Treatment When crossing is due for replacement (or fails) replace with a properly-sized circular SSP pipe with grade control weirs or a bridge. The steep slope of the stream channel below the crossing would require a series of weirs to provide fish passage (if deemed necessary). Lack of upstream fisheries benefit makes this site a poor candidate for replacement with restoration funds.

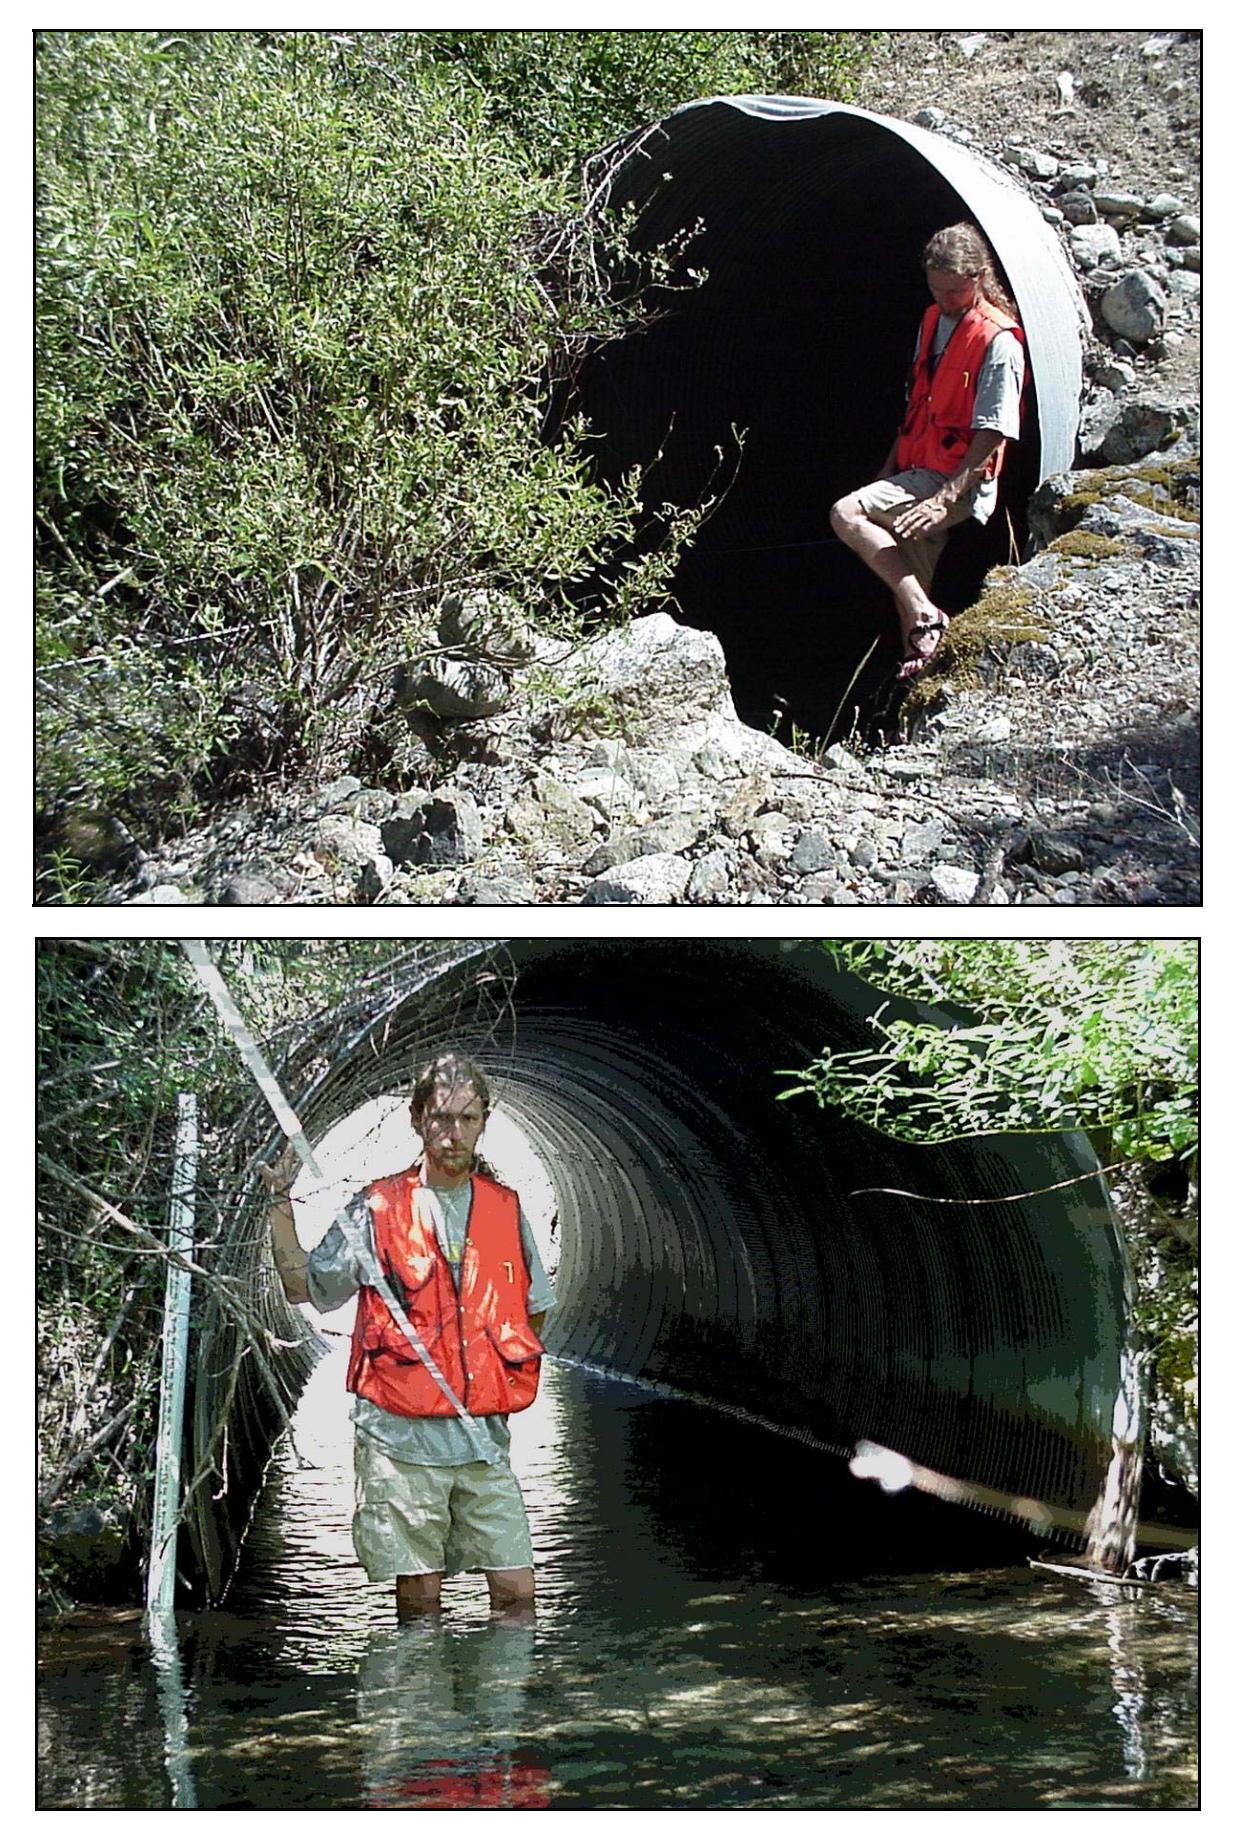
Fill Estimate: 456 cubic yards Overall condition: Fair, culvert floor is abraded.

Preferred Treatment: When crossing is due for replacement (or fails) replace with a properly-sized embedded circular SSP pipe or an open-bottom arch set on concrete footings to maintain the GREEN status of this crossing. Lack of upstream fisheries benefit makes this site a poor candidate for replacement with restoration funds.

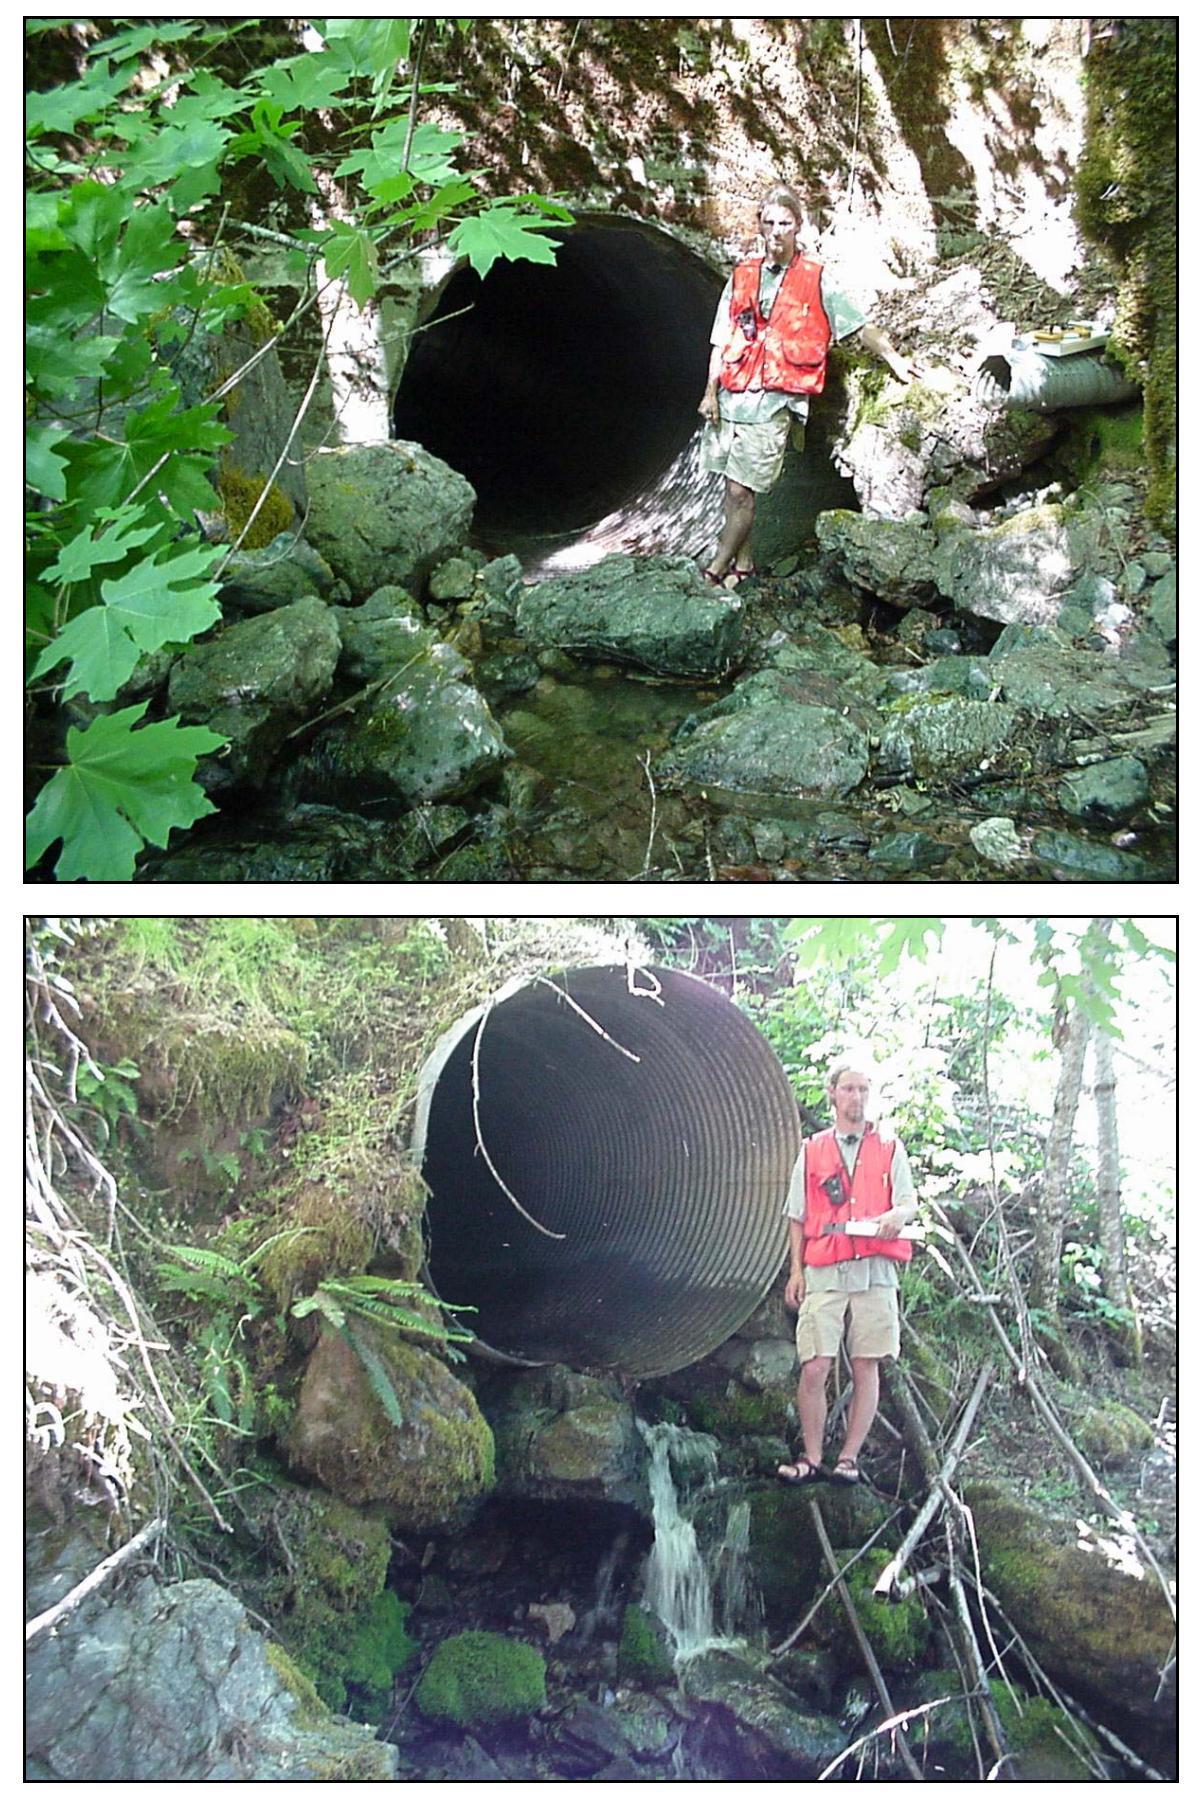
Fill Estimate: 1,607 cubic yards **Overall condition:** Poor, rusted through – at low flow, all of the flow seeps through holes before reaching the culvert outlet.

Barrier Status: RED: the Green-Gray-Red filter determined this crossing fails to meet passage criteria for all species of adult salmonids and all age classes of juveniles.

Preferred Treatment: When crossing is due for replacement (or fails) replace with a properly-sized circular SSP pipe with grade control weirs or a bridge. The steep slope of the stream channel below the crossing would require a series of weirs to provide fish passage (if deemed necessary). Lack of upstream fisheries benefit makes this site a poor candidate for replacement with restoration funds.

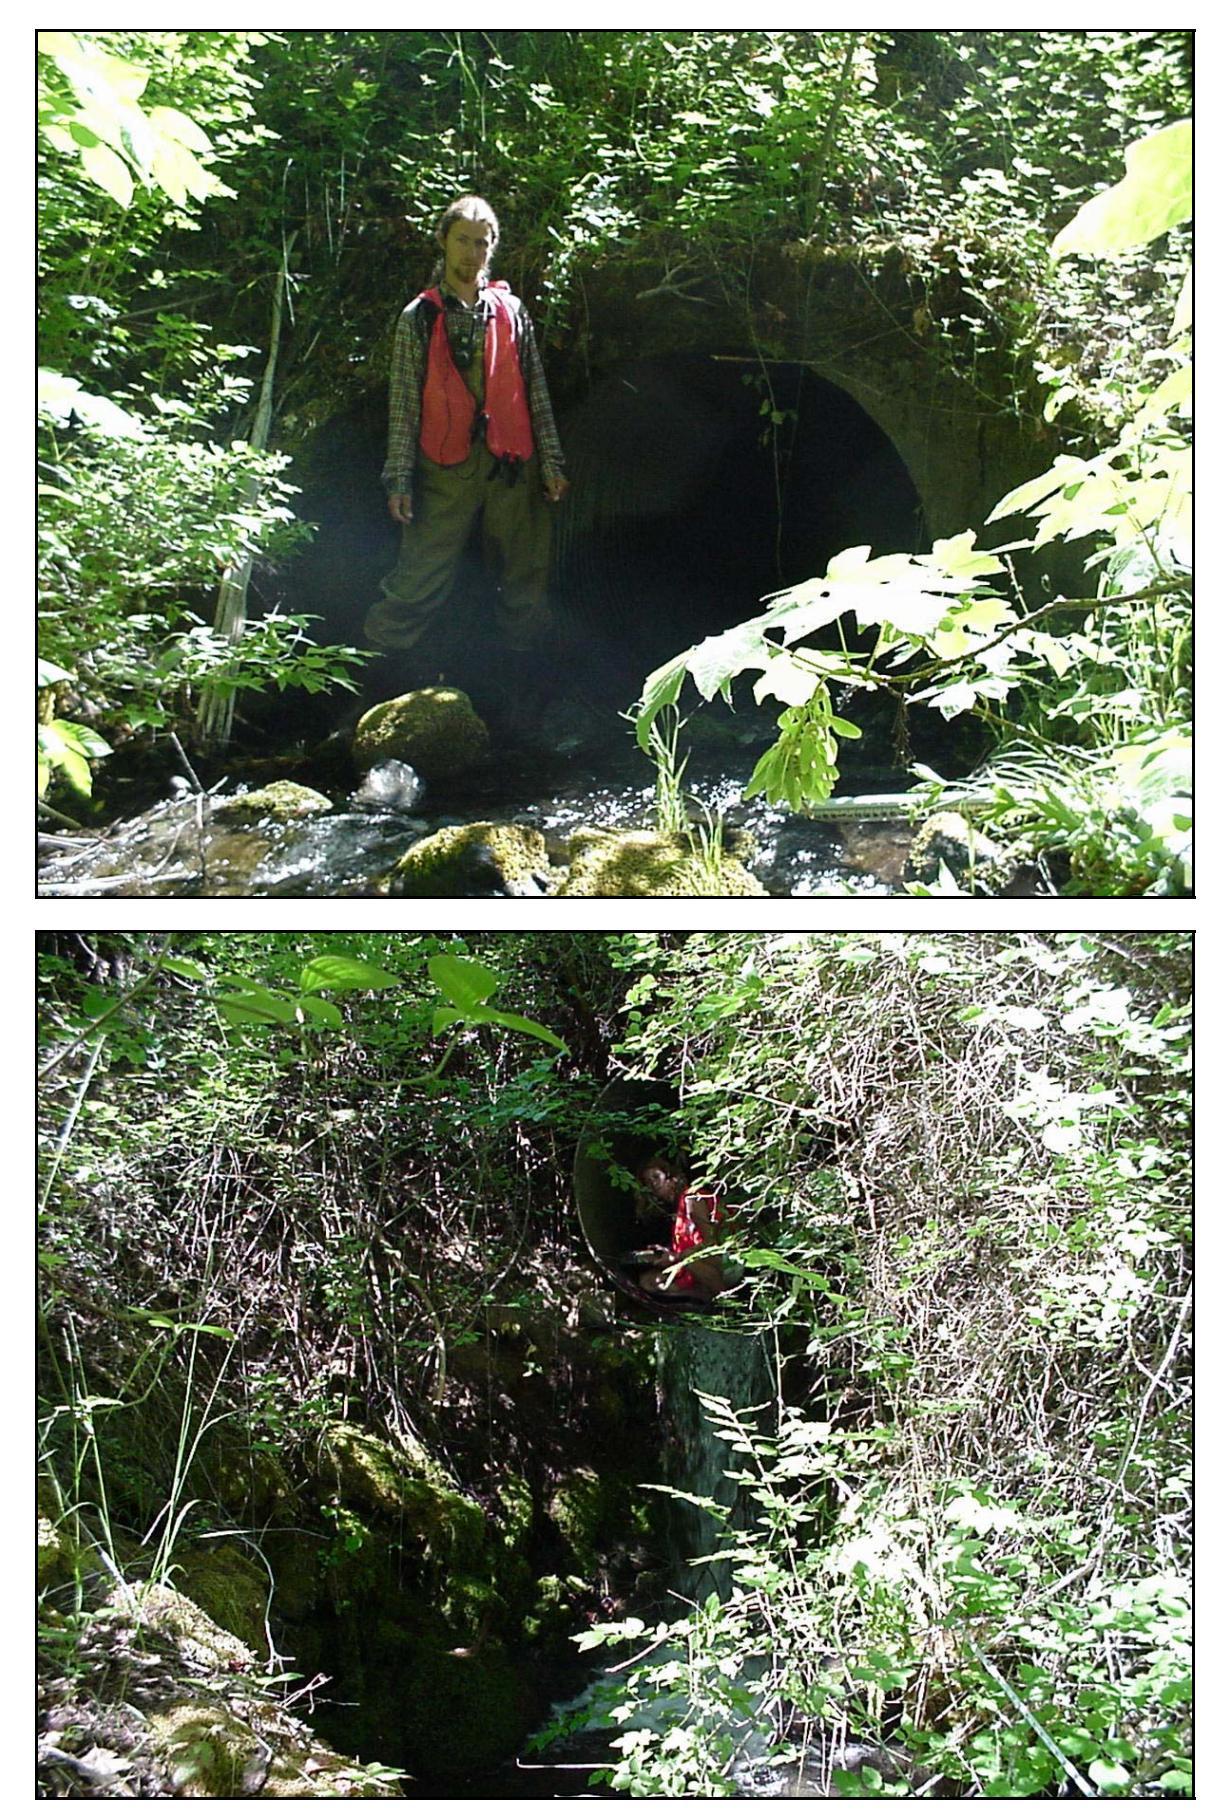
Average Active Channel Width: 9.5' Fill Estimate: 621 cubic yards Overall condition: Good.

Barrier Status: RED: the Green-Gray-Red filter determined this crossing fails to meet passage criteria for all species of adult salmonids and all age classes of juveniles.

Preferred Treatment: When crossing is due for replacement (or fails) replace with a properly-sized circular SSP pipe with grade control weirs or a bridge. The steep drop of the stream channel below the crossing would require a series of weirs to provide fish passage (if deemed necessary). The minimal fisheries benefit of restoring access to Jud Creek makes this site a poor candidate for replacement with restoration funds.

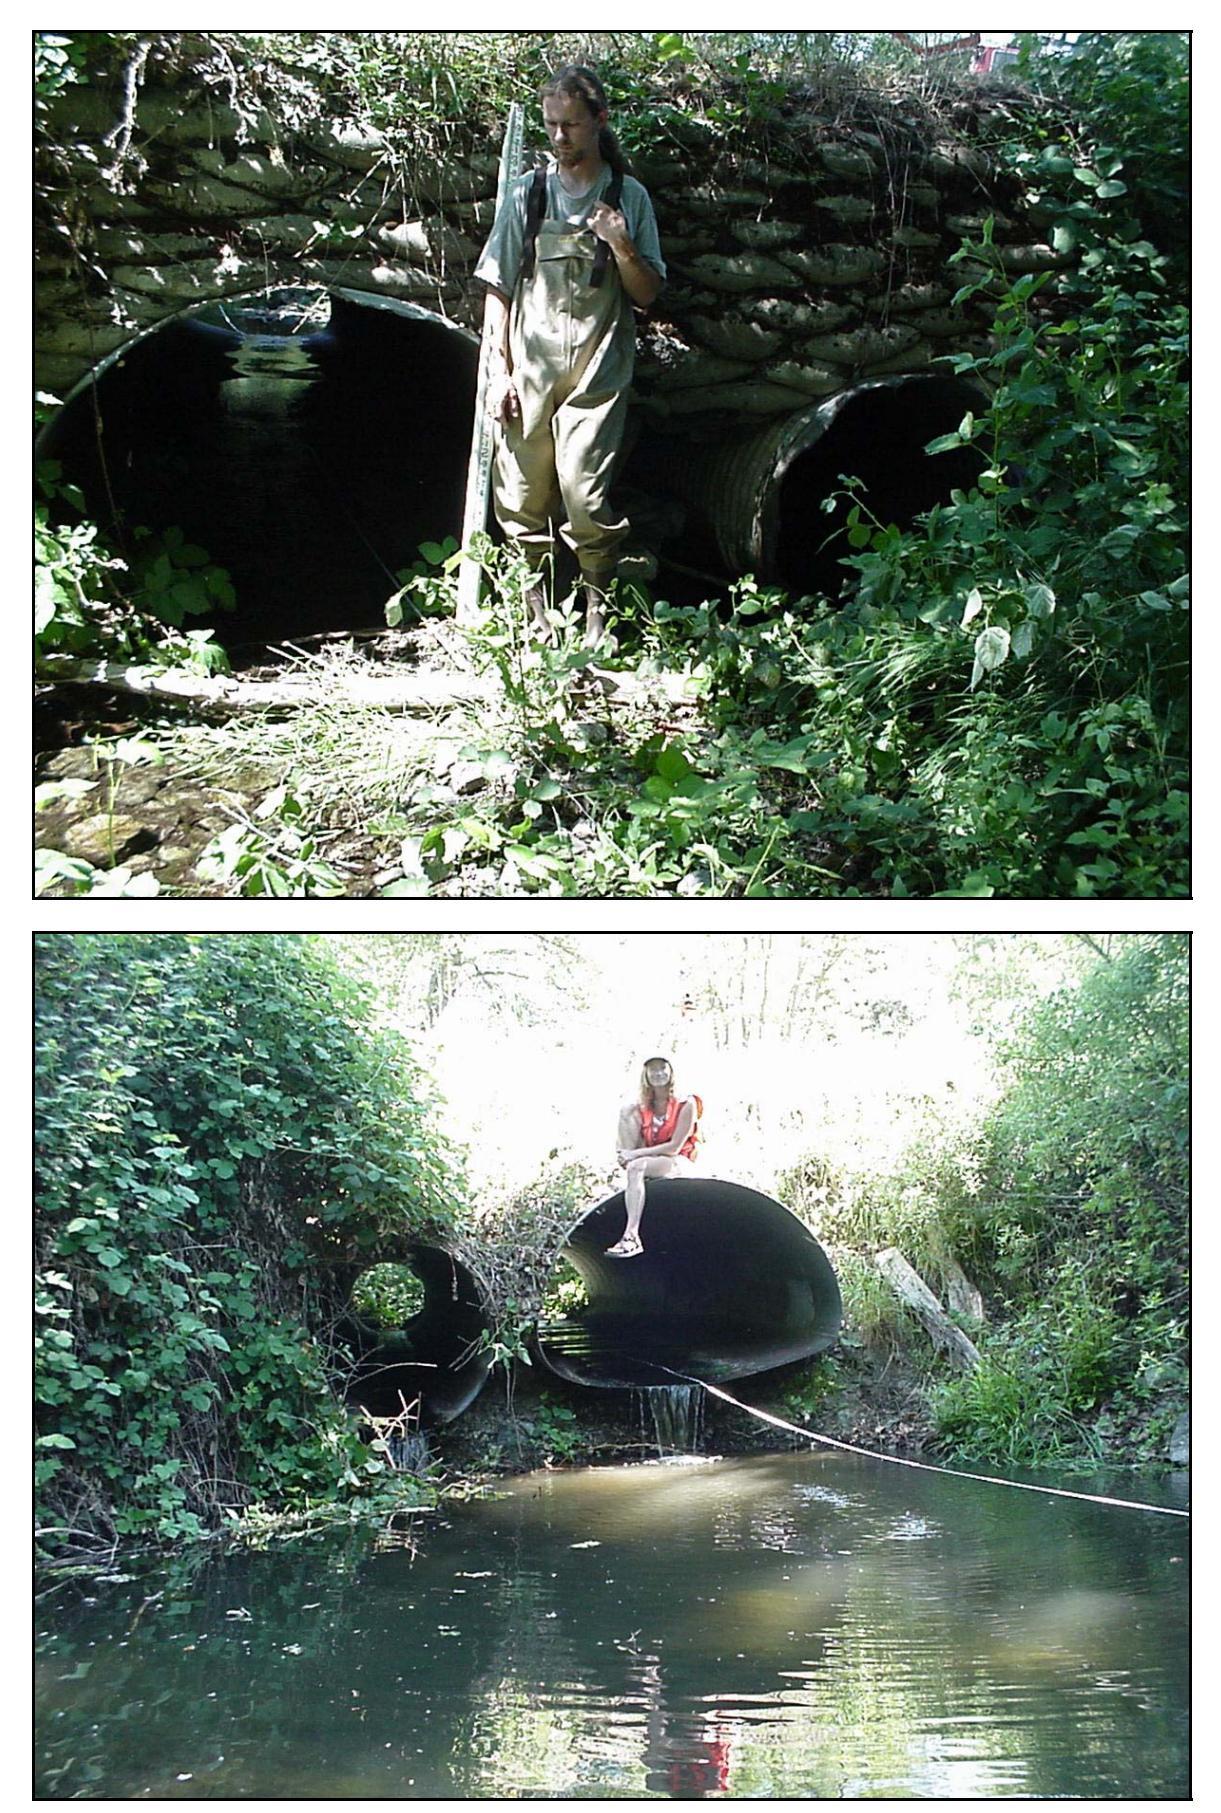
Average Active Channel Width: 7.8' Fill Estimate: 196 cubic yards Overall condition: Poor, both pipes are abraded, slightly crushed and slumping.

Barrier Status: LB= **GREY**: the Green-Gray-Red filter determined this crossing fails to meet passage criteria for all species of adult salmonids and all age classes of juveniles. RB= **RED**: The Green-Gray-Red filter determined this crossing fails to meet passage criteria for all species of adult salmonids and all age classes of juveniles.

Preferred Treatment: Replace with a properly-sized open-bottom arch set on concrete footings or a bridge.

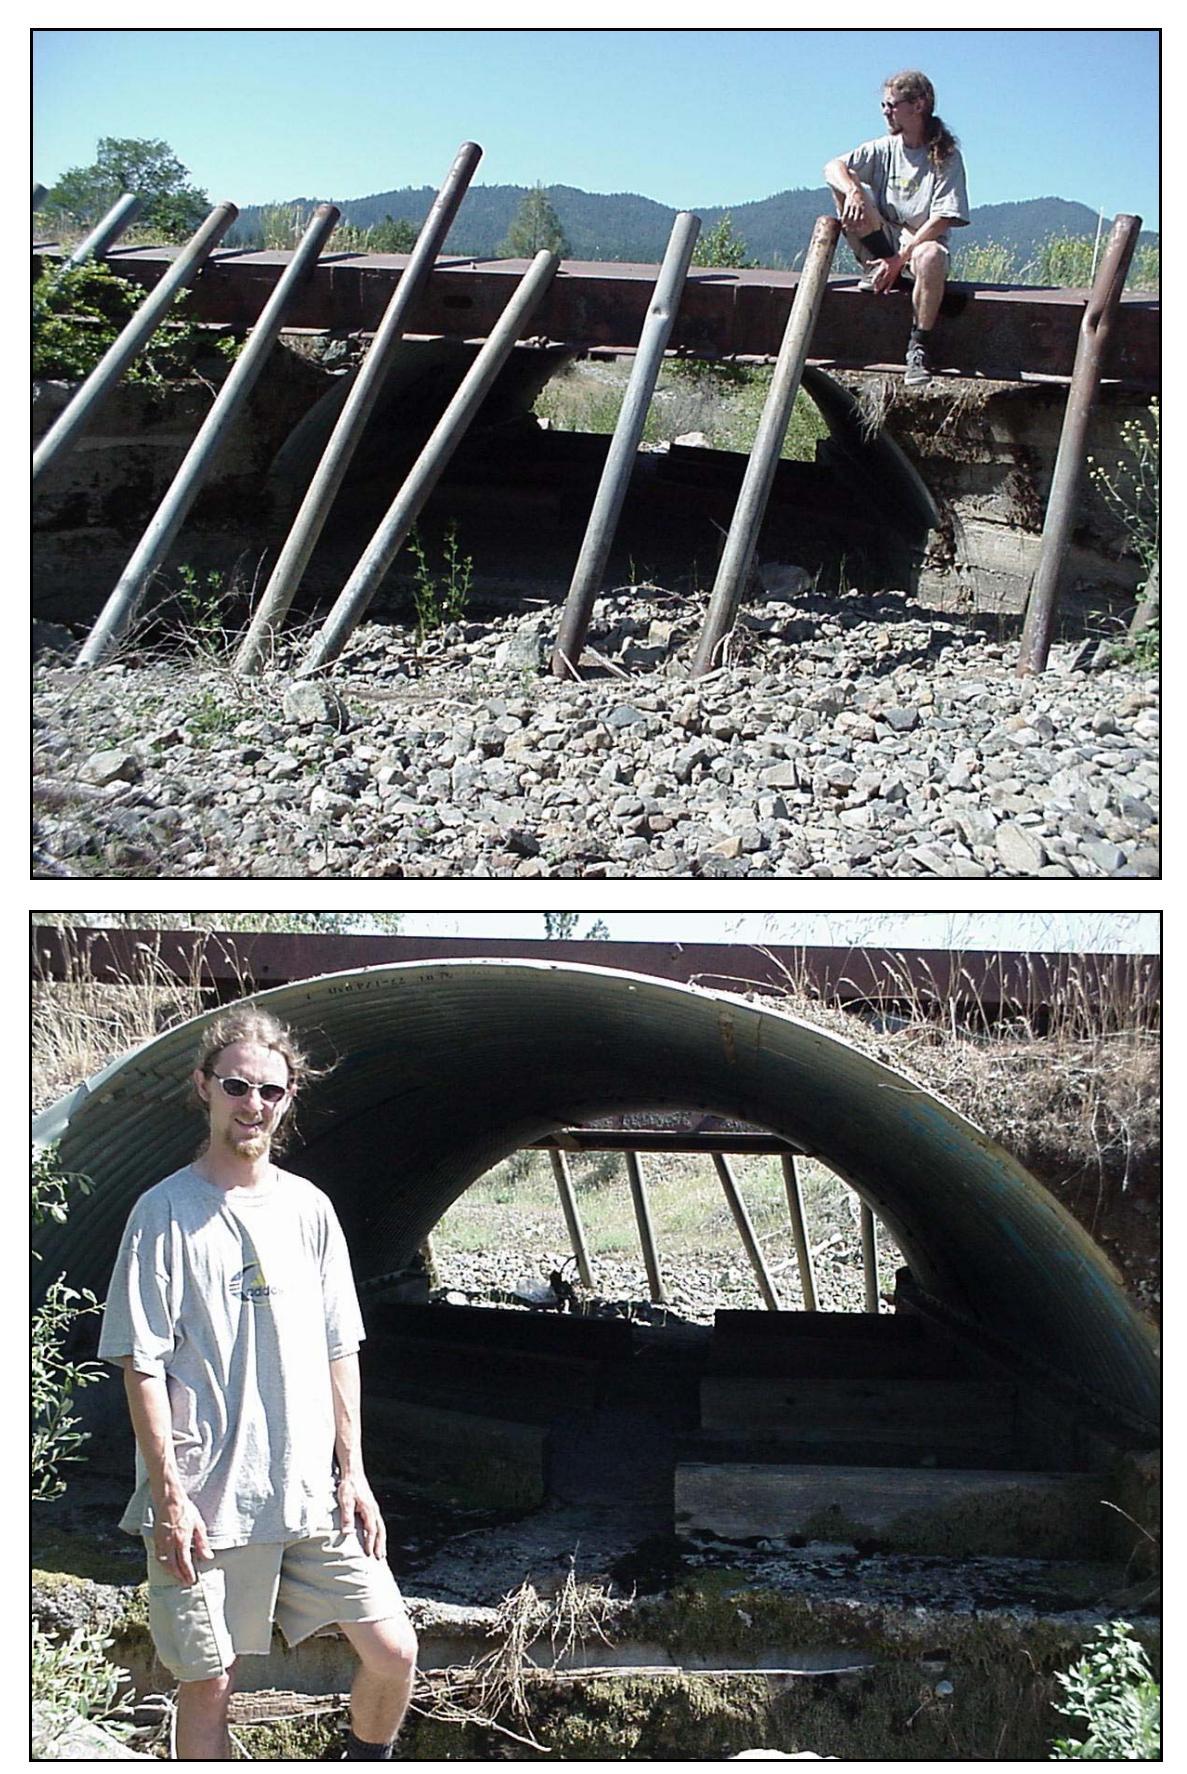
Site ID #7: Kingsbury Gulch #2/Morgan Hill Road; Hayfork Creek; South Fork Trinity River; Trinity River

Modifications: Wooden offset baffles 0.6' high. Four placed on LB perpendicular to flow, three on RB diagonal to flow - angled in a downstream direction. NOTE: the diagonal baffles are placed improperly and probably increase velocities through culvert. Trash rack at inlet of culvert.

Overall condition: Fair, culvert is abraded.

Barrier Status: RED: the Green-Gray-Red filter determined this crossing fails to meet passage criteria for all species of adult salmonids and all age classes of juveniles.

Preferred Treatment: Replace with a properly-sized open-bottom arch set on concrete footings or a bridge.

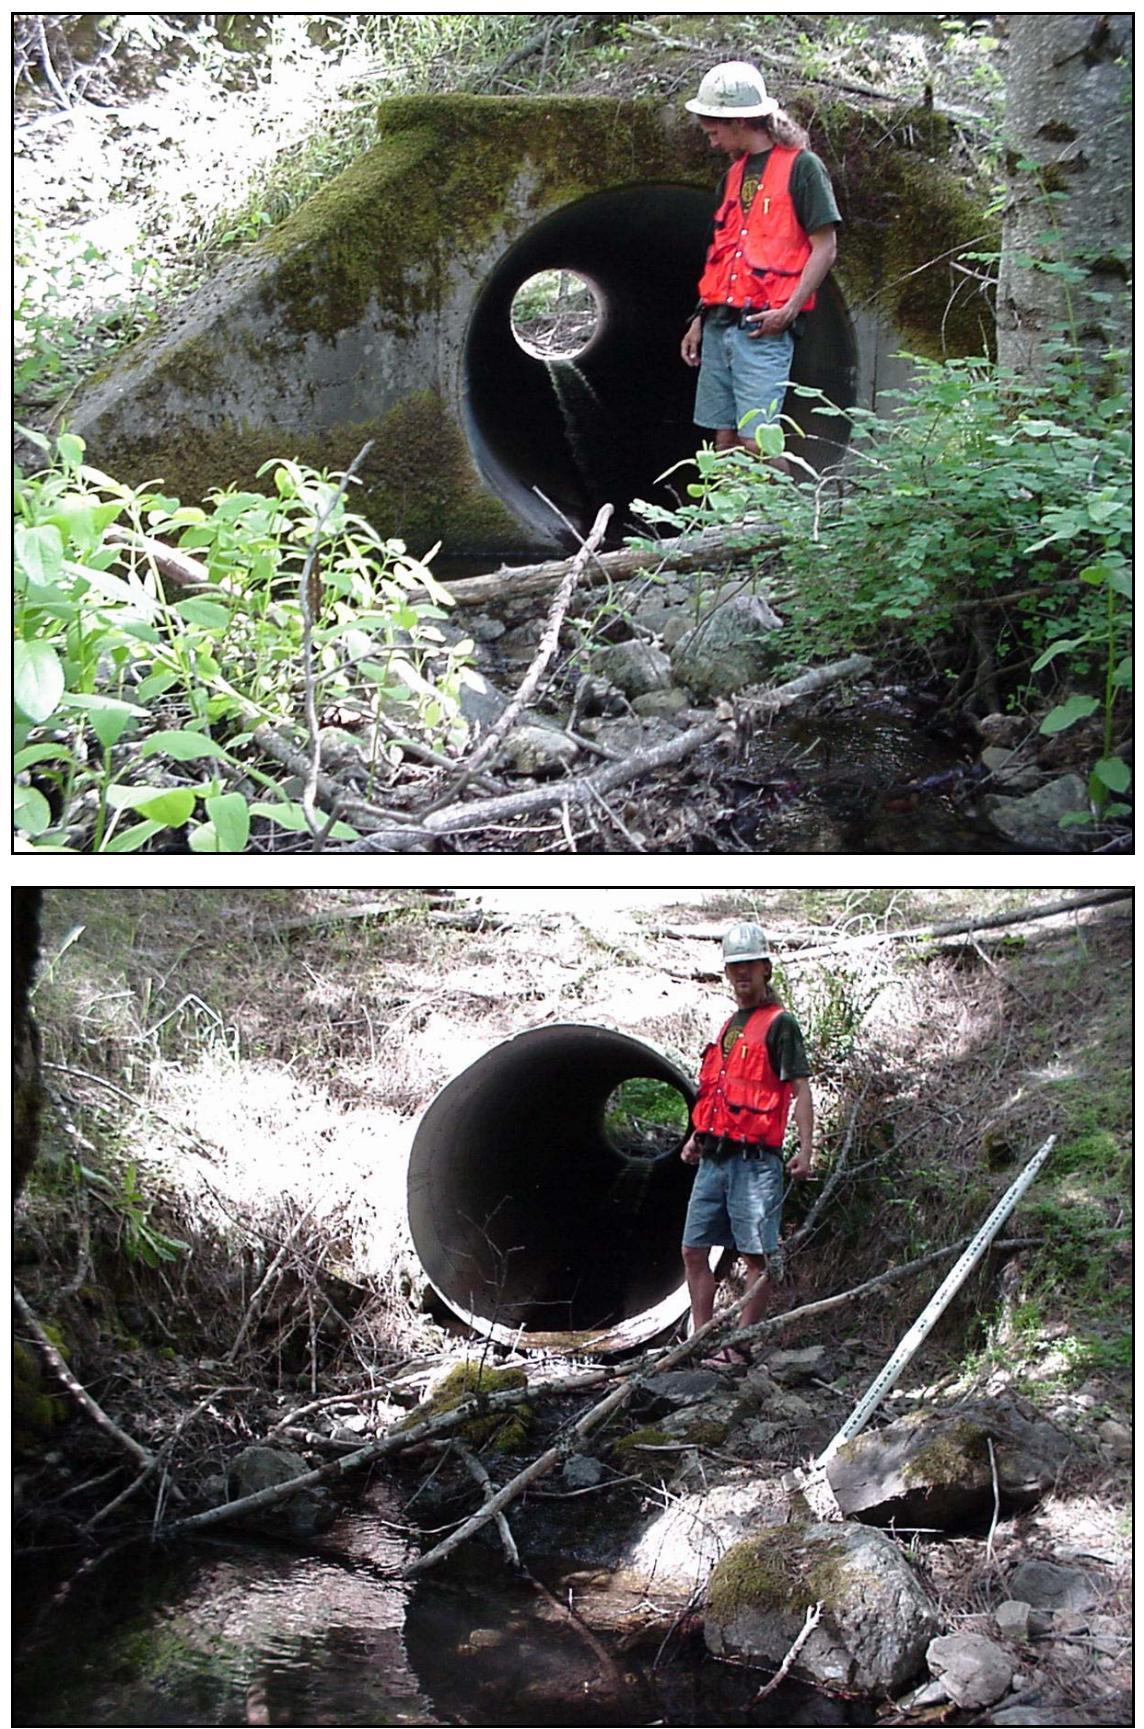
Site ID #9: Little Barker Creek/Barker Creek Road; Barker Creek; Hayfork Creek; South Fork Trinity River; <u>Trinity River</u>

Fill Estimate: 574 cubic yards Overall condition: Good.

Barrier Status: RED: the Green-Gray-Red filter determined this crossing fails to meet passage criteria for all species of adult salmonids and all age classes of juveniles. Steep slope (4.2%) was the main feature creating the migration barrier.

Preferred Treatment: When crossing is due for replacement (or fails) replace with a properly-sized openbottom arch set on concrete footings or a bridge. The privately-owned crossings below the county-maintained site should be assessed for fish passage prior to treating the Barker Creek Road crossing.

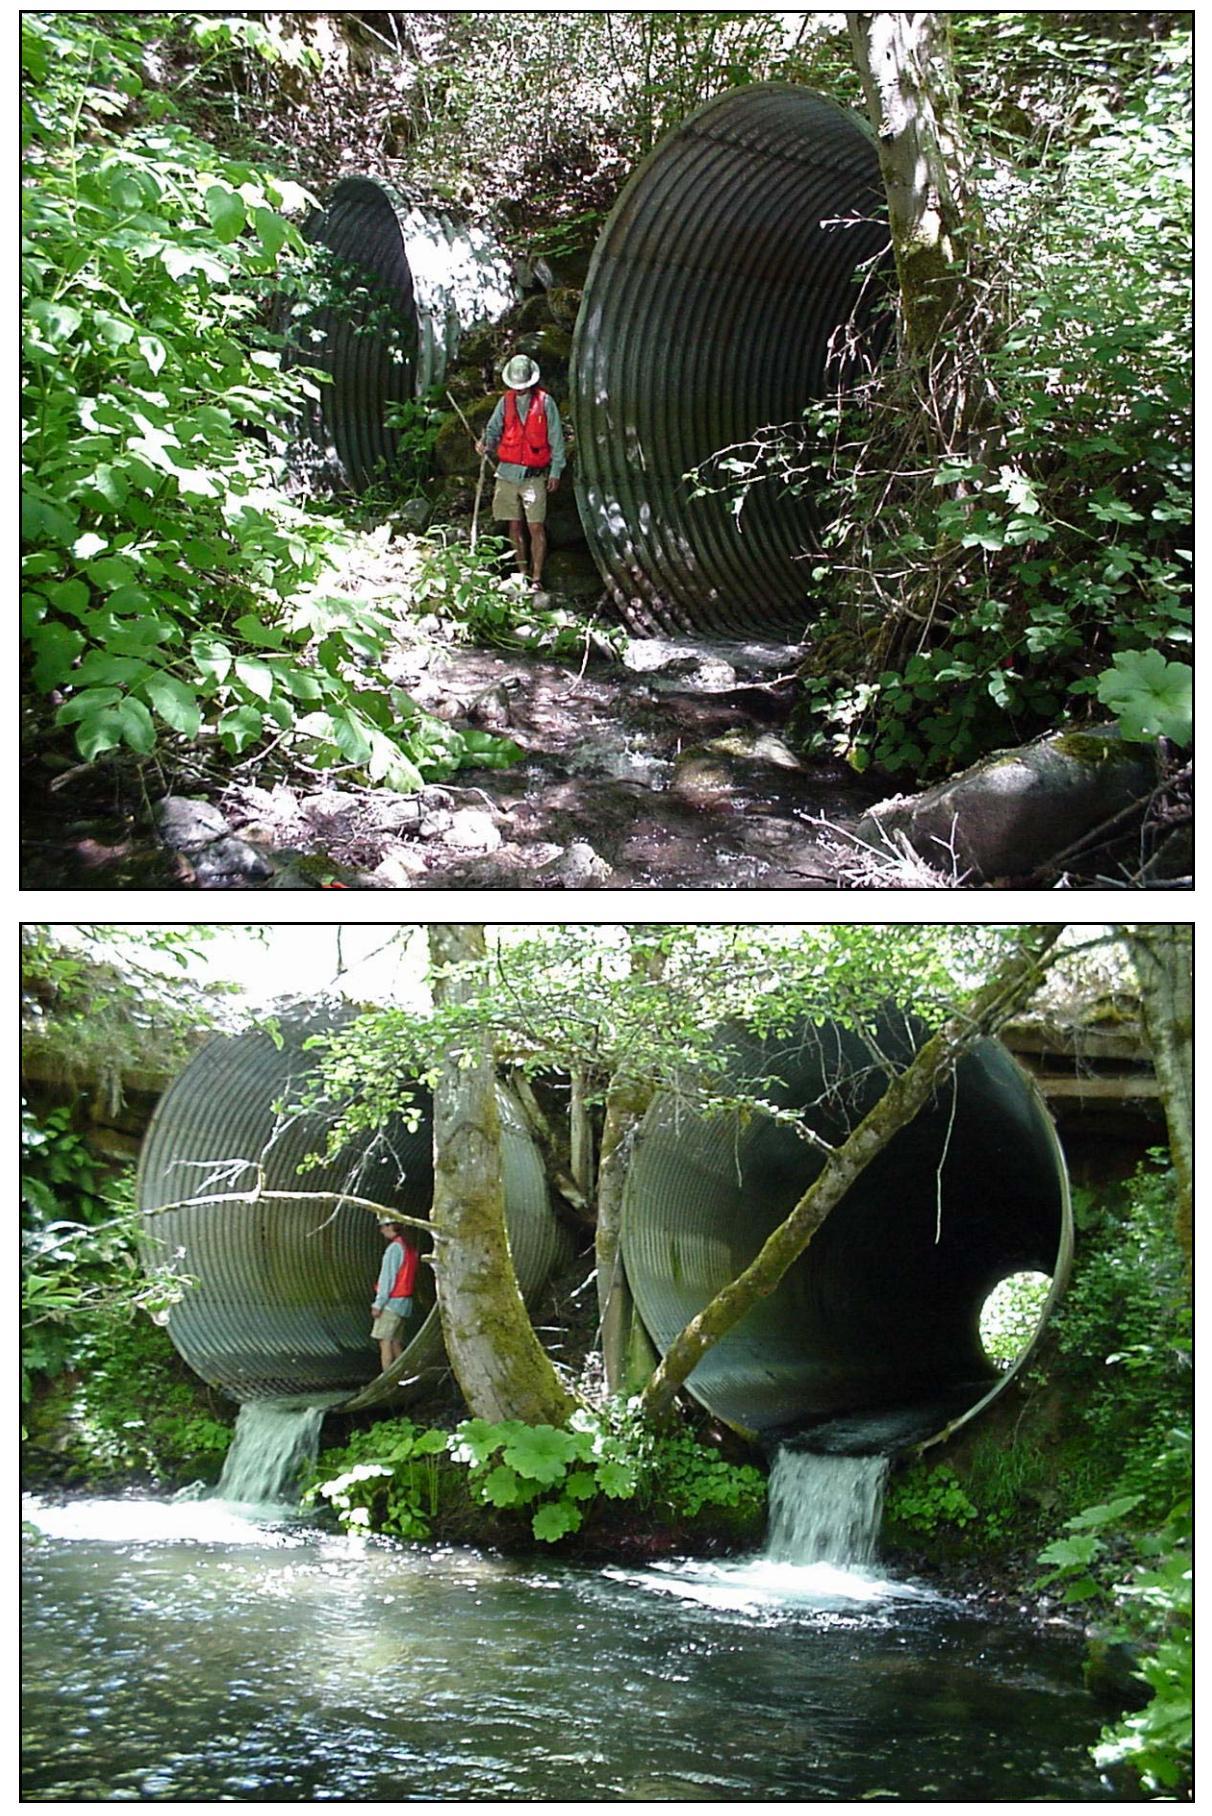
Site ID #19: Quinby Creek/Denny Road; New River; Trinity River

Habitat: .Quantity = approximately 3.8 miles of potential fish-bearing habitat upstream of the Denny Road. Quality = Good. No formal CDFG or USFS habitat or fisheries surveys were available for Quinby Creek. Quinby Creek was included on the Boberg and Kenyon (1979) fish distribution table as supporting only populations of resident rainbow trout. During the initial site survey on 5/30/01no salmonids were observed in the channel adjacent to this crossing. Conducting further investigation into Quinby Creek's potential fisheries benefits is recommended prior to developing proposals for submission to fisheries restoration funding sources.

Preferred Treatment: Periodically inspect culvert for condition and performance. When crossing is due for replacement (or fails) replace with a properly-sized open-bottom arch set on concrete footings or a bridge.

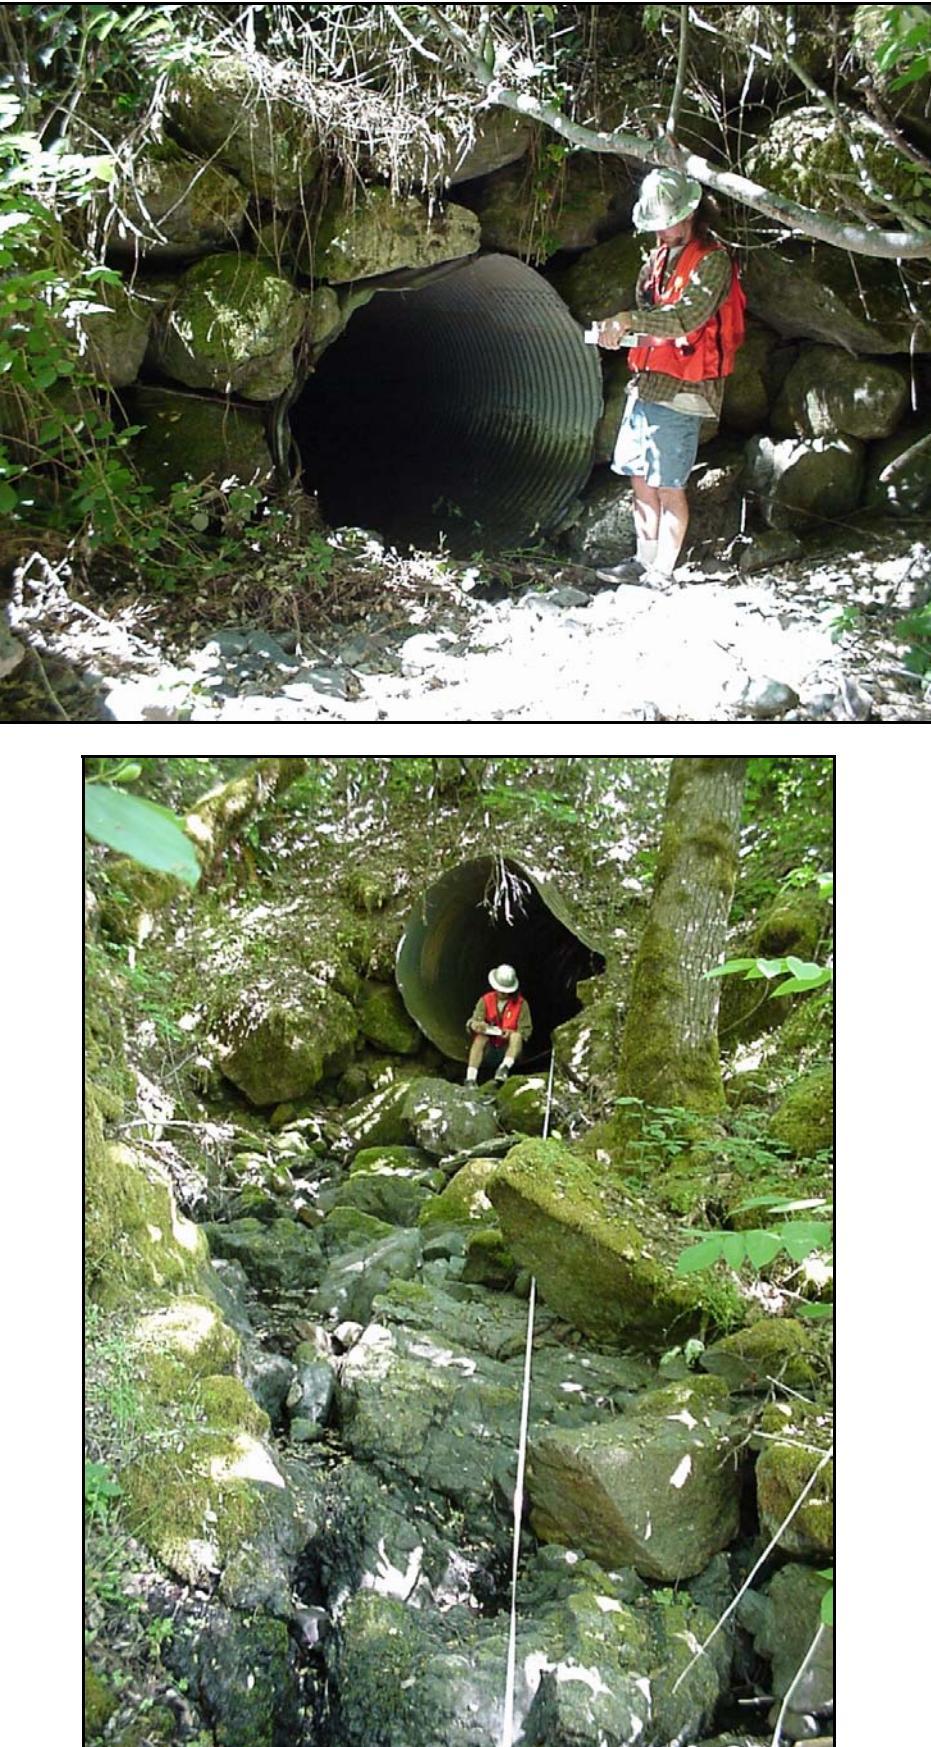
Site ID #21: Barney Gulch/East Fork Road; East Fork of the North Fork Trinity; North Fork of the Trinity; Trinity River

Habitat: Quantity = approximately 2.2 miles of potential fish-bearing habitat upstream of East Fork Road. Quality = Fair. No formal CDFG or USFS habitat or fisheries surveys were available for this unnamed tributary. During the initial site survey on 6/8/01 no salmonids were observed in the channel adjacent to this crossing –the channel was dry, with isolated pools downstream of East Fork Road. Although documented fisheries information is lacking, Barney Gulch should be considered potentially important spawning and rearing habitat for wild stocks of summer-run and winter-run steelhead (Everest, pers. comm.). Conducting further investigation into Barney Gulch's potential fisheries benefits is recommended.

Preferred Treatment: Periodically inspect culvert for condition and performance. When crossing is due for replacement (or fails) replace with a properly-sized SSP culvert or a bridge. Grade-control weirs may be required to minimize head-cutting of the upstream channel.
