APPENDIX B:

CATALOG OF TRINITY COUNTY CULVERTS LOCATED ON FISH-BEARING STREAM REACHES

Site ID #1: Unnamed tributary/South Fork Road; South Fork Trinity River; Trinity River

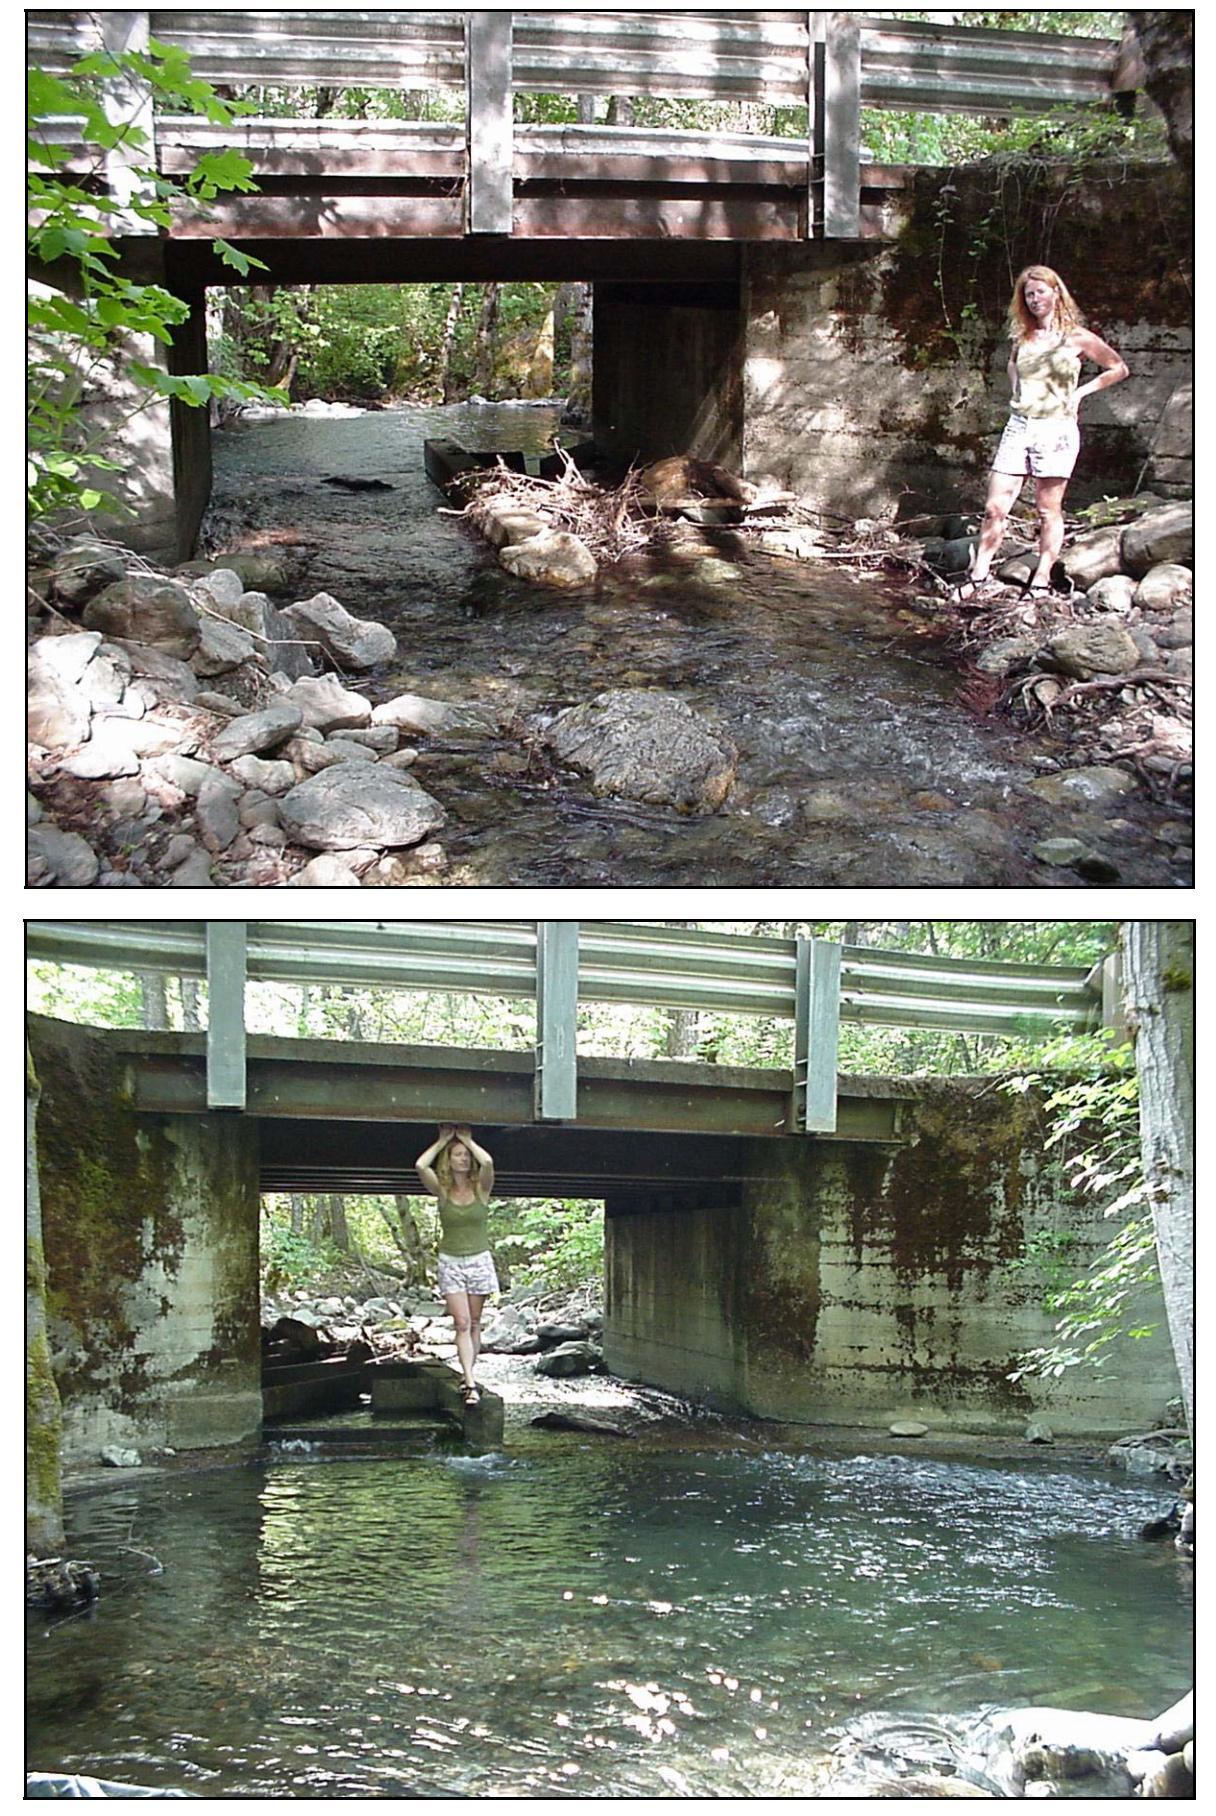
Site ID #22: Conner Creek #1/Conner Creek Road; Trinity River

Habitat: Quantity = approximately 1.8 miles of potential fish-bearing habitat. Quality = Good. USFS habitat surveys conducted on 8/16/74 and 5/15/80. Steelhead were presumed to use the lower 1.5 miles of creek, with suitable spawning areas located primarily in the lower mile. Pools were numerous and formed mostly by boulder and bedrock. Conner Creek has a dense riparian zone of mixed hardwoods and conifers. Habitat in the lower USFS steelhead spawning survey conducted on 3/25/80 – no evidence of spawning was observed. Approximately 2,300' above Red Hill Road, the channel steepens to an average slope of nearly 6% until the limit of anadromy at 8-10%. No fish were observed during site survey on 5/10/01, water temperature was $11^{\circ}C$ at 1:20 PM.

Preferred Treatment: Replace with a properly-sized open-bottom arch set on concrete footings or a bridge. The status of the downstream crossings should be assessed prior to treating the county-maintained culvert.

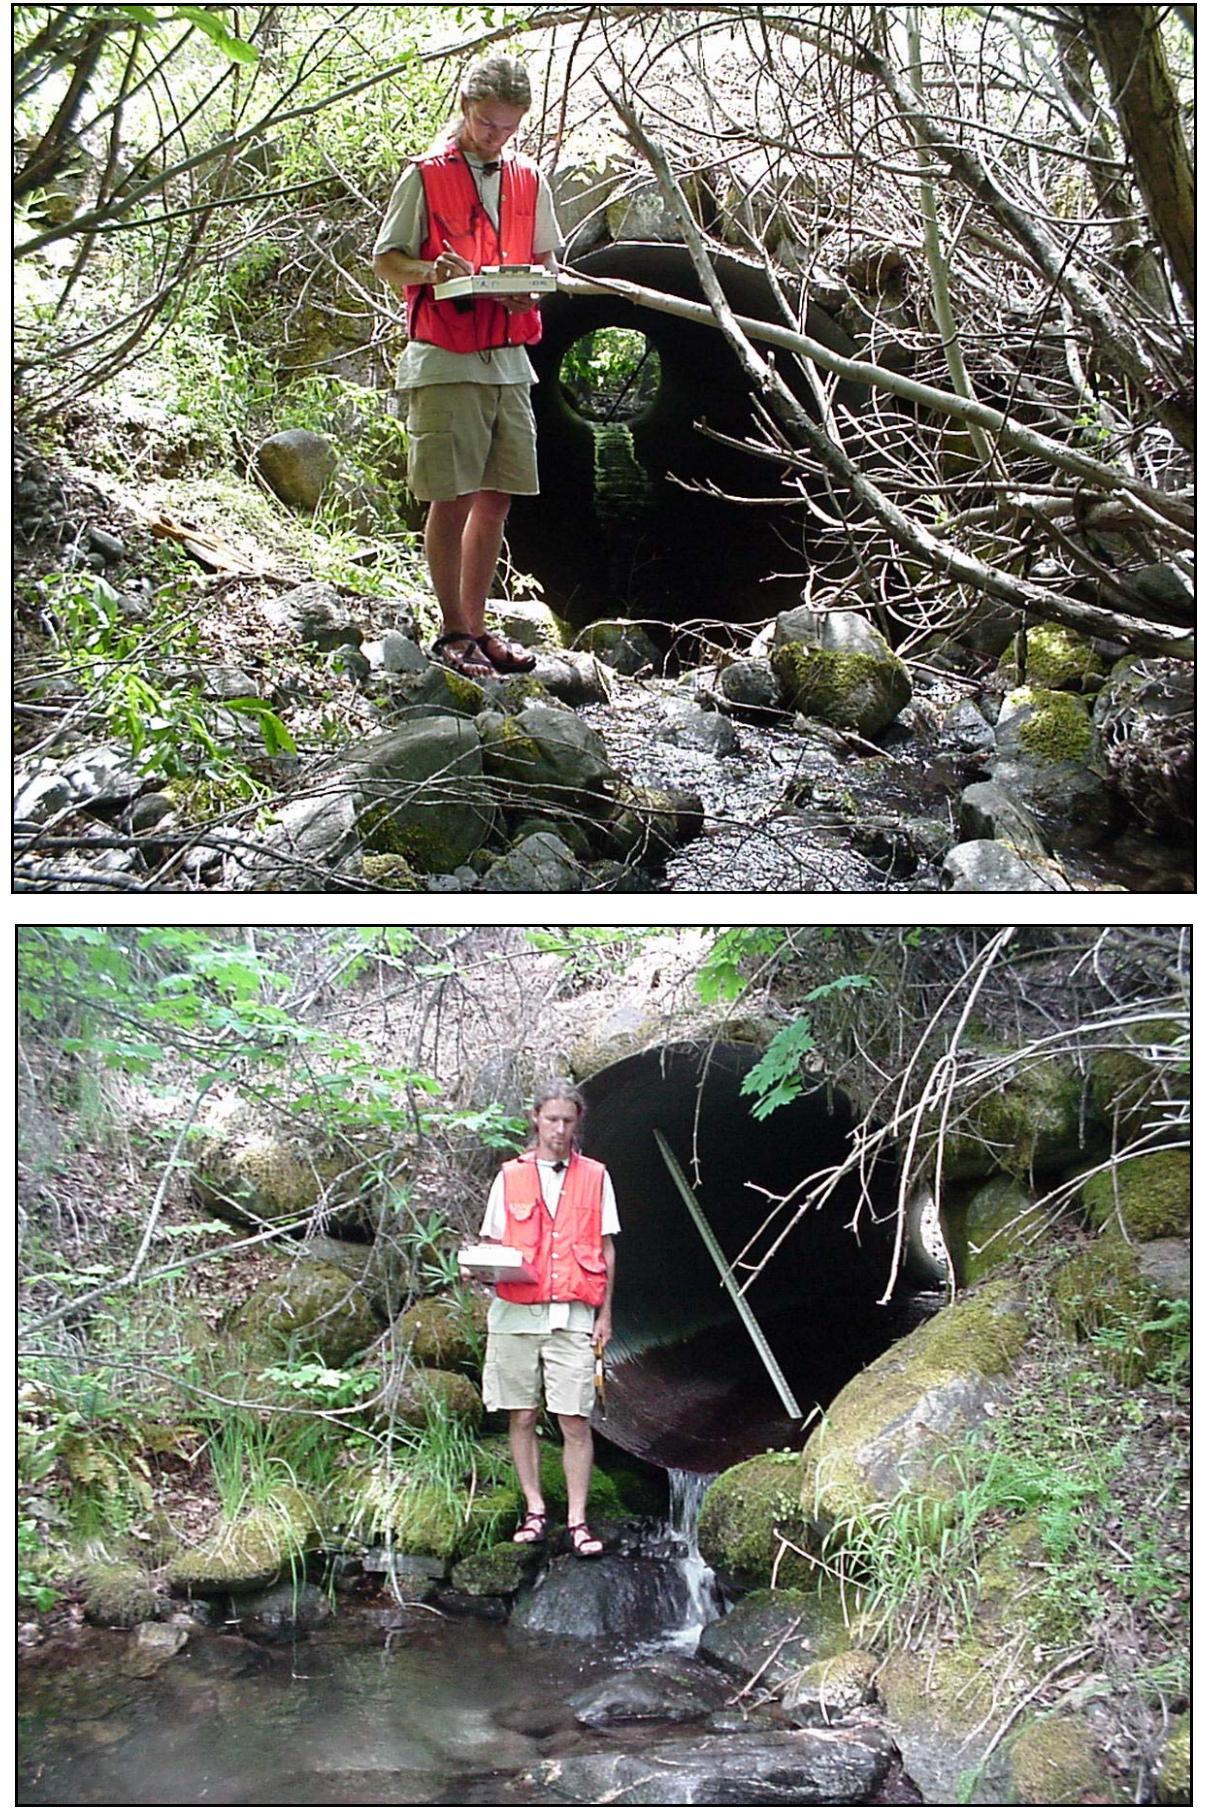
Site ID #25: Rarick Gulch/Canyon Creek Road; Canyon Creek; Trinity River

Slope: 11.29% Modifications: None. Rustline Height: 2.3' Average Active Channel Width: 11.8'

Fill Estimate: 2,110 cubic yards Overall condition: Fair, culvert floor is abraded.

Barrier Status: RED: the Green-Gray-Red filter determined this crossing fails to meet passage criteria for all species of adult salmonids and all age classes of juveniles. The steep slope (> 11%) is the crossing's main feature that creates a migration barrier due to excessive velocities.

Preferred Treatment: Periodically inspect culvert for condition and performance. When crossing is due for replacement (or fails) replace with a properly-sized open-bottom arch set on concrete footings or a bridge. All fish-bearing crossings along Canyon Creek Road should be improved to pass salmonids if major road work is ever scheduled for Canyon Creek Road. Cumulatively; Conrad, Rarick, and Gwin Gulches total nearly 2.1 miles of potential anadromous habitat.

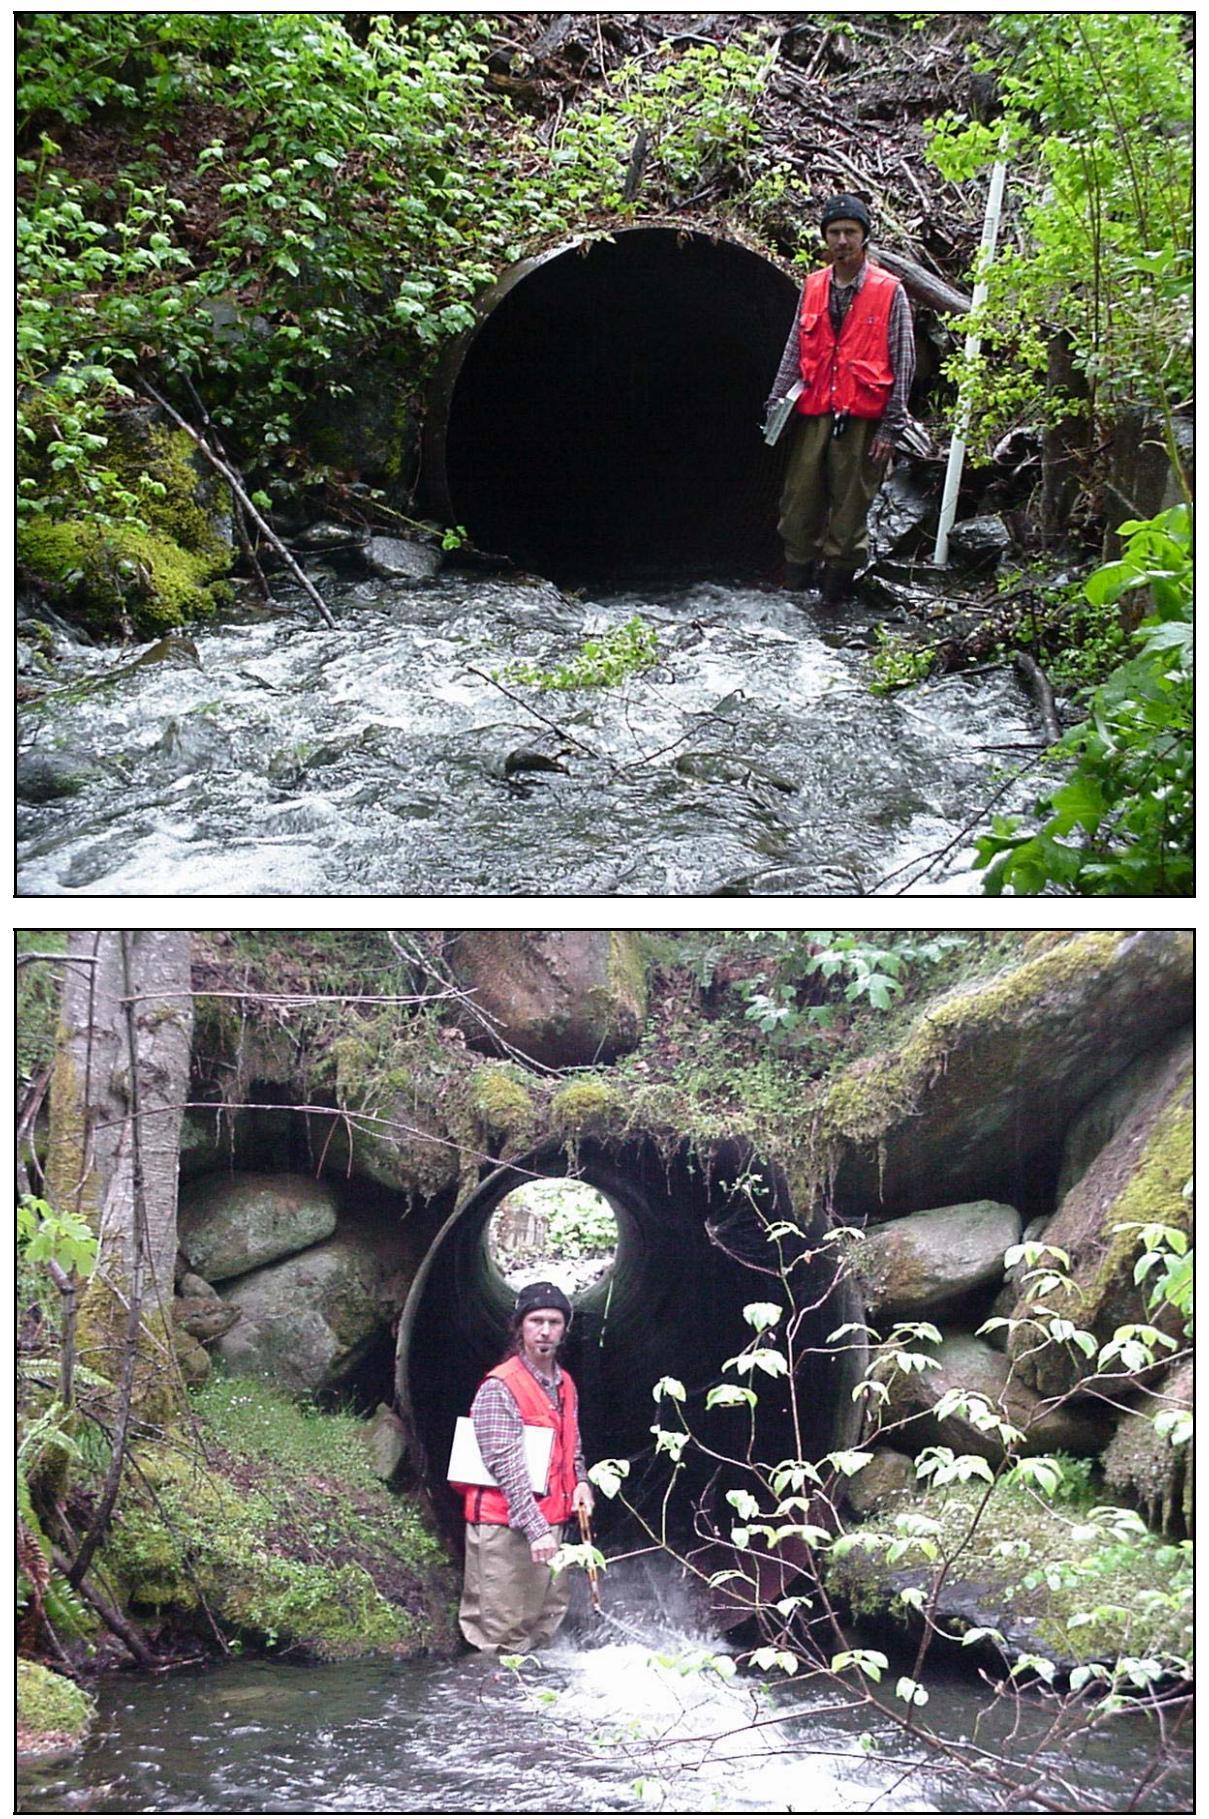
Site ID #26: Gwin Gulch/Canyon Creek Road; Canyon Creek; Trinity River Ranking: #32 = Low-Priority

Slope: 5.95% Modifications: None. Rustline Height: 2.3' Average Active Channel Width: 17.1'

Fill Estimate: 5,677 cubic yards Overall condition: Good.

Barrier Status: RED: the Green-Gray-Red filter determined this crossing fails to meet passage criteria for all species of adult salmonids and all age classes of juveniles. The culvert's steep slope and perched outlet are the crossing's features that create a migration barrier.

Preferred Treatment: Periodically inspect culvert for condition and performance. Modifying the existing culvert with either corner baffles or weirs within the culvert *and* a series of downstream grade-control weirs is recommended. A replacement is not warranted because the current culvert is properly sided and the large fill volume (>5,000 cubic yards) makes a replacement cost-prohibitive All fish-bearing crossings along Canyon Creek Road should be improved to pass salmonids if major road work is ever scheduled for Canyon Creek Road.

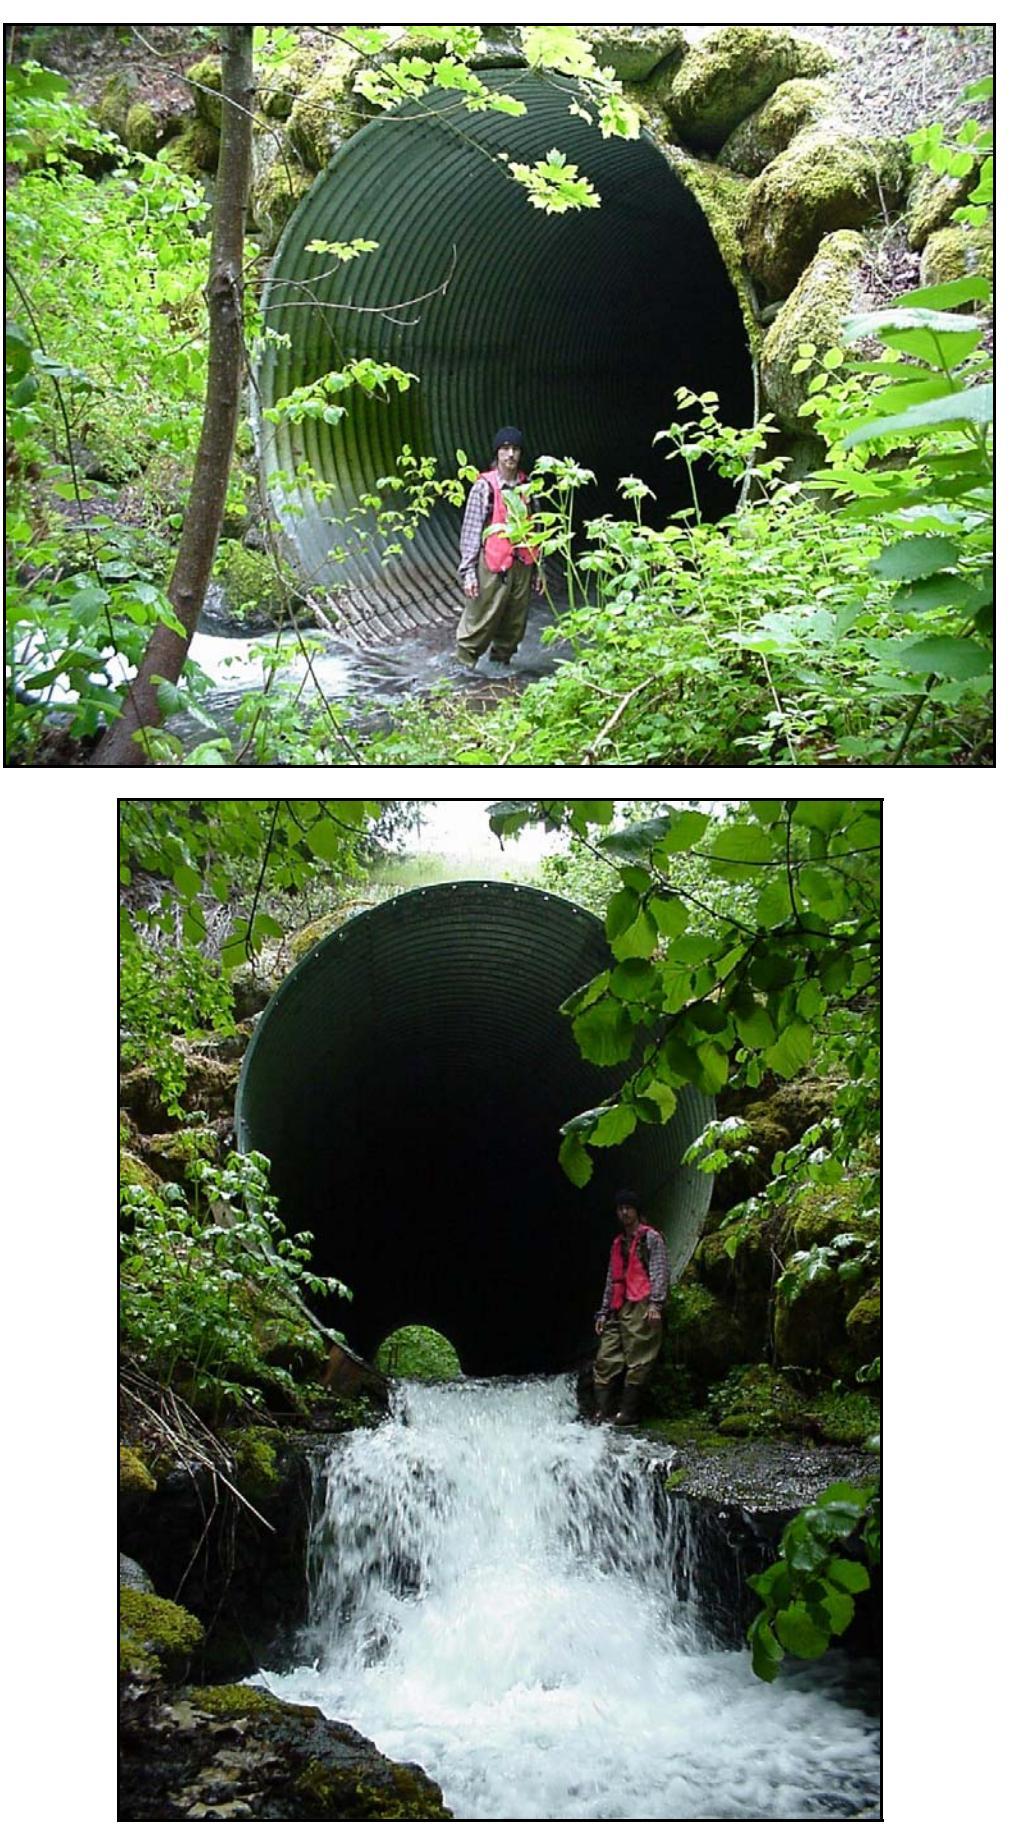
Site ID #27: McKinney Gulch/Red Hill Road; Trinity River Ranking: # 43 = Low-Priority

Slope: 6.51% Modifications: None. Rustline Height: N/A Average Active Channel Width: 7.2'

Fill Estimate: 381 cubic yards Overall condition: Good.

Barrier Status: RED: the Green-Gray-Red filter determined this crossing fails to meet passage criteria for all species of adult salmonids and all age classes of juveniles. The culvert's steep slope and outlet drop onto riprap are the crossing's features that create a migration barrier.

Preferred Treatment: Periodically inspect culvert for condition and performance. When crossing is due for replacement (or fails) replace with a properly-sized embedded SSP culvert or an open-bottom arch set on concrete footings. The minimal fisheries benefit of restoring access to McKinney Gulch makes this site a poor candidate for replacement with restoration funds.

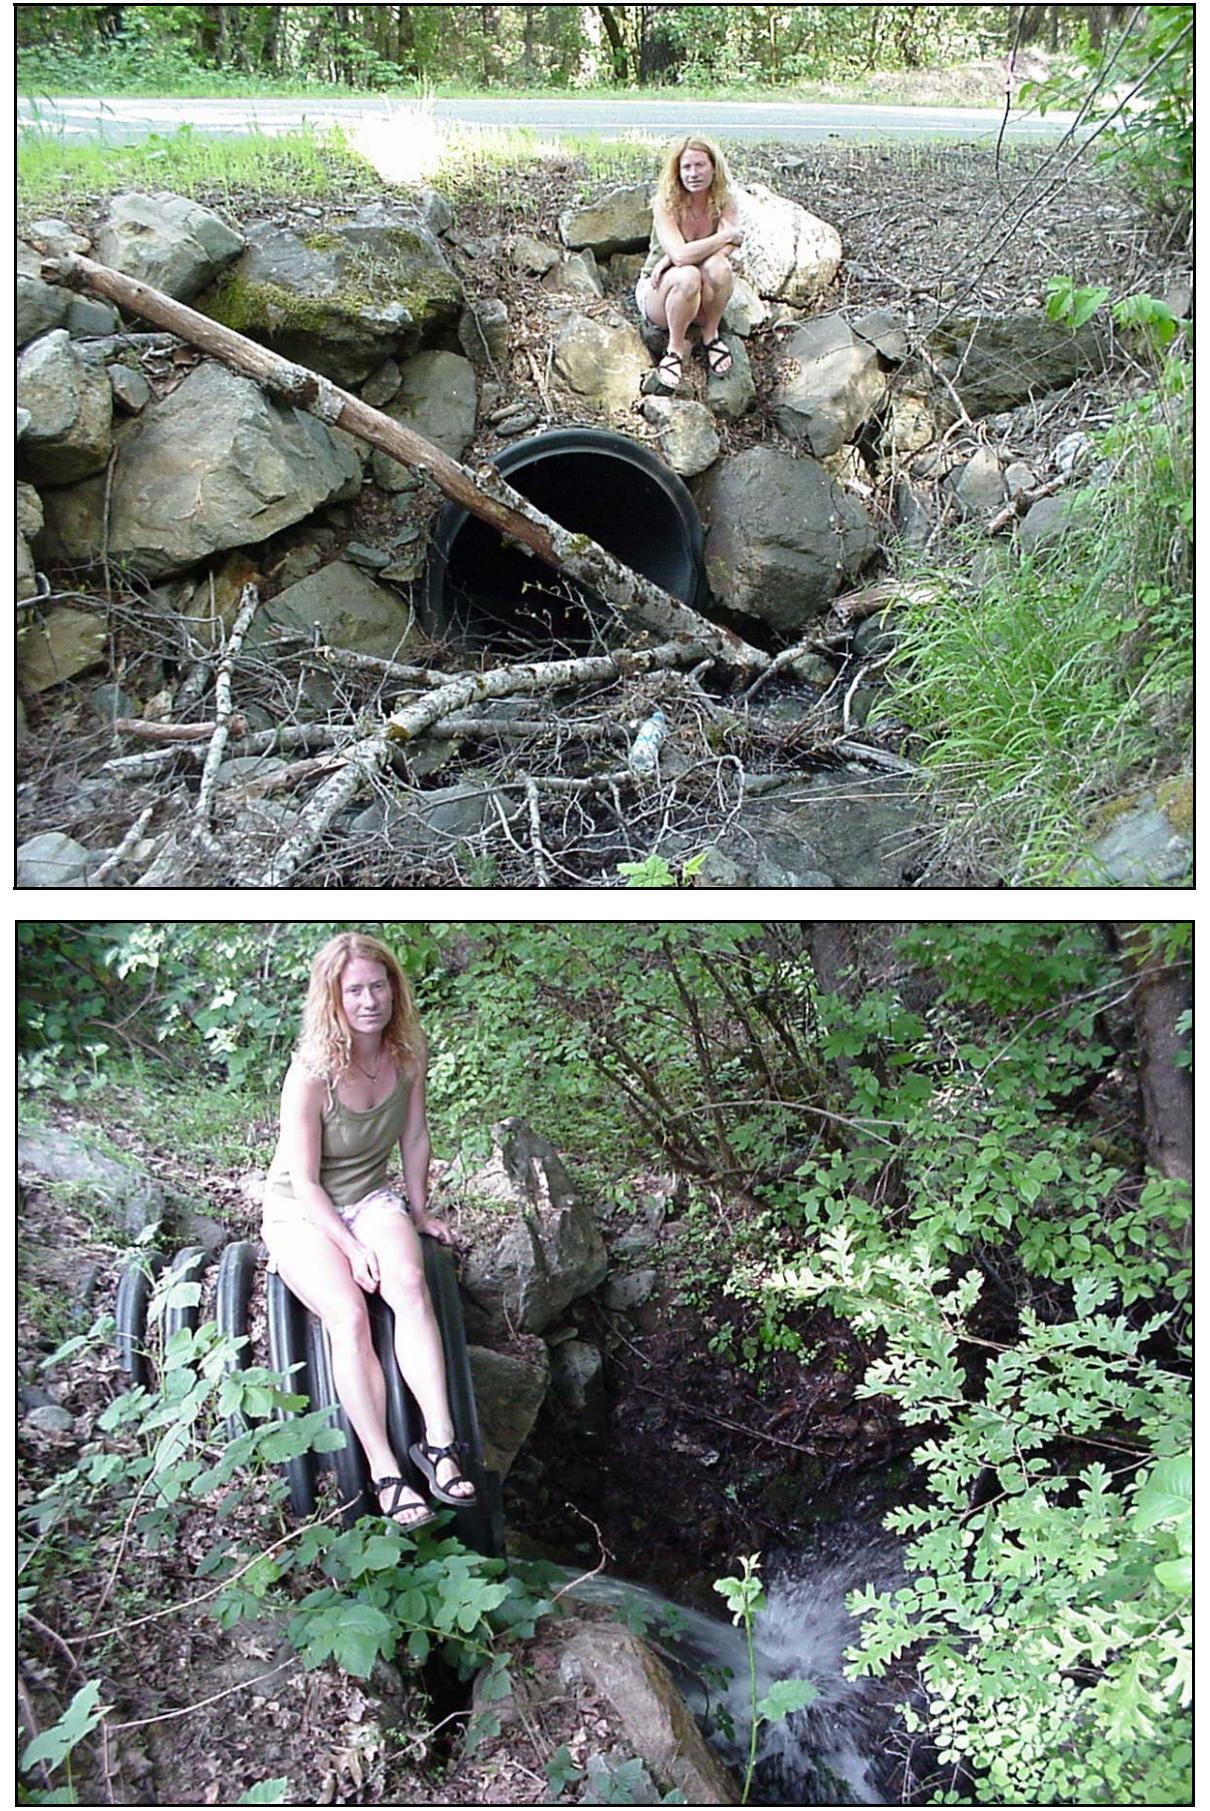
Site ID #28: Oregon Gulch/Sky Ranch Road; Trinity River Ranking: #4 = High-Priority

Length: 31.3' Slope: 1.98% Modifications: None. Rustline Height: N/A

Average Active Channel Width: 13.4' Fill Estimate: 172 cubic yards Overall condition: Fair, culvert floor is abraded and concrete is worn down.

Barrier Status: RED: the Green-Gray-Red filter determined this crossing fails to meet passage criteria for all species of adult salmonids and all age classes of juveniles.

Preferred Treatment: Replace with a properly sized open-bottom arch (such as a Conspan® arch) set on footings or a bridge. NOTE: an Oregon Gulch replacement is slated for construction during summer of 2003.

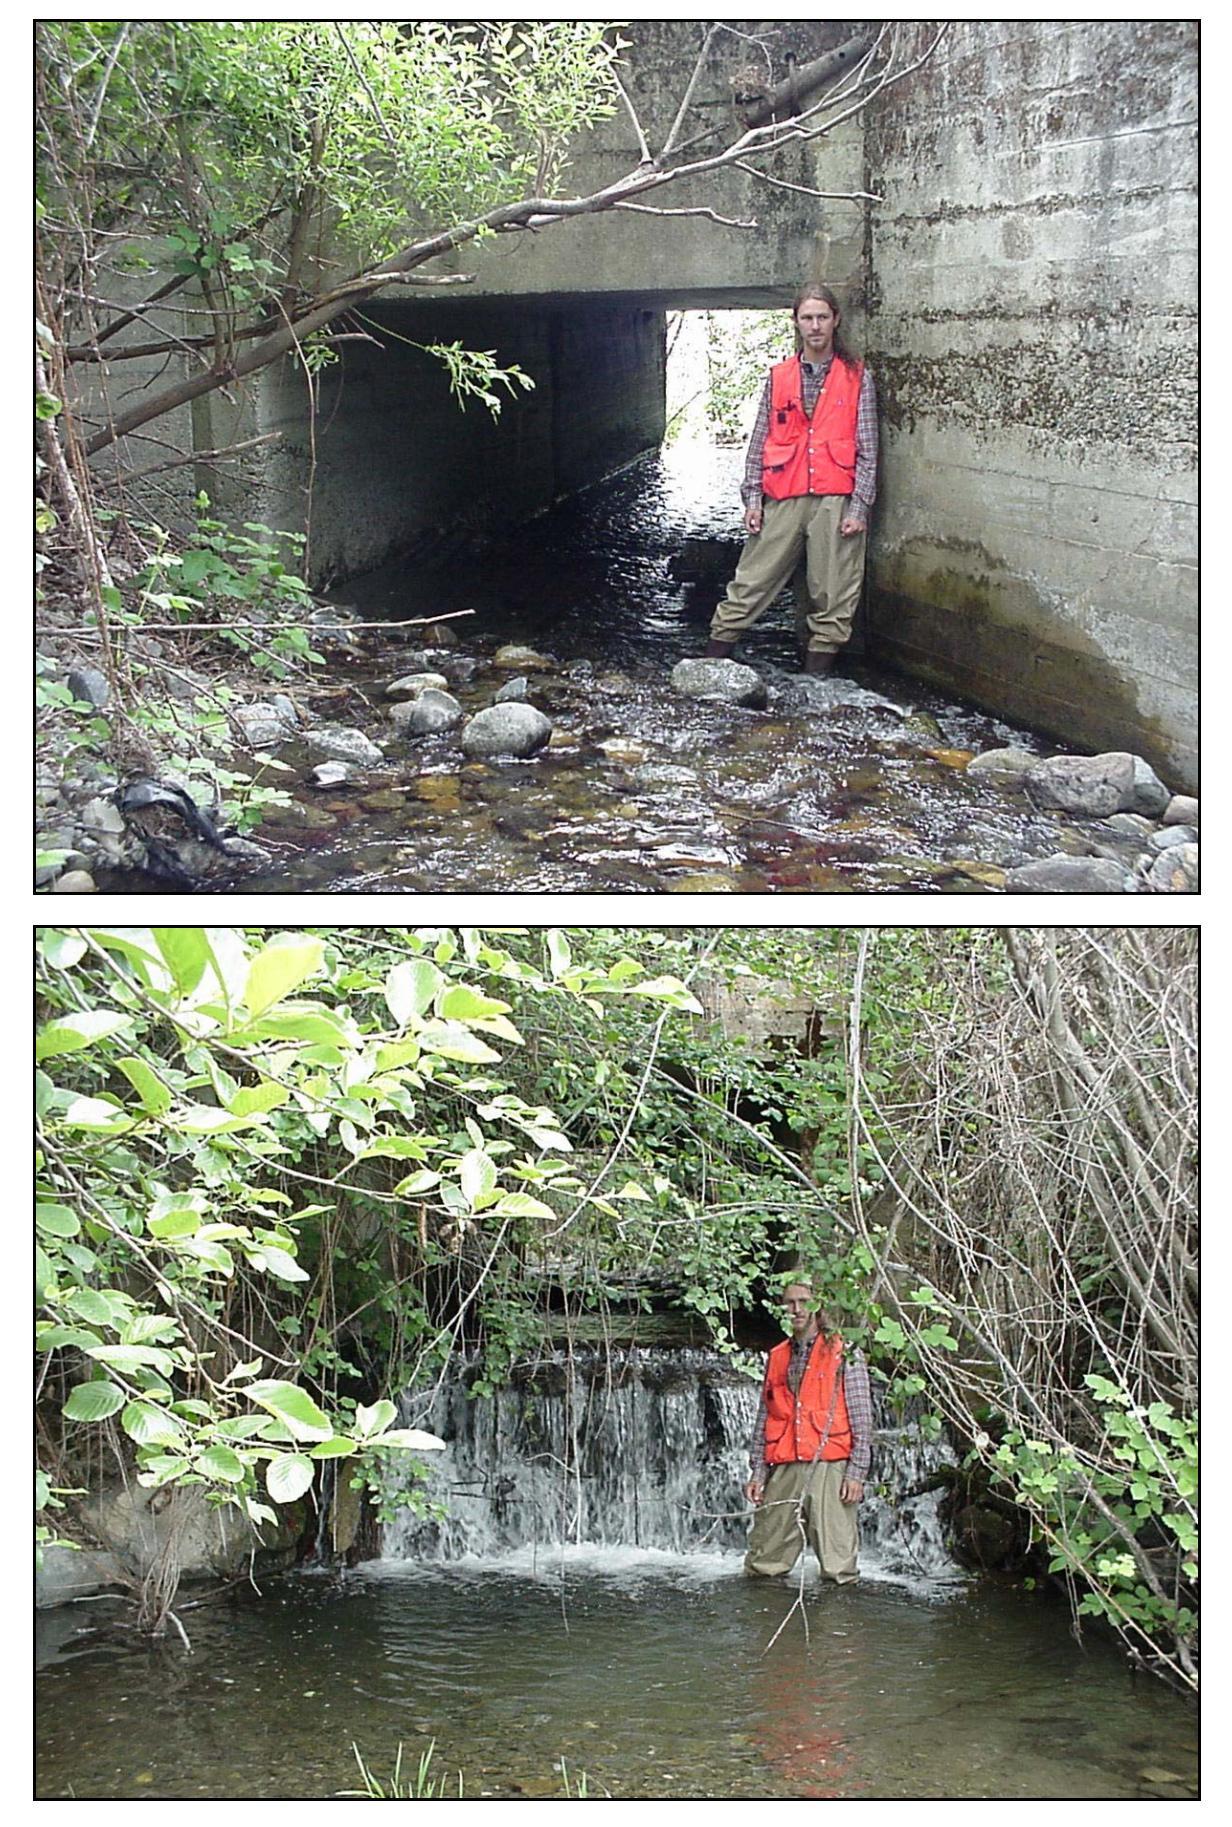
Site ID #29: Soldier Creek #1/Evans Bar Road; Trinity River Ranking: #11 = High-Priority

Slope: 2.98% Modifications: Four railroad rail baffles. Rustline Height: 2.3'

Average Active Channel Width: 14.2' Fill Estimate: 380 cubic yards Overall condition: Good.

Barrier Status: GREY: FishXing software estimated this crossing meets passage criteria for all species of adult salmonids on approximately 22% of migration flows and fails to meet the passage criteria for all age classes of juveniles. The culvert's perched outlet that spills over riprap is the main feature that inhibits fish passage.

Preferred Treatment: Replace with a properly sized open-bottom arch (such as a Conspan® arch) set on footings or a bridge.

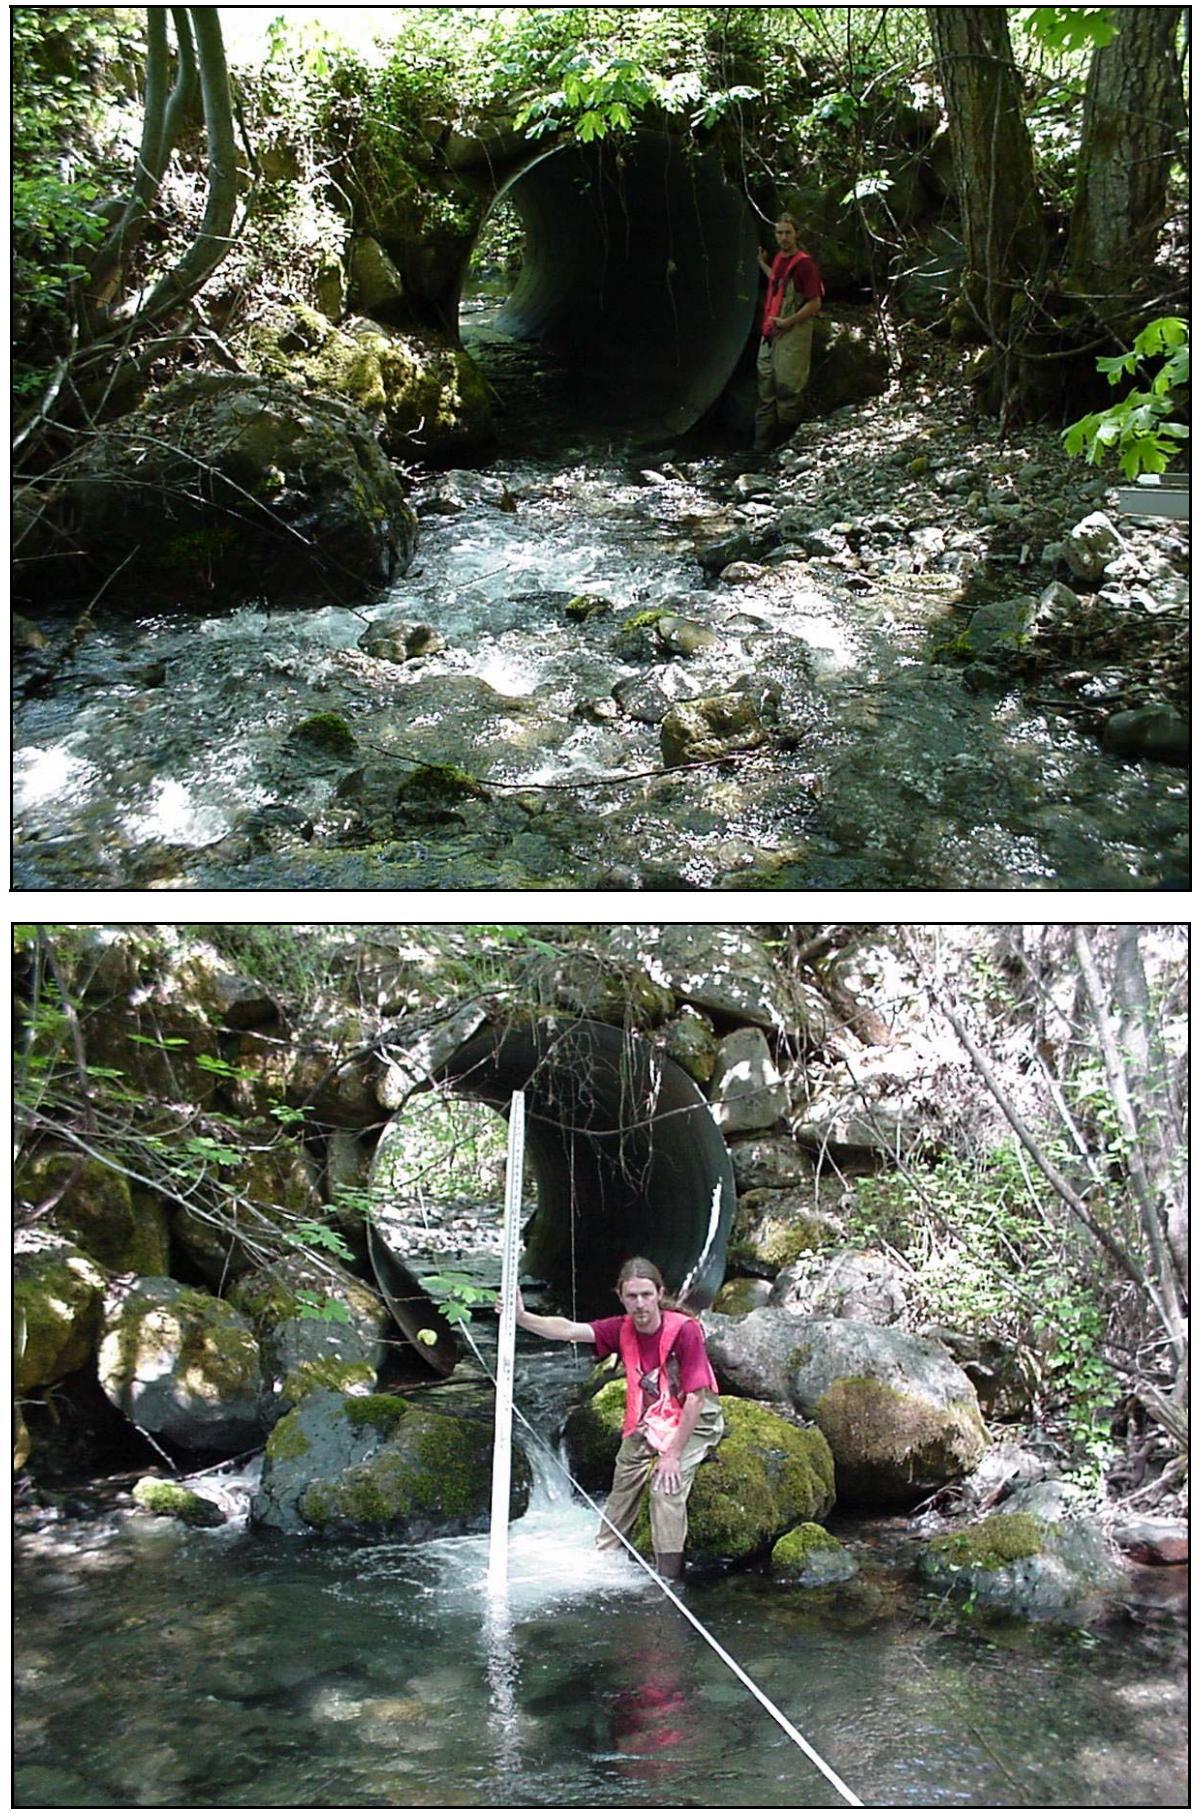
Site ID #30: Soldier Creek #2/Dutch Creek Road; Trinity River Ranking: #12 = High-Priority

Slope: 3.46% Modifications: Four railroad rail baffles. Rustline Height: 2.5'

Average Active Channel Width: 11.9' Fill Estimate: 474 cubic yards Overall condition: Good.

Barrier Status: GREY: FishXing estimated that this crossing meets passage criteria for all species of adult salmonids on approximately 13% of range of migration flows and fails to meet passage on all flows for all age classes of juveniles.

Preferred Treatment: Replace with a properly sized open-bottom arch (such as a Conspan® arch) set on footings or a bridge.

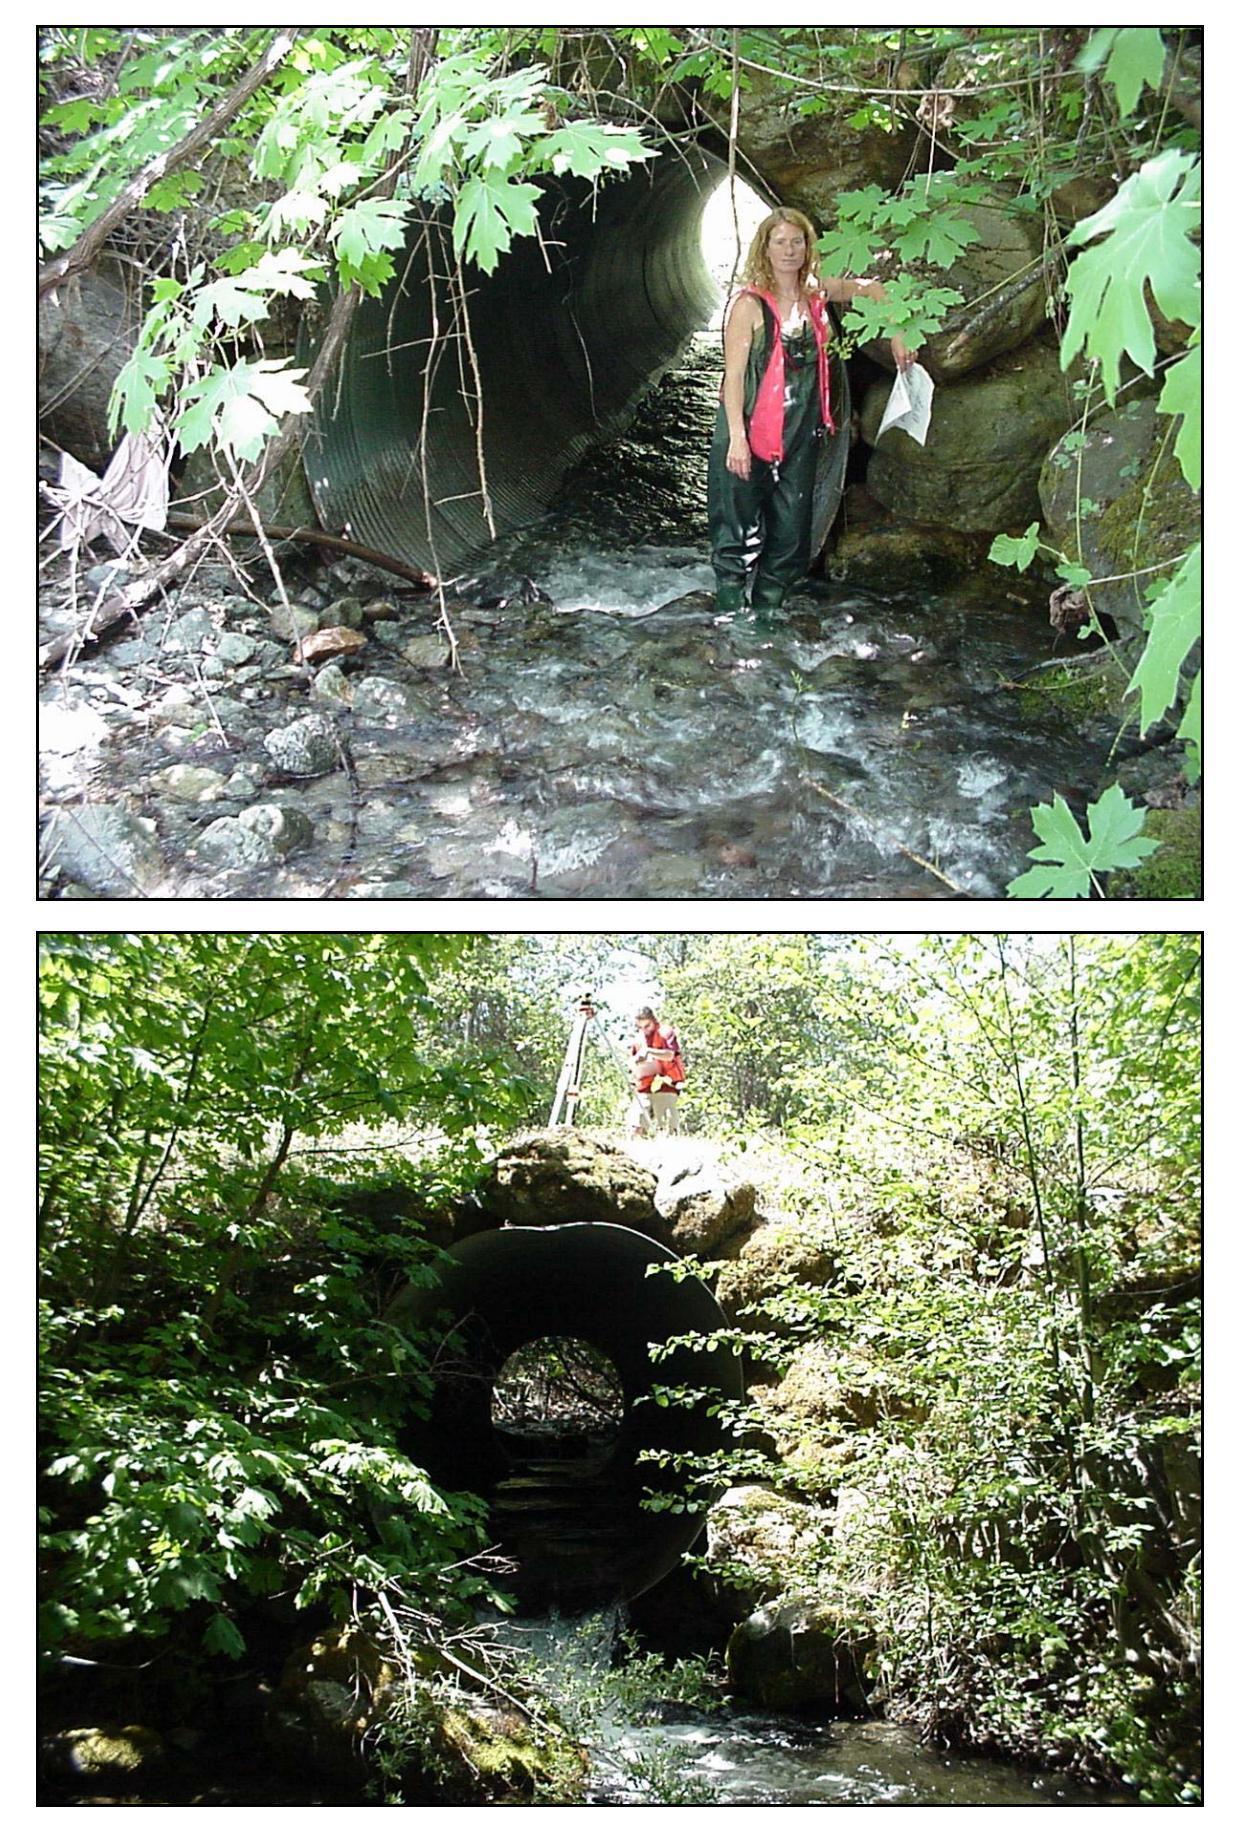
Site ID #31: Maple Creek/Dutch Creek Road; Dutch Creek; Trinity River Ranking: #49= Low-Priority

Slope: 3.97% Modifications: Six railroad rail baffles. Rustline Height: 0.7'

Average Active Channel Width: 10.1' Fill Estimate: 432 cubic yards Overall condition: Fair, abraded.

Barrier Status: GREY: FishXing estimated that this crossing meets passage criteria for all species of adult salmonids on approximately 42% of the range3 of migration flows and fails to meet passage criteria all age classes of juveniles over the entire range of migration flows.

Preferred Treatment: Periodically inspect culvert for condition and performance. When crossing is due for replacement (or fails) replace with a properly-sized circular SSP pipe with downstream grade-control weirs. Lack of upstream fisheries benefit makes this site a poor candidate for replacement with restoration funds.

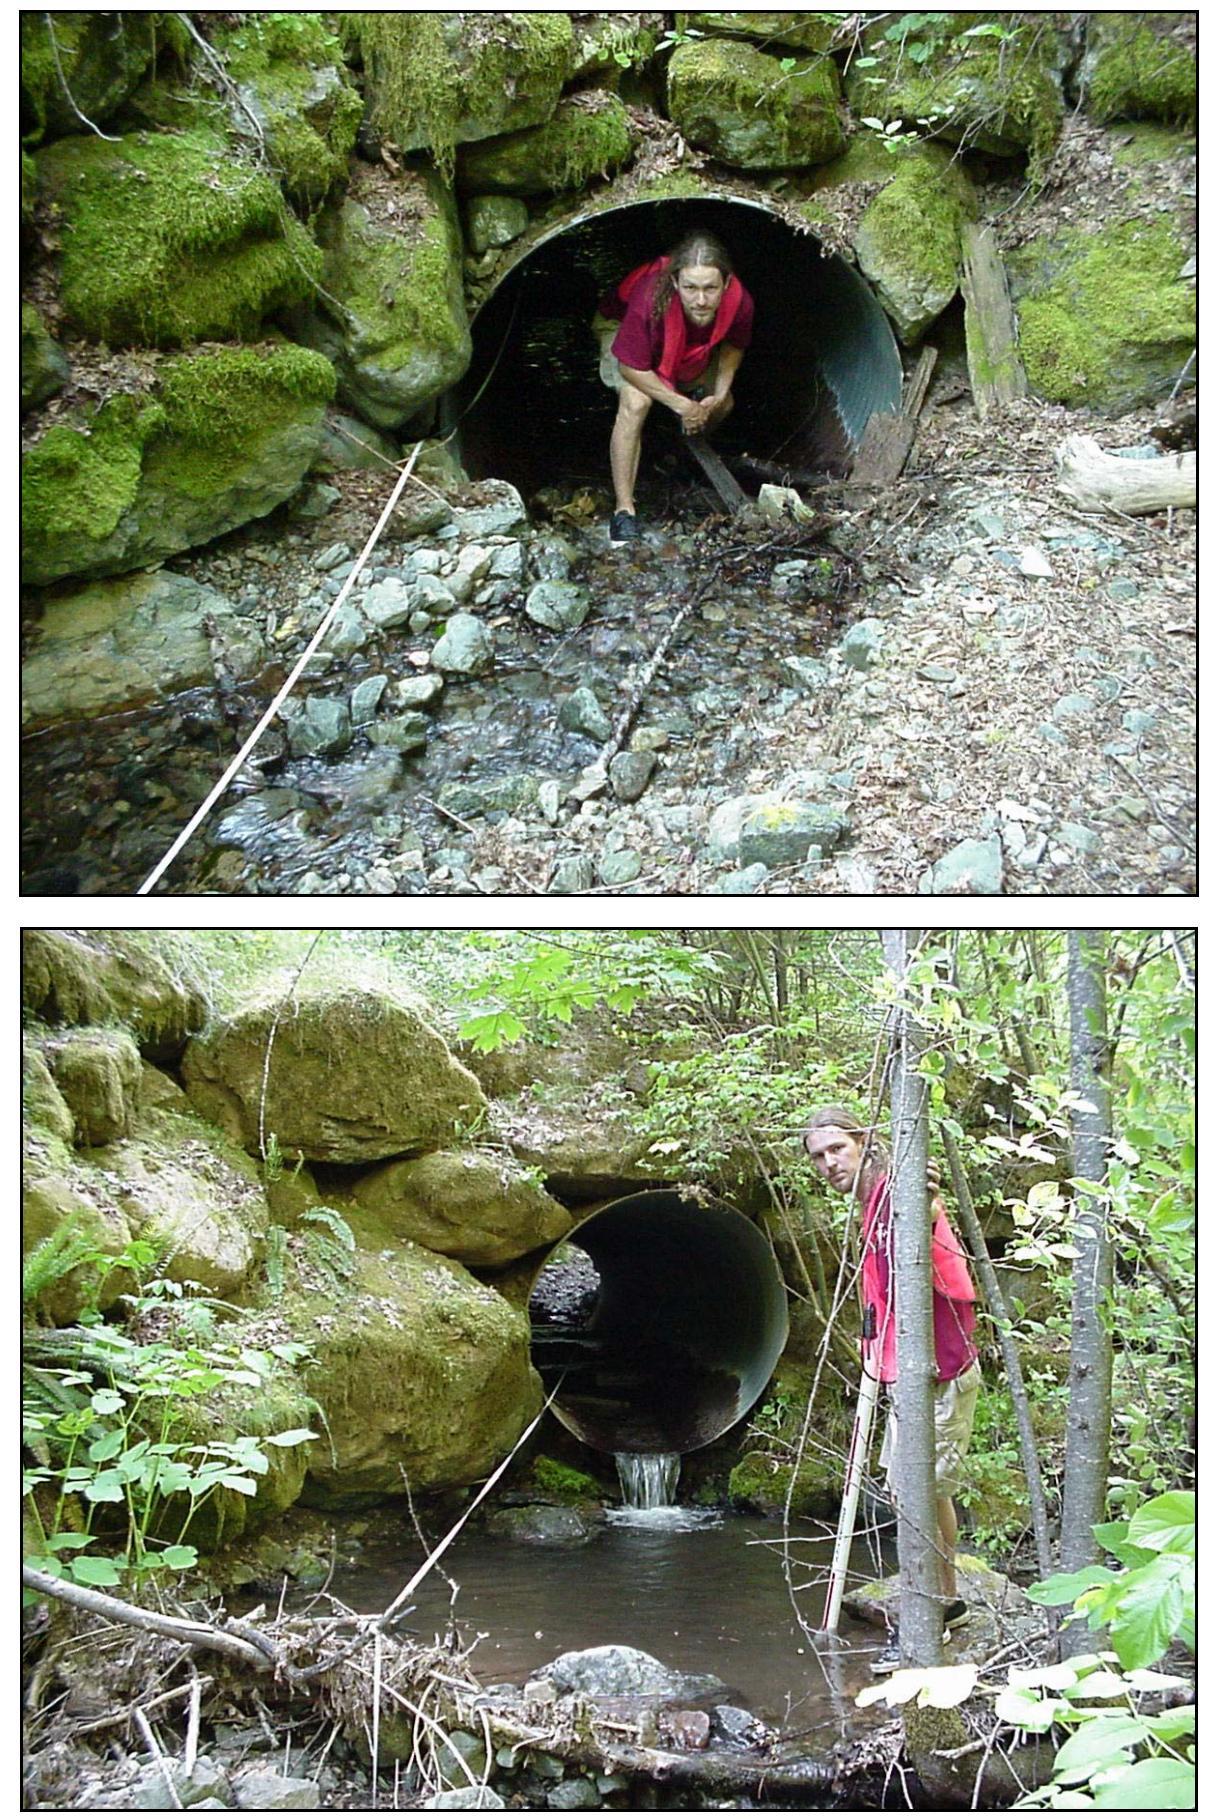
Site ID #32: Middleton Gulch/Deerlick Springs Road; Browns Creek; Trinity River

Rustline Heights: LB = 3.0'; RB = 2.5' Average Active Channel Width: 8.8' Fill Estimate: 149 cubic yards

Overall condition: Poor, both pipes were rusted through.

Barrier Status: LB = **RED**: the Green-Gray-Red filter determined this crossing fails to meet passage criteria for all species of adult salmonids and all age classes of juveniles. RB = GREY: FishXing estimated that this culvert meets passage criteria for all species of adult salmonids on approximately 30% of expected migration flows and fails to meet passage criteria for all age classes of juveniles over entire range of migration flows.

Preferred Treatment: Periodically inspect culvert for condition and performance. When crossing is due for replacement (or fails) replace with a properly-sized embedded circular or oval SSP pipe. Lack of upstream fisheries benefit makes this site a poor candidate for replacement with restoration funds.
