APPENDIX B:

CATALOG OF TRINITY COUNTY CULVERTS LOCATED ON FISH-BEARING STREAM REACHES

Site ID #1: Unnamed tributary/South Fork Road; South Fork Trinity River; Trinity River

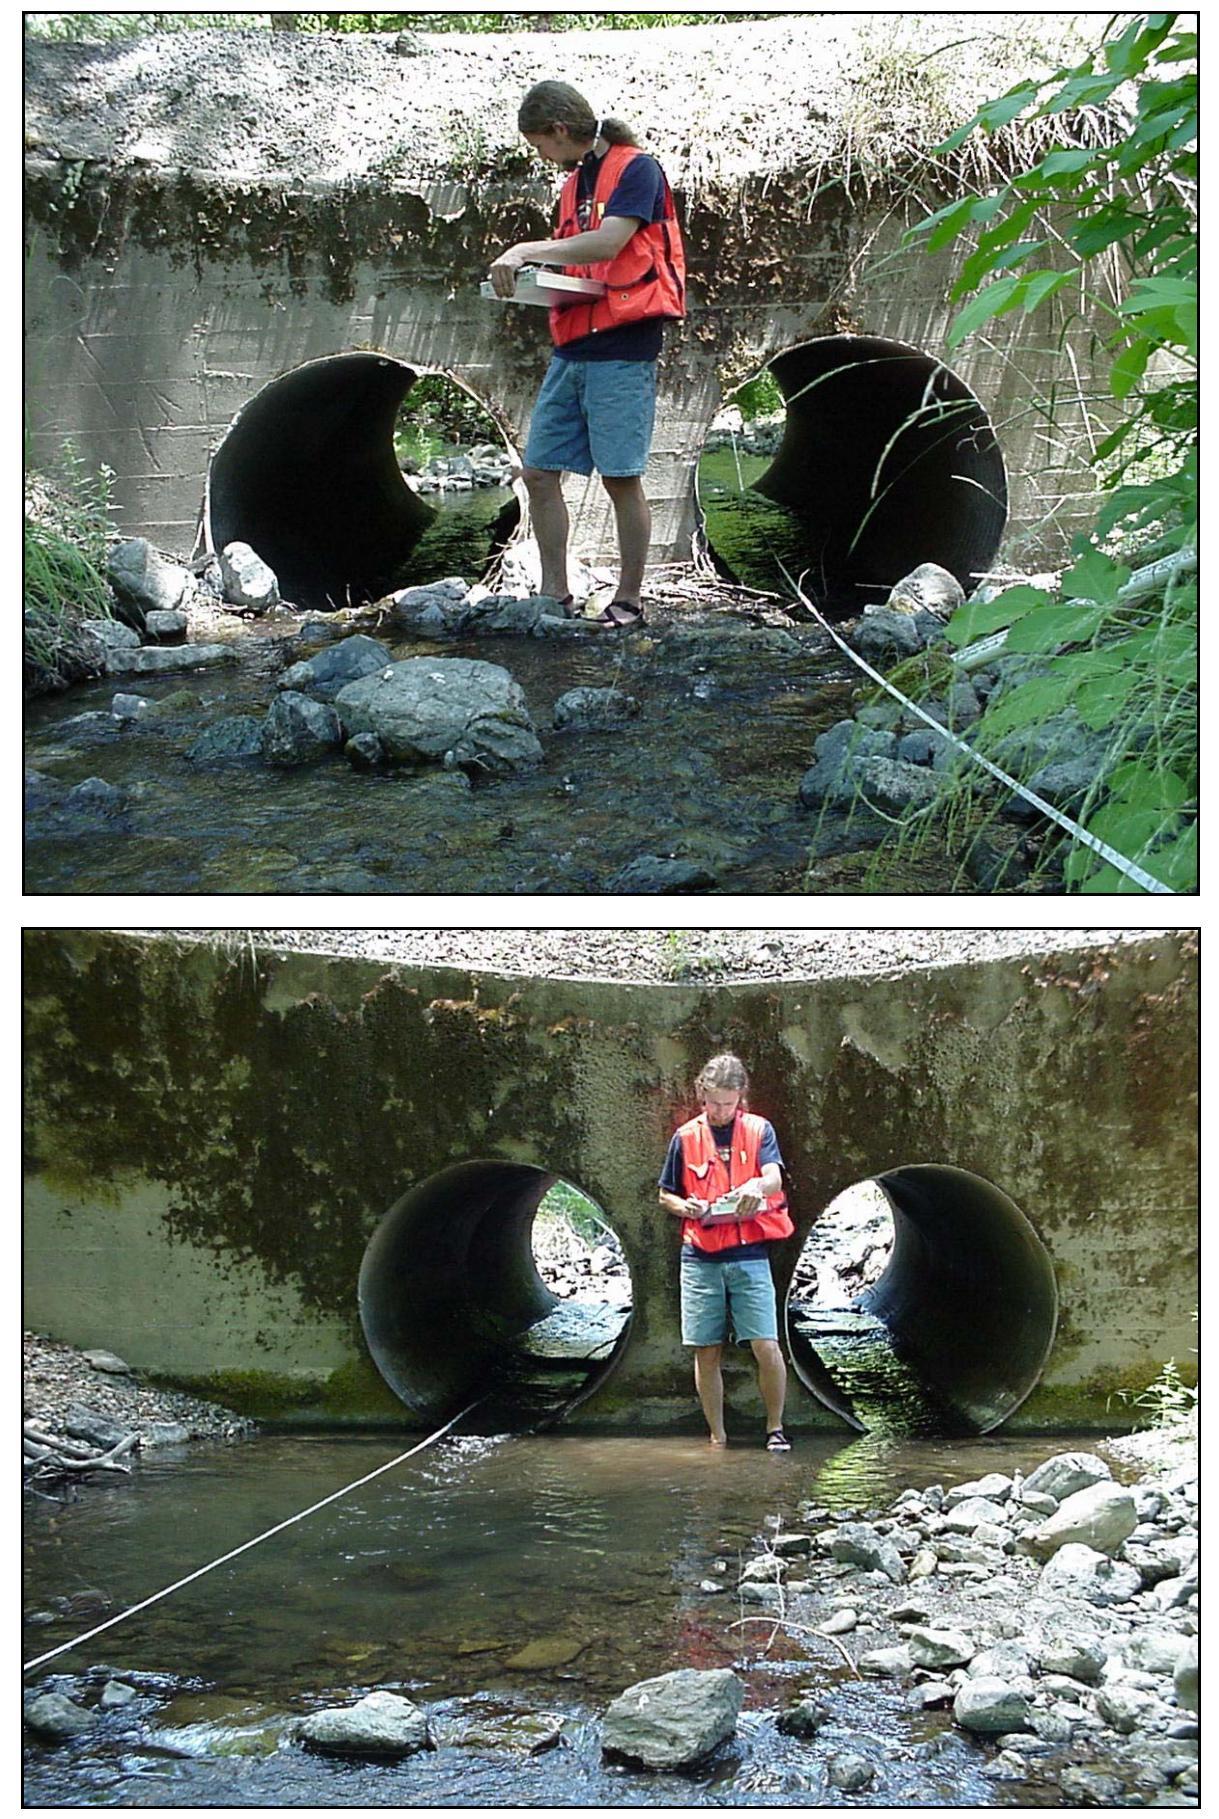
Site ID #33: Spring Gulch/Deerlick Springs Road; Browns Creek; Trinity River Ranking: #35 = Low-Priority

Rustline Heights: Both pipes = 0.5' **Average Active Channel Width:** 4.9'

Fill Estimate: 91 cubic yards Overall condition: Poor, both pipes rusted through.

Barrier Status: RED: the Green-Gray-Red filter determined this crossing fails to meet passage criteria for all species of adult salmonids and all age classes of juveniles. The steeply sloped concrete outlet apron is the crossing's main feature that creates a migration barrier. Also, there is inadequate depth below the apron for fish to complete a successful leap attempt onto the apron.

Preferred Treatment: Periodically inspect culvert for condition and performance. When crossing is due for replacement (or fails) replace with a properly-sized circular SSP pipe with downstream grade-control weirs. Lack of upstream fisheries benefit makes this site a poor candidate for replacement with restoration funds.

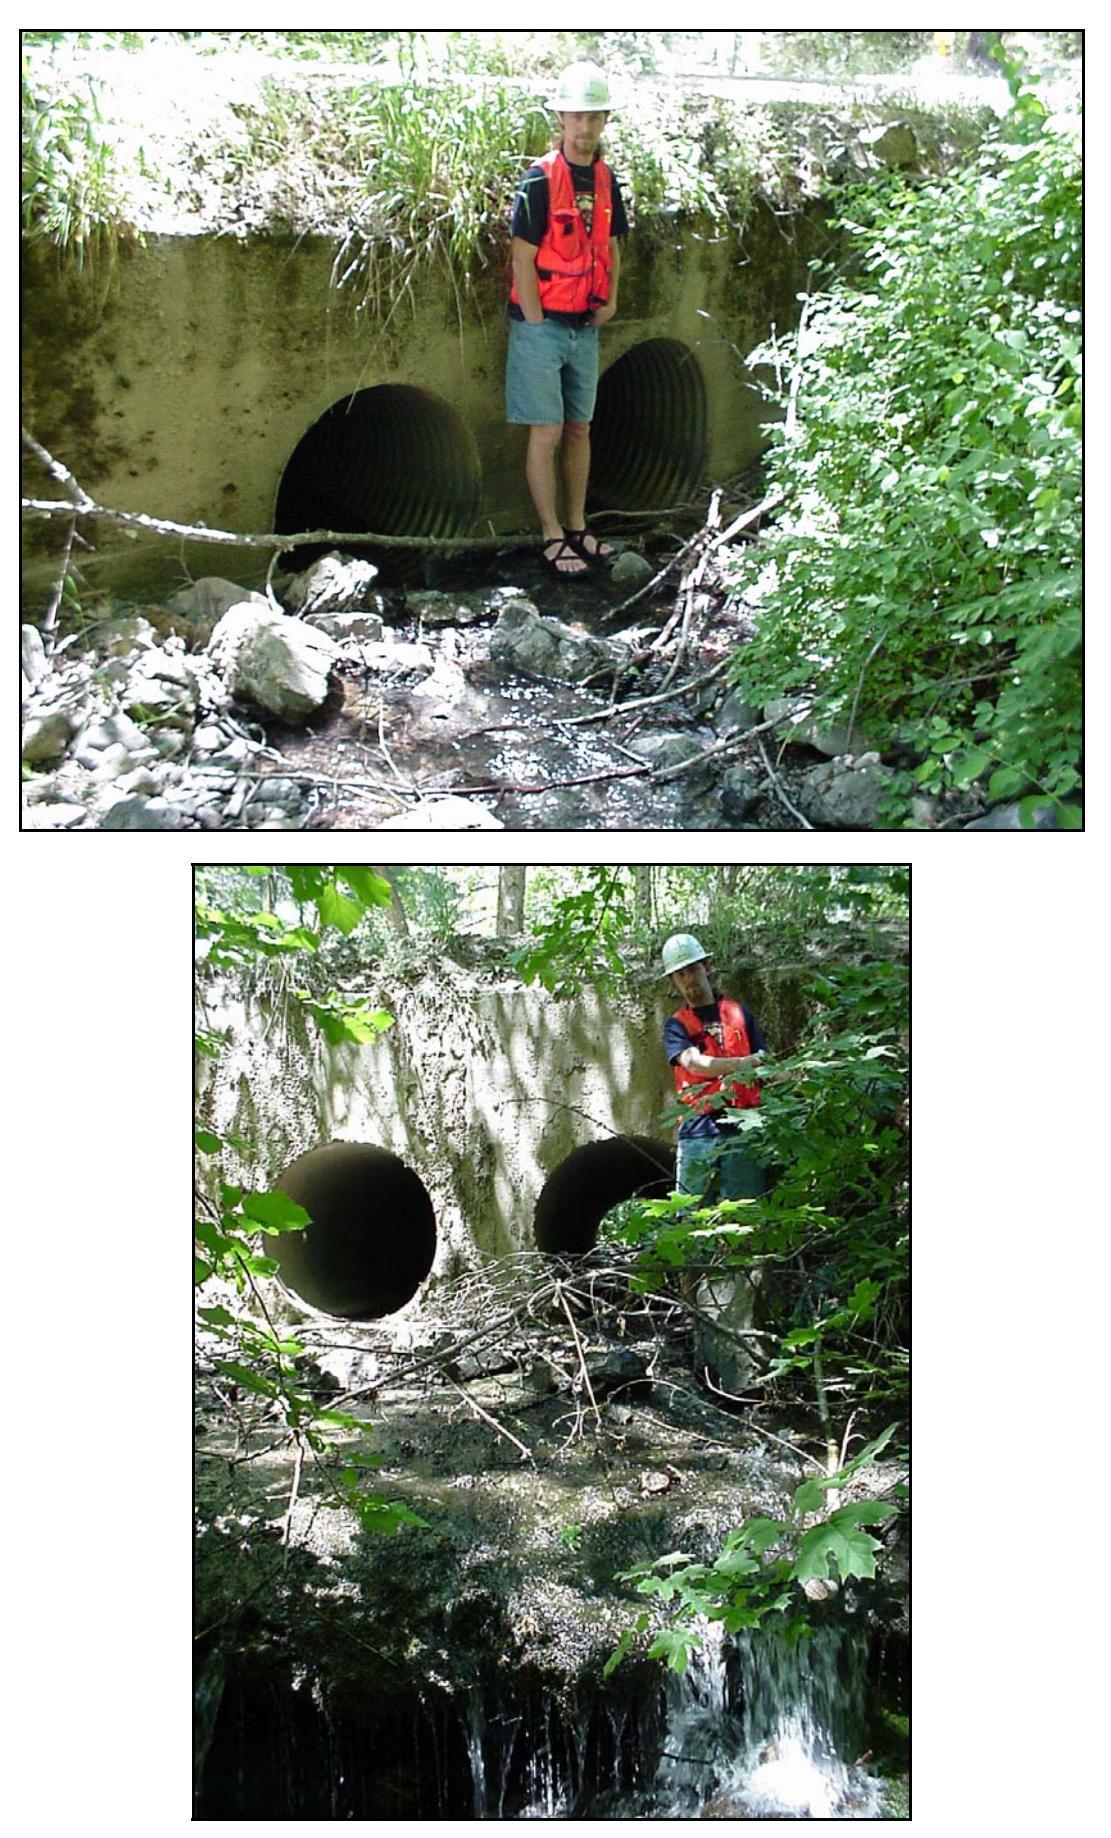
Site ID #34: Barleyfield Creek/Reading Creek Road; Reading Creek; Trinity River

Slope: 8.03% Modifications: None. Rustline Heights: 1.0' Average Active Channel Width: 3.4'

Fill Estimate: 242 cubic yards Overall condition: Good.

Barrier Status: RED: the Green-Gray-Red filter determined this crossing fails to meet passage criteria for all species of adult salmonids and all age classes of juveniles. The culvert's steep slope is the crossing's main feature that creates a migration barrier for salmonids.

Preferred Treatment: Periodically inspect culvert for condition and performance. When crossing is due for replacement (or fails) replace with a properly-sized circular SSP pipe with downstream grade-control weirs. Lack of upstream fisheries benefit makes this site a poor candidate for replacement with restoration funds.

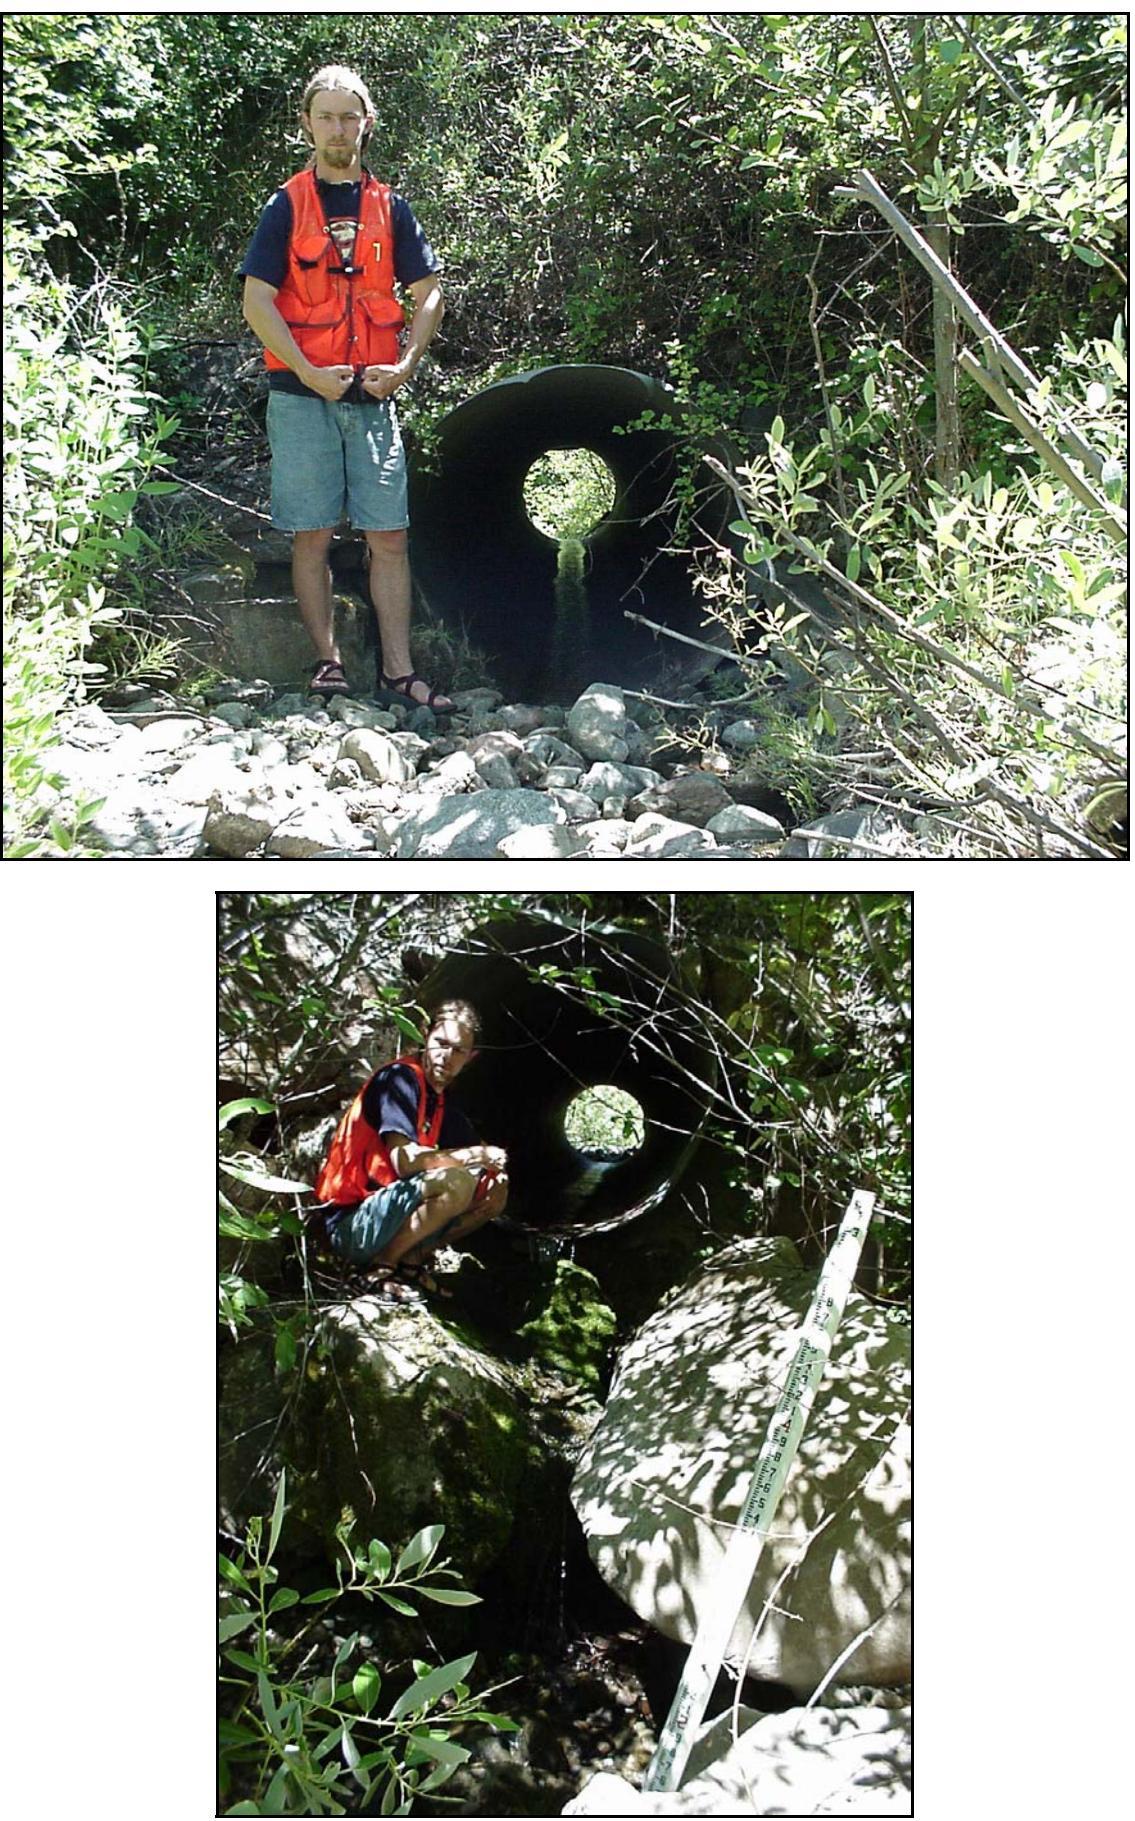
Site ID #35: Little Browns Creek/Roundy Road; Weaver Creek; Trinity River Ranking: #2 = High-Priority

Modifications: None. Rustline Heights: All three pipes = 1.0' Average Active Channel Width: 3.4'

Fill Estimate: 482 cubic yards Overall condition: Abraded.

Barrier Status: RED: the Green-Gray-Red filter determined this crossing fails to meet passage criteria for all species of adult salmonids and all age classes of juveniles. The extremely perched outlets of all three culverts is the crossing's main feature that creates a migration barrier.

Preferred Treatment: Replace with a properly-sized circular SSP pipe with grade control weirs or a bridge. The large drop at the current crossing's outlet would require a series of grade-control weirs to minimize the potentially excessive headwall cutting of the upstream channel.

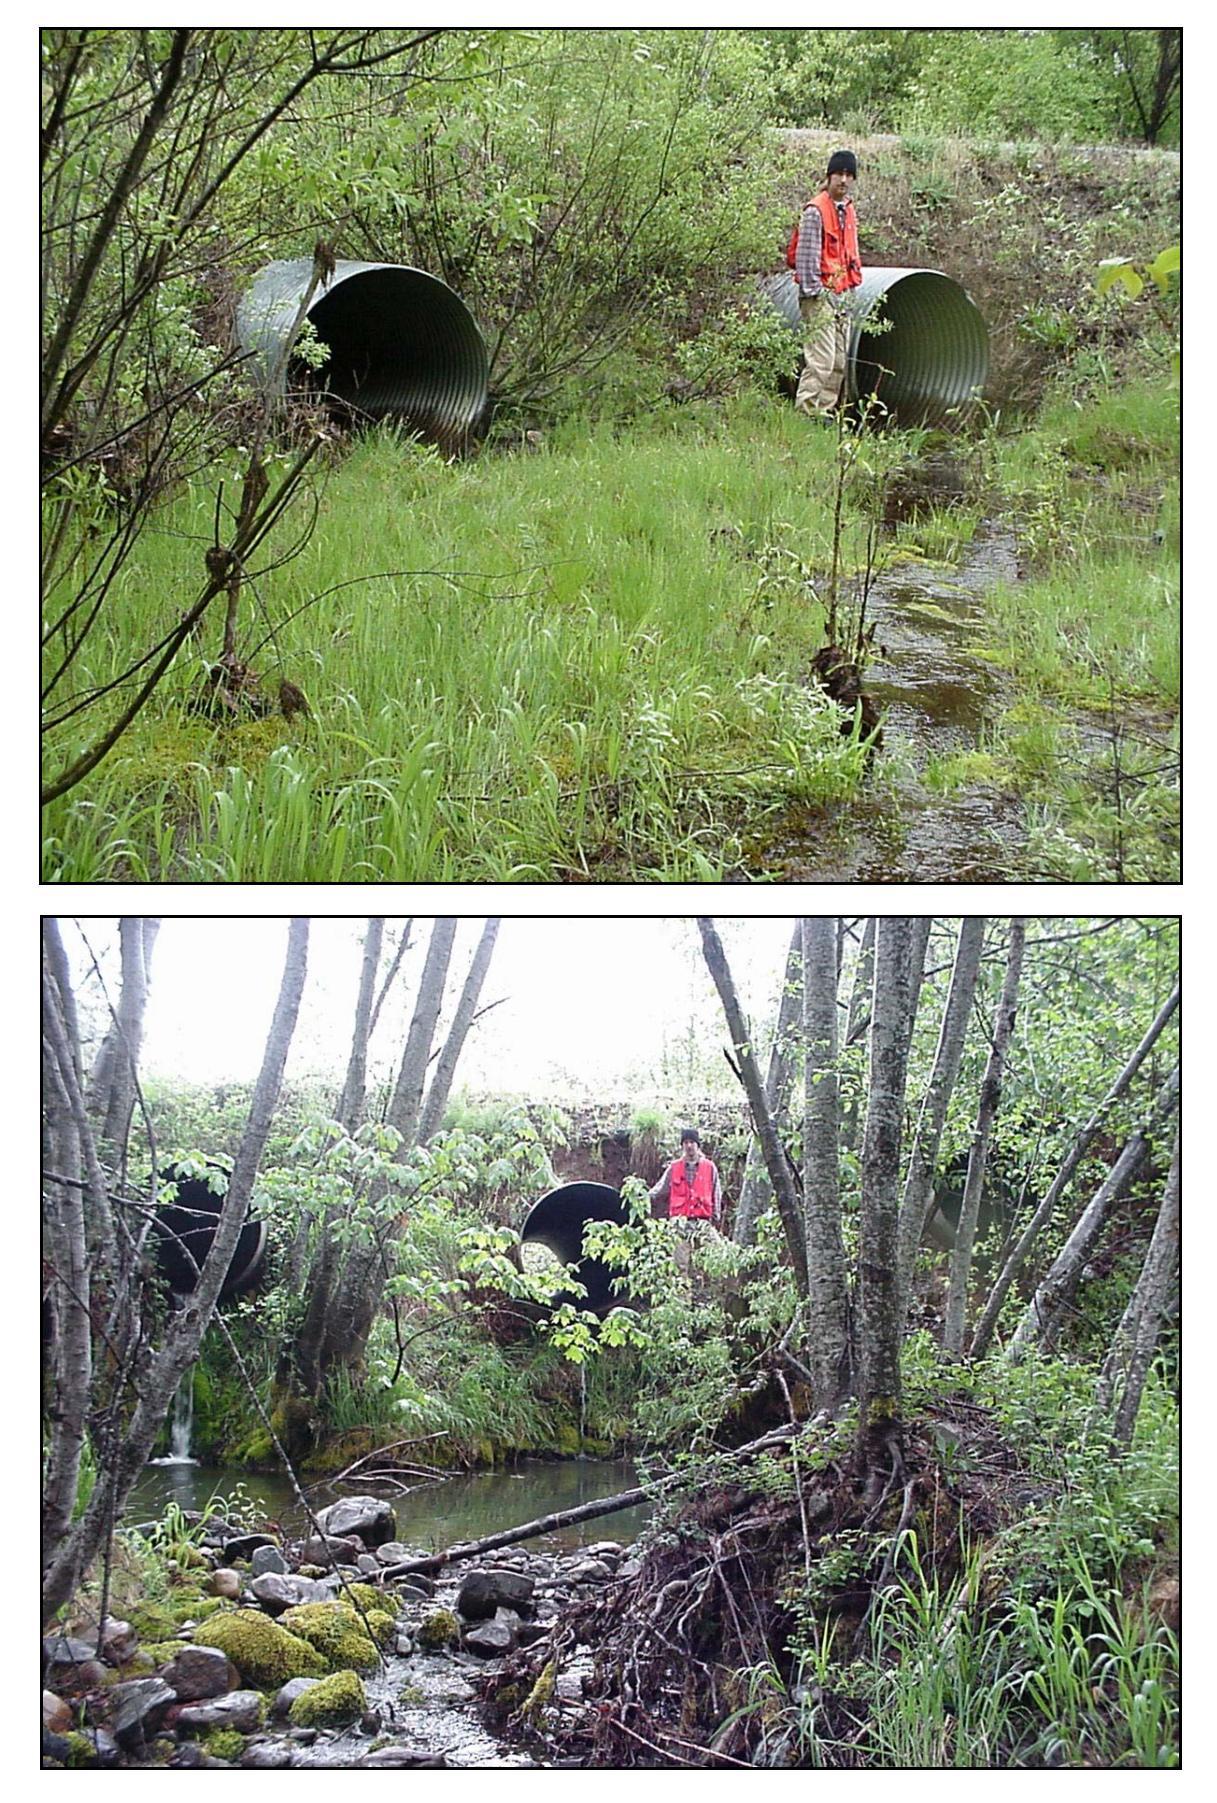
Site ID #36: Middle Weaver Creek/Oregon Street; Weaver Creek; Trinity River Ranking: #29 = Low-Priority

Length: 91.0' Slope: 1.91% Modifications: None. Rustline Height: 0.7'

Fill Estimate: 628 cubic yards Overall condition: Fair, culvert floor is abraded.

Preferred Treatment: None recommended at this point. Periodically inspect culvert for condition and performance. When crossing is due for replacement (or fails) replace with a properly-sized open-bottom arch set on concrete footings or a bridge.

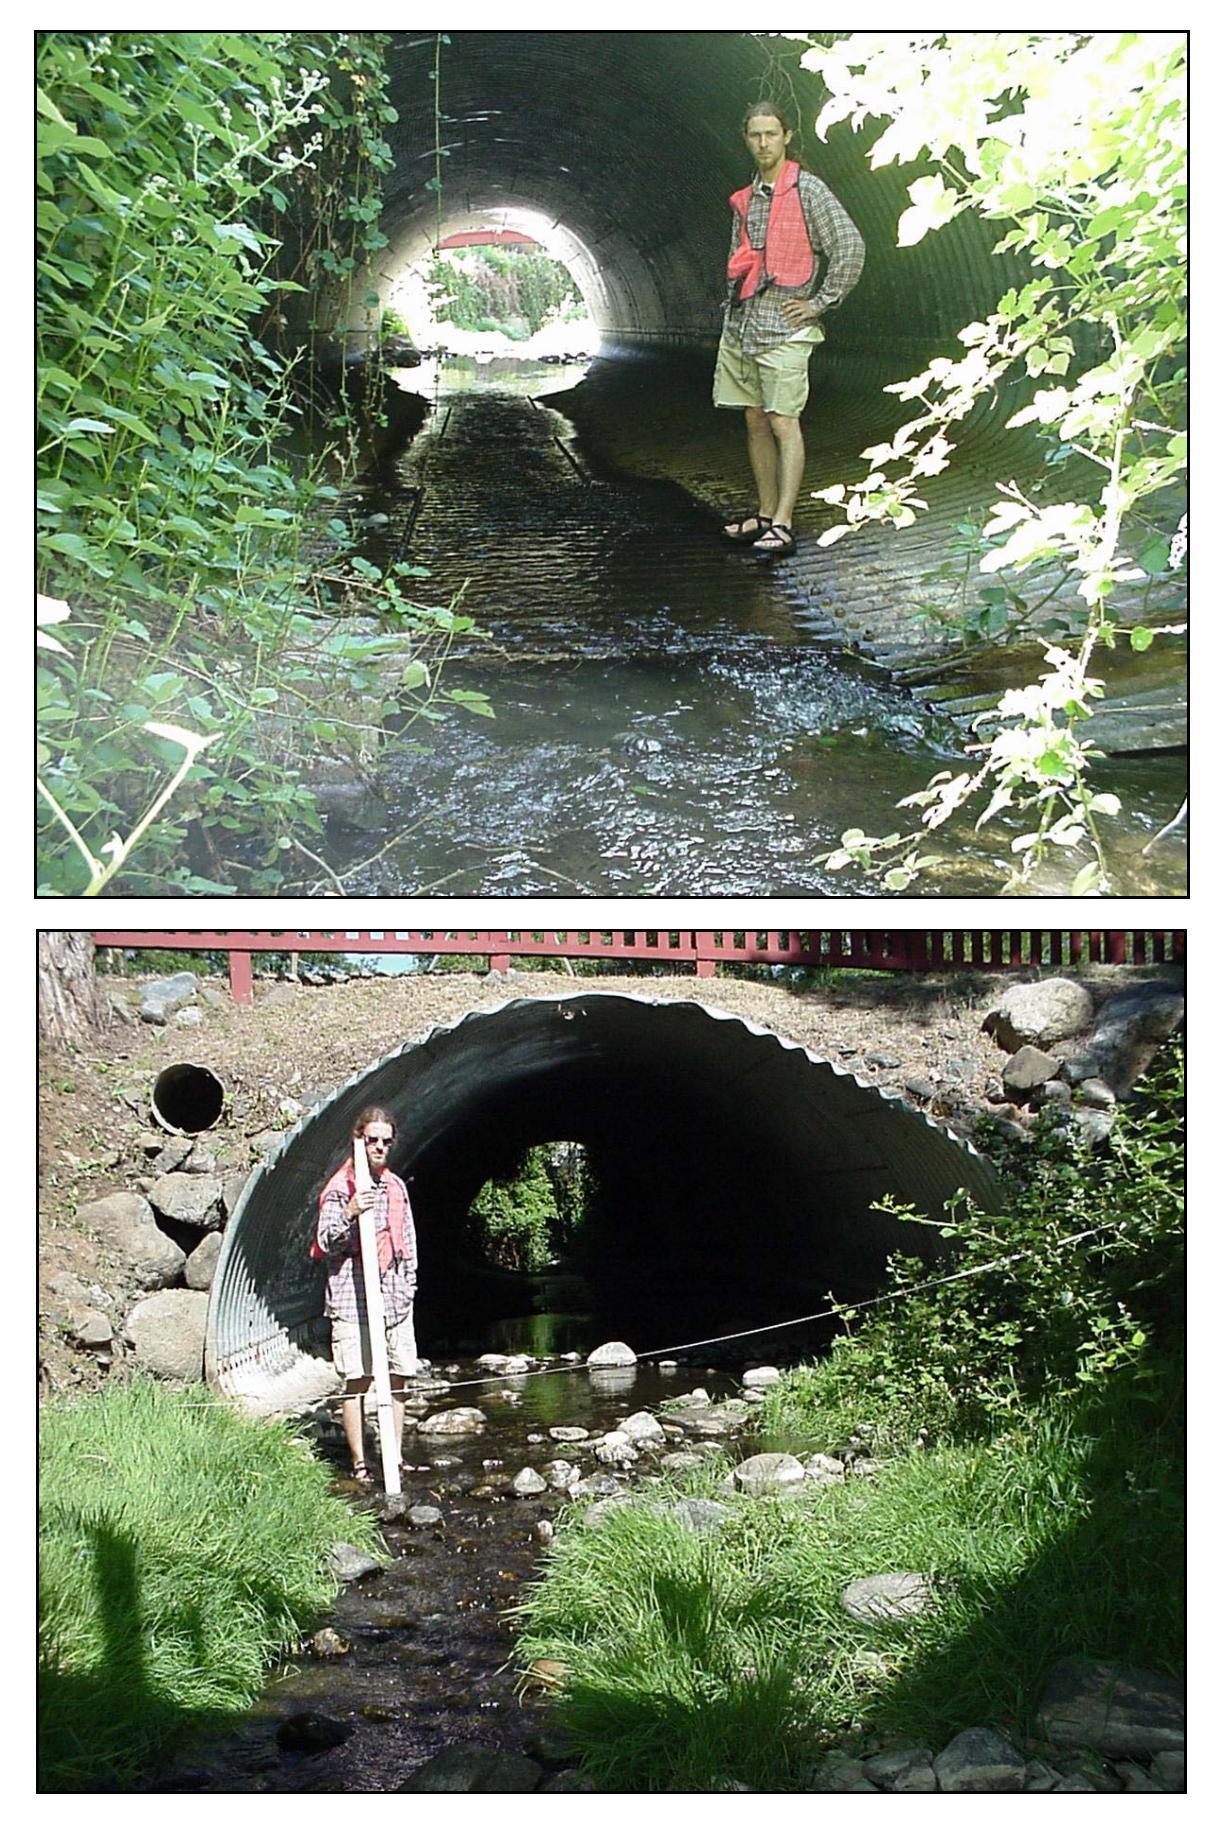
Site ID #37: Sidney Gulch/Memorial Drive; Middle Weaver Creek; Weaver Creek; Trinity River Ranking: #6 = High-Priority

Rustline Height: 0.7' Average Active Channel Width: 7.1' Fill Estimate: 766 cubic yards

Overall condition: Fair, bottom had rusted through and was repaired by pouring a concrete floor.

Barrier Status: RED: the Green-Gray-Red filter determined this crossing fails to meet passage criteria for all species of adult salmonids and all age classes of juveniles. The culvert's nearly 2% slope over a smooth concrete floor combined with a length of nearly 90 feet creates excessive velocities for successful upstream passage. The culvert has concrete aprons on both sides which compounds the existing passage problems.

Preferred Treatment: Replace with a properly sized open-bottom arch (such as a Conspan® arch) set on footings or a bridge.

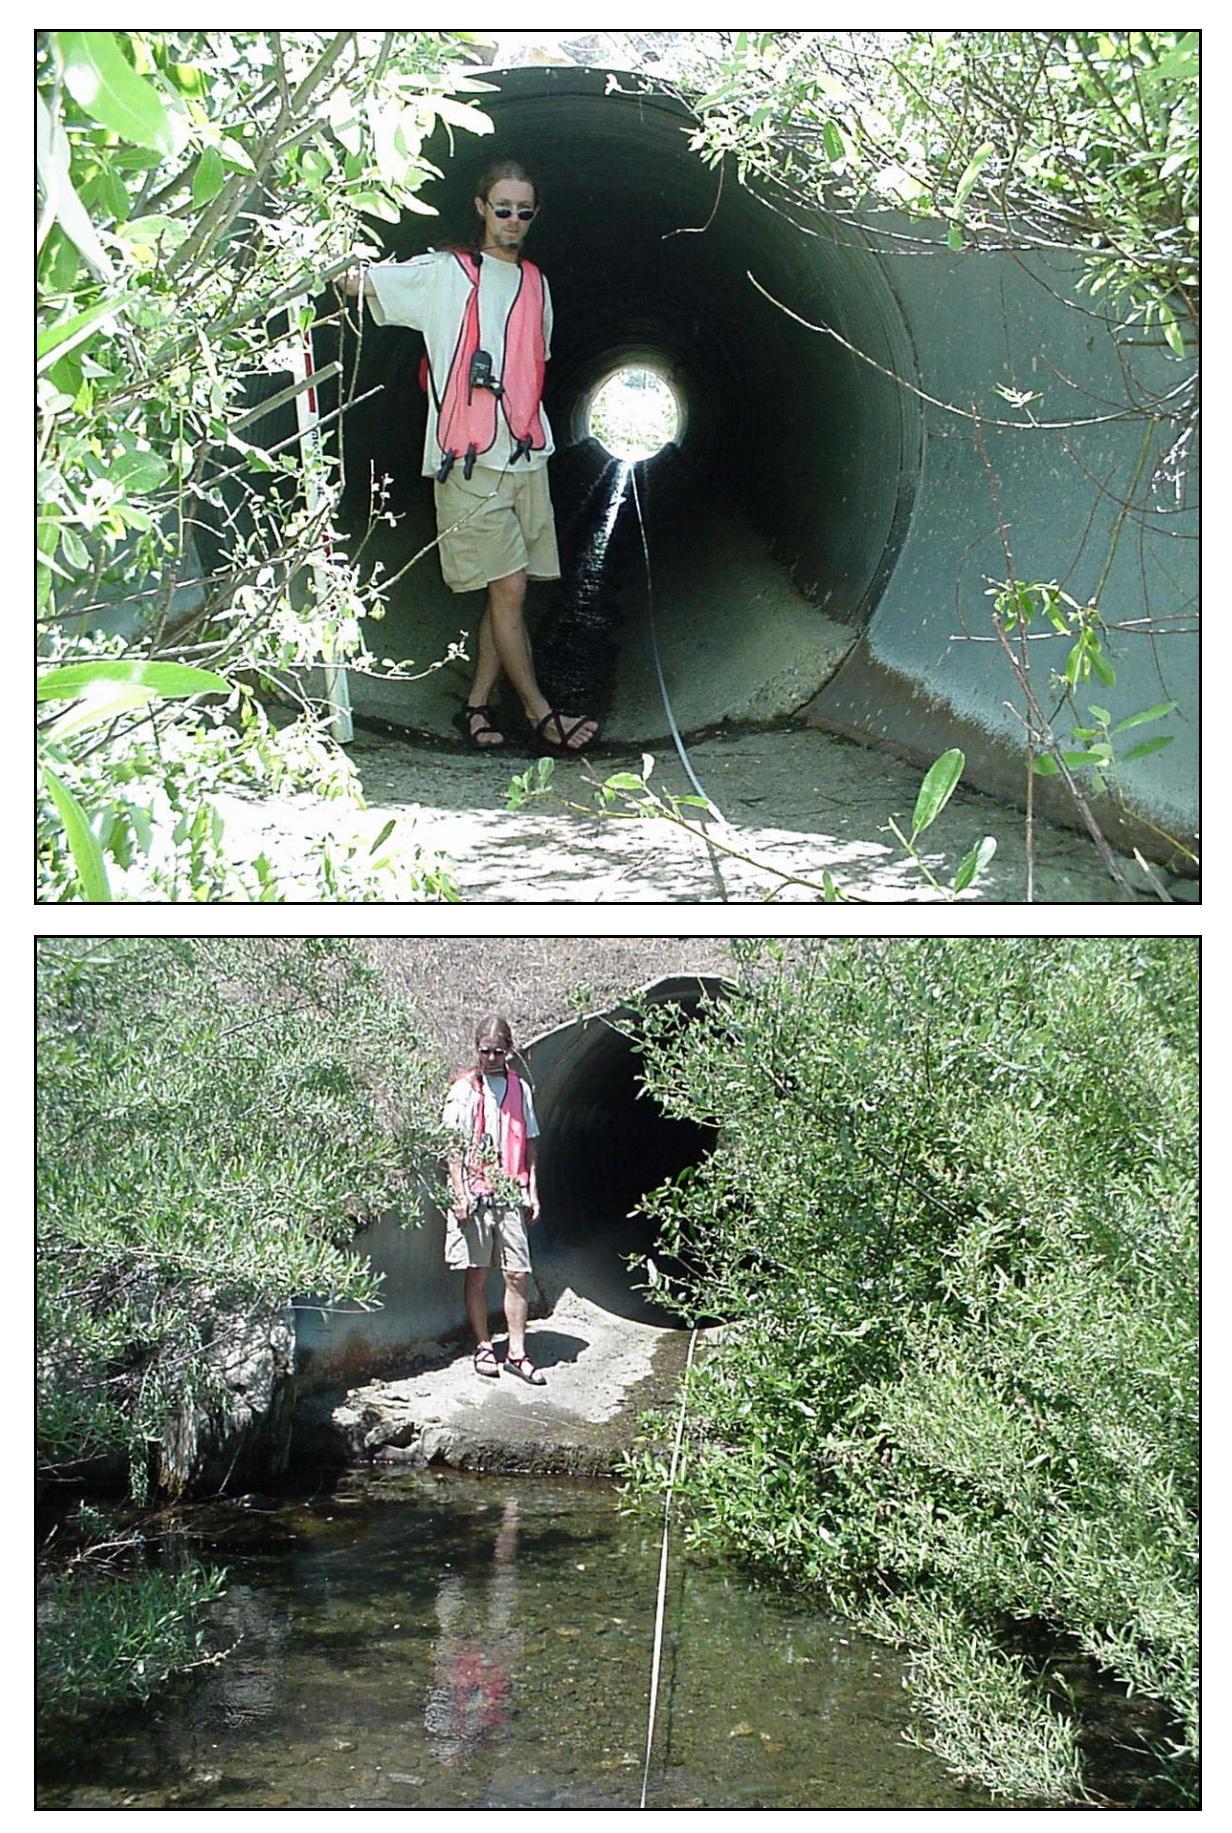
Site ID #38: Garden Gulch/Easter Avenue; Middle Weaver Creek; Weaver Creek; Trinity River Ranking: #5 = High-Priority

Rustline Height: None present Average Active Channel Width: 5.8' Fill Estimate: 513 cubic yards

Overall condition: Fair, floor is abraded and rusted through in several areas underneath the steel plates.

Barrier Status: RED: the Green-Gray-Red filter determined this crossing fails to meet passage criteria for all species of adult salmonids and all age classes of juveniles. The steep slope and steel plates within the culvert were the crossing's main feature that created a migration barrier.

Preferred Treatment: Replace with a properly sized open-bottom arch (such as a Conspan® arch) set on footings or a bridge. However, it is important that CalTrans address their barrier at Highway 299.

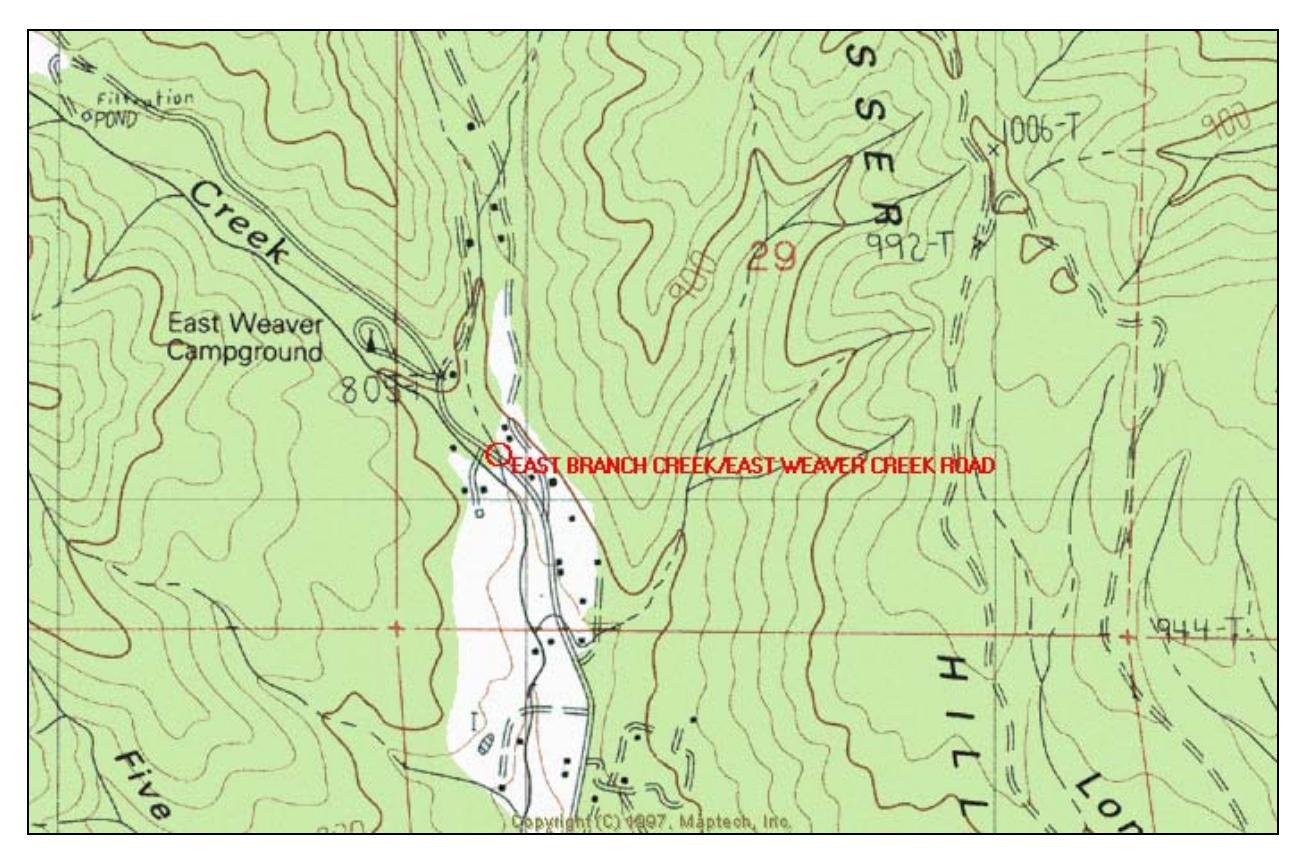
Fill Estimate: 592 cubic yards Overall condition: Fair, culvert floor is abraded and rusted.

Barrier Status: RED: the Green-Gray-Red filter determined this crossing fails to meet passage criteria for all species of adult salmonids and all age classes of juveniles. The steep slope through the culvert and the concrete apron are this crossing's main features that create a migration barrier.

Preferred Treatment: Replace with a properly sized open-bottom arch (such as a Conspan® arch) set on footings or a bridge.

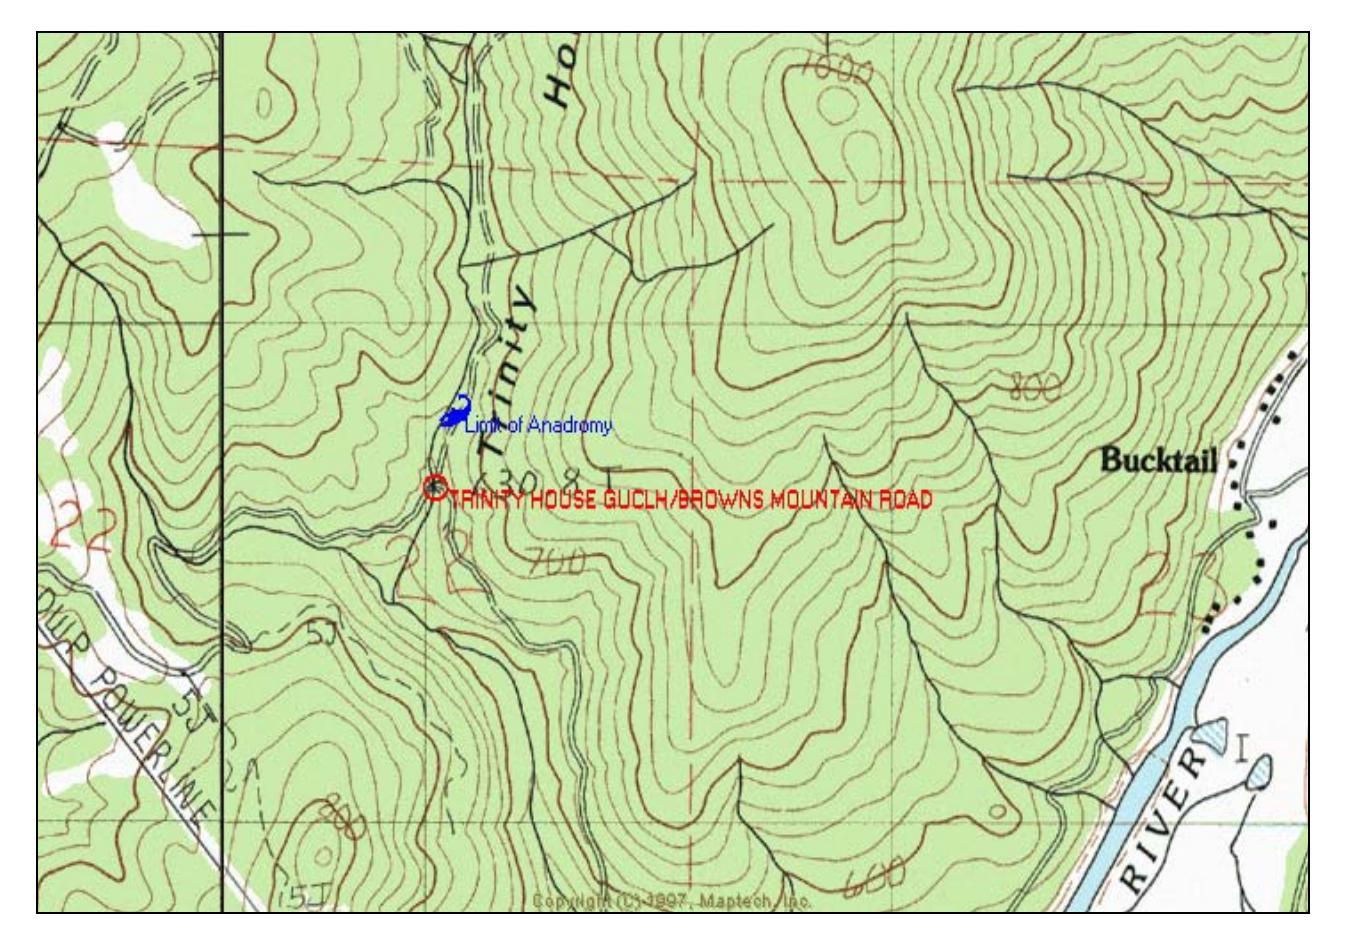
Site ID #40: Trinity House Gulch/Browns Mountain Road; Trinity River

Fill Estimate: 180 cubic yards Overall condition: Good.

Barrier Status: RED: the Green-Gray-Red filter determined this crossing fails to meet passage criteria for all species of adult salmonids and all age classes of juveniles. The culvert's steep slope and drop over riprap at the outlet are this crossing's main features that create a migration barrier.

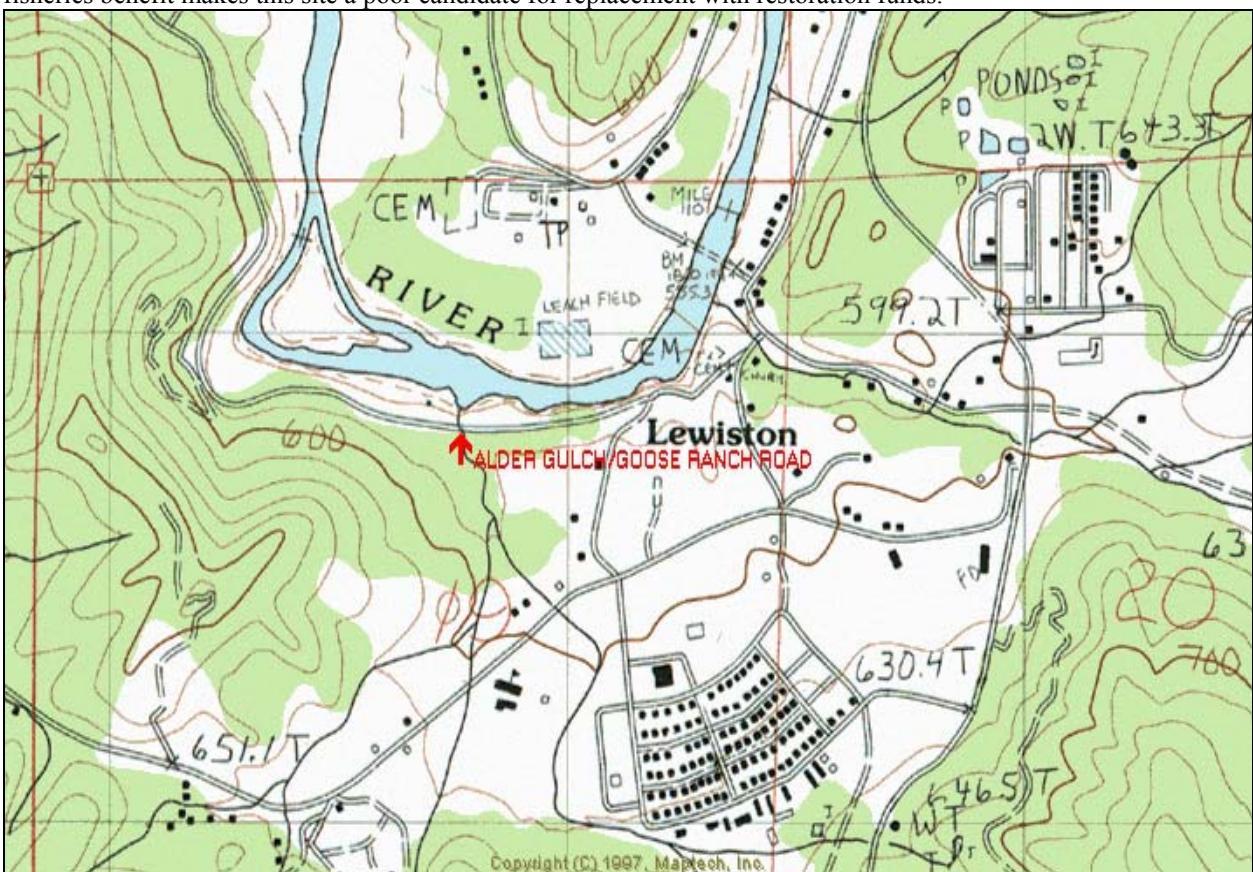
Fill Estimate: 299 cubic yards Overall condition: Good.

Barrier Status: RED: the Green-Gray-Red filter determined this crossing fails to meet passage criteria for all species of adult salmonids and all age classes of juveniles. The culvert's steep slope and perched outlet are this crossing's main features that create a migration barrier.

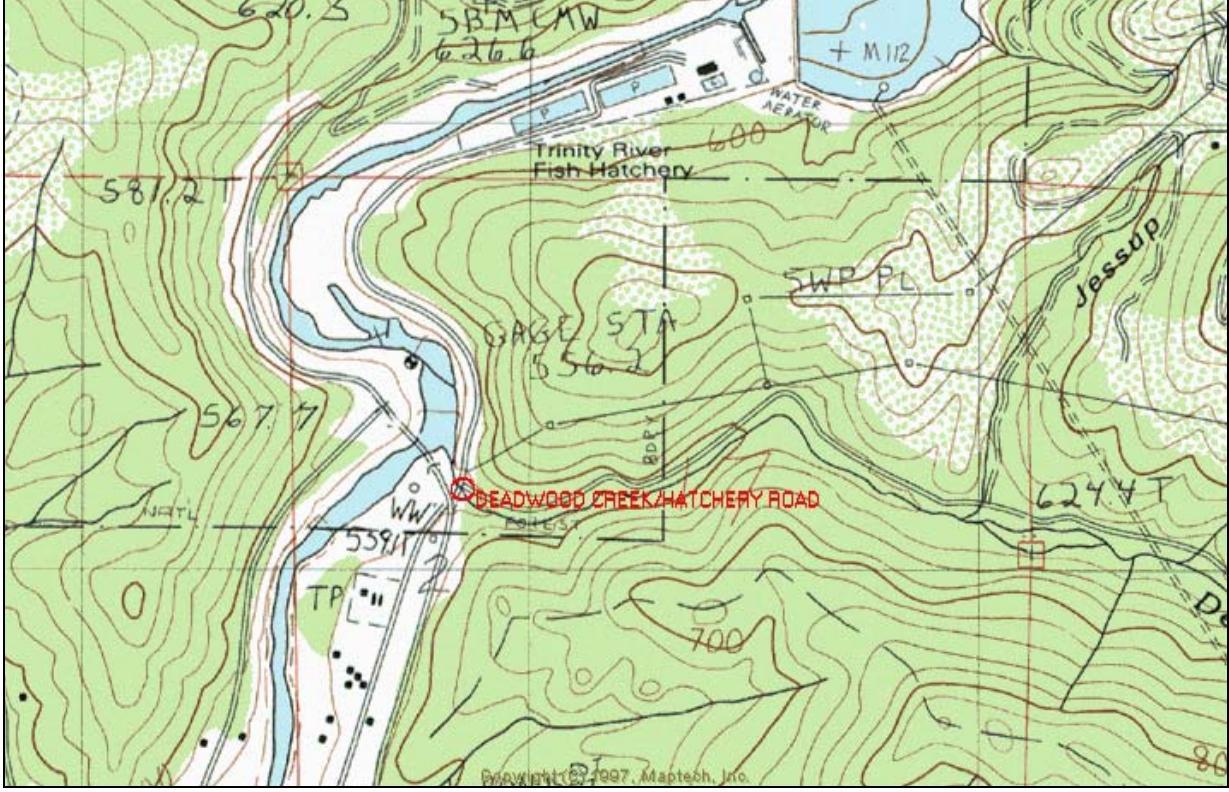
Fill Estimate: 2,849 cubic yards Overall condition: Fair, culvert floor is abraded.

Preferred Treatment: the best long-term solution is to replace with a properly sized open-bottom arch (such as a Conspan® arch) set on footings or a bridge. However, the large amount of road fill makes a full replacement expensive. The County should consider attempting to backwater the culvert with a series of downstream weirs.

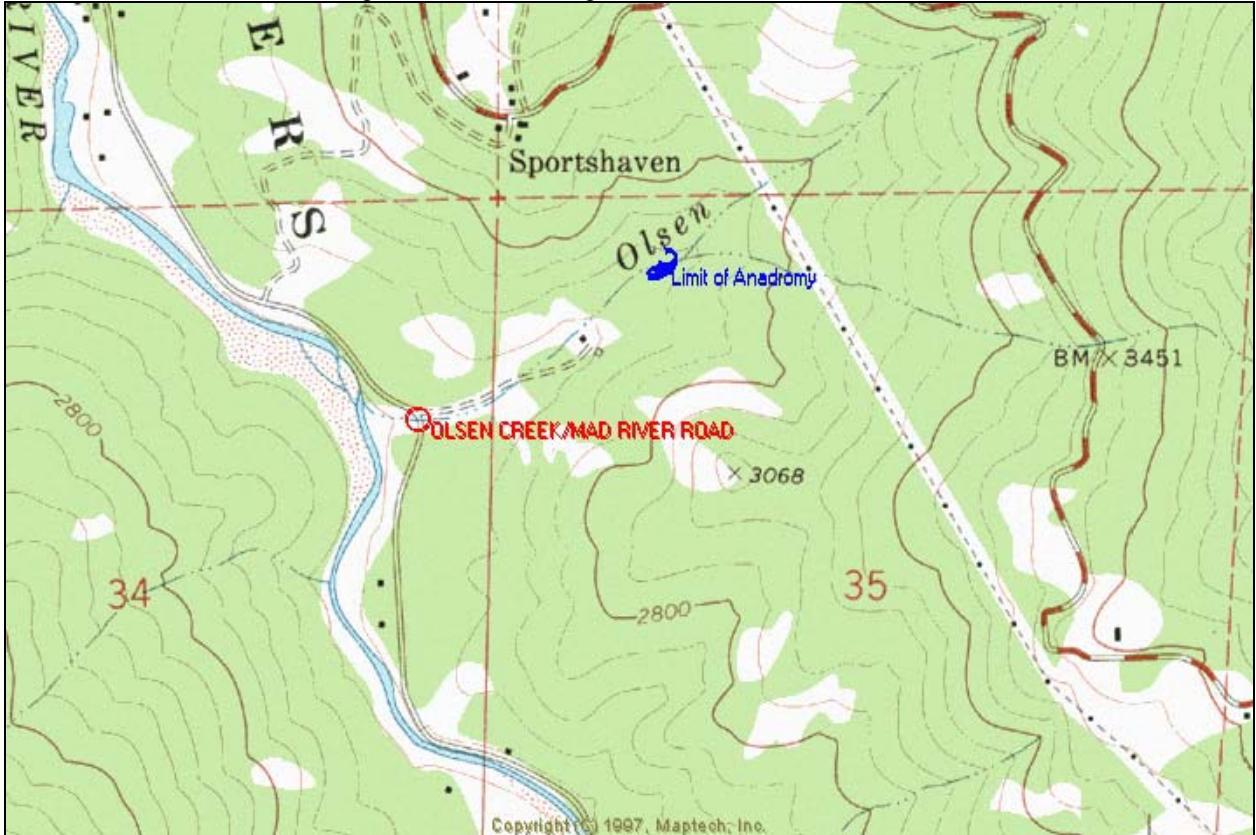
Overall condition: Fair, sides were abraded.

Barrier Status: RED: the Green-Gray-Red filter determined this crossing fails to meet passage criteria for all species of adult salmonids and all age classes of juveniles. The drop over rip rap at the outlet was the crossing's main feature that may inhibit fish migration.

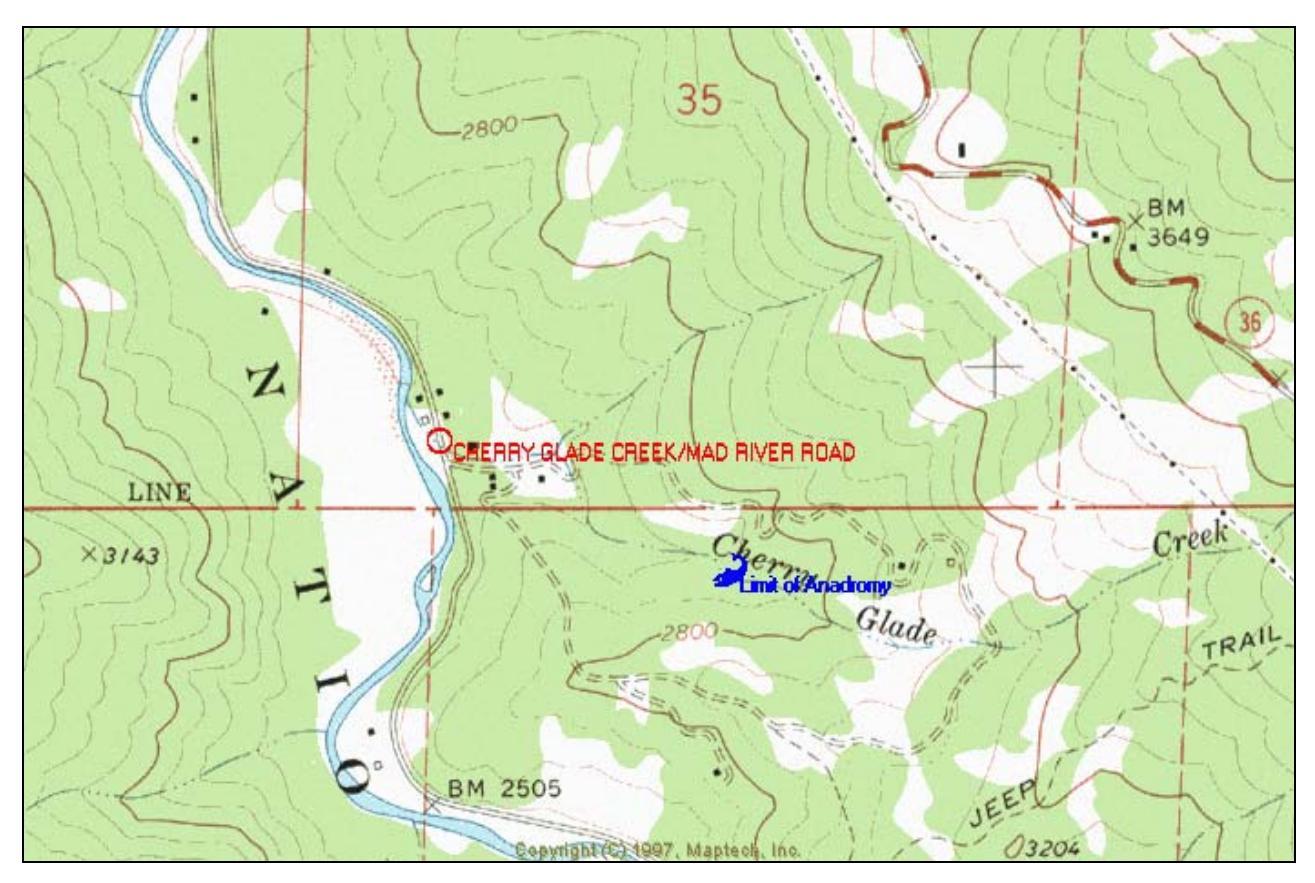
Site ID #44: Cherry Glade Creek/Mad River Road; Mad River

Fill Estimate: 499 cubic yards **Overall condition:** Fair, culvert floor was abraded and rusted underneath steel plates.

Barrier Status: RED: the Green-Gray-Red filter determined this crossing fails to meet passage criteria for all species of adult salmonids and all age classes of juveniles. The culvert's steep slope and smooth bottom are this crossing's main features that create a migration barrier.

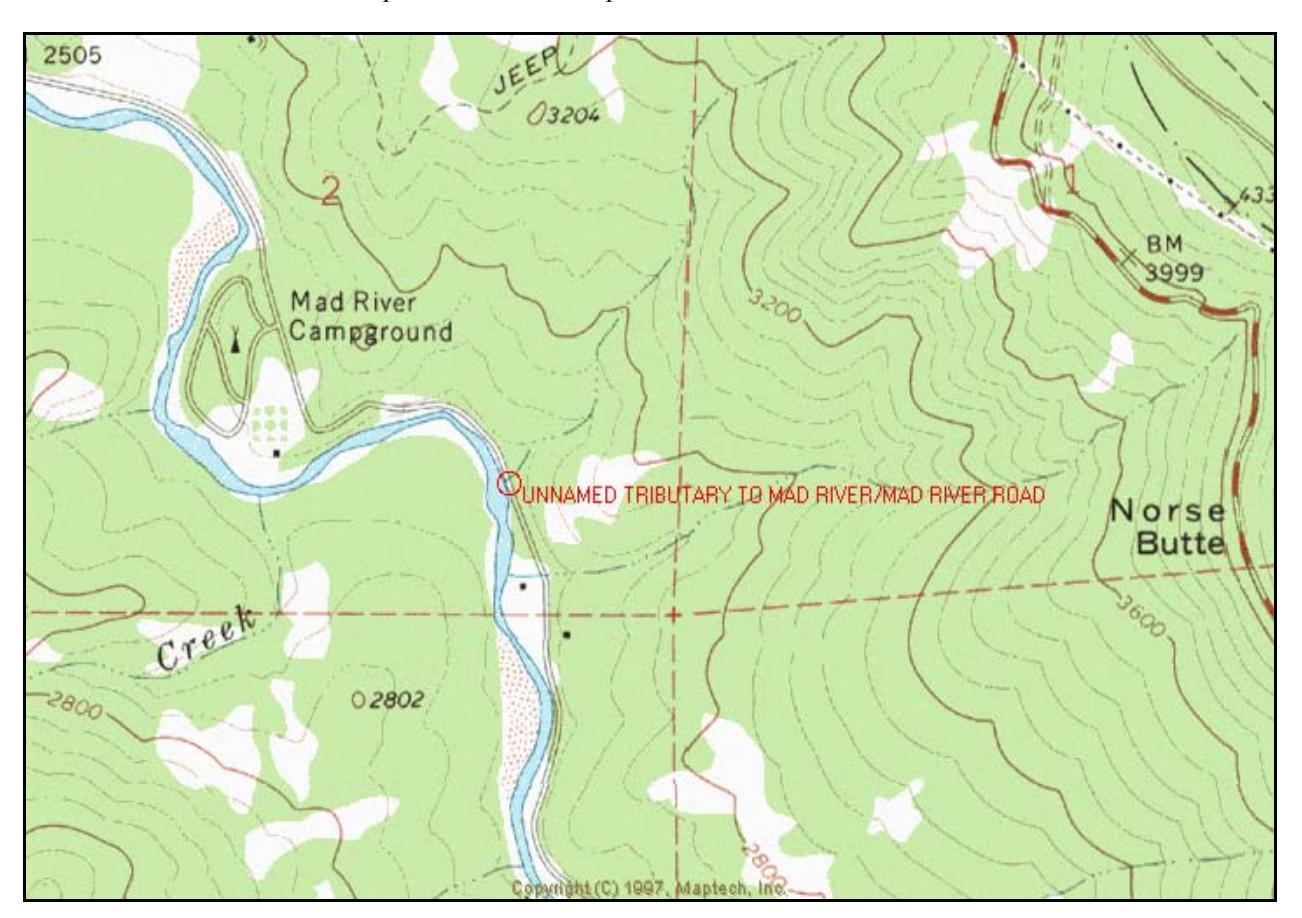
Fill Estimate: 188 cubic yards Overall condition: Fair, concrete was abraded and culvert floor was undercut on downstream end.

Barrier Status: RED: the Green-Gray-Red filter determined this crossing fails to meet passage criteria for all species of adult salmonids and all age classes of juveniles. The culvert's moderate slope, smooth floor, and perched outlet were this crossing's main features creating a migration barrier.
