APPENDIX B:

CATALOG OF TRINITY COUNTY CULVERTS LOCATED ON FISH-BEARING STREAM REACHES

Site ID #1: Unnamed tributary/South Fork Road; South Fork Trinity River; Trinity River

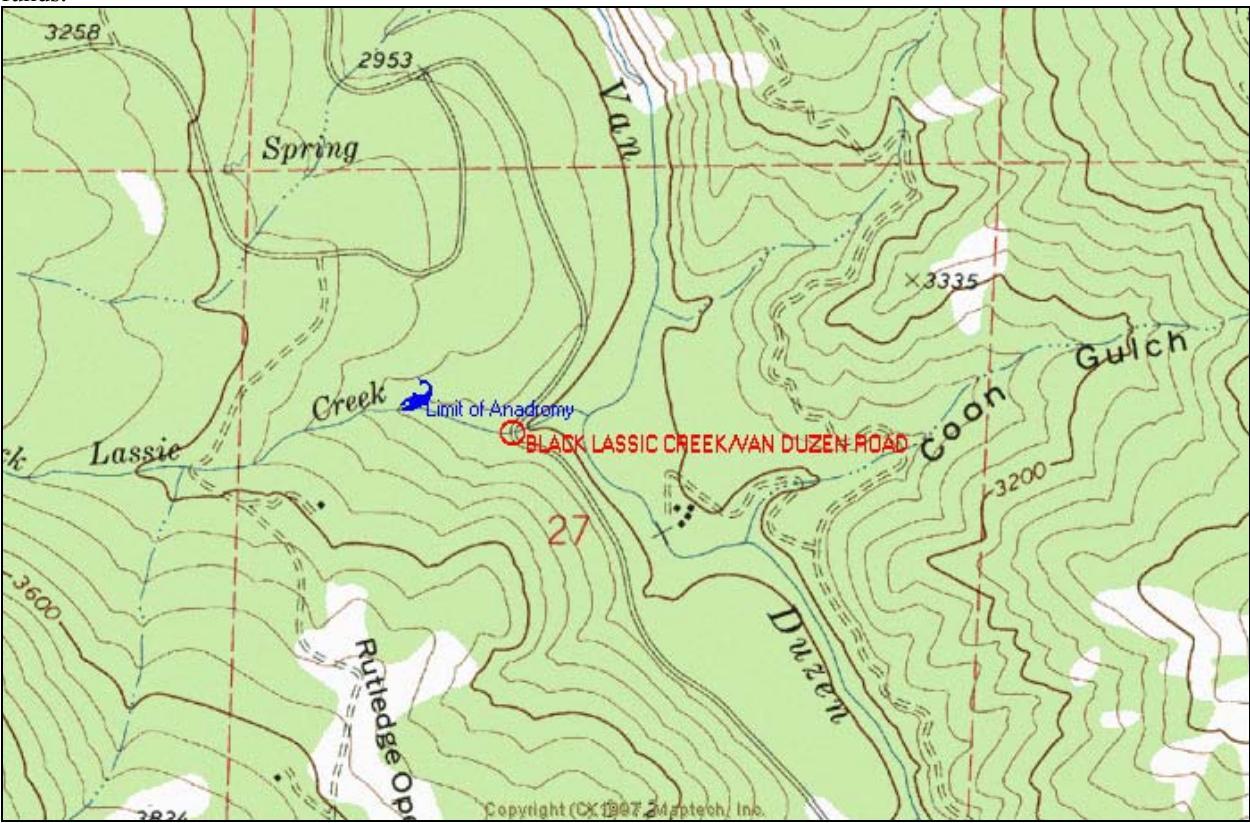
Fill Estimate: 3,611 cubic yards Overall condition: Good.

Barrier Status: RED: the Green-Gray-Red filter determined this crossing fails to meet passage criteria for all species of adult salmonids and all age classes of juveniles. The culvert's steep slope, steel-plated floor, and outlet drop onto rip rap are this crossing's features that create a migration barrier.

Preferred Treatment: Periodically inspect culvert for condition and performance. Lack of upstream fisheries benefit and the high cost of any improvements makes this site a poor candidate for replacement with restoration funds.

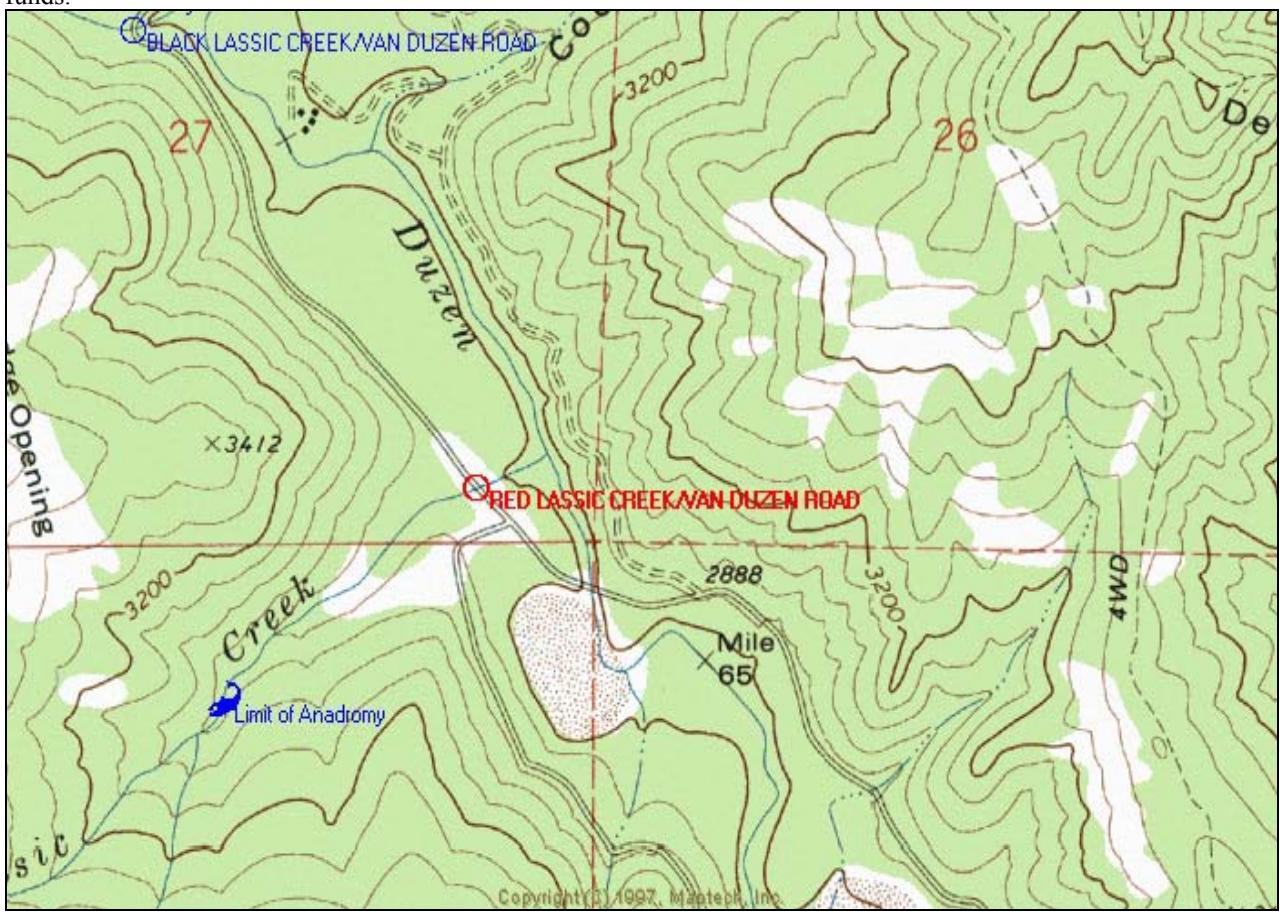
Overall condition: Poor, culvert floor was rusted through.

Barrier Status: RED: the Green-Gray-Red filter determined this crossing fails to meet passage criteria for all species of adult salmonids and all age classes of juveniles. The culvert's moderately steep slope and the outlet drop over bedrock are this crossing's main features which create a migration barrier.

Preferred Treatment: Periodically inspect culvert for condition and performance. Lack of upstream fisheries benefit and the high cost of any improvements makes this site a poor candidate for replacement with restoration funds.

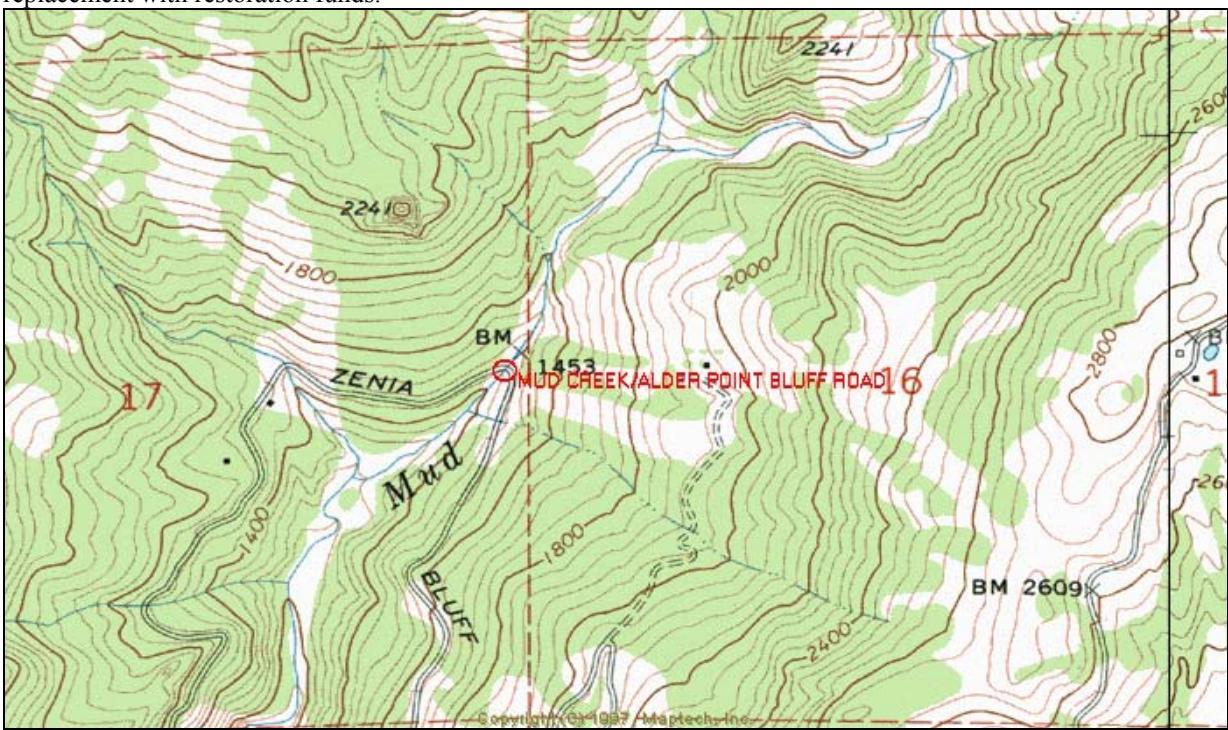
Modifications: Smooth steel plates on the bottom of the culvert, probably to cover rust holes. The plates are being pried up.

Overall condition: Poor, culvert floor is rusted through and then covered with steel plates.

Barrier Status: RED: the Green-Gray-Red filter determined this crossing fails to meet passage criteria for all species of adult salmonids and all age classes of juveniles. A lack of depth and the large drop over rip rap at the outlet are this crossing's main features which create a migration barrier.

Preferred Treatment: Periodically inspect culvert for condition and performance. When crossing is due for replacement (or fails) replace with an embedded properly-sized circular SSP pipe, an open-bottom arch set on concrete footings, or a bridge. Lack of upstream fisheries benefit makes this site a poor candidate for replacement with restoration funds.

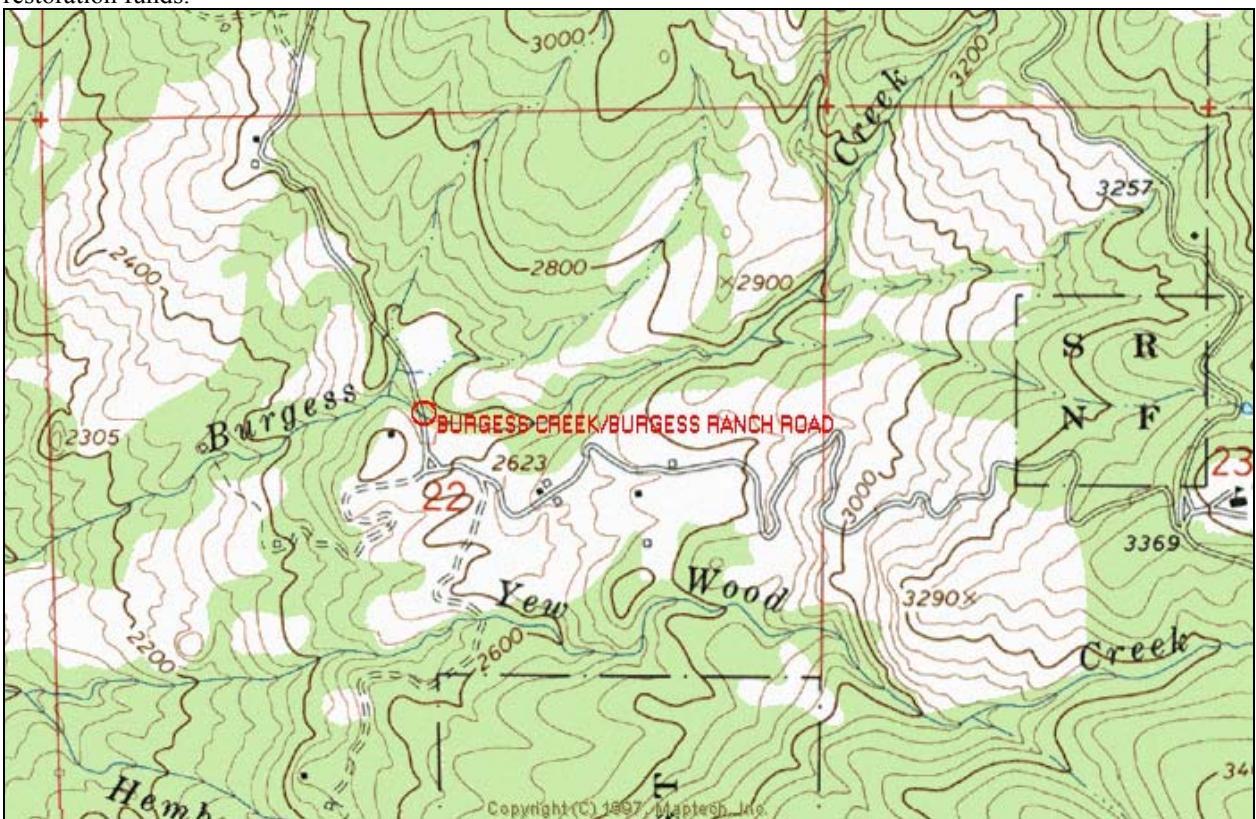
Site ID #49: Burgess Creek/Burgess Ranch Road; Hembry Creek; South Dobbyn Creek; Dobbyn Creek; Eel River

Overall condition: Fair, culvert floor was abraded.

Barrier Status: RED: the Green-Gray-Red filter determined this crossing fails to meet passage criteria for all species of adult salmonids and all age classes of juveniles.

Preferred Treatment: Periodically inspect culvert for condition and performance. When crossing is due for replacement (or fails) replace with an embedded properly-sized circular SSP pipe or an open-bottom arch set on concrete footings. Lack of upstream fisheries benefit makes this site a poor candidate for replacement with restoration funds.

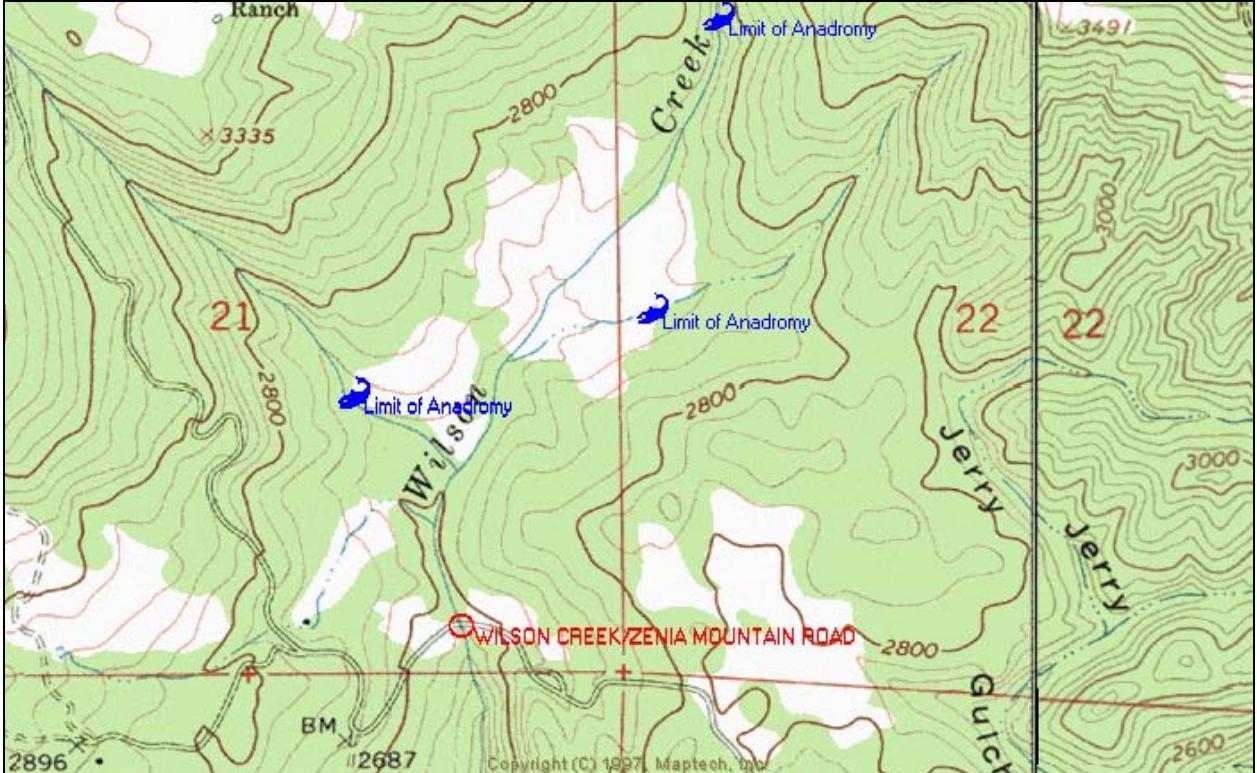
Fill Estimate: 466 cubic yards Overall condition: Good.

Barrier Status: RED: the Green-Gray-Red filter determined this crossing fails to meet passage criteria for all species of adult salmonids and all age classes of juveniles.

Preferred Treatment: Periodically inspect culvert for condition and performance. When crossing is due for replacement (or fails) replace with an embedded properly-sized circular SSP pipe or an open-bottom arch set on concrete footings. Lack of knowledge of upstream fisheries benefit and steep channel below the culvert makes this site a poor candidate for replacement with restoration funds.

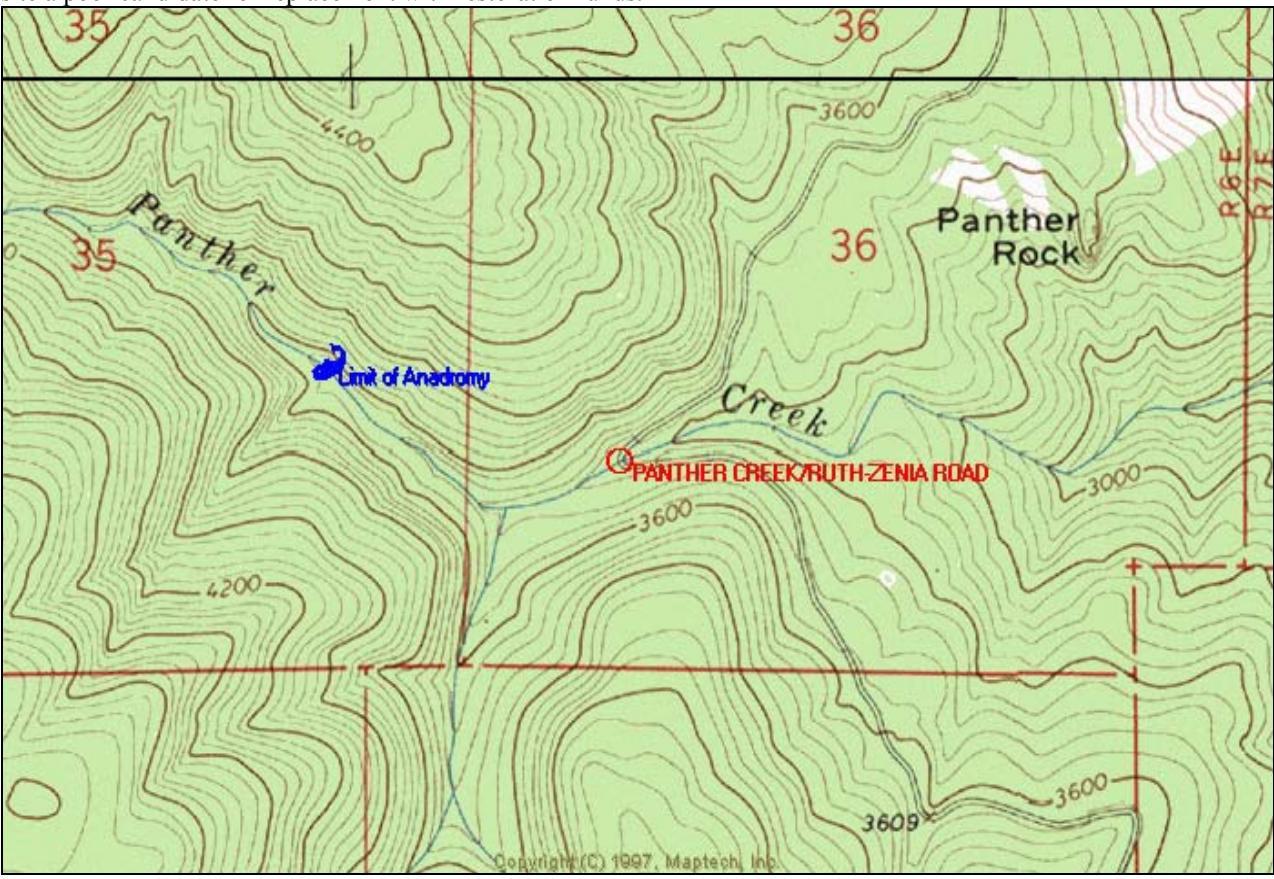
Site ID #51: Panther Creek /Ruth Zenia Road; Bar Creek; West Fork Eel River; North Fork Eel River; Eel River

Fill Estimate: 2,434 cubic yards Overall condition: Good.

Barrier Status: RED: the Green-Gray-Red filter determined this crossing fails to meet passage criteria for all species of adult salmonids and all age classes of juveniles. The culvert's steep slope and perched outlet are this crossing's main features that create a migration barrier.

Preferred Treatment: Periodically inspect culvert for condition and performance. When crossing is due for replacement (or fails) replace with a properly-sized circular or arch SSP pipe. A series of grade control weirs is required to raise the outlet pool elevation – presence of bedrock may limit excavating down prior to installing the new culvert. Lack of knowledge of upstream fisheries benefit and steep channel below the culvert makes this site a poor candidate for replacement with restoration funds.
