Attachment 1 – Project Elements Narrative

Ryan Creek Migration Barrier Removal Project Progress Report No. 3 Reporting Period: *April 1, 2011 – September 30, 2011*

NOAA Open Rivers Initiative Grant No. NA10NMF4630221

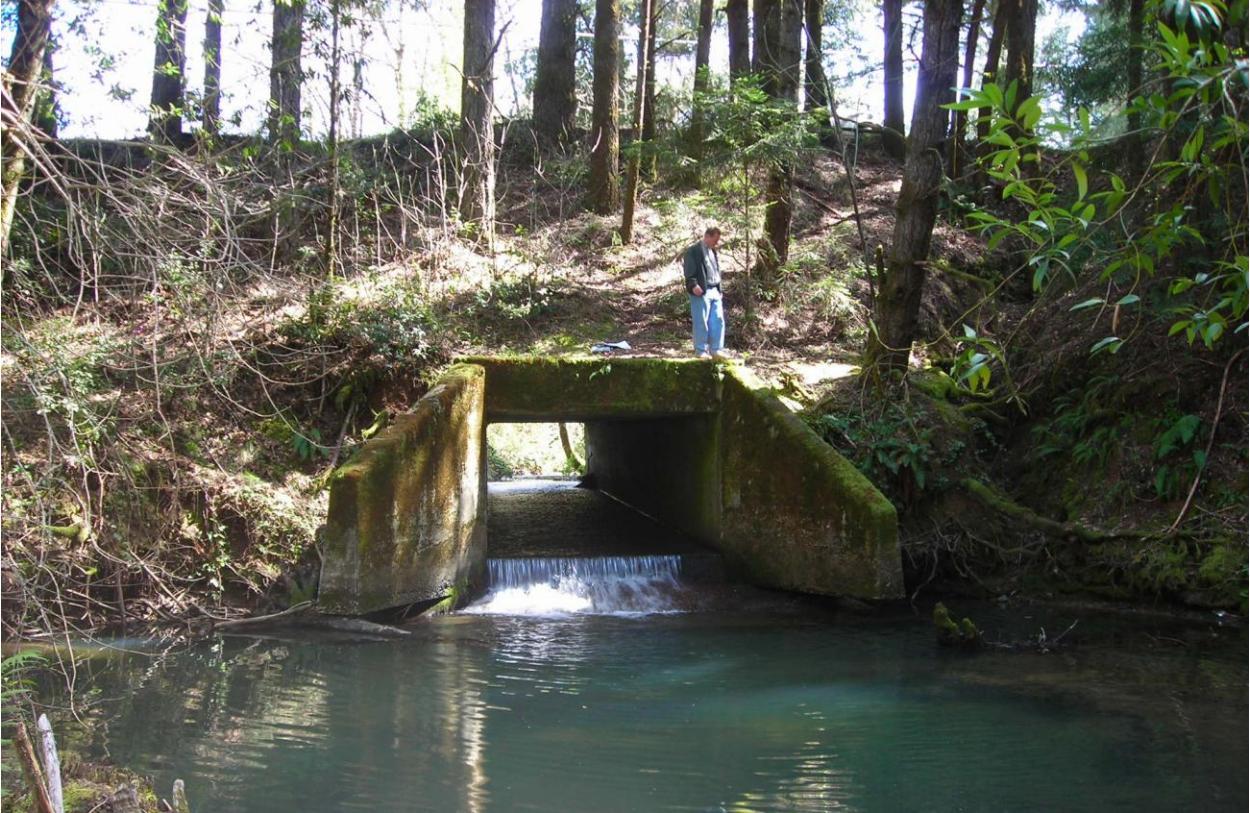
Project Manager, Alex Straessle of Mendocino County DOT, at outlet of the concrete box culvert on Ryan Creek Road – October 24, 2010
