## **FINAL REPORT** Whites Gulch Migration Barrier Removal Project

United States Department of the Interior - Bureau of Reclamation **Klamath River Restoration Program** Grant Agreement No. R10AP20673

## Attachment 2: Project Photolog Whites Gulch Migration Barrier Removal Project

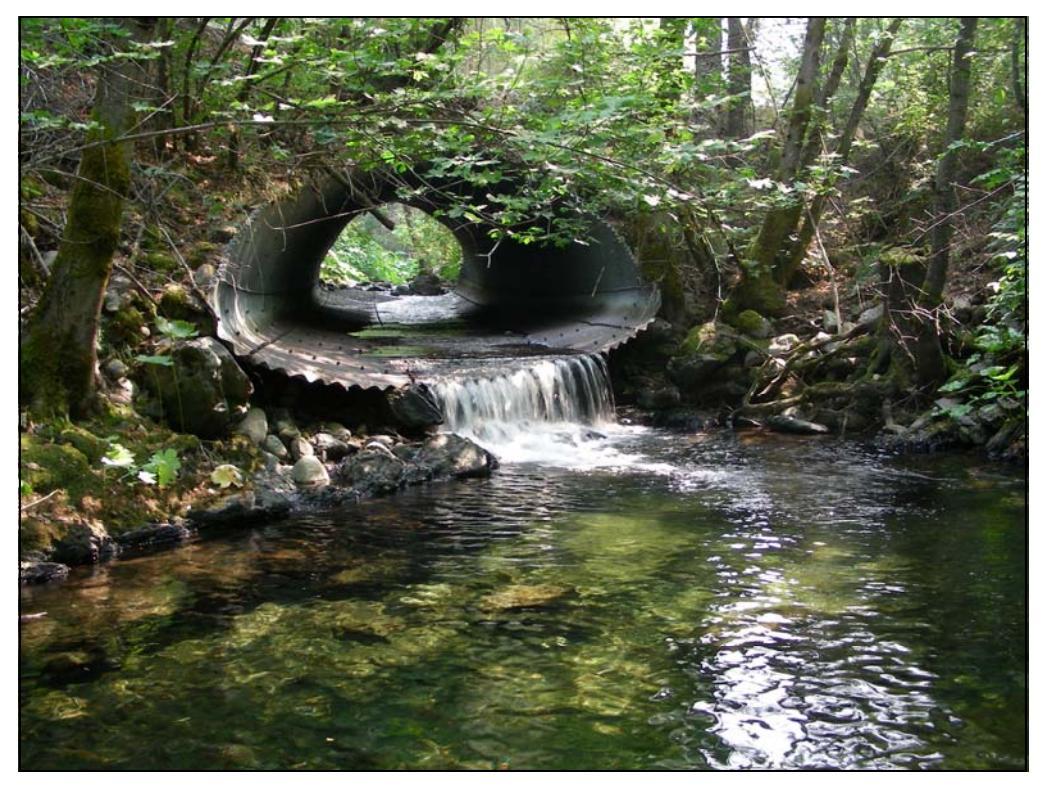
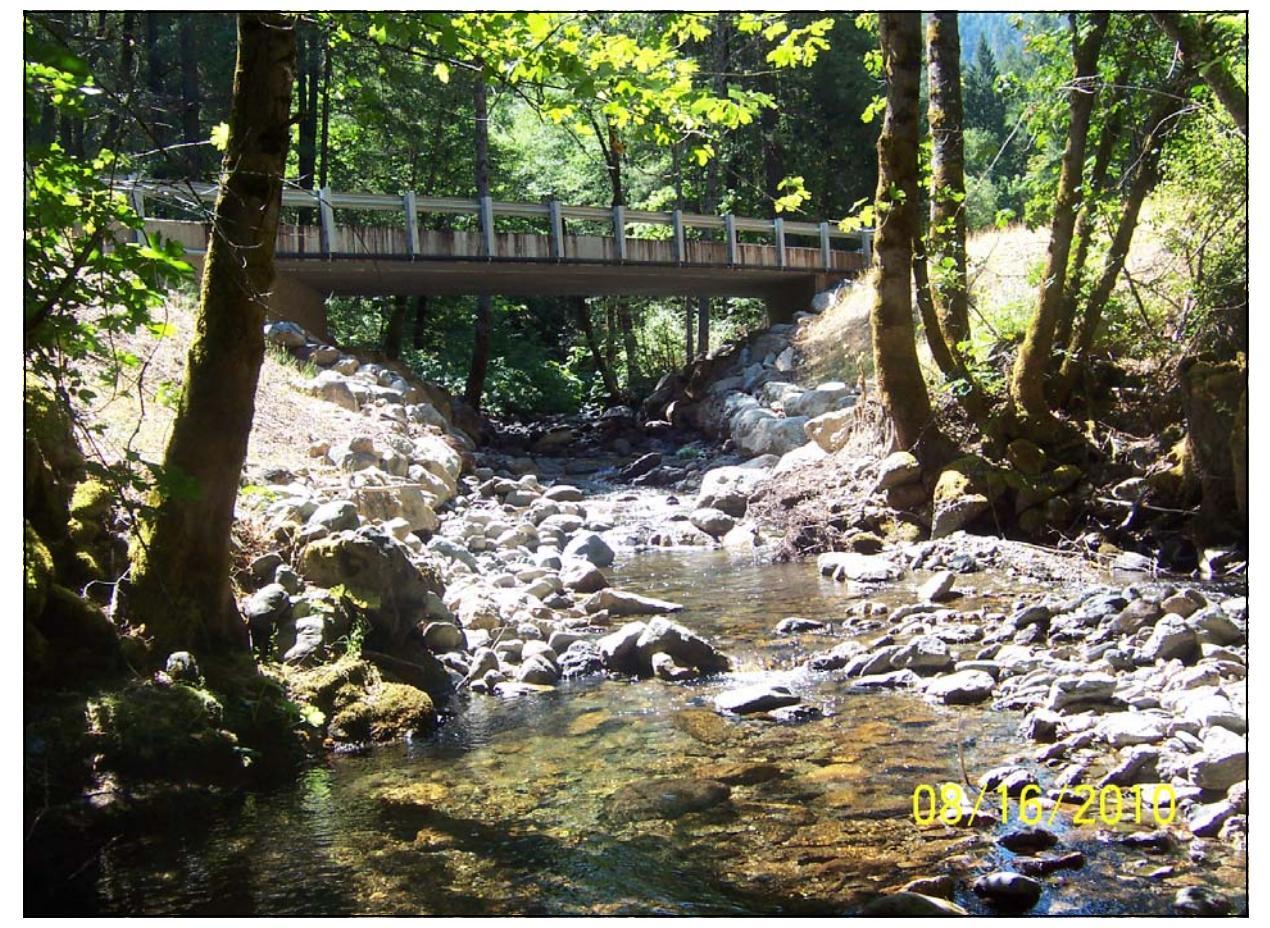
Top: Outlet of 10' tall x 14' wide x 90' long multiplate arch culvert on Whites Gulch Road (August 2006)

\*Note culvert perch on bedrock and alder trees on left & right banks Bottom: View upstream to constructed bridge (August 2010)

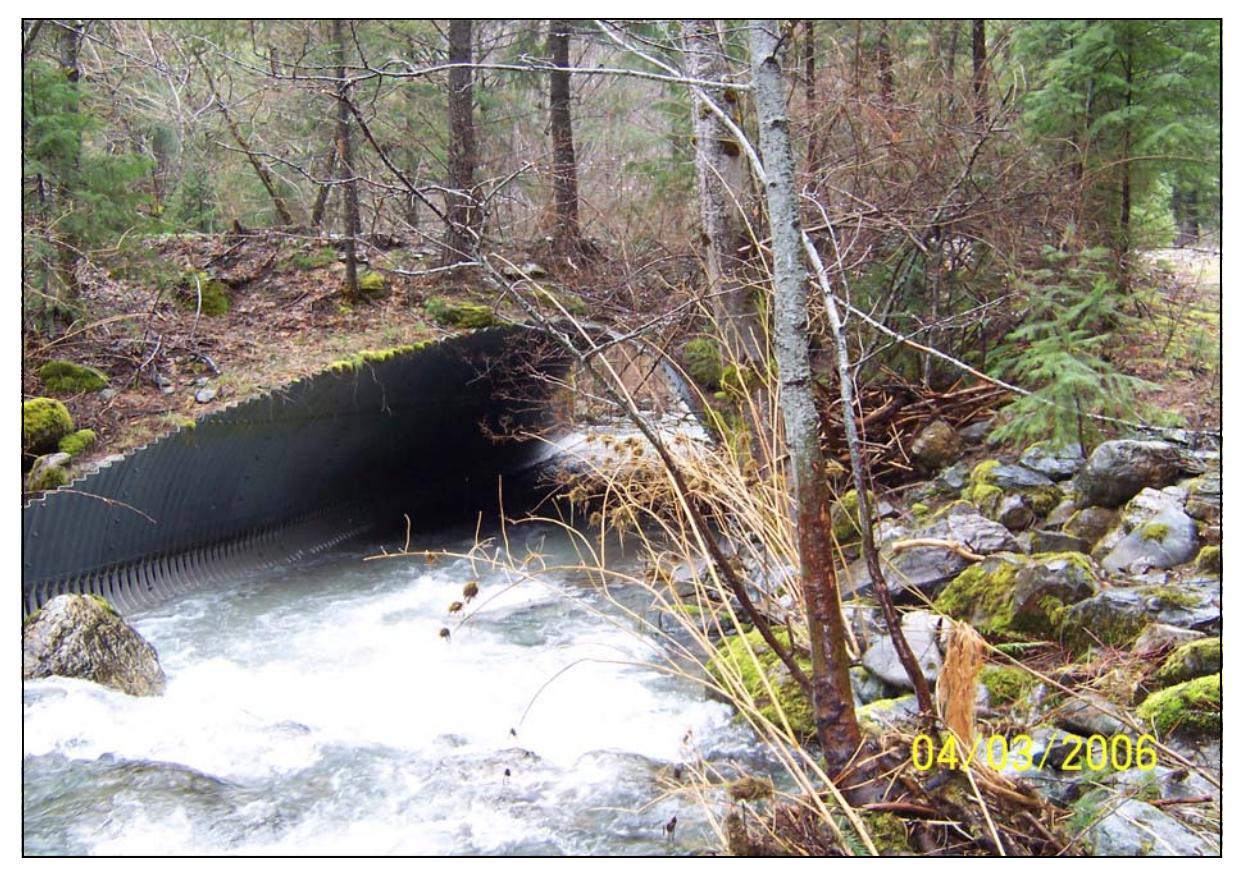
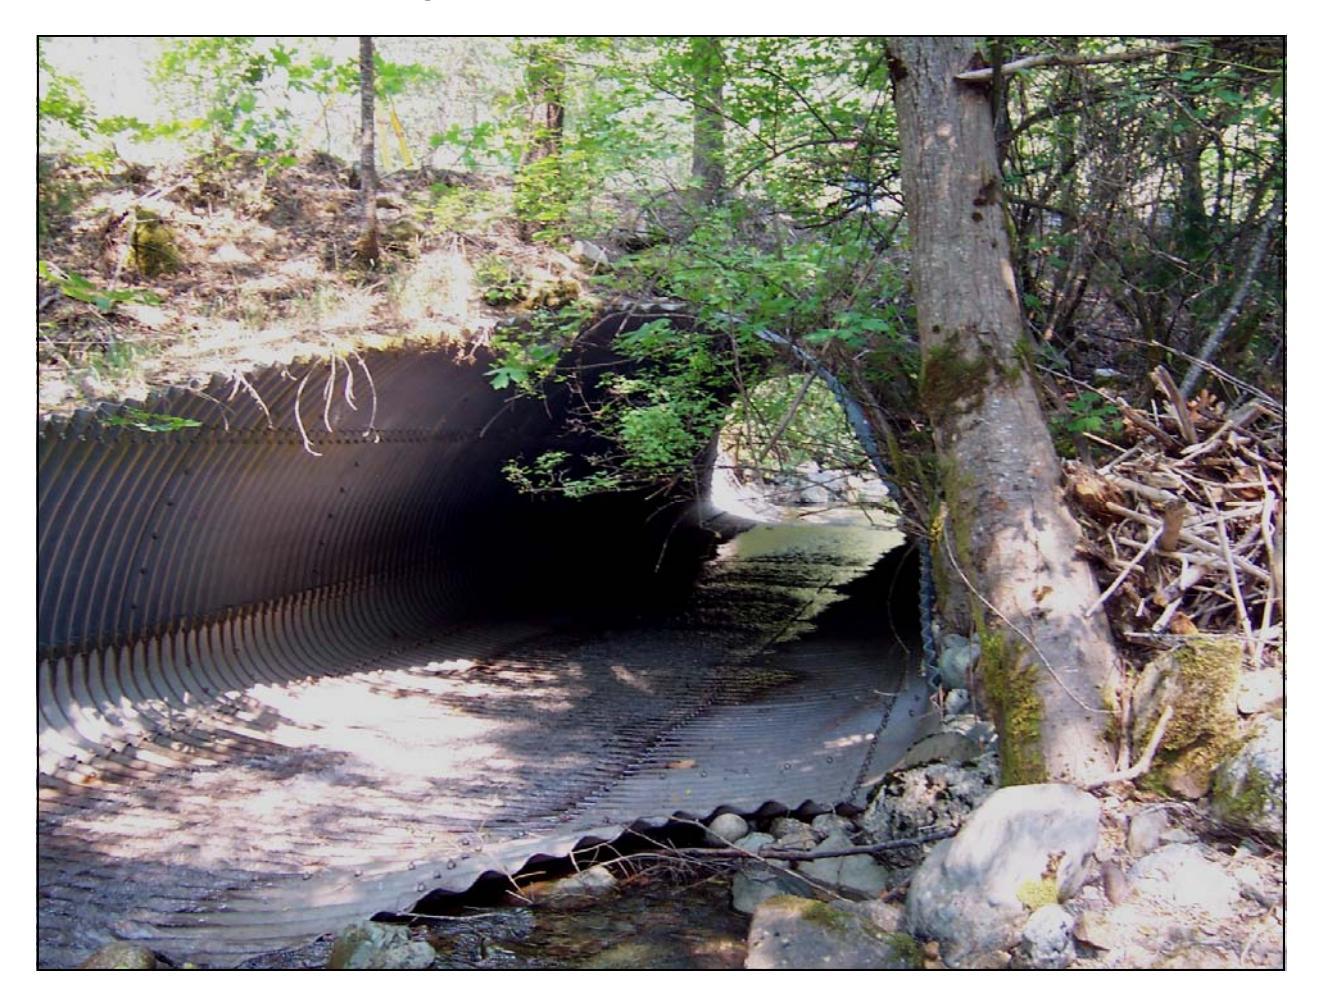
Top: Culvert inlet in April 2006 with moderate flows Bottom: Same view in August 2006 shows lack of depth & sub-structure flow

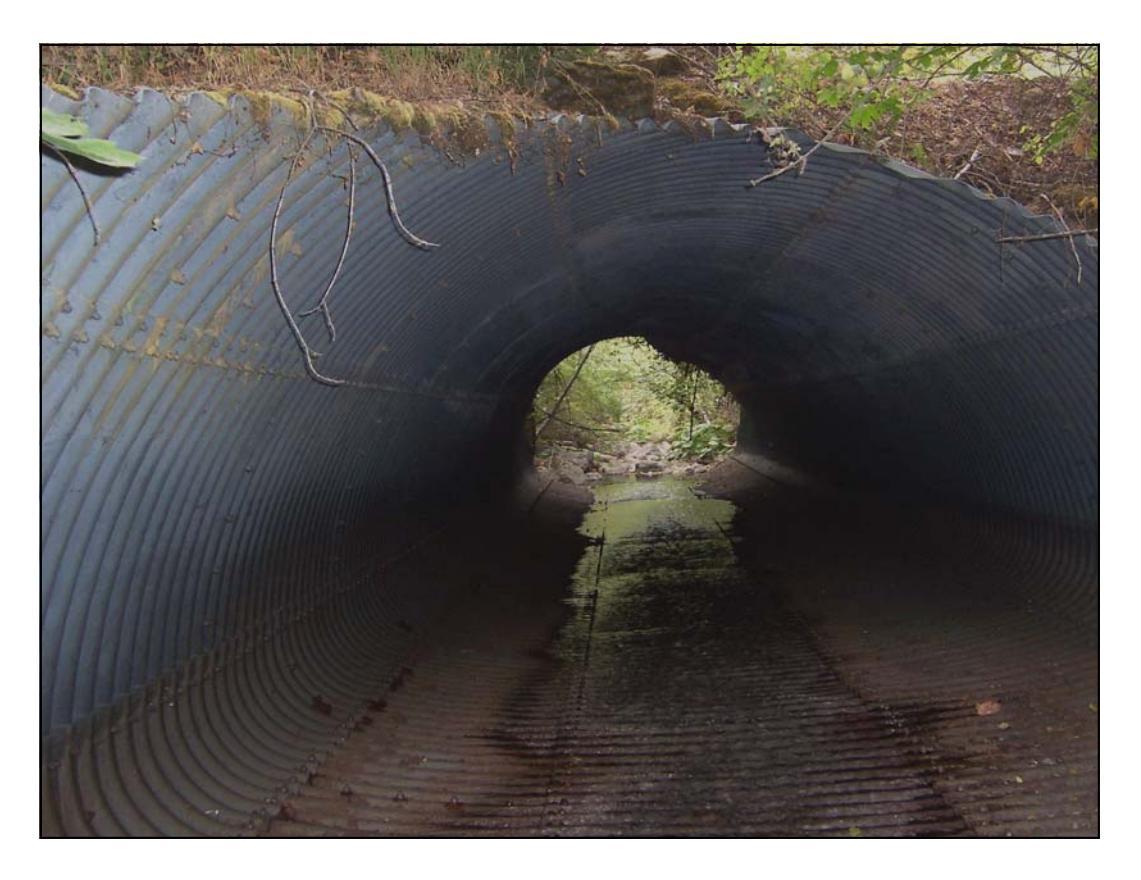
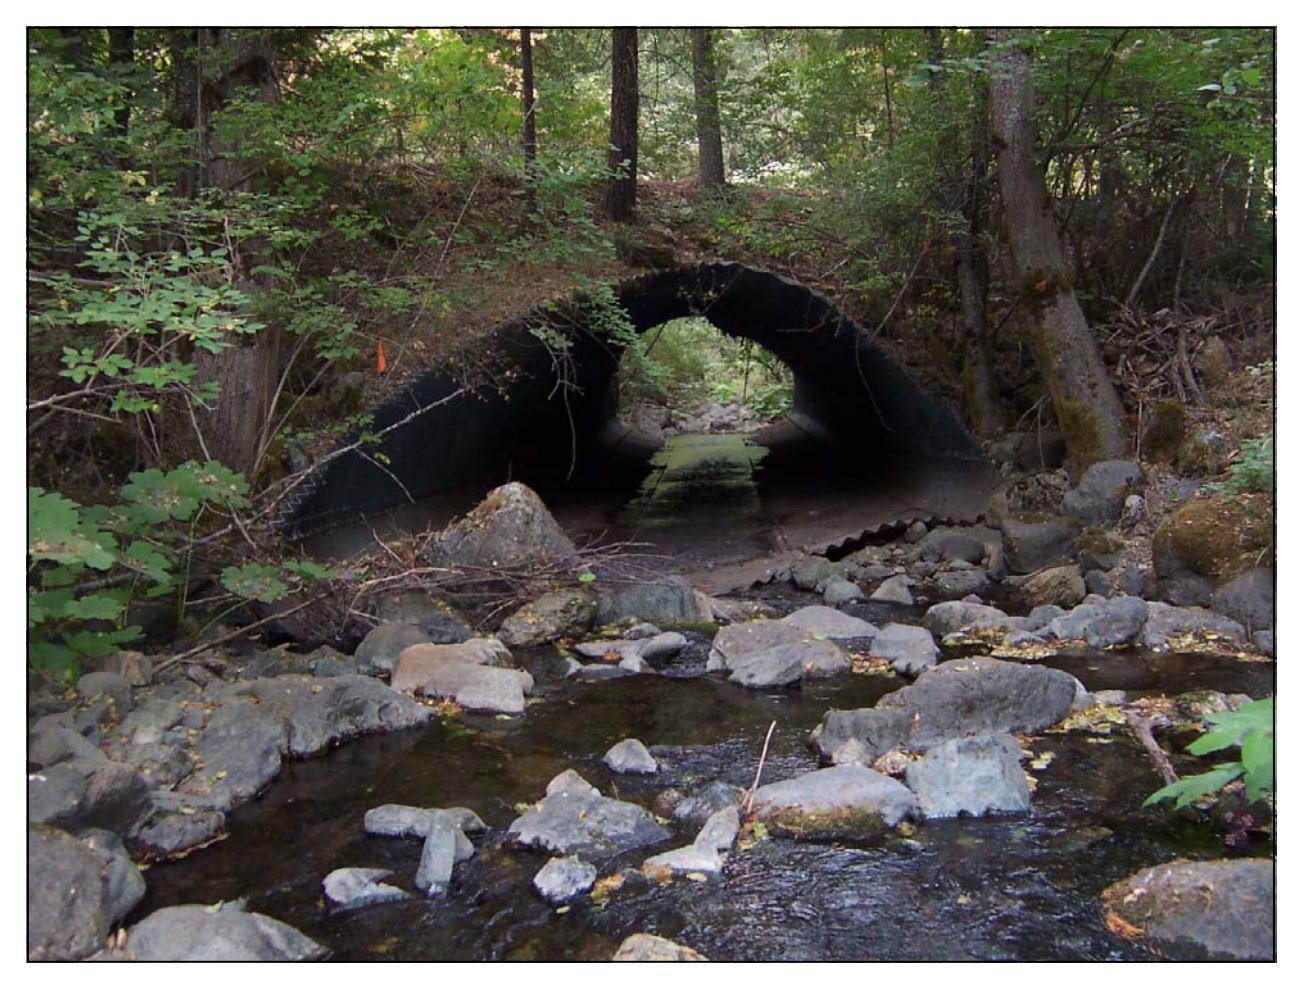
Top: Culvert interior in October 2008 Bottom: Inlet with large rock/streambed material typical of channel & subsurface

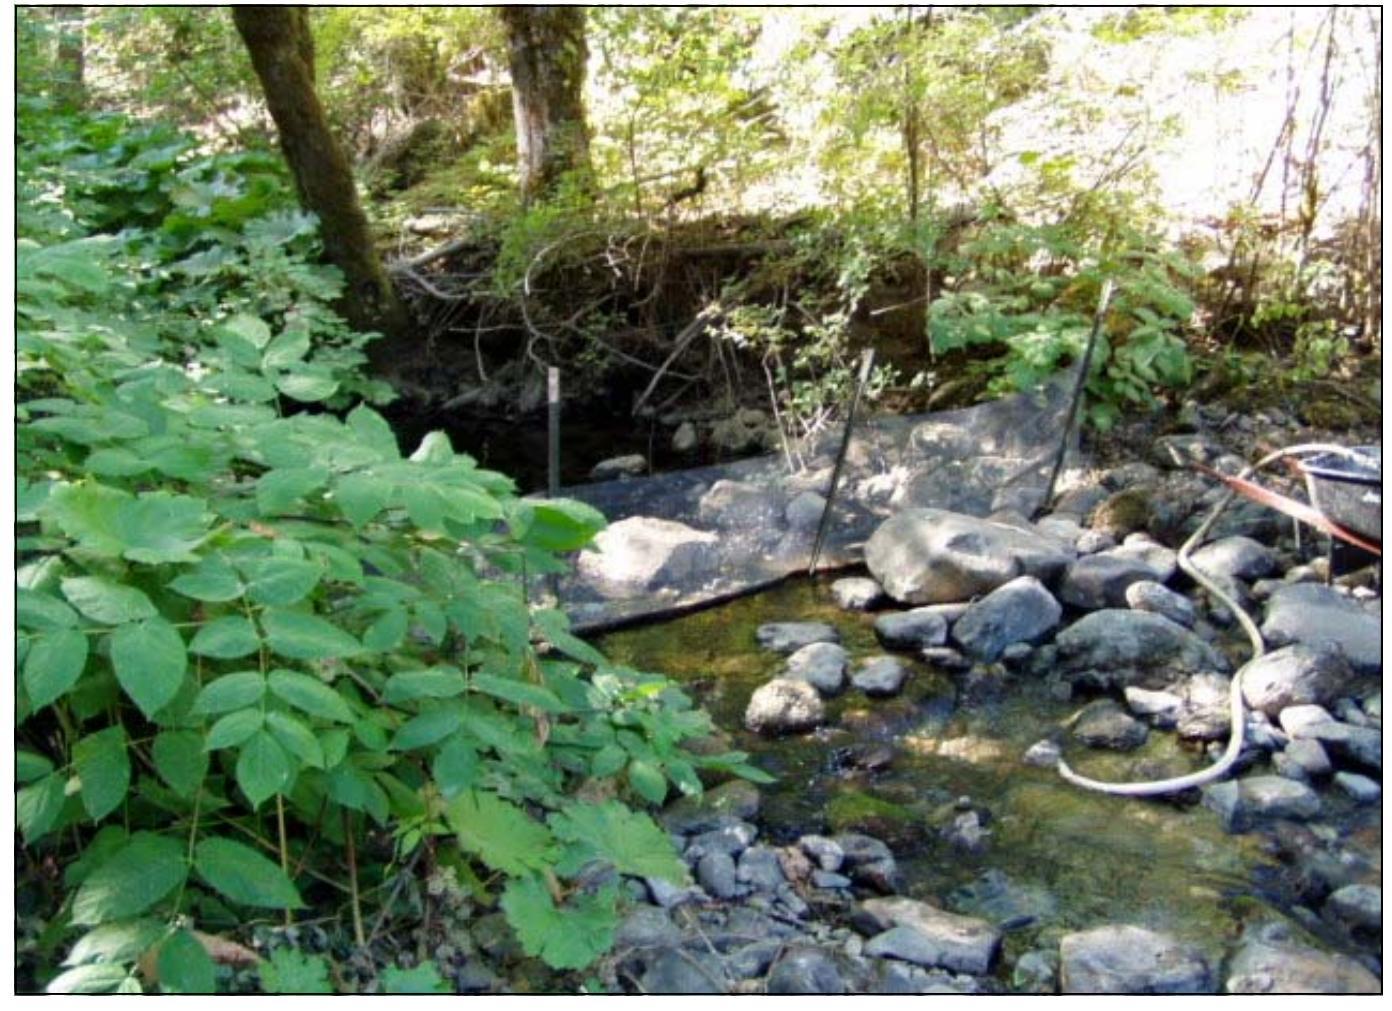
Top: Installed upstream fish screen with screened water pump just downstream to pump

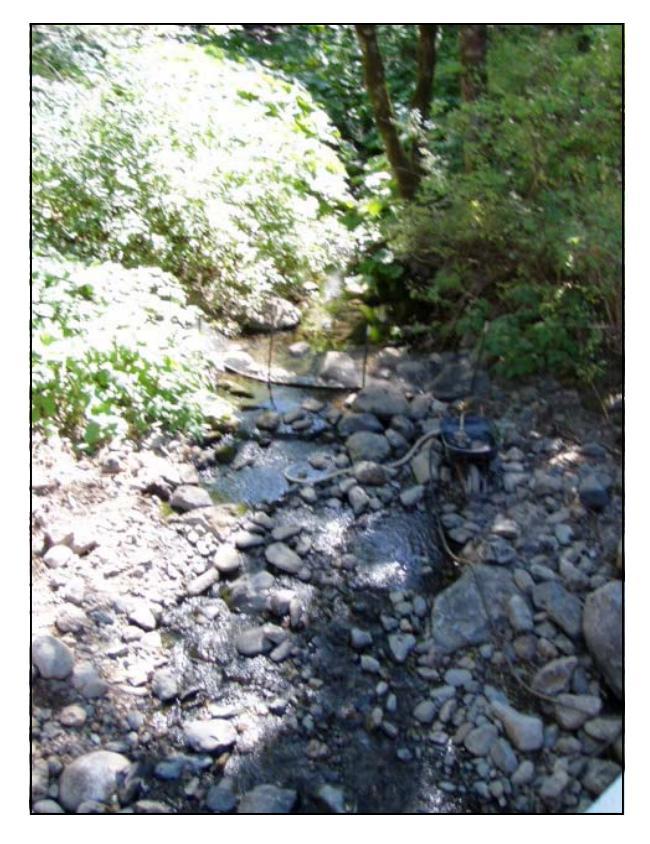
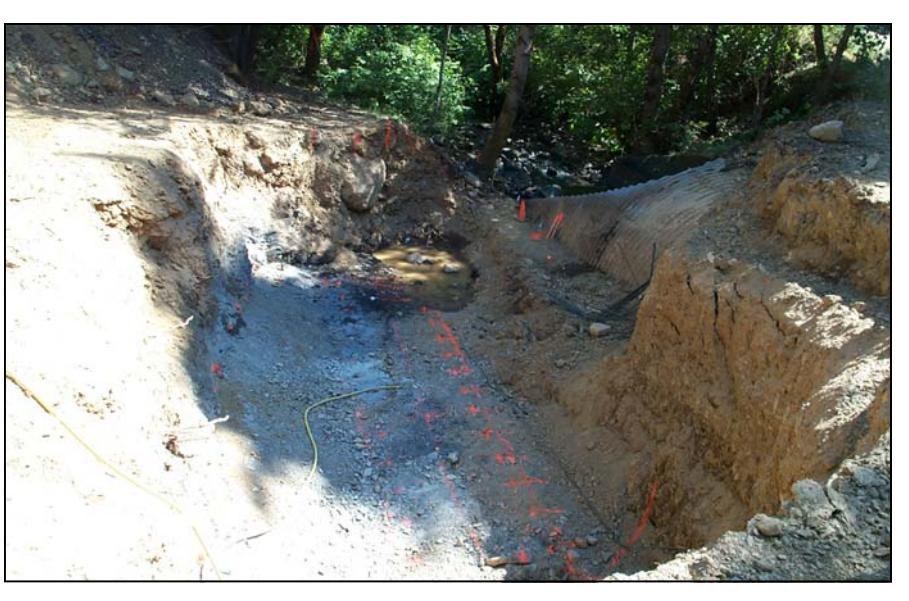
Left : Fish screen and pump Right: Excavation of Footing area for Abutment One

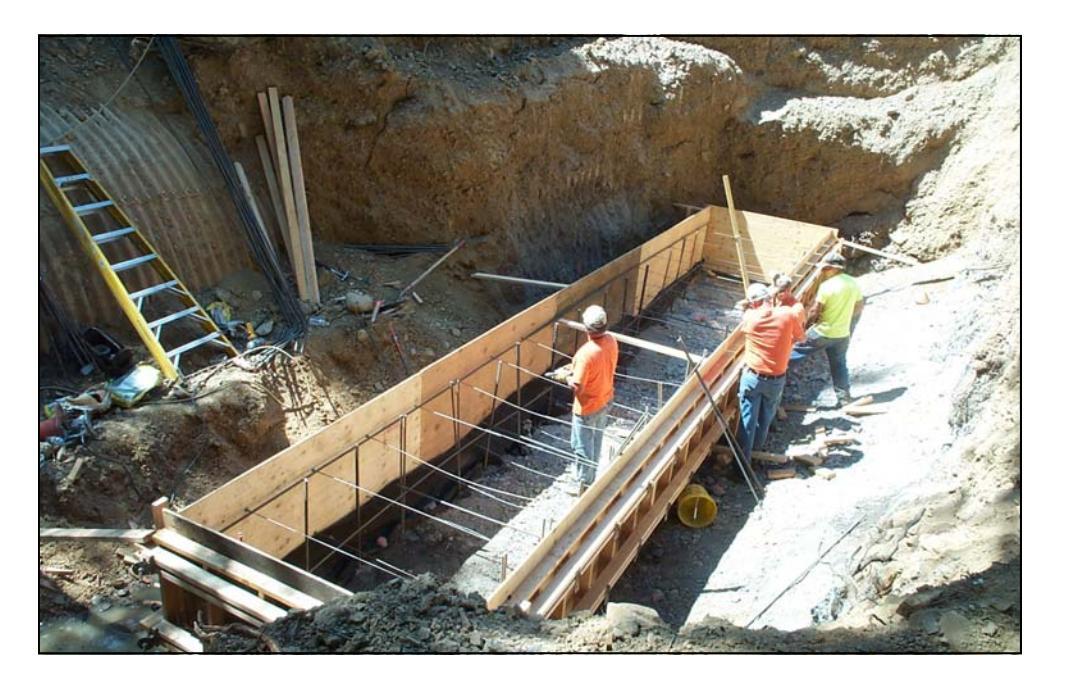
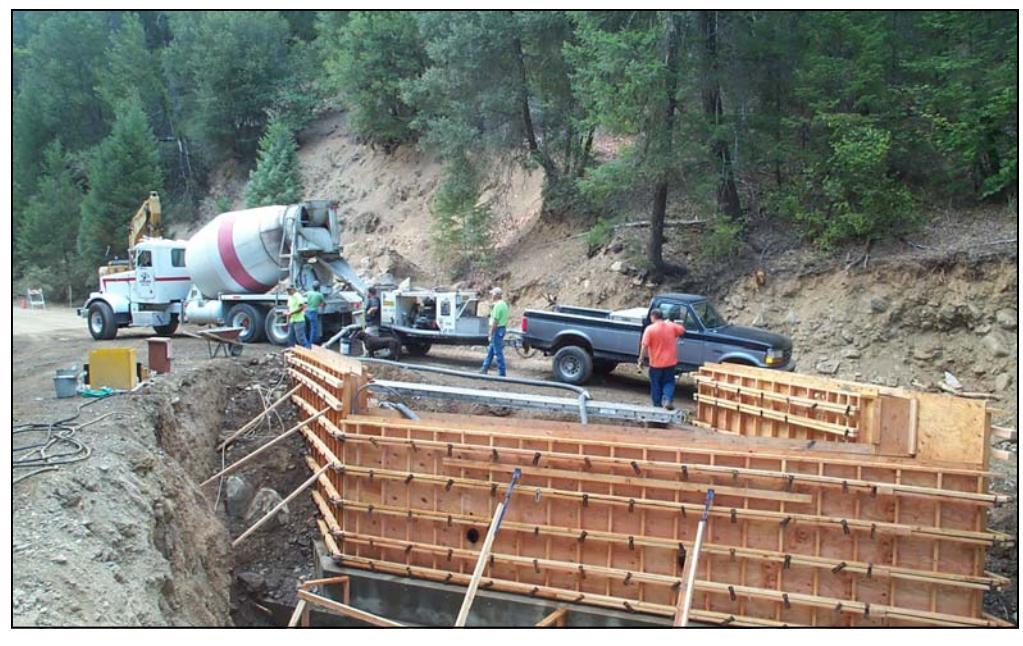
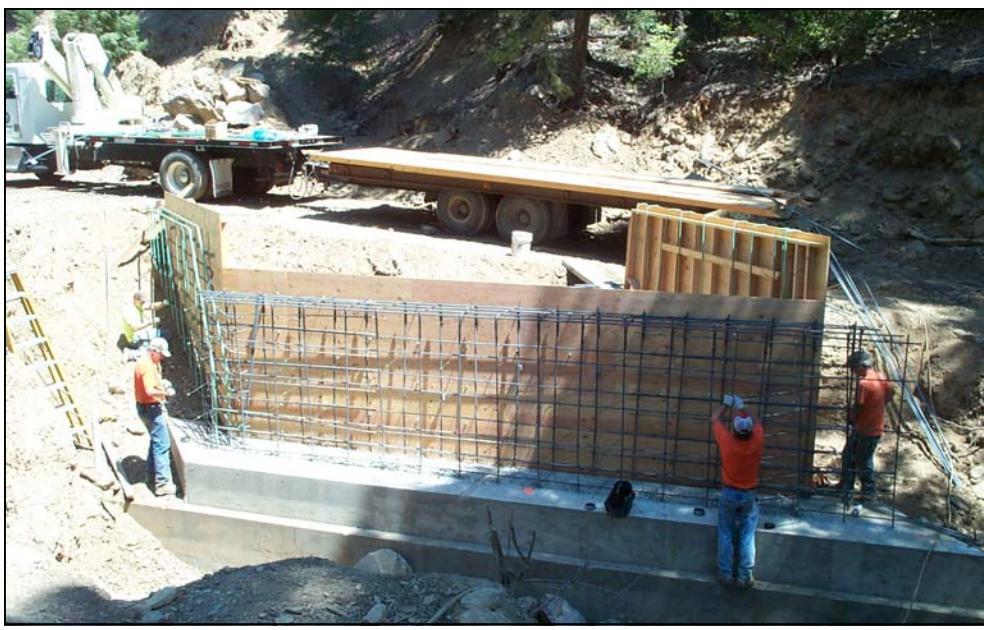
Top: Finishing the pour for Abutment One Footing

Center: Preparing to pour Abutment One after framing installed

Bottom: Footing and Framing for Abutment One with rebar ties

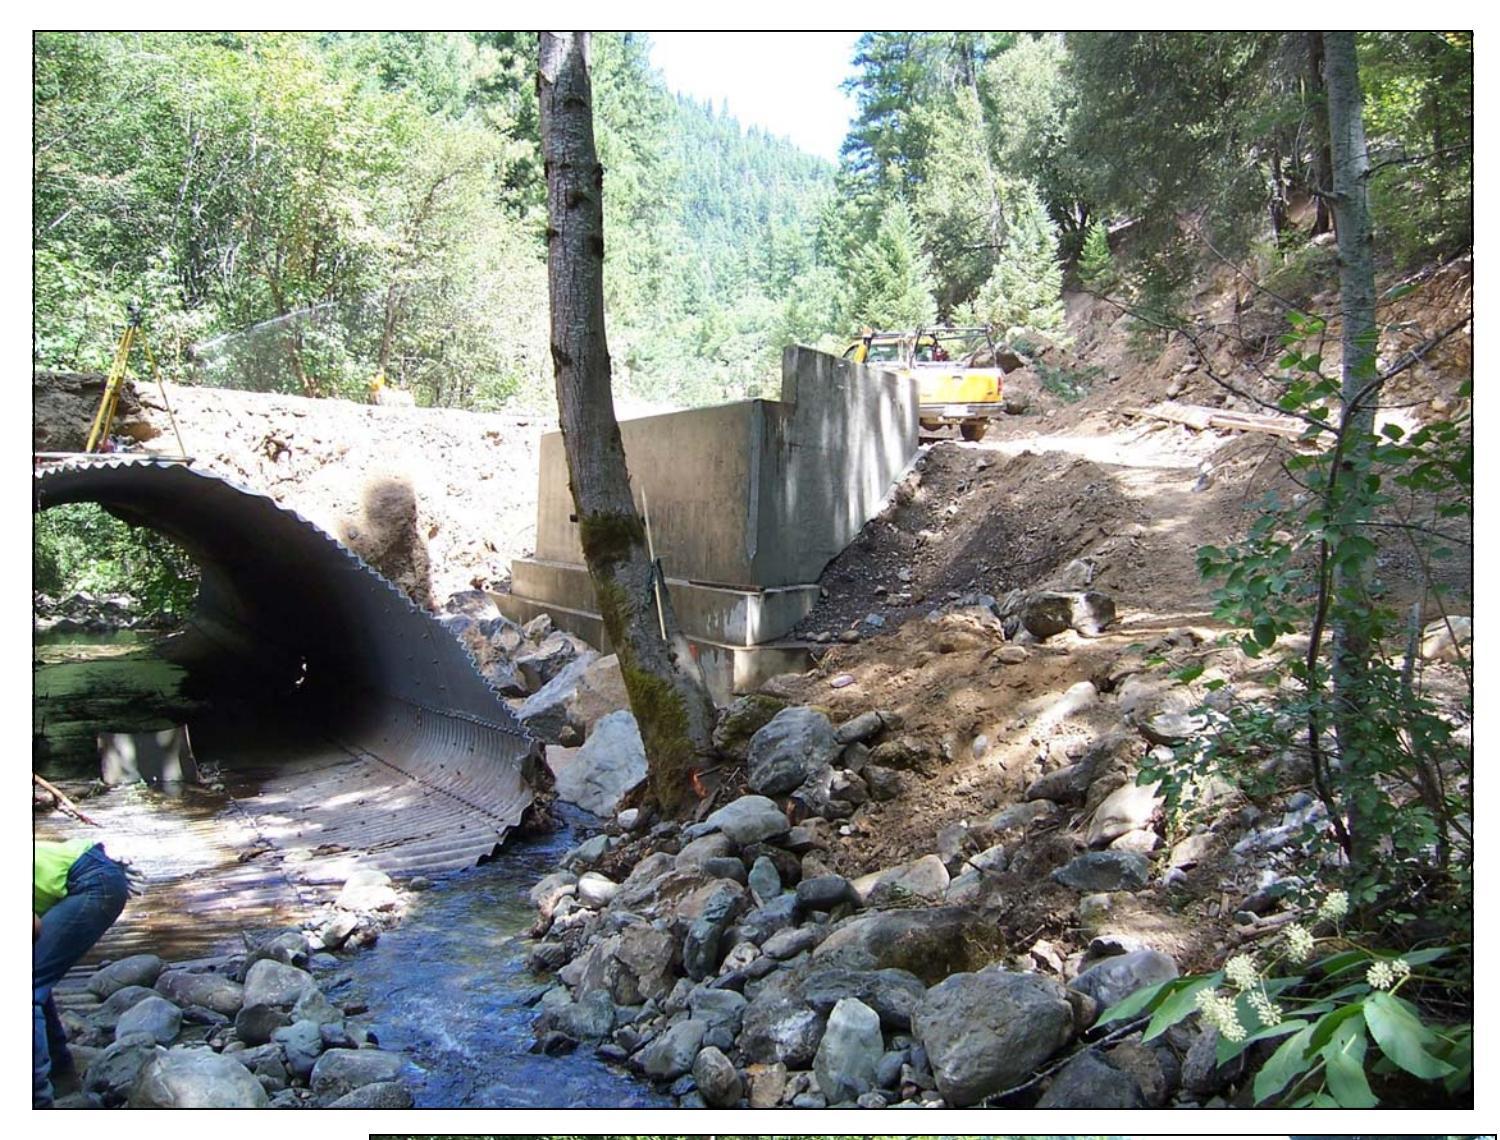
Top: Finished Abutment One & Footing

Bottom: Footing excavation for Abutment Two (note one-lane road at right & culvert as bypass)

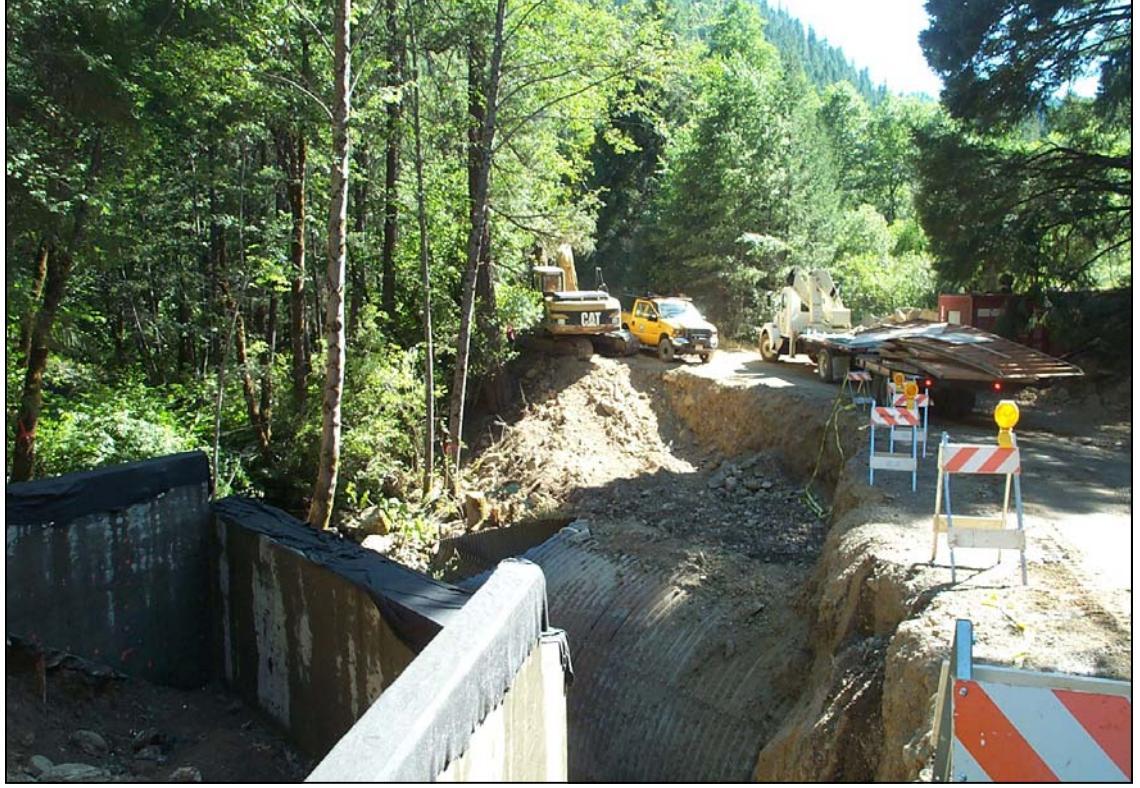
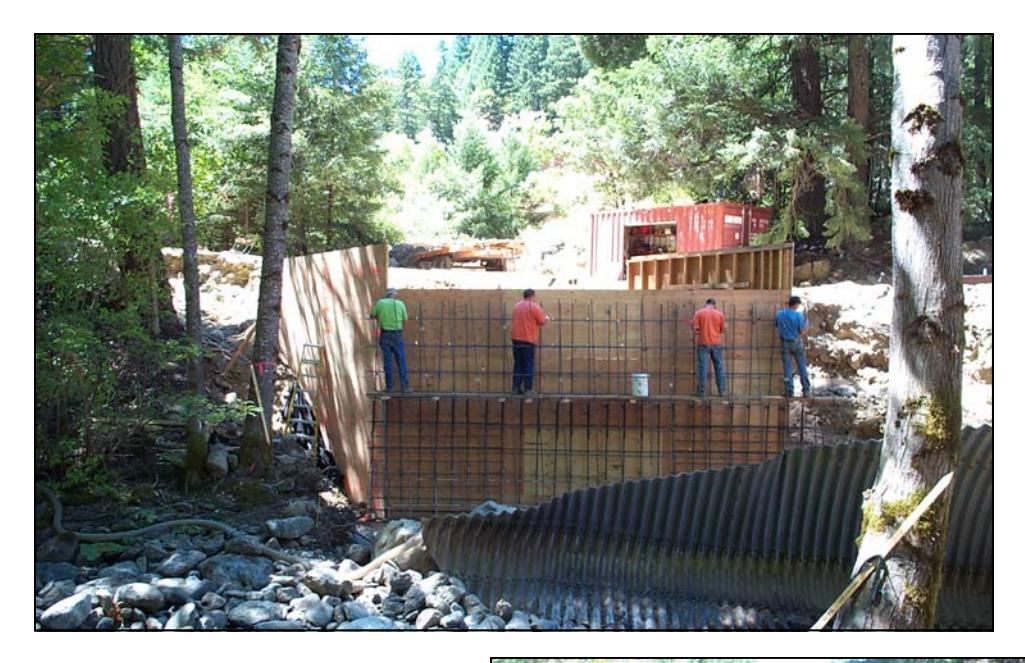
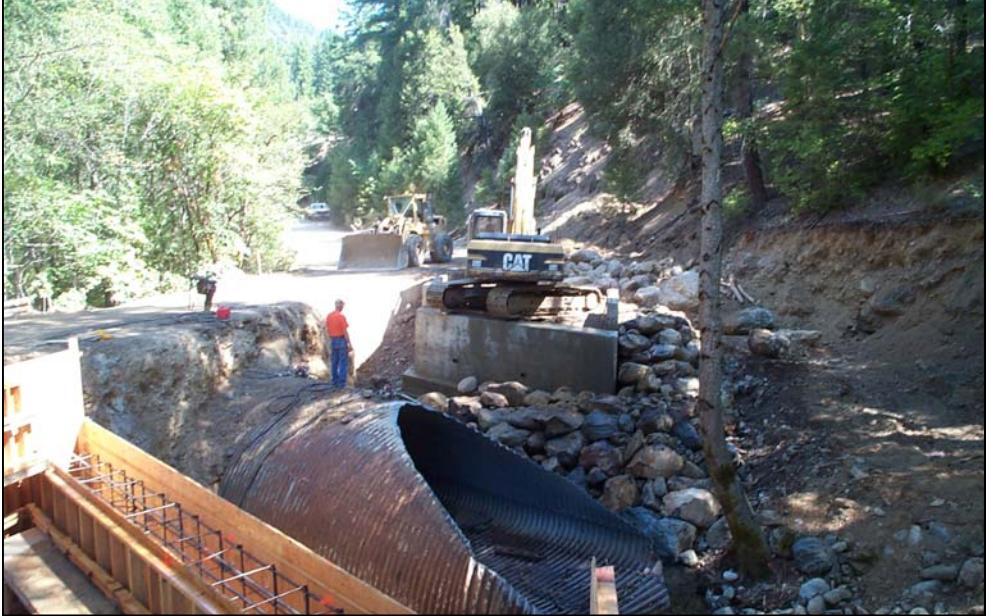
Top: Framing Abutment Two (note pump & culvert diversion

Center: View of Abutment One with rock slope protection installed

Bottom: Existing culvert as bypass with separation shown between Abutment Two pour area & active stream channel

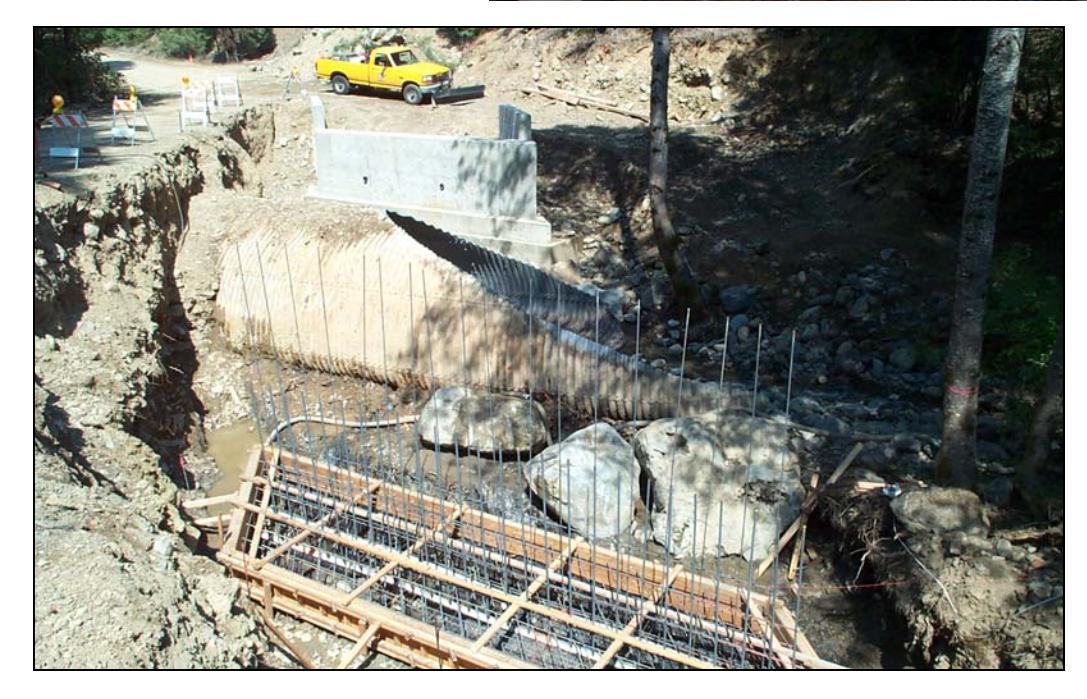
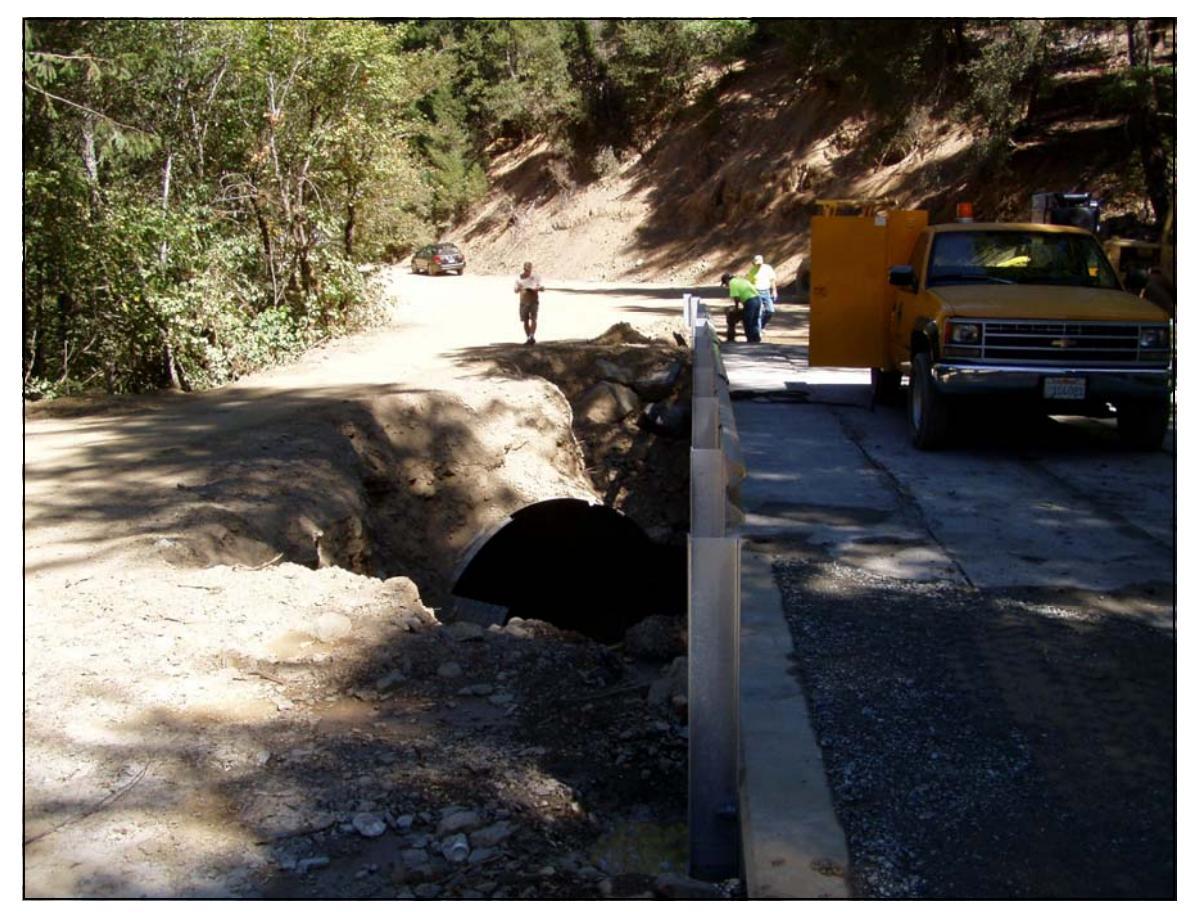
Top: One-lane road through project area (bridge decks set at right with culvert as diversion Bottom: Existing Culvert as bypass with bridge deck sections & one guardrail installed

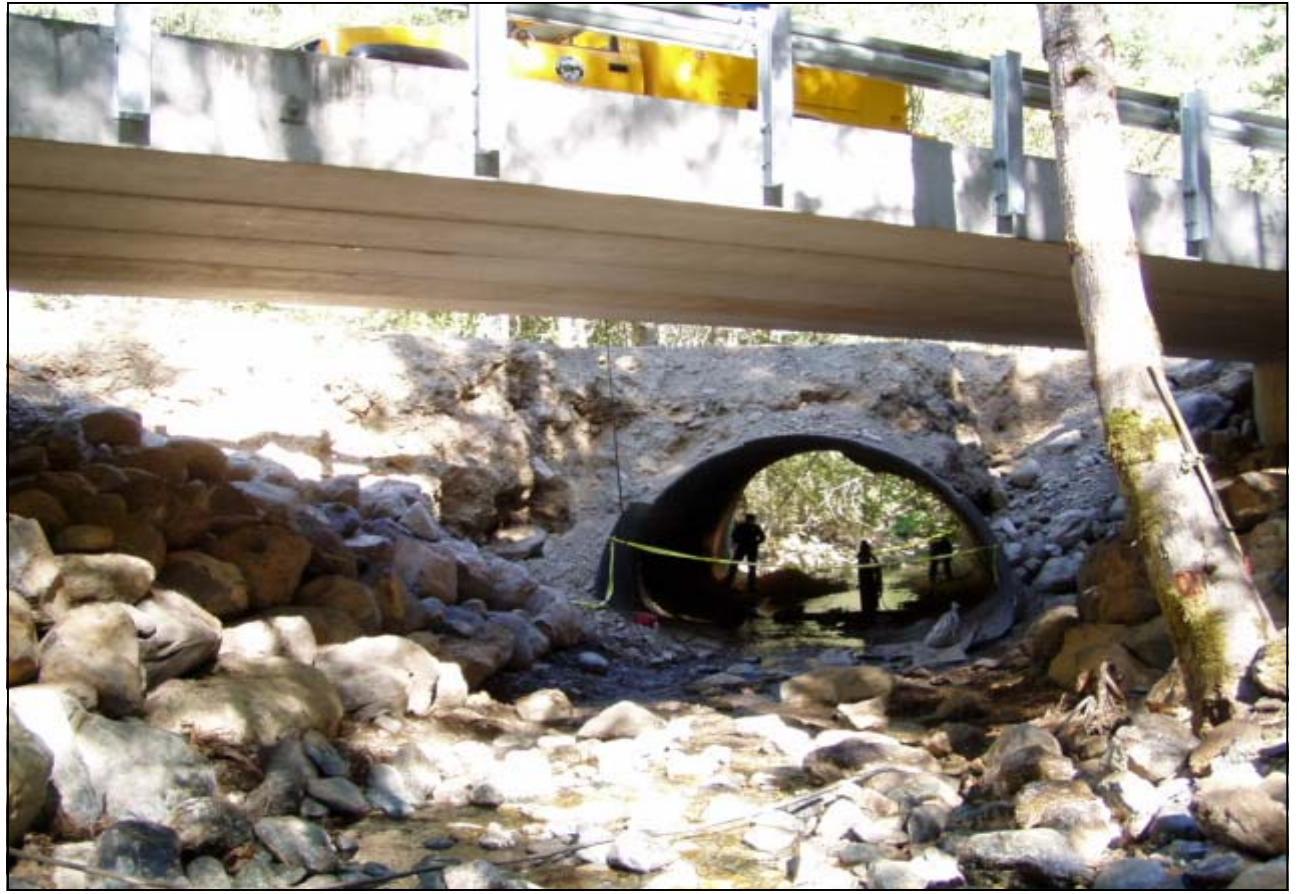
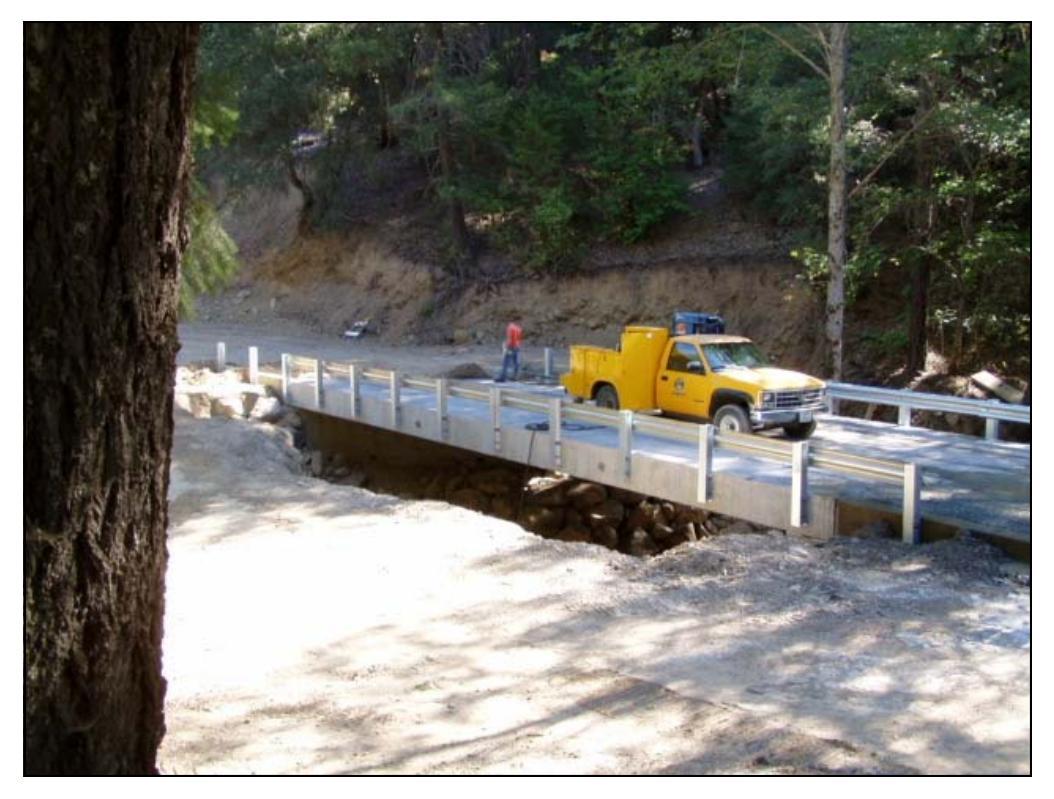
Top: Bridge decks set with guardrails installed Bottom: Approach compacted & rocked with one-lane road still at right

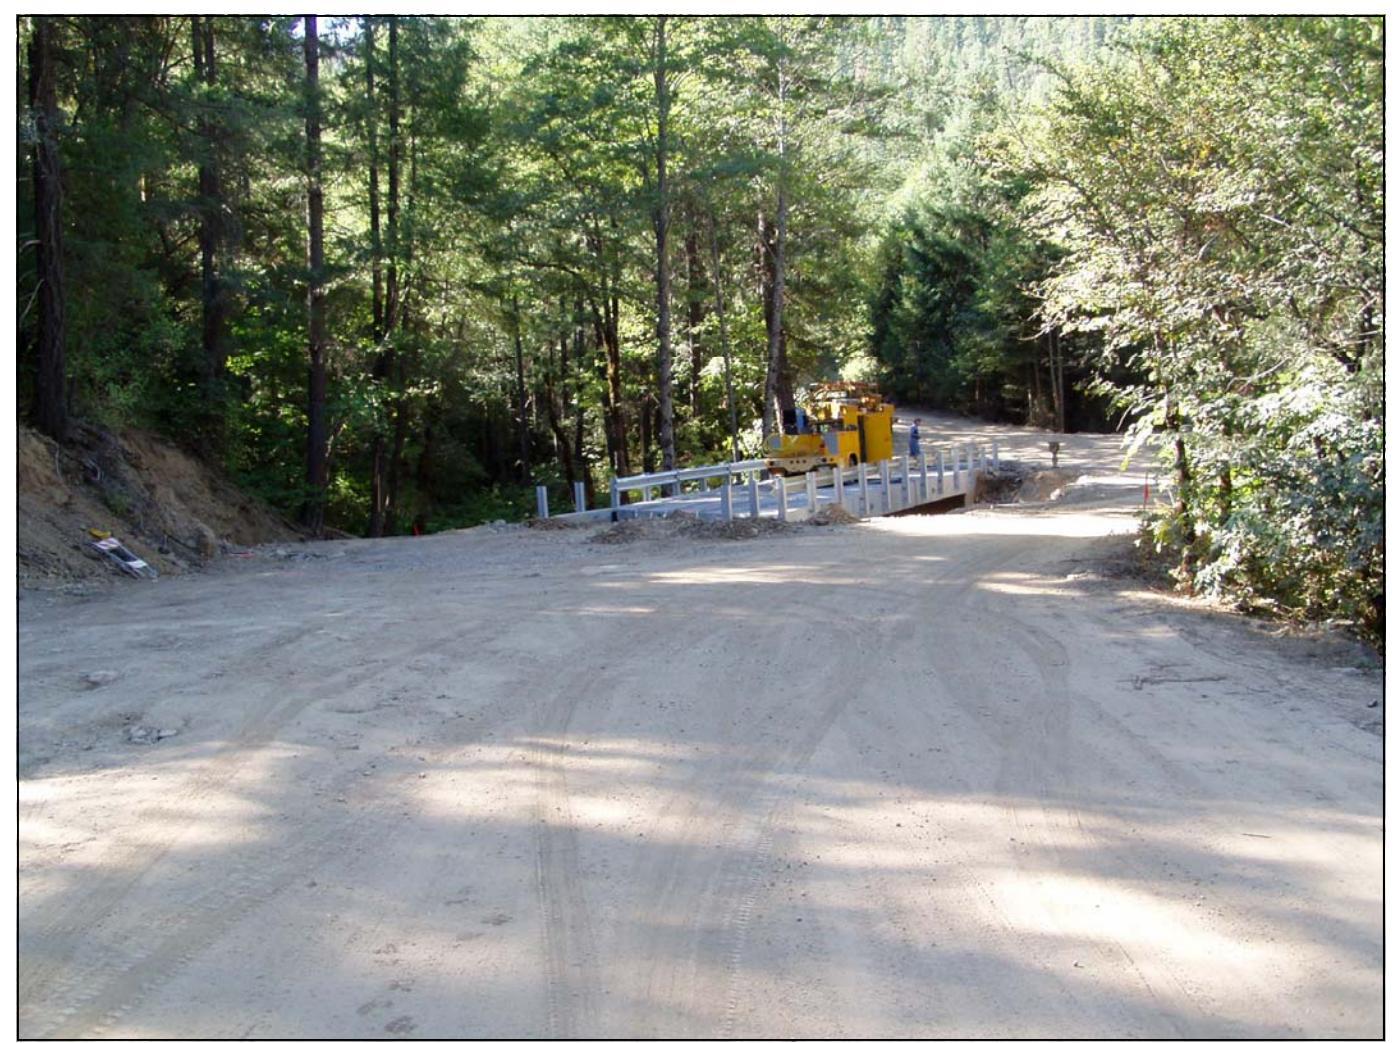
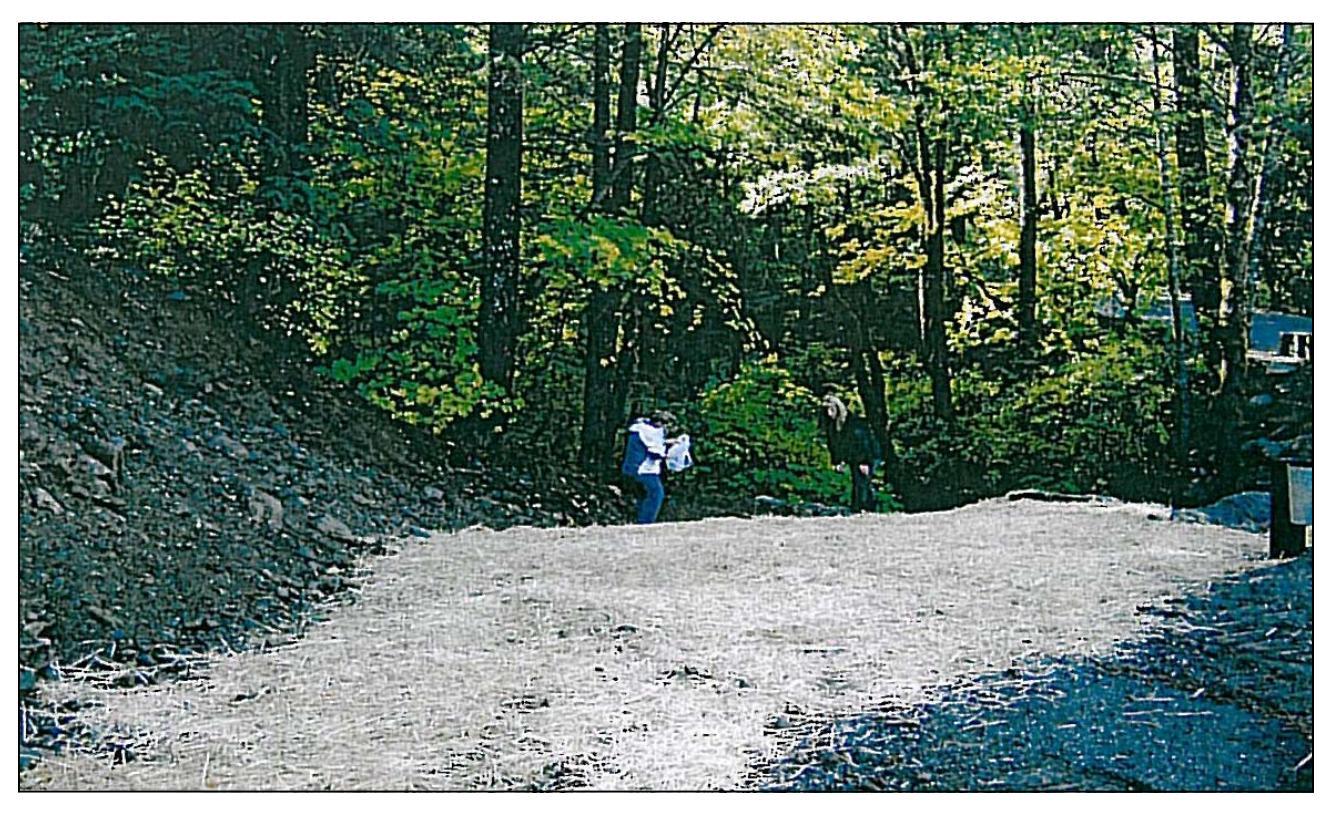
Top: Revegetating with native grass seed & straw mulch (November 2009) Bottom: Looking upstream at bridge prior to revegetation efforts in November 2009

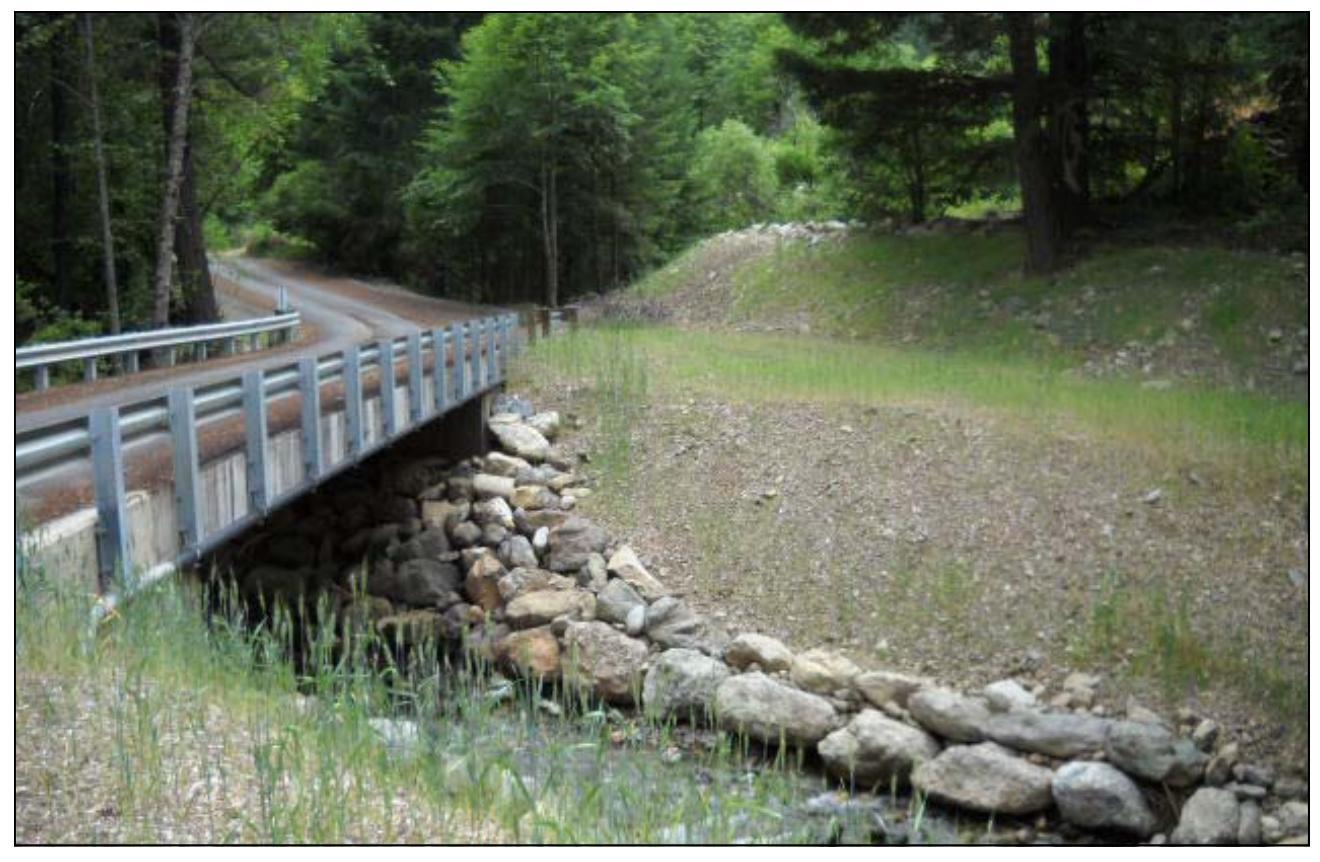
Old roadway approaches excavated and revegetated. Upstream is to the left: note road realignment in upper left portion of photo Native grass seed donated by the Klamath National Forest: Conifer & Riparian tree species to be planted in Fall 2010
