## **FINAL REPORT** Whites Gulch Migration Barrier Removal Project

United States Department of the Interior - Bureau of Reclamation **Klamath River Restoration Program** Grant Agreement No. R10AP20673

## Attachment 2: Project Photolog Whites Gulch Migration Barrier Removal Project

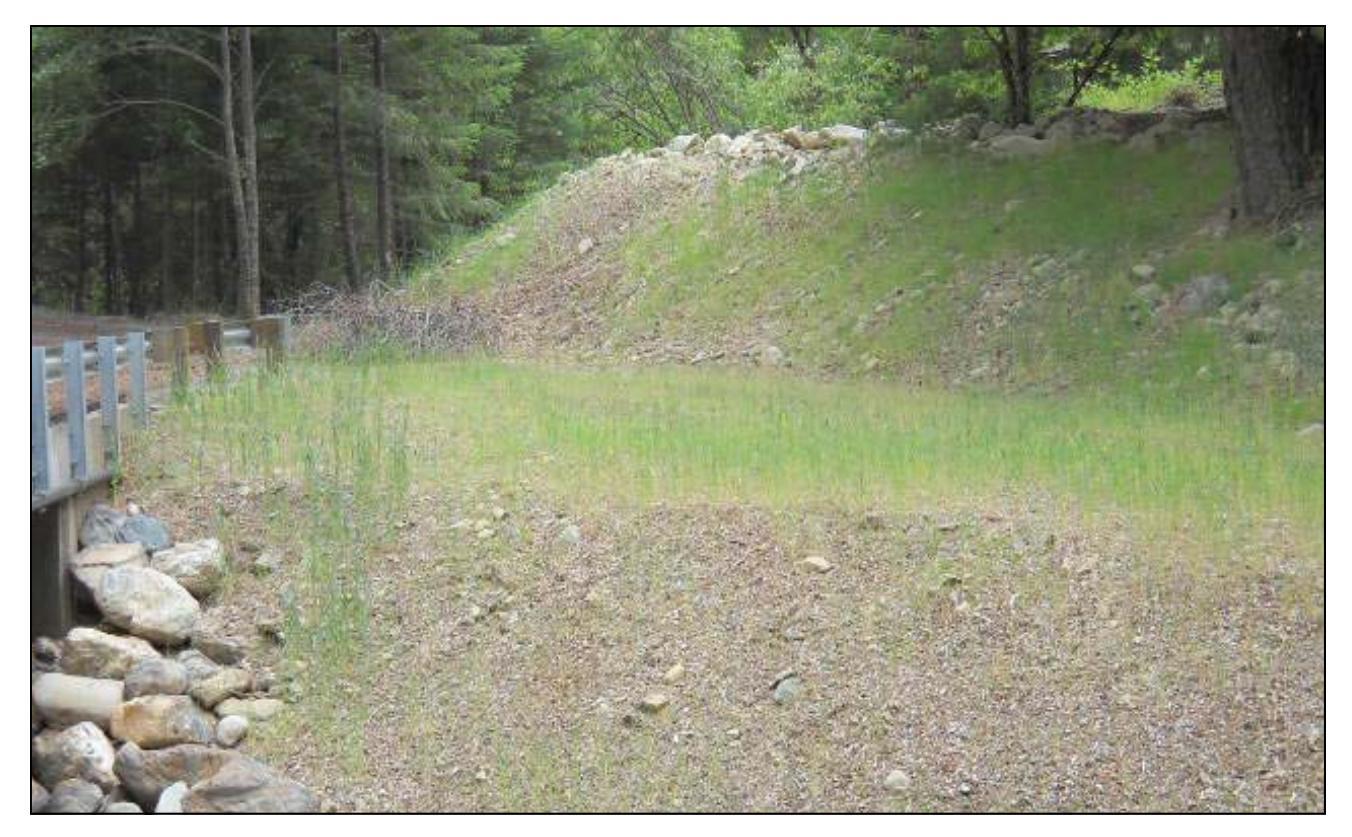
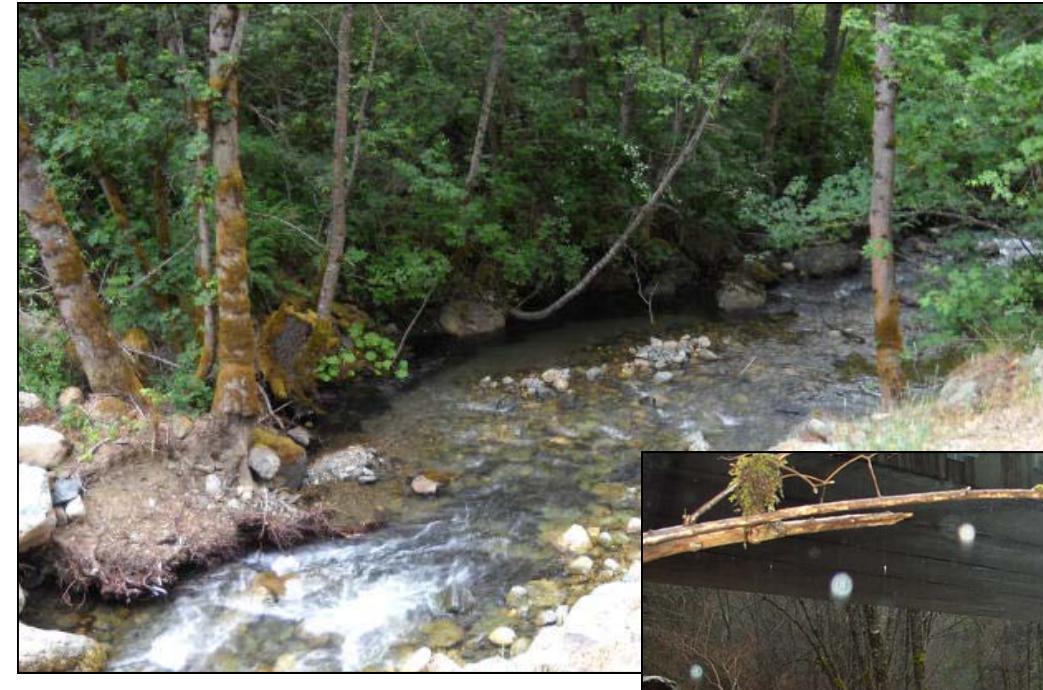
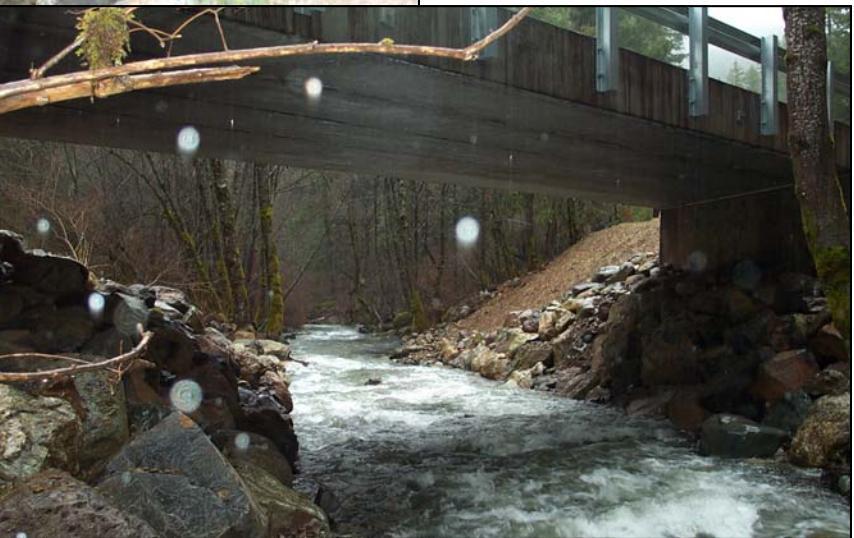
Top: Channel adjustment through the historic outlet pool area

Center & Bottom: January 2010 flows under the bridge

Pre-project longitudinal and thalweg surveys were completed in 2006. A postproject longitudinal survey will not be completed unless Siskiyou County engineering staff start to notice that there is a potential barrier forming downstream of the bridge. Current conditions show that the downstream outlet pool is filling in and the channel is adjusting downstream of the bridge to a more natural grade. There are several small jump pools and the reach from 25 feet downstream of the bridge; up through the bridge inlet can best be characterized as a low gradient riffle. Siskiyou DPW staff continues to monitor the channel adjustment as well as the revegetation success.
